International Space Station (ISS) Soyuz Vehicle Descent Module Evaluation of Thermal Protection System (TPS) Penetration Characteristics

Hypervelocity Impact Technology Group

February 2013

**International Space Station (ISS) Soyuz Vehicle
Descent Module Evaluation of Thermal Protection
System (TPS) Penetration Characteristics**

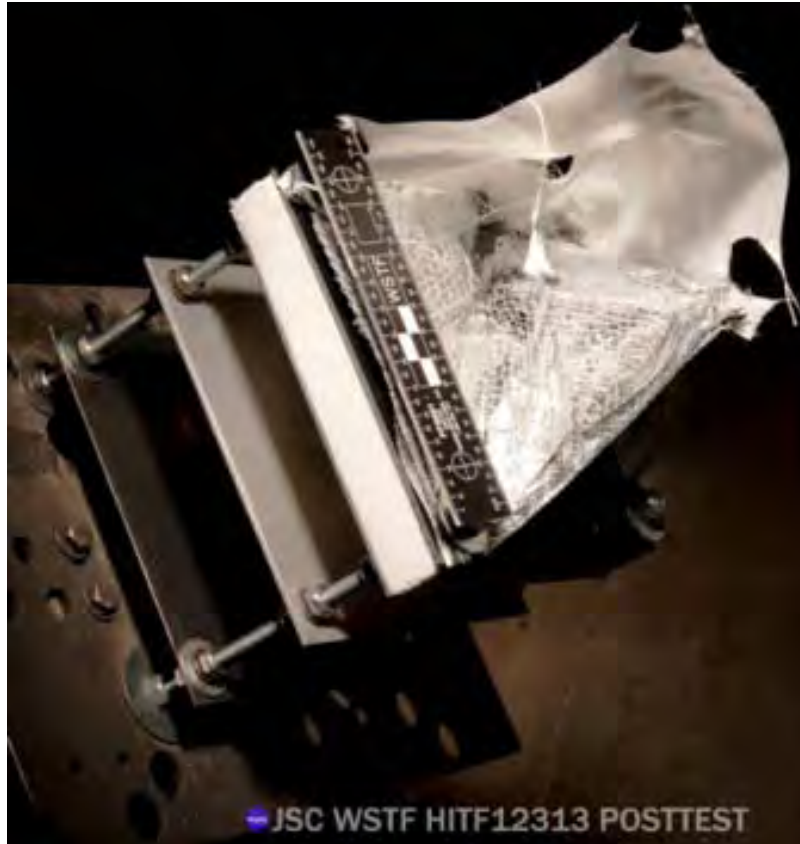
Figure 543 Overall View of Sample in the Target Tank (post-test)

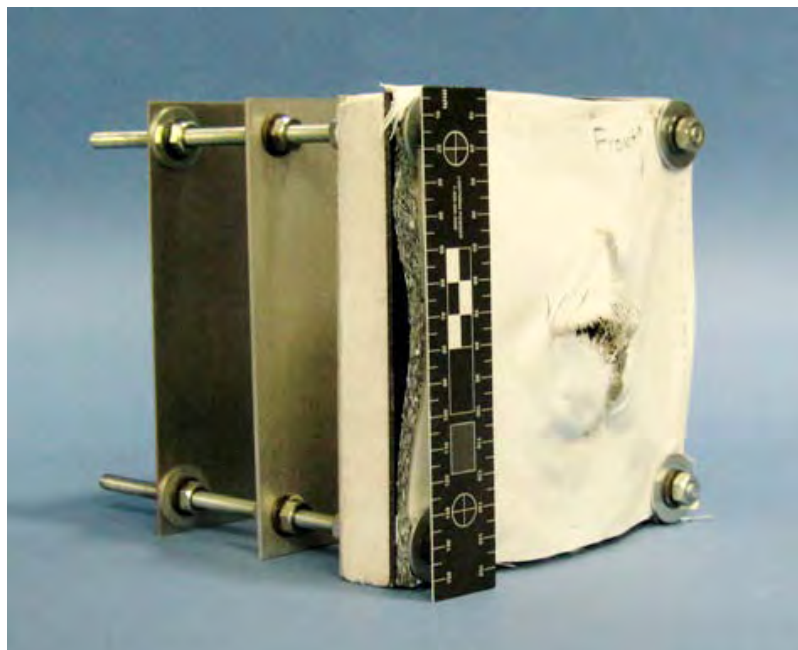
Figure 544 Overall Front Oblique View of Sample (scale in 5mm increments)

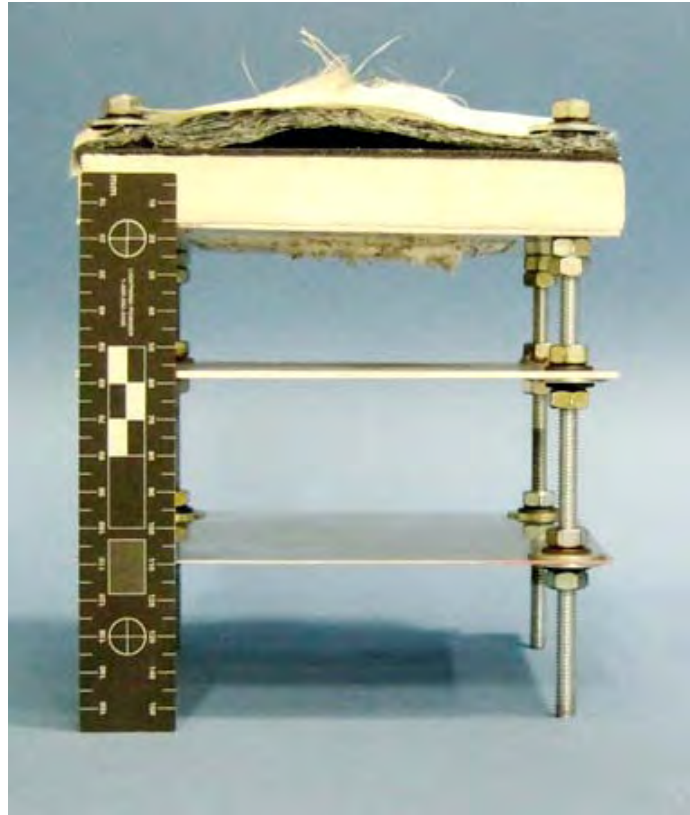
Figure 545 Overall Side View of Sample (scale in 5mm increments)

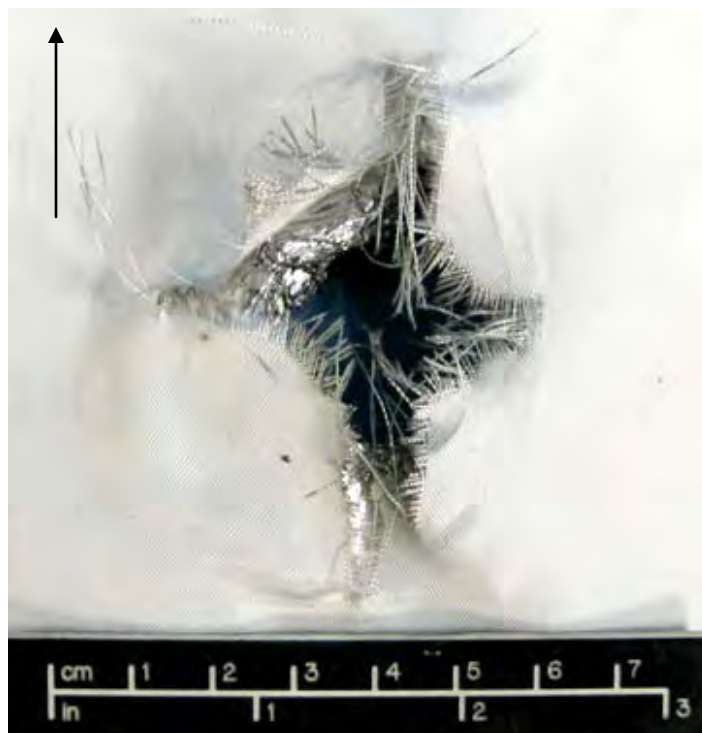
Figure 547 Close-up View of Damage to Front of MLI (scale in 5mm increments / black arrow indicates flight path of projectile)

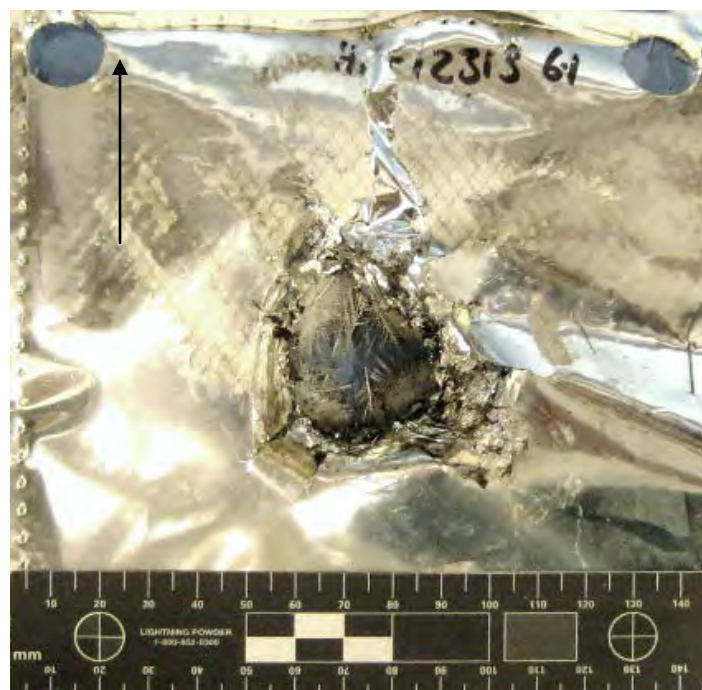
Figure 548 Overall View of Damage to Back Side of MLI (scale in 5mm increments / black arrow indicates flight path of projectile)

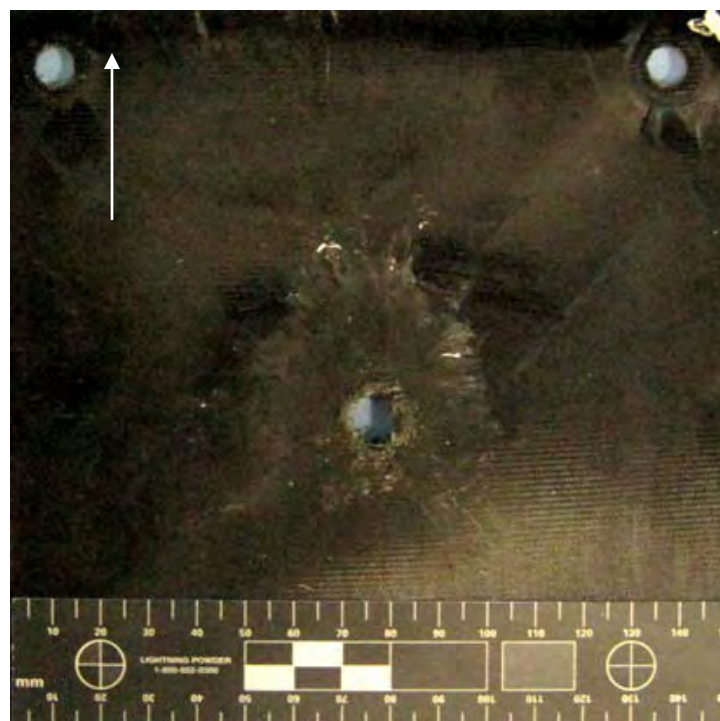
Figure 550 Overall View of Damage to Front of NP 504 Substrate (scale in 5mm increments / white arrow indicates flight path of projectile)

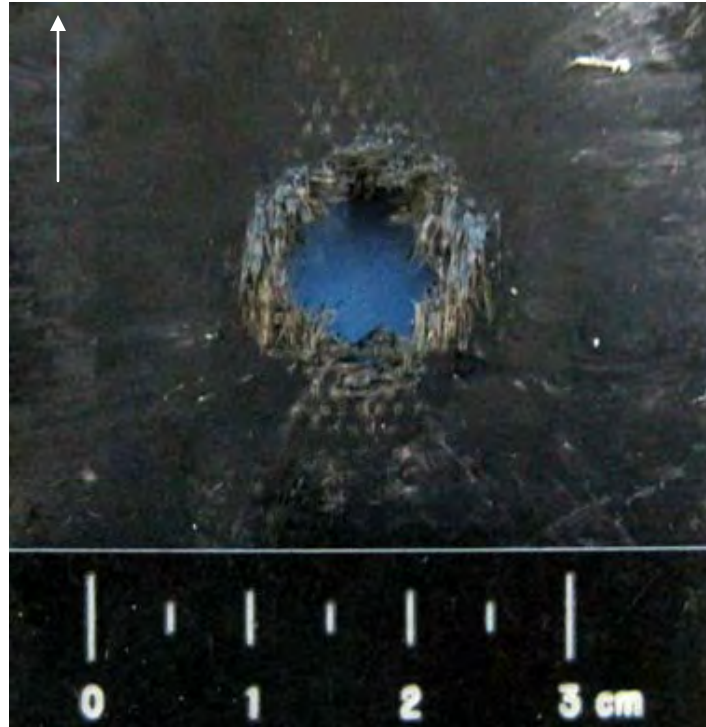
Figure 551 Close-up View of Damage to Front of NP 504 Substrate (scale in 5mm increments / white arrow indicates flight path of projectile)

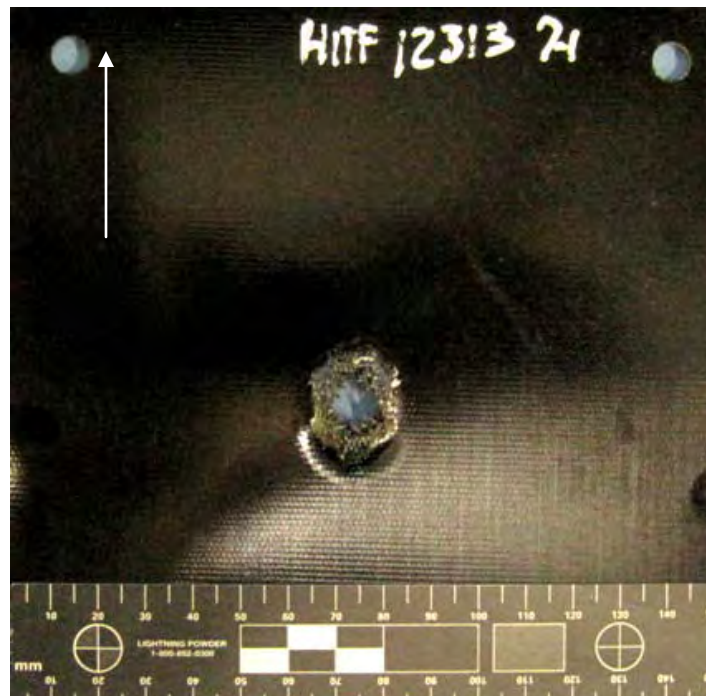
Figure 552 Overall View of Damage to Back Side of NP 504 Substrate (scale in 5mm increments / white arrow indicates flight path of projectile)

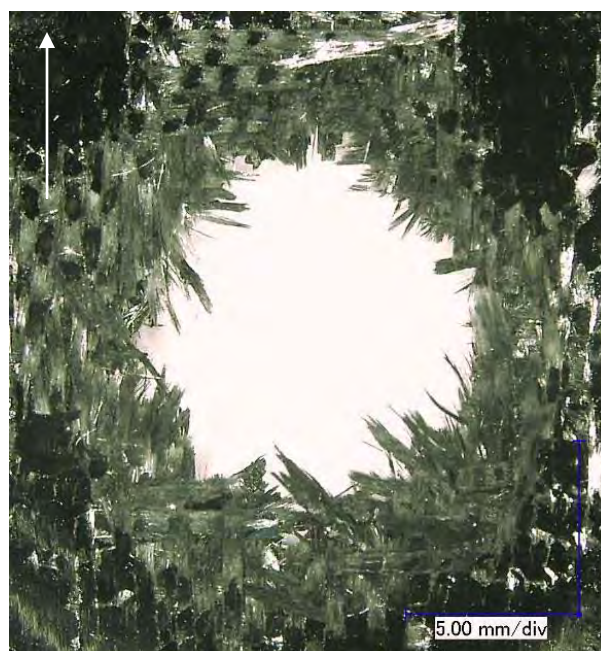
Figure 554 Close-up View of Most Significant Damage to Back Side of NP 504 Substrate (black arrow indicates flight path of projectile / damage within red circle in Figure 584)

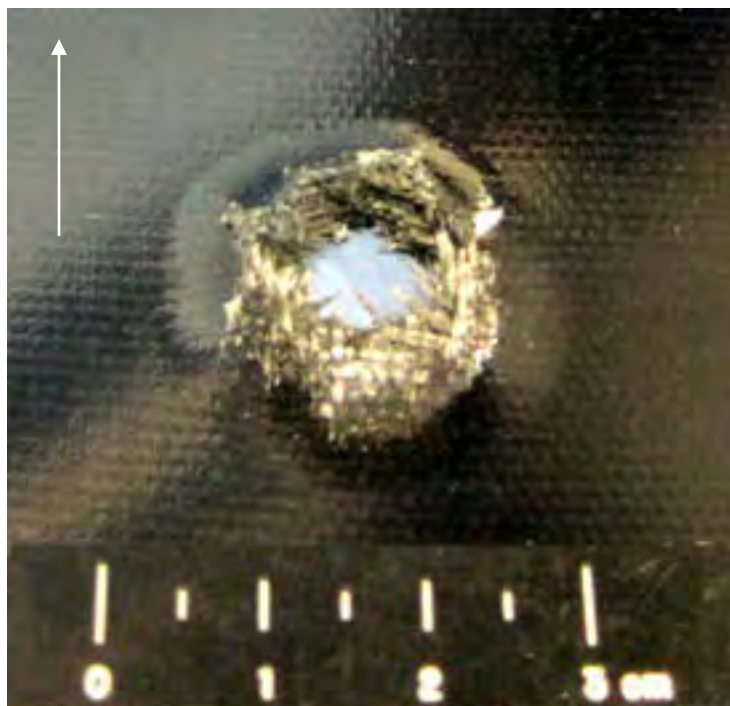
Figure 555 Close-up Oblique Side View of Damage to Back Side of NP 504 Substrate (scale in 5mm increments / white arrow indicates flight path of projectile)

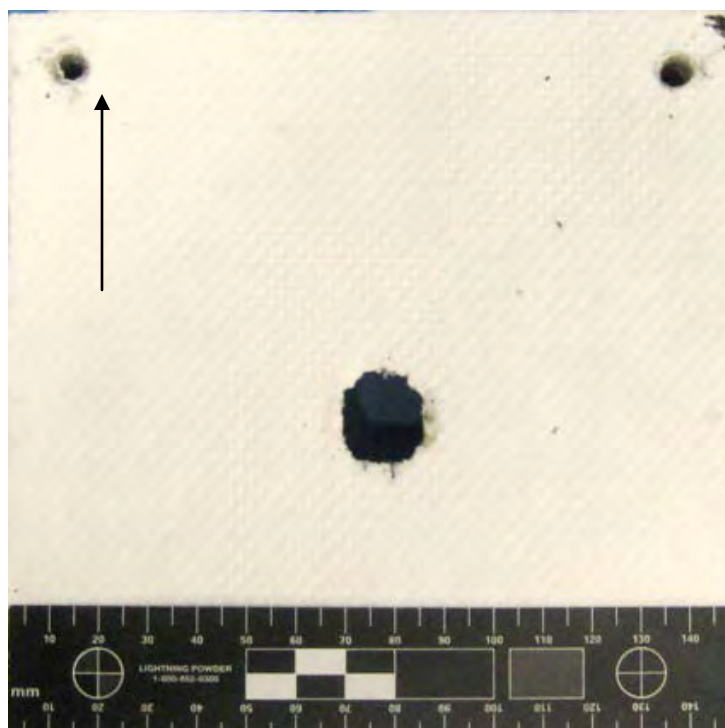
Figure 556 Overall View of Damage to Front of Saffil Layer (scale in 5mm increments / black arrow indicates flight path of projectile)

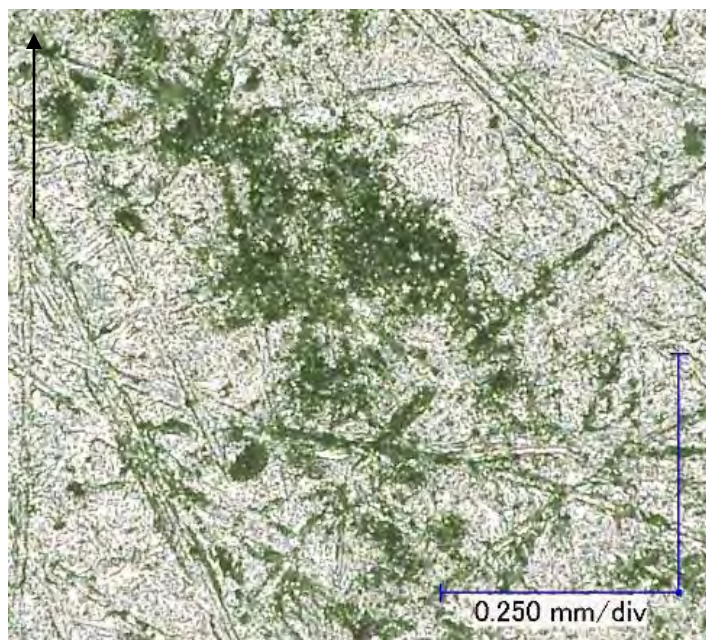
Figure 562 Close-up View of Most Significant Damage to Front of Rear Wall (black arrow indicates flight path of projectile / damage within red circle in Figure 592)

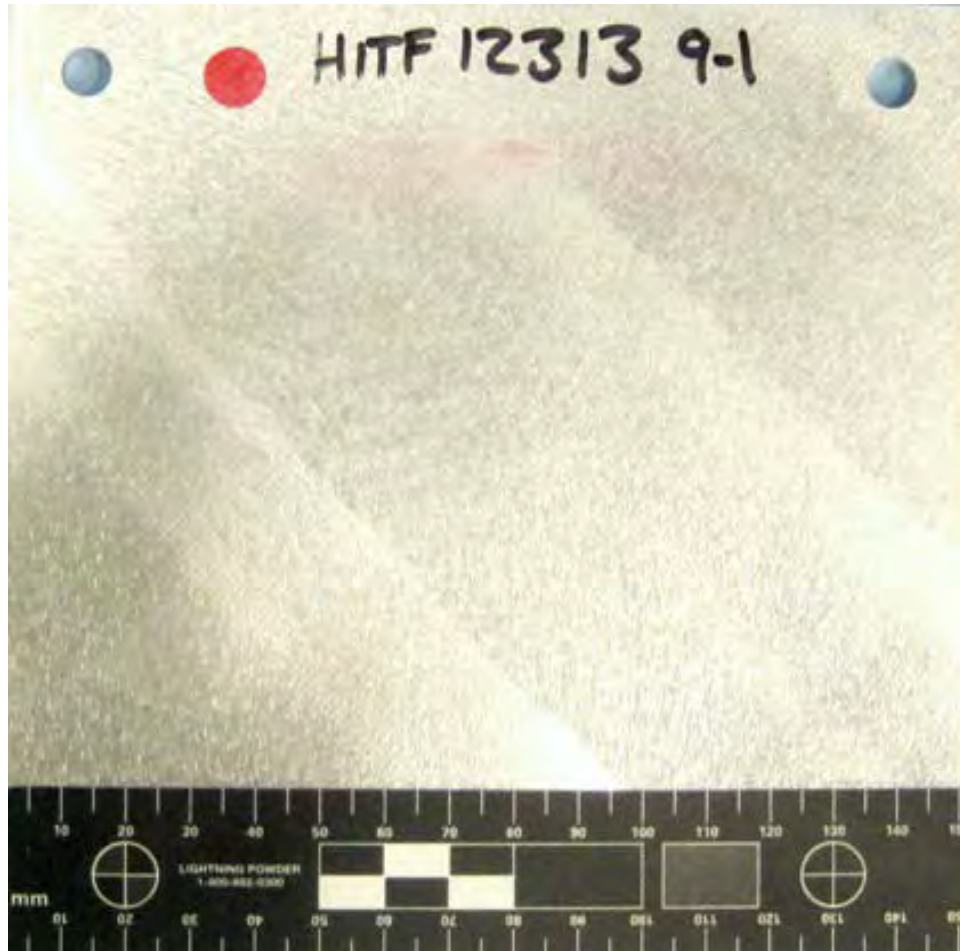
Figure 563 Overall View of Back Side of Rear Wall (scale in 5mm increments / black arrow indicates flight path of projectile)

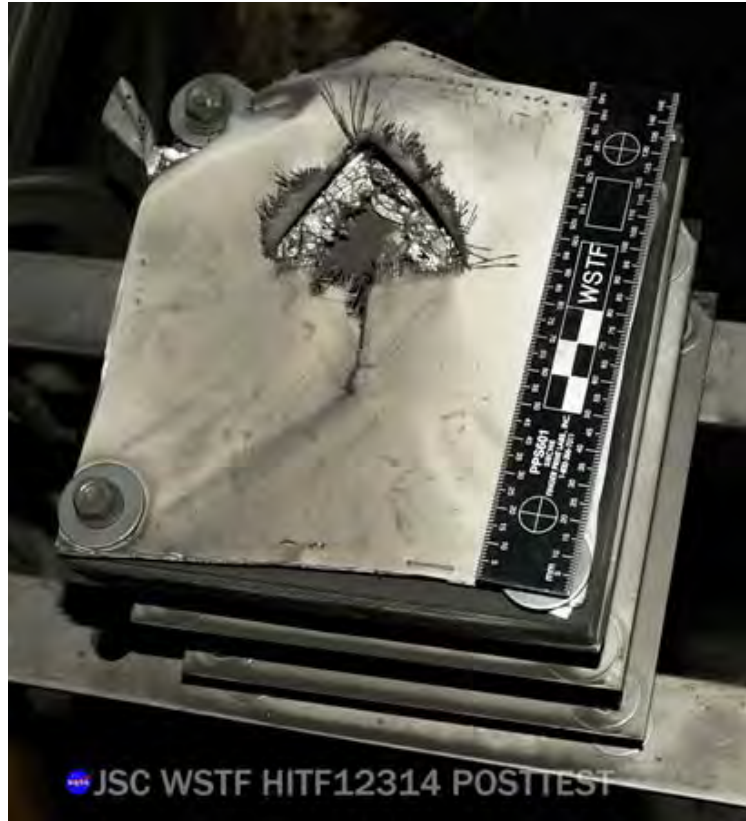
Figure 564 Overall View of Sample in the Target Tank (post-test)

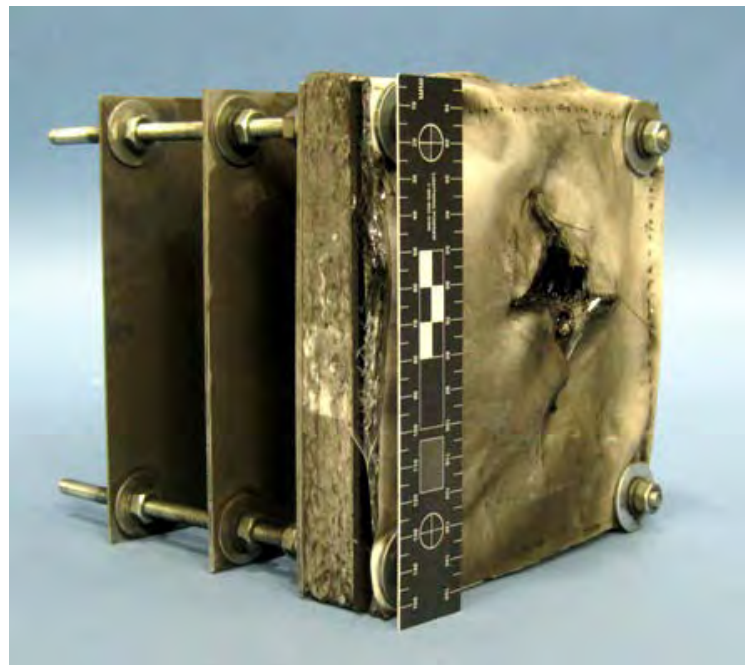
Figure 565 Overall Front Oblique View of Sample (scale in 5mm increments)

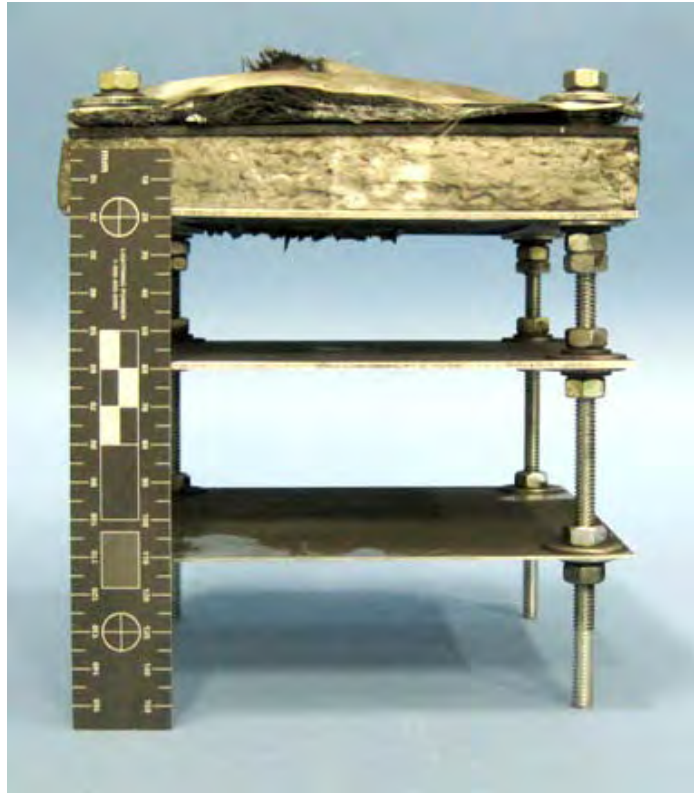
Figure 566 Overall Side View of Sample (scale in 5mm increments)

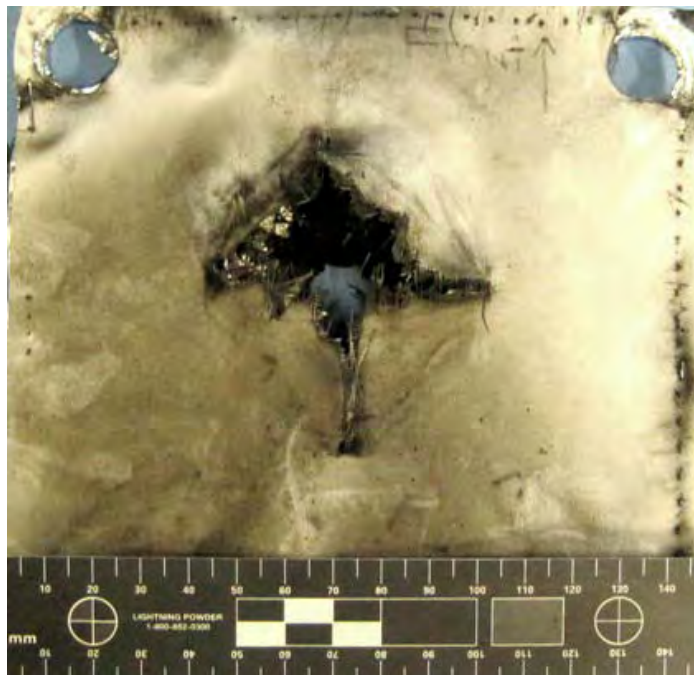
Figure 567 Overall View of Damage to Front of MLI (scale in 5mm increments / black arrow indicates flight path of projectile)

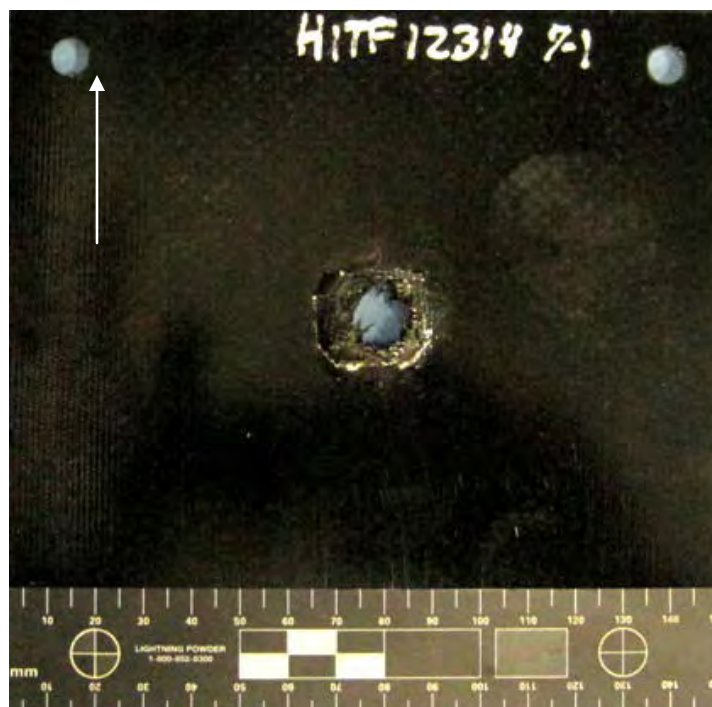
Figure 573 Overall View of Damage to Back Side of NP 504 Substrate (scale in 5mm increments / white arrow indicates flight path of projectile)

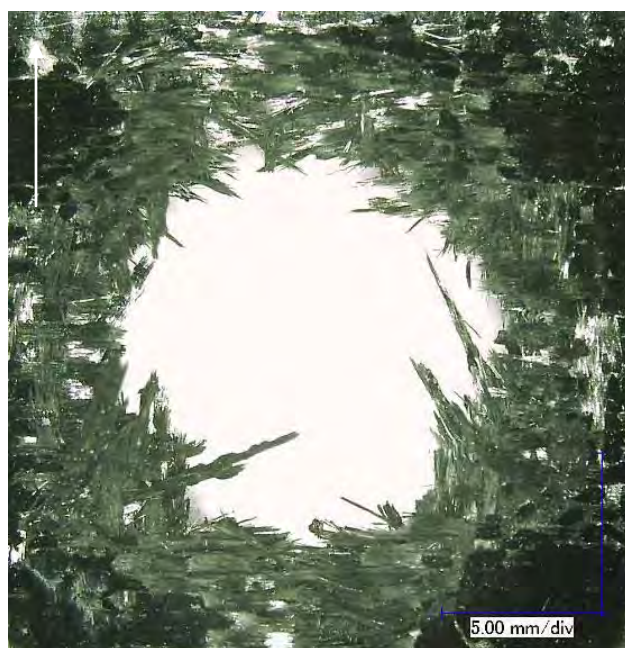
Figure 575 Close-up View of Most Significant Damage to Back Side of NP 504 Substrate (black arrow indicates flight path of projectile / damage within red circle in Figure 574)

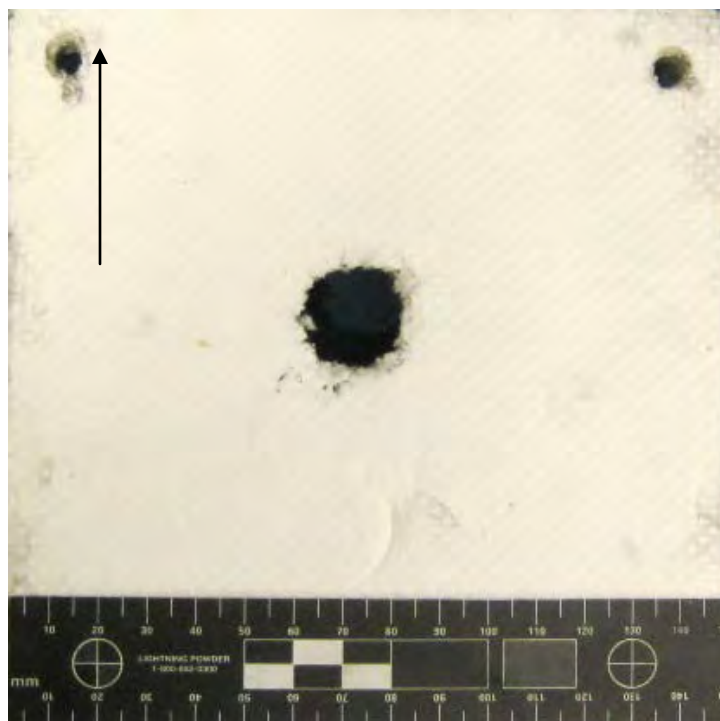
Figure 577 Overall View of Damage to Front of Saffil Layer (scale in 5mm increments / black arrow indicates flight path of projectile)

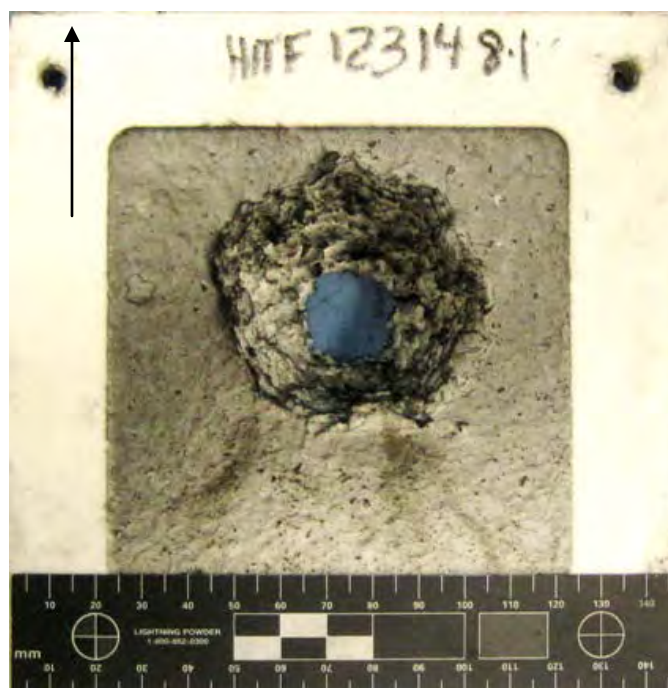
Figure 579 Overall View of Damage to Back Side of Saffil Layer (scale in 5mm increments / black arrow indicates flight path of projectile)

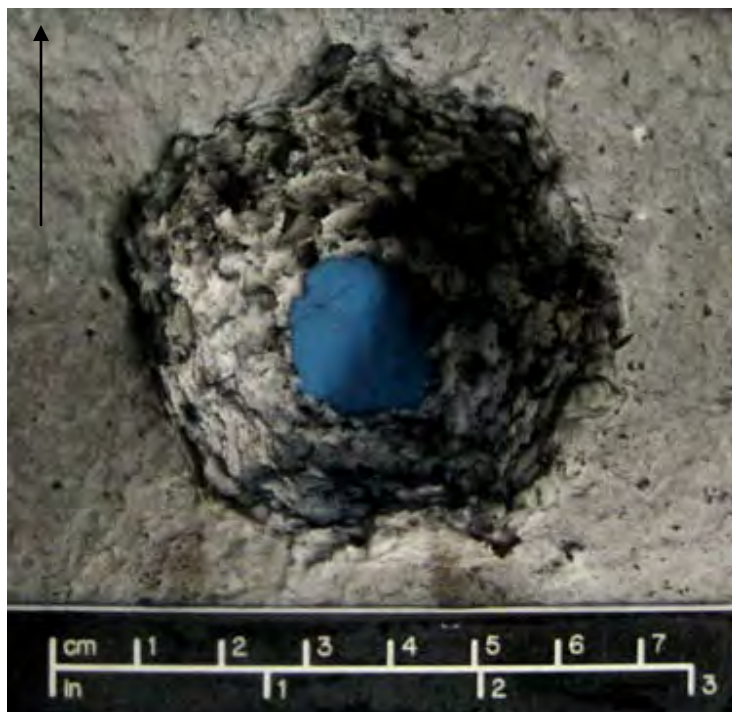
Figure 580 Close-up View of Damage to Back Side of Saffil Layer (scale in 1cm increments / black arrow indicates flight path of projectile)

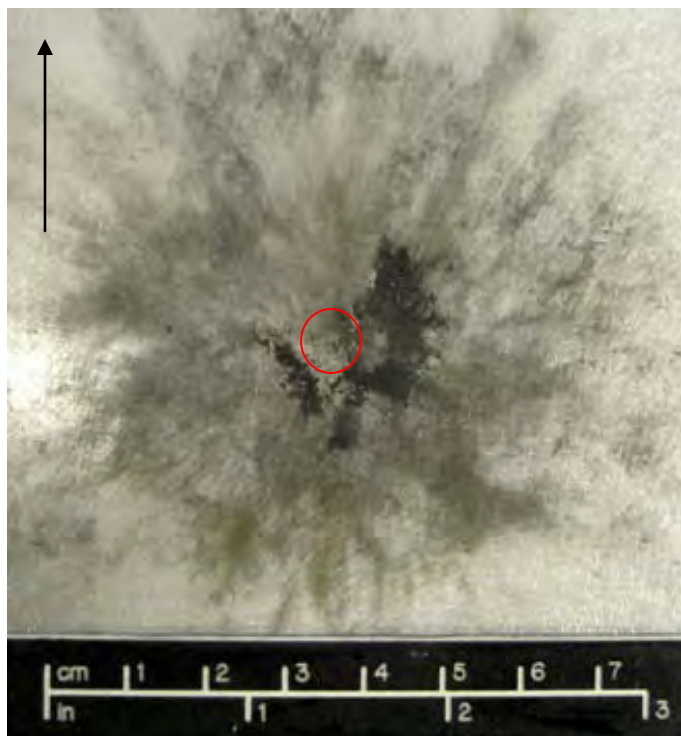
Figure 584 Close-up View of Damage to Front of Rear Wall (scale in 1cm increments / black arrow indicates flight path of projectile / cleaned)

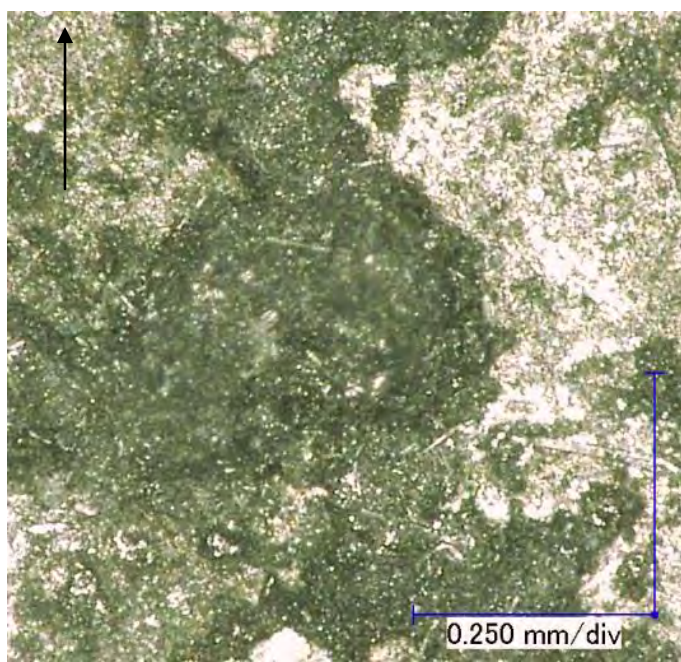
Figure 585 Close-up View of Most Significant Damage to Front of Rear Wall (black arrow indicates flight path of projectile / cleaned / damage within red circle in Figure 616)

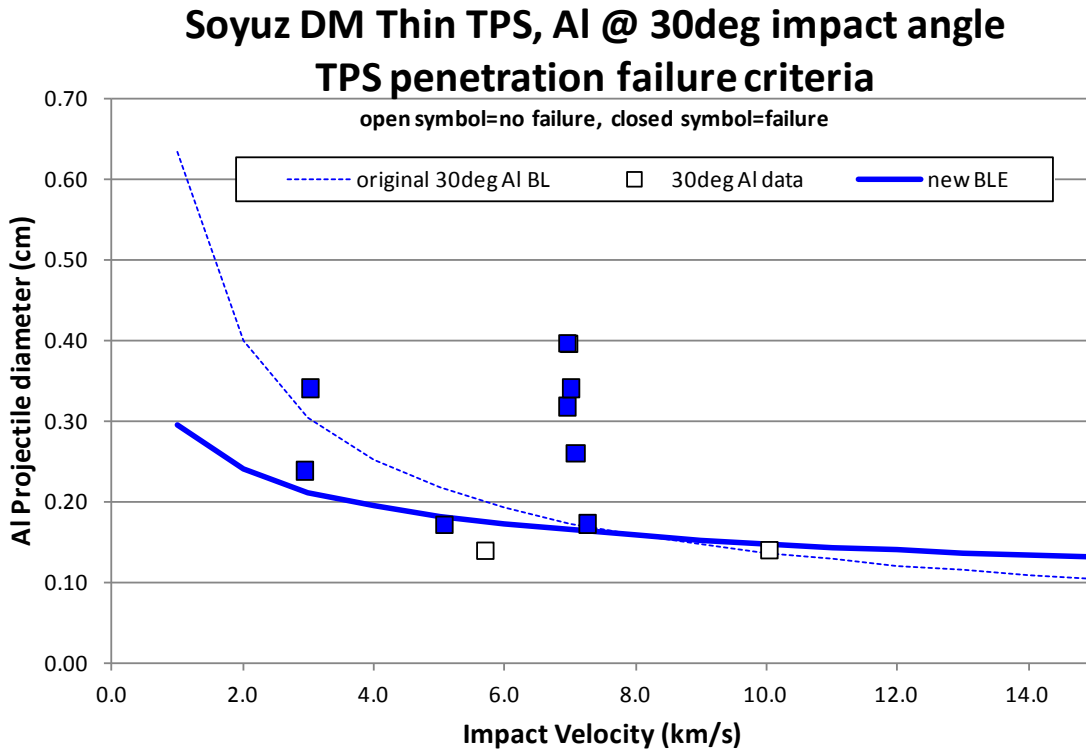
Figure B1. Predicted BLE versus test data for 30 deg impacts by aluminum projectiles on thin TPS (target type 1)

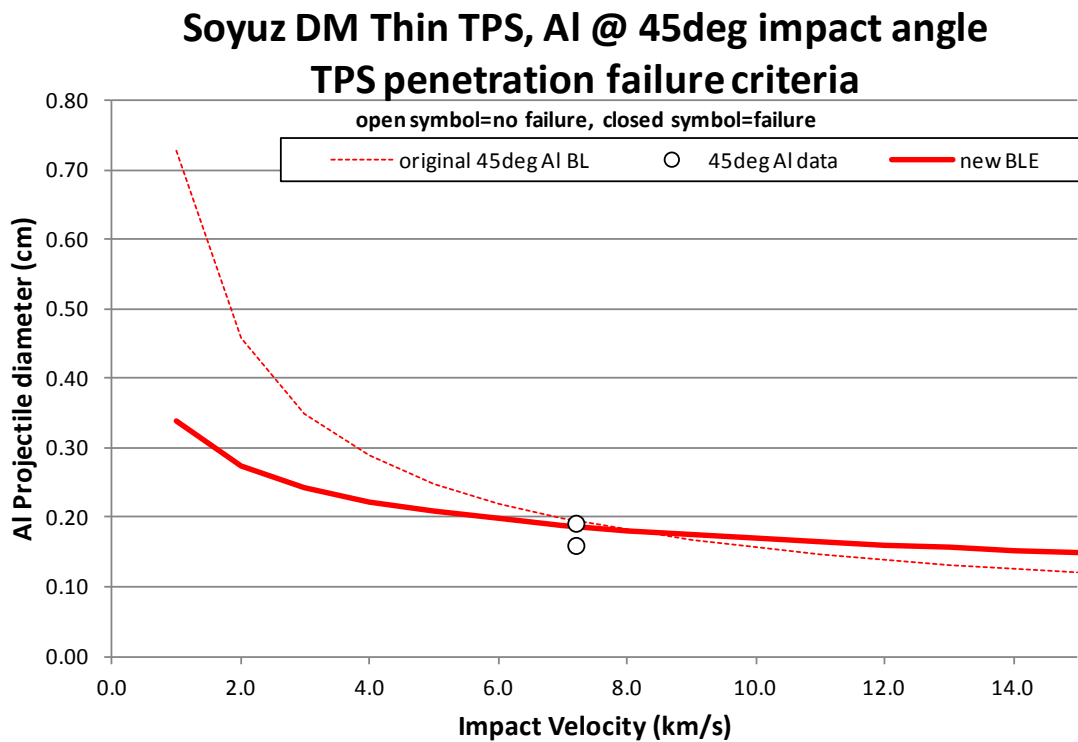
Figure B2. Predicted BLE versus test data for 45 deg impacts by aluminum projectiles on thin TPS (target type 1)

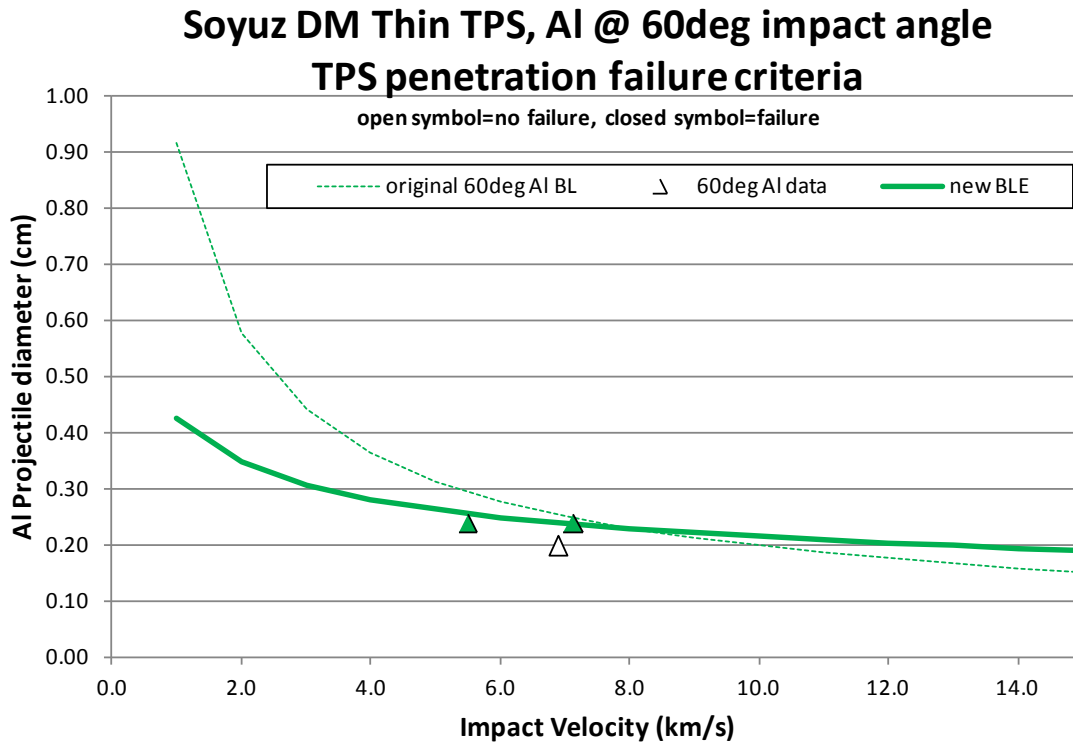
Figure B3. Predicted BLE versus test data for 60 deg impacts by aluminum projectiles on thin TPS (target type 1)

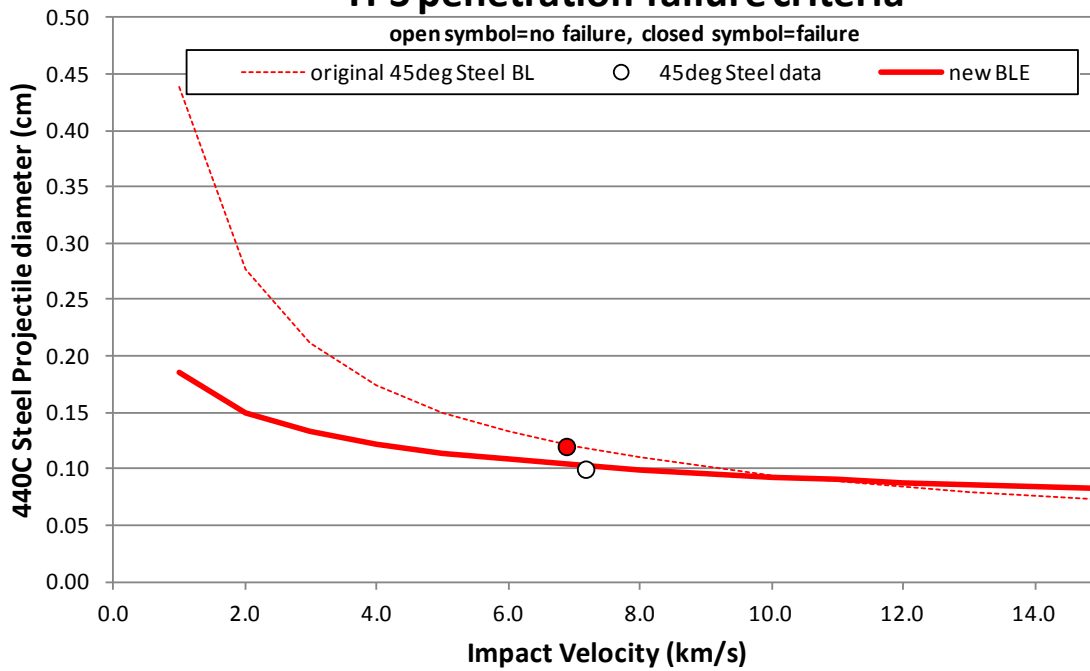
Soyuz DM Thin TPS, Steel @ 45deg impact angle TPS penetration failure criteria

Figure B5. Predicted BLE versus test data for 45 deg impacts by steel projectiles on thin TPS (target type 1)

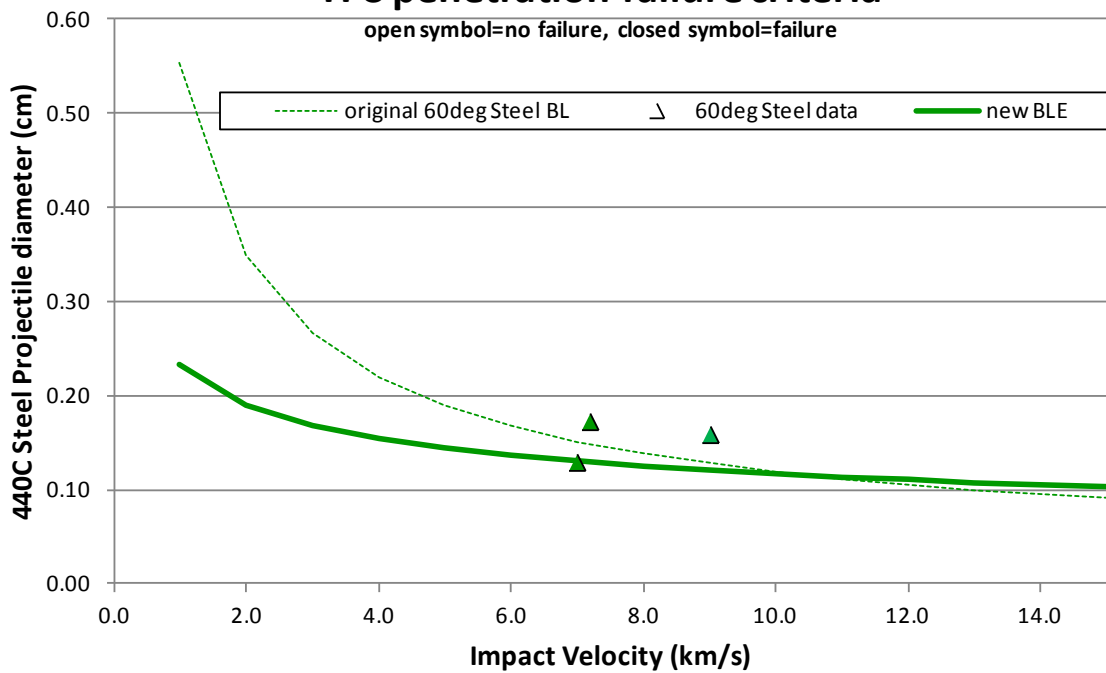
Soyuz DM Thin TPS, Steel @ 60deg impact angle TPS penetration failure criteria

Figure B6. Predicted BLE versus test data for 60 deg impacts by steel projectiles on thin TPS (target type 1)

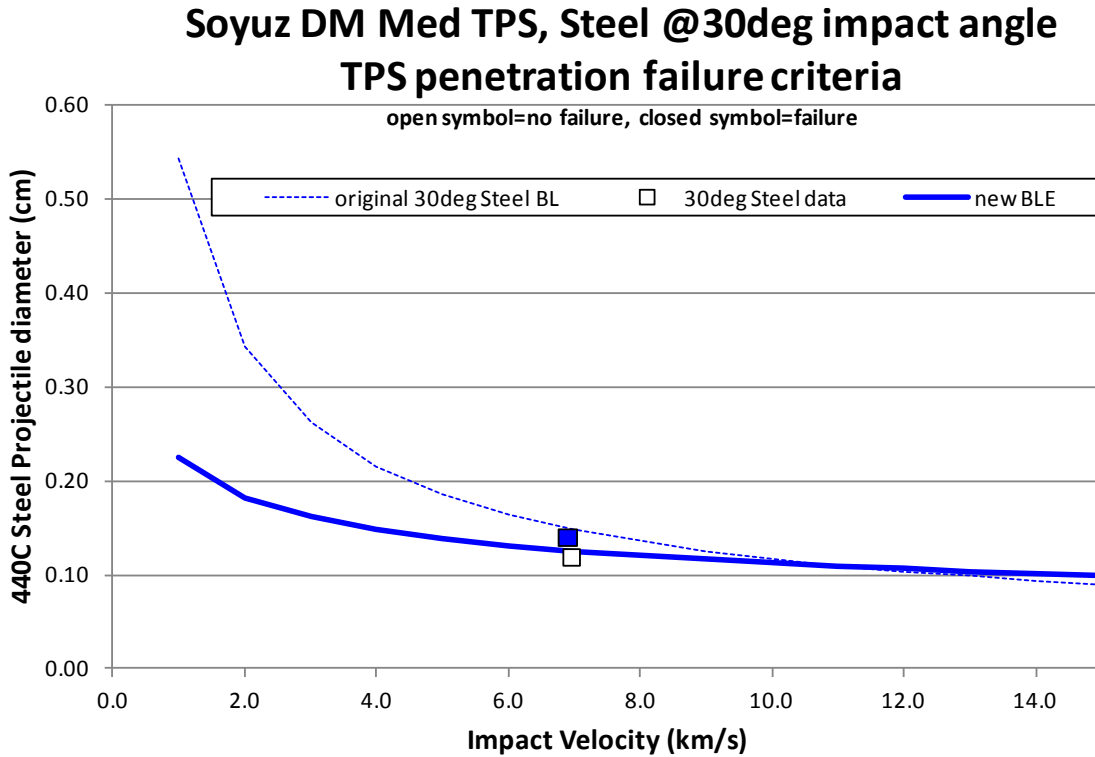
Figure B7. Predicted BLE versus test data for 30 deg impacts by steel projectiles on medium TPS (target type 2)

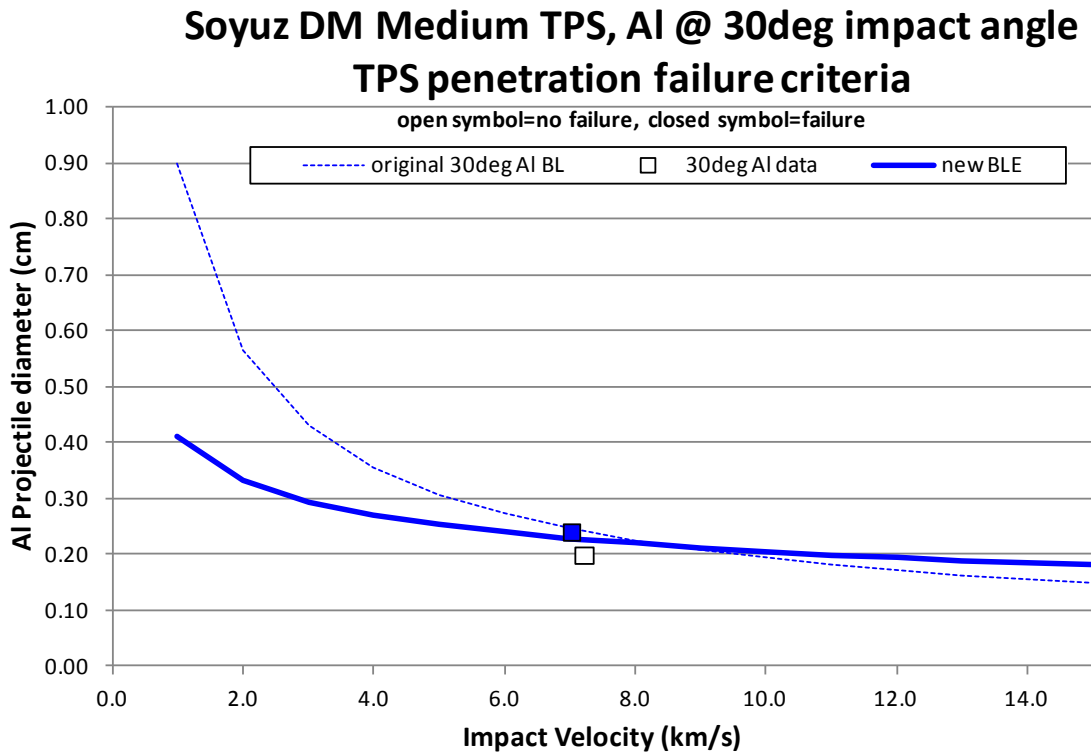
Figure B8. Predicted BLE versus test data for 30 deg impacts by aluminum projectiles on medium TPS (target type 2)

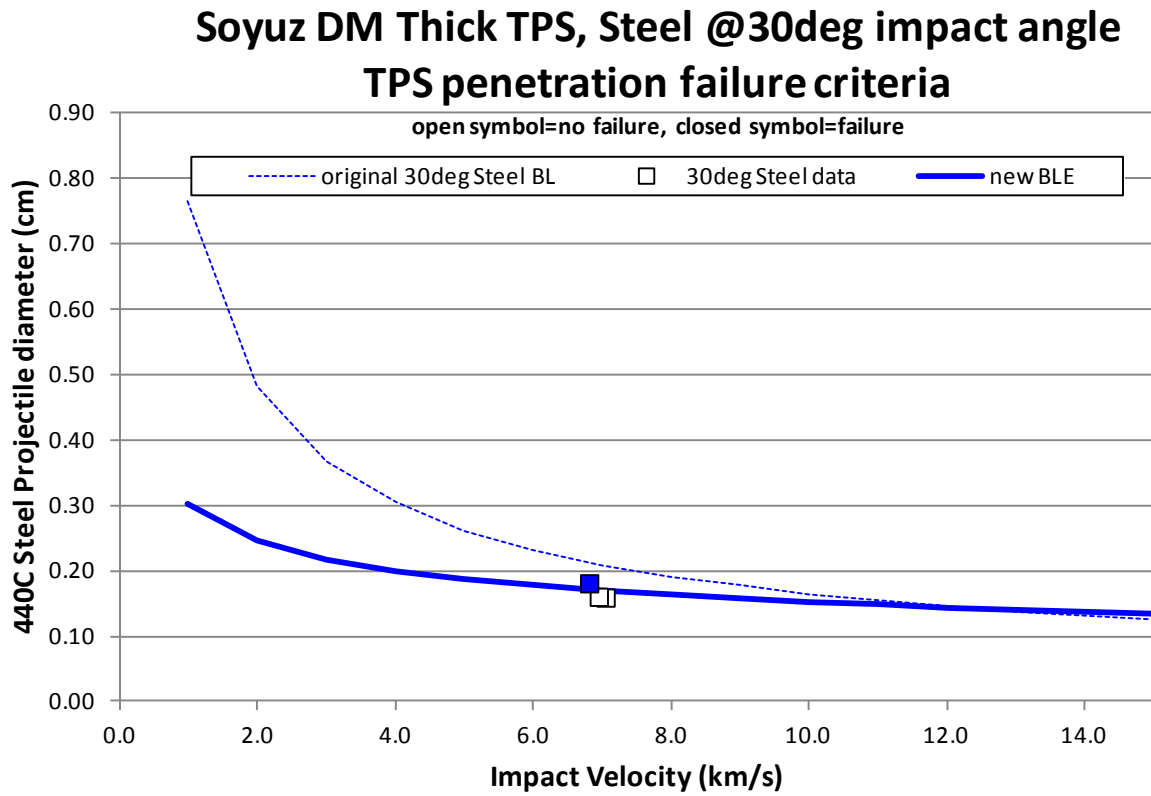
Figure B9. Predicted BLE versus test data for 30 deg impacts by steel projectiles on thick TPS (target type 3)

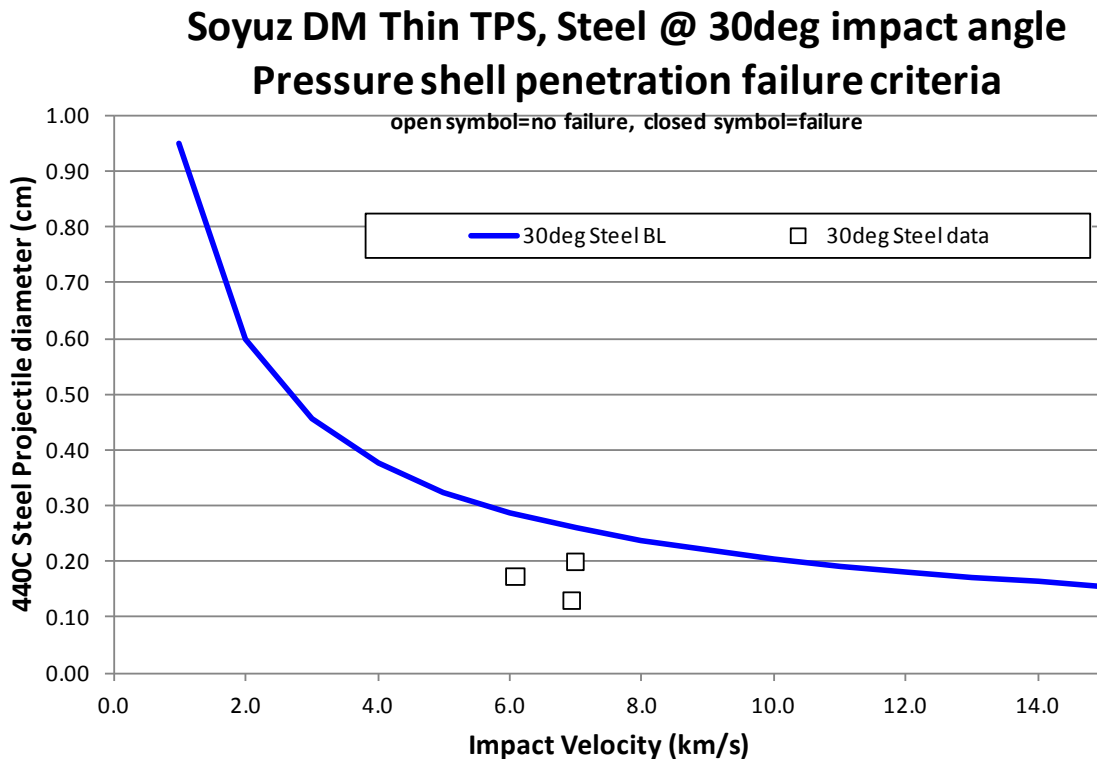
Figure B11. Predicted BLE for perforation failure of the pressure shell behind the TPS versus test data for 30 deg impacts by steel projectiles on thin TPS (target type 1)

A second failure mode of interest is penetration through the TPS, the low-density insulation behind the TPS substrate, and the aluminum pressure shell. The predicted ballistic limit particle size given in the following tables and figures are based on threshold penetration through the aluminum pressure shell behind the TPS. The predicted ballistic limits were derived from BUMPER code calculations provided by J.L. Hyde [6], with a summary of the ballistic limit parameters provided below.

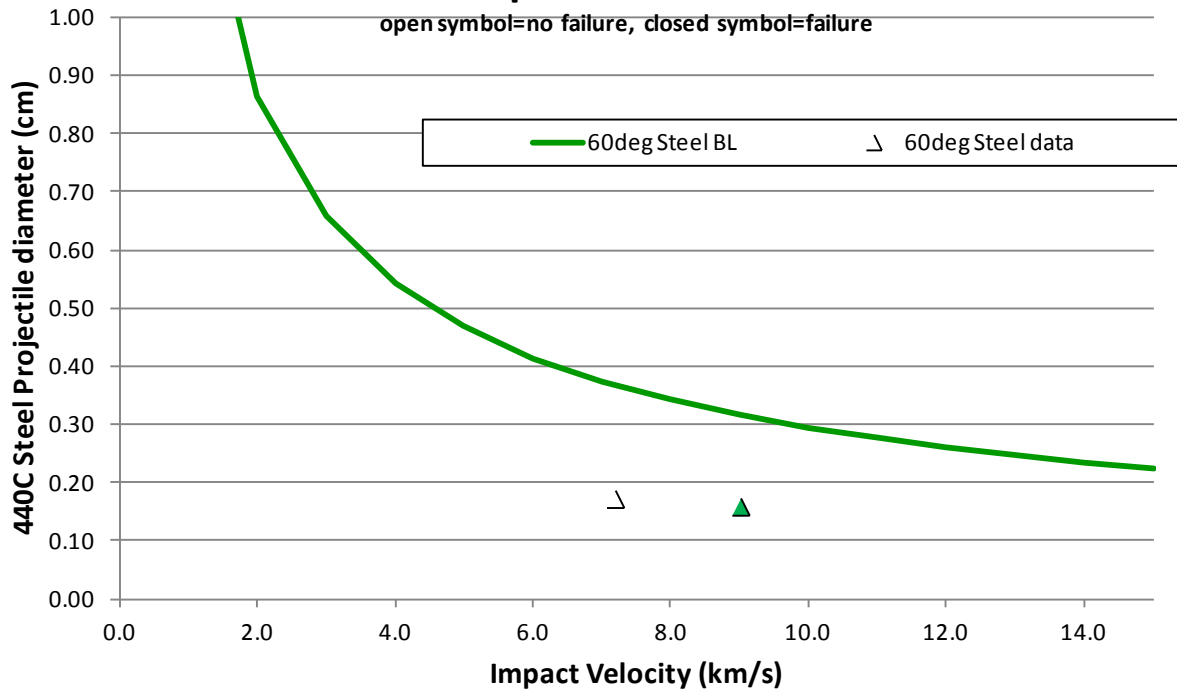
Soyuz DM Thin TPS, Steel @ 60deg impact angle Pressure shell penetration failure criteria

Figure B12. Predicted BLE for perforation failure of the pressure shell behind the TPS versus test data for 60 deg impacts by steel projectiles on thin TPS (target type 1)

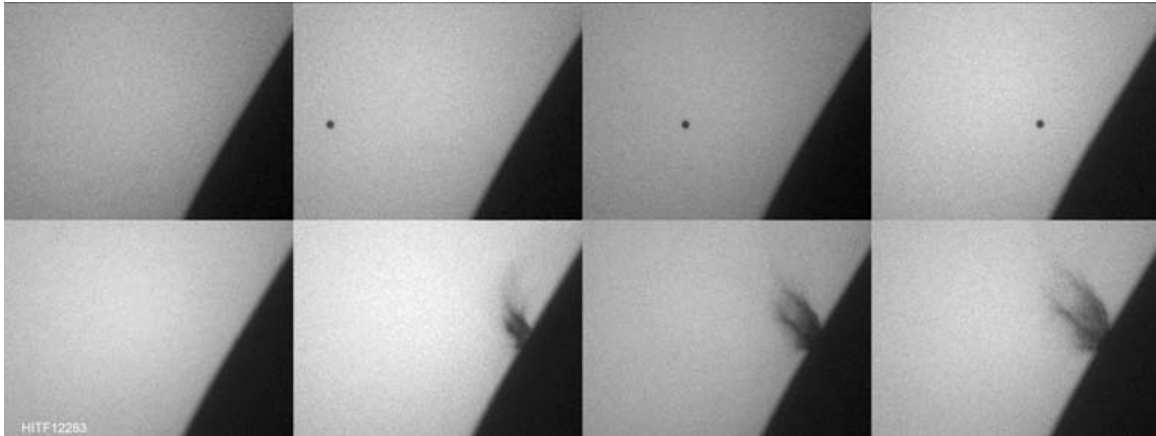
HITF12283 / Test #1

Figure C1 Projectile Captured Prior to Impact and Impacting Target (via SIMX-8 Camera)

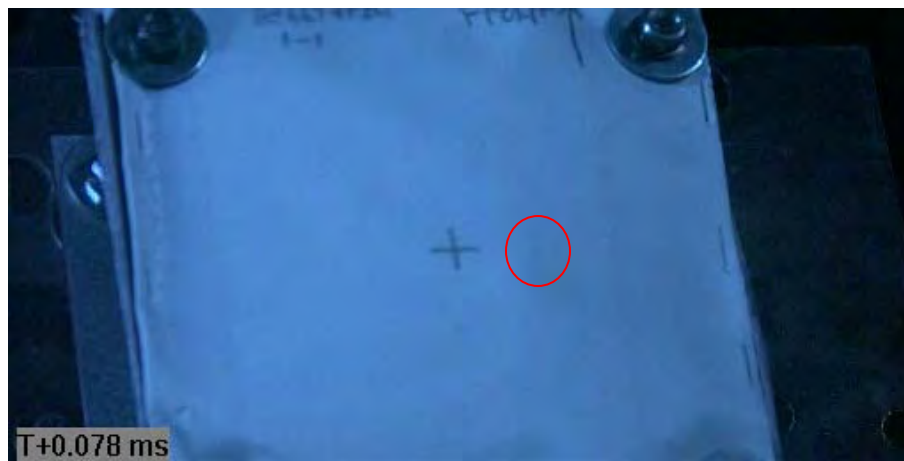
Figure C2 Faint Image of Projectile Captured Prior to Impact (via Phantom v711 / projectile within red circle)
