International Space Station (ISS) Soyuz Vehicle Descent Module Evaluation of Thermal Protection System (TPS) Penetration Characteristics

Hypervelocity Impact Technology Group

February 2013

**International Space Station (ISS) Soyuz Vehicle
Descent Module Evaluation of Thermal Protection
System (TPS) Penetration Characteristics**

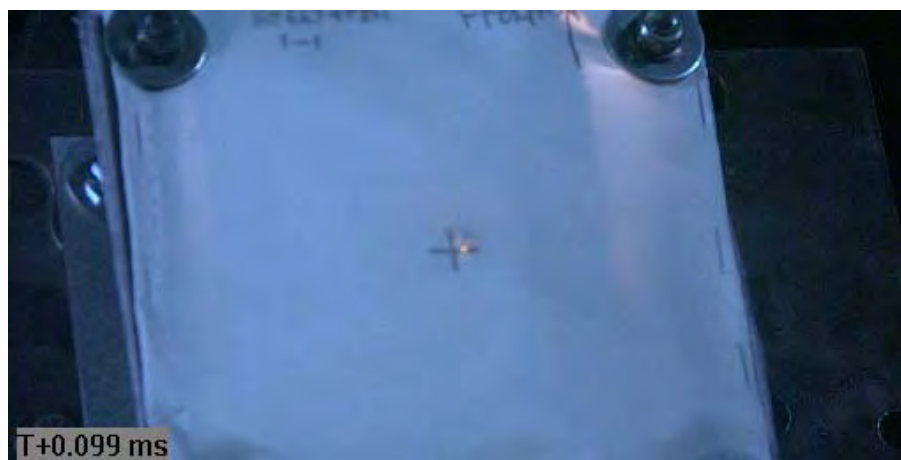
Figure C3 Projectile Impacting Target (via Phantom v711)

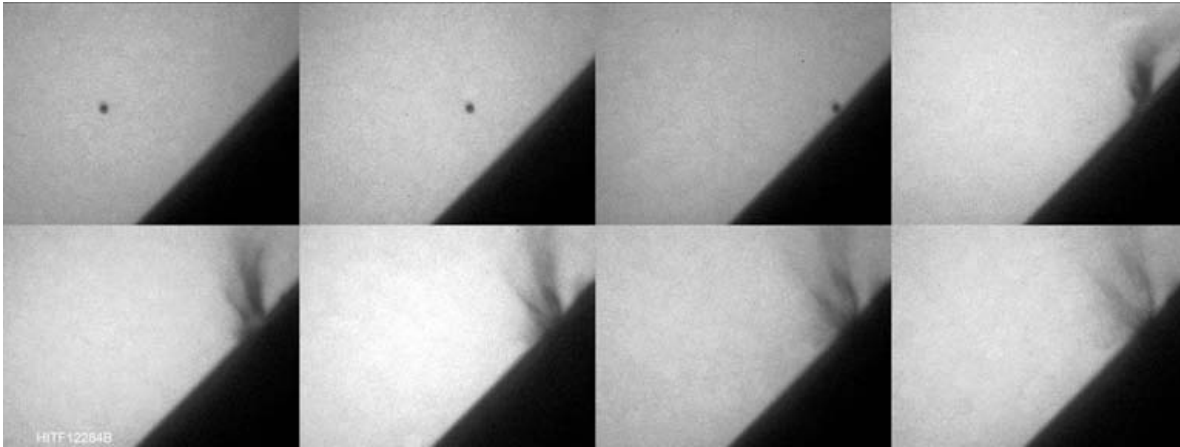
HITF12284 / Test #2

Figure C4 Projectile Captured Prior to Impact and Impacting Target (via SIMX-8 Camera)

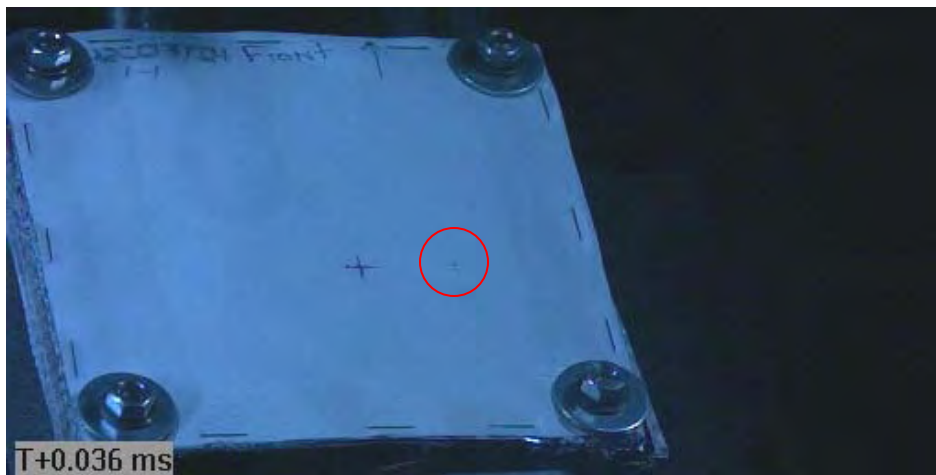
Figure C5 Image of Projectile Captured Prior to Impact (via Phantom v711 / projectile within red circle)

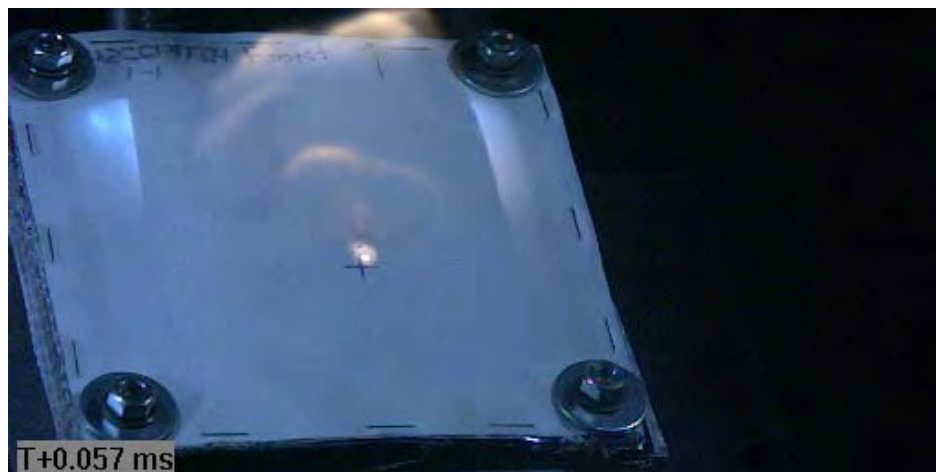
Figure C6 Projectile Impacting Target (via Phantom v711)

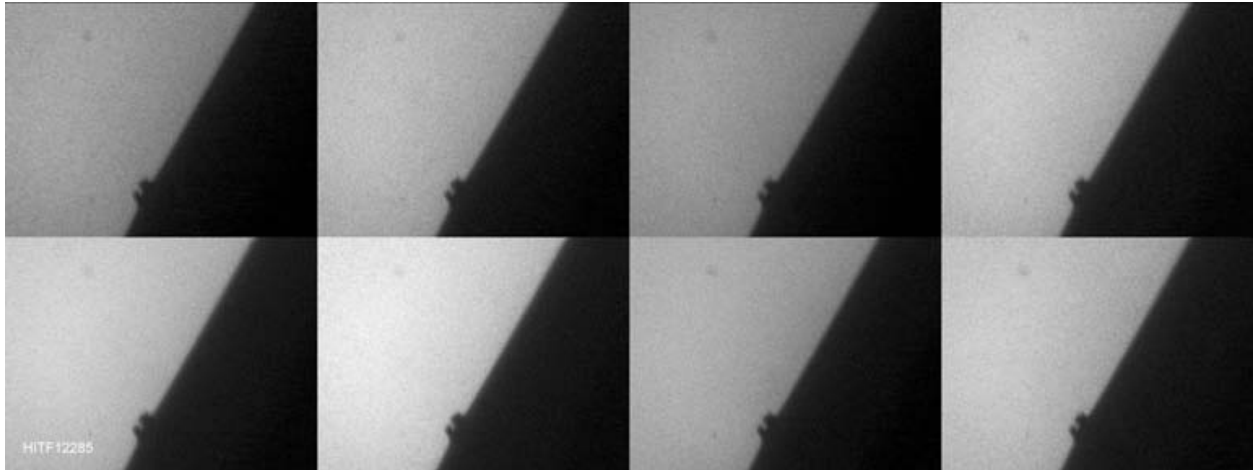
HITF12285 / Test #3

Figure C7 Projectile Not Captured Prior to Impact (via SIMX-8 Camera / projectile impacted before camera triggered)

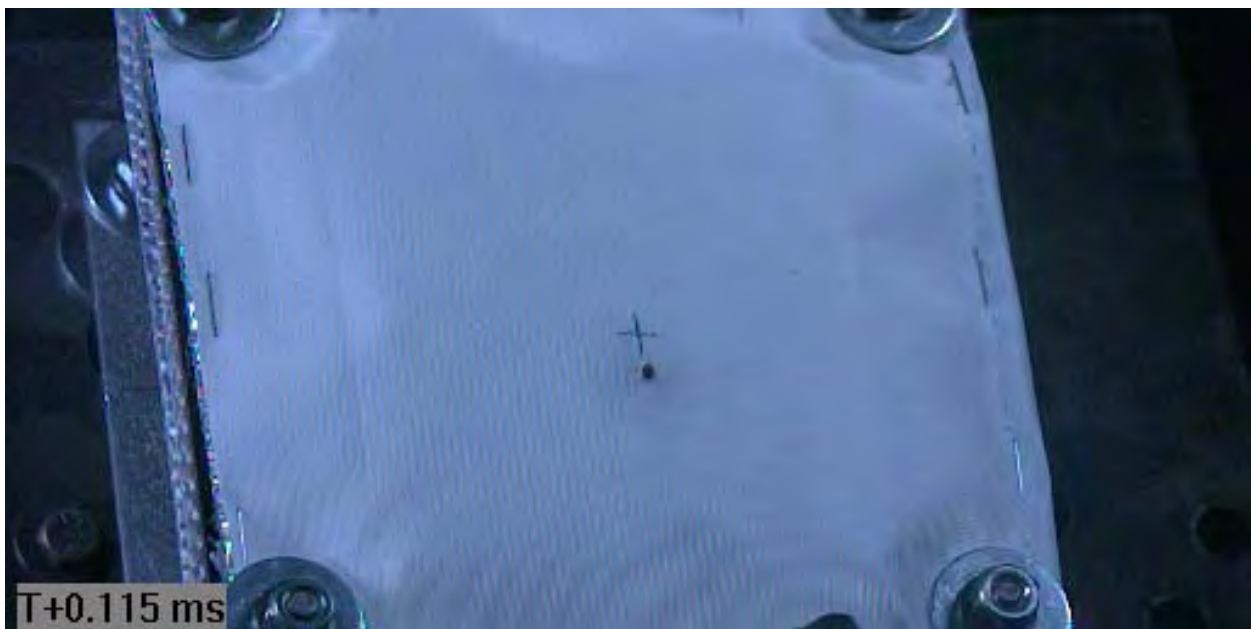
Figure C8 Projectile Not Captured Prior to Impact (via Phantom v711 / projectile impacted before camera triggered)

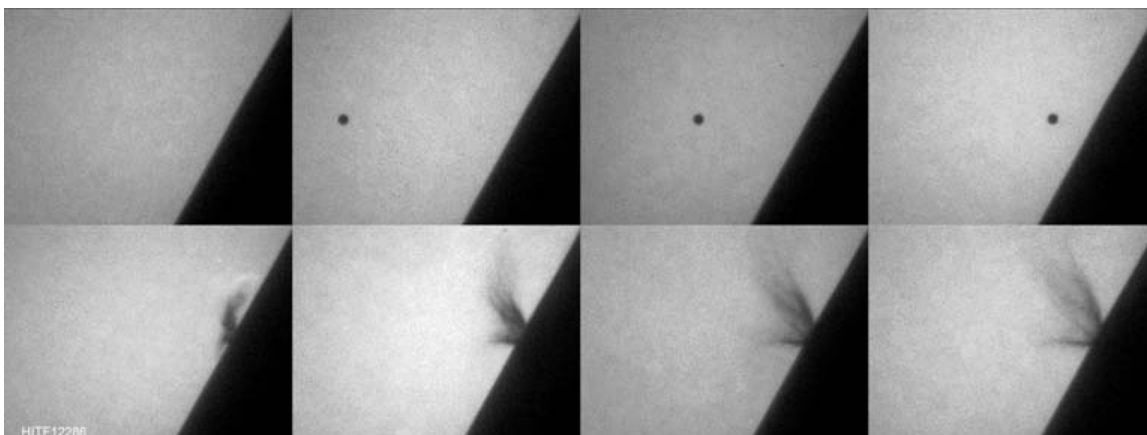
HITF12286 / Test #4

Figure C9 Projectile Captured Prior to Impact and Impacting Target (via SIMX-8 Camera)

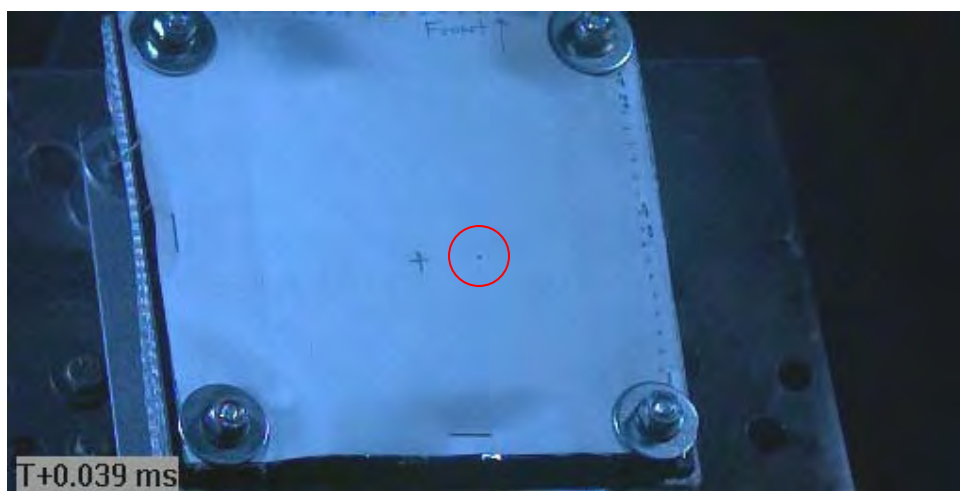
Figure C10 Image of Projectile Captured Prior to Impact (via Phantom v711 / projectile within red circle)

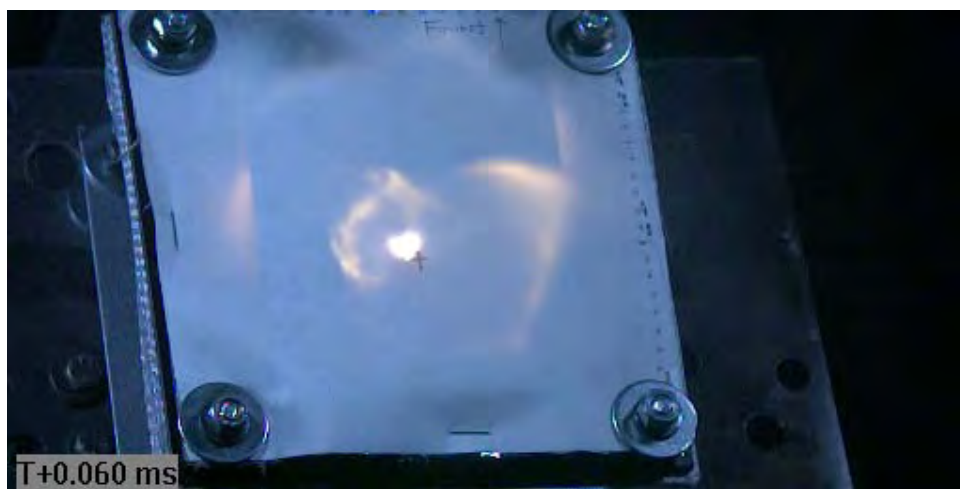
Figure C11 Projectile Impacting Target (via Phantom v711)

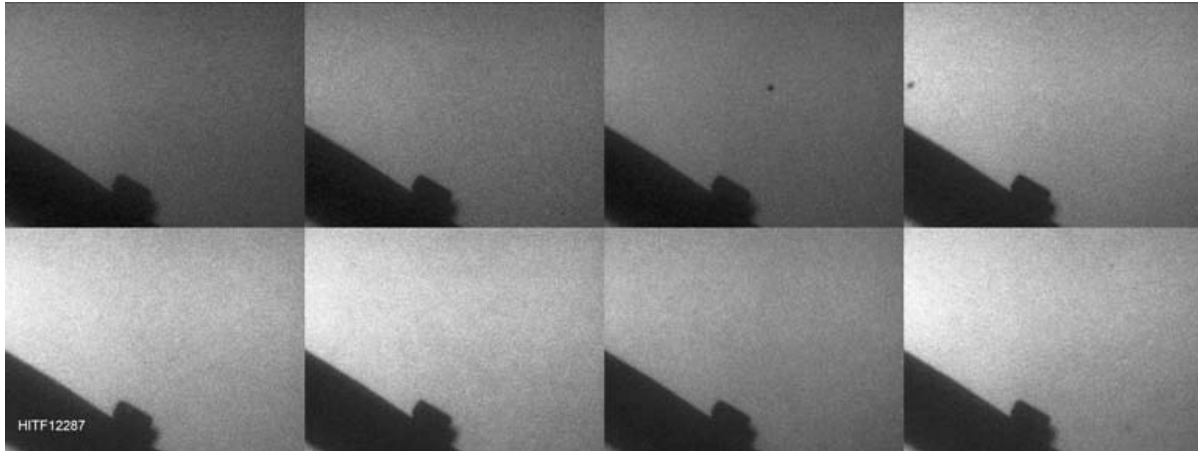
HITF12287 / Test #5

Figure C12 Projectile Captured Prior to Impact (via SIMX-8 Camera)

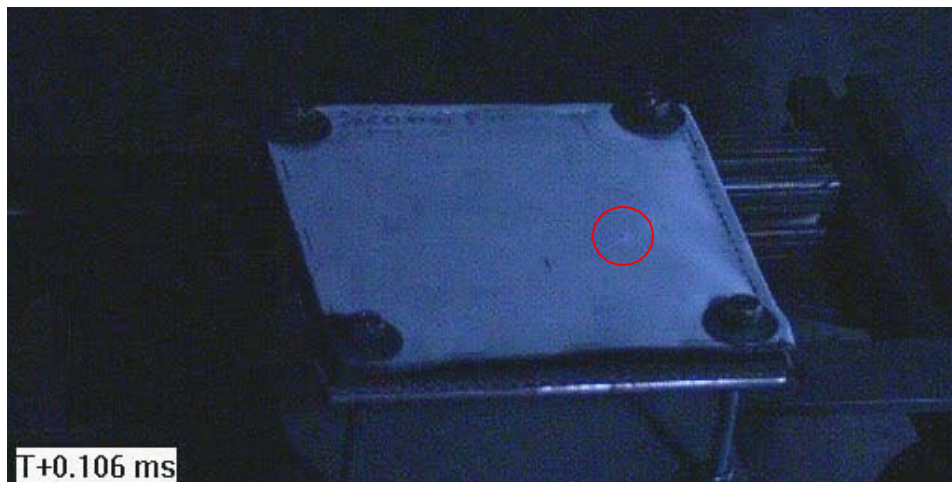
Figure C13 Image of Projectile Captured Prior to Impact (via Phantom v711 / projectile within red circle)

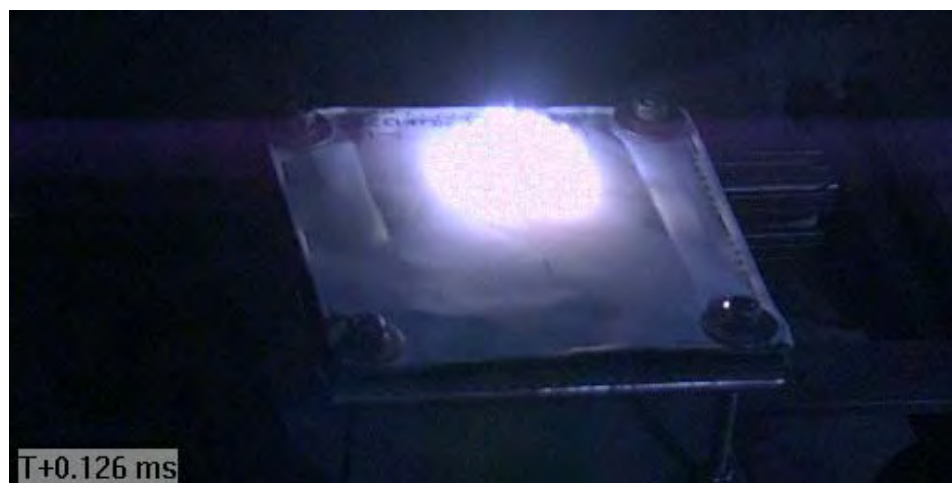
Figure C14 Projectile Impacting Target (via Phantom v711)

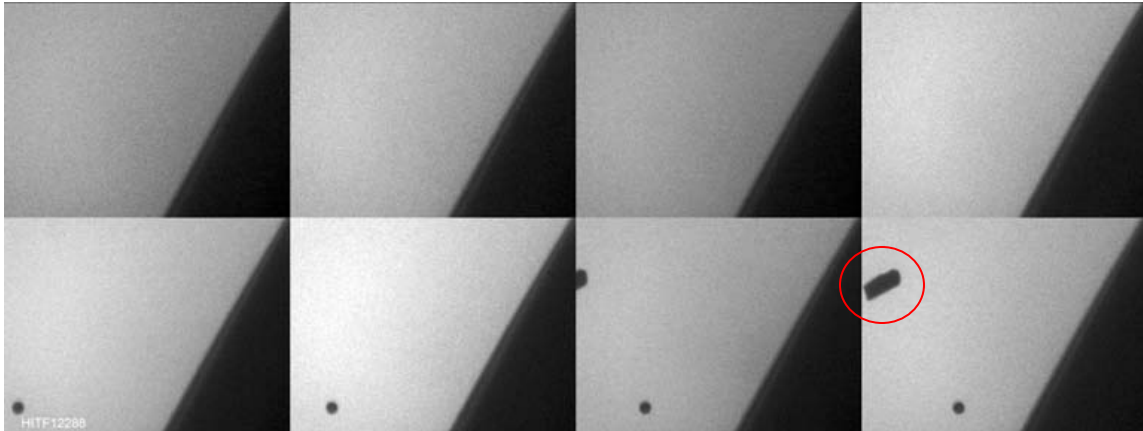
HITF12288 / Test #6

Figure C15 Projectile and Sabot Petal Captured Prior to Impact (via SIMX-8 Camera / sabot petal within red circle)

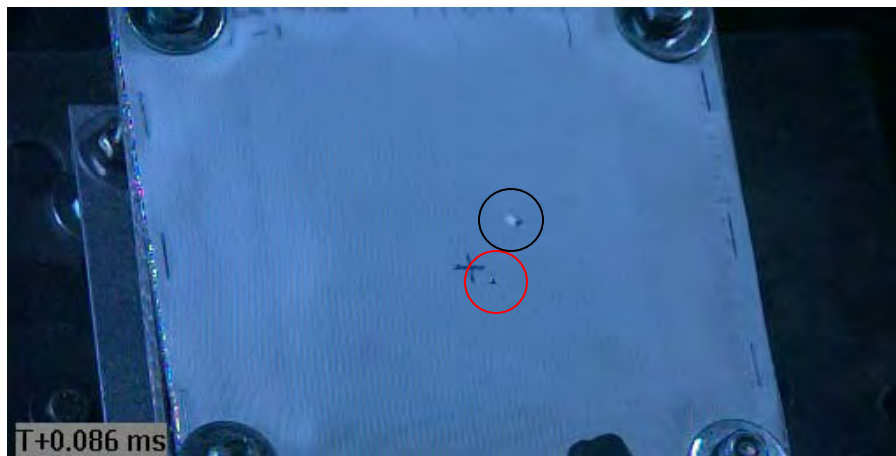
Figure C16 Image of Projectile and Sabot Petal Captured Prior to Impact (via Phantom v711 / projectile within red circle / sabot petal within black circle)

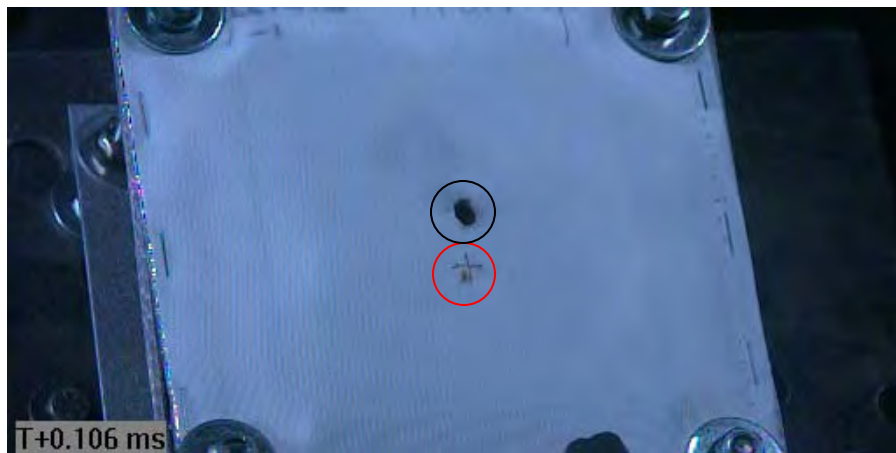
Figure C17 Image of Projectile and Sabot Petal Impacting Target (via Phantom v711 / projectile impact within red circle / sabot petal impact within black circle)

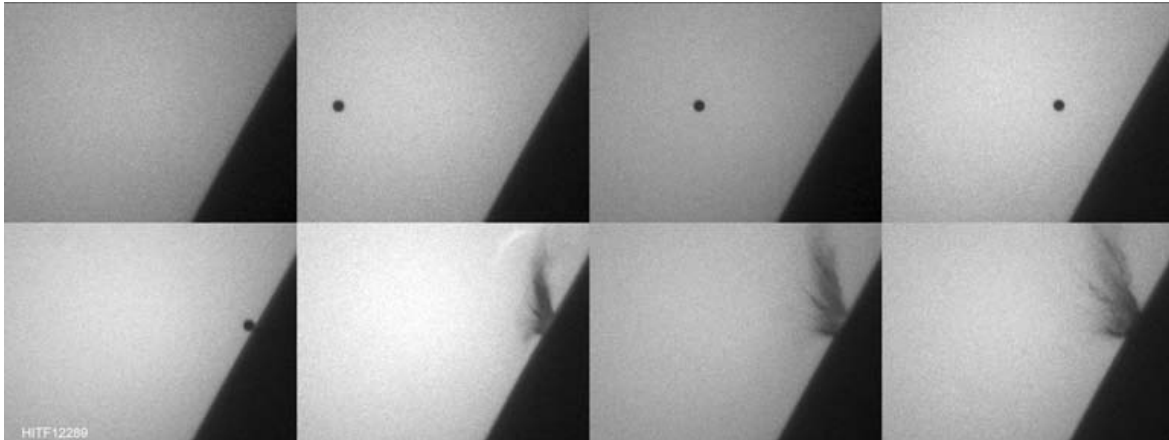
HITF12289 / Test #7

Figure C18 Projectile Captured Prior to Impact and Impacting Target (via SIMX-8 Camera)

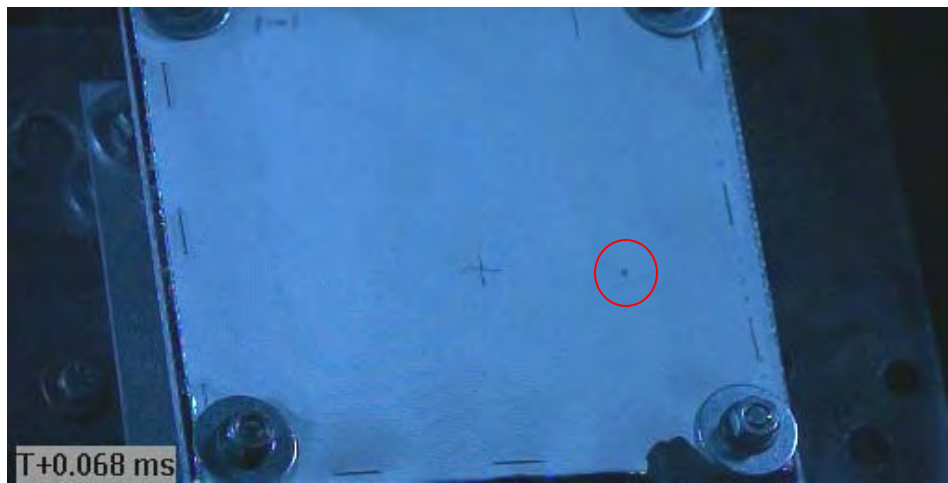
Figure C19 Image of Projectile Captured Prior to Impact (via Phantom v711 / projectile within red circle)

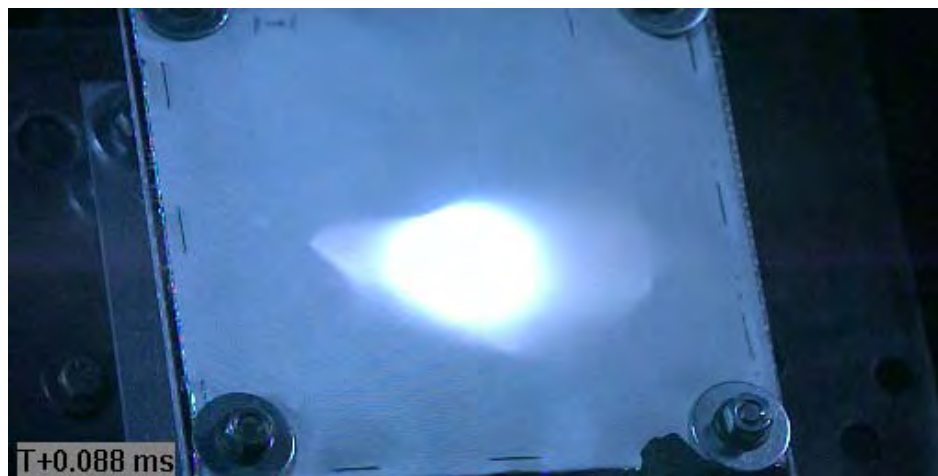
Figure C20 Projectile Impacting Target (via Phantom v711)

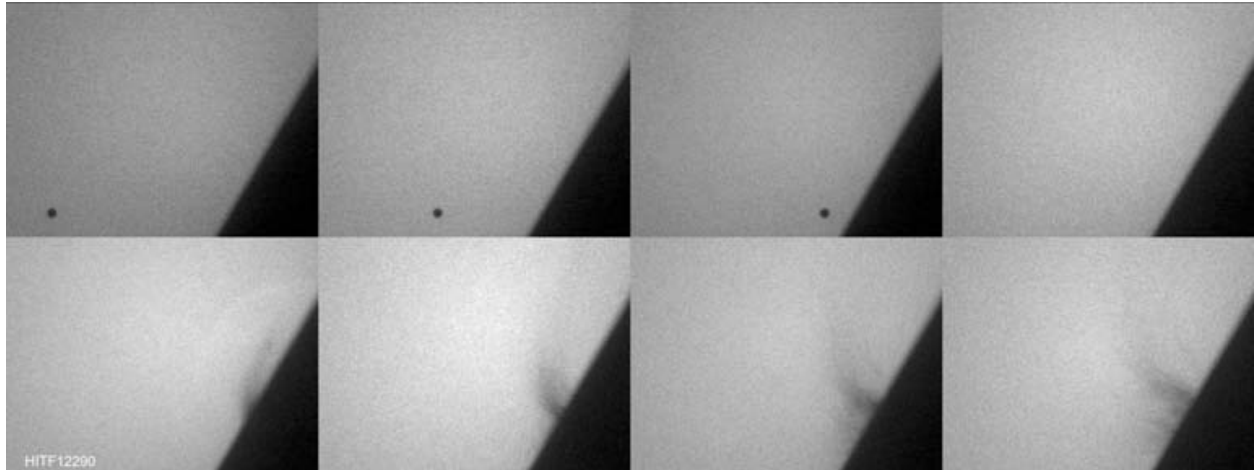
HITF12290 / Test #8

Figure C21 Projectile Captured Prior to Impact and Impacting Target (via SIMX-8 Camera)

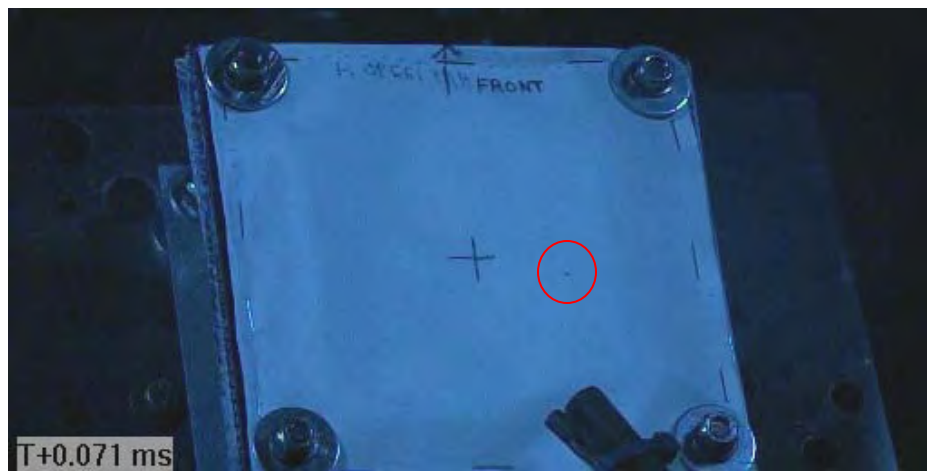
Figure C22 Image of Projectile Captured Prior to Impact (via Phantom v711 / projectile within red circle)

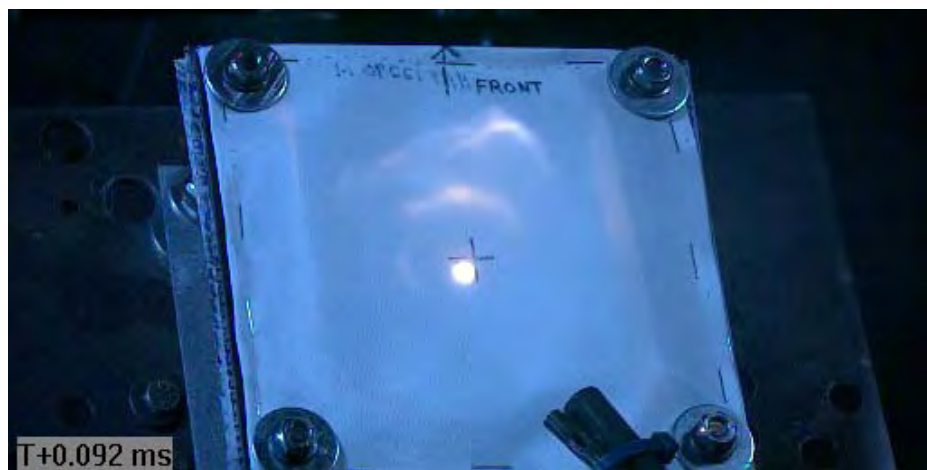
Figure C23 Projectile Impacting Target (via Phantom v711)

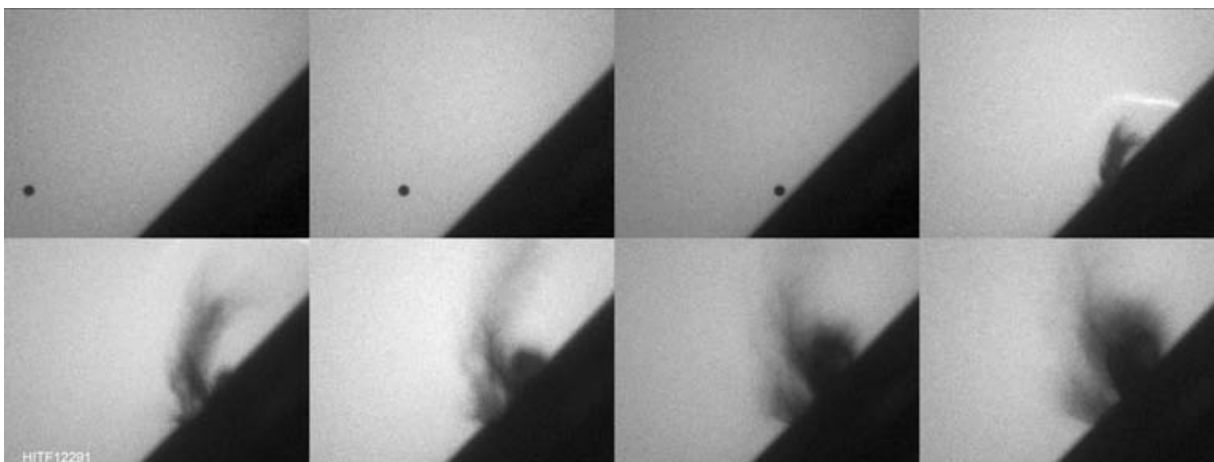
HITF12291 / Test #9

Figure C24 Projectile Captured Prior to Impact and Impacting Target (via SIMX-8 Camera)

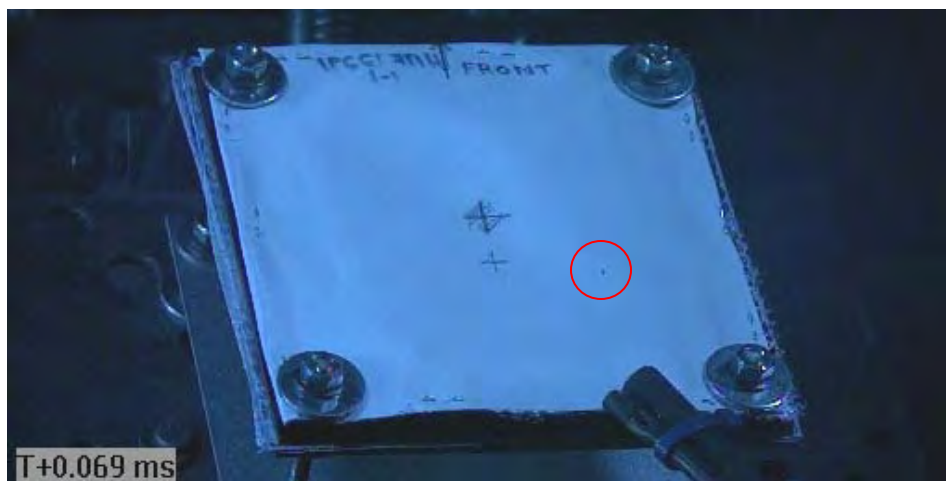
Figure C25 Image of Projectile Captured Prior to Impact (via Phantom v711 / projectile within red circle)

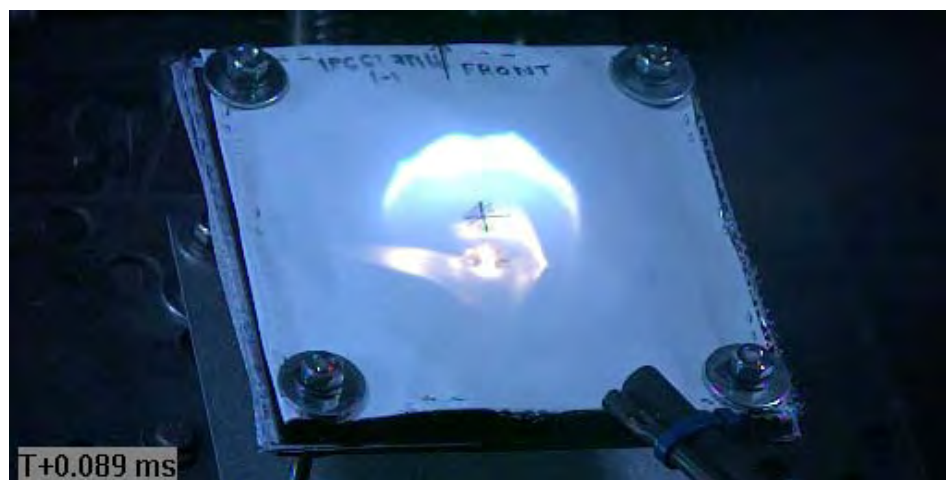
Figure C26 Projectile Impacting Target (via Phantom v711)

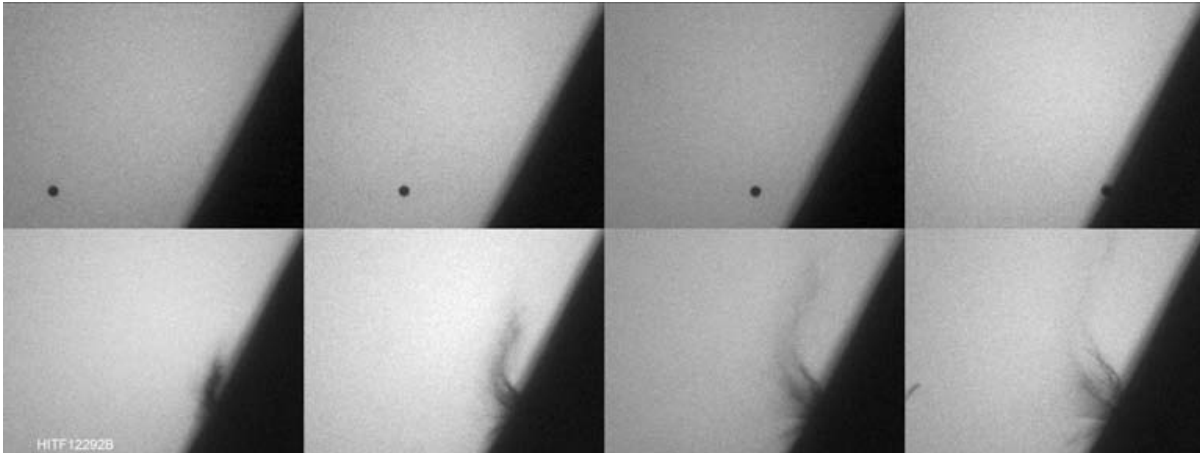
HITF12292 / Test #10

Figure C27 Projectile Captured Prior to Impact and Impacting Target (via SIMX-8 Camera)

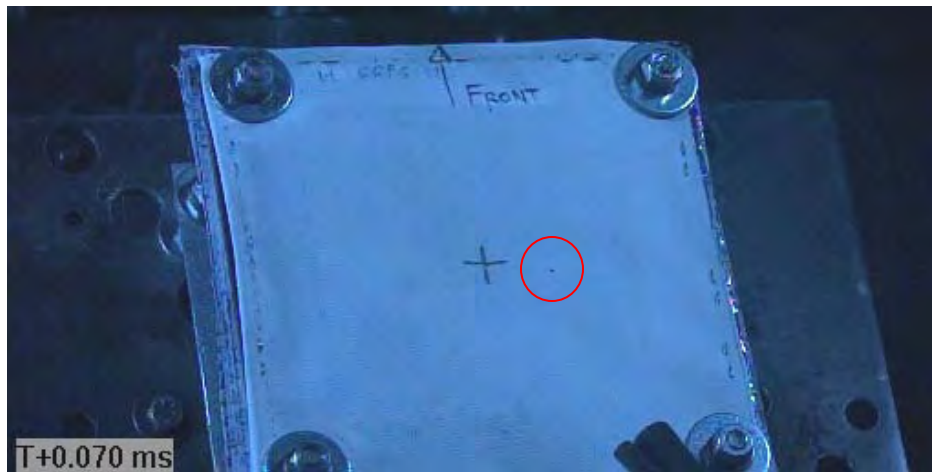
Figure C28 Image of Projectile Captured Prior to Impact (via Phantom v711 / projectile within red circle)

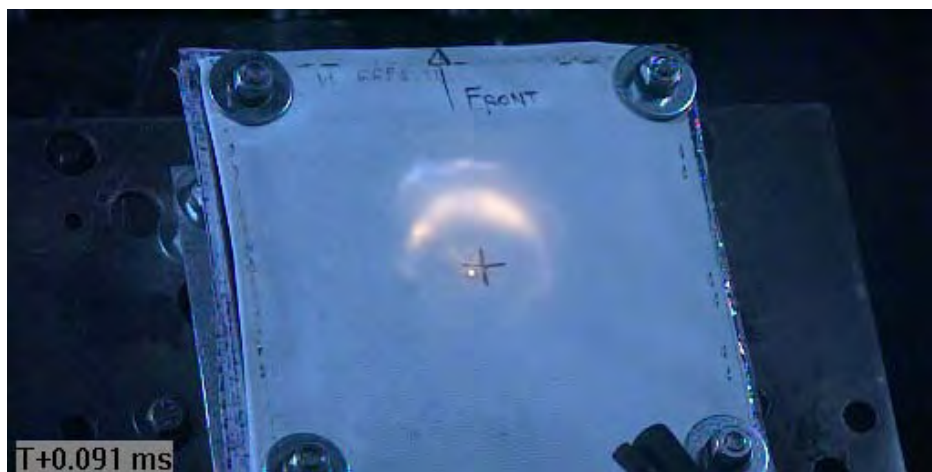
Figure C29 Projectile Impacting Target (via Phantom v711)

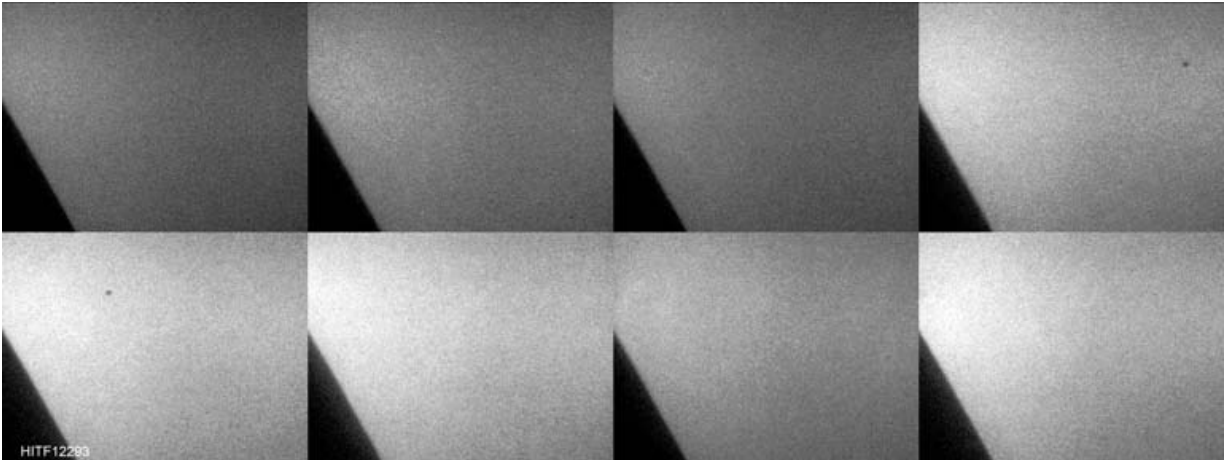
HITF12293 / Test #11

Figure C30 Projectile Captured Prior to Impact (via SIMX-8 Camera)

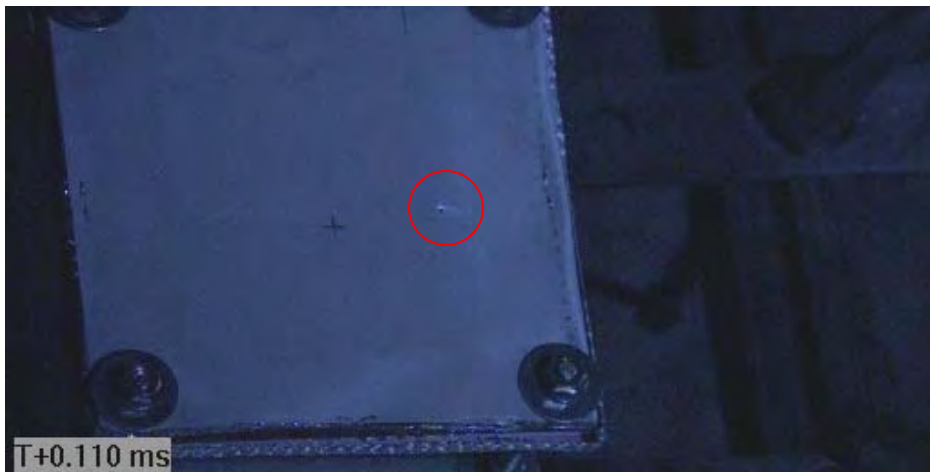
Figure C31 Image of Projectile Captured Prior to Impact (via Phantom v711 / projectile within red circle)

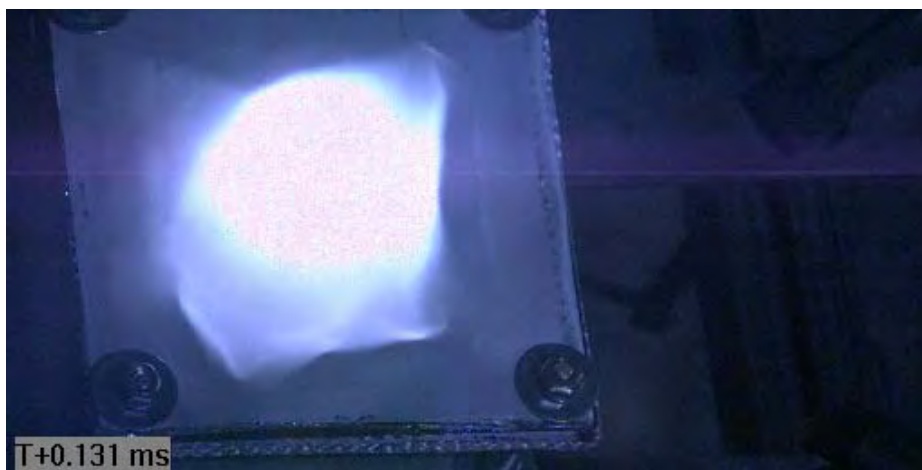
Figure C32 Projectile Impacting Target (via Phantom v711)

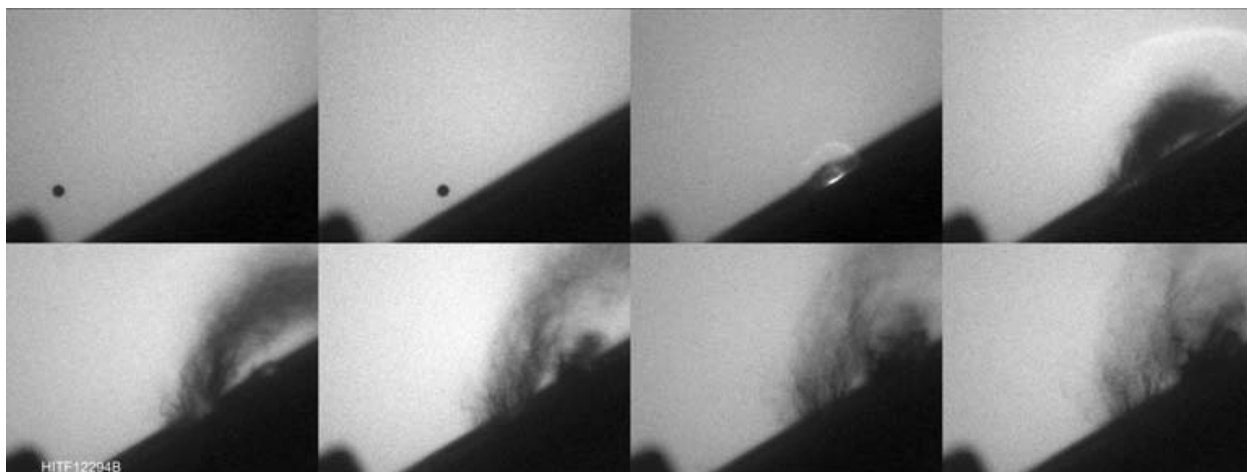
HITF12294 / Test #12

Figure C33 Projectile Captured Prior to Impact and Impacting Target (via SIMX-8 Camera)

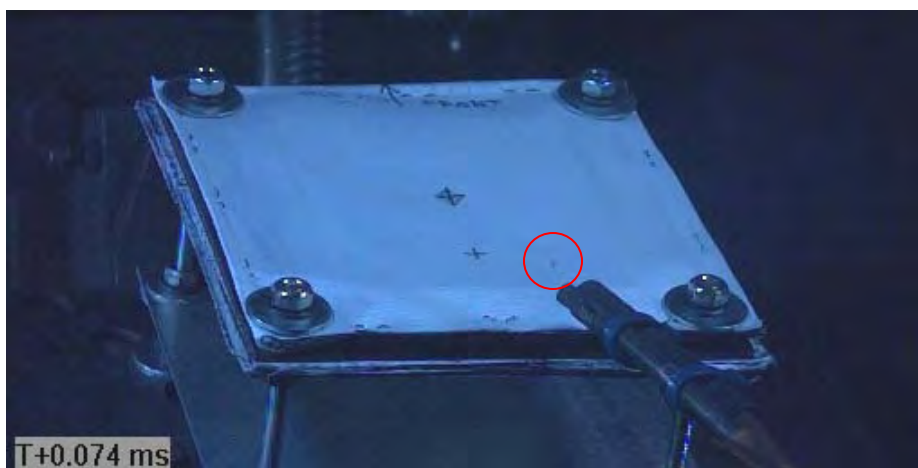
Figure C34 Image of Projectile Captured Prior to Impact (via Phantom v711 / projectile within red circle)

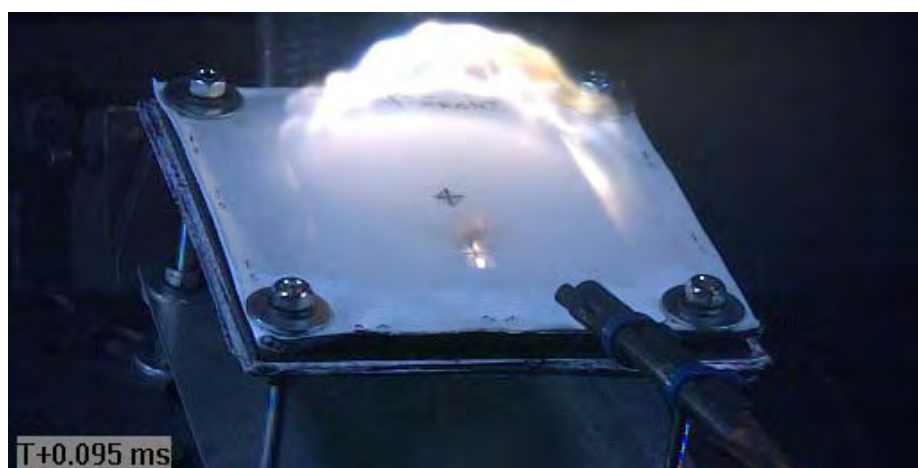
Figure C35 Projectile Impacting Target (via Phantom v711)

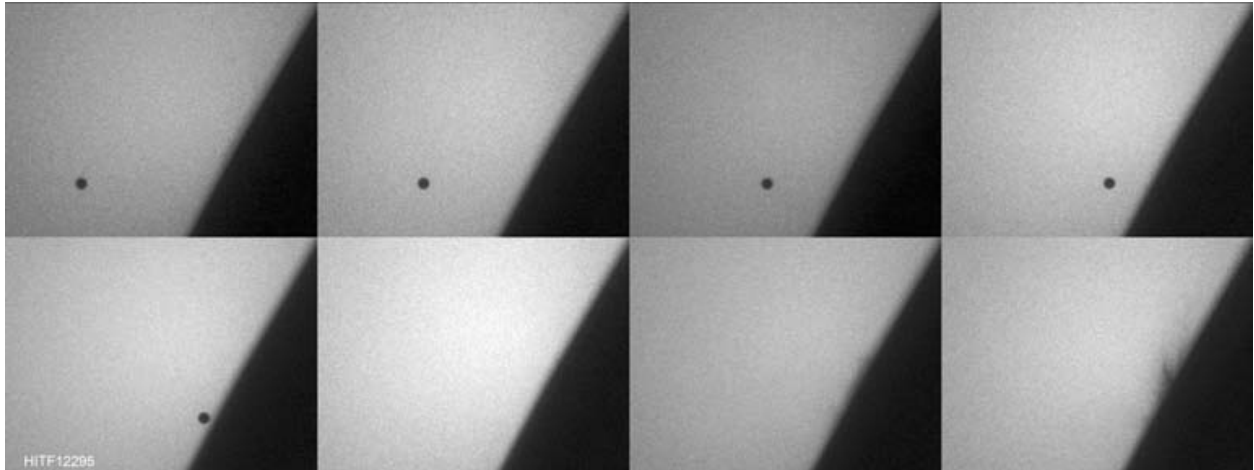
HITF12295 / Test #13

Figure C36 Projectile Captured Prior to Impact and Impacting Target (via SIMX-8 Camera)

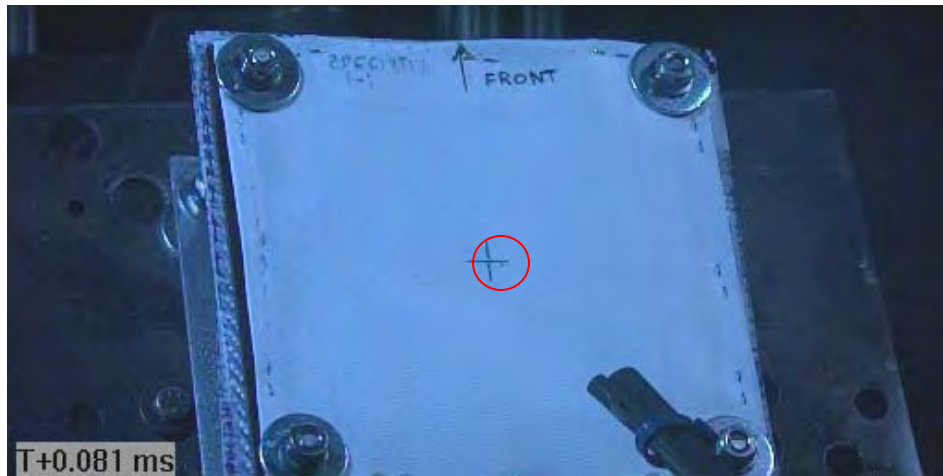
Figure C37 Image of Projectile Captured Prior to Impact (via Phantom v711 / projectile within red circle)

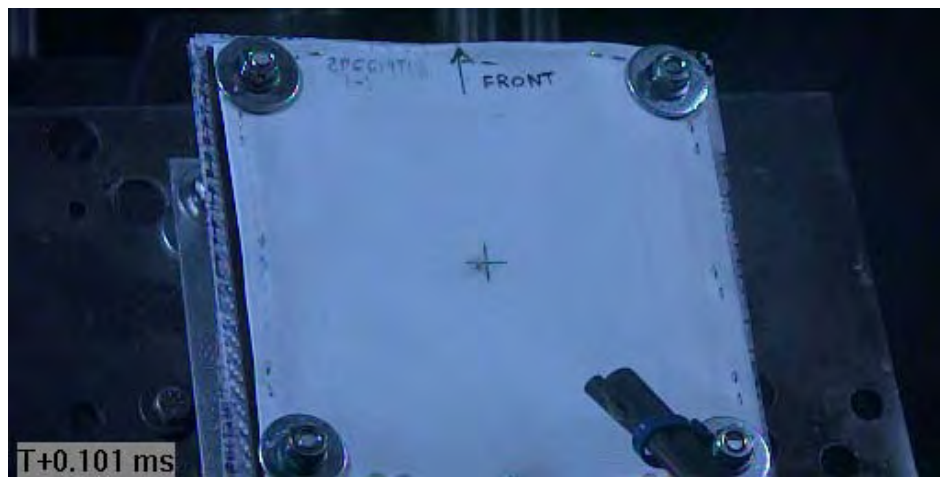
Figure C38 Projectile Impacting Target (via Phantom v711)

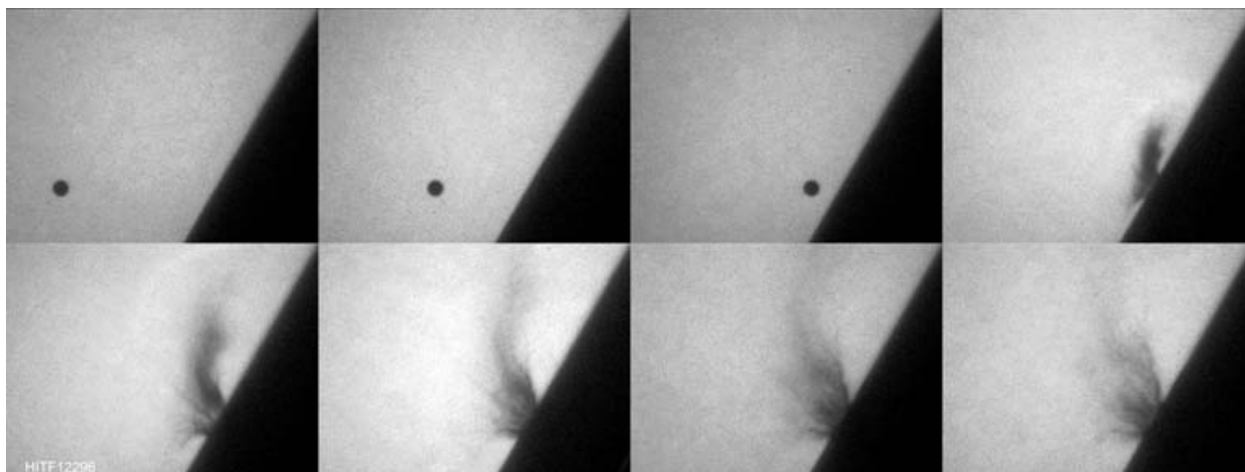
HITF12296 / Test #14

Figure C39 Projectile Captured Prior to Impact and Impacting Target (via SIMX-8 Camera)

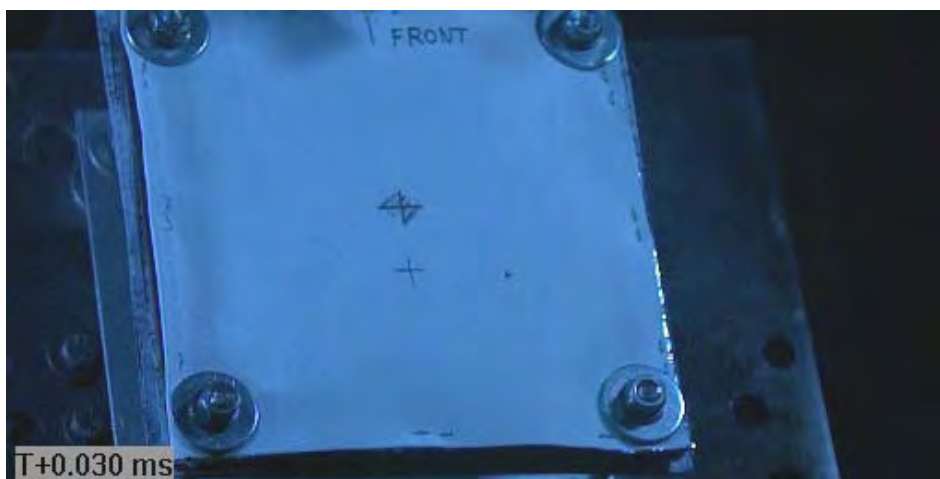
Figure C40 Image of Projectile Captured Prior to Impact (via Phantom v711 / projectile within red circle)

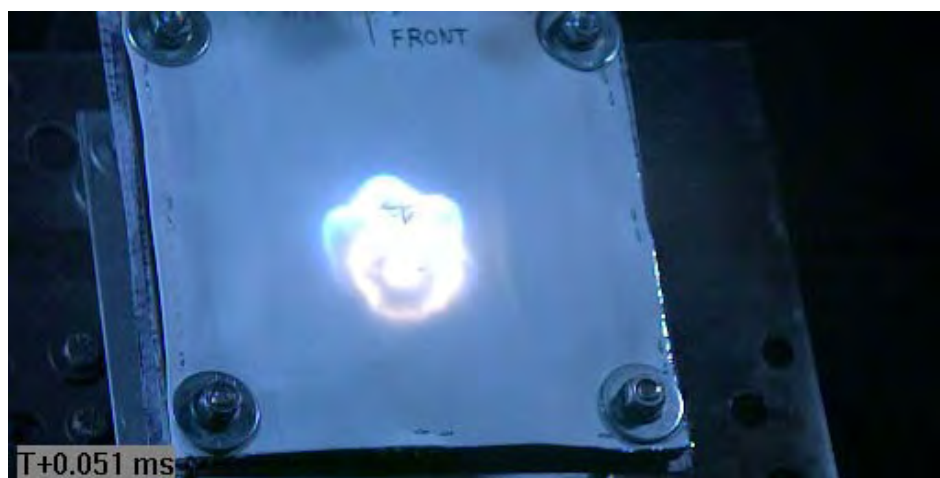
Figure C41 Projectile Impacting Target (via Phantom v711)

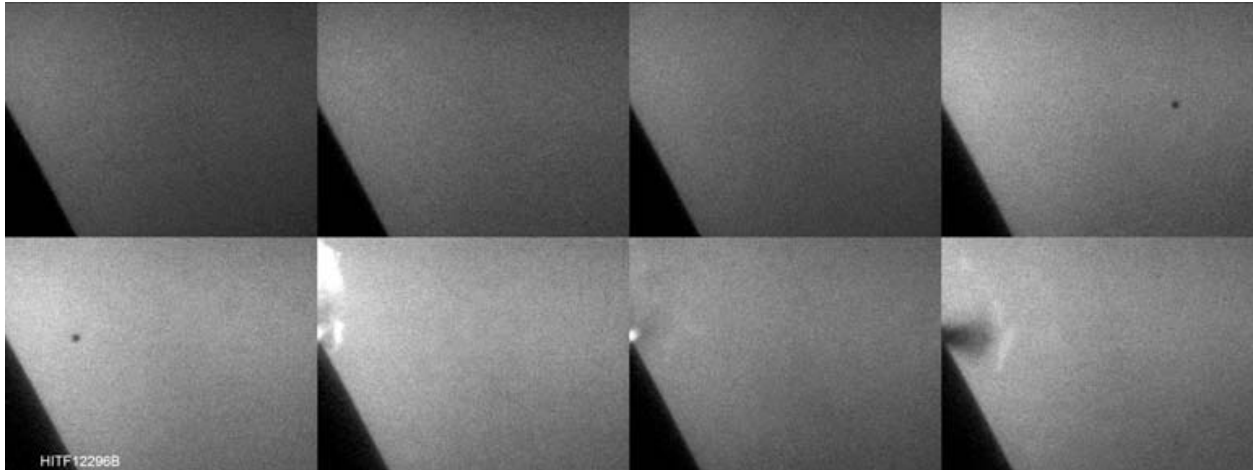
HITF12296-B / Test #14-B

Figure C42 Projectile Captured Prior to Impact and Impacting Target (via SIMX-8 Camera)

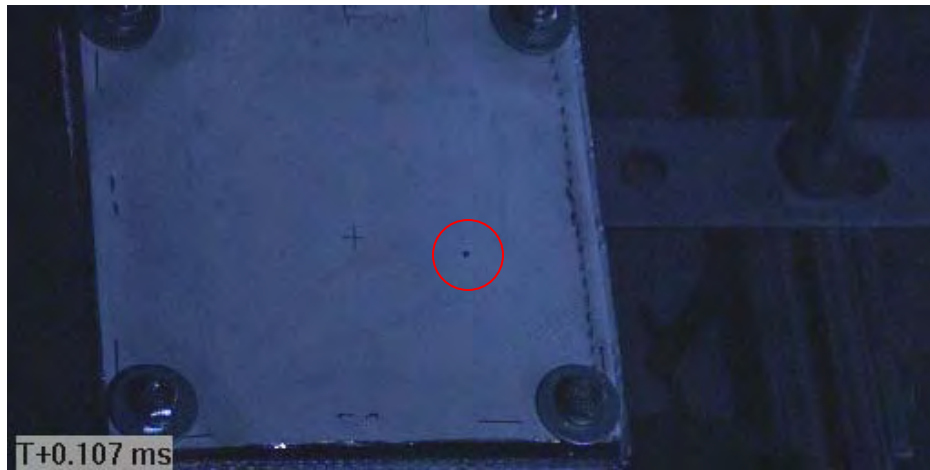
Figure C43 Image of Projectile Captured Prior to Impact (via Phantom v711 / projectile within red circle)

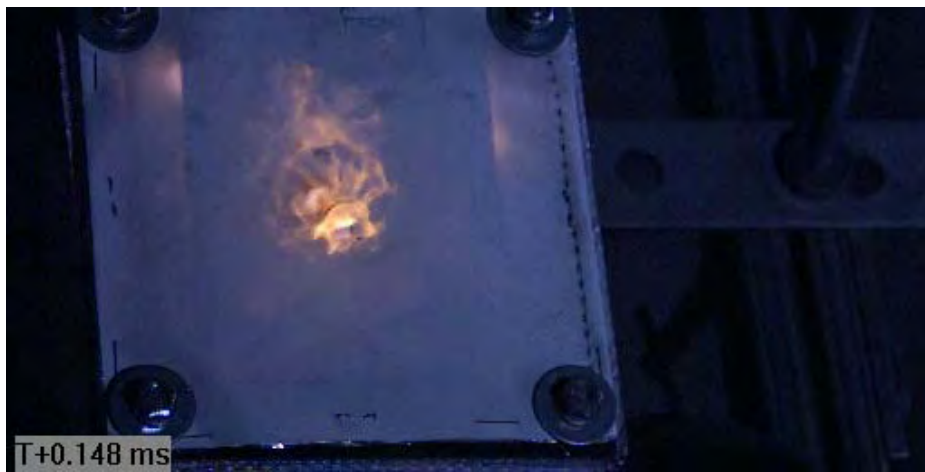
Figure C44 Projectile Impacting Target (via Phantom v711)

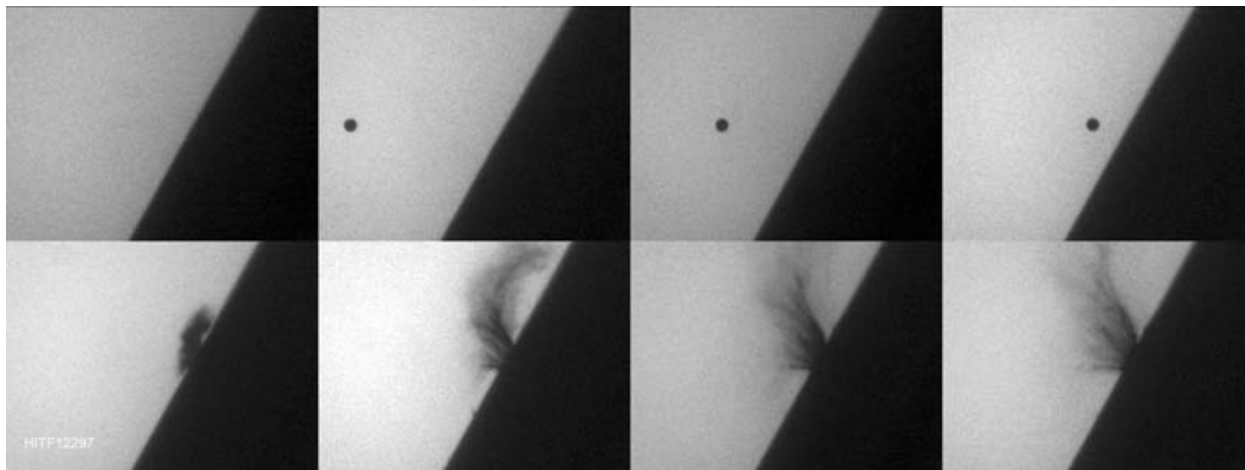
HITF12297 / Test #15

Figure C45 Projectile Captured Prior to Impact and Impacting Target (via SIMX-8 Camera)

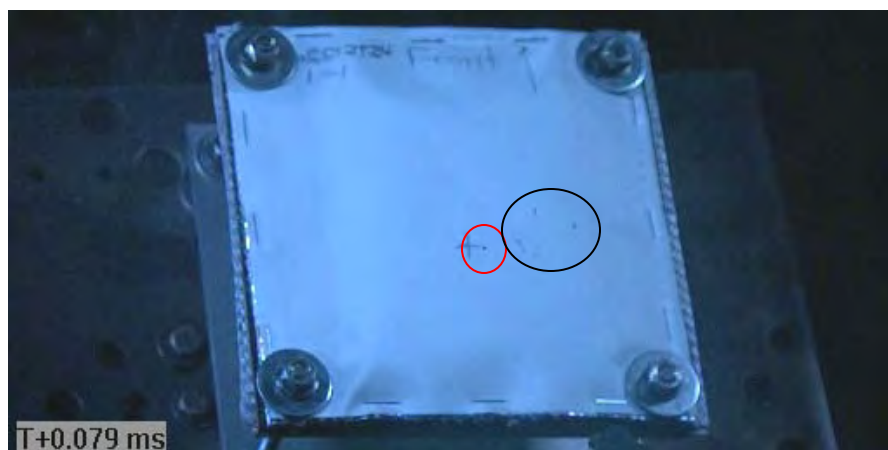
Figure C46 Image of Projectile and Secondary Debris Captured Prior to Impact (via Phantom v711 / projectile within red circle / secondary debris within black circle)

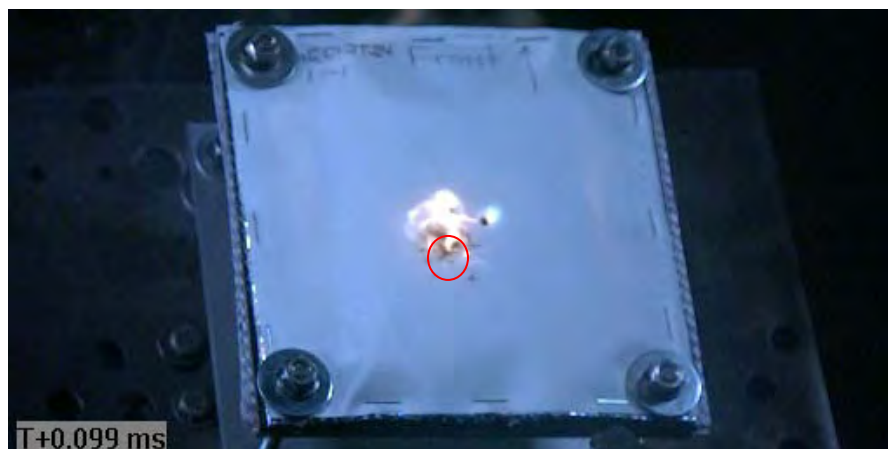
Figure C47 Image of Projectile and Secondary Debris Impacting Target (via Phantom v711 / projectile impacting within red circle, the remaining impacts are secondary debris)
