International Space Station (ISS) Soyuz Vehicle Descent Module Evaluation of Thermal Protection System (TPS) Penetration Characteristics

Hypervelocity Impact Technology Group

February 2013

**International Space Station (ISS) Soyuz Vehicle
Descent Module Evaluation of Thermal Protection
System (TPS) Penetration Characteristics**

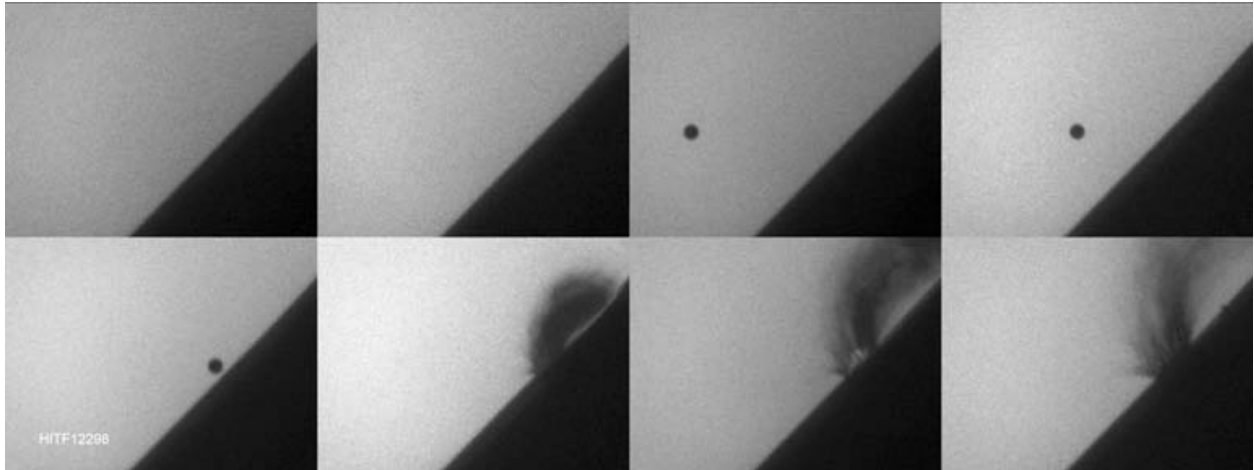
HITF12298 / Test #16

Figure C48 Projectile Captured Prior to Impact and Impacting Target (via SIMX-8 Camera)

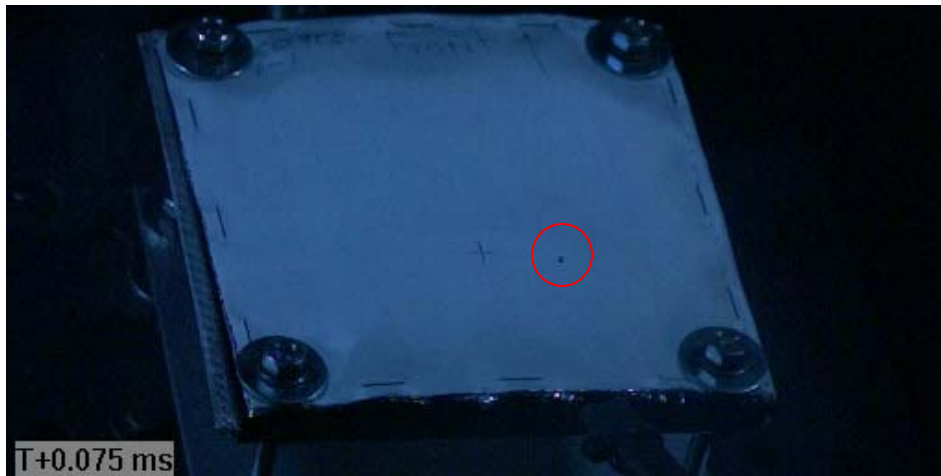
Figure C49 Image of Projectile Captured Prior to Impact (via Phantom v711 / projectile within red circle)

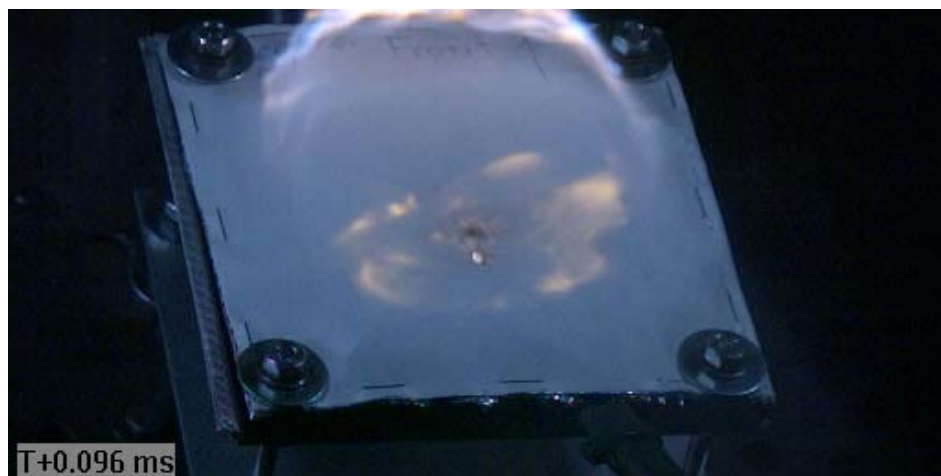
Figure C50 Projectile Impacting Target (via Phantom v711)

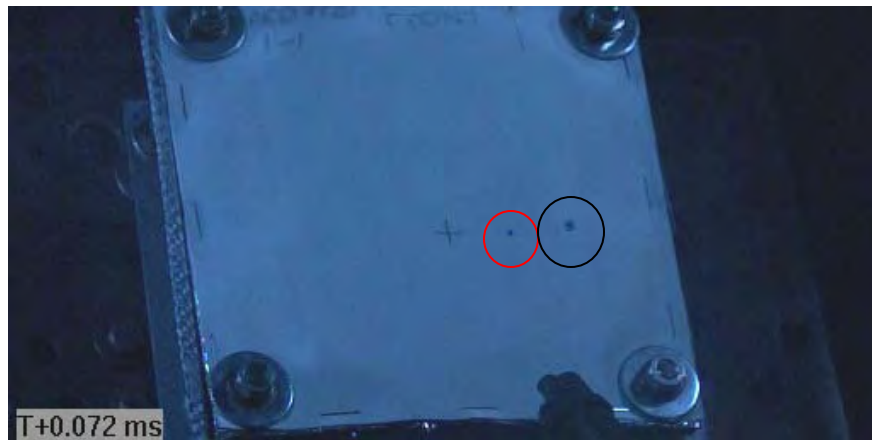
Figure C52 Image of Projectile and Secondary Debris Captured Prior to Impact (via Phantom v711 / projectile within red circle / secondary debris within black circle)

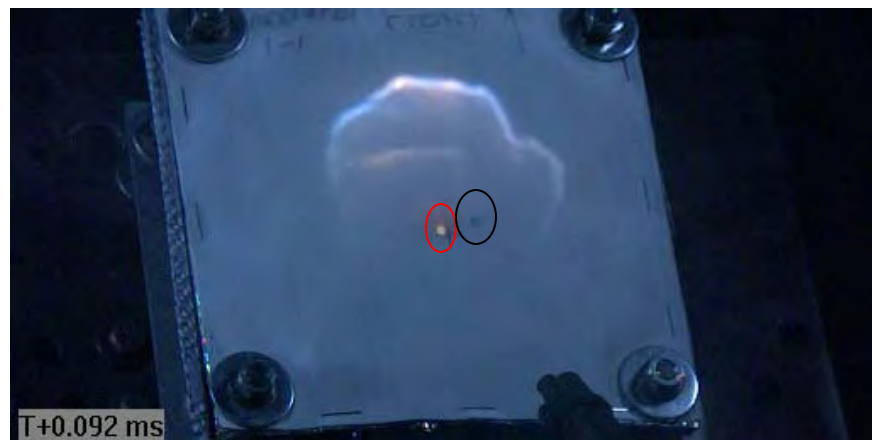
Figure C53 Image of Projectile Impacting Target and Secondary Debris Just Prior to Impacting Target (via Phantom v711 / projectile impacting within red circle / secondary debris within black circle and impacted directly above projectile entry damage)

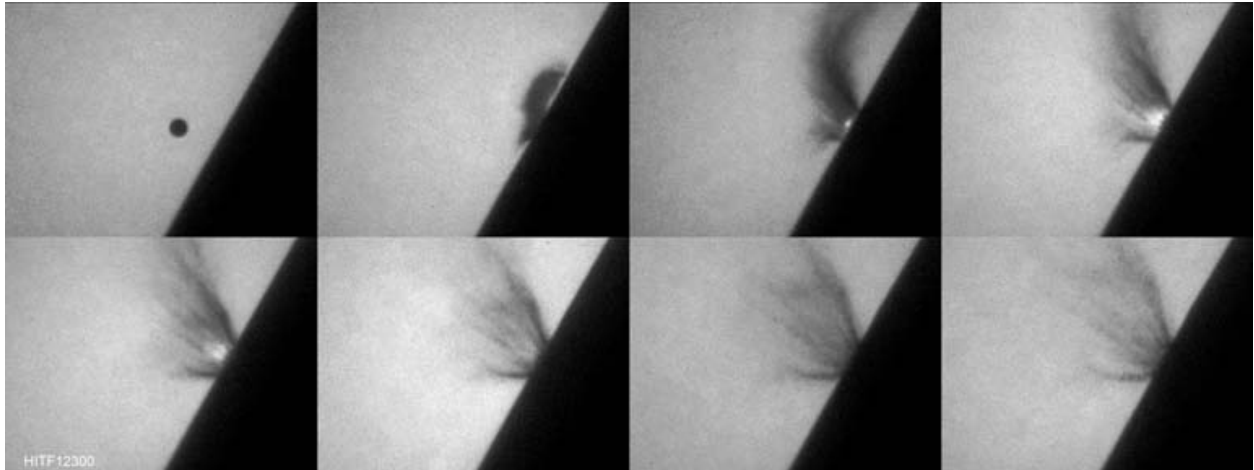
HITF12300 / Test #18

Figure C54 Projectile Captured Prior to Impact and Impacting Target (via SIMX-8 Camera)

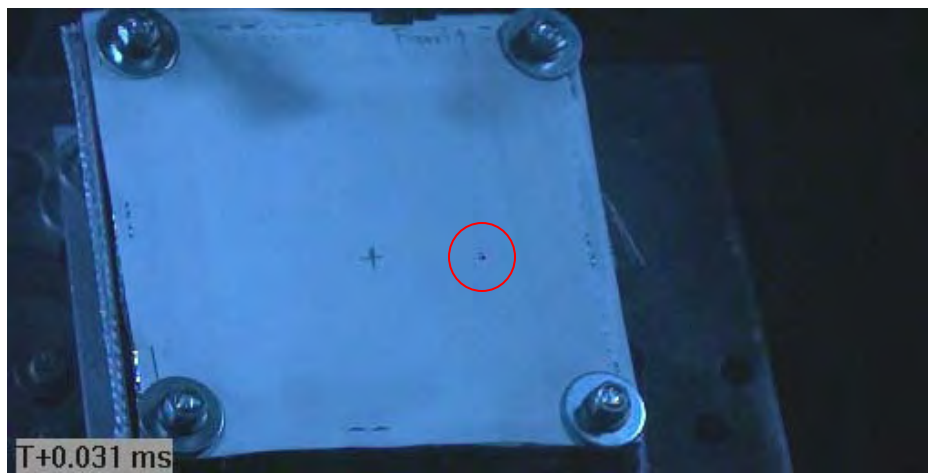
Figure C55 Image of Projectile Captured Prior to Impact (via Phantom v711 / projectile within red circle)

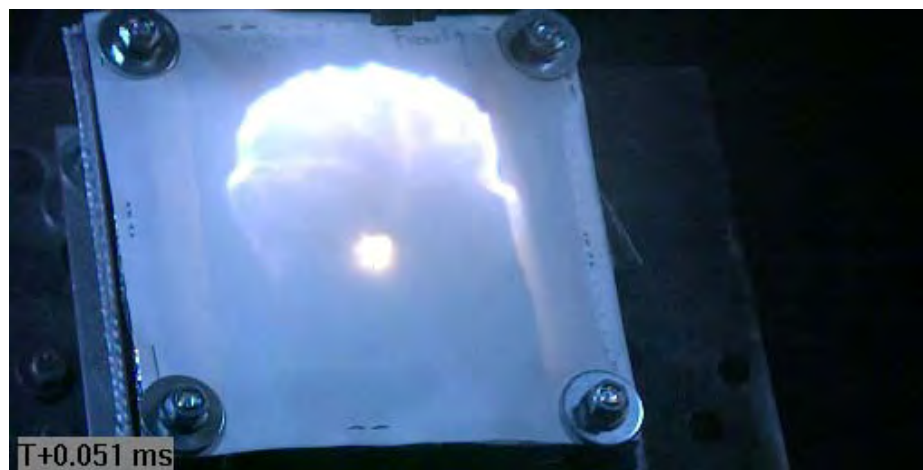
Figure C56 Projectile Impacting Target (via Phantom v711)

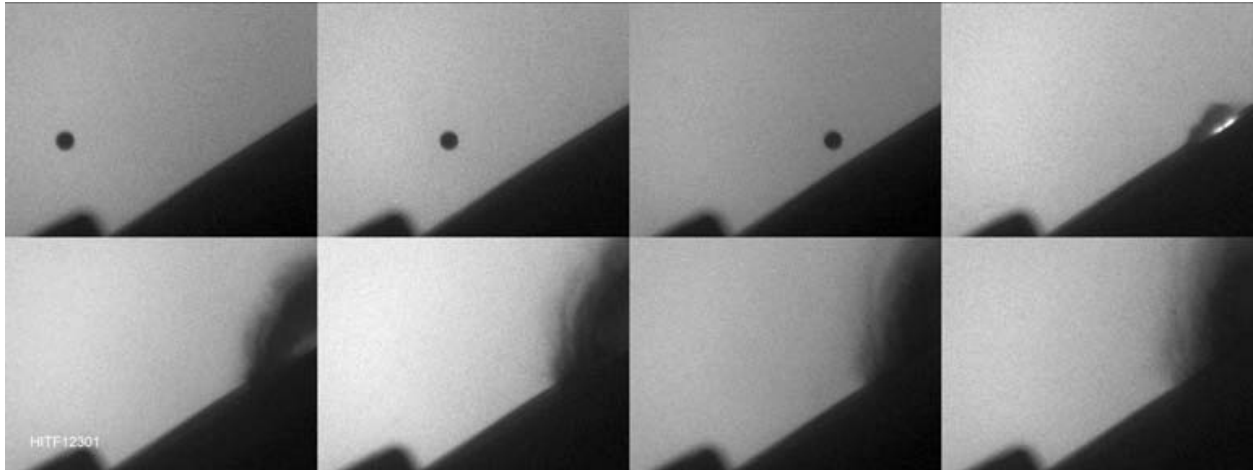
HITF12301 / Test #19

Figure C57 Projectile Captured Prior to Impact and Impacting Target (via SIMX-8 Camera)

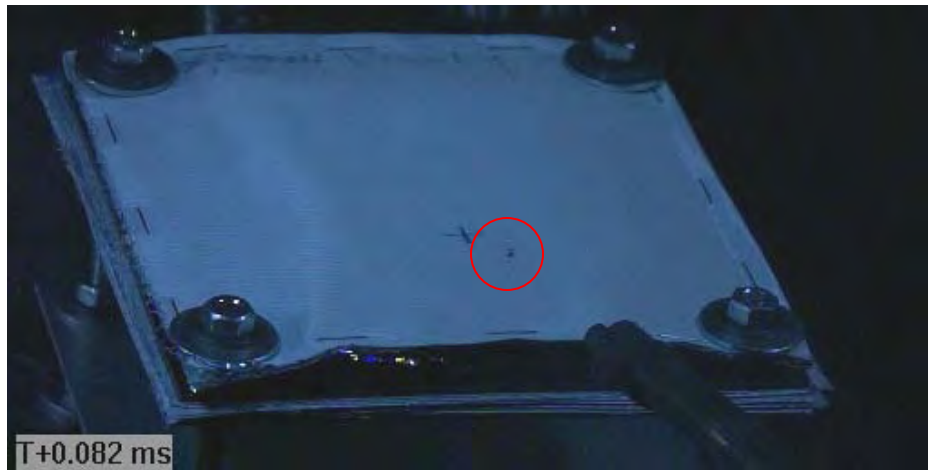
Figure C58 Image of Projectile Captured Prior to Impact (via Phantom v711 / projectile within red circle)

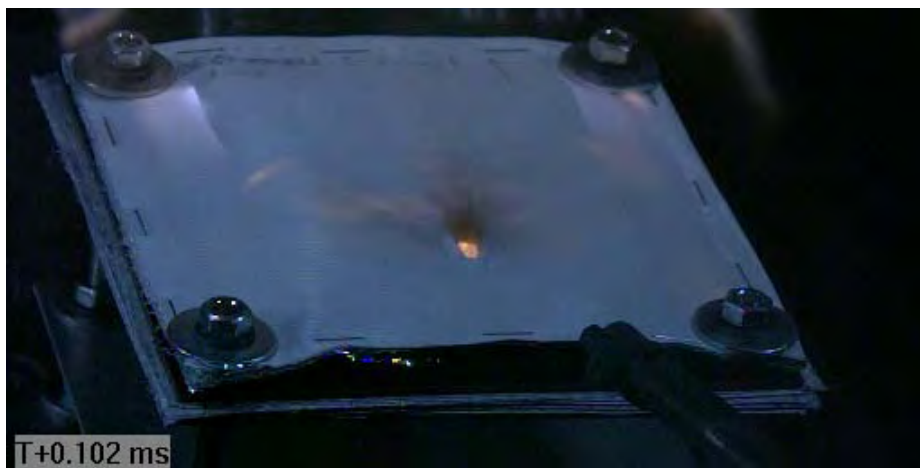
Figure C59 Projectile Impacting Target (via Phantom v711)

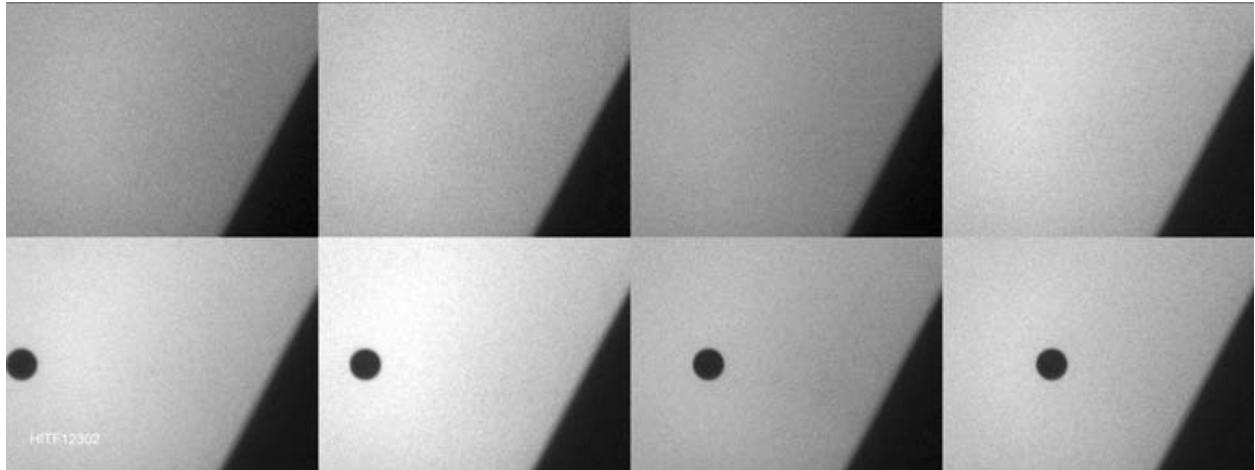
HITF12302 / Test #20

Figure C60 Projectile Captured Prior to Impacting Target (via SIMX-8 Camera)

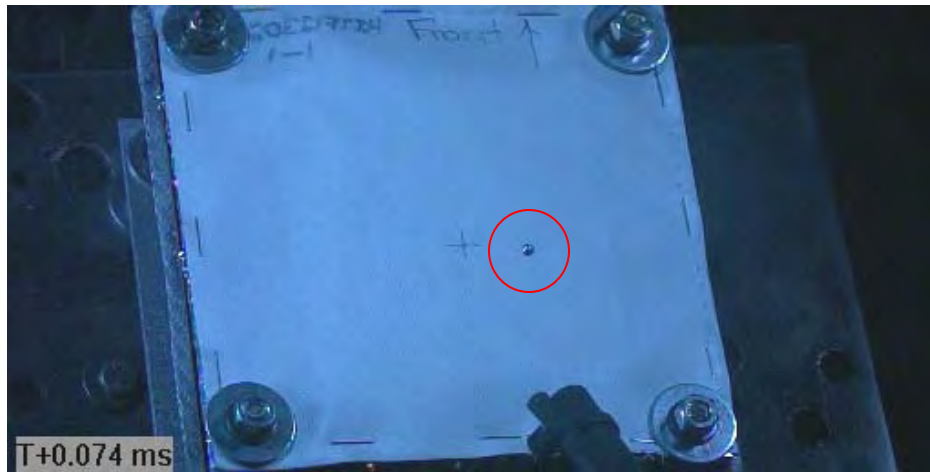
Figure C61 Image of Projectile Captured Prior to Impact (via Phantom v711 / projectile within red circle)

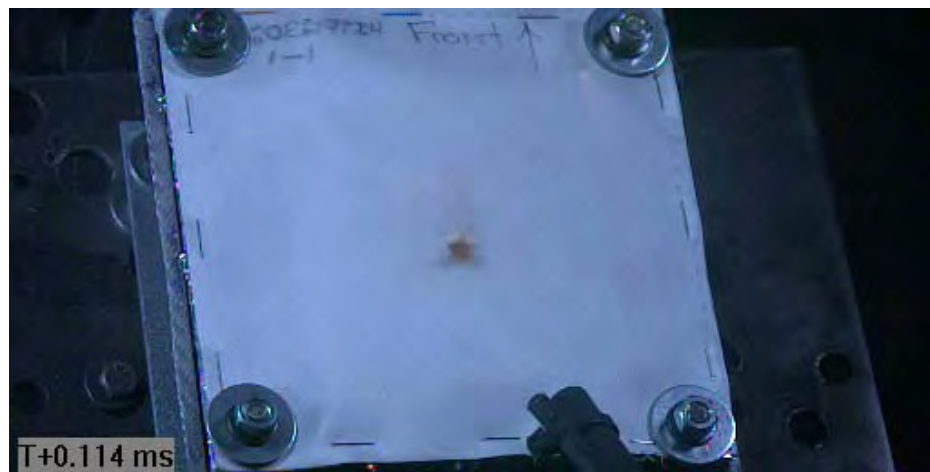
Figure C62 Projectile Impacting Target (via Phantom v711)

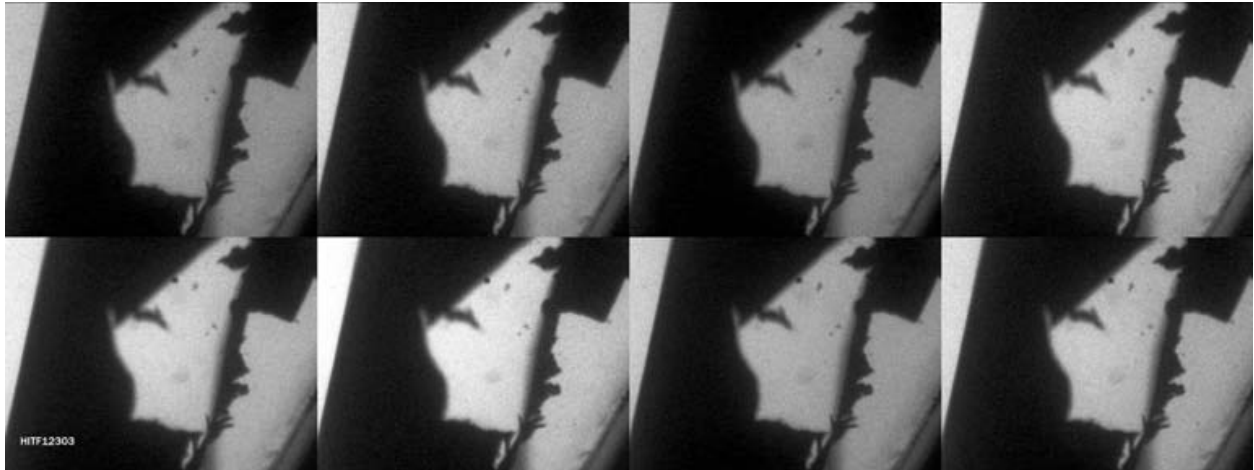
HITF12303 / Test #21

Figure C63 Projectile Not Captured Prior to Impact (via SIMX-8 Camera / camera triggered after impact occurred)

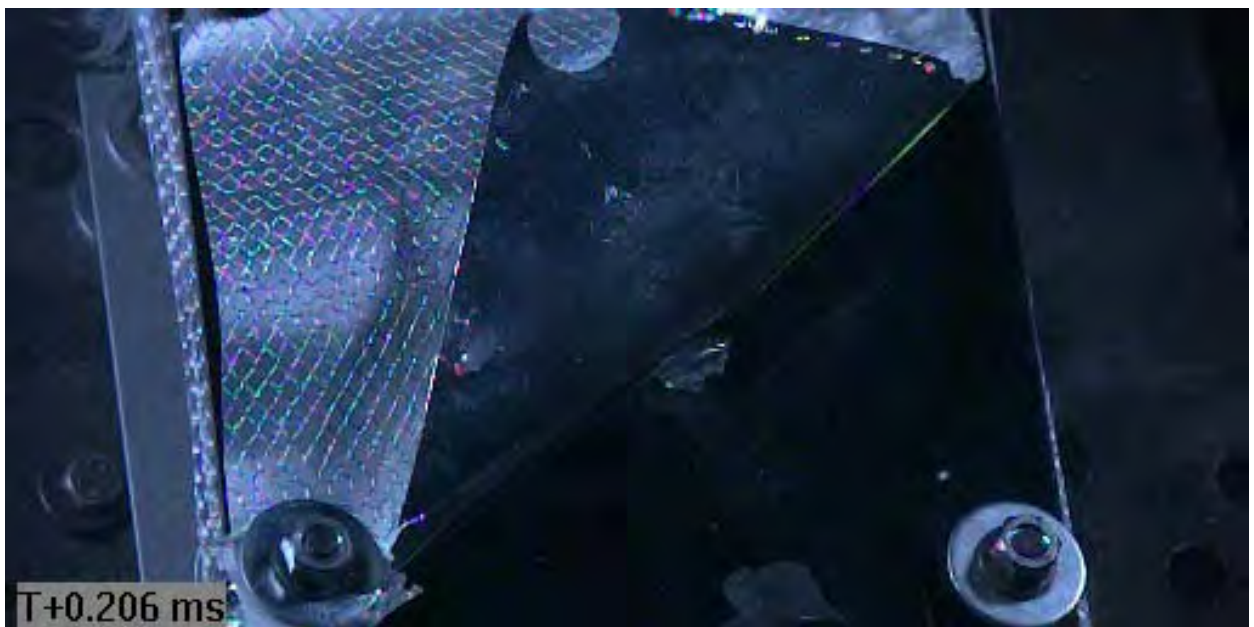
Figure C64 Projectile Not Captured Prior to Impact (Phantom v711 Camera / camera triggered after impact occurred)

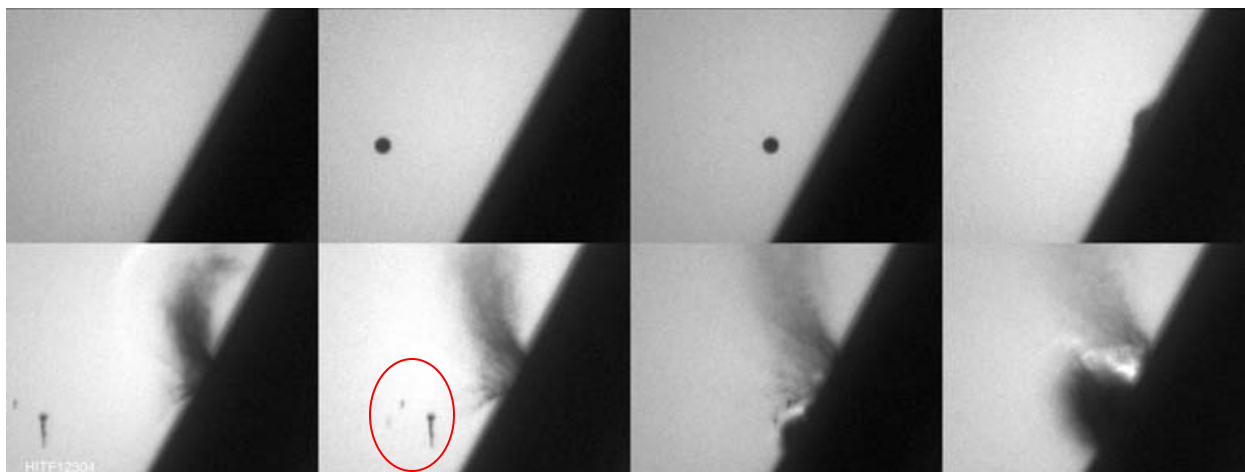
HITF12304 / Test #22

Figure C65 Projectile and Secondary Debris Captured Prior to Impact and Impacting Target (via SIMX-8 Camera / secondary debris within red circle)

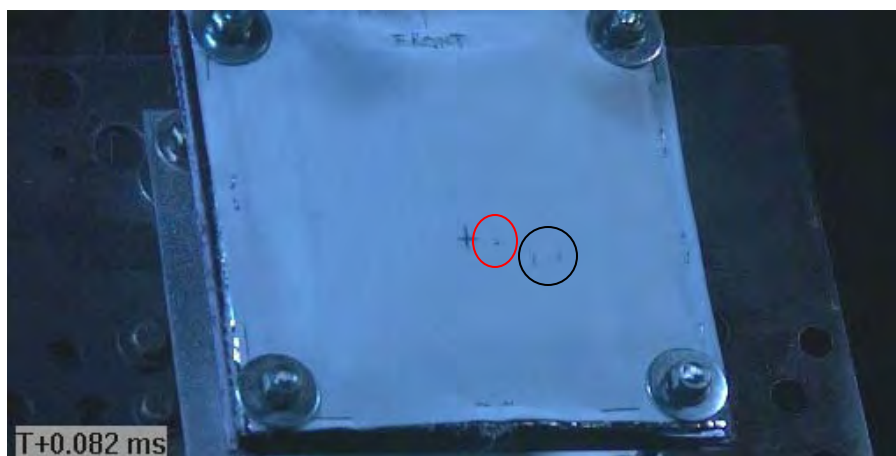
Figure C66 Image of Projectile and Secondary Debris Captured Prior to Impact (via Phantom v711 / projectile within red circle / secondary debris within black circle)

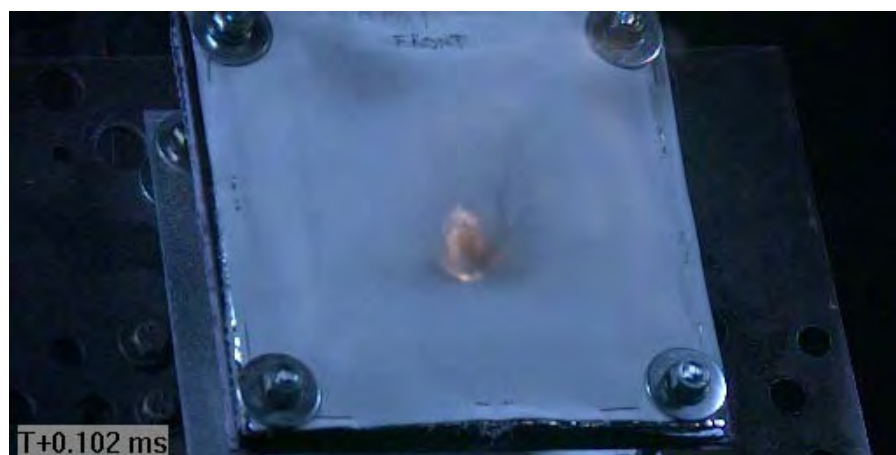
Figure C67 Image of Projectile and Secondary Debris Impacting Target (via Phantom v711)

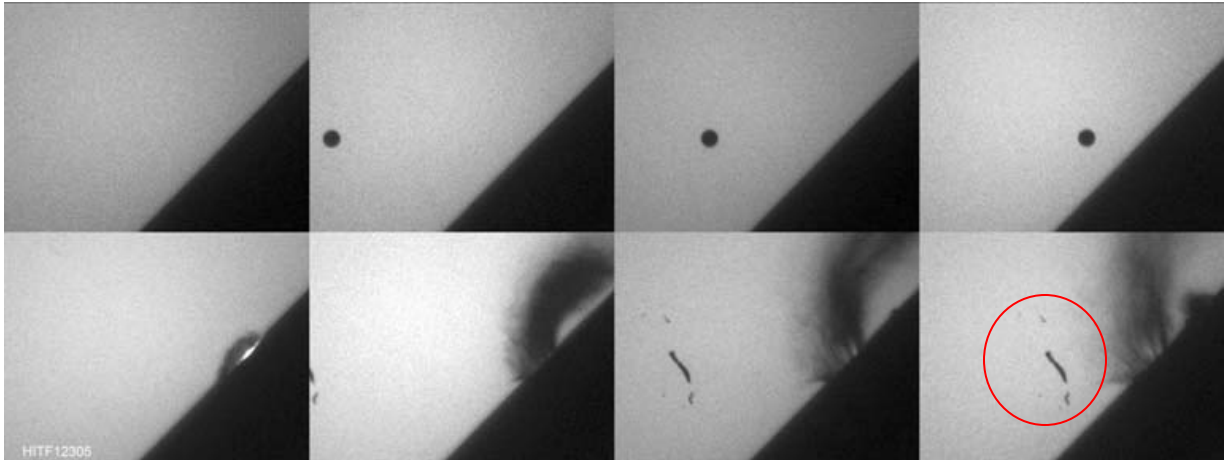
HITF12305 / Test #23

Figure C68 Projectile and Secondary Debris Captured Prior to Impact and Impacting Target (via SIMX-8 Camera / secondary debris within red circle)

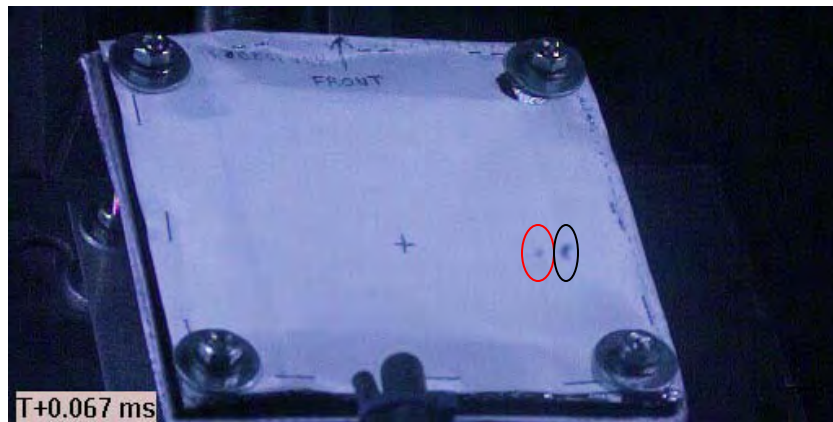
Figure C69 Image of Projectile and Secondary Debris Captured Prior to Impact (via Phantom v711 / projectile within red circle / secondary debris within black circle)

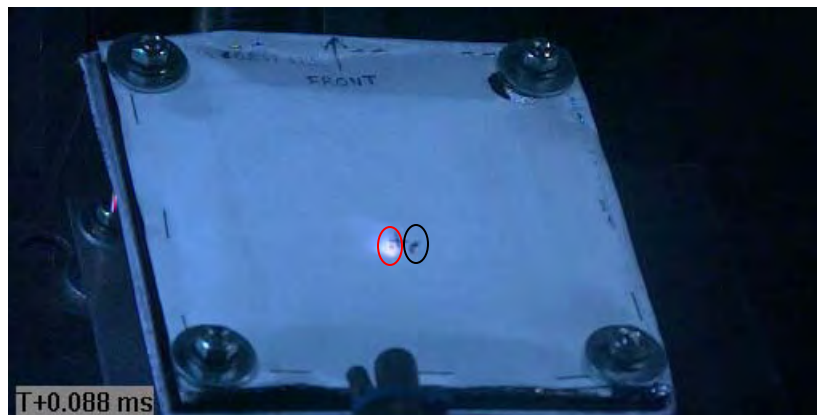
Figure C70 Image of Projectile Impacting Target and Secondary Debris Just Prior to Impacting Target (via Phantom v711 / projectile impacting within red circle / secondary debris within black circle and impact directly behind projectile entry damage)

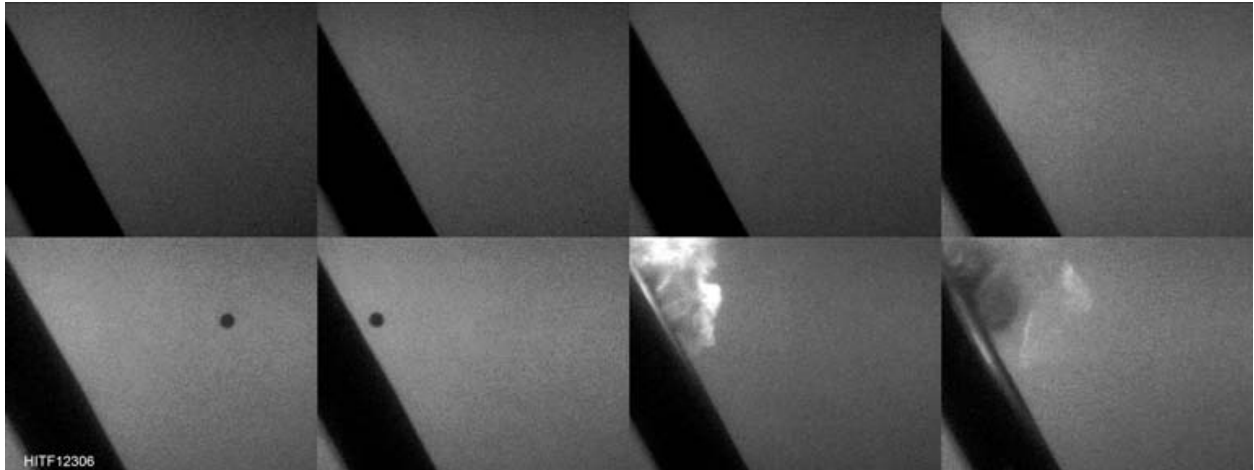
HITF12306 / Test #24

Figure C71 Projectile Captured Prior to Impact and Impacting Target (via SIMX-8 Camera)

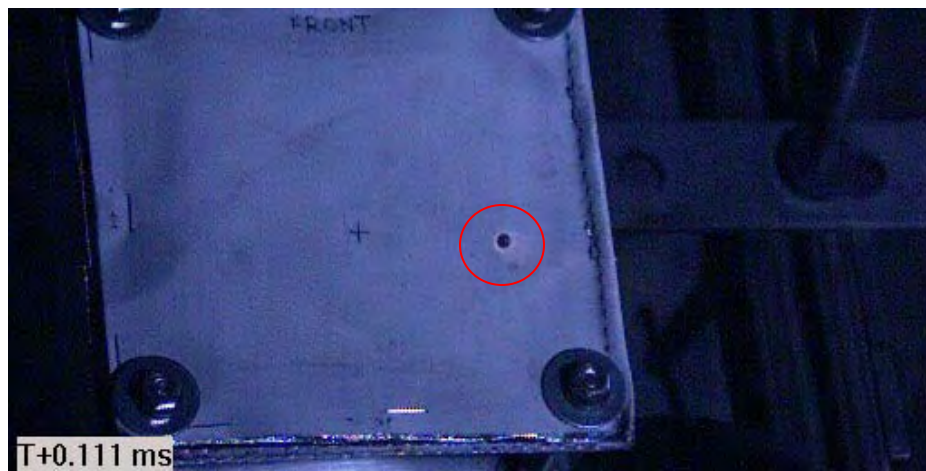
Figure C72 Image of Projectile Captured Prior to Impact (via Phantom v711 / projectile within red circle)

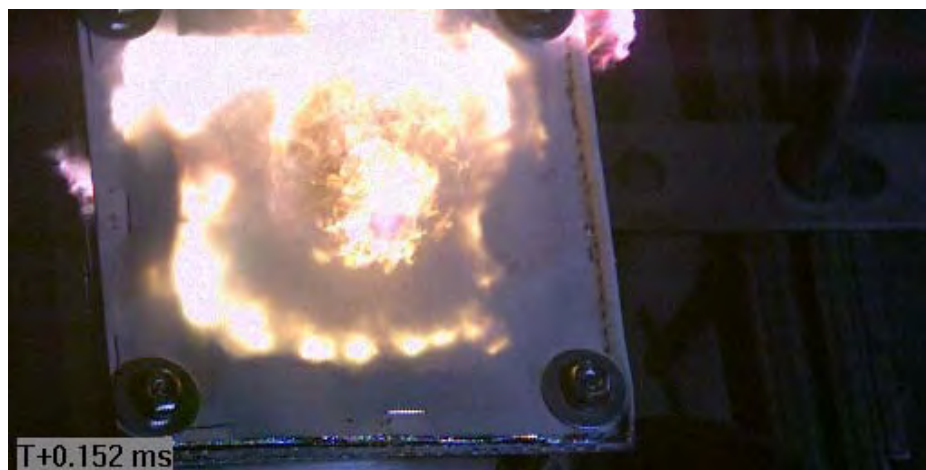
Figure C73 Projectile Impacting Target (via Phantom v711)

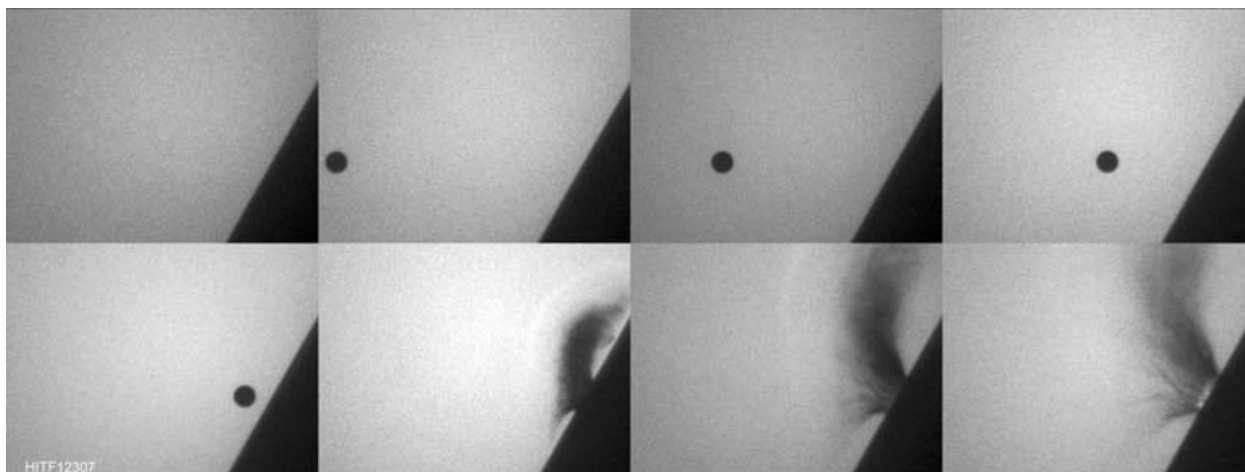
HITF12307 / Test #25

Figure C74 Projectile Captured Prior to Impact and Impacting Target (via SIMX-8 Camera)

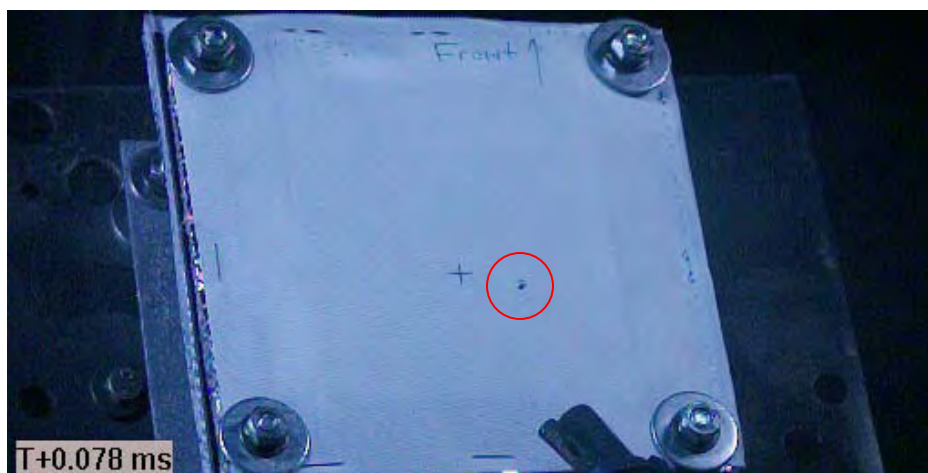
Figure C75 Image of Projectile Captured Prior to Impact (via Phantom v711 / projectile within red circle)

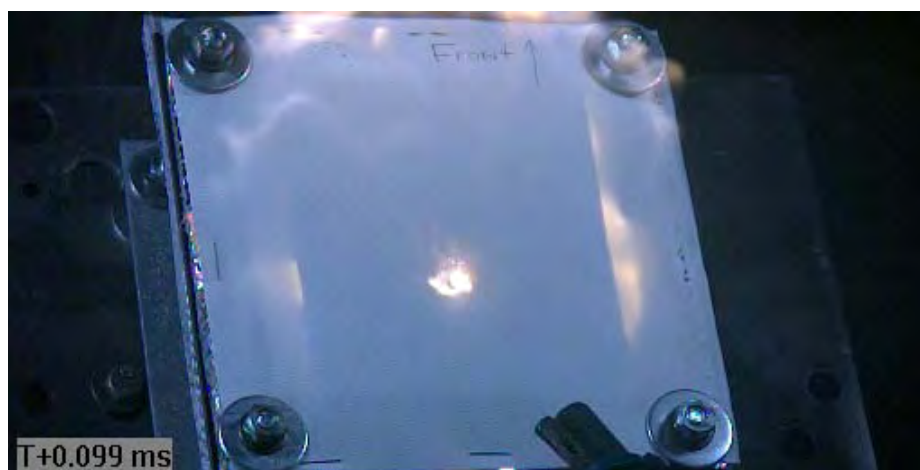
Figure C76 Projectile Impacting Target (via Phantom v711)

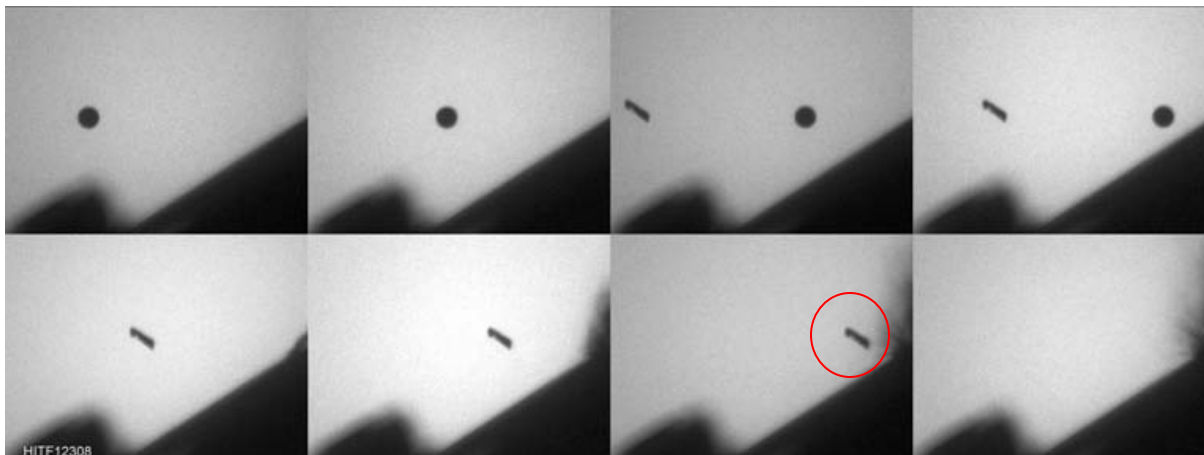
HITF12308 / Test #26

Figure C77 Projectile and Secondary Debris Captured Prior to Impact and Impacting Target (via SIMX-8 Camera / secondary debris within red circle)

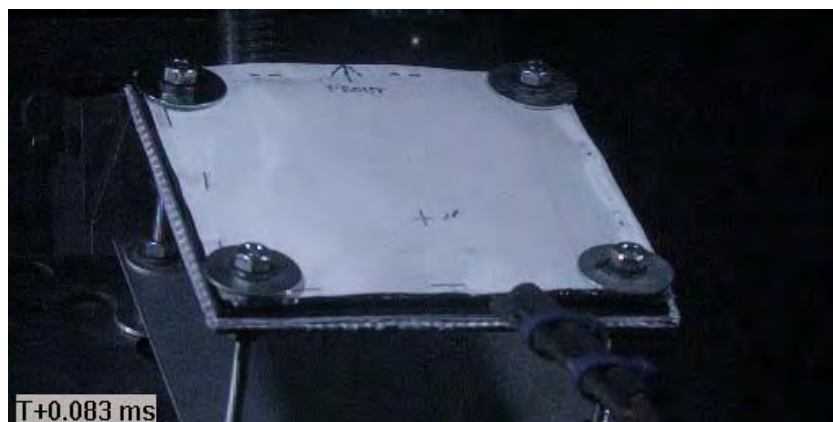
Figure C78 Image of Projectile and Secondary Debris Captured Prior to Impact (via Phantom v711 / projectile and secondary debris traveling close to one another)

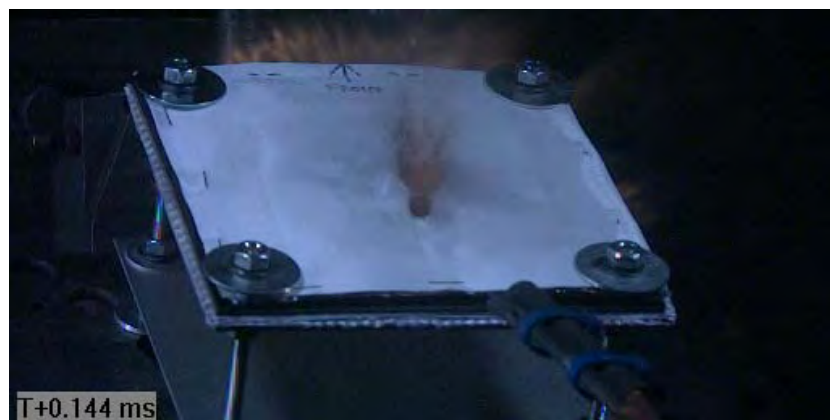
Figure C79 Image of Projectile and Secondary Debris Impacting Target (via Phantom v711 / the lower impact on the target was the projectile and secondary debris impacted above projectile impact)

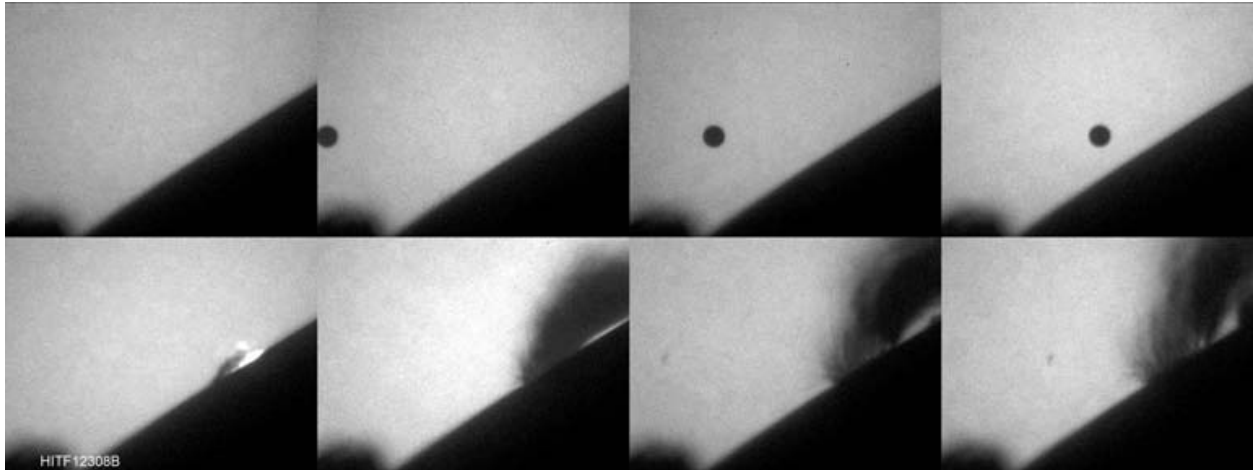
HITF12308-B / Test #26-B

Figure C80 Projectile Captured Prior to Impact and Impacting Target (via SIMX-8 Camera)

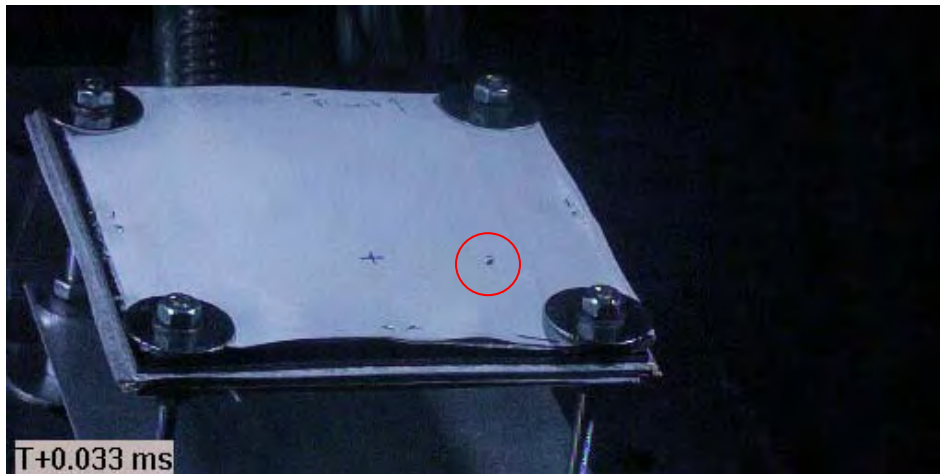
Figure C81 Image of Projectile Captured Prior to Impact (via Phantom v711 / projectile within red circle)

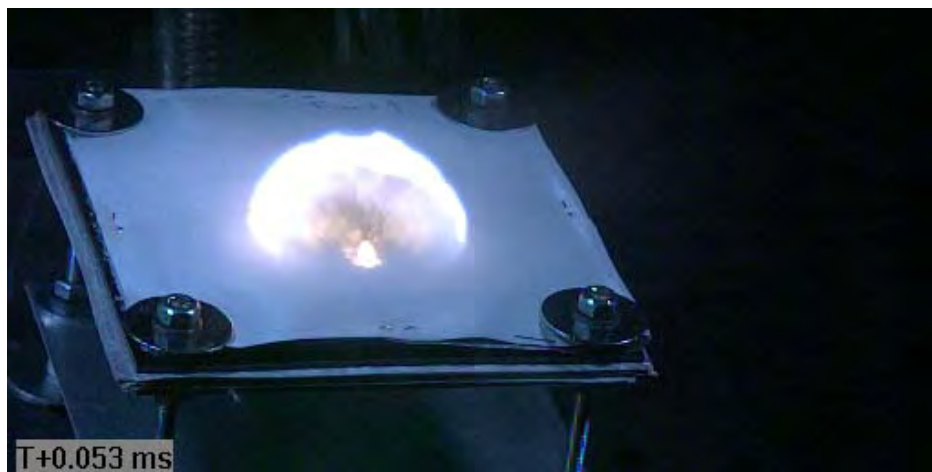
Figure C82 Image of Projectile Impacting Target (via Phantom v711)

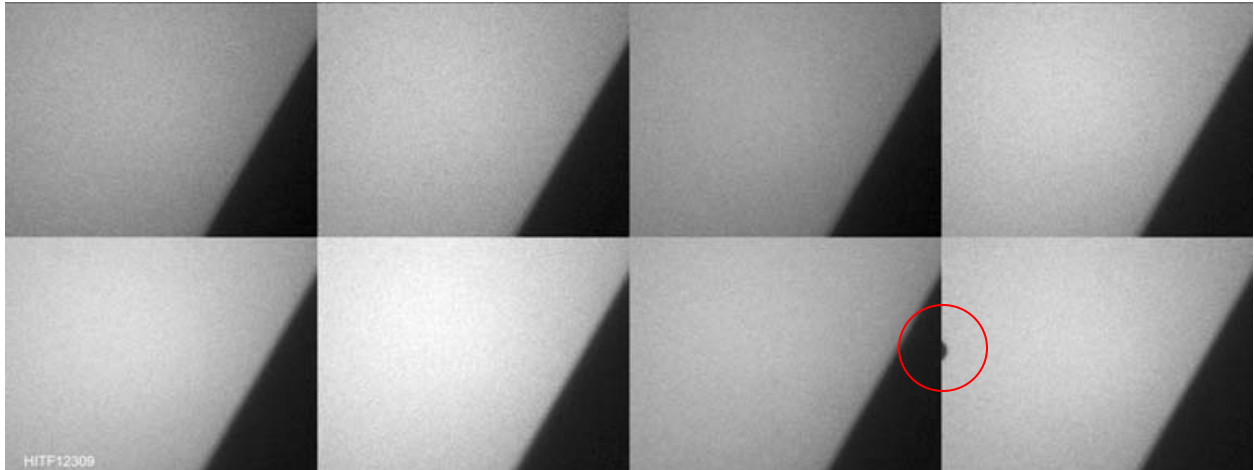
HITF12309 / Test #27

Figure C83 Partial Projectile Captured Prior to Impact (via SIMX-8 Camera / partial projectile within red circle)

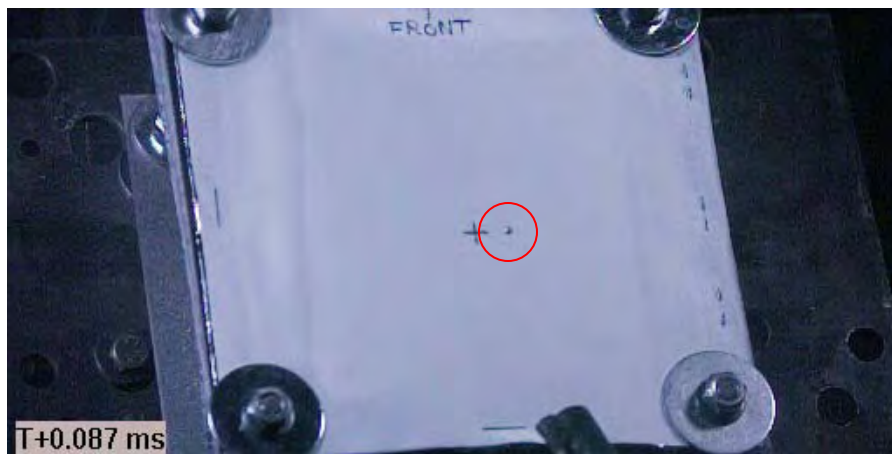
Figure C84 Image of Projectile Captured Prior to Impact (via Phantom v711 / projectile within red circle)

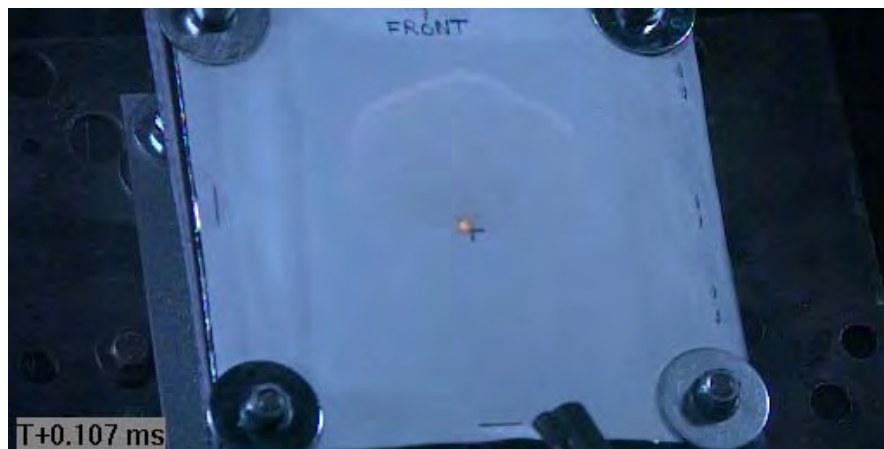
Figure C85 Image of Projectile Impacting Target (via Phantom v711)

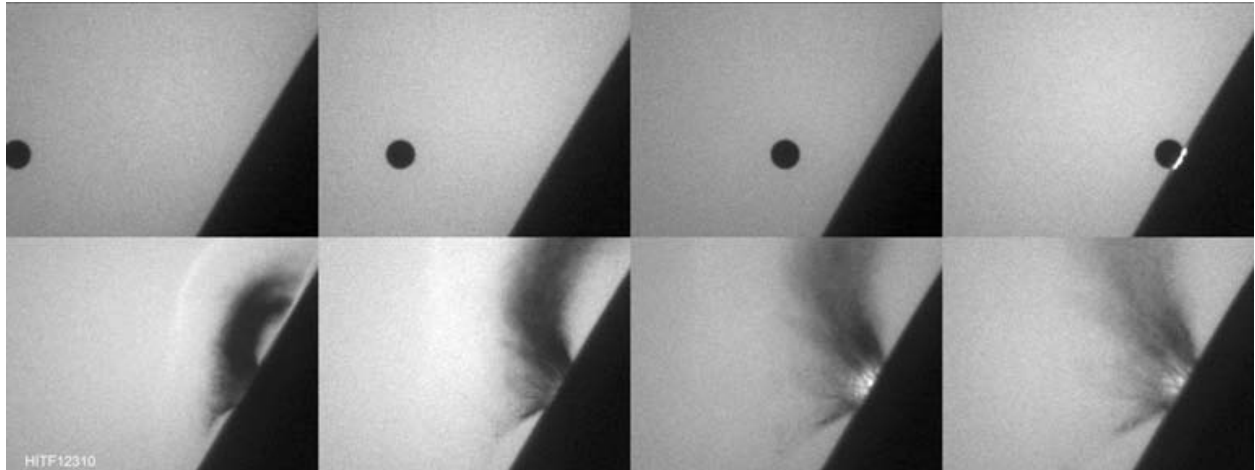
HITF12310 / Test #28

C86 Projectile Captured Prior to Impact and Impacting Target (via SIMX-8 Camera)

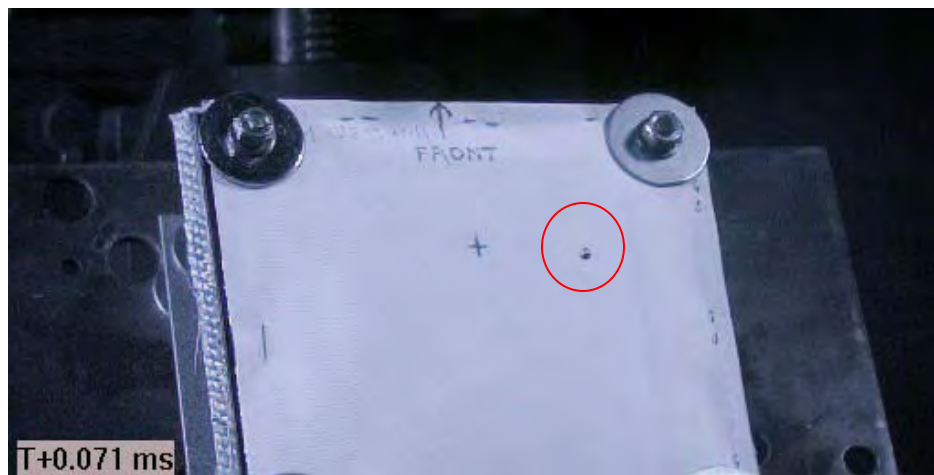
Figure C87 Image of Projectile Captured Prior to Impact (via Phantom v711 / projectile within red circle)

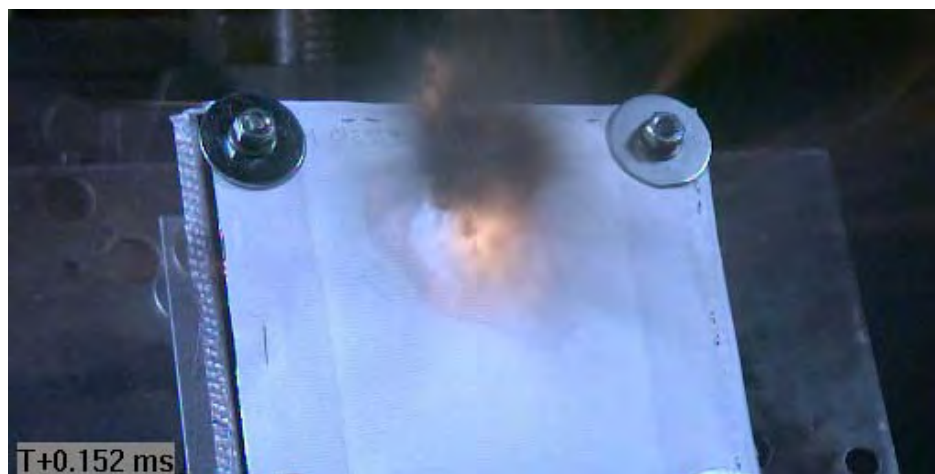
Figure C88 Image of Projectile Impacting Target (via Phantom v711)

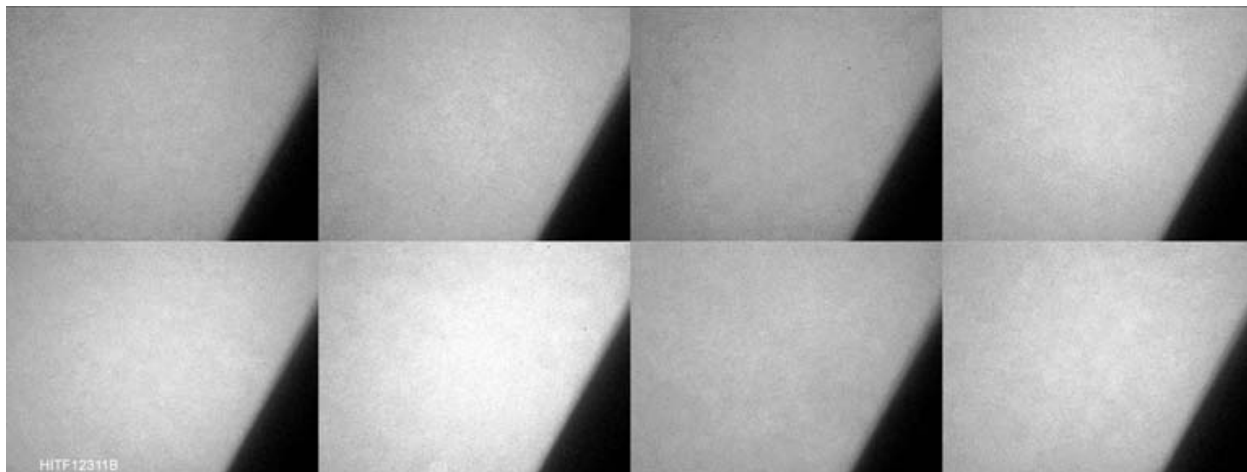
HITF12311 / Test #29

Figure C89 Projectile Not Captured Prior to Impact (via SIMX-8 Camera)

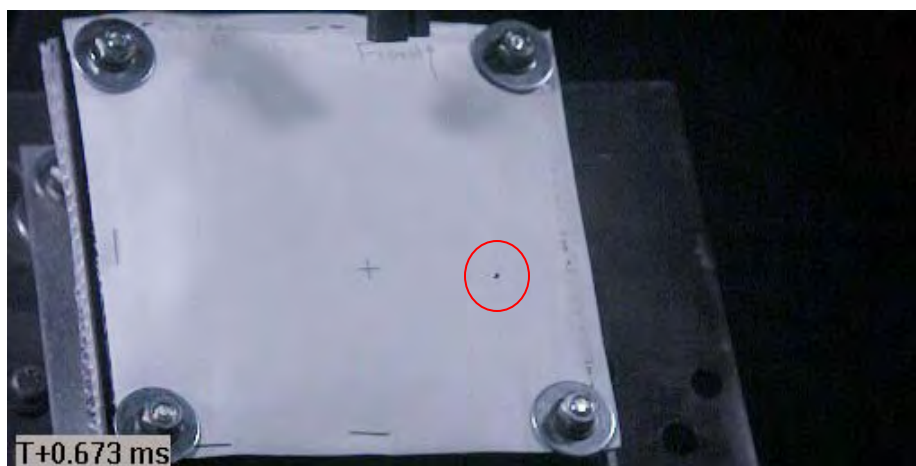
Figure C90 Image of Projectile Captured Prior to Impact (via Phantom v711 / projectile within red circle out of round)

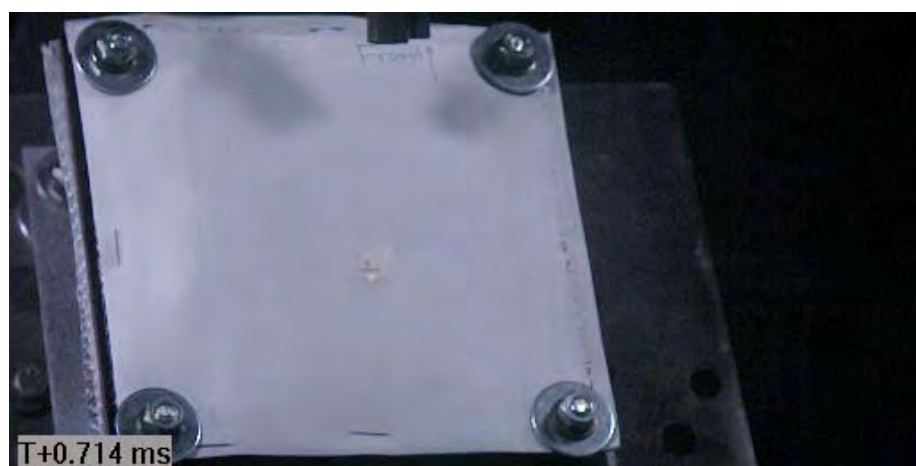
Figure C91 Image of Projectile Impacting Target (via Phantom v711)

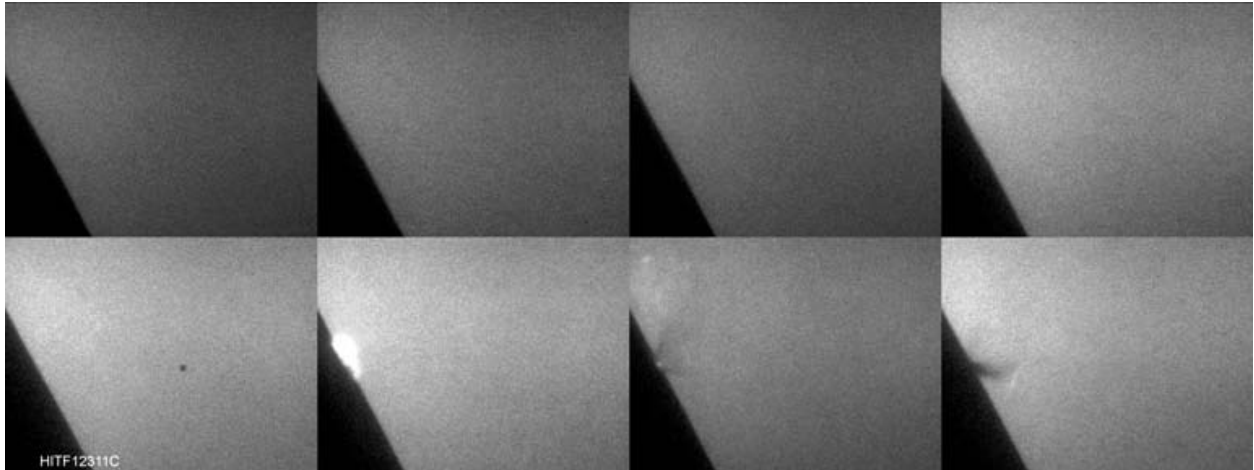
Figure C92 Projectile Captured Prior to Impact and Impacting Target (via SIMX-8 Camera)

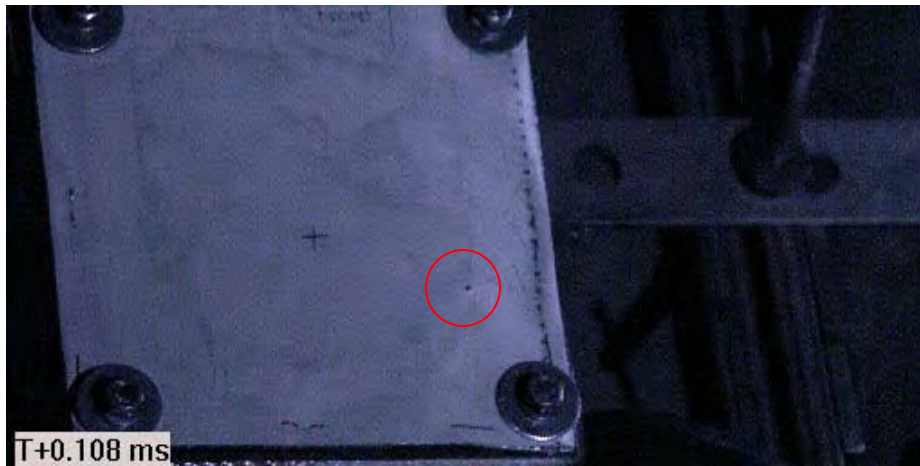
Figure C93 Image of Projectile Captured Prior to Impact (via Phantom v711 / projectile within red circle)
