International Space Station (ISS) Soyuz Vehicle Descent Module Evaluation of Thermal Protection System (TPS) Penetration Characteristics

Hypervelocity Impact Technology Group

February 2013

**International Space Station (ISS) Soyuz Vehicle
Descent Module Evaluation of Thermal Protection
System (TPS) Penetration Characteristics**

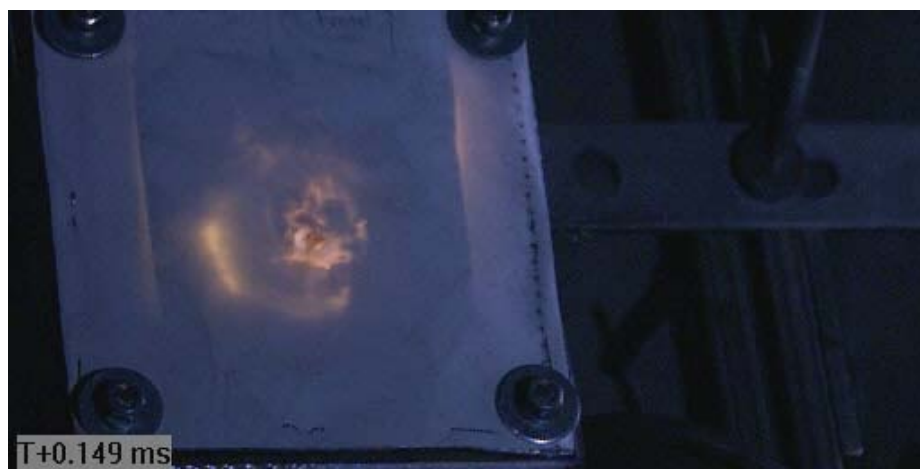
Figure C94 Image of Projectile Impacting Target (via Phantom v711)

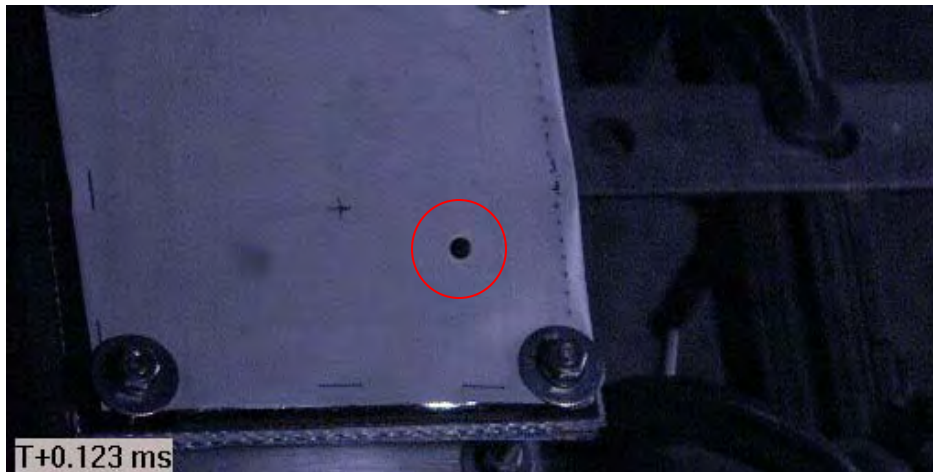
Figure C96 Image of Projectile Captured Prior to Impact (via Phantom v711 / projectile within red circle)

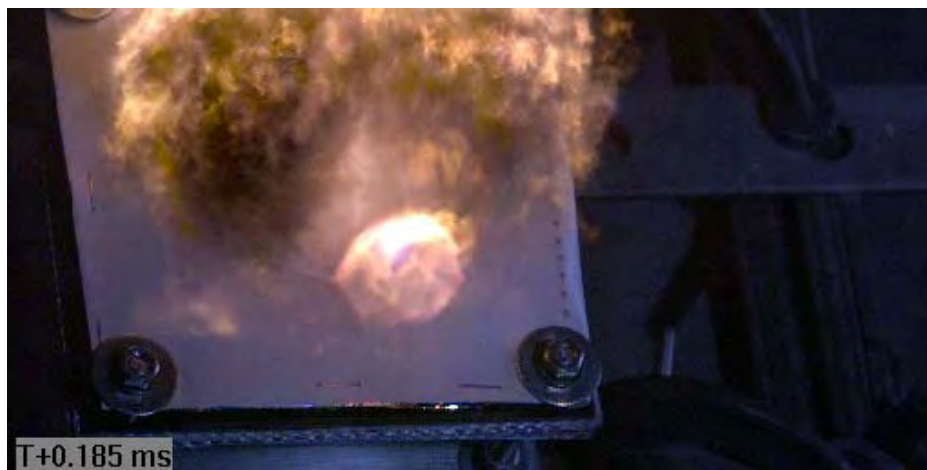
Figure C97 Image of Projectile Impacting Target (via Phantom v711)

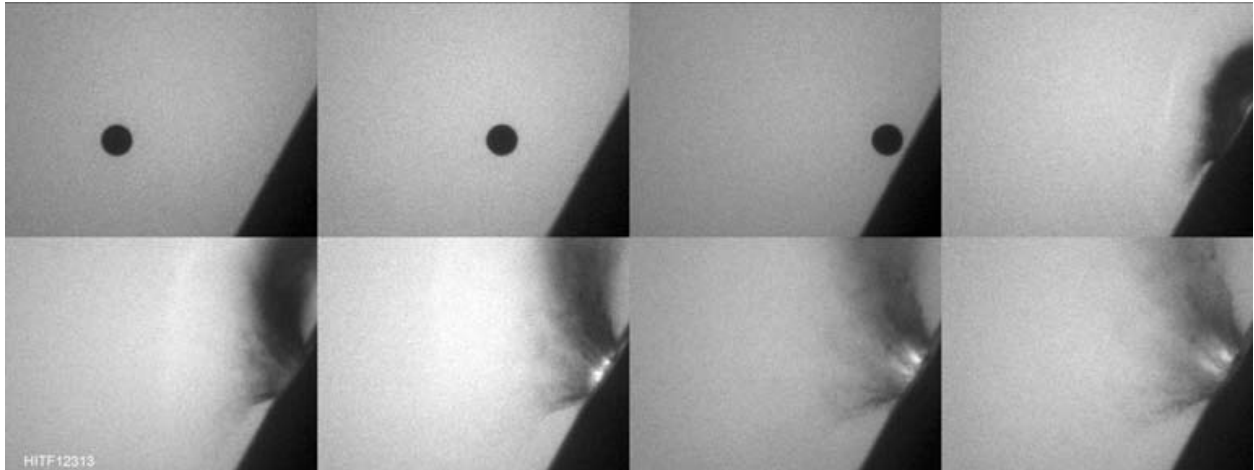
Figure C98 Projectile Captured Prior to Impact and Impacting Target (via SIMX-8 Camera)

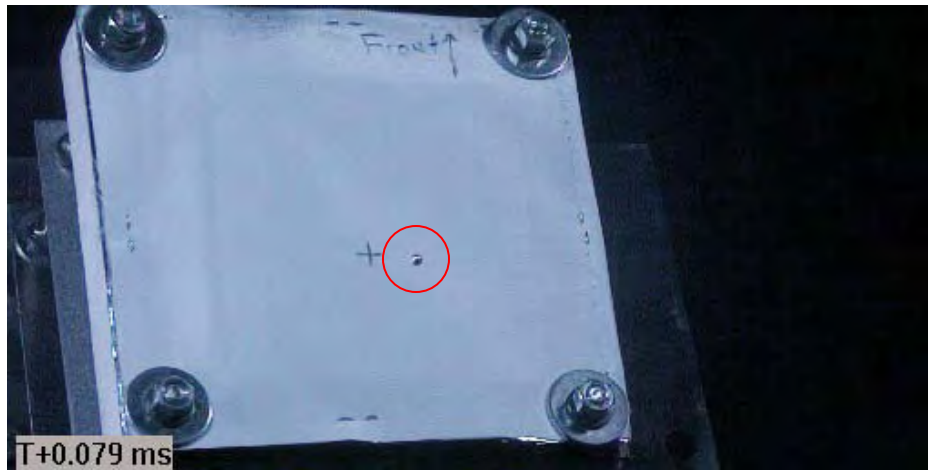
Figure C99 Image of Projectile Captured Prior to Impact (via Phantom v711 / projectile within red circle)

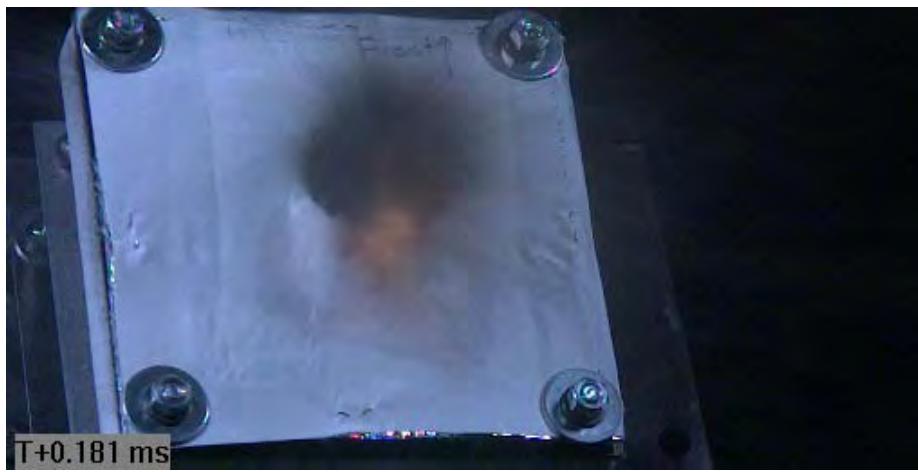
Figure C100 Image of Projectile Impacting Target (via Phantom v711)

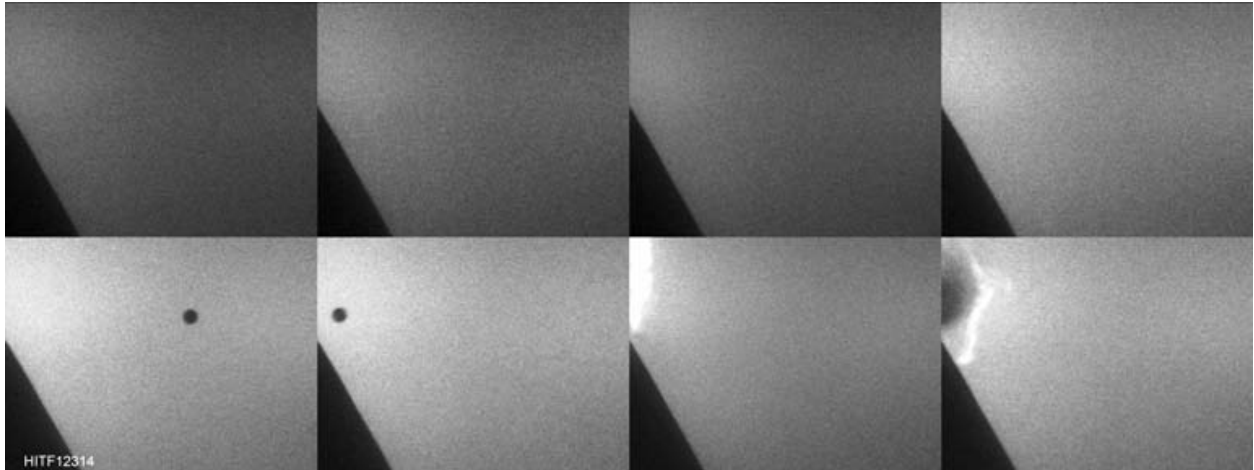
Figure C101 Projectile Captured Prior to Impact and Impacting Target (via SIMX-8 Camera)

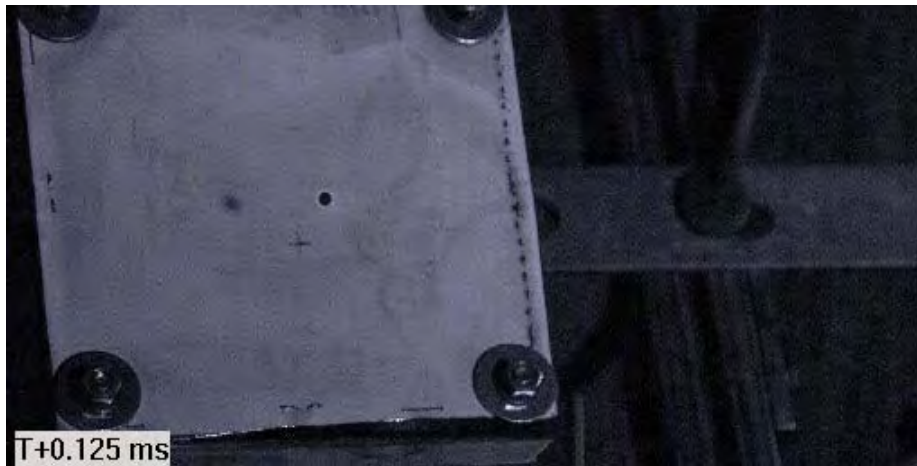
Figure C102 Image of Projectile Captured Prior to Impact (via Phantom v711 / projectile within red circle)

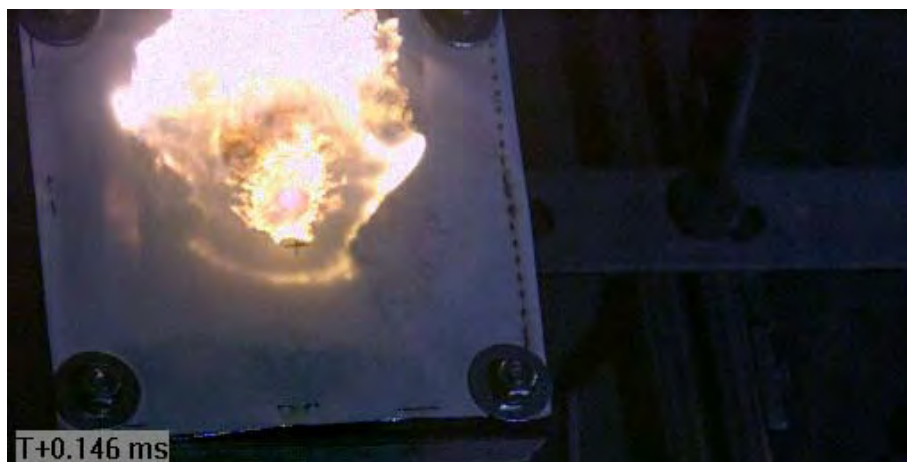
Figure C103 Image of Projectile Impacting Target (via Phantom v711)
