(NASA-RP-1375) FAILURES AND ANOMALIES ATTRIBUTED TO SPACECRAFT CHARGING (NASA, Marshall Space Flight Center) 31 p

# Failures and Anomalies Attributed to Spacecraft Charging

NASA Reference Publication 1375

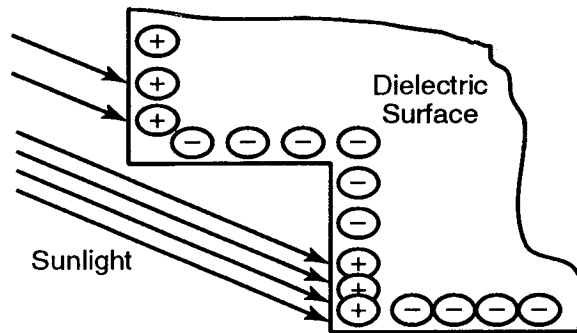
Differential charging is caused by a variation in the charged particle flux from surface to surface and the use of dielectric external surfaces which are poor distributors of accumulated charge.

The largest differential potentials will be between sunlit and shaded surfaces.

Absolute charging, sometimes referred to as frame charging, occurs when the satellite, as a whole, acquires a net potential relative to the ambient plasma. If the spacecraft is all metal (i.e., conductive), the entire spacecraft will be charged to the same potential. Absolute charging is nearly instantaneous, with characteristic periods on the order of microseconds. If dielectric surface materials are used on a spacecraft, and the current from surface to surface varies, surfaces may charge to different floating potentials, a process called differential charging (fig. 4).

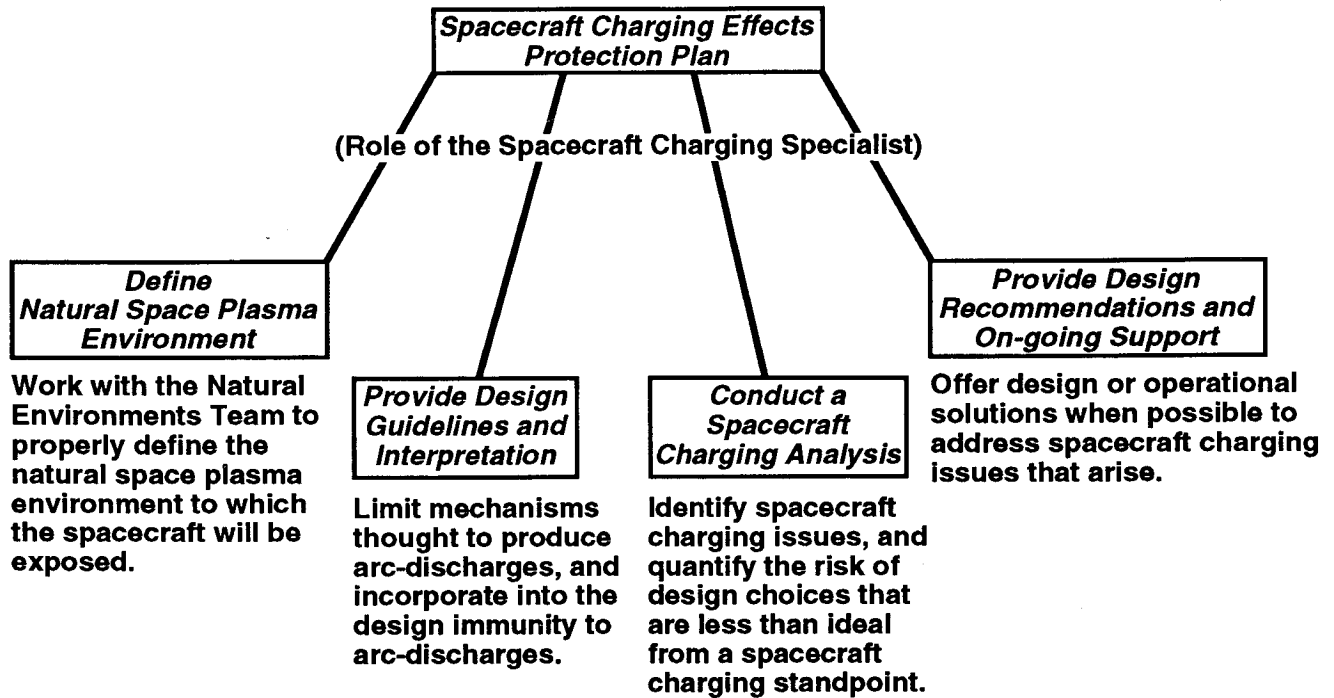
Figure 5. Spacecraft charging effects protection plan.

The NASA MSFC Electromagnetics and Environments Branch has developed a methodology to help project engineers protect against the possible detrimental effects of spacecraft charging. This methodology is outlined in a "Spacecraft Charging Effects Protection Plan" that involves defining the natural space plasma in which the spacecraft will operate and developing guidelines to reduce or eliminate the predicted detrimental effects due to spacecraft charging. A computer analysis program models the charging level of the spacecraft and determines how spacecraft charging effects interfere with mission goals and objectives (fig. 5). This analysis is particularly important if some design guidelines were excluded in favor of other design considerations. A complete set of design guidelines and recommendations tailored for a particular mission is provided in the "Spacecraft Charging Effects Protection Plan." A summary of analyses on spacecraft and a description of associated charging effects are also included in the document.

As previously mentioned, an important step in implementing a "Spacecraft Charging Effects Protection Plan" is the application of computer modeling. Three-dimensional computer programs specifically designed for this purpose are: (1) the NASA charging analyzer program for low-Earth orbit (NASACAP/LEO) used to simulate spacecraft charging of low inclination, low altitude Earth spacecraft; (2) the potentials of large spacecraft in auroral regions program (POLAR) used to model spacecraft in low altitude, polar orbit; and (3) the NASA charging analyzer program for geosynchronous orbit (NASACAP/GEO) used to model spacecraft charging by a geomagnetic substorm.
