DAMAGE TOLERANCE OF A GEODESICALLY STIFFENED ADVANCED COMPOSITE STRUCTURAL CONCEPT FOR AIRCRAFT STRUCTURAL APPLICATIONS

Marshall Rouse and Damodar R. Ambur
NASA Langley Research Center
Hampton, VA 23665-5225

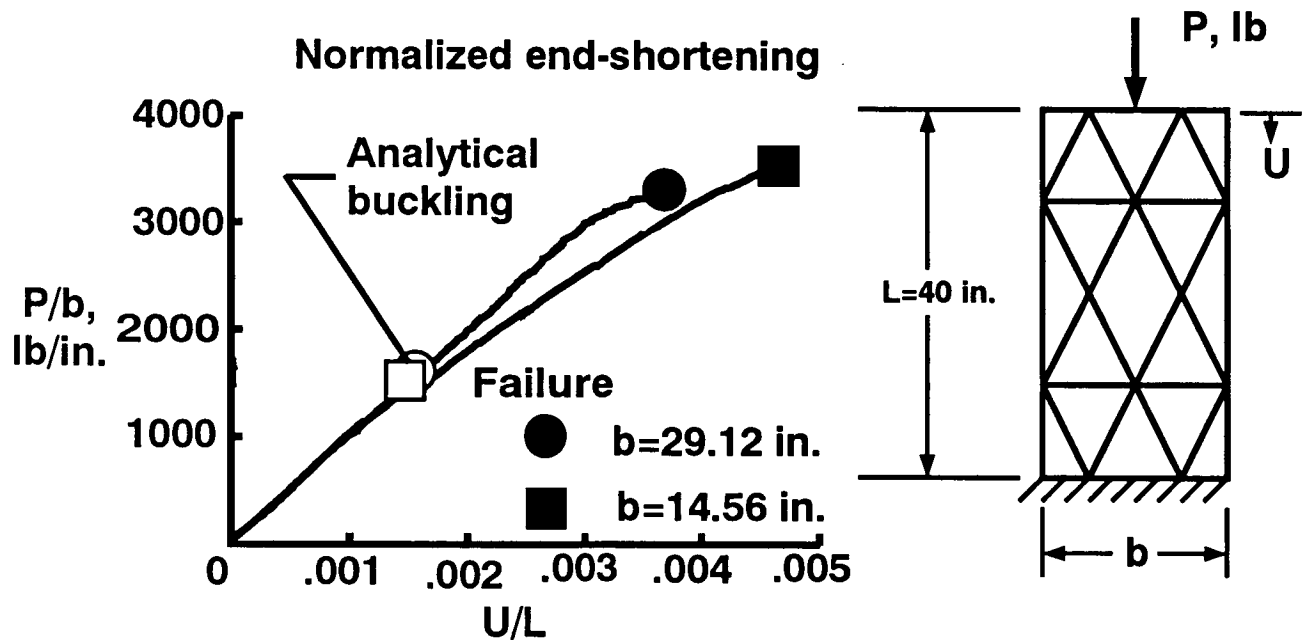
Figure 2. Summary of results for specimens tested without impact damage

A summary of results for all of the panels that was tested without impact damage is shown in Figure 2. The panels were loaded in compression using a one million pounds capacity hydraulic test machine. Applied load P normalized by the width of the test section b plotted as a function of end-shortening u normalized by the length of the test section L is shown on the left of the figure. Results for the 29.12- and 14.56-inch-wide panels are represented by the circles and the squares, respectively. The theoretical buckling load is indicated by the open symbols. The experimental failure load of the panel is indicated by the filled symbols. The panels buckled at a normalized applied load of approximately 1400 lb/in. All of the panels tested without damage failed at a value of applied load greater than the analytical buckling load. The 29.12-inch-wide panel failed at a value of normalized applied load of 3,312 lb/in. The 14.56-inch-wide panel failed at a value of normalized applied load of 3,540 lb/in.

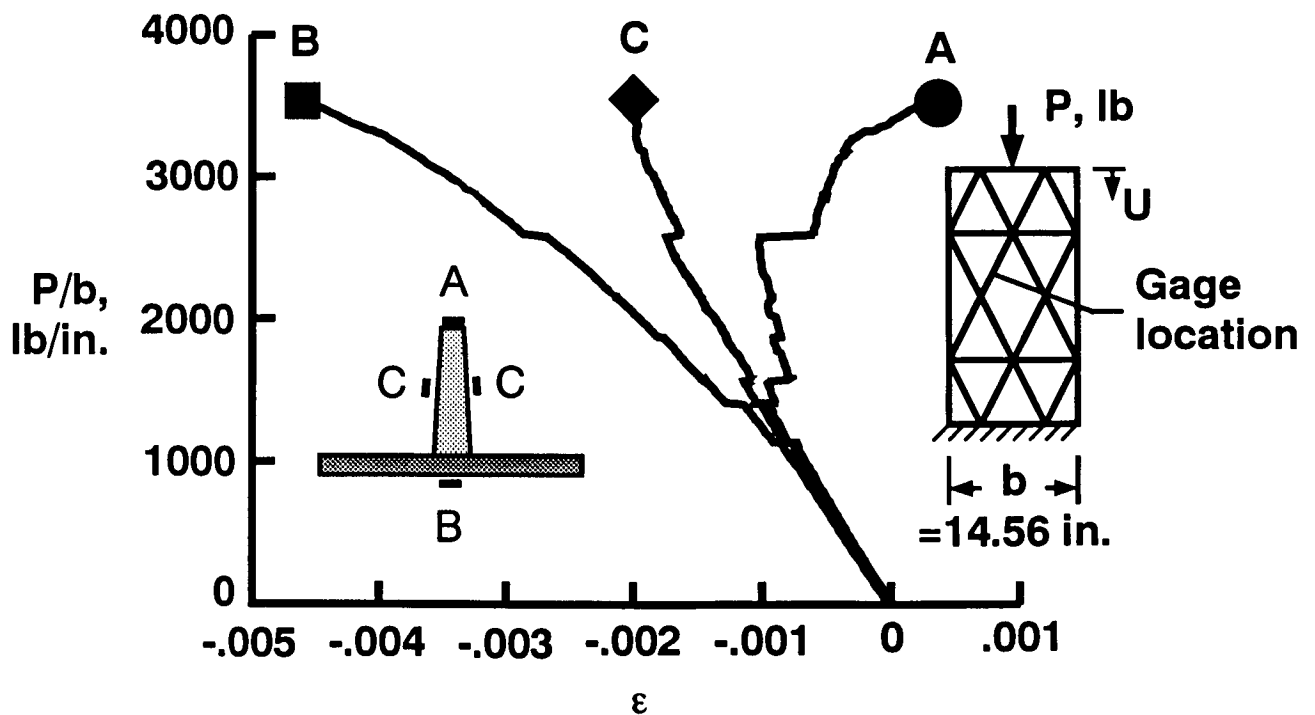
Figure 5. Typical axial strain results for a 14.56-inch-wide panel

Typical stiffener axial strain results for a 14.56-inch-wide panel tested without impact damage are presented in Figure 5 as a function of the normalized applied load. The axial strain ϵ results were recorded from strain gages oriented parallel to the direction of the stiffener at locations midway between stiffener intersections. Axial strain data at location A on the crown of the stiffener are indicated by the filled circle. Surface strain data on the skin below the stiffener are indicated by the filled square. Axial strain data at locations C on the sides of the stiffener are indicated by the filled diamond. A maximum tensile strain at failure of approximately 0.0005 in./in. was measured at location A. The panel had a maximum compressive strain at Location B of approximately 0.0047 in./in. at failure. Divergence of the axial strain data at locations A and B suggests that bending strains occurred about a plane parallel to the mid plane of the skin as it was loaded into the postbuckling range. The panel had a maximum compressive strain value at locations C of approximately 0.002 in./in. at failure. The results at locations C also suggest that no lateral bending of the stiffener occurred. Also, the discontinuities in the load-strain curves shown in Figure 5 suggest that a redistribution of load occurred in the panel due to local failures prior to the failure of the panel.
