COMPRESSIVE STRENGTH OF DAMAGED AND REPAIRED COMPOSITE PLATES

Scott R. Finn and George S. Springer
Department of Aeronautics and Astronautics
Stanford University, Stanford, California

ABSTRACT

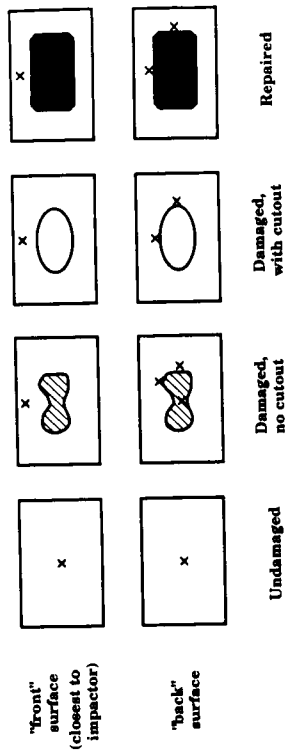
x · Strain gauge locations
 Figure 3. Locations of the strain gauges.

After holes were cut in the plates, the plates were repaired by placing a "plug" (made of the same material as the plate) in the hole (Figure 1). This plug had the same shape and size as the hole, and had the same layup as the plate. American Cyanamid FM300 adhesive was placed between the plug and the plate. One layer of Fiberite T300/976 graphite-epoxy cloth "patch" was placed above the plug on each side of the plate. The dimensions of the patch are given in Figure 2. The plates were vacuum bagged and cured. Strain gauges were then mounted on the plates (Figure 3).

- 1) "Delamination buckling" load F_{db} is defined as the load at which the plate locally buckles above the damaged area. The load at which this occurs was determined from the output of the strain gauge placed at the center of the damaged region on the "back" surface.

- 2) "Damage growth" load F_g is defined as the load at which the damaged area starts to grow. The load at which this occurs was determined from the strain gauges on the "back" surface of the plate located at the edge of the damaged area (plates without cutout), near the edge of the hole (plates with cutout), or near the edge of the repaired zone (repaired plates). The damage growth load data for plates with cutout or with repair were normalized with respect to the damage growth loads of damaged plates with no cutout F_g^{nc} .

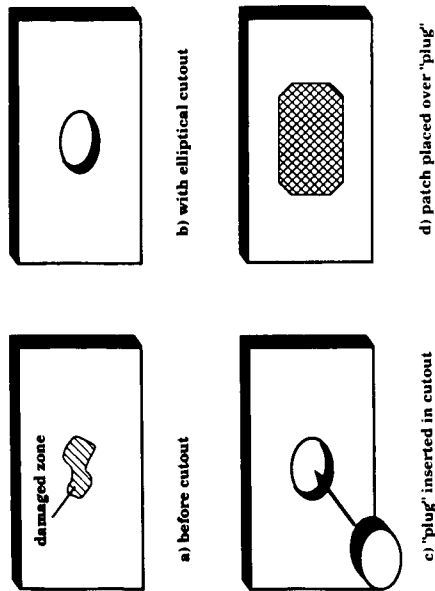
Figure 1. Description of the plate a) before cutout, b) with cutout, c) with plug inserted in cutout, and d) with patch placed over plug.

The damaged zone was removed by grinding out an elliptical hole through the entire thickness of the plate (Figure 1). After grinding, the plate was again X-rayed to establish that the process did not damage the plate further.

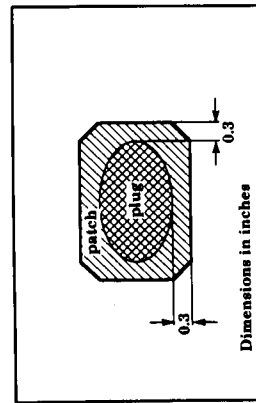
Figure 2. Dimensions of the patch used in repairing the plate.

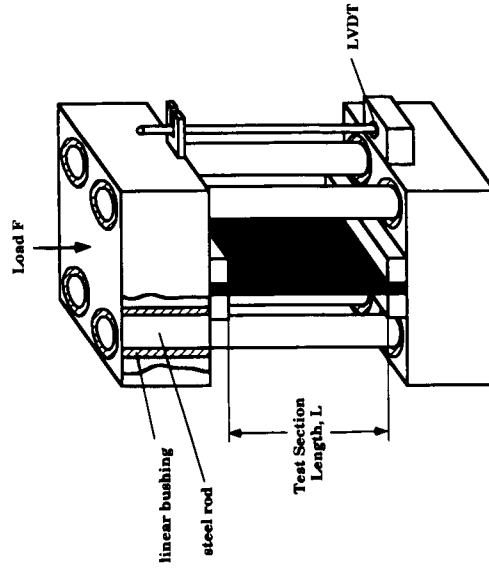
Figure 4. Compression test fixture.

The compressive strength of each plate was measured by clamping the two short edges of the plate in a specially built fixture (Figure 4). The compressive load was applied at a displacement rate of 2×10^{-5} in/sec, and the load versus strains and the load versus displacement were measured.

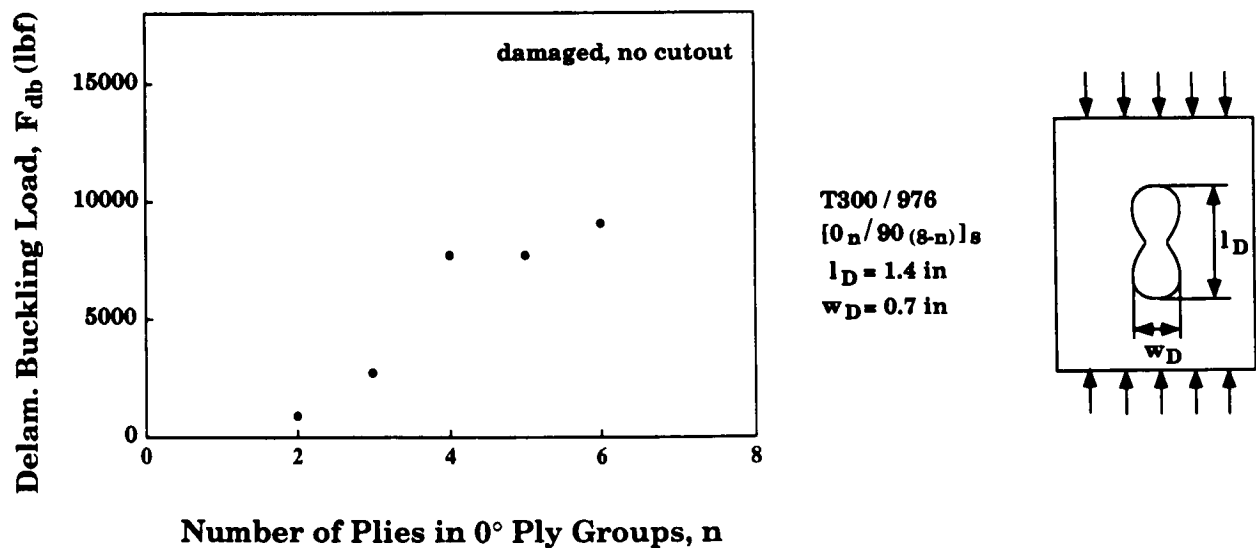
Figure 5. Delamination buckling load F_{db} as a function of the number of plies n in the 0° ply groups. Test section length $L = 3$ in.

The load (delamination buckling load F_{db}) at which a sublaminates in the damaged zone buckles increased as the number n of plies in the 0° ply groups increased, i.e., as the thickness of the back ply group increased (Figure 5). This can be explained by observing that when the load was applied, the sublaminates below the damaged zone (at the "back" side of the plate) buckled. A thicker back ply group corresponds to a sublaminates which is stiffer and thus more resistant to buckling.

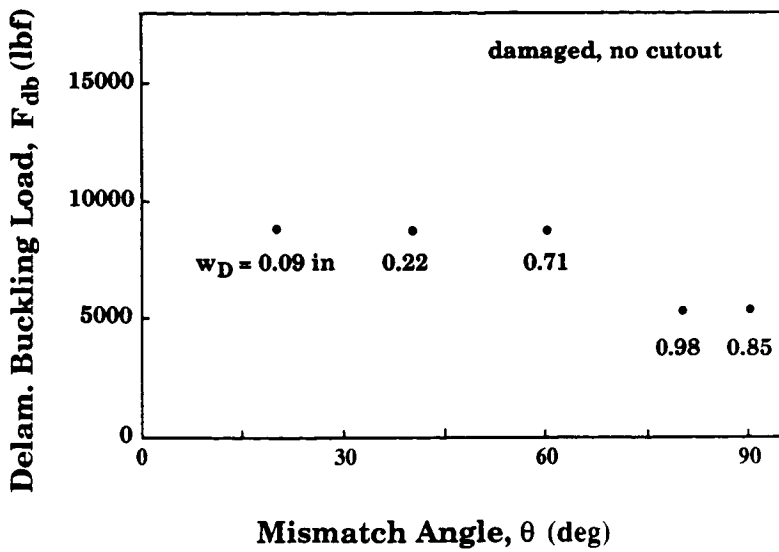
Figure 6. Delamination buckling load F_{db} as a function of the mismatch angle θ . Test section length $L = 3$ in.

The delamination buckling load F_{db} decreased with mismatch angle q (Figure 6). To explain the reason for this, we observe that the data shown in this figure apply to plates in which the damage length was constant ($l_D = 1.5$ in), while the width was not controlled independently. In fact, the damage width w_D (and consequently the damaged area) increased with the mismatch angle q (Figure 6). Thus the size of the damaged area increased resulting in a decrease in the delamination buckling load F_{db} with increasing mismatch angle q .

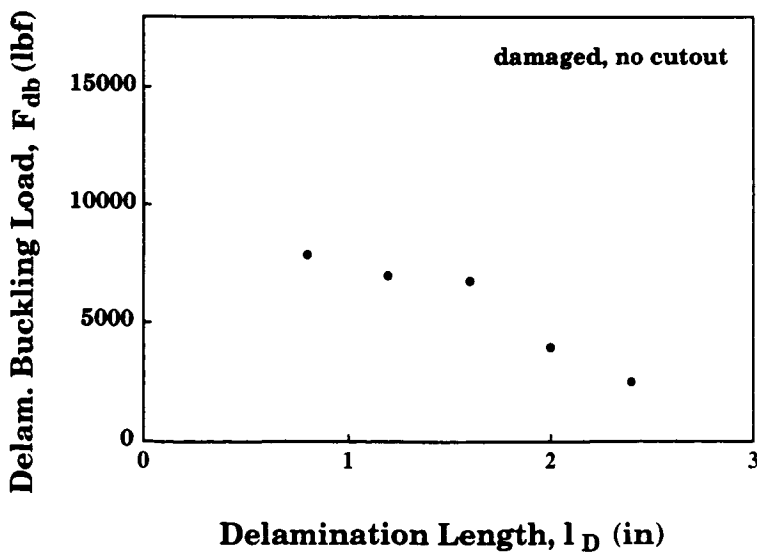
Figure 7. Delamination buckling load F_{db} as a function of the initial damaged zone length l_D . Test section length $L = 3$ in.

The delamination buckling load F_{db} as a function of the initial damaged zone length l_D is shown in Figure 7. For these $[0_4/90_4]_S$ plates, the width w_D of the damaged zone was approximately equal to one half of the damage length l_D . As the length l_D increased (and with it, the size of the damaged zone), the load required to buckle the sublaminates decreased.

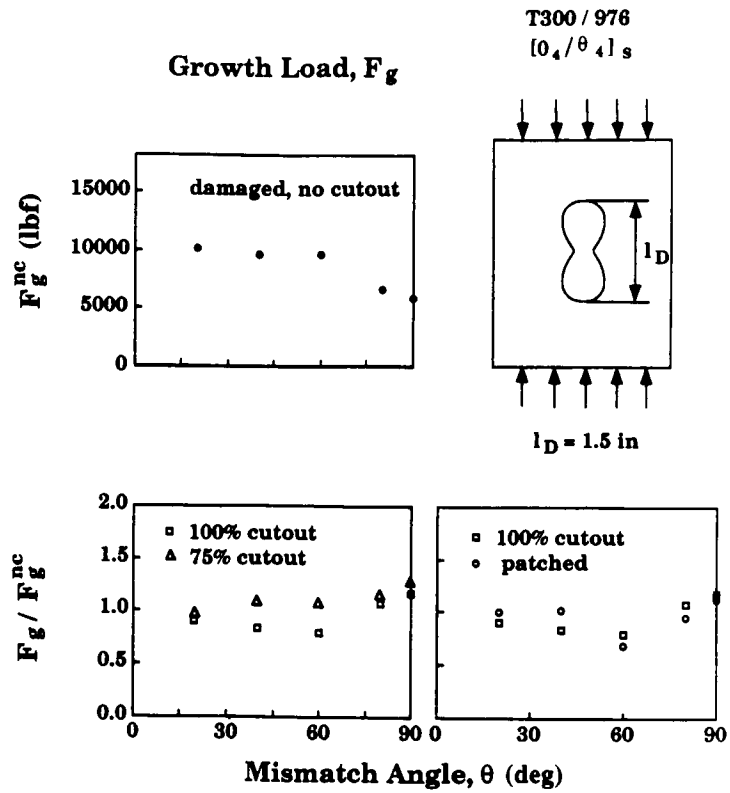
Figure 9. Damage growth load F_g as a function of the mismatch angle θ . Test section length $L = 3$ in.

The damage growth load F_g as a function of the mismatch angle q is shown in Figure 9. For damaged plates with no cutout, the growth load decreased as the mismatch angle increased (Figure 9, top). The reason for this decrease was that larger mismatch angles were accompanied by larger initial damaged zones (as was discussed in Section 3.1) and lower delamination buckling loads F_{db} (Figure 6). Since the size of the damaged zone increased with increasing mismatch angle q , the growth load F_g^{nc} decreased. Neither removing the damaged zone nor repairing it had a significant effect on the damage growth loads, as shown in Figure 9, bottom.

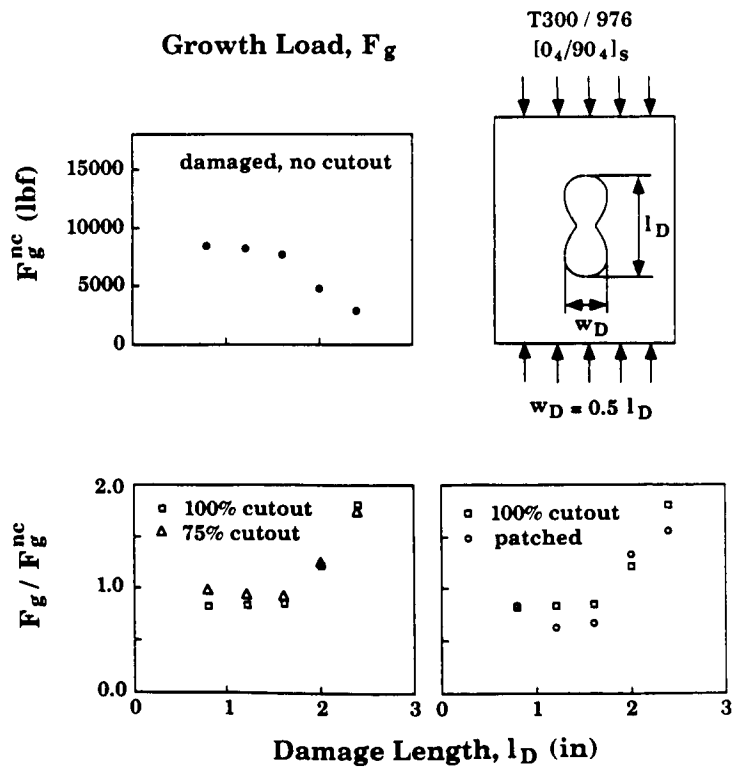
Figure 10. Damage growth load F_g as a function of the initial damaged zone length l_D . Test section length $L = 3$ in.

The damage growth load F_g as a function of the initial damaged zone length l_D is shown in Figure 10. For plates with no cutout or repair, the damage growth load F_g^{nc} decreased with the damage length l_D . Since the damage width w_D increased along with the damage length, the overall size of the damaged zone increased. This increase in the size of the damaged zone resulted in the decrease in growth load F_g^{nc} .

For plates with relatively "small" initial damage lengths ($l_D < 2$ in), the damage started to grow before the sublaminates buckled. Hence, in this case, cutting out the damaged zone did not change significantly the damage growth load, i.e. the damage growth loads for plates with and without cutouts were nearly the same (Figure 10, middle). For plates with larger initial damage lengths ($l_D \geq 2$ in), the sublaminates buckled, and this event governed the damage growth. In this case, cutting out the damaged zone resulted in an increase in the damage growth loads F_g . Repairing the plates seemed to produce little or no change in the growth load compared with plates with 100% cutout (Figure 10, right).

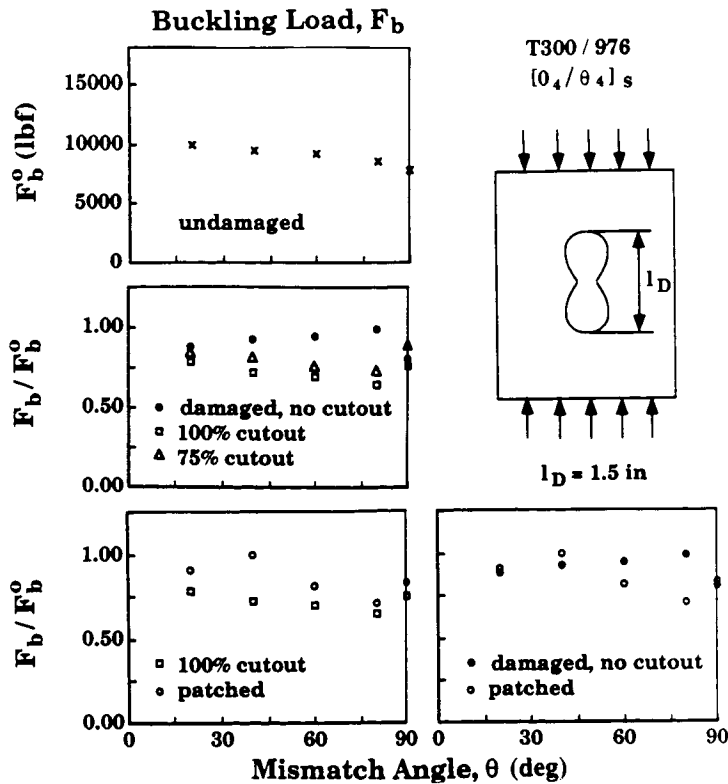
Figure 12. Buckling load F_b as a function of the mismatch angle θ . Test section length $L = 3$ in.

The global buckling load as a function of the mismatch angle q is shown in Figure 12. For initially undamaged plates, the buckling load F_b^0 exhibited a slight decrease with mismatch angle (Figure 12, top). As the angle q increased, the stiffness of the laminate in the lengthwise direction decreased leading to the decrease in the buckling load.

Damaged plates with no cutout had lower buckling loads than undamaged plates ($F_b/F_b^0 < 1$), but higher buckling loads than plates with the damaged zone removed. Removal of the material, even though it was damaged, resulted in less resistance to plate buckling. Repaired plates had higher buckling loads F_b than plates with a 100% cutout, but only about the same buckling loads as damaged plates with no cutout.

The ultimate load F_u is shown in Figure 15 as a function of the mismatch angle q . For undamaged plates, the ultimate load F_u^0 decreased with the mismatch angle. Again, there are two reasons for this decrease. First, the buckling load F_b^0 decreased with mismatch angle (Figure 12). Lower buckling loads lead to a decrease in the ultimate load. Second, increasing the angle q in the $[0_4/q_4]_S$ plates moved the fiber direction of the middle ply group farther out of alignment with respect to the applied axial load F . This resulted in higher longitudinal stresses for a given applied load, and hence to a decrease in the ultimate load F_u with increasing mismatch angle q .

Damaged plates had lower ultimate loads F_u than corresponding undamaged plates. Cutting out some or all of the damaged zone further reduced the ultimate loads, because cutouts decreased the buckling loads of the plates (Figure 12). Repair of the plates did not change significantly the ultimate loads F_u .

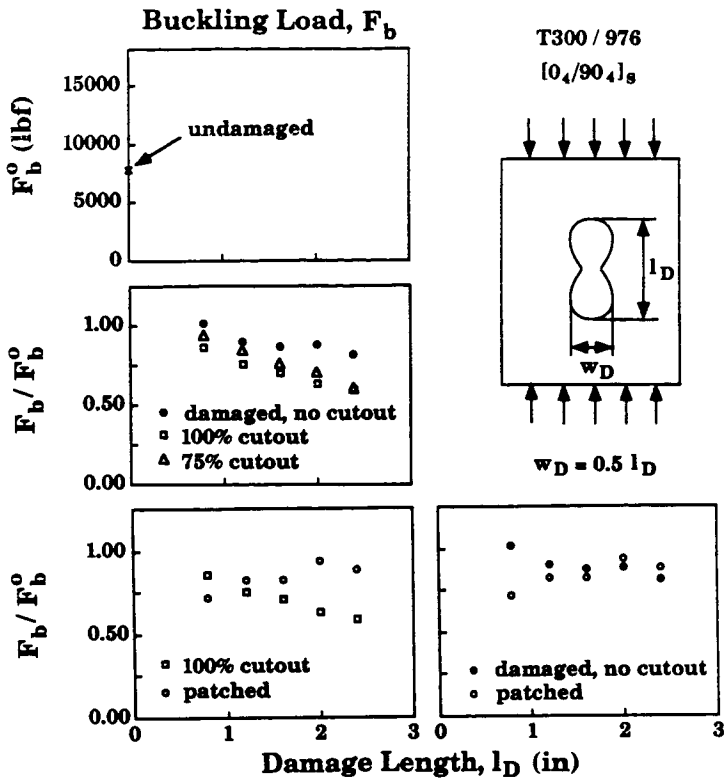
Figure 13. Buckling load F_b as a function of the initial damaged zone length l_D for T300/976 graphite/epoxy. Test section length $L = 3$ in.

For damaged plates with and without cutouts, the buckling load F_b decreased as the initial damaged zone length l_D increased (Figure 13). Since the damage width w_D increased with the damage length l_D , the size of the damaged zone also increased. This increase in the size of the damaged zone caused a decrease in the global buckling load F_b . Again, damaged plates without a cutout generally had higher buckling loads than the plates with either 100% or 75% cutouts.

Repaired plates had higher buckling loads than plates with 100% cutout but only about the same buckling loads as damaged plates with no cutout.

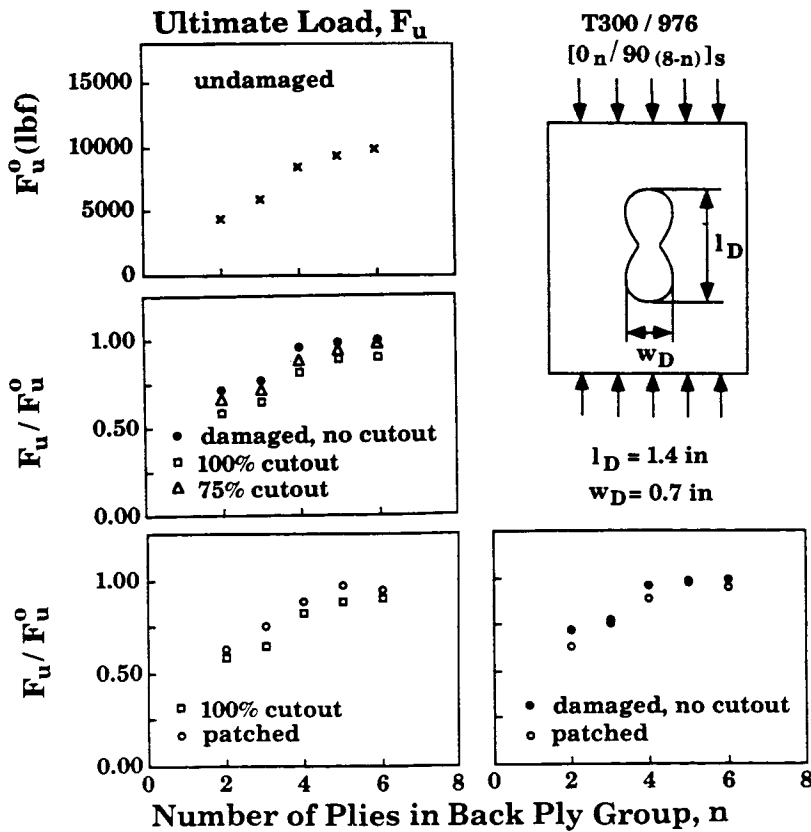
Figure 14. Ultimate load F_u as a function of the number of plies n in the 0° ply groups. Test section length $L = 3$ in.

The ultimate load F_u as a function of the number of plies n in the 0° ply groups is shown in Figure 14. For initially undamaged plates, the ultimate load F_u^0 increased as n (and correspondingly, the number of 0° plies in the plate) increased. There are two reasons for this trend. First, the plate buckling load F_b increased with n (Figure 11), and higher buckling loads generally cause higher ultimate loads. Second, for a load applied in the lengthwise direction, a higher number of 0° plies in the plates corresponds to a lower longitudinal stress in each ply. Since the ply stresses decreased with the number n of plies in the 0° ply groups, the ultimate load F_u^0 increased.

Damaged plates, of course, had lower ultimate loads than undamaged plates. Cutting out some or all of the damaged zone further reduced the ultimate loads. It is interesting to note that while, in general, cutting out the damaged zone increased the damage growth loads F_g (Figure 8), it reduced the ultimate loads. Thus, cutting out the damaged zone may not always be advantageous.

Repaired plates had higher ultimate loads F_u than plates with 100% cutout, but about the same ultimate loads as damaged plates with no cutout. Hence, repair does not seem to enhance the ultimate load.

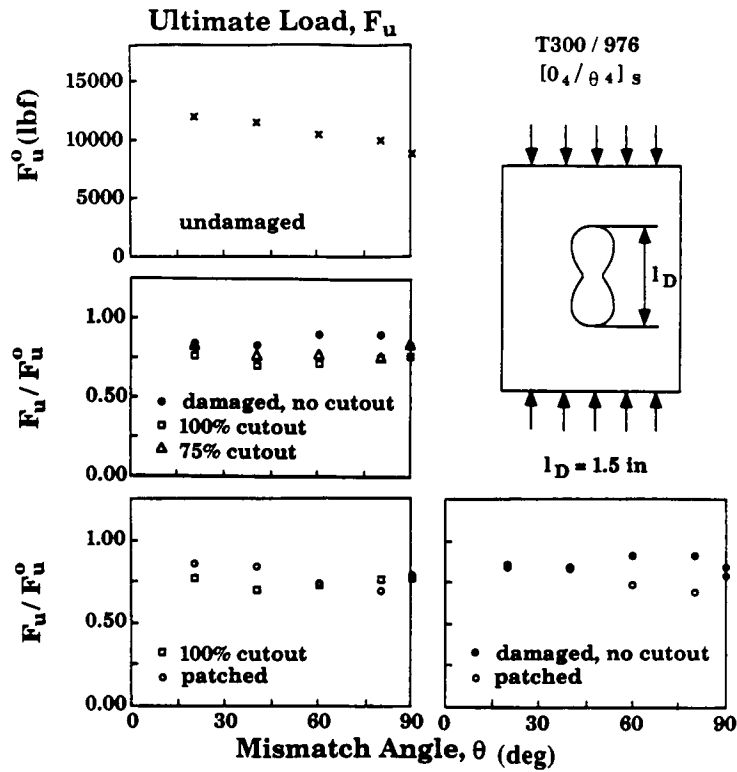
Figure 15. Ultimate load F_u as a function of the mismatch angle θ . Test section length $L = 3$ in.

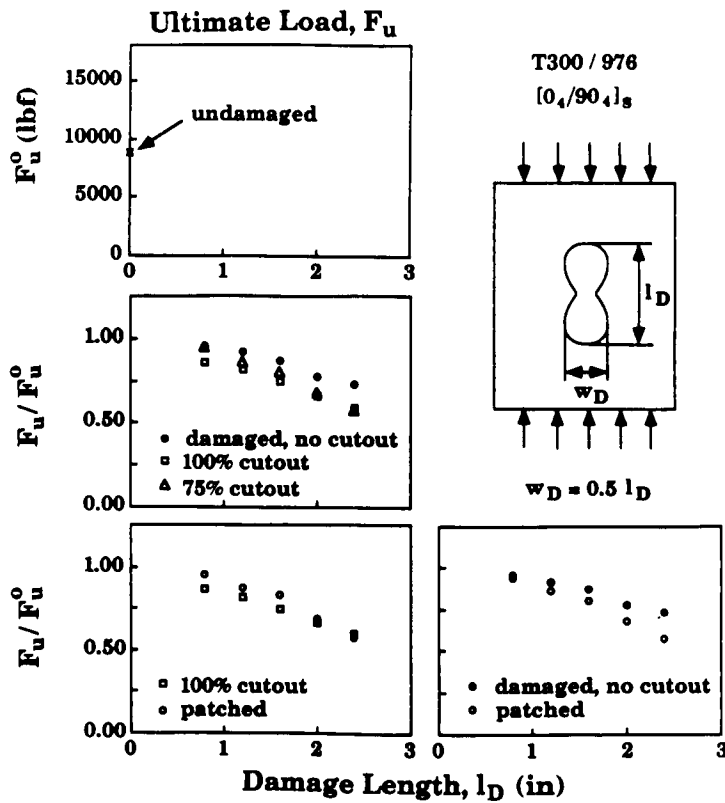
Figure 16. Ultimate load F_u as a function of the initial damaged zone length l_D for T300/976 graphite/epoxy. Test section length $L = 3$ in.

For damaged plates with no cutout, the ultimate load F_u decreased as the initial damaged zone length l_D increased for all three materials (Figure 16). Since the damage width w_D increased with the damage length l_D , the overall size of the damaged zone also increased. The increase in the size of the

damaged zone caused a decrease in the ultimate load F_u . For all three materials, the removal of part or all of the damaged zone resulted in the plates having lower ultimate loads F_u than damaged plates with no cutout.
