FULL-SCALE TESTING AND ANALYSIS OF FUSELAGE STRUCTURE

M. Miller, M. L. Gruber, K. E. Wilkins, R. E. Worden
The Boeing Company, Seattle, Washington 98124

SUMMARY

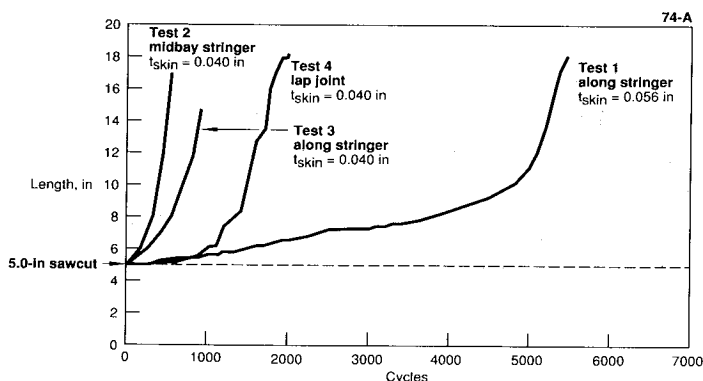
Figure 5. Crack growth test results for panel 74-A.

Test 1 on this panel consisted of a longitudinal 5 inch (127 mm) sawcut adjacent to stringer 4L in the 0.056 inch (1.32 mm) skin. The strap stiffness ratio R_s was 0.14. The panel was subjected to a cyclic differential pressure of 8.6 psi (.059 MPa) with a stress ratio of zero. As is typical with sawcuts at such a location, the direction of fatigue crack growth gradually diverged from longitudinal. In this case, failure consisted of a controlled decompression as shown in Figure 4. Figure 5 shows that 5400 pressure cycles were required to grow the crack to its final length.

Test 3 consisted of a longitudinal five inch (127 mm) sawcut adjacent to stringer 4R in the 0.04 inch (1.02 mm) gage skin. The direction of crack growth was similar to test 1 and resulted in a controlled decompression after 950 cycles. Comparison of the data in Figure 5 shows that the midbay crack of test 2 has a shorter crack growth life than the crack in test 3. This is consistent with data presented in Reference 1. The crack length at instability for Test 3 of 14.8 inches (380 mm) can be compared with a crack length at instability of 18 inches (460 mm) in Test 1, attributable in part to the stresses associated with the different skin gages.

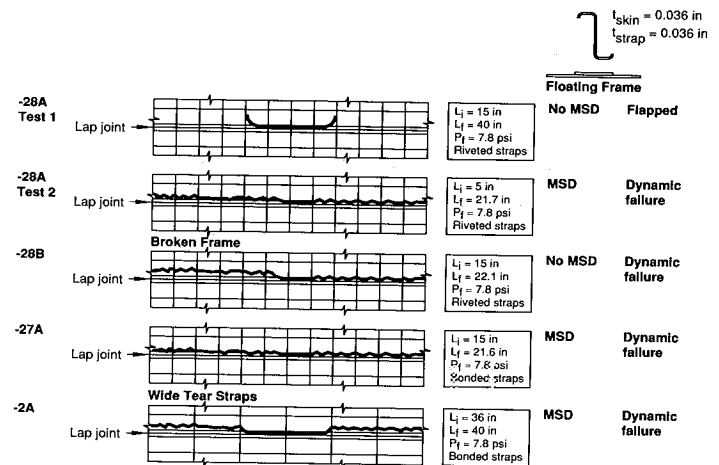
A number of additional tests of cracks in lap joints in narrow-body panels are summarized in the chart in Figure 12. The data expand on results previously presented in Reference 2. All pressure cycling was at a differential pressure of 7.8 psi (.054 MPa). The illustrations in the figure describe schematically the behavior of the cracks. Some of the tests, as noted on the figure, contained multiple site damage (MSD) in the fastener holes ahead of the lead crack. A controlled decompression occurred during the first test on panel 28A only. This panel did not include any MSD. In all other cases, the lead crack continued to grow in an essentially longitudinal direction throughout the test. However in several cases, similar to Test 74-B discussed above, the crack grew out of the lap joint into the basic skin before final panel failure. No clear trends emerge from these results. However, it does appear that MSD forces the lead crack to stay in the upper fastener row of the lap joint for a longer period of time. Comparison of Test 2 on panel 28A and the test on panel 27A shows that panel behavior is independent of the method of attaching the tear strap to the skin. However, it should be noted that the tear strap is spliced using rivets at the lap joint location in such a way that both the riveted and bonded designs are locally similar.

Figure 12. Summary of miscellaneous narrow-body lap joint crack growth tests.

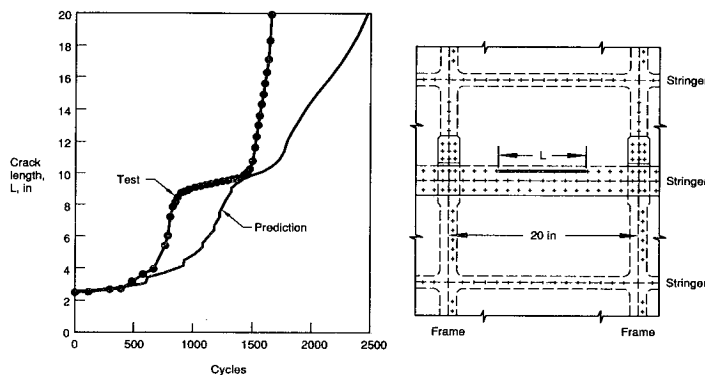
Figure 29. Comparison between test and predicted crack growth for panel 74-B containing a lap joint crack.

A comparison of skin fatigue crack growth lives for Panel 74-B is shown in Figure 29. In general, the prediction follows the test but tends to overestimate the life by about 50%. The analysis assumed fasteners behaved elastically at all times. In view of the high stresses calculated for the tear straps and frames, it is certain that several fasteners would have exceeded their yield strength. As a result, the stress intensity factor in the skin is likely to be greater than shown in Figure 25, especially for cracks beyond 20 inches (508 mm) in length. This may account for the observed differences between predicted and measured crack growth rates at the longest crack lengths.

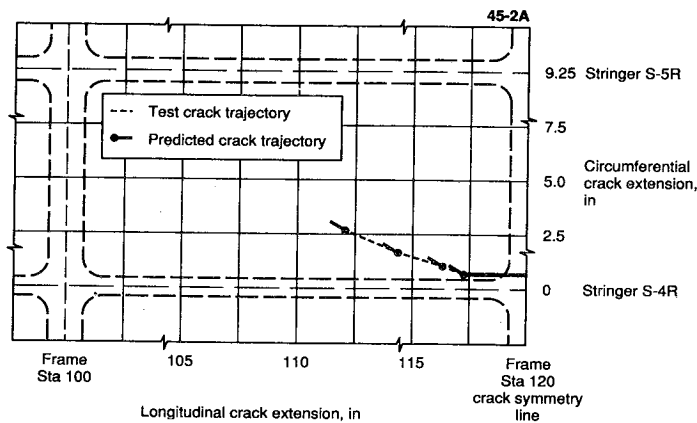
Figure 30. Comparison between test and predicted crack trajectory for narrow-body panel 45-2A containing a longitudinal crack.

Fully automated remeshing schemes for curving cracks are not yet available within Boeing although such a capability is under development such as the effort described in Reference 3. As a result, only a few attempts to predict crack trajectories have been made. One such attempt was made on Panel 45-2A. This narrow-body panel consisted of .036 inch (0.9 mm) 2024-T3 skin with 3 inch (76 mm) wide bonded tear straps, R_s equal to 0.15, at a 20 inch (508 mm) pitch. The panel had floating frames coincident with the tear straps. The initial damage in the panel consisted of a 5 inch (127 mm) sawcut across and including a broken tear strap. Predicted

crack trajectories are based on the maximum strain energy release rate. The predicted and measured crack trajectories are shown in Figure 30 to be in good agreement at all crack lengths. Final failure in this panel was by means of a controlled decompression. It can be observed that this failure mode can occur without the beneficial influence of nearby tear straps.
