DOT/FAA/CT-92/6

Aircraft Cabin Water Spray Disbenefits Study

October 1993

Final Report

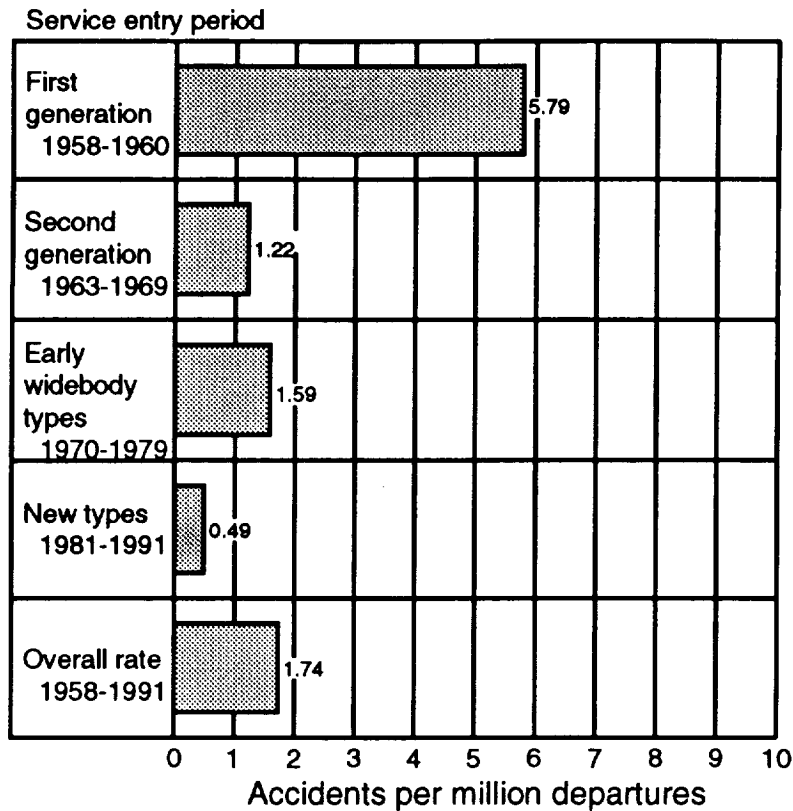
Worldwide Commercial Jet Fleet — 1958-1991

* Excludes: sabotage, military action

The current regulatory activity to establish Net Safety and Cost Benefit Analyses for justification of a cabin water spray system is based on a total of 88 "survivable" accidents between 1966 and 1991. A substantial portion of this group of 88 accidents involved 1st and 2nd generation commercial jet transports with documented accident rates an order of magnitude higher than those for newer generation aircraft introduced during the last 10 to 15 years (Preface Figure 1). This is significant in two respects; first, it demonstrates the tremendous improvements in accident avoidance and passenger safety achieved by newer aircraft types, and second, as the accident rate decreases, the true cost of a cabin water spray system to the airlines and the flying public again increases substantially beyond the \$18 million per (UK) life saved currently estimated. With this in mind, and with many of these early commercial jets either out of service or due to be retired before any regulation requiring the incorporation of water spray systems is mandated, it would seem appropriate to include only those recently manufactured aircraft, that would be affected by a potential rule, in the cost and safety benefit analyses. This would be the only proper course of action to determine the true relative worth of cabin water spray systems to both the current and future jet fleets.

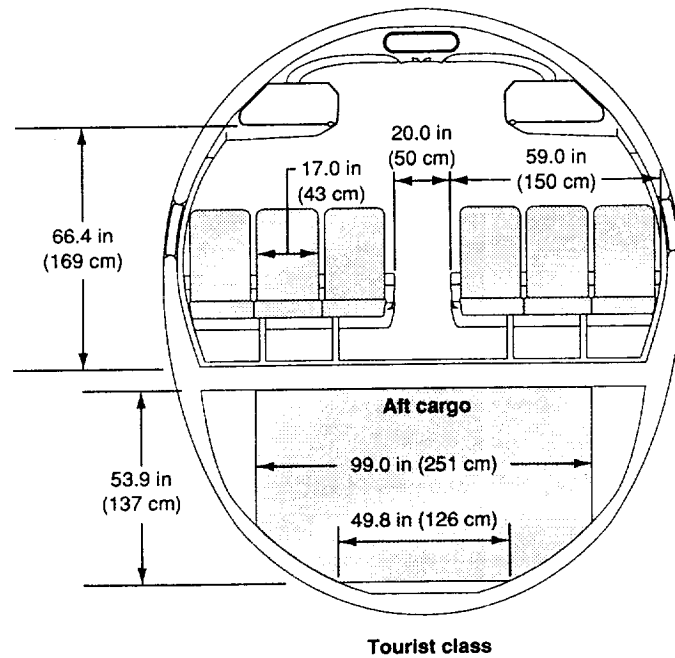
Figure 4.4-3. 757 Cross Section.

Consideration given to spraying above ceiling panels was also approached generically. This spray requirement would prove particularly difficult, as demonstrated by Figures 4.4-2 and 4.4-3. Space above the ceiling panels on the standard body airplanes (737, 757) is extremely limited, and it would be very difficult to install the piping and nozzles required for cabin water spray. Also, this space limitation would not allow a proper spray pattern to develop, and would expose overhead mounted components to direct spray, with little absorbent material for protection. As a result, overhead mounted components were also studied for behavior in the presence of water, but not a specific amount. The value of spray in these areas should be reviewed.

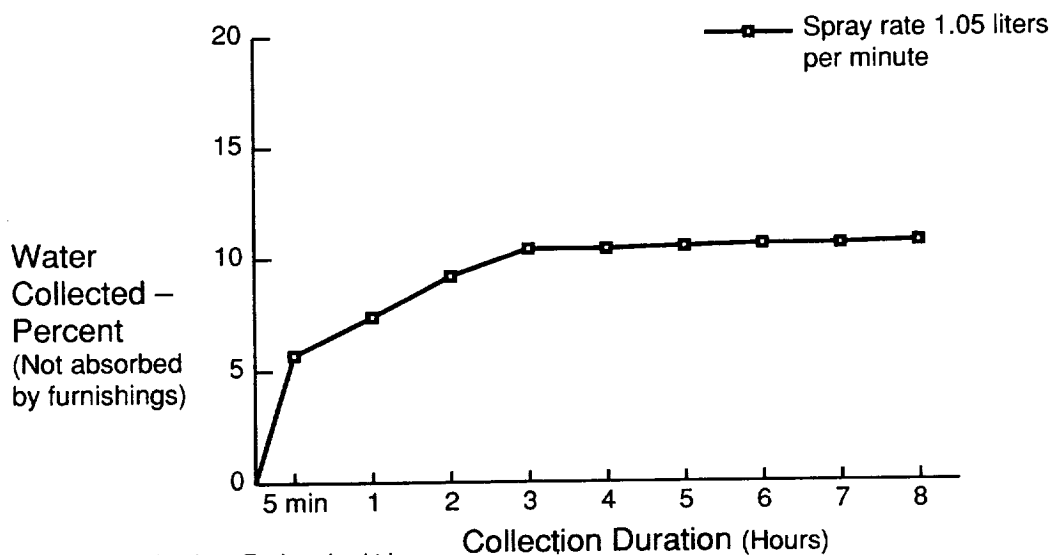
Figure 5.1-1. Carpet Absorption Characteristics (3-Minute Spray).

A water absorption test was performed by Darchem Engineering Ltd., to quantify the amount of water which might be absorbed following a 3-minute water spray. Worn wool carpeting used in the test was provided to Darchem by British Airways. This carpet was tested in their cabin water spray test chamber (no seats installed), equipped with a steel grid floor, and under floor drains and collection points, over which the carpeting was installed. The water spray system was set-up to spray at specified application rates, and allowed to run for 3-minutes. Water was collected over the next eight hours.

For the flow rate of 1.05 liter/minute, only 10% of the sprayed water was collected in that time period (Figure 5.1-1). Assuming an additional 10% trapped in the collection piping, it is clear that the carpet will entrap a very large percentage (up to 80%). For conservatism, a 70% absorption was considered for this study (Section 5.2.1). This number is significant, and indicates a high probability that water “flooding” through the floor panels into the lower lobe, and towards the front of the cabin onto the flight deck will not occur, although a certain amount can be expected to be “squeezed out” of the carpet by passenger traffic, ultimately dripping through seams in floor panels. While certainly not definitive data, these results do seem to indicate that water passing beyond the passenger cabin might be manageable, and should be verified by further testing. How water in the carpet might affect an emergency evacuation is discussed in Section 5.1.3.2.

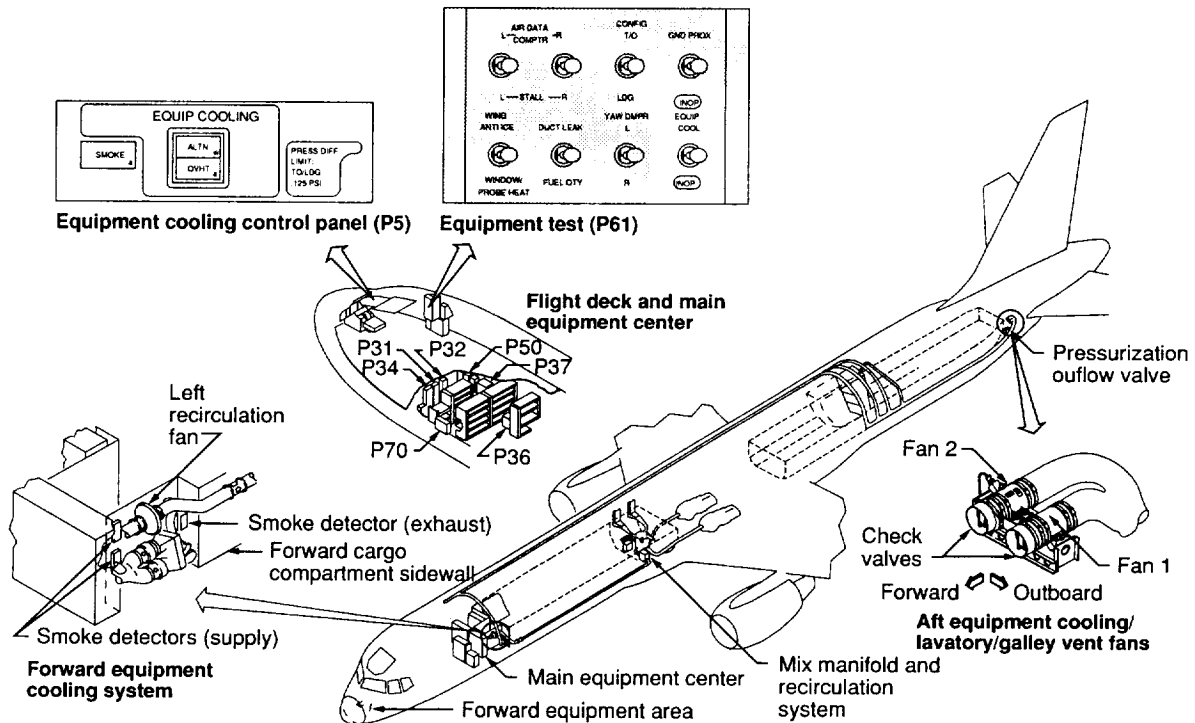
Figure 5.2-2. Electrical/Electronic Equipment Cooling System.

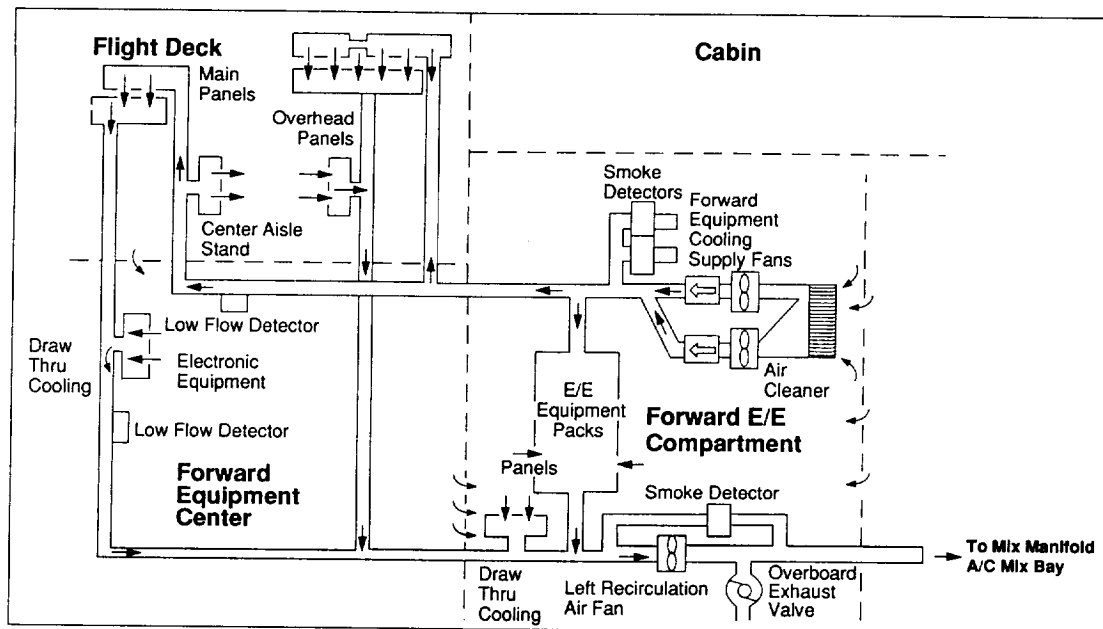
Figure 5.2-6. 757-200 Equipment Cooling Airflow Distribution.

Cabin air, during normal cruise operation, is drawn from the passenger cabin into the lower lobe by the right-hand recirculation fan, left-hand recirculation fan, forward equipment cooling supply fans, lavatory/galley fan, and by the pressure differential at the aft outflow valve. Air in the aft portion of the cabin is blown overboard through the aft outflow valve. A small amount of air in the aft portion of the passenger cabin is drawn through the aft bay electronics (E6 rack) by the lavatory/galley fan prior to discharge over-board via the aft outflow valve. Air in the forward section of the passenger cabin is drawn to the lower lobe by the right-hand and left-hand recirculation fans, and the forward equipment cooling supply fans. A majority of air drawn by the left-hand recirculation fan provides draw through cooling to the electronics prior to being drawn through the fan and into the mix bay. Air drawn by the forward equipment cooling supply fans provide cooling to the blow-through cooled electronics prior to being recirculated by the left-hand recirculation fan. Air drawn by the right-hand recirculation fan is used for cabin ventilation purposes only and is directly drawn from the cabin to the mix bay for reconditioning. Figure 5.2-5 depicts the test data airflow distribution for the entire airplane. Figure 5.2-6 shows airflow distribution in the E/E bay for equipment cooling.

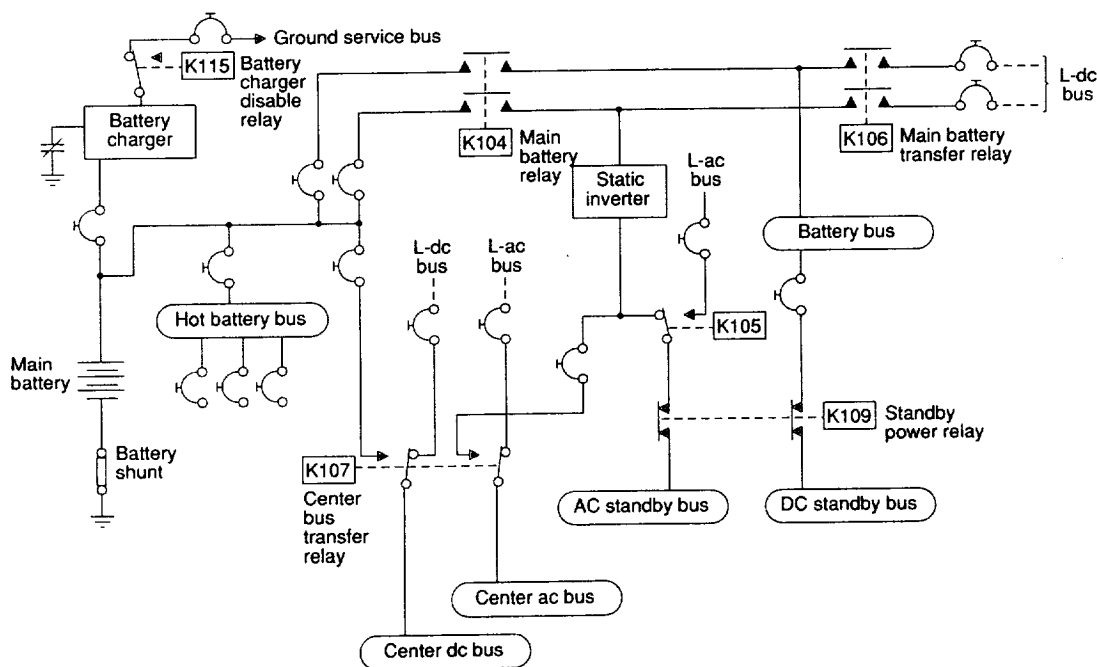
A standby power system is provided to supply 28V-dc and single phase 115V-ac power to essential instrument, communication and navigation equipment in the event of complete loss of primary ac power (Appendix B). This system is supplied by a 40 amp-hour nickel-cadmium battery, and consists of the standby battery and battery charger, battery current monitor, a single phase 115V-ac, 400-Hz, 1000 volt-amp static inverter, various control relays, the hot battery bus, battery bus and ac and dc standby buses. A functional diagram of the standby system is shown in Figure 5.3-3. The static inverter functions to convert nominal 28V-dc power from the hot battery bus (or the dc left main bus) to single phase, 115V, 400-Hz ac power.

Figure 5.3-3. Electrical Standby Power System.

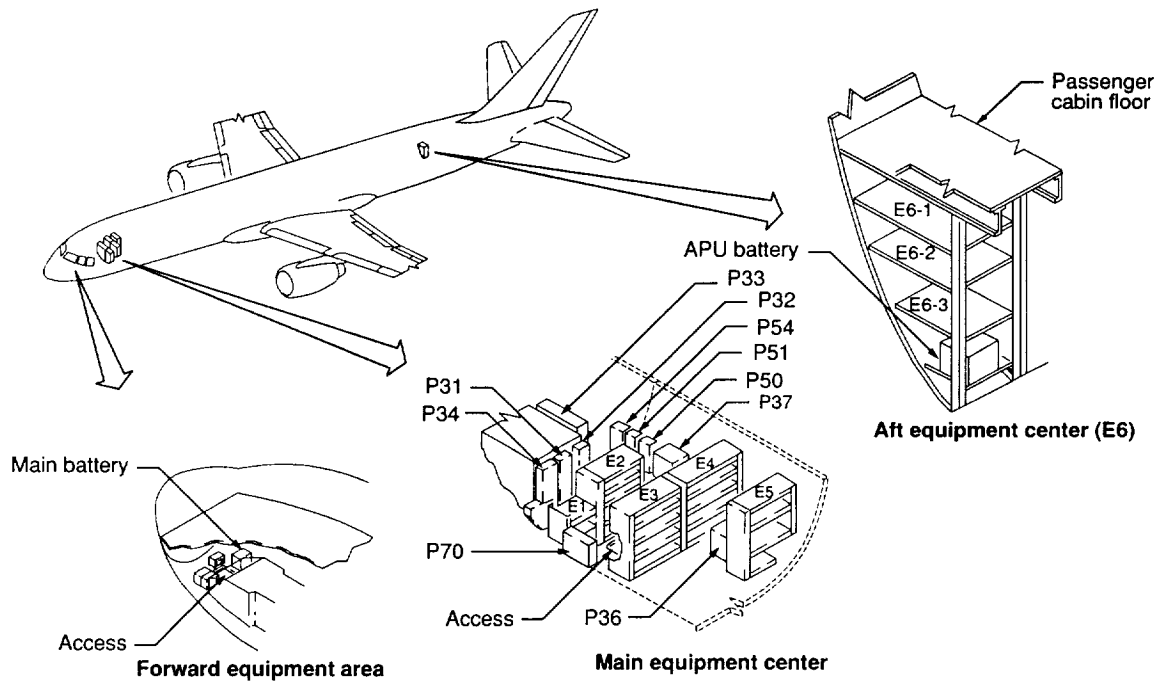
Equipment associated with the electrical power system is installed in the 757 airplane at the various locations shown in Figure 5.3-4. This equipment is connected with different wire and connector types, each suited to the installation location. Wire routing and installation practices follow the wire separation criteria developed for the 757 airplane.

Figure 5.3-4. Equipment Centers.
