FLIGHT TESTS OF VARIOUS TAIL MODIFICATIONS

ON THE BREWSTER XSBA-1 AIRPLANE

I - MEASUREMENTS OF FLYING QUALITIES

WITH ORIGINAL TAIL SURFACES

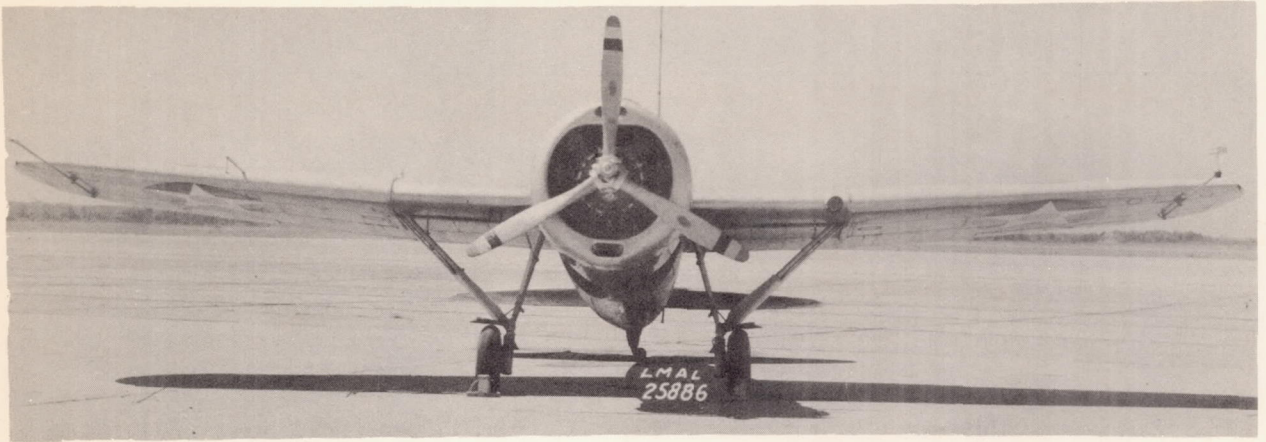
Figure 1.- Front view of Brewster XSBA-1 airplane.

The XSBA-1 airplane is a two-place, single-engine, mid-wing, cantilever monoplane with retractable landing gear. For the investigations described in this report, the cut-outs in the flap were sealed to give a conventional partial-span split flap. (See figs. 1 to 4.) The general specifications of the airplane follow:

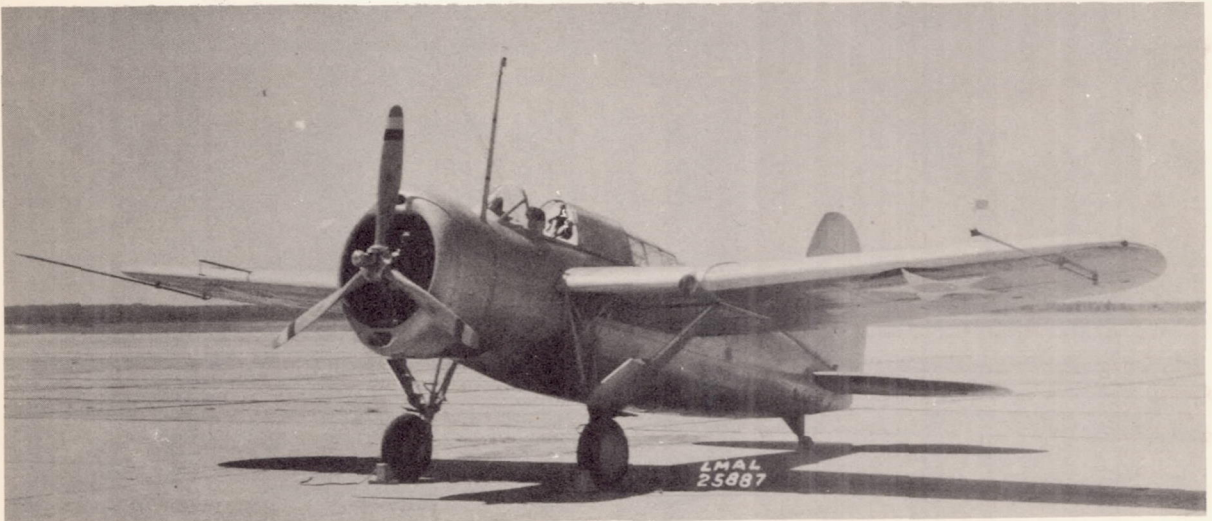
Figure 2.- Three-quarter front view of Brewster XSBA-1 airplane.

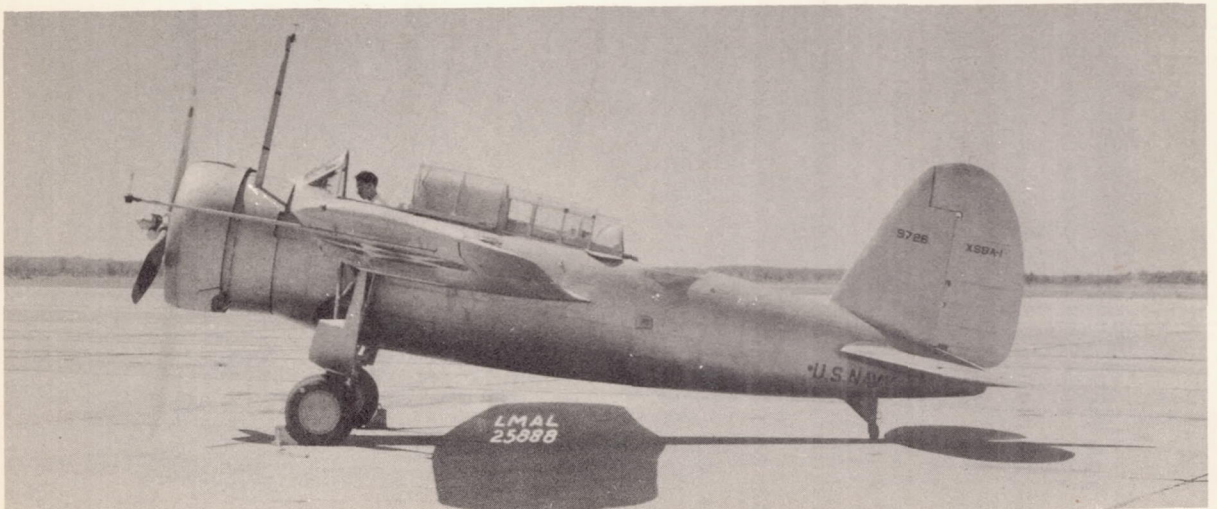
Figure 3.- Side-view of Brewster XSBA-1 airplane.

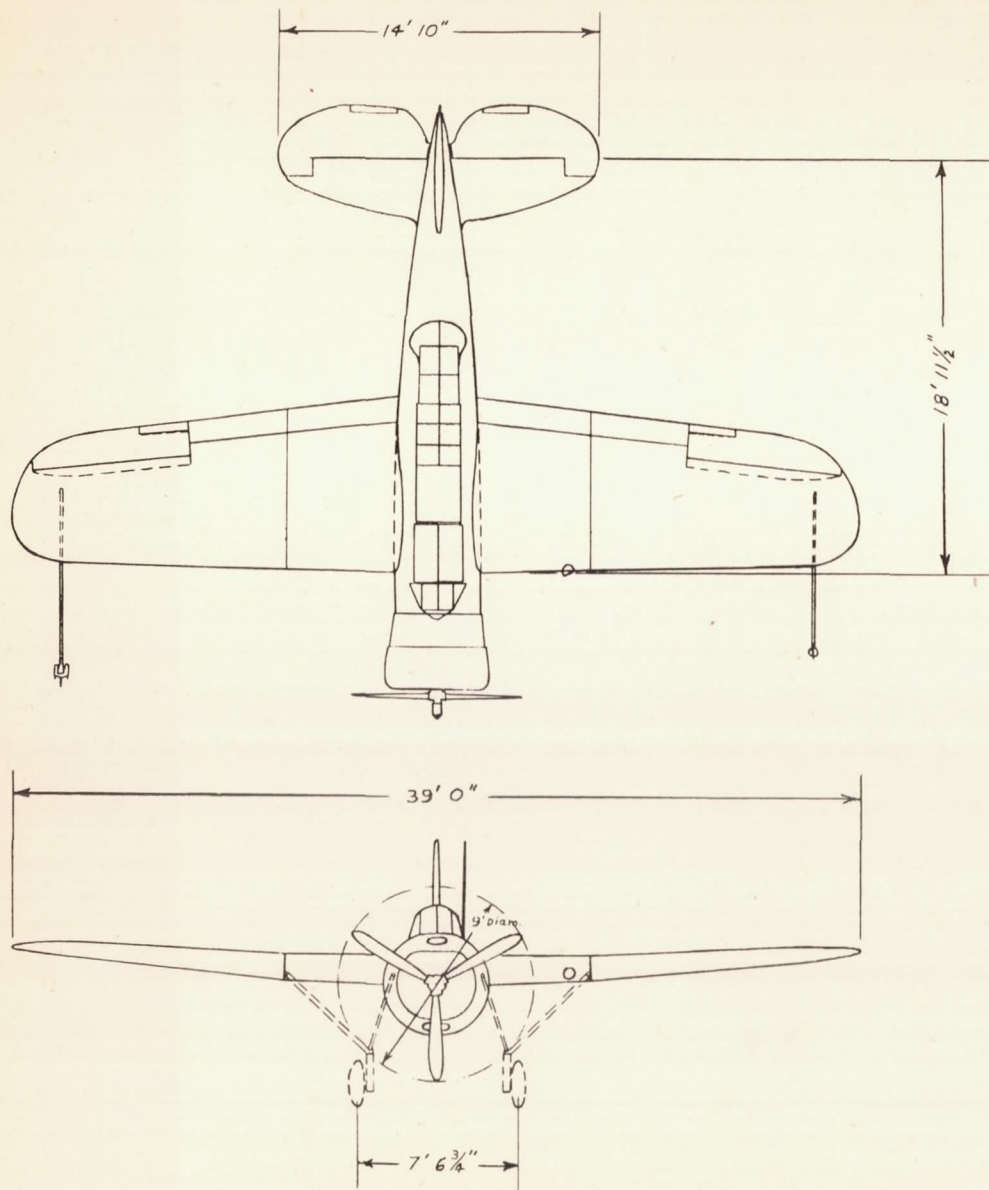
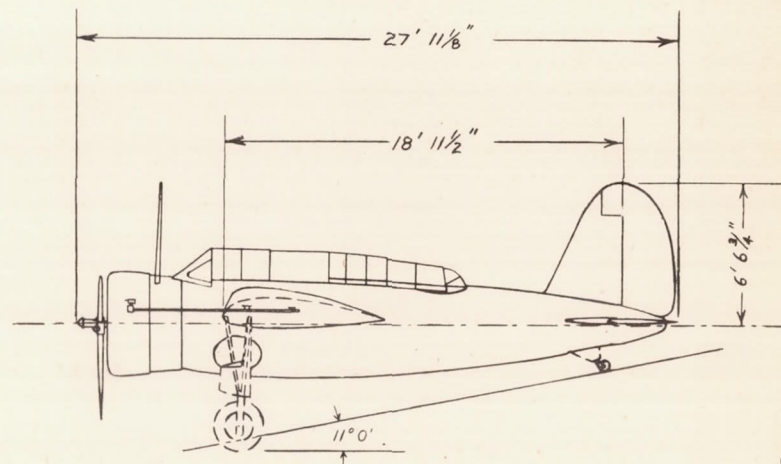
Figure 4. - Three-view drawing of the Brewster XSBA-1 airplane.

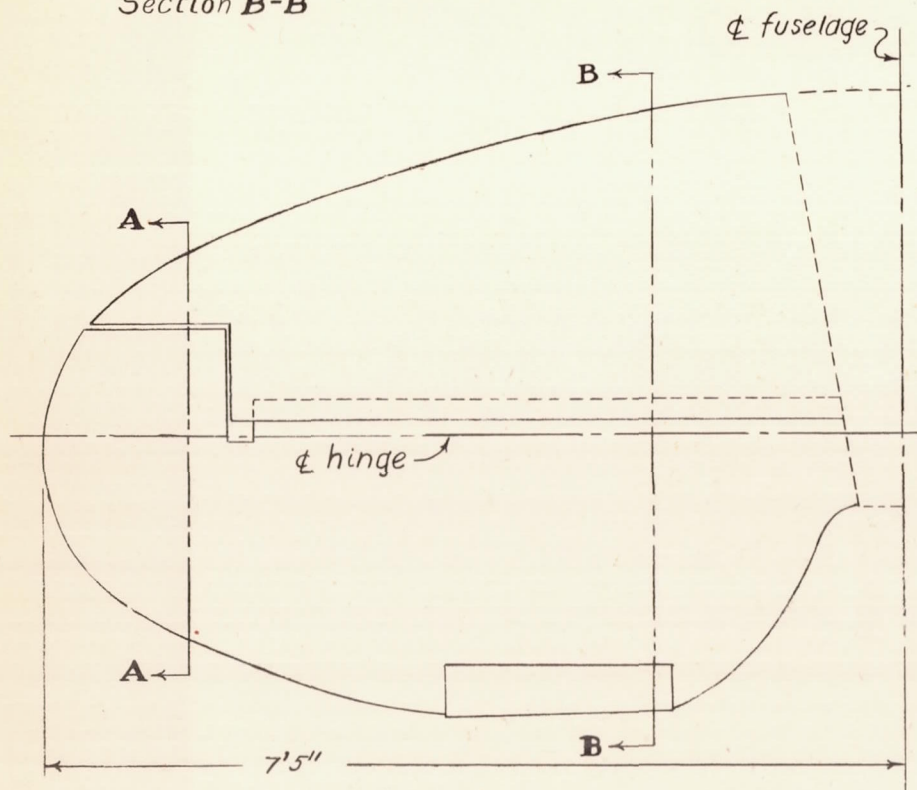
Figure 5. - Original horizontal tail surfaces of Brewster XSBA-1 airplane.

The original horizontal and vertical tail surfaces are shown in figures 5 and 6.

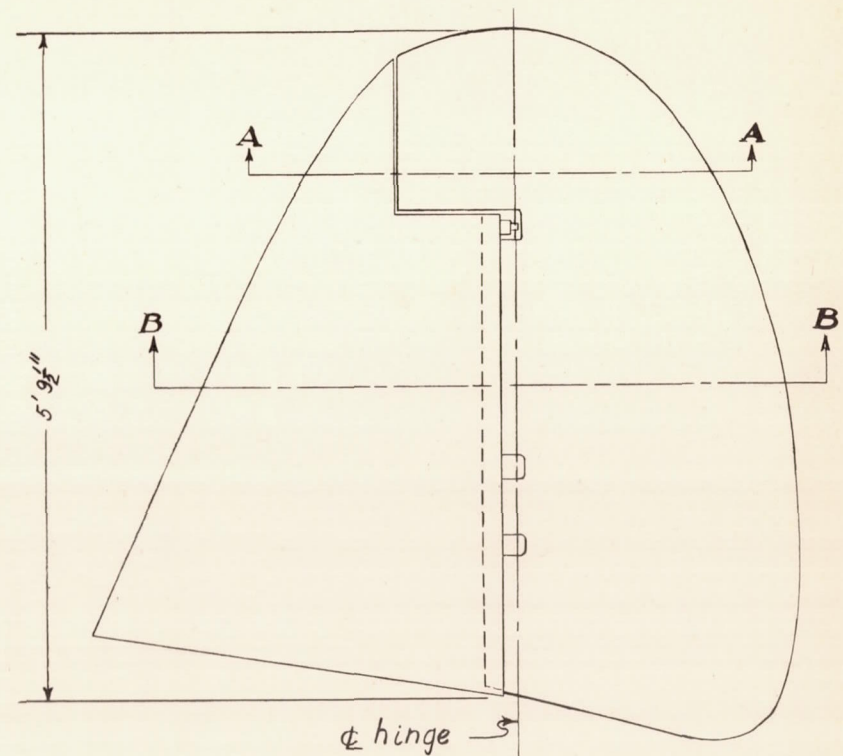
Figure 6. - Original vertical tail surface of the Brewster XSBA-1 airplane.

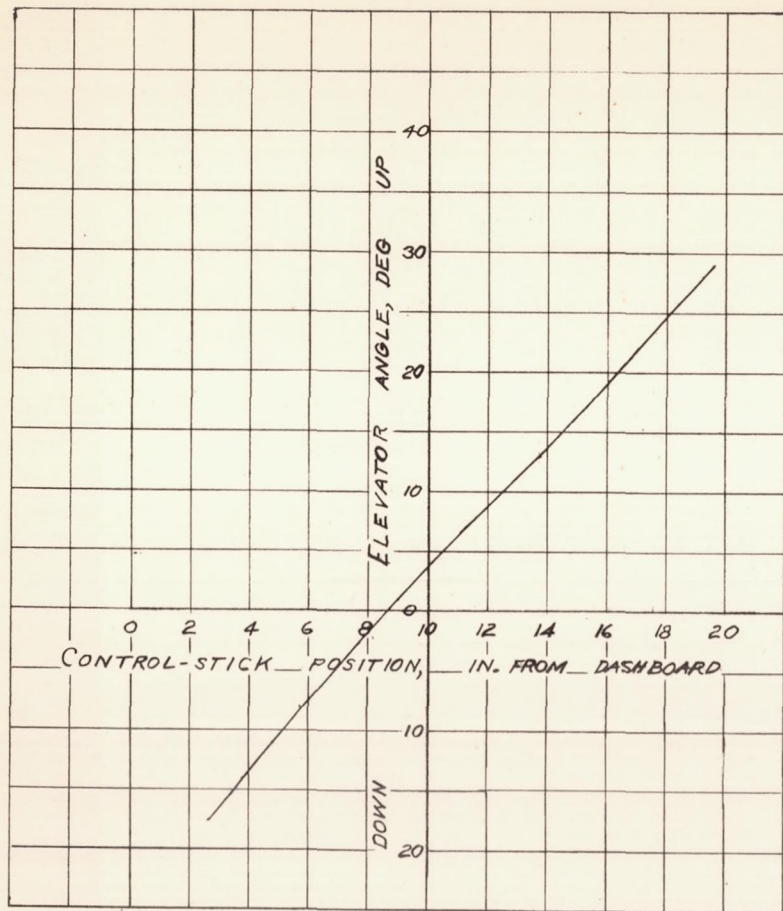
Figure 7. - Variation of elevator angle with position of the top of the control stick in front cockpit, Brewster XSBA-1 airplane.

The relation between the control-stick position and the elevator and aileron angles is shown in figures 7 and 8.

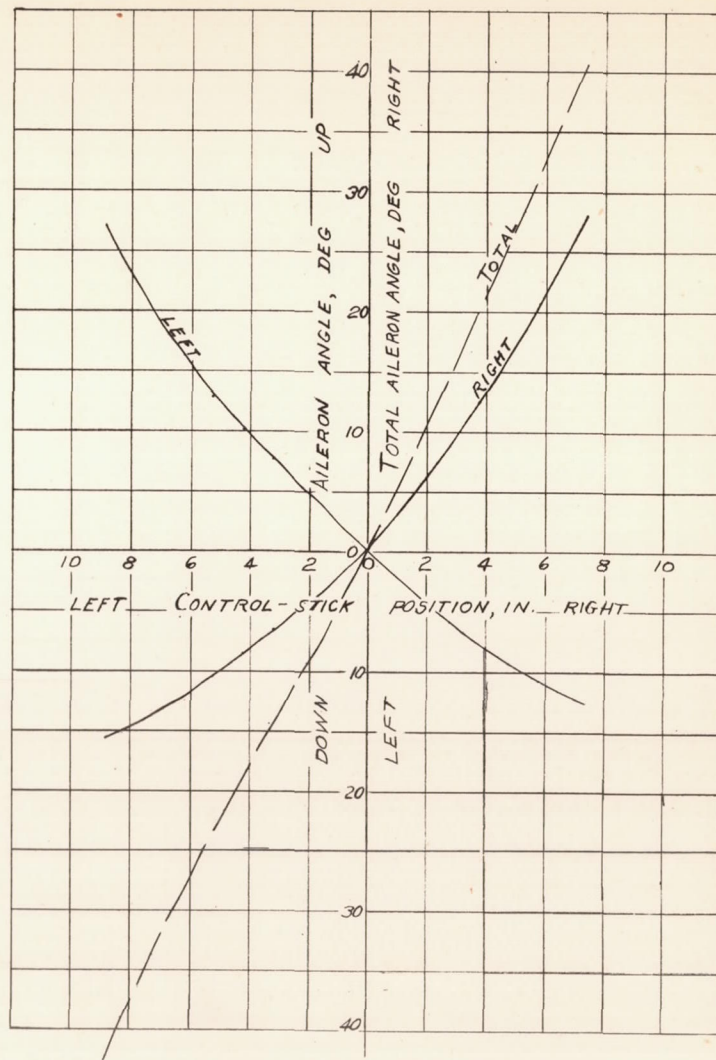
Figure 8. - Variation of angles of left and right ailerons and total aileron deflection with position of top of control stick. Brewster XSBA-1 airplane.

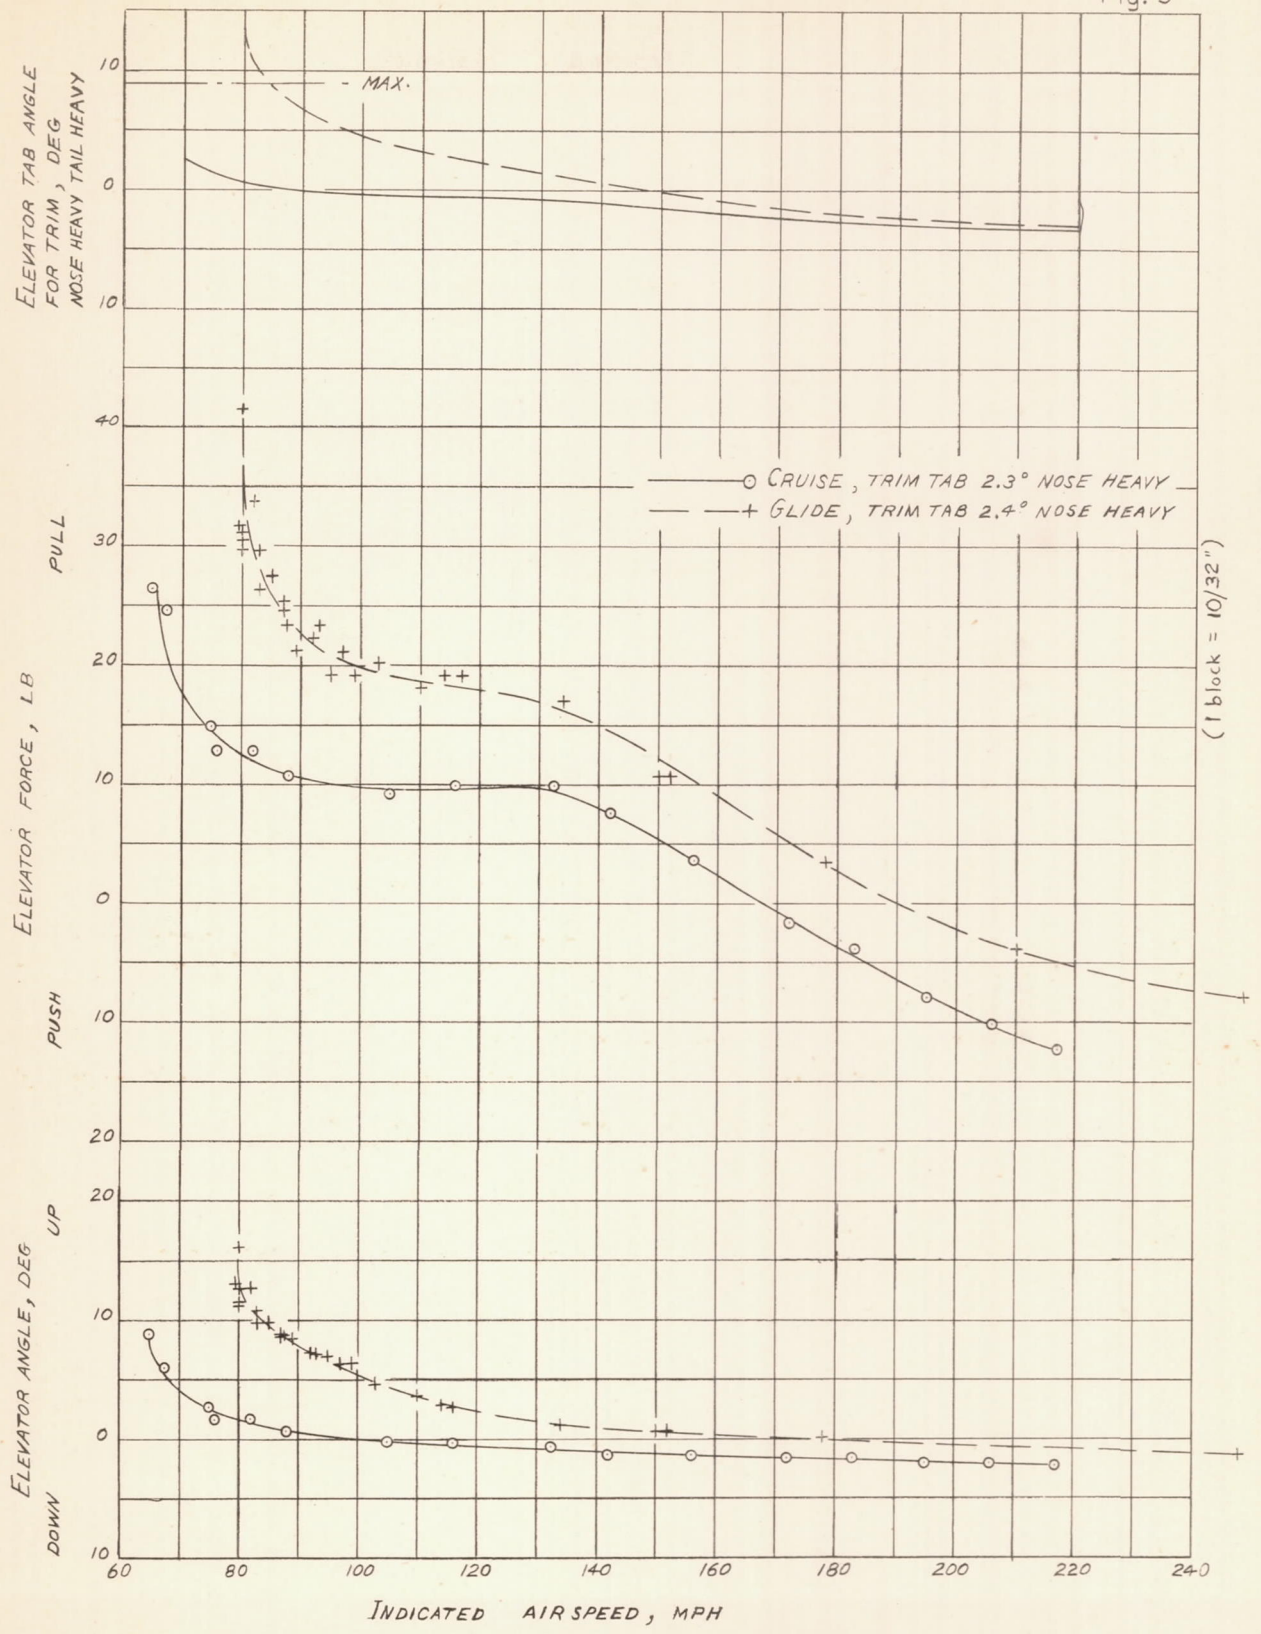
Fig. 9

Figure 9. - Variation of elevator angle, elevator force, and elevator tab angle required for trim with indicated airspeed in the gliding and cruising conditions; Brewster XSBA-1 airplane.

(1) In all the flight conditions tested, stick-fixed static stability existed, as shown by the negative slopes of the curves of elevator angle against airspeed (figs. 9 to 12). The stability was greatest in the landing condition (flaps and landing gear down, power off). It was also relatively large in the gliding condition (flaps and landing gear up, power off). The large increase in up elevator angle at low speeds in the gliding condition was believed to be caused by separation of the flow at the wing root as the stall was approached. The static stability possessed by this airplane in the flaps-down, power-on conditions of flight was unusually large, inasmuch as static instability is often encountered in these conditions.

The stick force per degree trimming-tab change as a function of indicated airspeed in various flight conditions is shown in figure 20. The trimming-tab setting required to trim at zero stick force in these conditions is plotted in figures 9 to 11. The trimming tabs were sufficiently powerful to

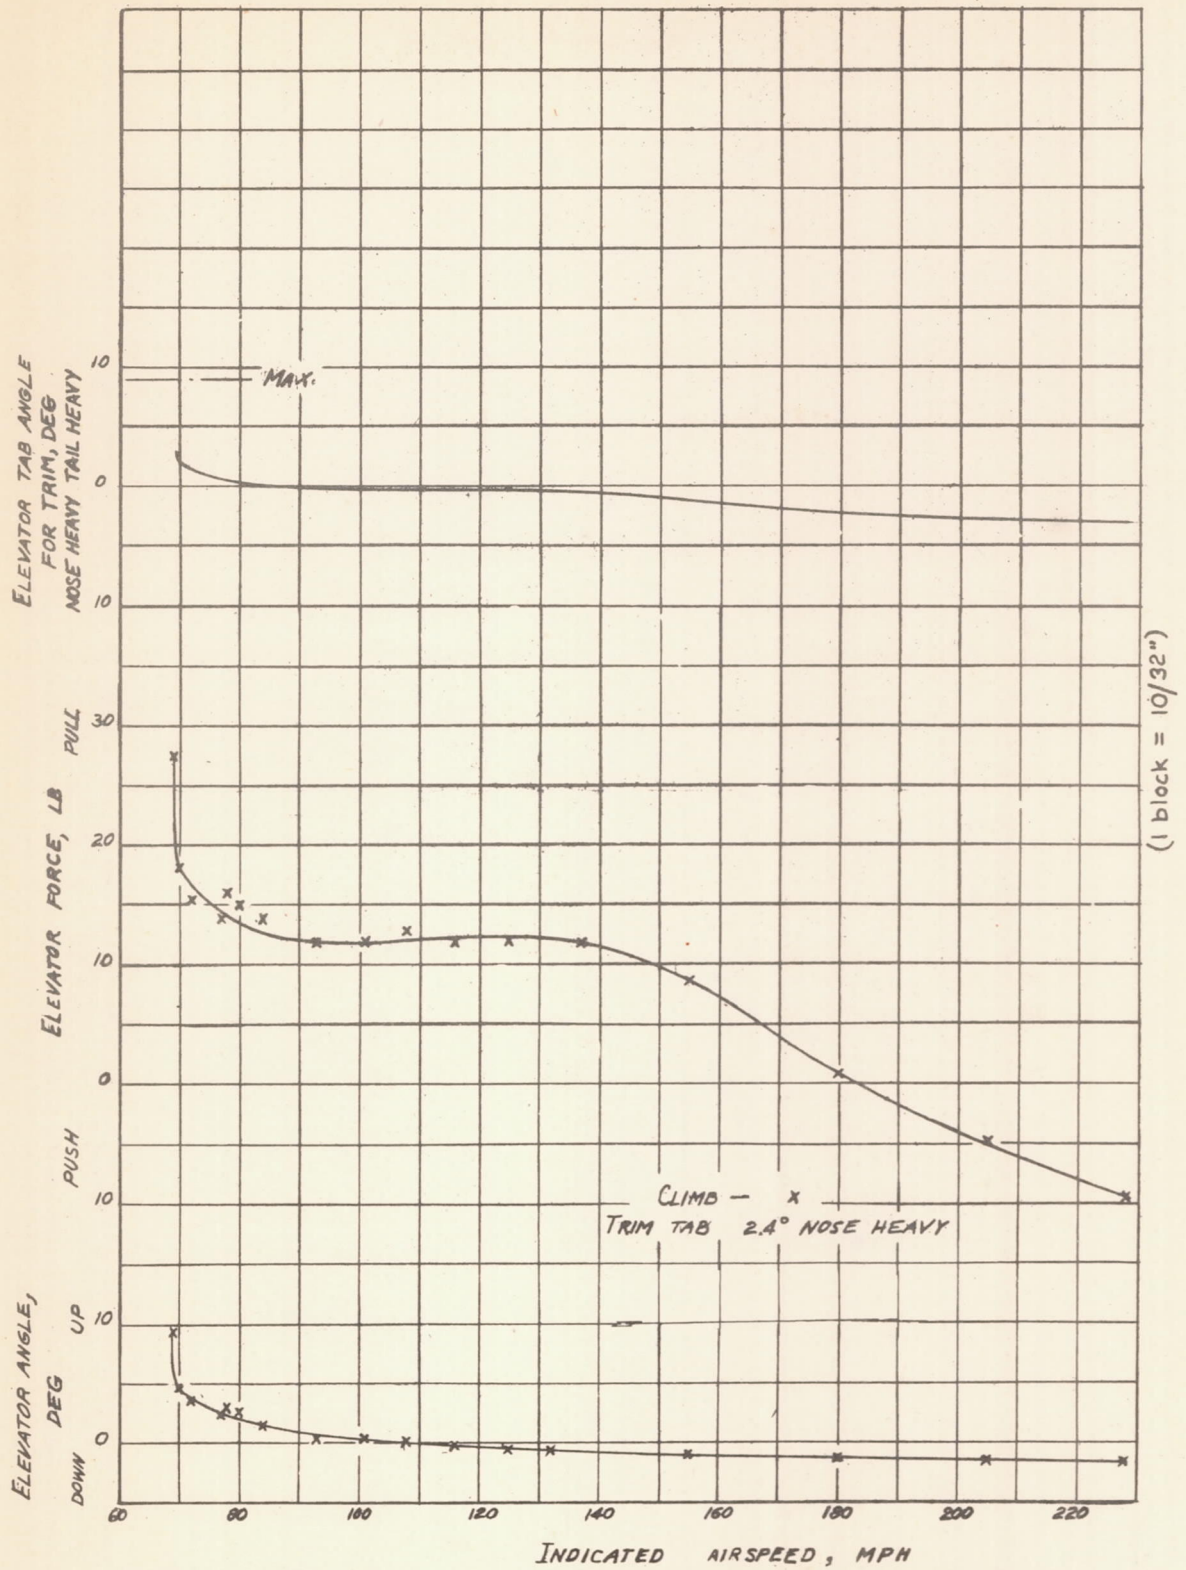
Figure 10. - Variation of elevator angle, elevator force, and elevator tab angle required for trim with indicated airspeed in the climbing condition; Brewster XSBA-1 airplane.

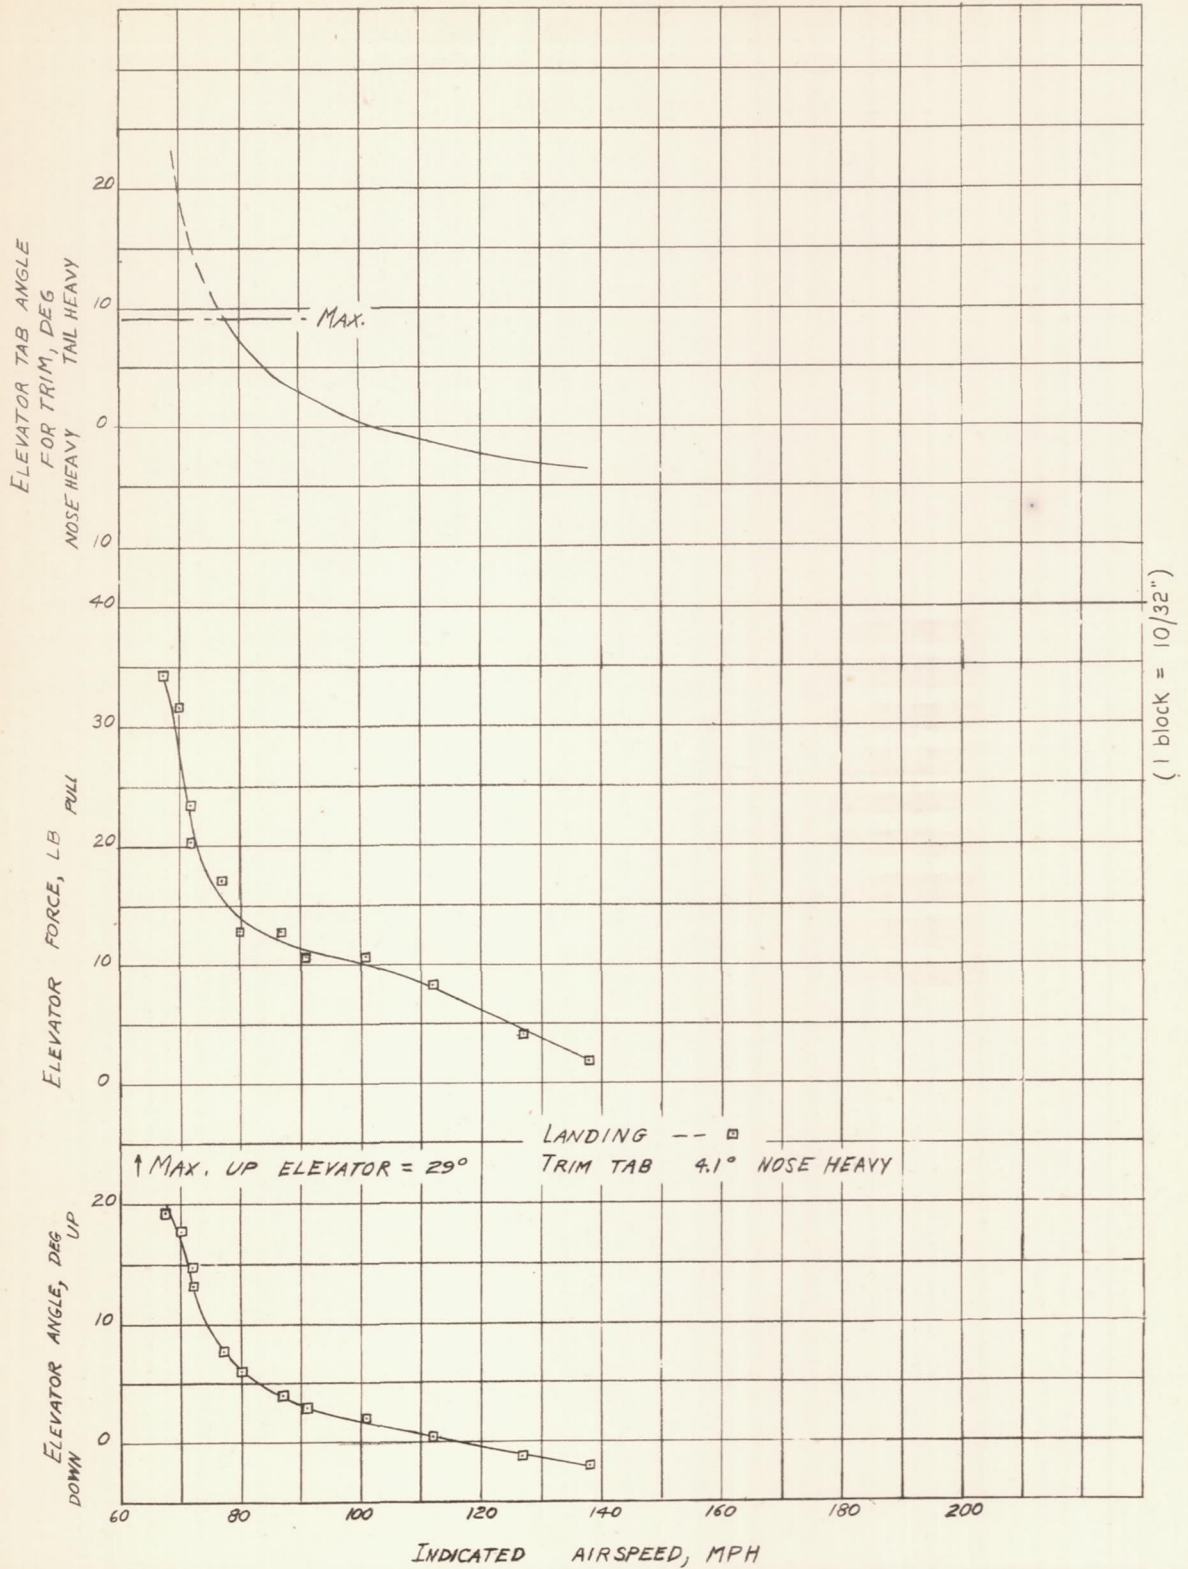
Figure 11. - Variation of elevator angle, elevator force, and elevator tab angle required for trim with indicated airspeed in the landing condition; Brewster XSBA-1 airplane.

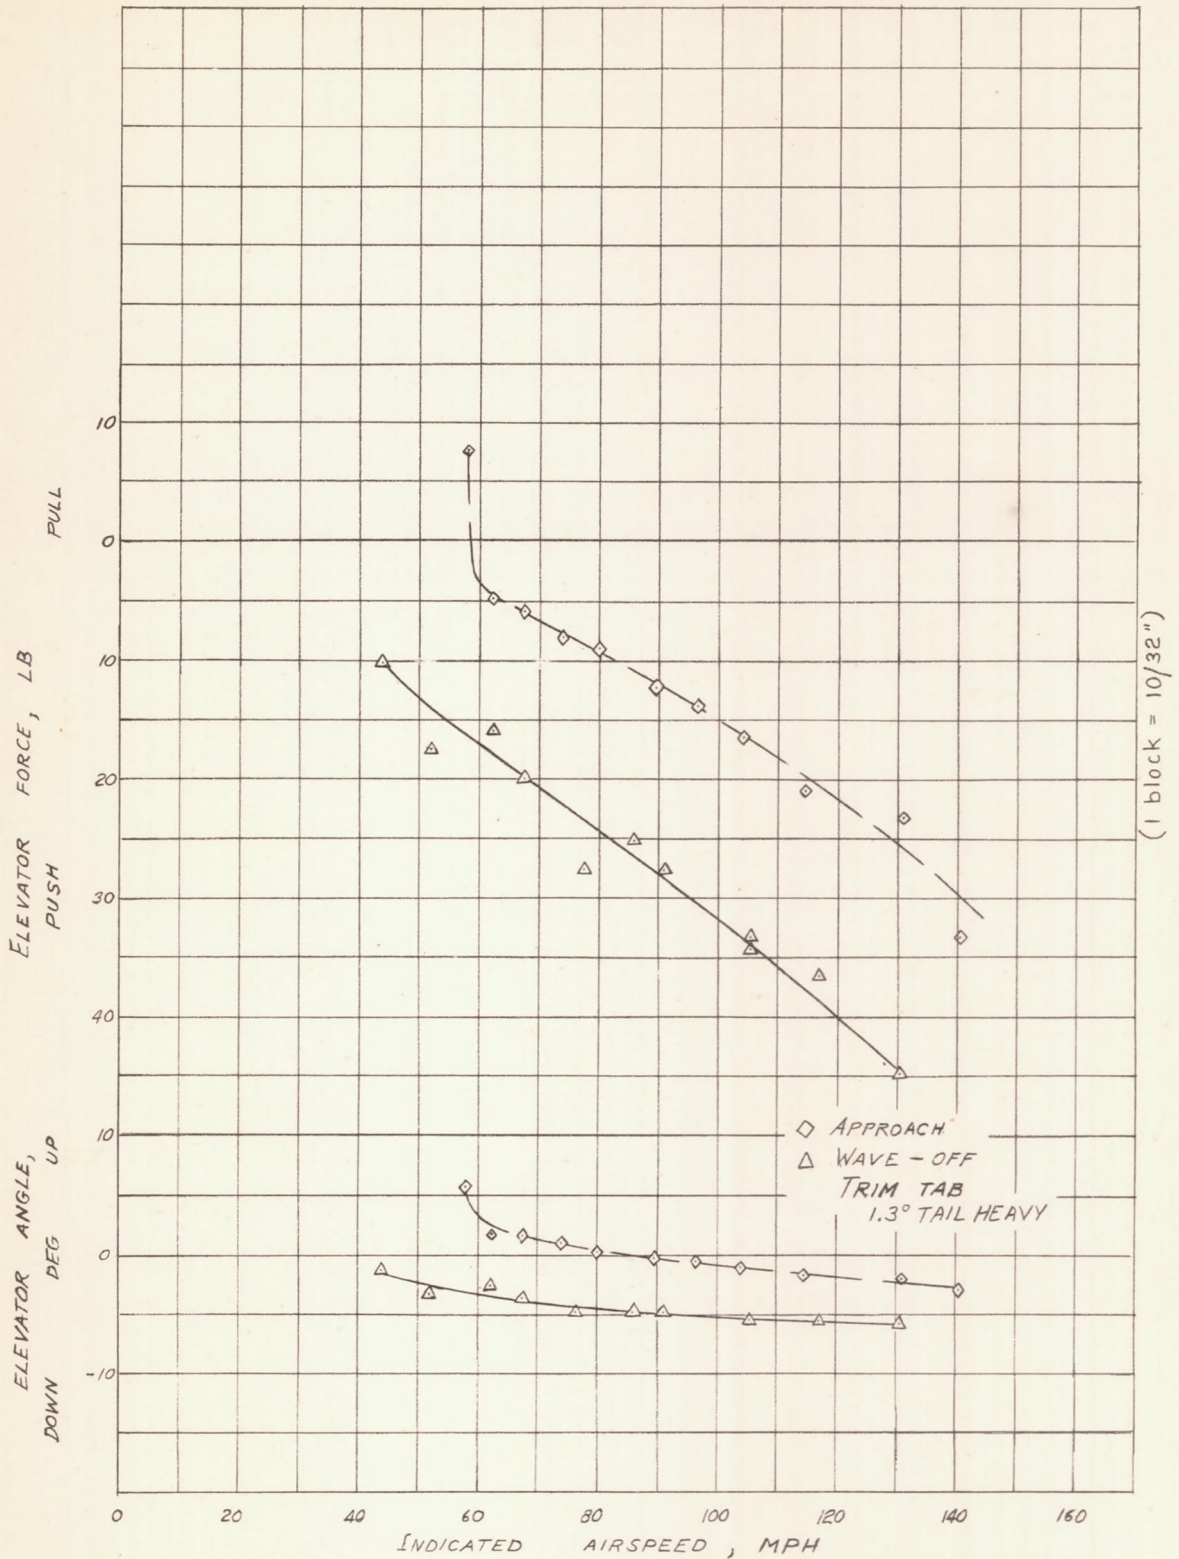
Figure 12. - Variation of elevator angle and elevator force with indicated airspeed in the approach and wave-off conditions; Brewster XSBA-1 airplane.

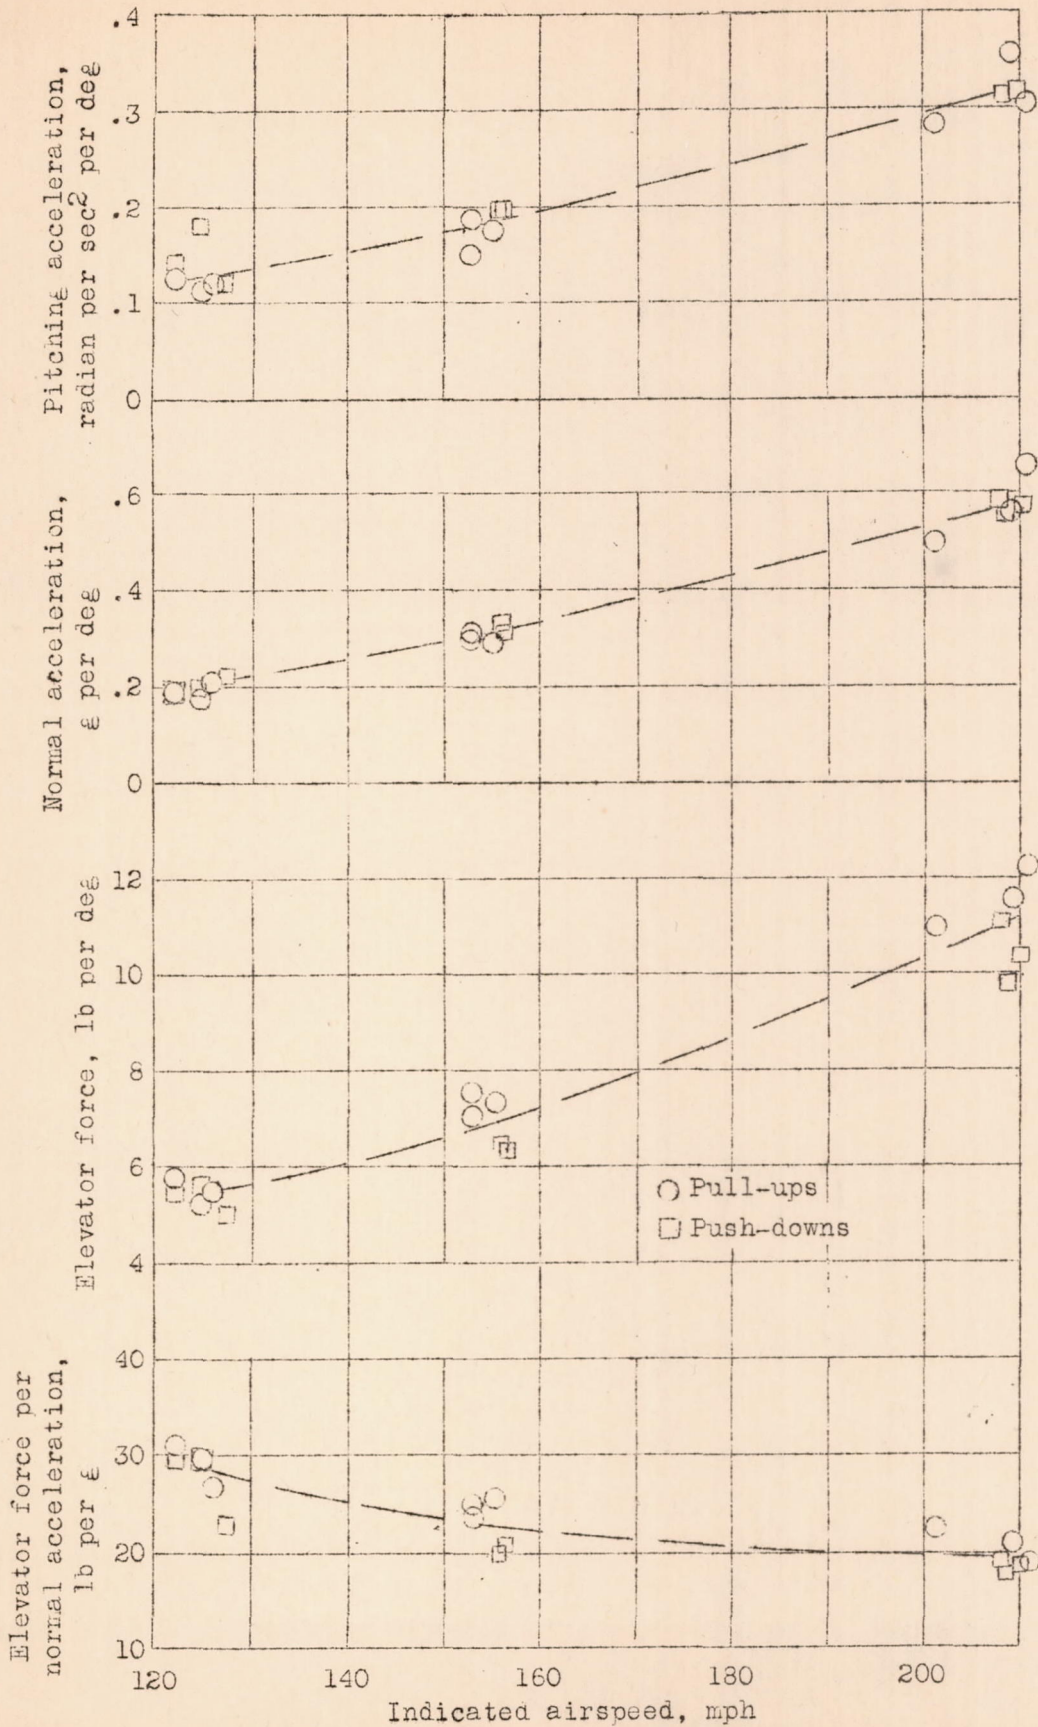
Figure 13.- Elevator control characteristics as measured in pull-ups and push-downs from level flight (flaps up, gear up). Brewster XSBA-1 airplane.

Characteristics of the elevator control in accelerated flight. - The characteristics of the elevator control in accelerated flight were determined from measurements taken in abrupt pull-ups and push-downs from level flight and in rapid 180° turns. The results of the pull-ups and push-downs are presented in figure 13. Time histories of representative turns are presented in figures 14 to 17. The results of the tests pertaining to the elevator control may be summarized as follows:

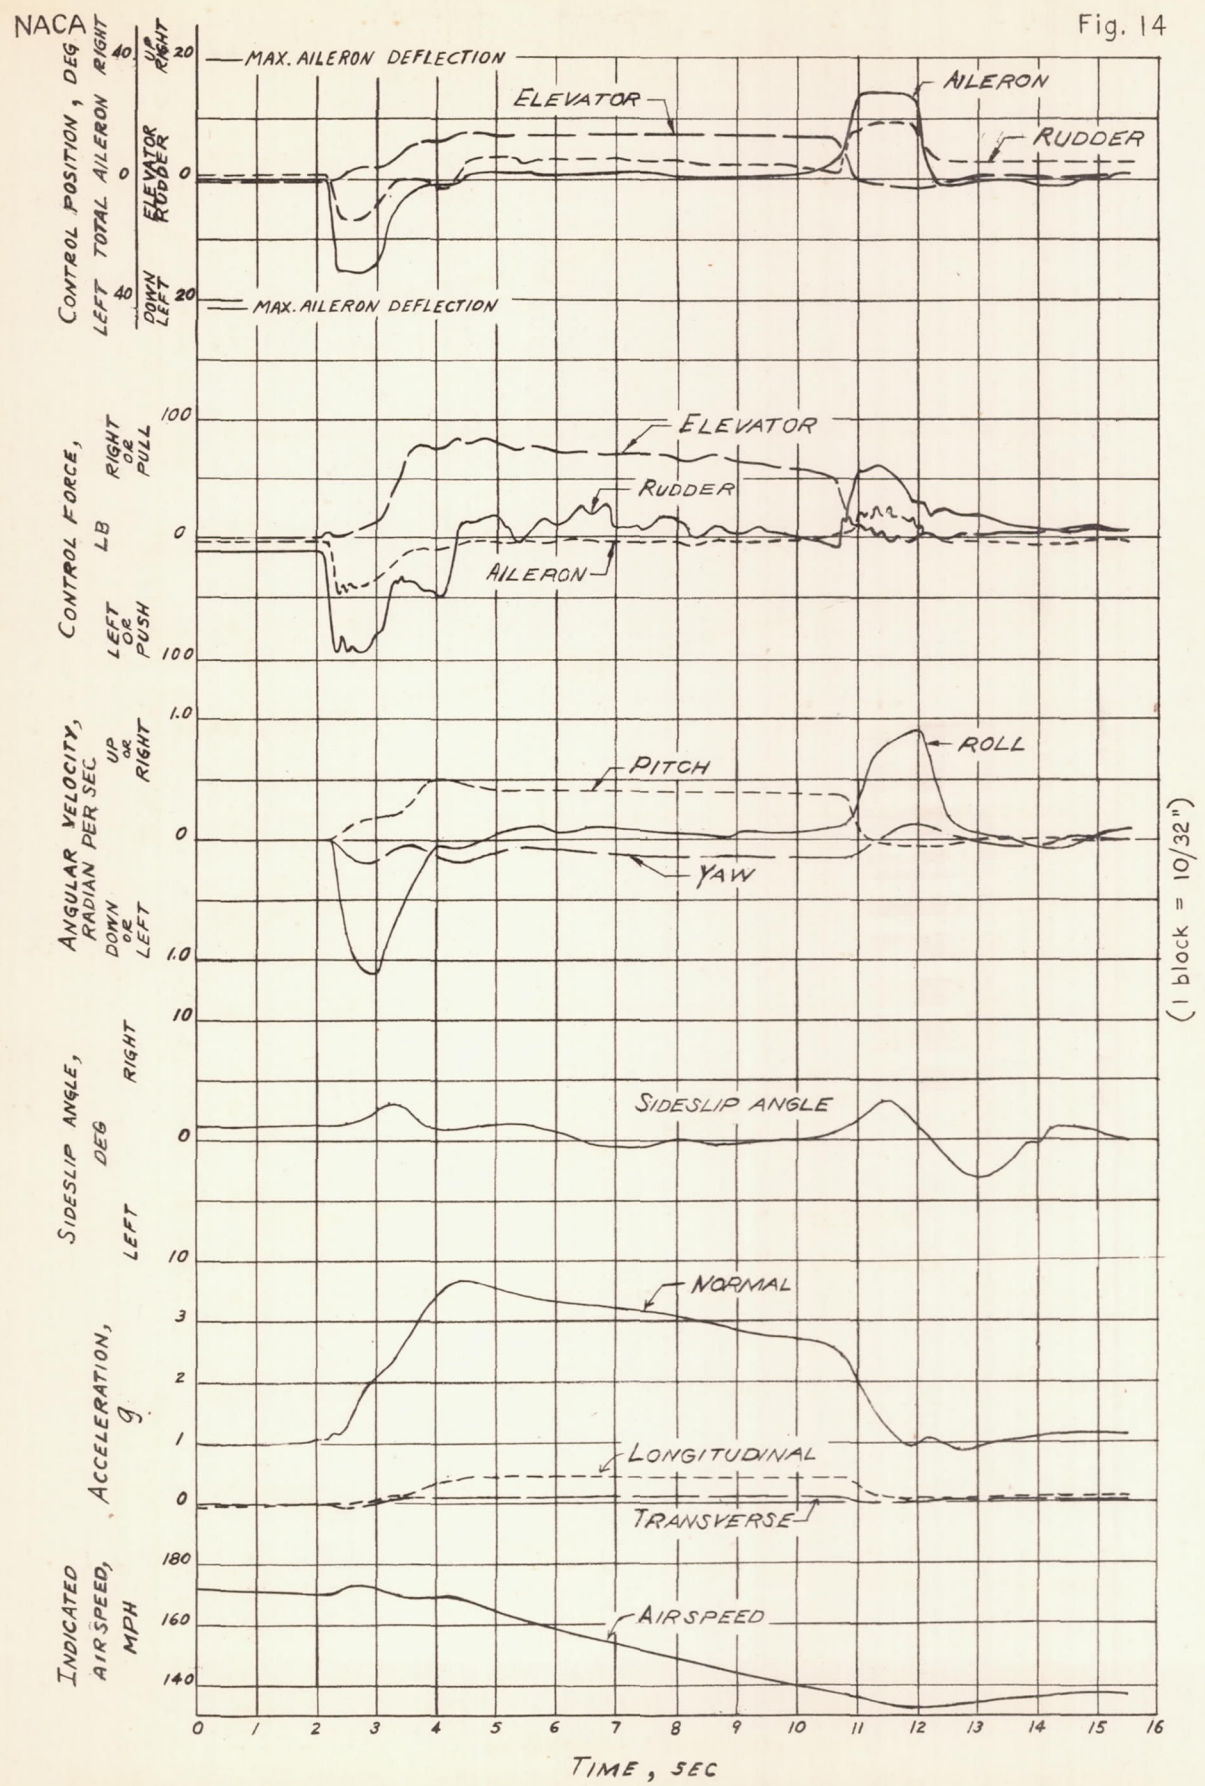
Fig. 14

Figure 14. - Time history of a rapid 180° turn to the left started at 172 miles per hour. Note large elevator force. Brewster XSBA-1 airplane, flaps up, gear up, 18 inches Hg manifold pressure, 1800 rpm.

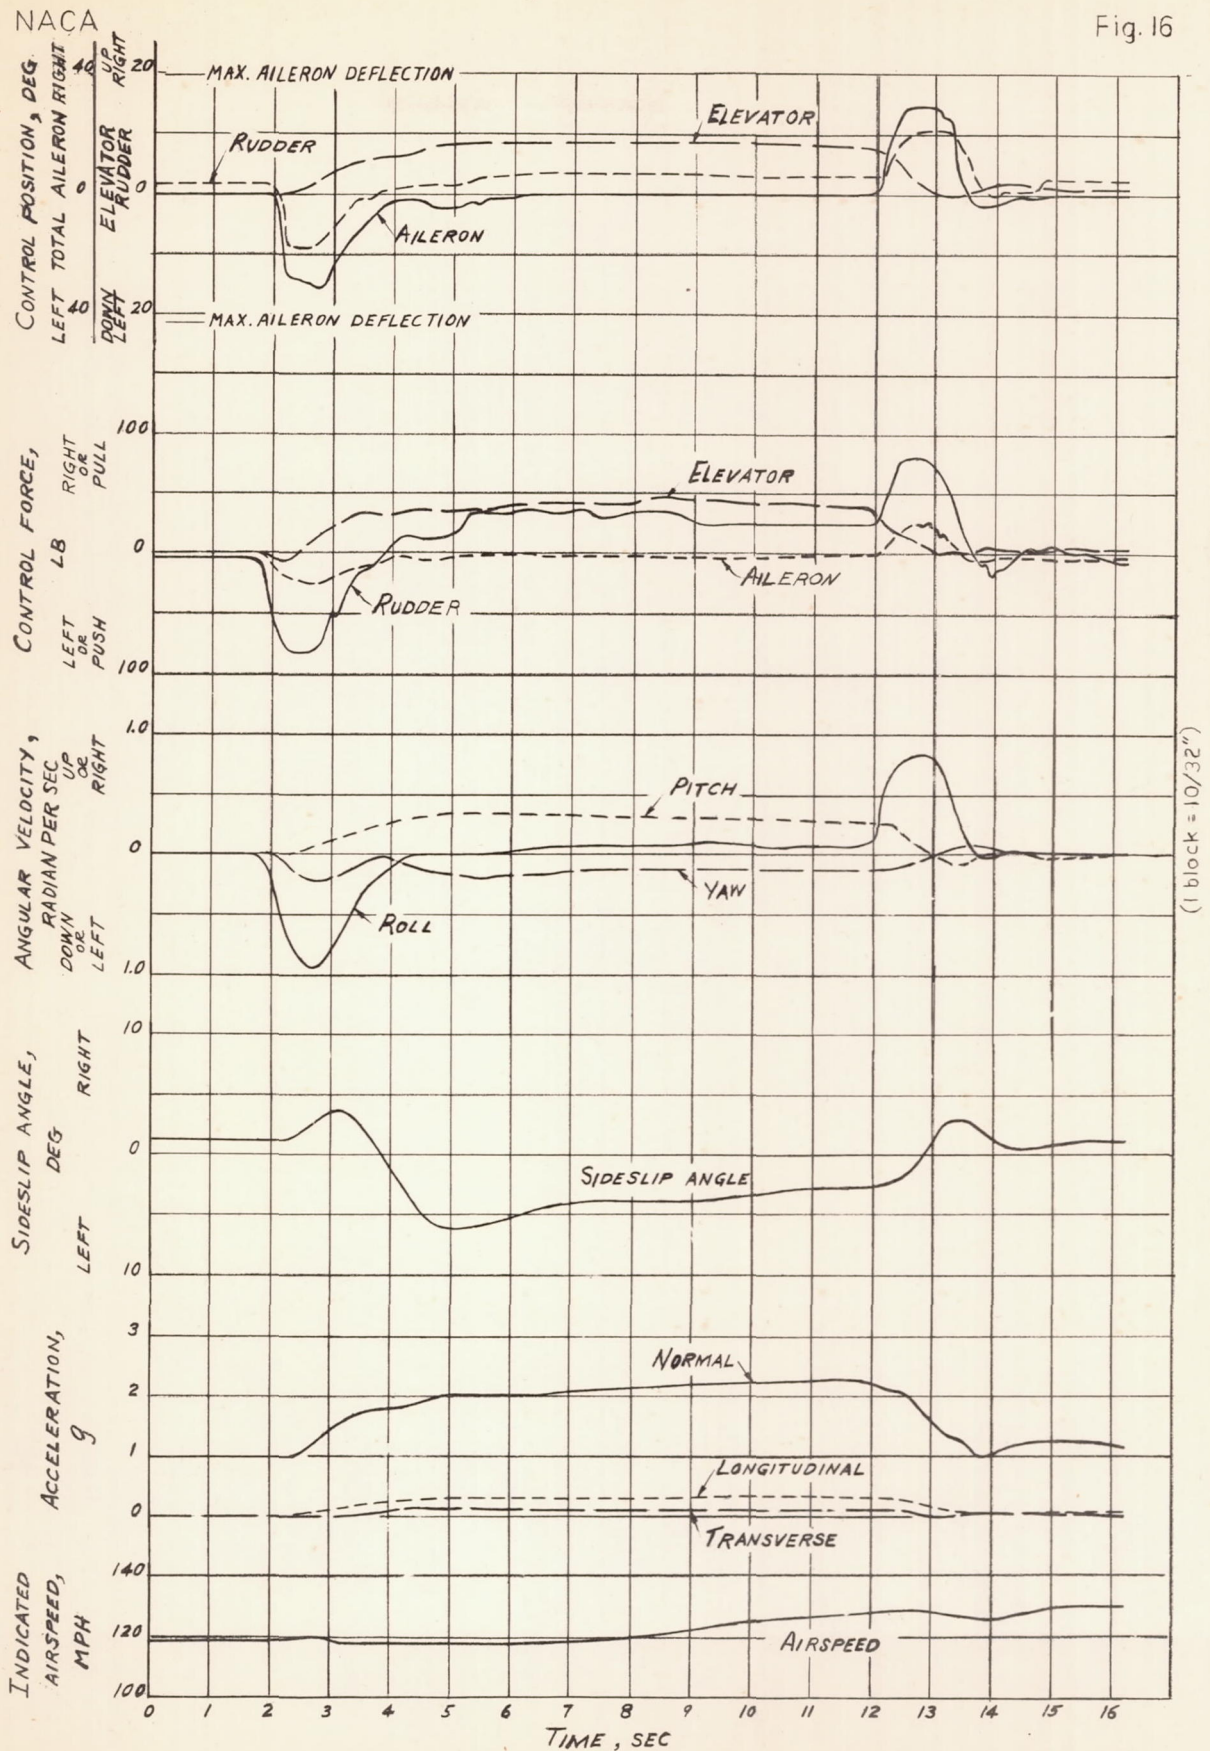
Figure 16. - Time history of a rapid 180° turn to the left started at 119 miles per hour. Brewster XSBA-1 airplane; flaps up, gear up, 18 inches Hg manifold pressure, 1800 rpm.
