FLIGHT TESTS OF VARIOUS TAIL MODIFICATIONS

ON THE BREWSTER XSBA-1 AIRPLANE

I - MEASUREMENTS OF FLYING QUALITIES

WITH ORIGINAL TAIL SURFACES

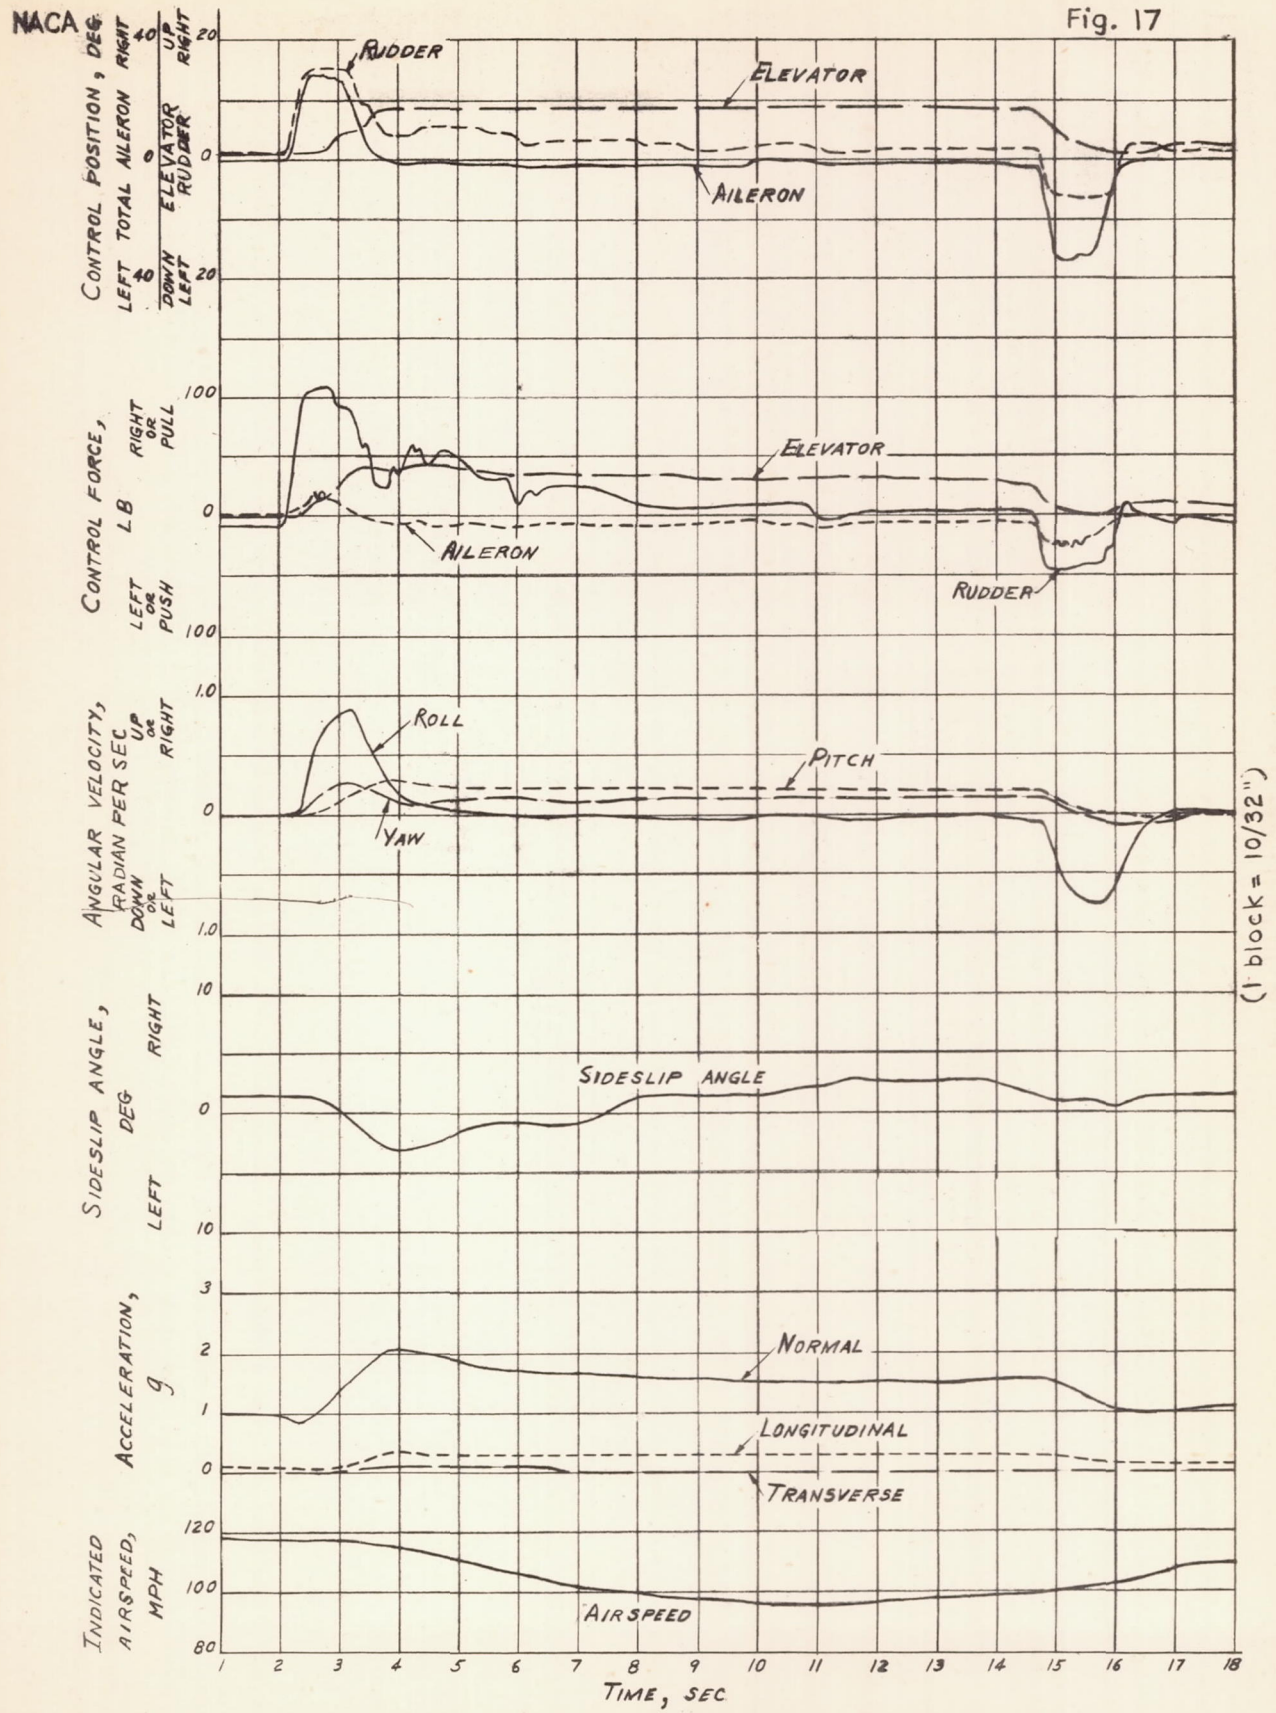
Fig. 17

Figure 17. - Time history of a rapid 180° turn to the right started at 118 miles per hour. Brewster X3BA-1 airplane; flaps up, gear up, 18 inches Hg manifold pressure, 1800 rpm.

Characteristics of the elevator control in accelerated flight. - The characteristics of the elevator control in accelerated flight were determined from measurements taken in abrupt pull-ups and push-downs from level flight and in rapid 180° turns. The results of the pull-ups and push-downs are presented in figure 13. Time histories of representative turns are presented in figures 14 to 17. The results of the tests pertaining to the elevator control may be summarized as follows:

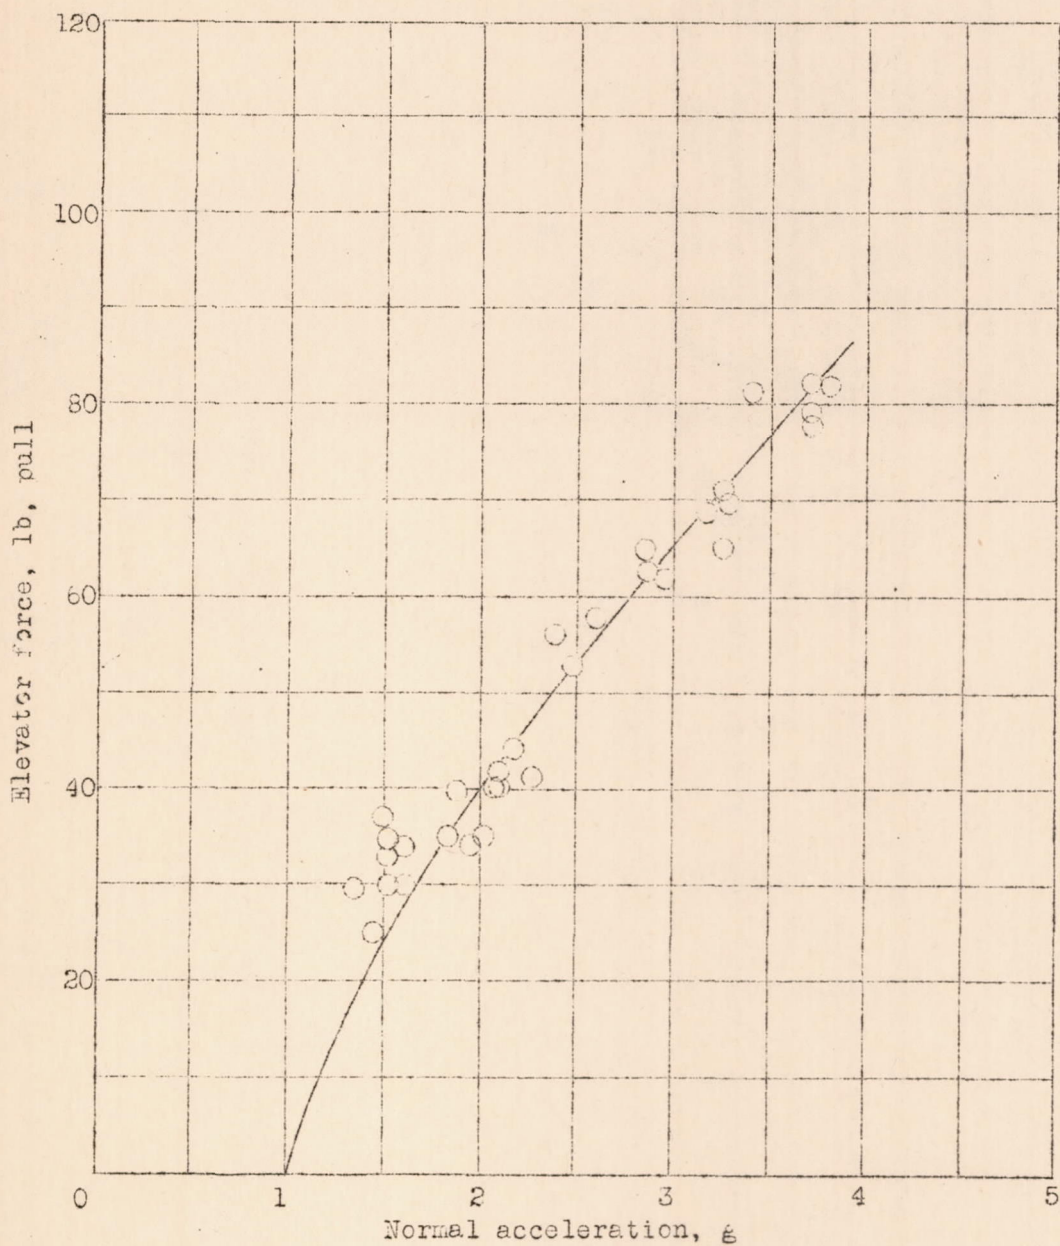
Figure 18.- Variation of elevator stick force with normal acceleration in 180° turns. Brewster XSEA-1 airplane; flaps up, gear up, 18 inches H_g manifold pressure, 1800 rpm.

(4) The variation of stick force with normal acceleration in 180° turns is plotted in figure 18. A large increase in stick force and elevator angle occurred as the stall was approached. For this reason, turns made at lift coefficients near the stall required a greater force per g acceleration than turns made at low lift coefficients.

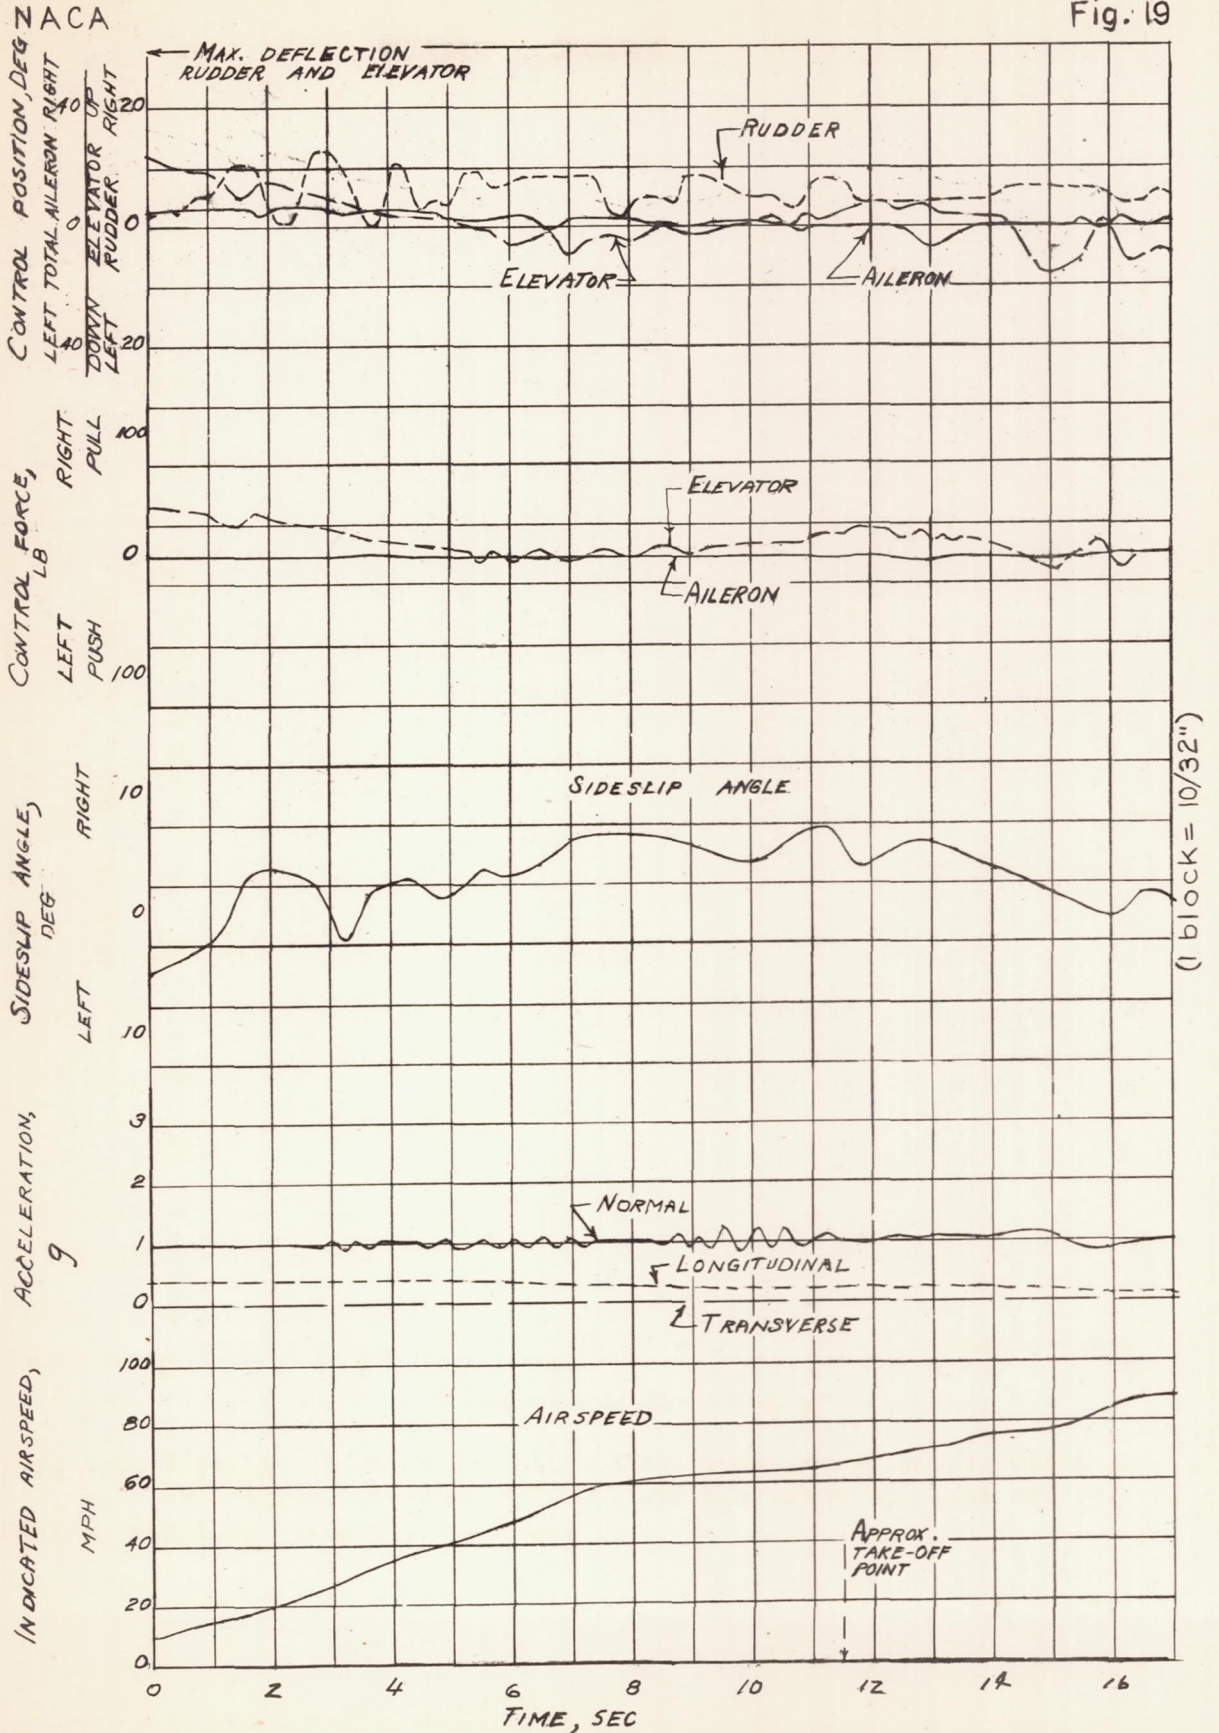
Figure 19. - Time history of a take-off with flaps full down, 35 inches Hg manifold pressure, 2200 rpm. Brewster XSBA-1 airplane.

The elevator was adequate to raise the tail or to adjust the attitude angle as desired during take-off. Figure 19 shows a time history of a take-off in which the tail was raised fairly early in the run.

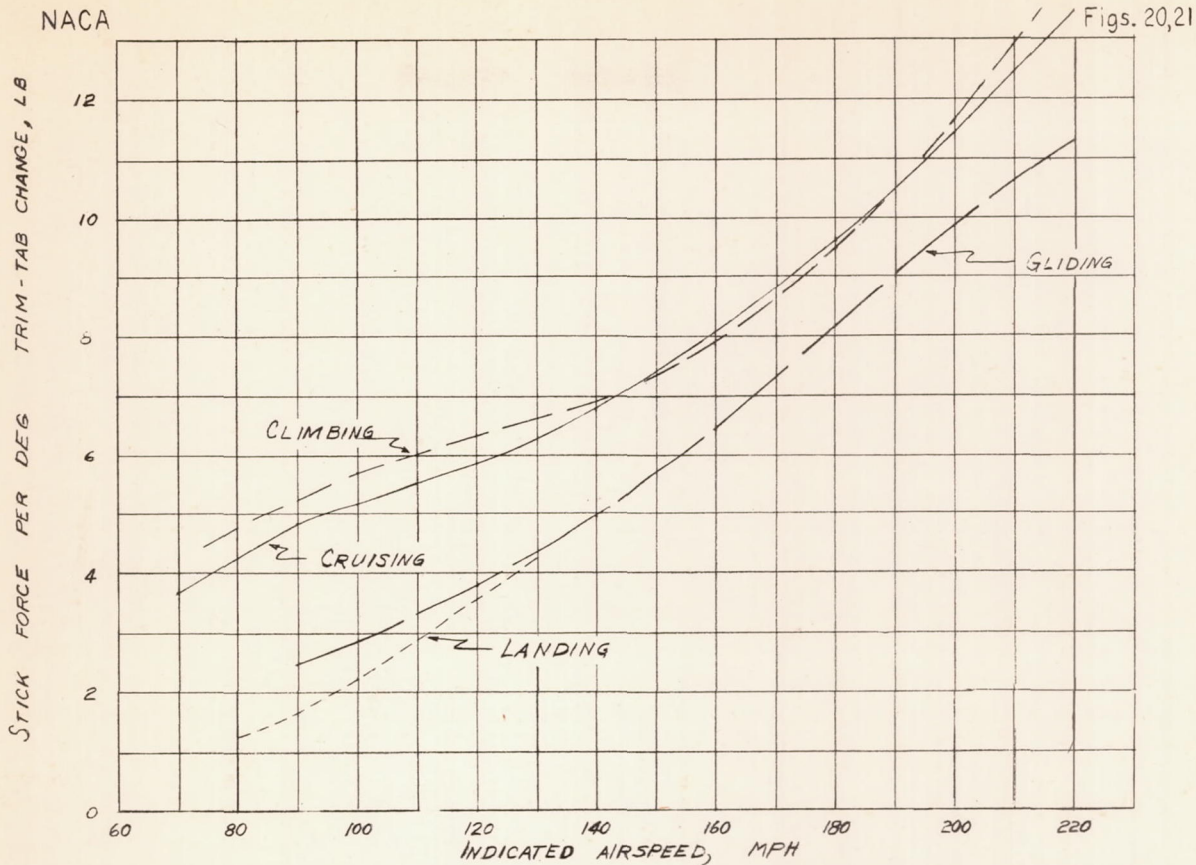
Figure 20. - Variation of stick force per degree trim-tab change with indicated airspeed, Brewster XSBA-1 airplane.

The stick force per degree trimming-tab change as a function of indicated airspeed in various flight conditions is shown in figure 20. The trimming-tab setting required to trim at zero stick force in these conditions is plotted in figures 9 to 11. The trimming tabs were sufficiently powerful to

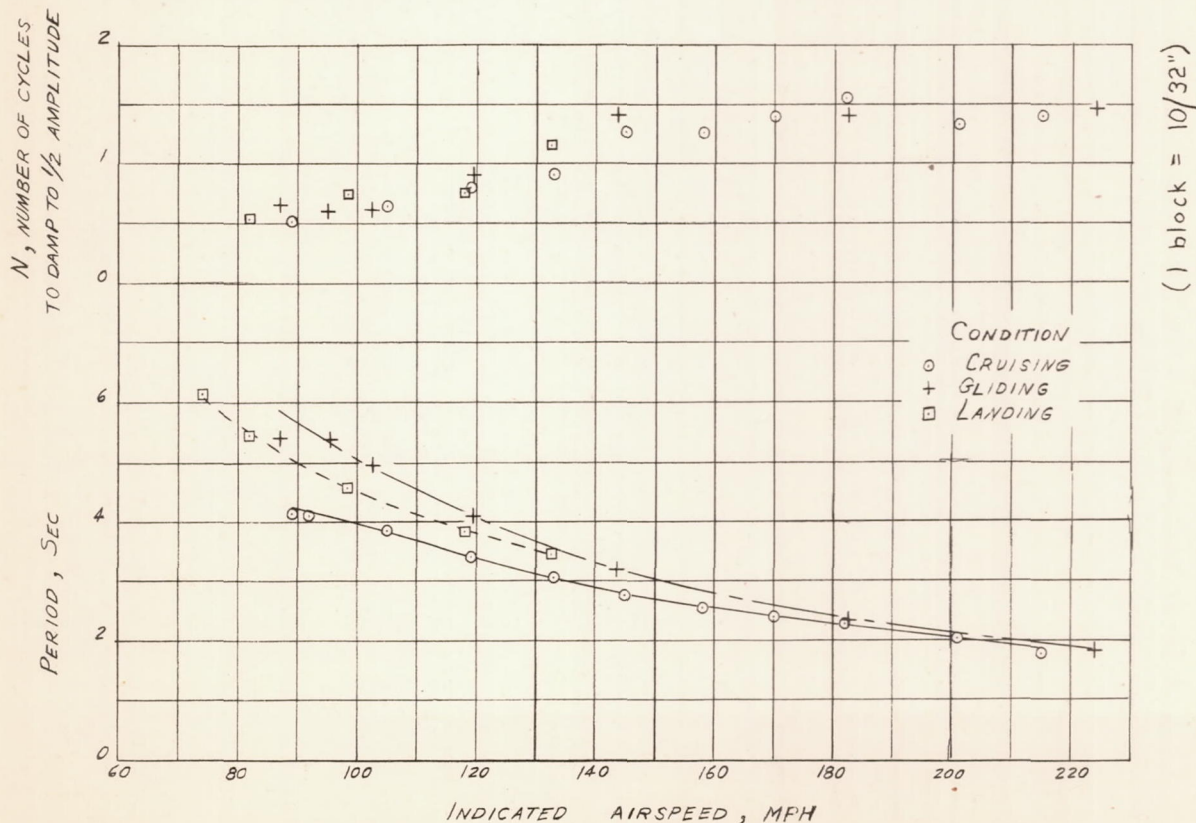
Figure 21. - Variation of period and damping of lateral oscillations with indicated airspeed. Brewster XSBA-1 airplane.

Characteristics of uncontrolled lateral and directional motion. - The lateral motion of the Brewster XSBA-1 airplane with controls free following a disturbance was measured in the cruising, gliding, and landing flight conditions at various speeds. The period and damping of these lateral oscillations as functions of airspeed are shown in figure 21. The conclusions reached with regard to the uncontrolled lateral and directional motion are as follows:

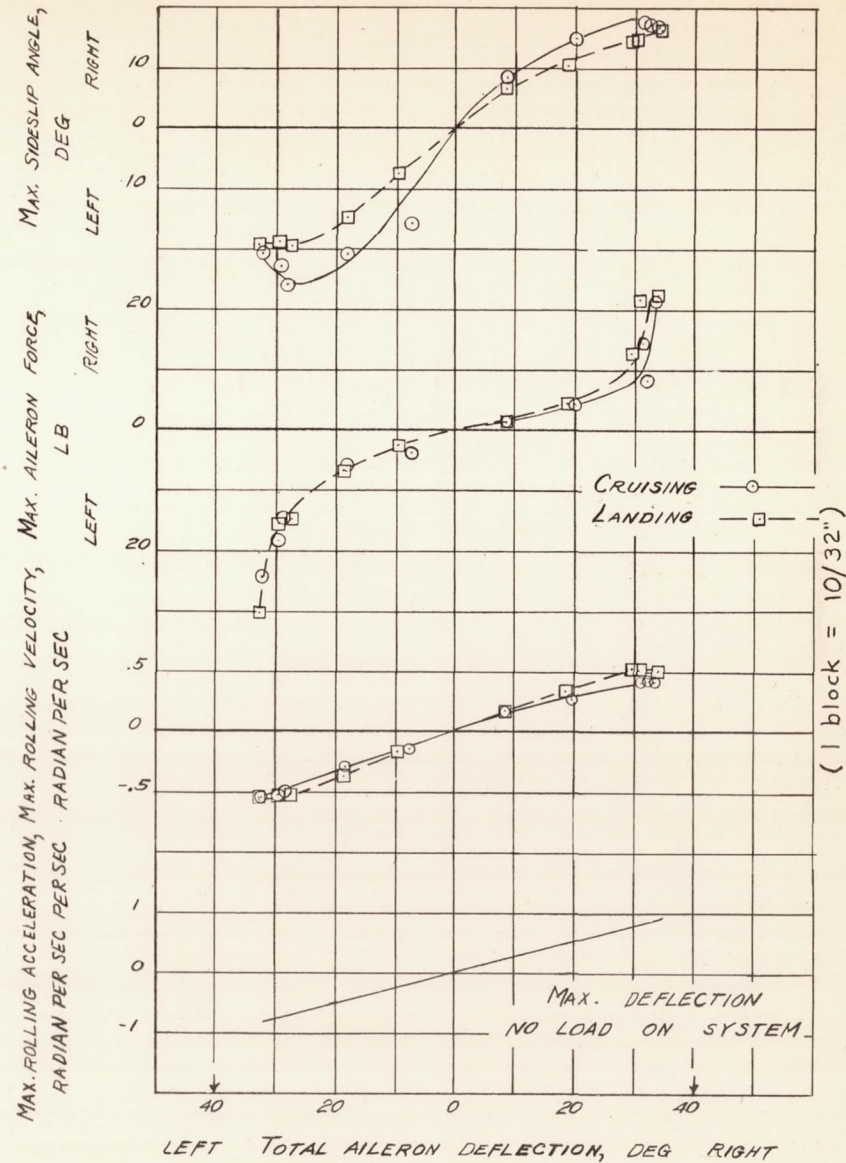
Figure 23. - Variation of maximum sideslip angle, aileron force, rolling velocity, and angular acceleration with aileron deflection in the landing condition at 85 miles per hour and in the cruising condition at 76 miles per hour. Brewster XSBA-1 airplane.

The results of the aileron tests are presented in figures 22 to 24. Figures 22 and 23 show the variation of the maximum values of sideslip angle, aileron force, rolling velocity, and rolling acceleration reached in aileron rolls with various aileron deflections in the cruising and landing conditions at low speeds. The quantities are plotted against total aileron deflection, which is the sum of the deflections of the right and left ailerons from their trim positions.

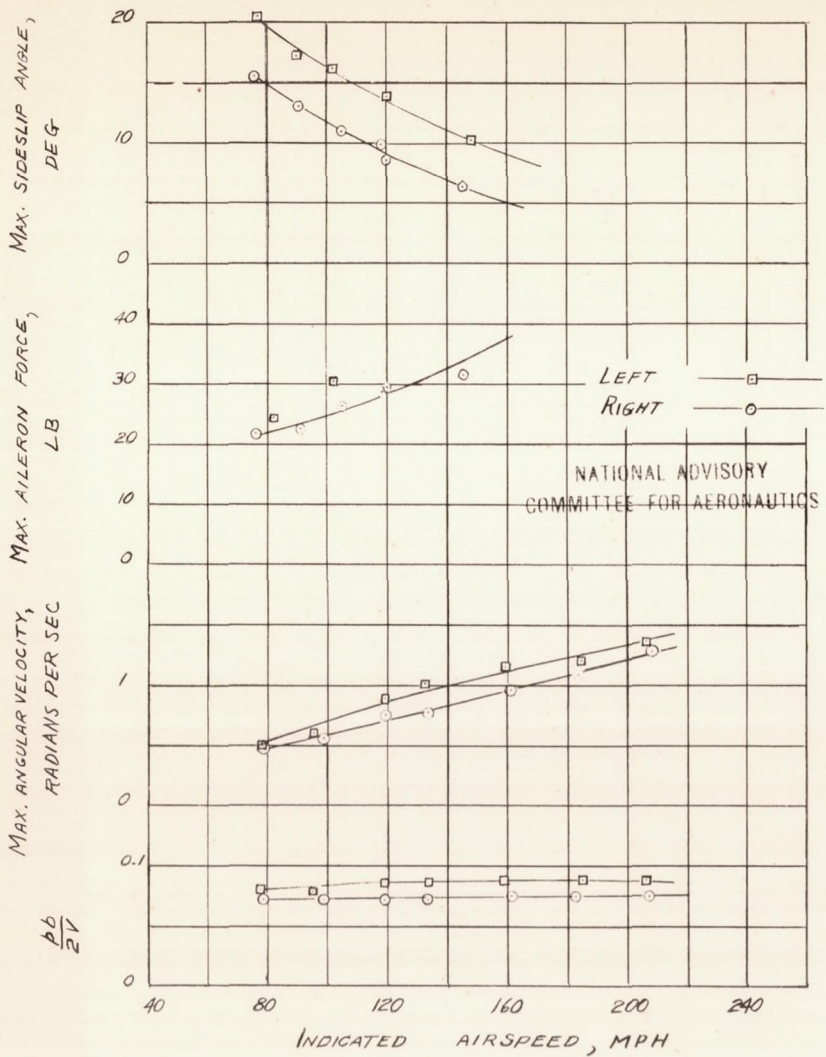
Figure 24. - Variation of maximum sideslip angle, maximum aileron force, maximum rolling velocity, and pb/2V with indicated airspeed in level flight for rolls with full aileron deflection (flaps up, gear up). Brewster XSBA-1 airplane.

The aileron forces for maximum deflection were considered excessive. From figure 24, it is seen that a force greater than 20 pounds was required to obtain full aileron deflection even at the minimum flying speed and that, at 175 miles per hour, which was about 80 percent of the maximum indicated speed, a force of about 42 pounds was required. This force exceeds the upper limit of 30 pounds at 80 percent of the maximum indicated speed given in reference 1.

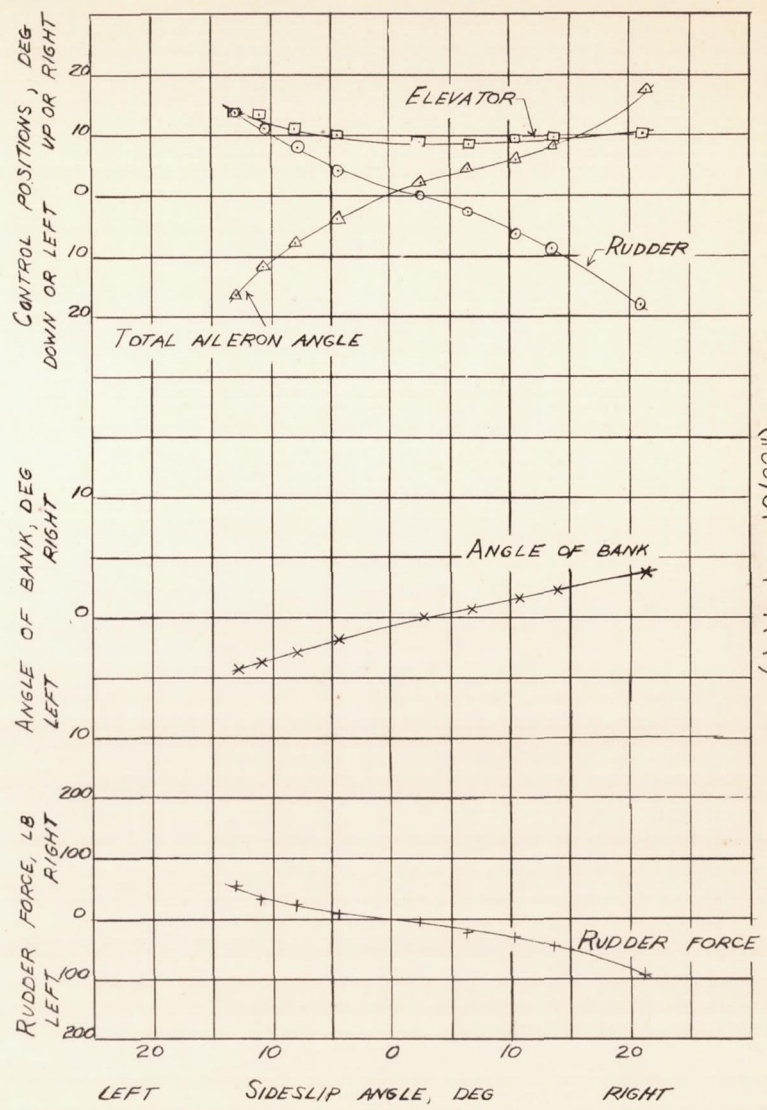
Figure 25. - Steady-sideslip characteristics in the gliding condition at 85 miles per hour (flaps up, gear up, power off). Brewster XSBA-1 airplane.

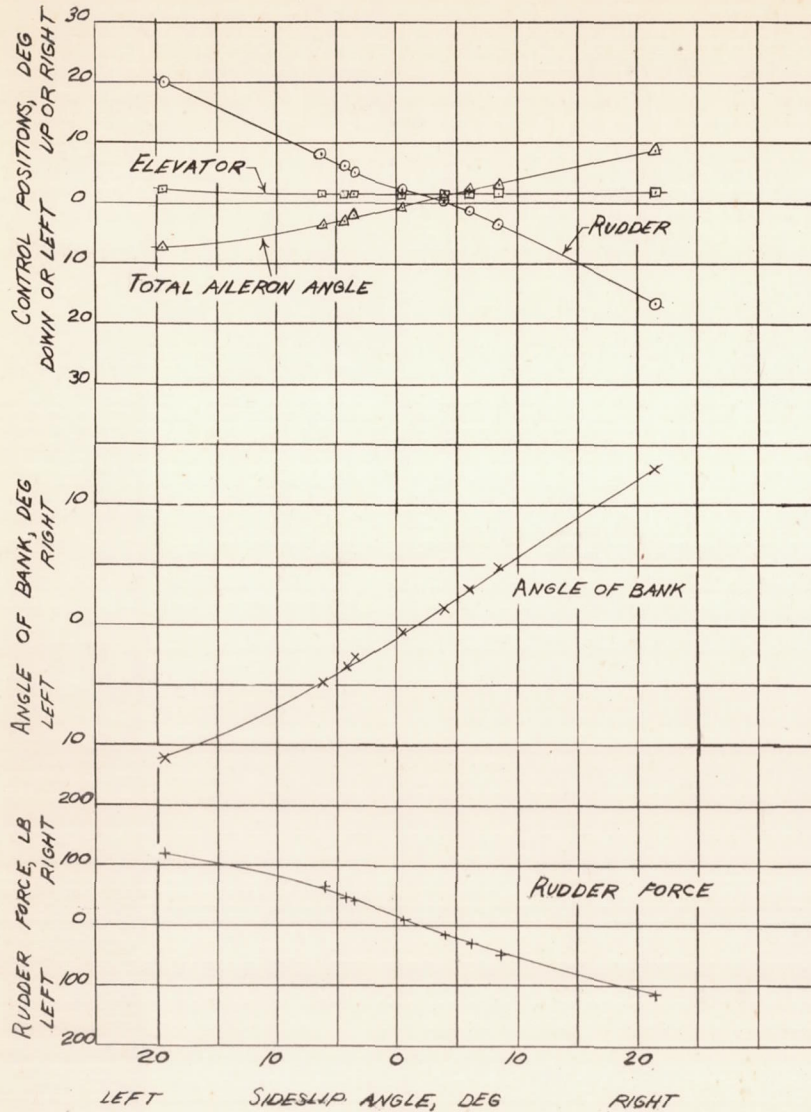
Figure 28. - Steady-sideslip characteristics in the cruising condition at 122 miles per hour (flaps up, gear up, cruising power). Brewster XSBA-1 airplane.

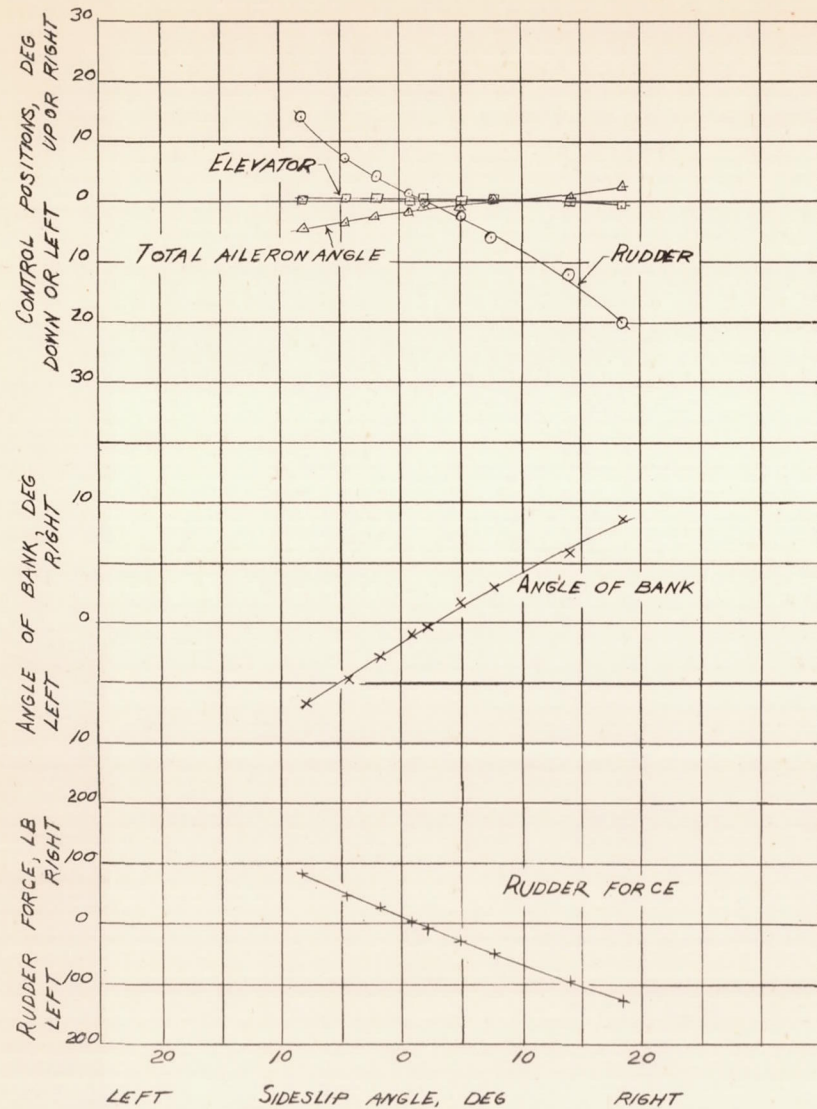
Figure 30. - Steady-sideslip characteristics in the landing condition at 115 miles per hour (flaps down, gear down, power off). Brewster XSBA-1 airplane.

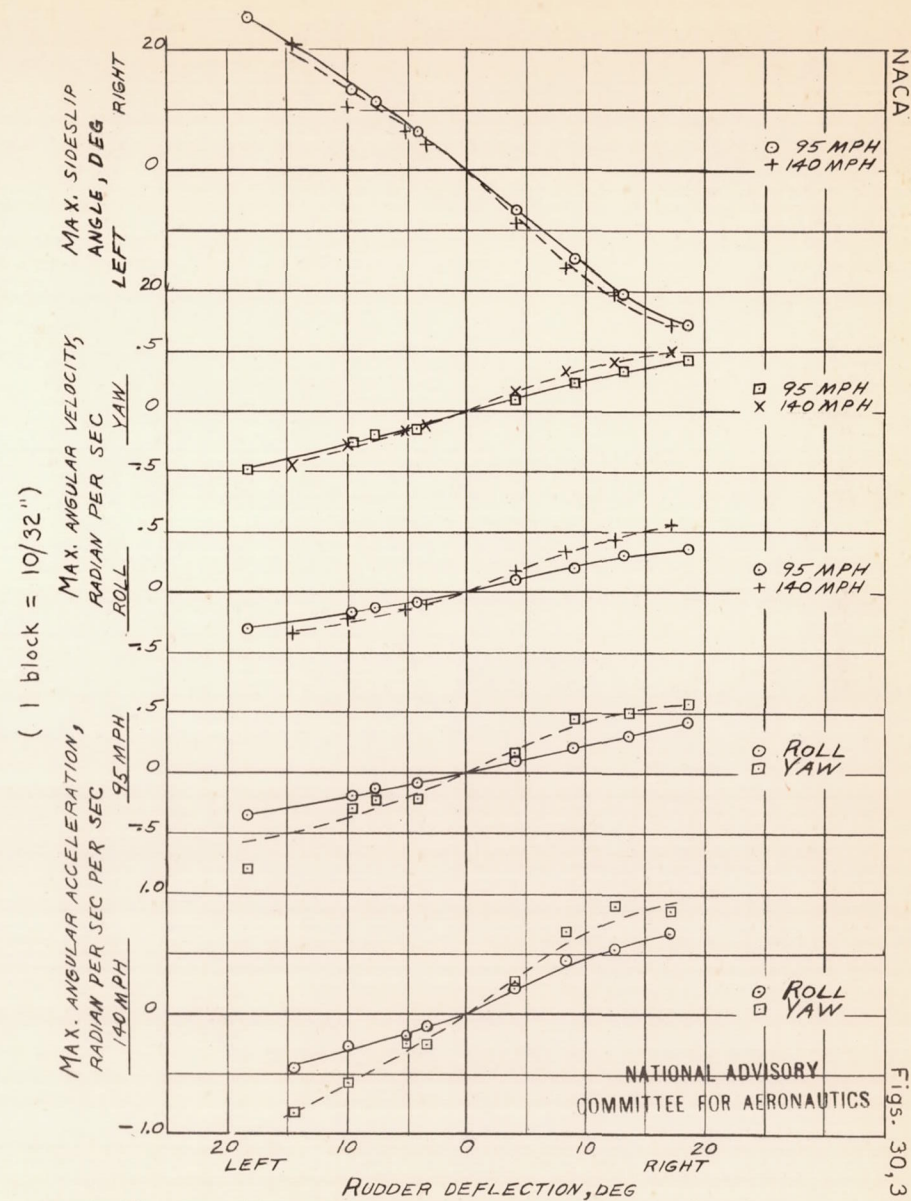
Figure 31.- Variation of maximum values of sideslip angle, angular velocities, and angular accelerations with rudder deflection in abrupt rudder kicks in the cruising condition at 95 and 140 miles per hour (flaps up, gear up, cruising power). Brewster XSBA-1 airplane.

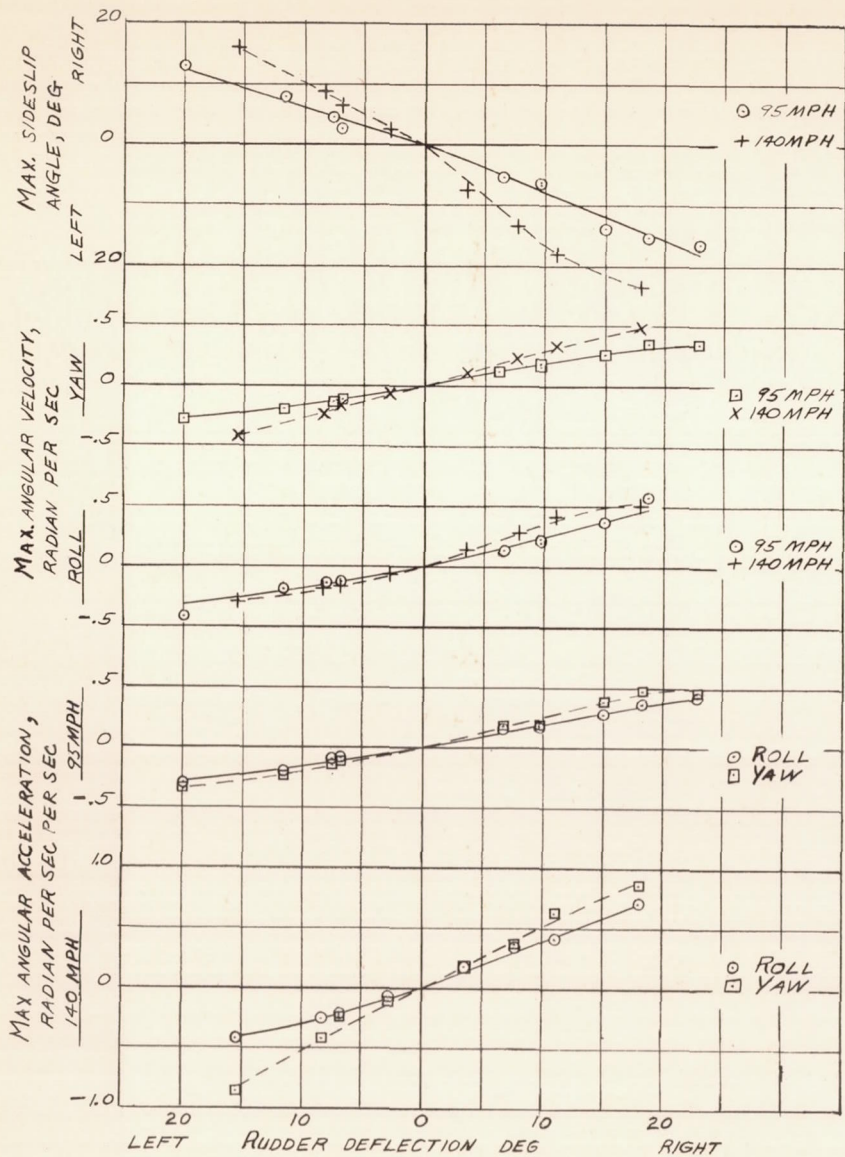
Figure 32. - Variation of maximum values of sideslip angle, angular velocities, and angular accelerations with rudder deflection in abrupt rudder kicks in the landing condition at 95 and 140 miles per hour (flaps up, gear up, power off). Brewster XSBA-1 airplane.

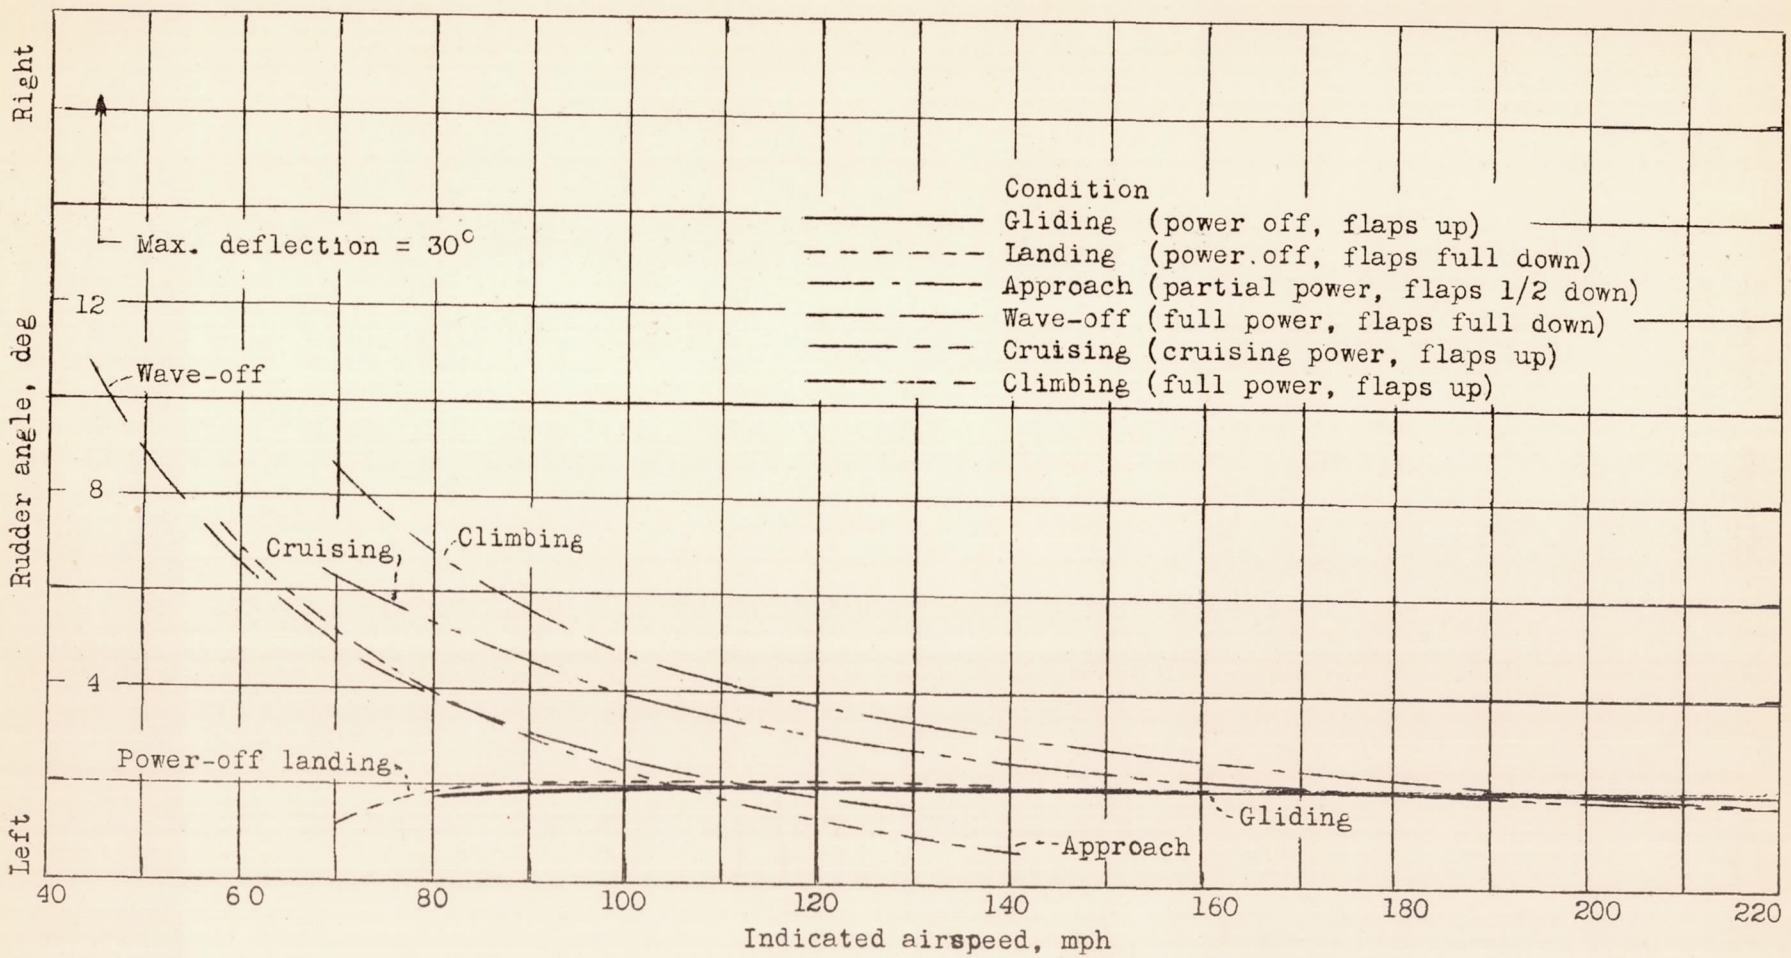
Fig. 34

Figure 34.- Variation of rudder angle required for trim with indicated airspeed. Brewster XSBA-1 airplane.

(3) Figure 34 shows that, for each condition tested, the rudder was sufficiently powerful to trim the airplane at all speeds greater than the minimum speed of the airplane.

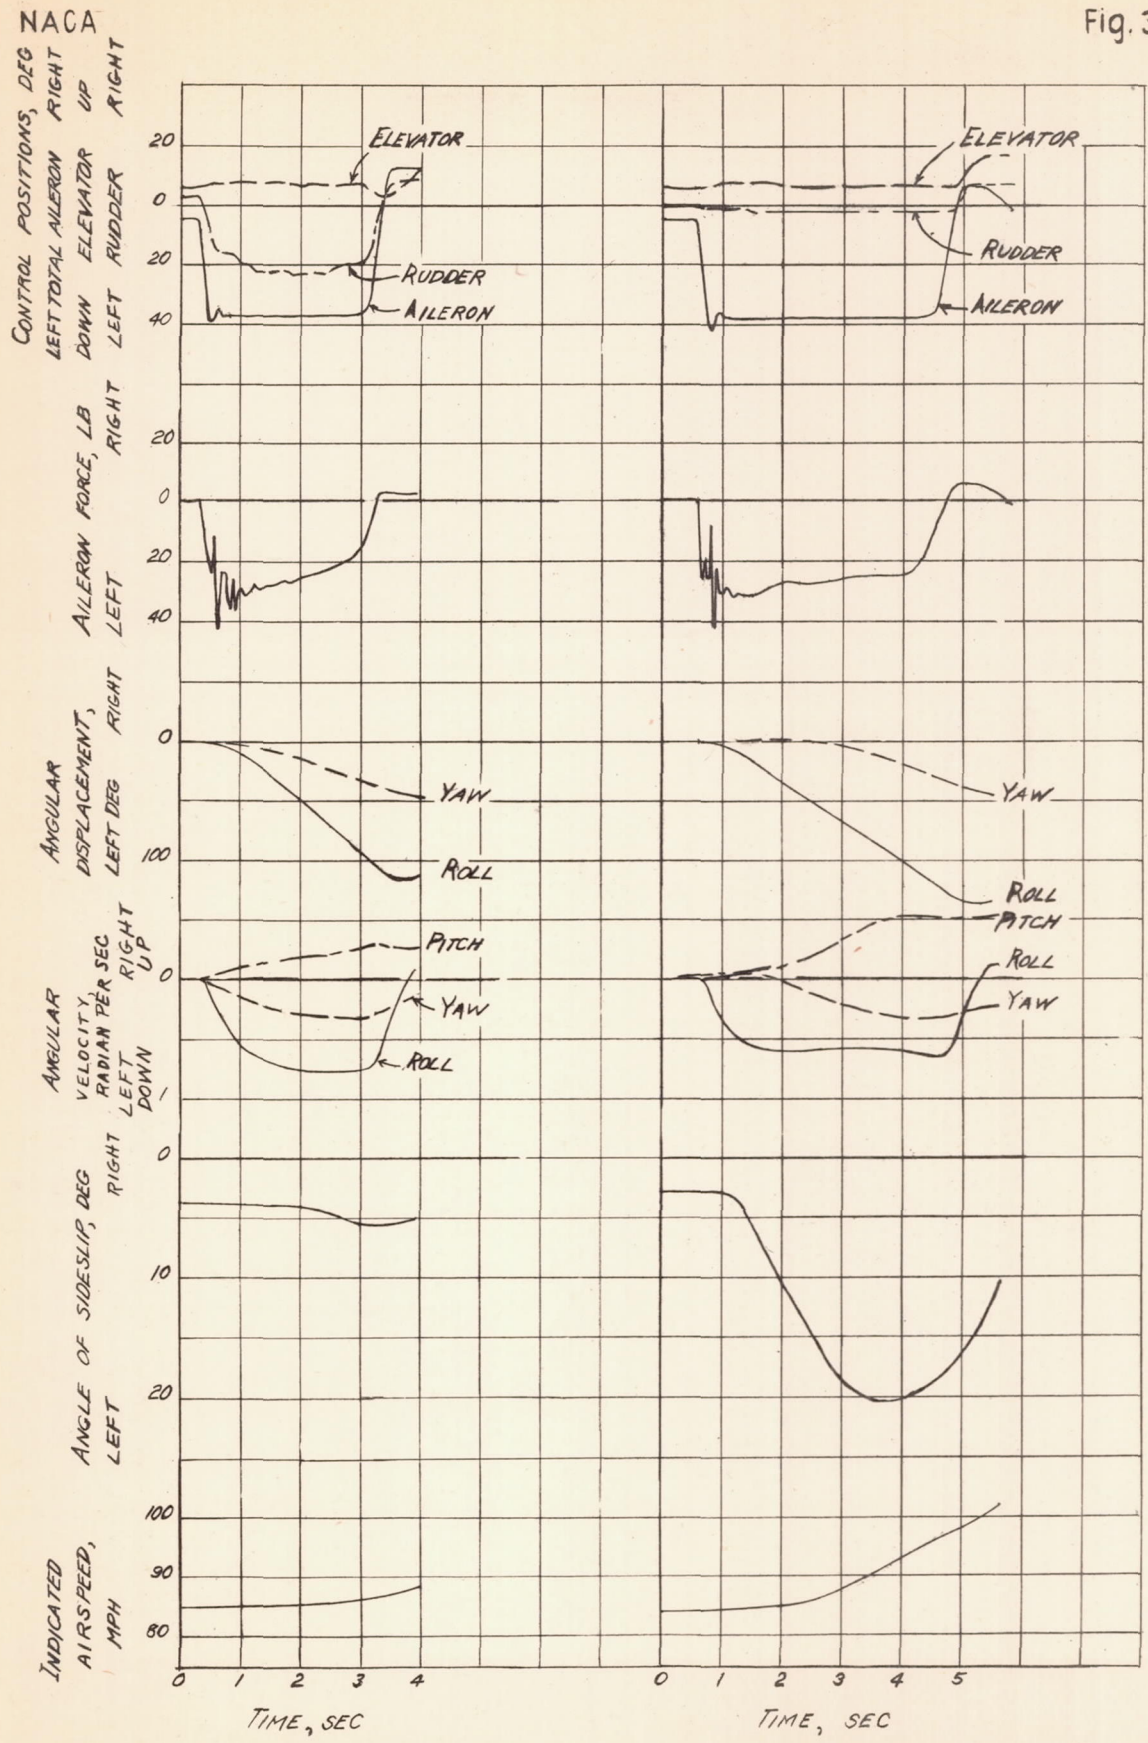
Fig. 35

(a) Rudder used to maintain zero sideslip.

(b) Rudder held in trim position.

Figure 35. - Time histories of aileron rolls made in the landing condition.

- (1) The rudder control was sufficiently powerful to overcome the adverse aileron yawing moment in all conditions tested. This fact is shown by the time histories of aileron rolls (figs. 35 and 36), in which the rudder was used to

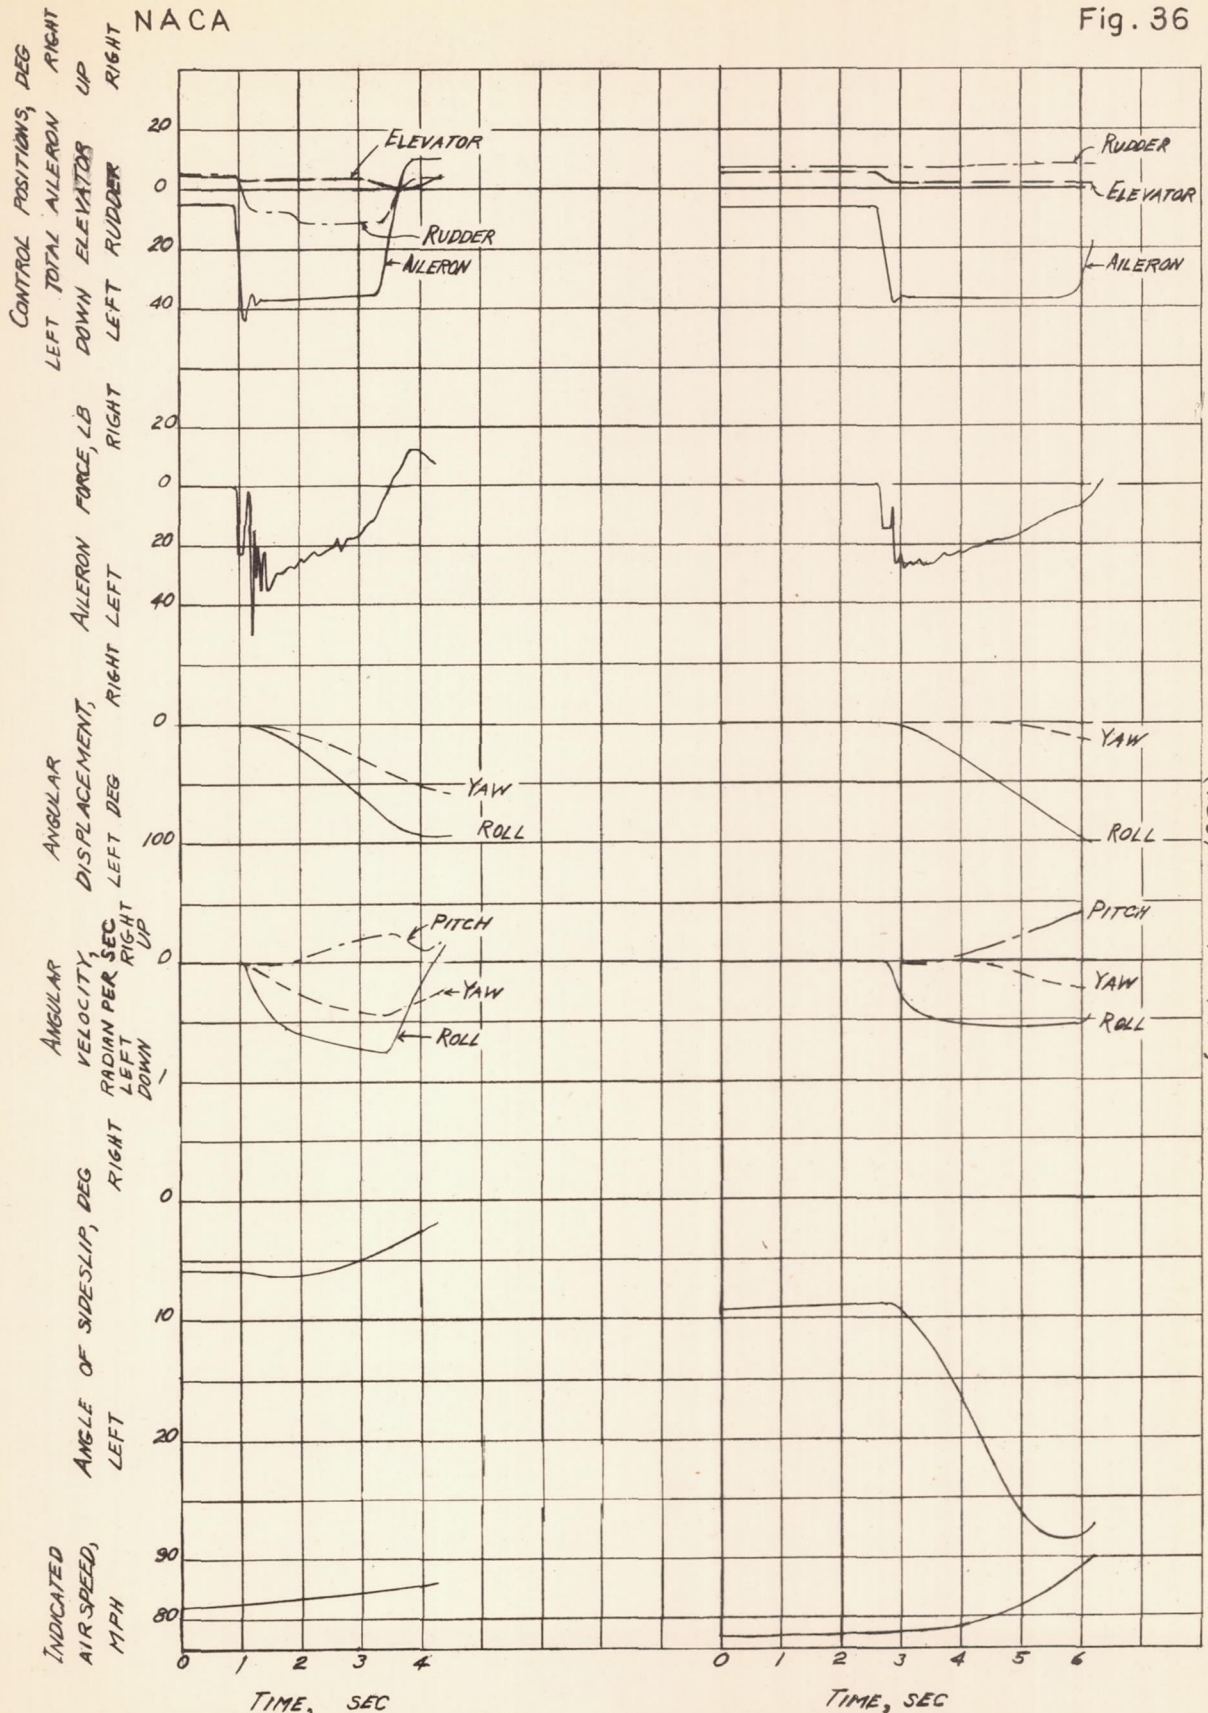
Fig. 36

(a) Rudder used to maintain zero sideslip.

(b) Rudder held in trim position.

Figure 36. - Time histories of aileron rolls made in the cruising condition.
