FLIGHT TESTS OF VARIOUS TAIL MODIFICATIONS

ON THE BREWSTER XSBA-1 AIRPLANE

I - MEASUREMENTS OF FLYING QUALITIES

WITH ORIGINAL TAIL SURFACES

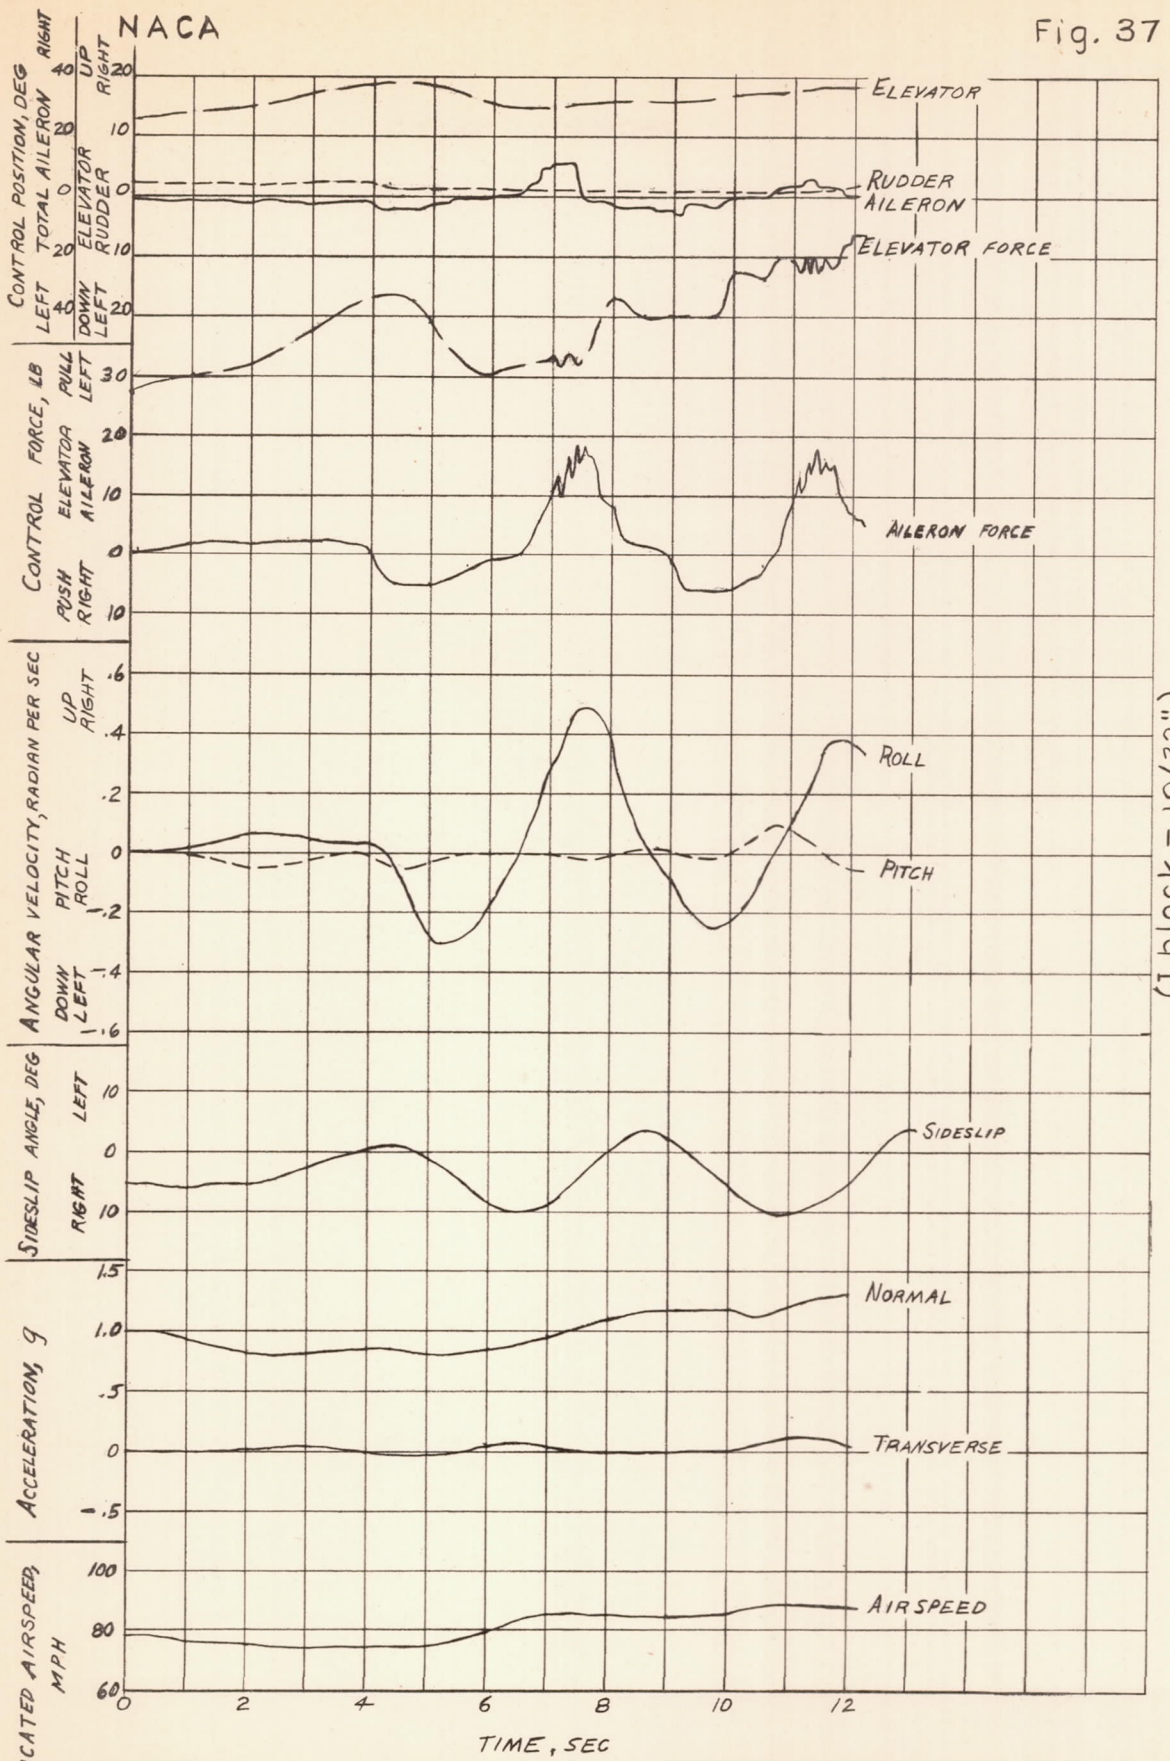
Figure 37. - Time history of a stall in gliding condition (flaps up, gear up, power off) with controls held fixed. Airplane performs rolling oscillation of constant amplitude. Brewster XSBA-1 airplane.

The results of these tests are presented in the form of time histories (figs. 37 to 48). The conclusions reached are as follows:

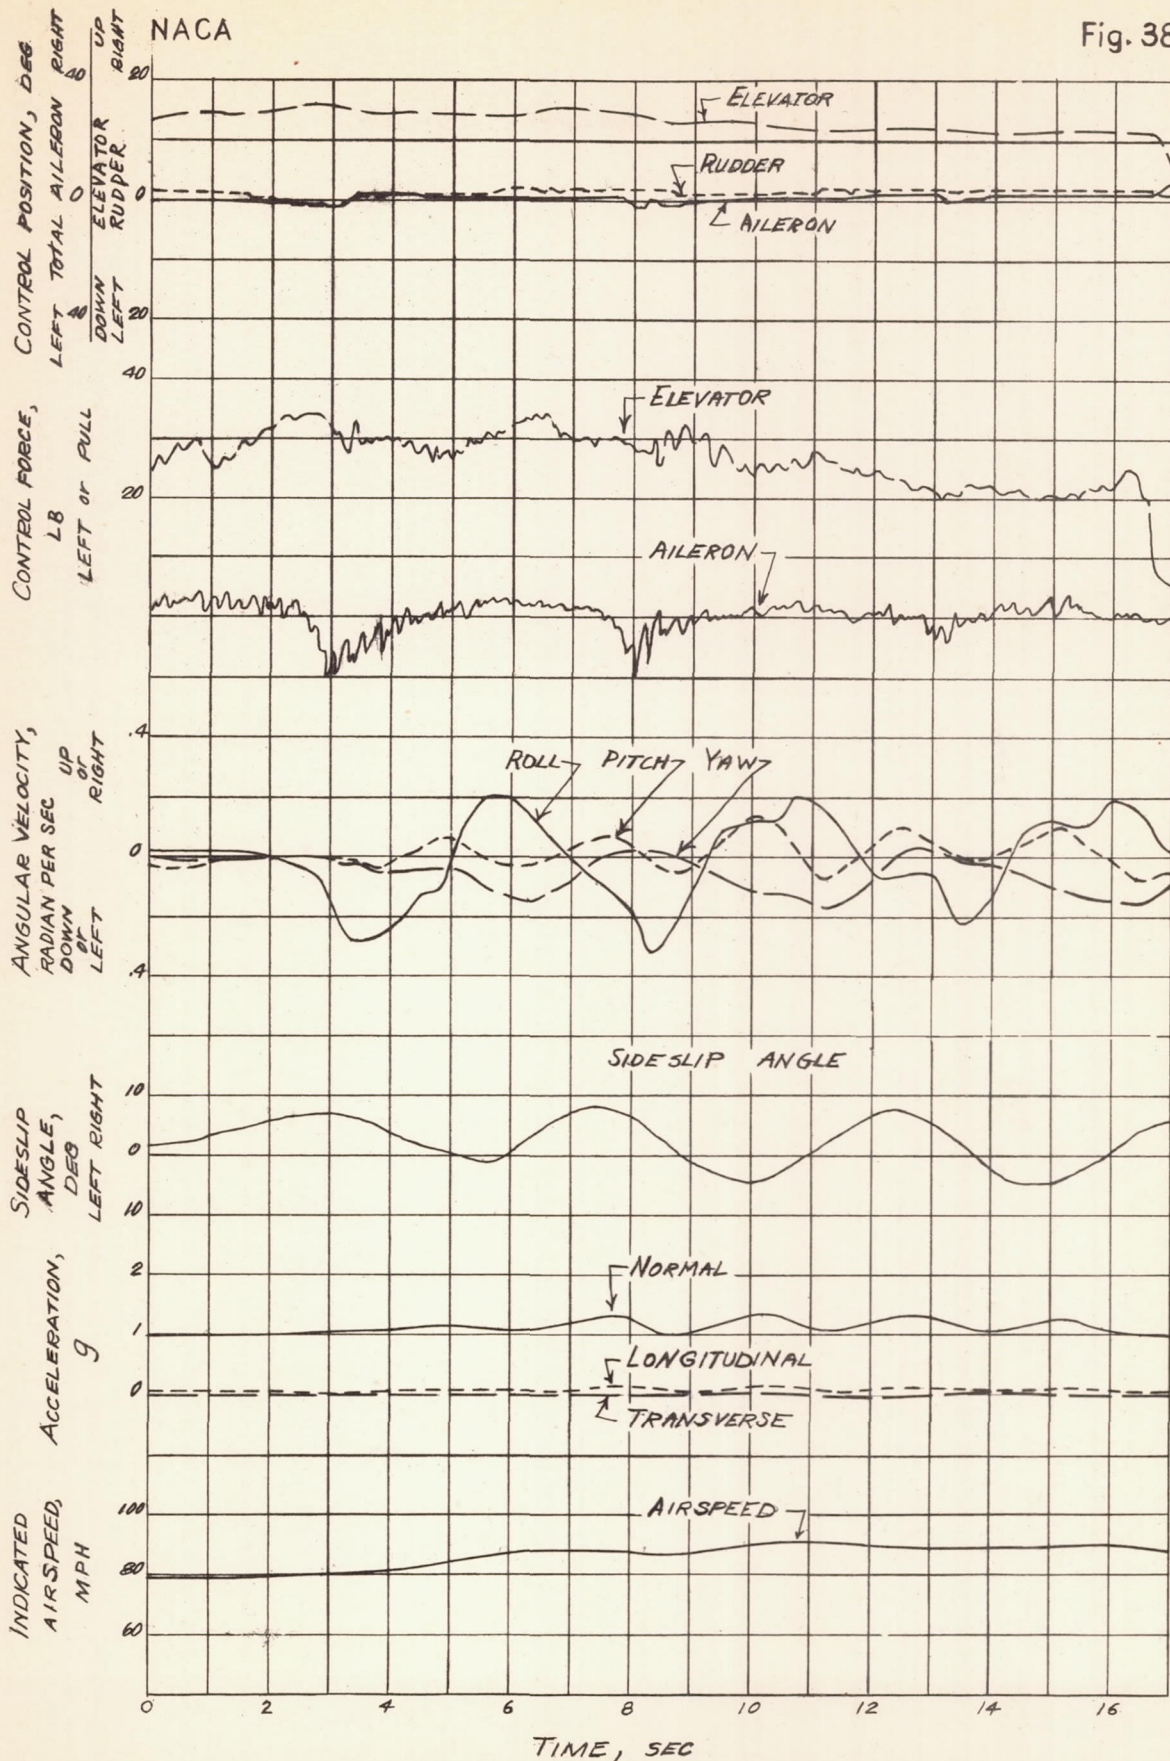
Figure 38. - Time history of a stall in gliding condition (flaps up, gear up, power off) holding controls fixed. Note complicated rolling and pitching oscillation of constant amplitude. Pitching oscillation has twice frequency of rolling oscillation. Brewster XSBA-1 airplane.

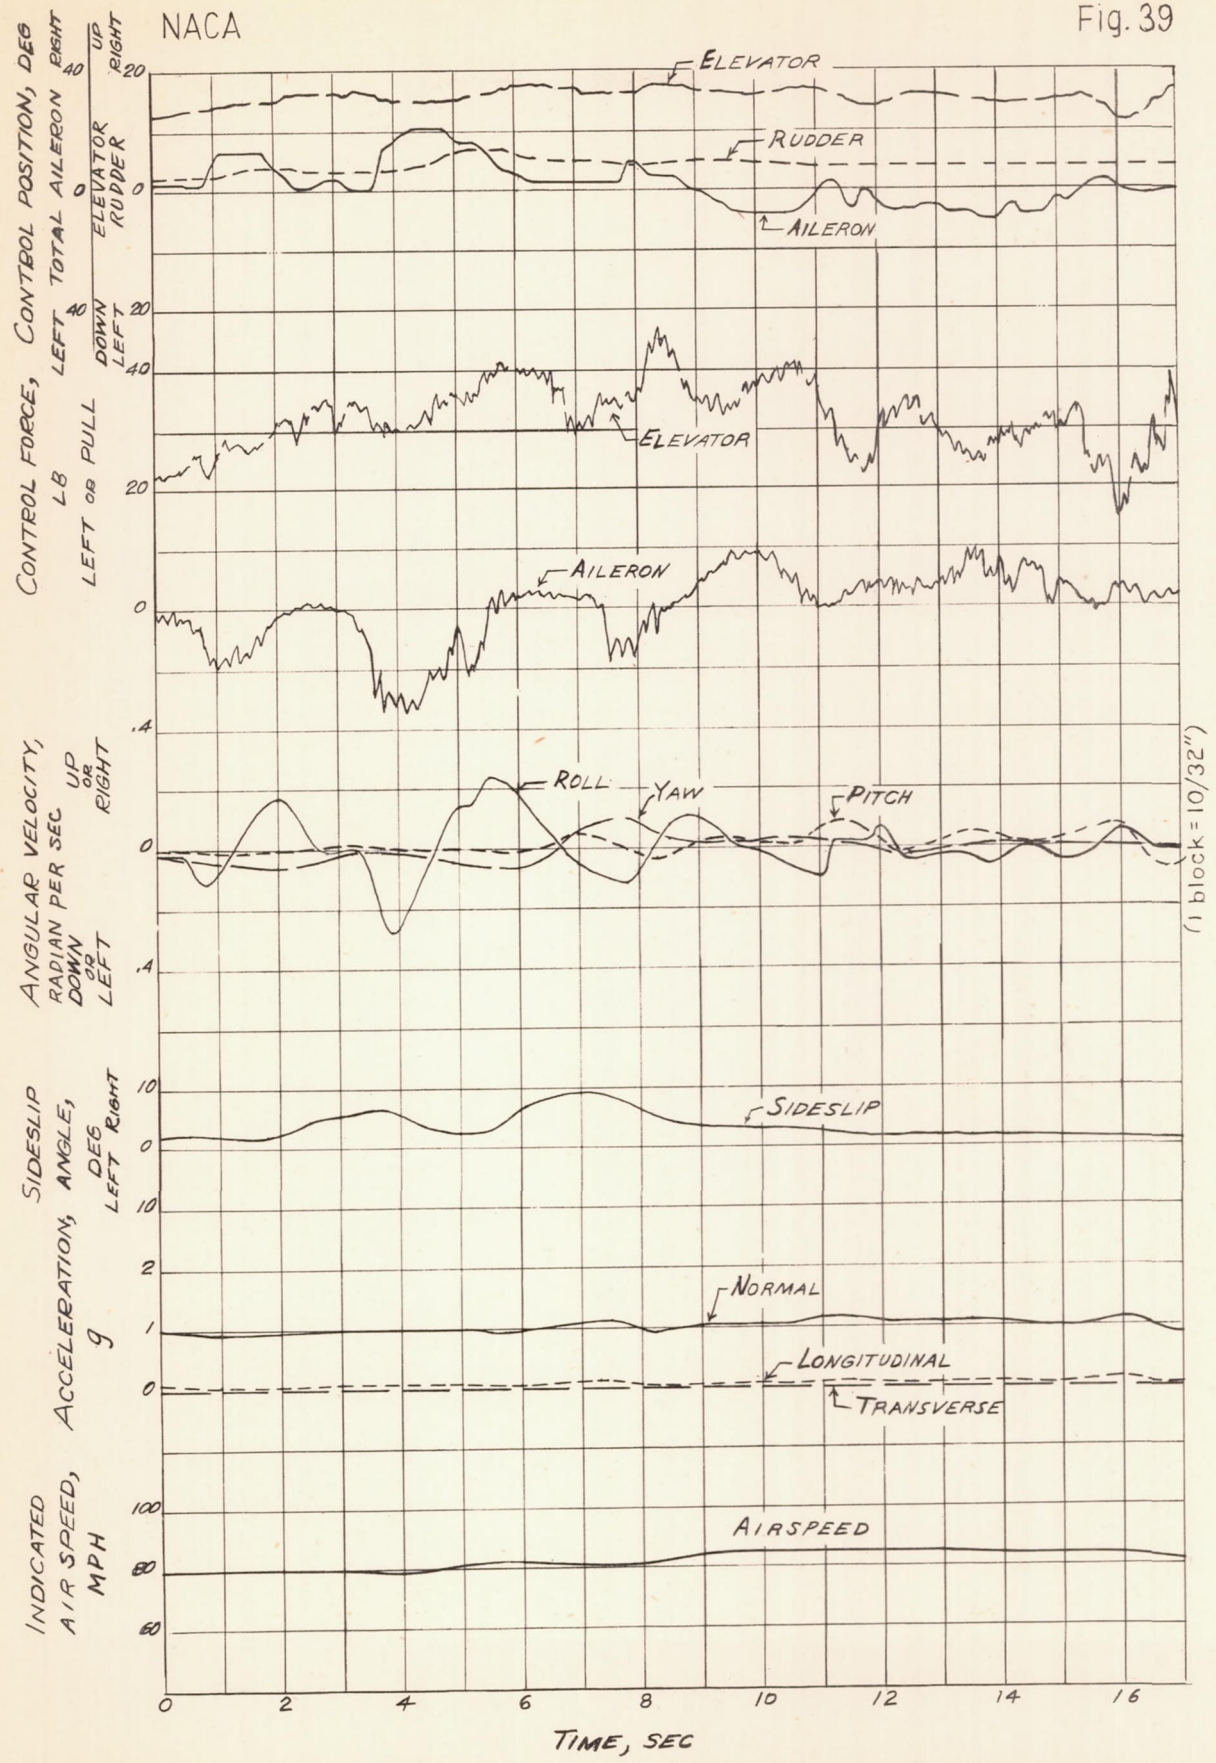
Fig. 39

Figure 39. - Time history of a stall in the gliding condition (flaps up, gear up, power off) Control is maintained by use of the ailerons. Brewster XSBA-1 airplane.

11. The stalling characteristics were good. Adequate stall warning existed in all conditions of flight in the form of pitching and rolling motions of the airplane. Control of the airplane in a partly stalled condition could be

maintained in all except the landing condition. Recovery from the stall was prompt in all conditions.

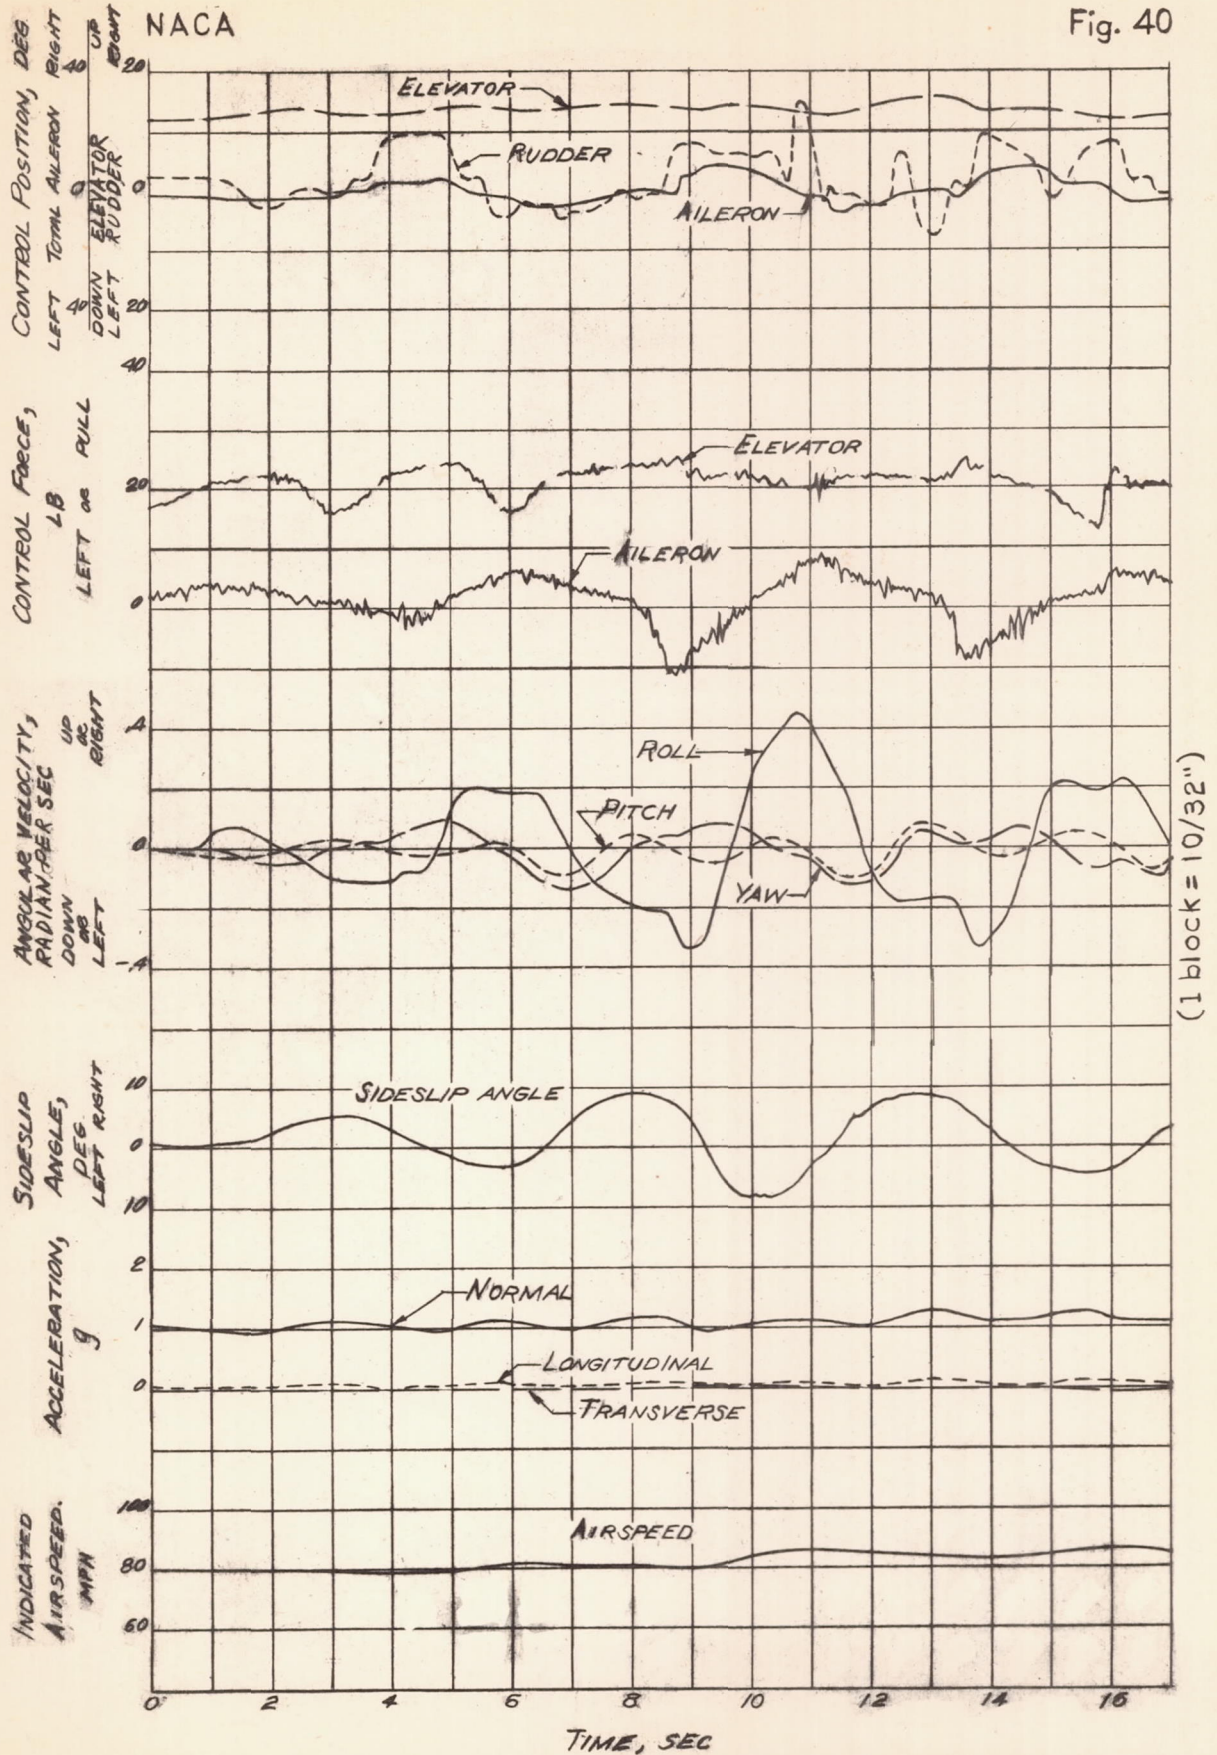
Figure 40. - Time history of a stall in the gliding condition (flaps up, gear up, power off). Control is maintained by use of the rudder. Brewster XSEA-1 airplane.

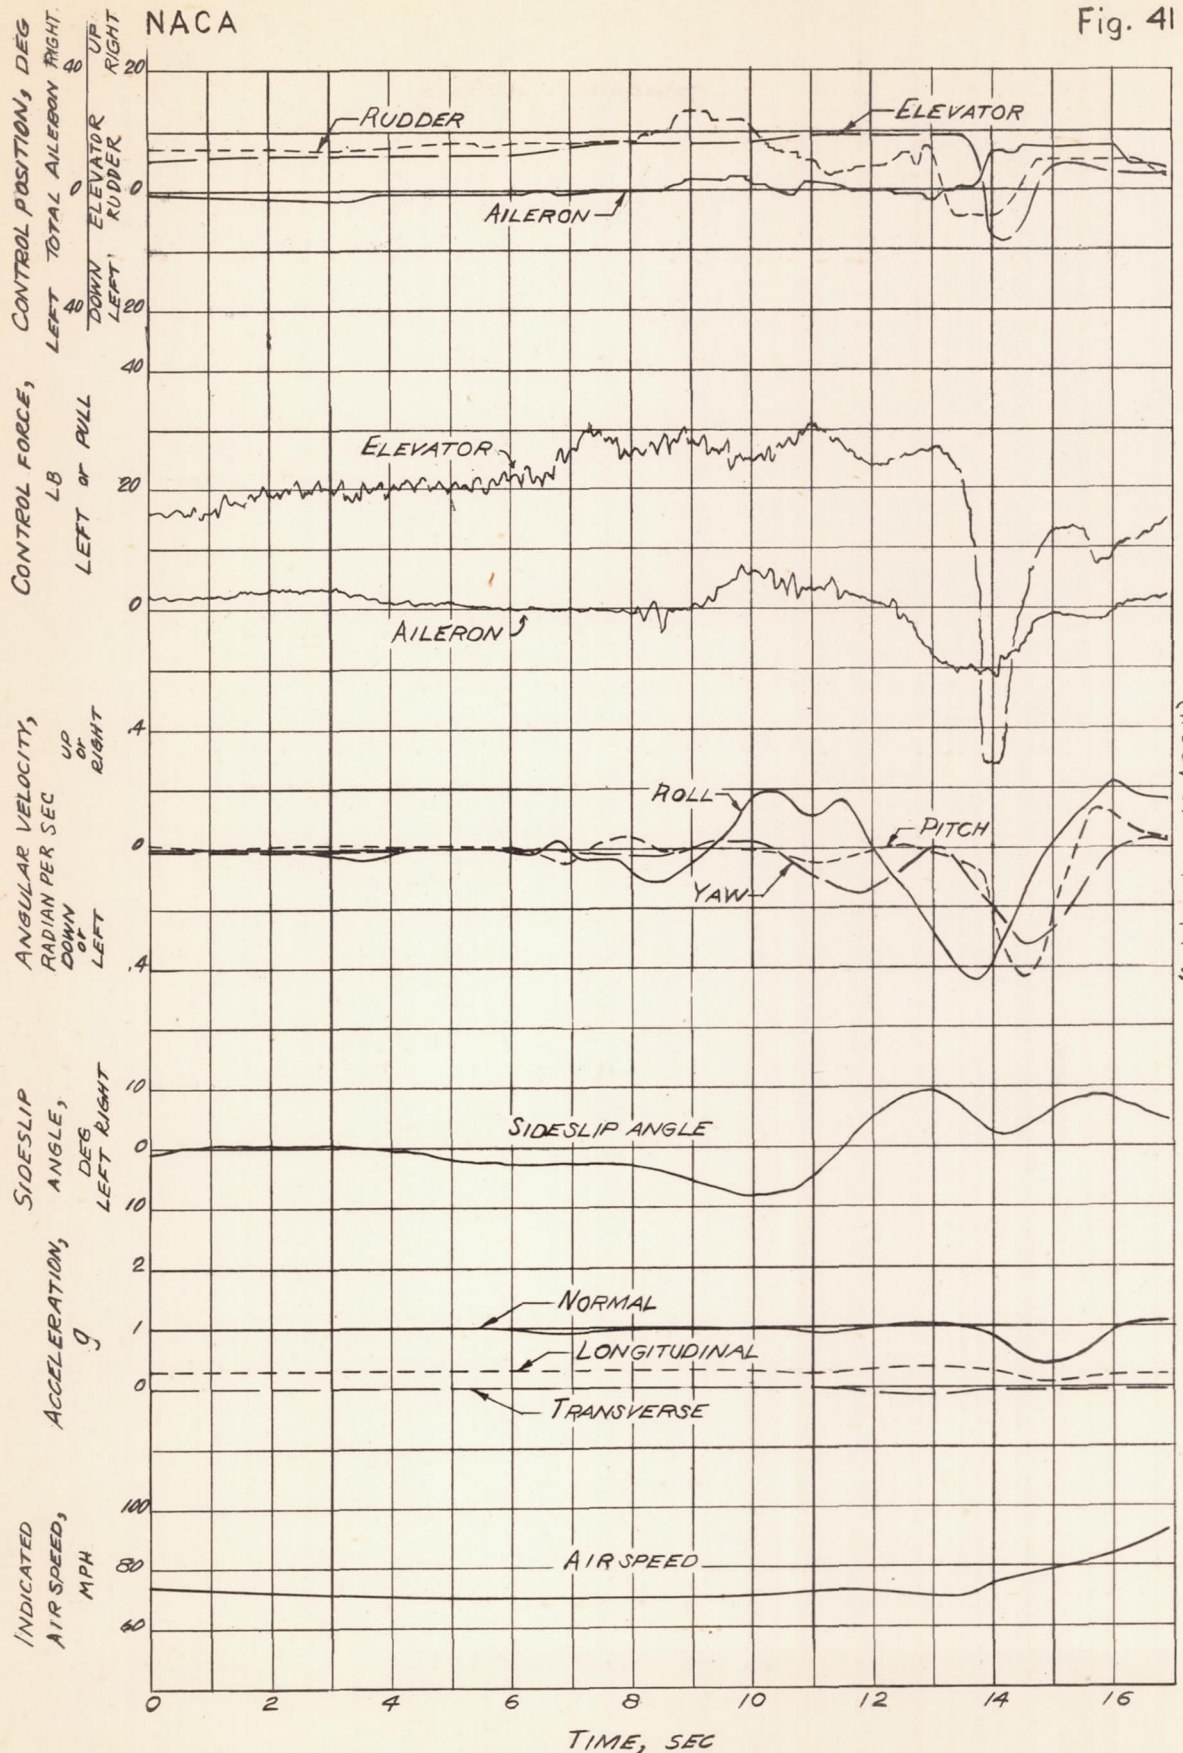
Figure 41. - Time history of a stall in the cruising condition (flaps up, gear up, 23 inches Hg manifold pressure, 1750 rpm). Control was maintained by use of rudder until roll-off to the left occurred. Brewster XSBA-1 airplane.

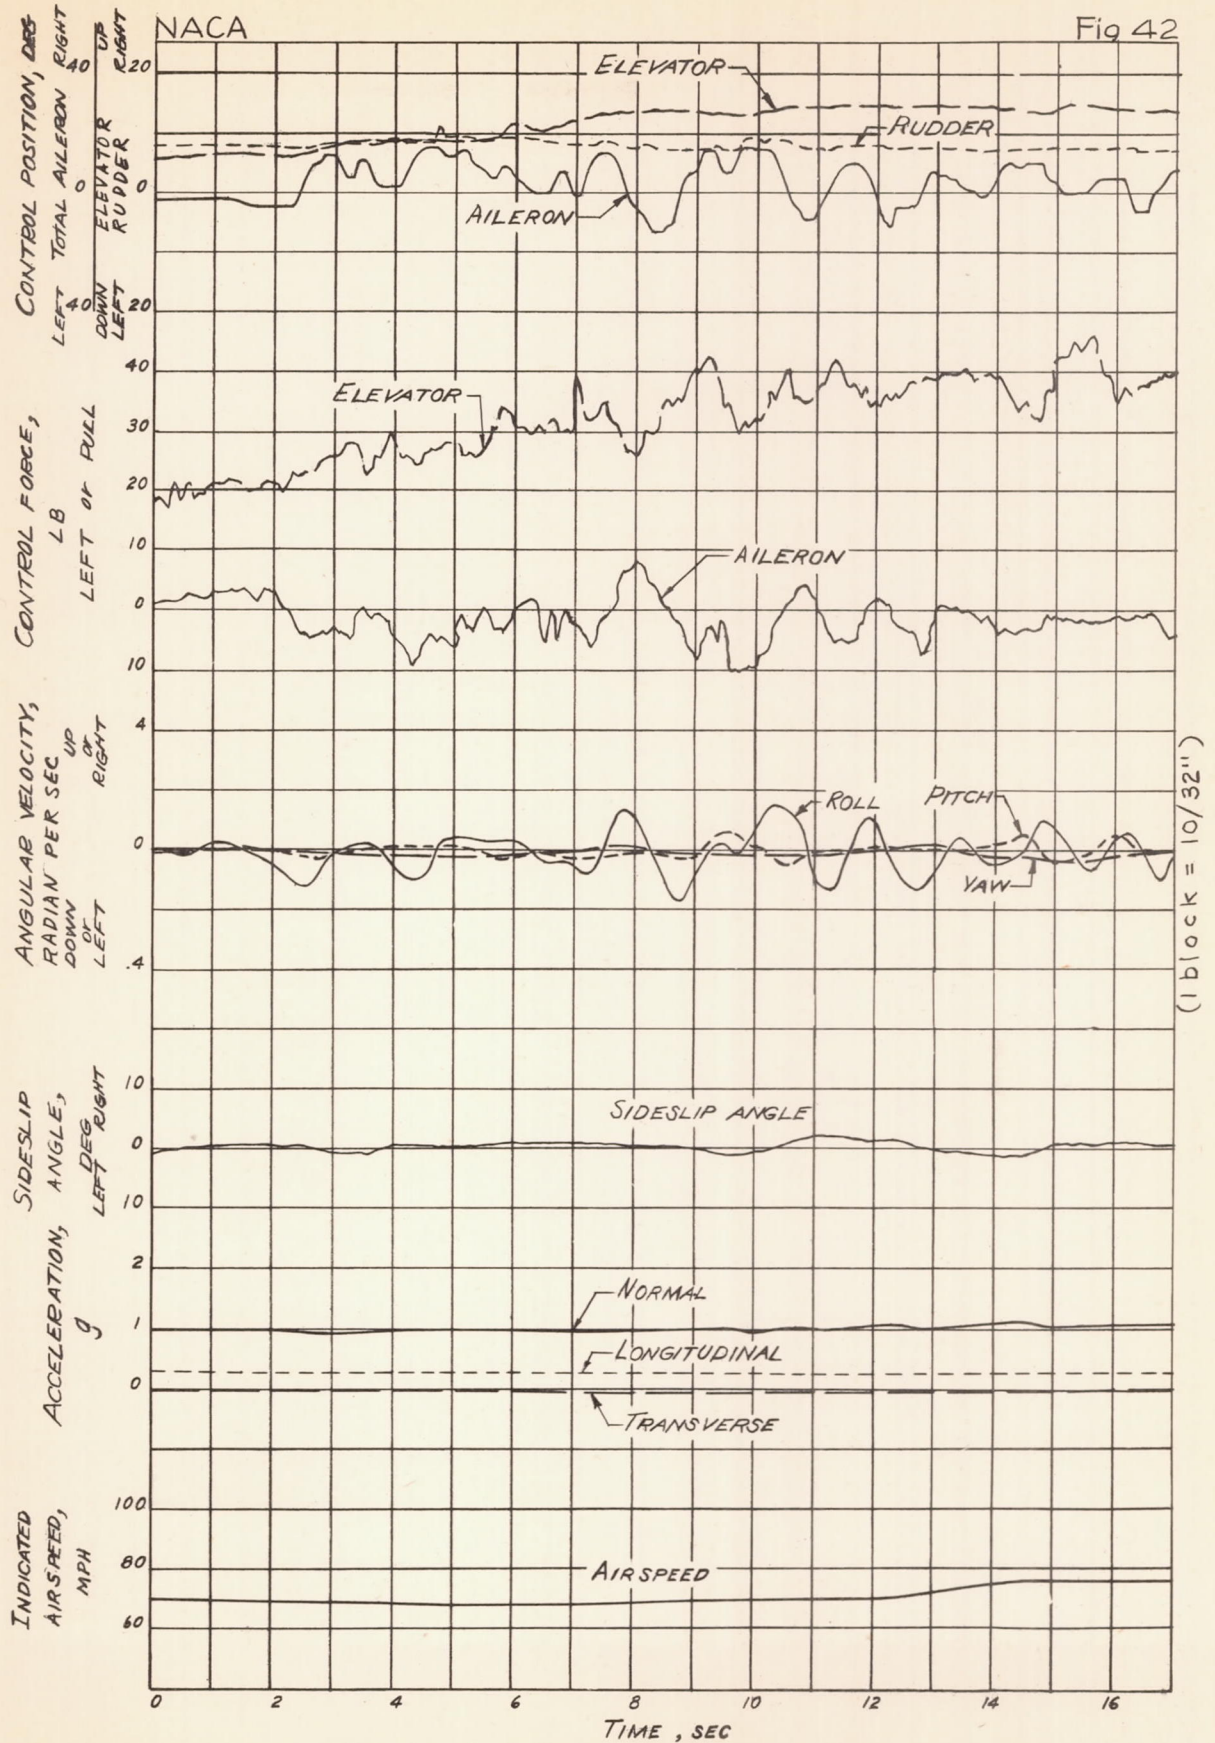
Figure 42. - Time history of a stall in the cruising condition (flaps up, gear up, 23 inches Hg manifold pressure, 1750 rpm). Control is effectively maintained by use of the ailerons. Brewster XSBA-1 airplane.

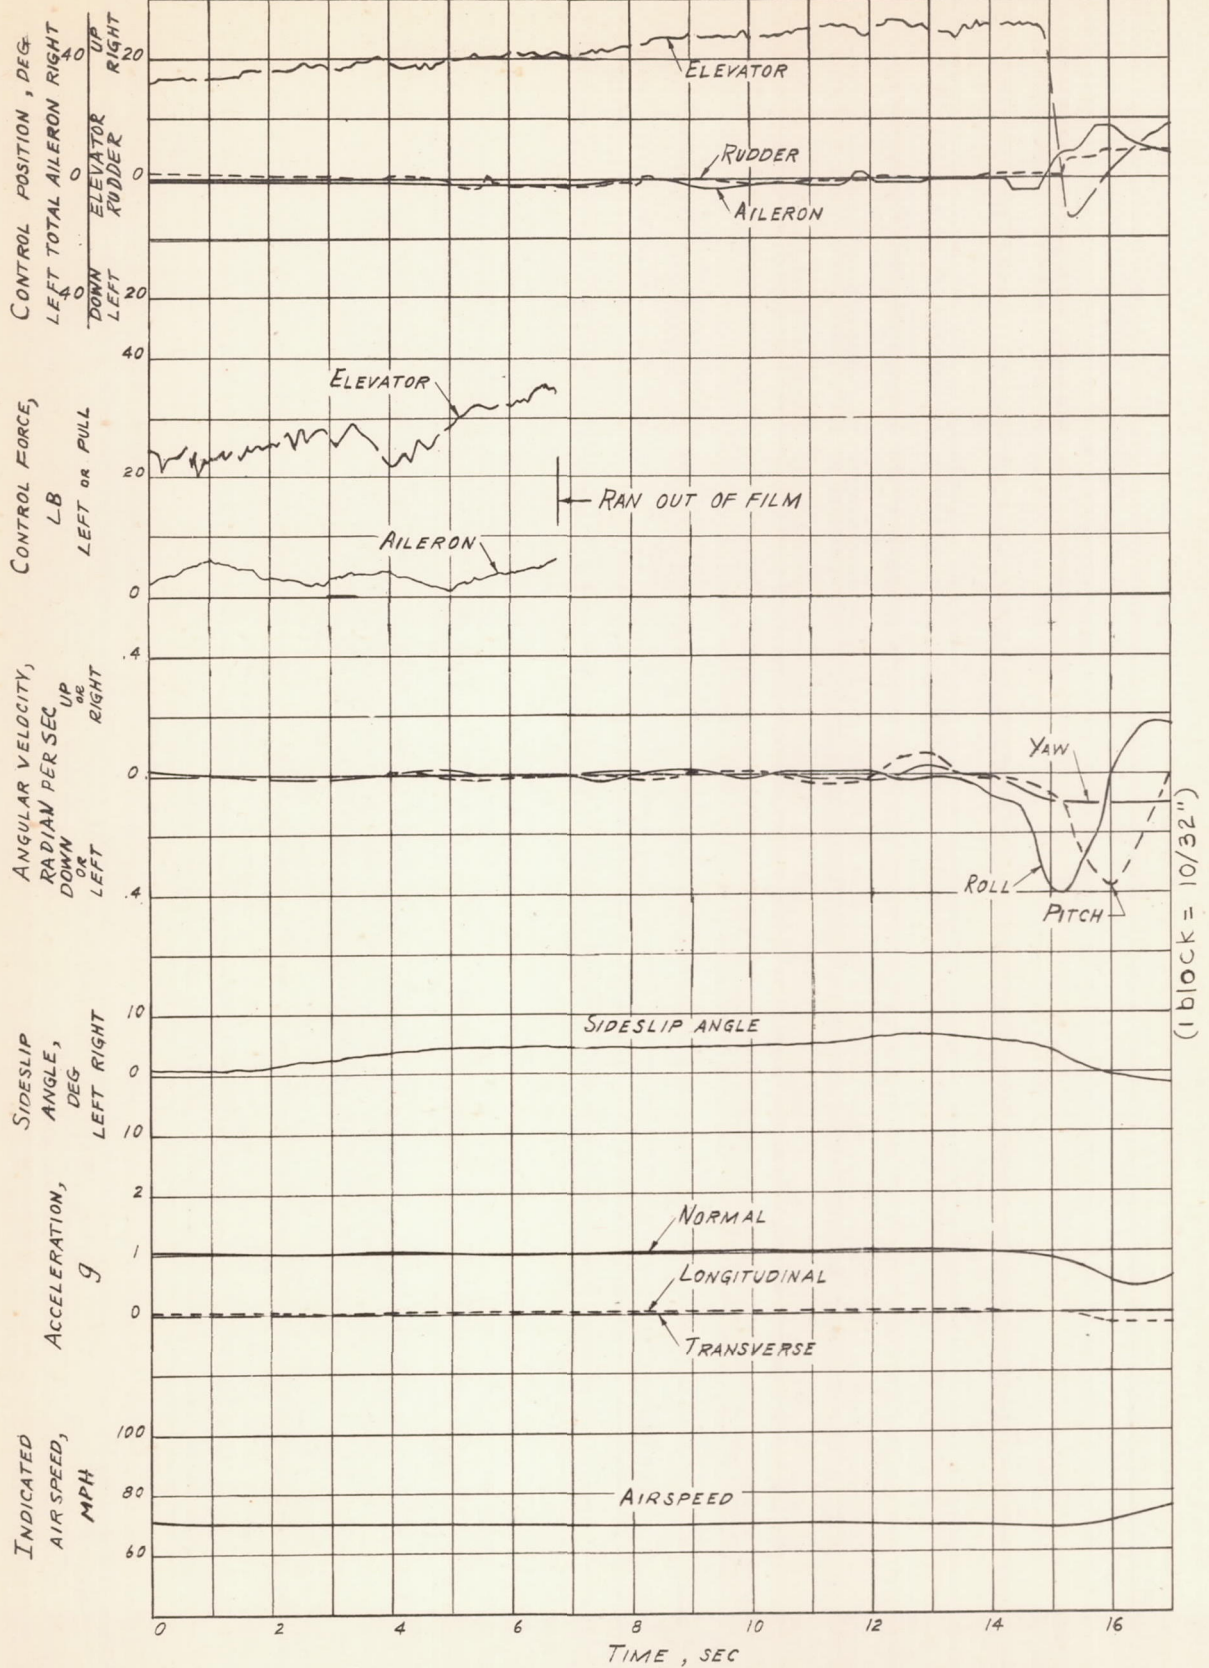
Figure 43. - Time history of a stall in the landing condition (flaps down, gear down, power off). Controls held fixed until roll-off to left occurred. Note adequate stall warning in form of slight rolling and pitching oscillations. Brewster XSBA-1 airplane.

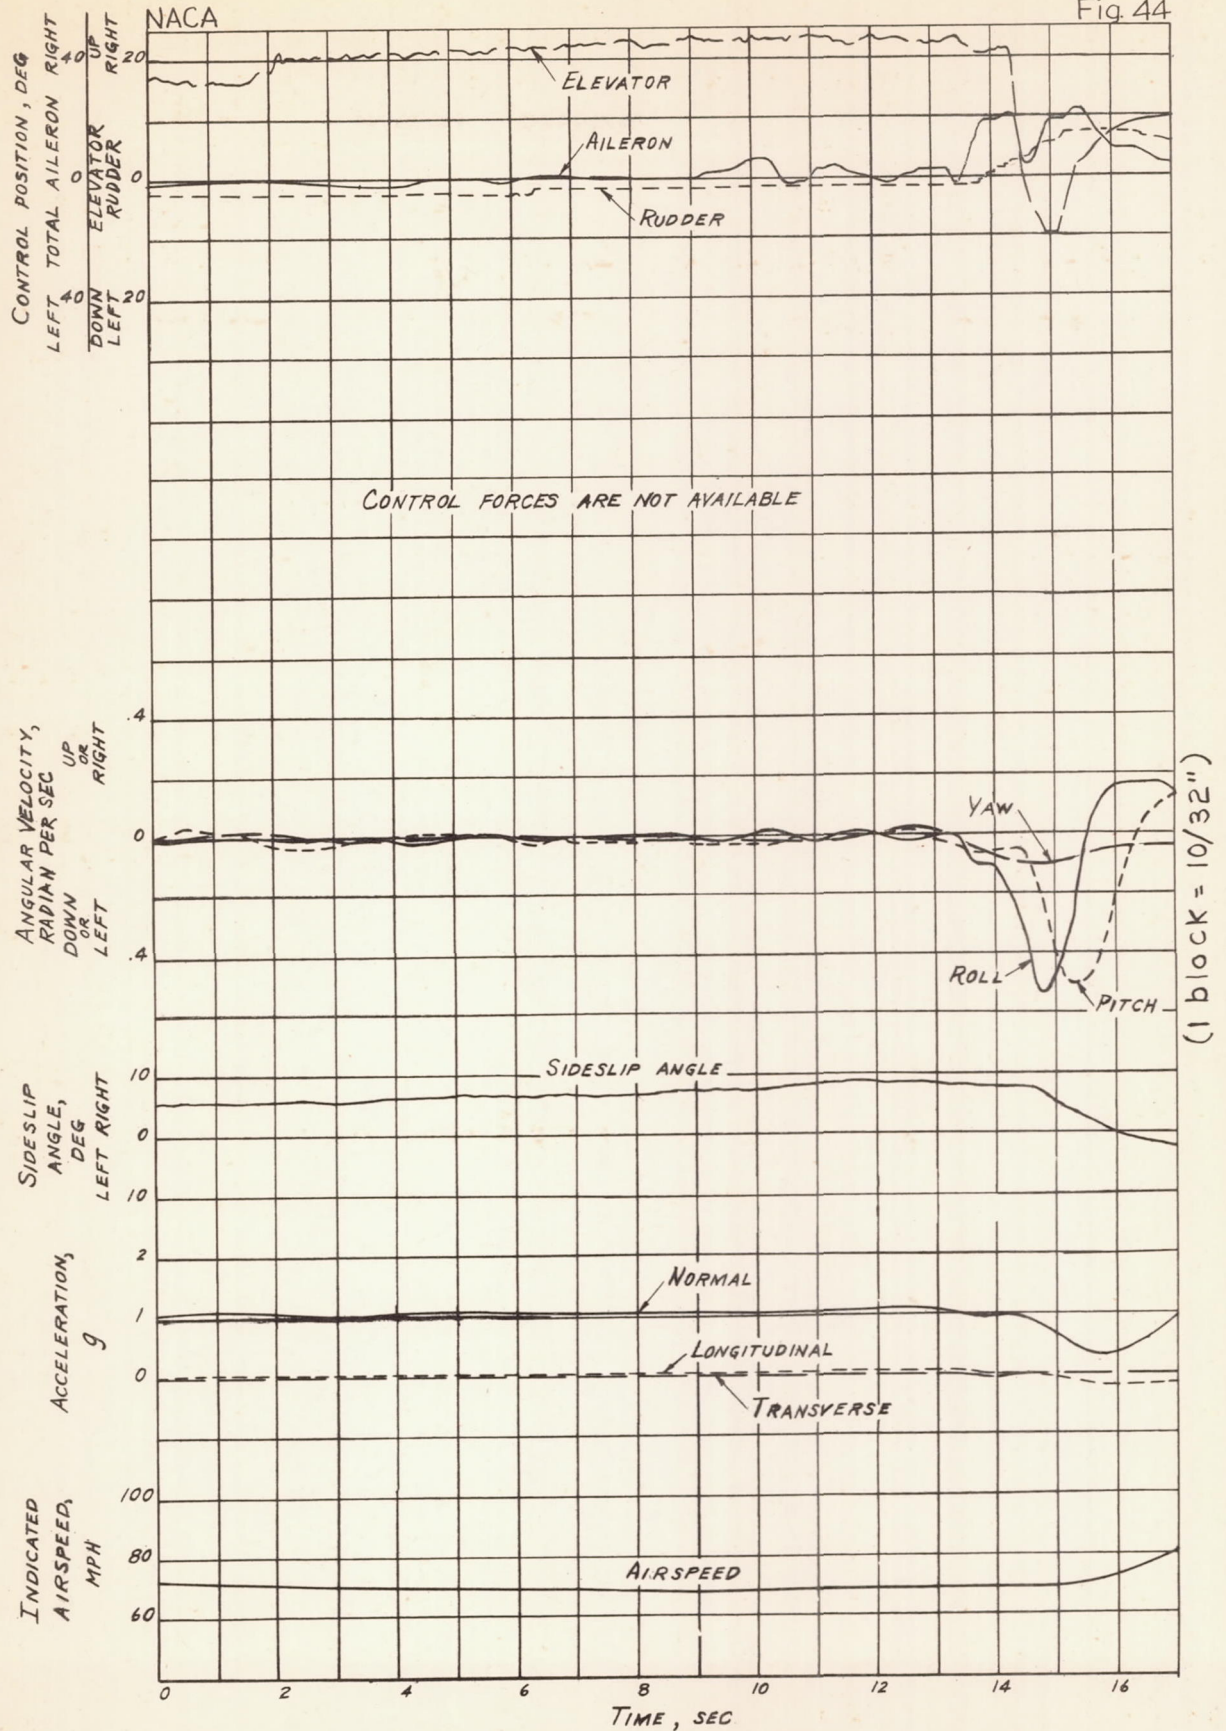
Fig. 44

Figure 44. - Time history of a stall in the landing condition (flaps down, gear down, power off). Control attempted with aileron was ineffective in preventing roll-off to left. Brewster XSBA-1 airplane. .1

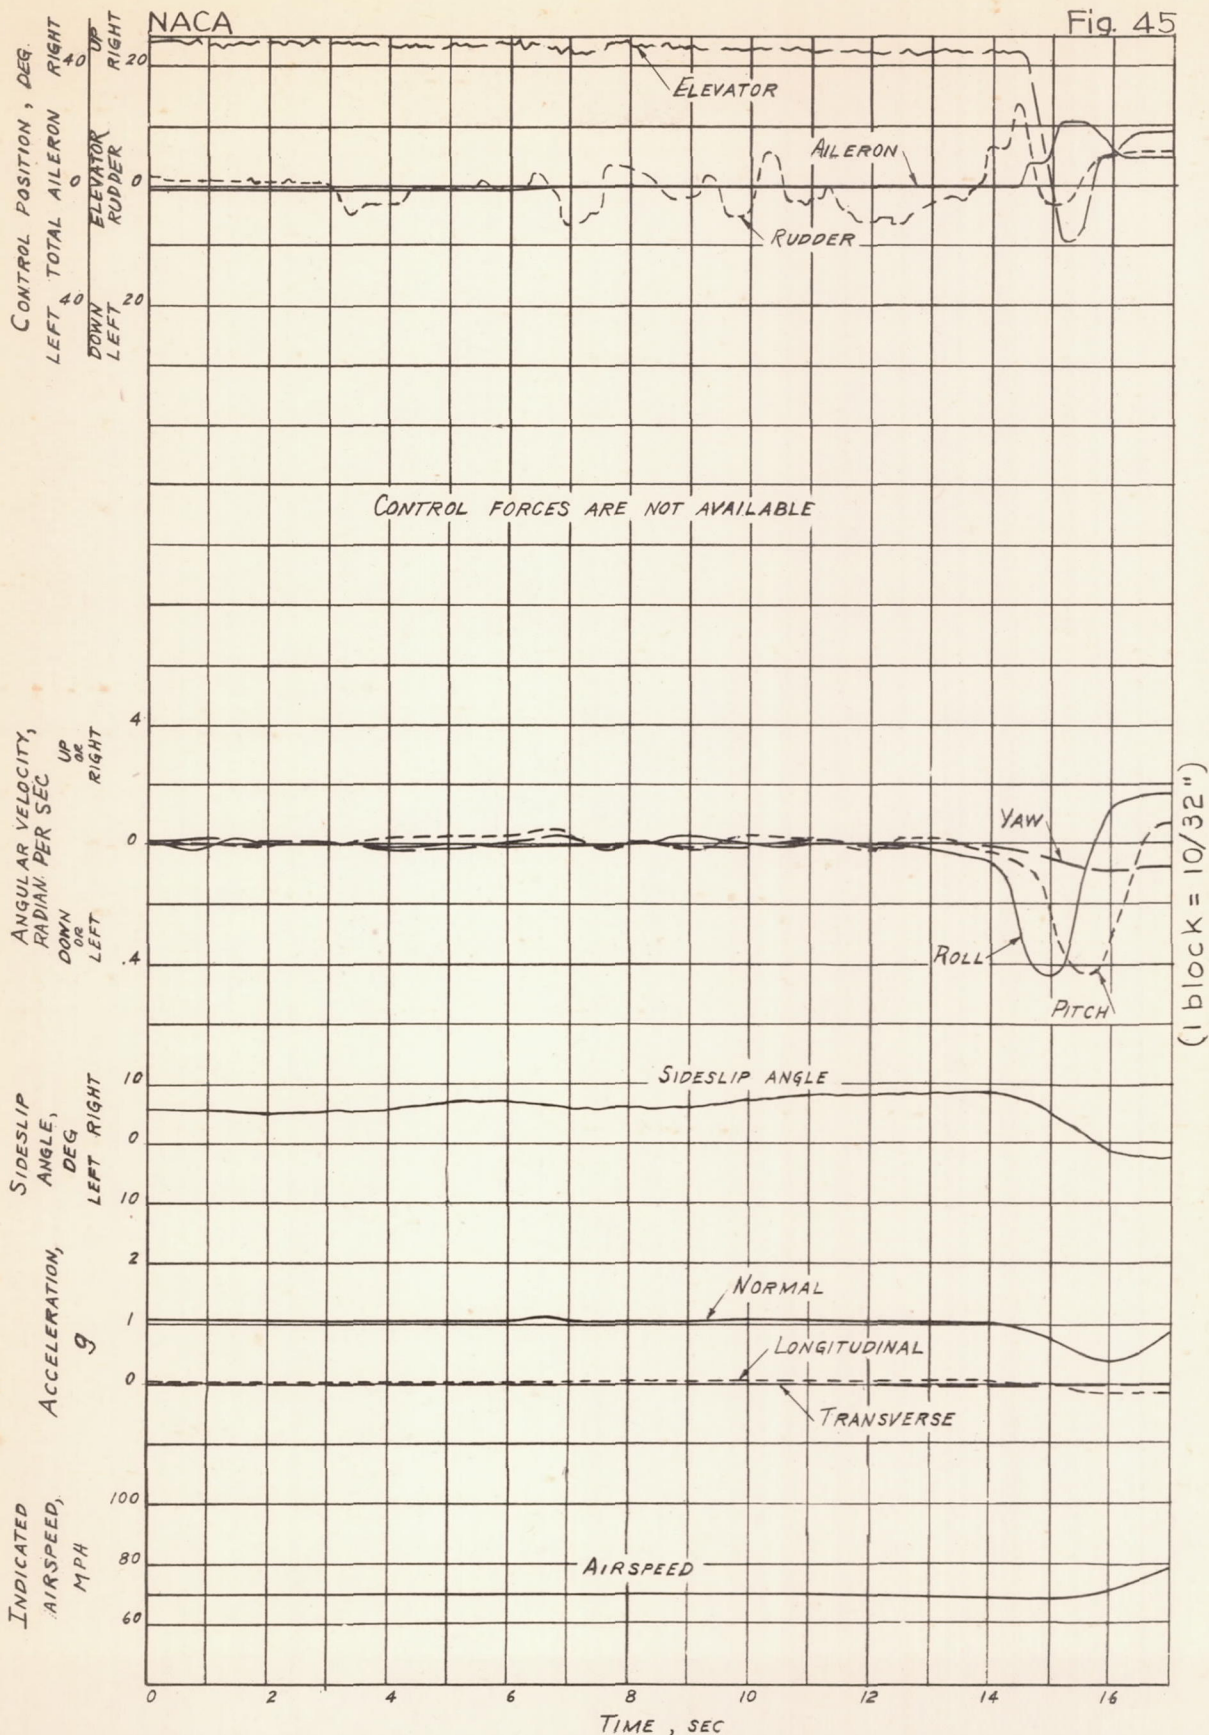
Figure 45. - Time history of a stall in the landing condition (flaps down, gear down, power off). Control maintained by use of rudder until roll-off to the left occurred. Brewster XSBA-1 airplane.

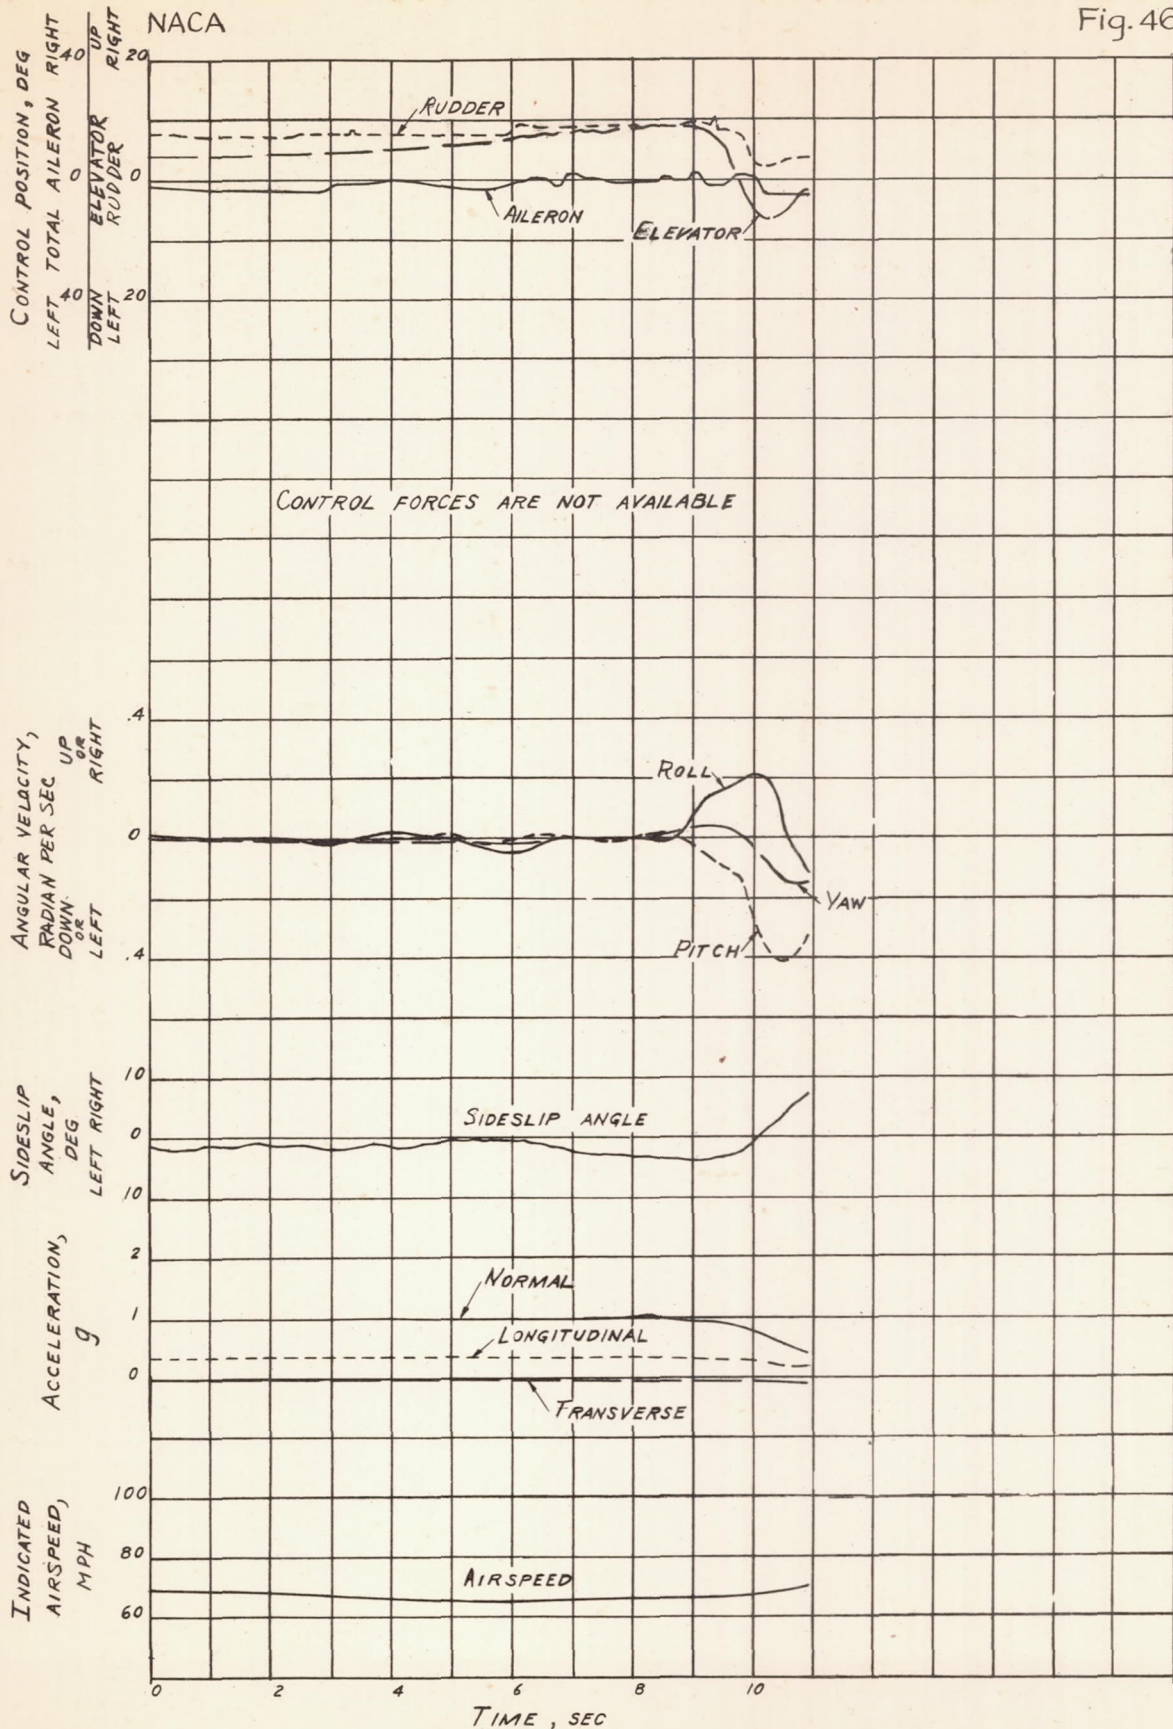
Figure 46. - Time history of a stall in the take-off condition (flaps up, gear down, 35 inches Hg manifold pressure, 2050 rpm). Controls held fixed until mild roll-off to right occurred. Note stall warning in form of rolling and pitching oscillation. Brewster XSBA-1 airplane.
