FLIGHT TESTS OF VARIOUS TAIL MODIFICATIONS

ON THE BREWSTER XSBA-1 AIRPLANE

I - MEASUREMENTS OF FLYING QUALITIES

WITH ORIGINAL TAIL SURFACES

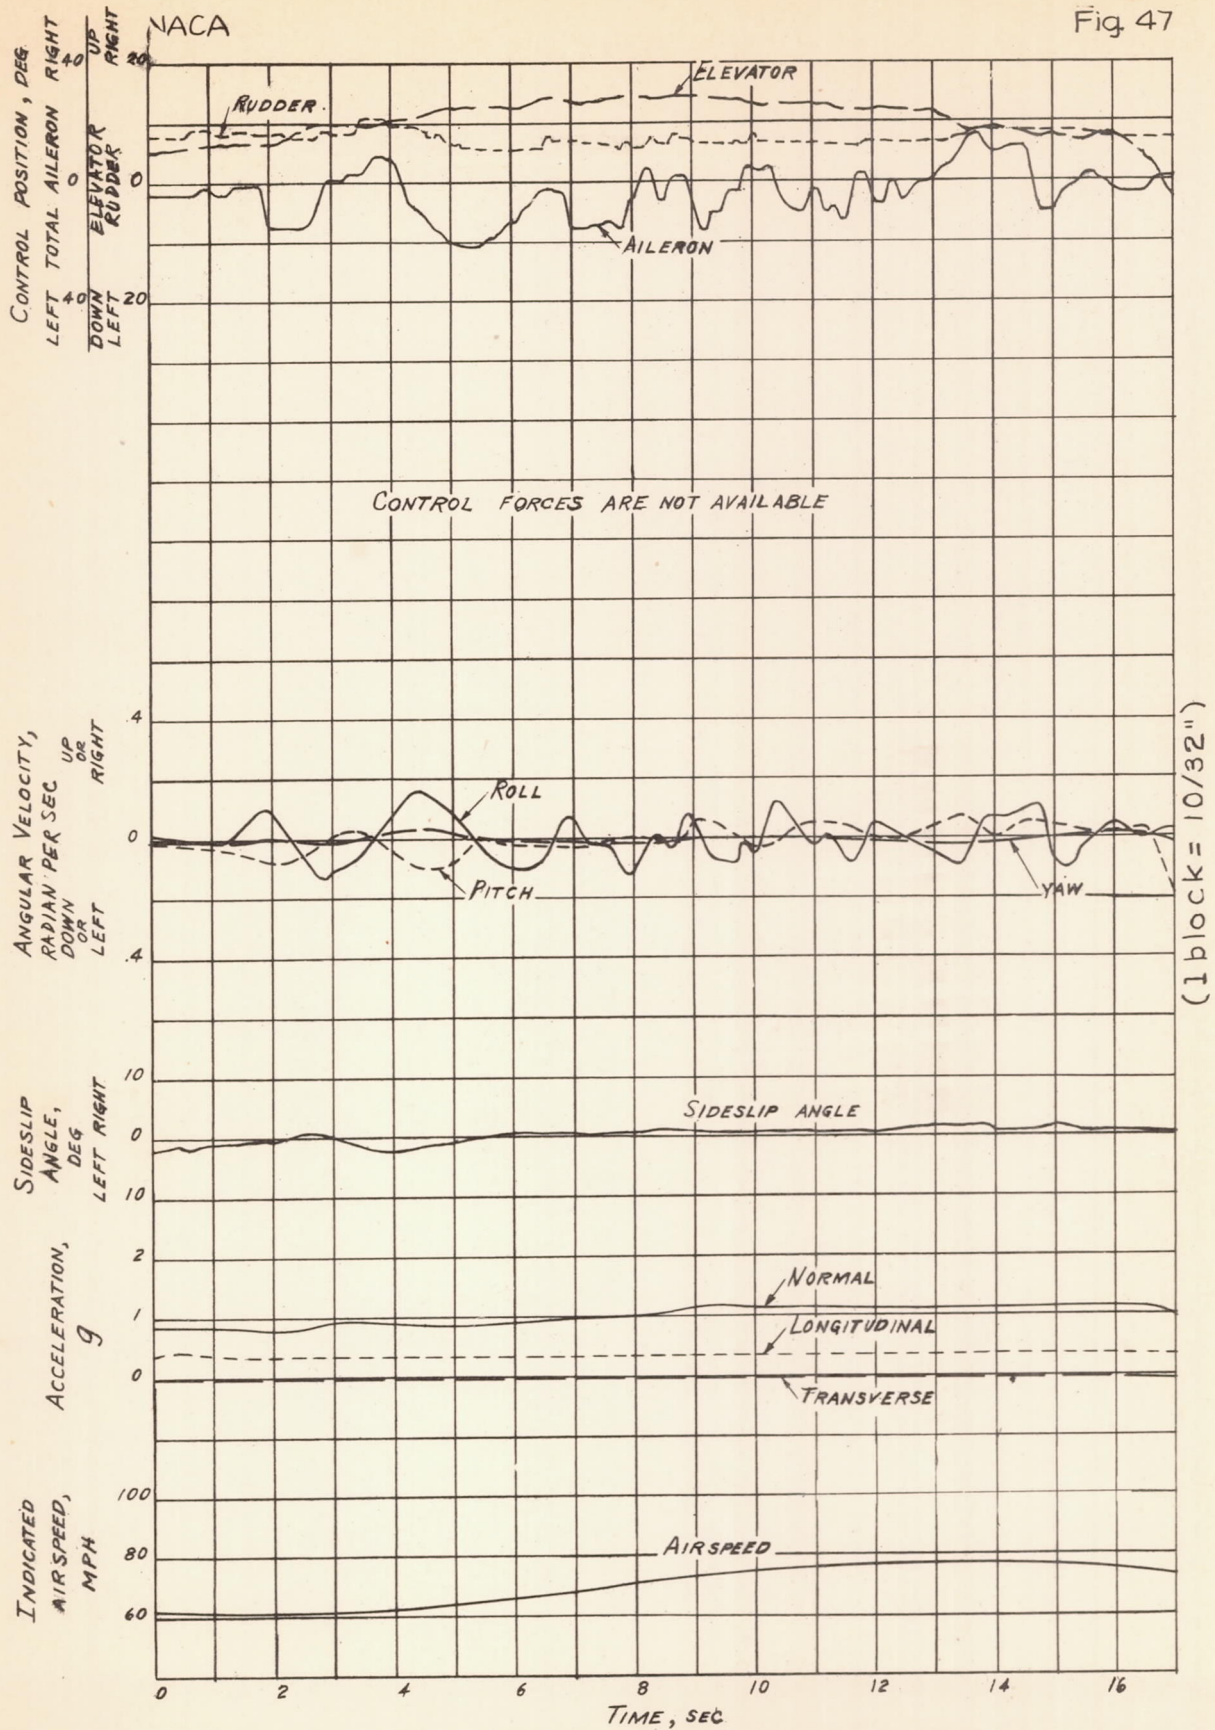
Figure 47. - Time history of a stall in the take-off condition (flaps up, gear down, 35 inches Hg manifold pressure, 2050 rpm). Control maintained by use of the ailerons. Brewster XSBA-1 airplane.

11. The stalling characteristics were good. Adequate stall warning existed in all conditions of flight in the form of pitching and rolling motions of the airplane. Control of the airplane in a partly stalled condition could be

maintained in all except the landing condition. Recovery from the stall was prompt in all conditions.

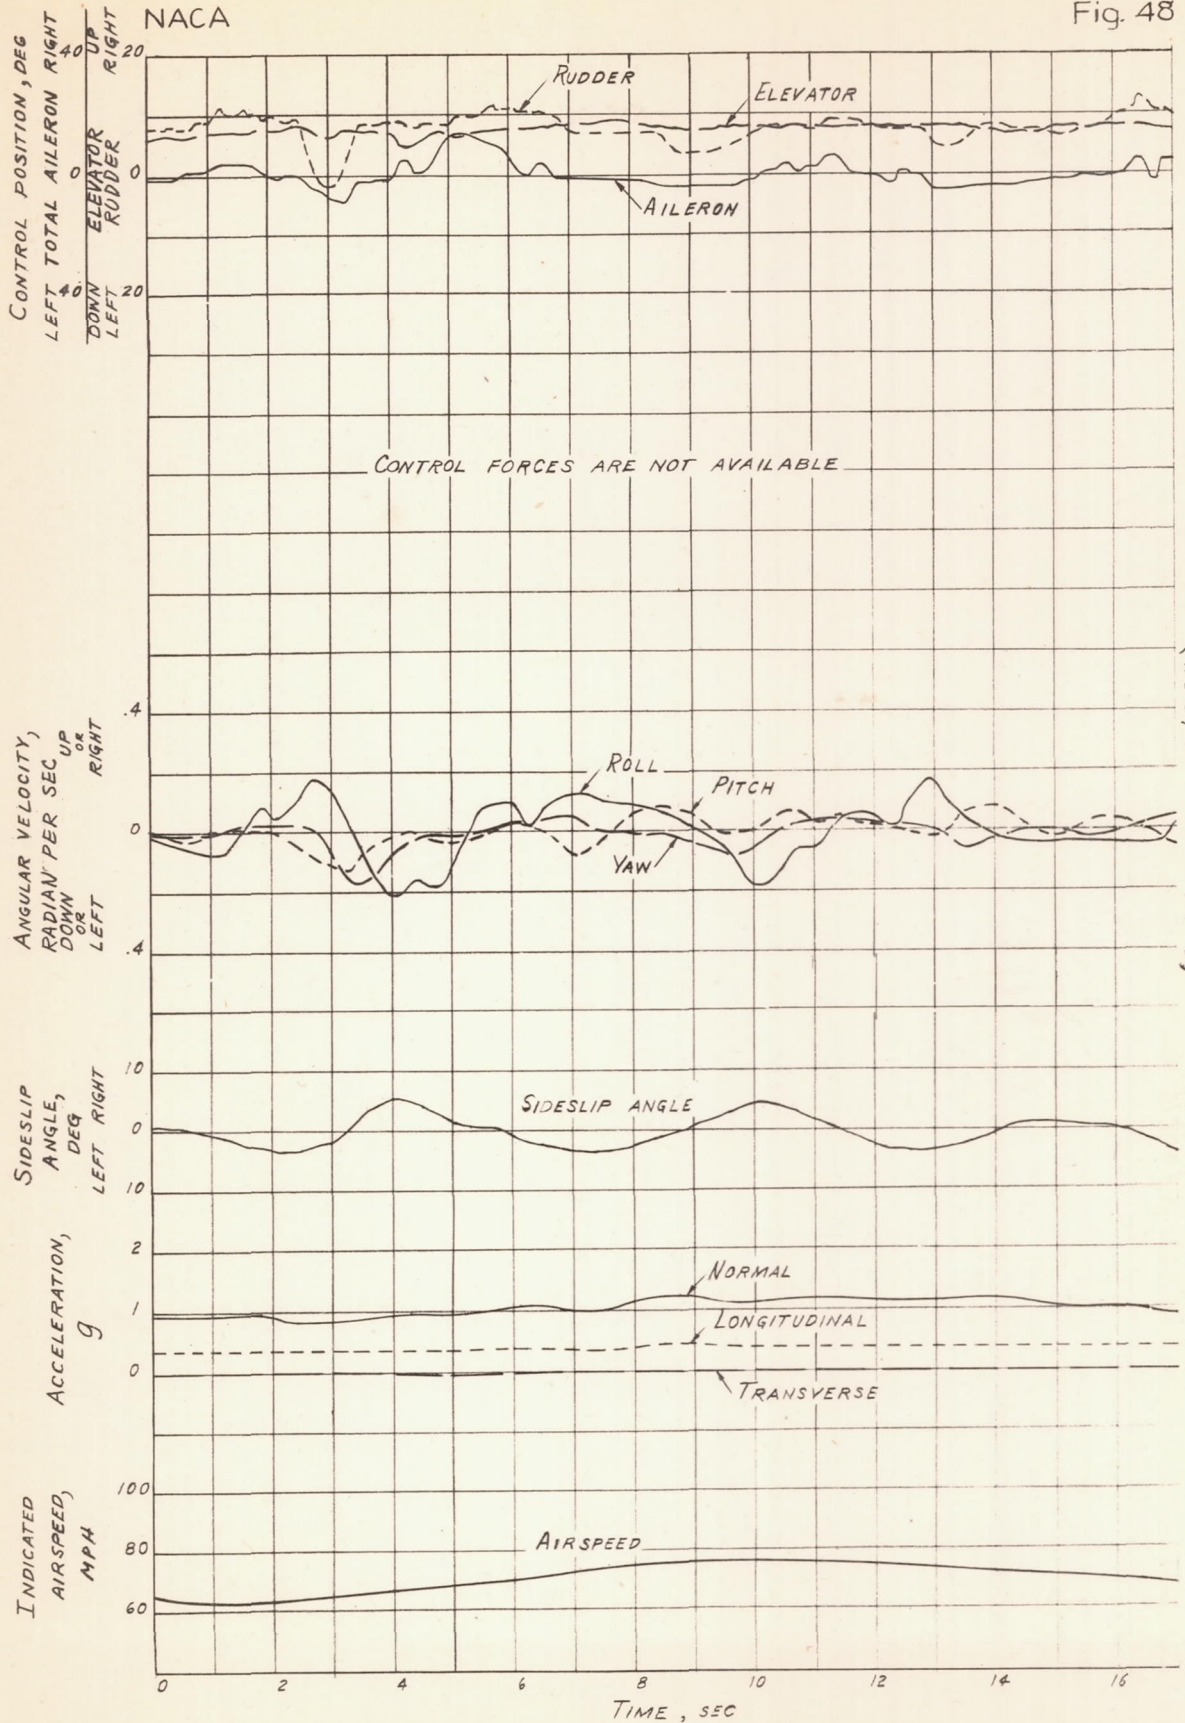
Figure 48. - Time history of a stall in the take-off condition (flaps up, gear down, 35 inches Hg manifold pressure, 2050 rpm). Control is maintained by use of the rudder, though rolling oscillation is rather violent. Brewster XSBA-1 airplane.
