MEASUREMENT OF FLYING QUALITIES OF A DOUGLAS A-26B AIRPLANE

III - STALLING CHARACTERISTICS

By S. A. Sjoberg, H. L. Crane, and H. H. Hoover

Langley Memorial Aeronautical Laboratory
Langley Field, Va.

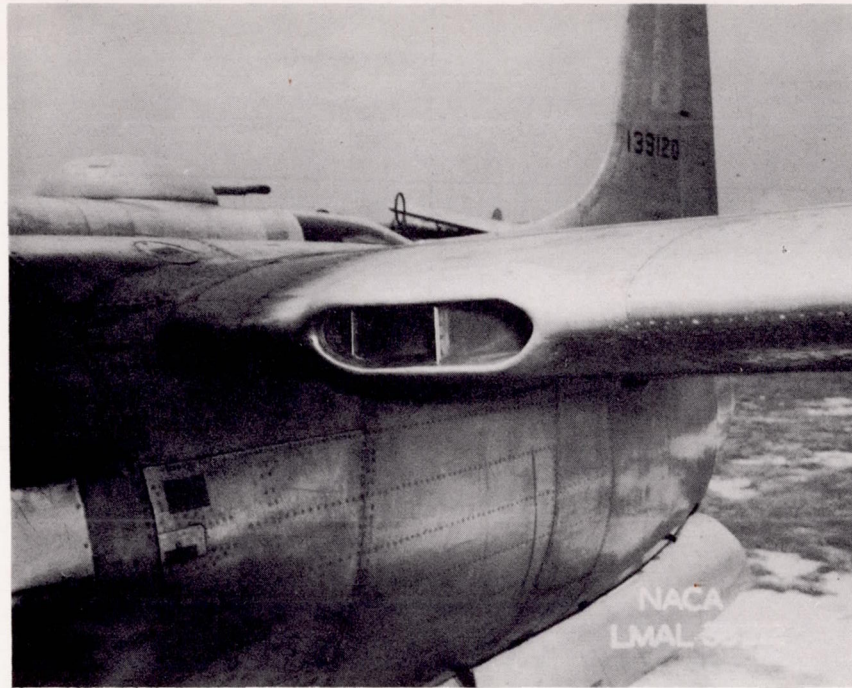
(a) Leading edge at oil-cooler duct.

Figure 2.- Photographs showing surface condition of Douglas A-26B wing.

Figure 1 shows a three-view drawing of the airplane and sections of the wing and tail surfaces. A description of the airplane and several photographs of the airplane are given in reference 1. Figure 2 presents photographs of the wing surface condition and the oil-cooler air intake. Figure 3 is a side-view photograph of the airplane showing the location of the service airspeed head. The airplane was equipped with double-slotted flaps. Figure 4 shows a section of the flap at various deflections.

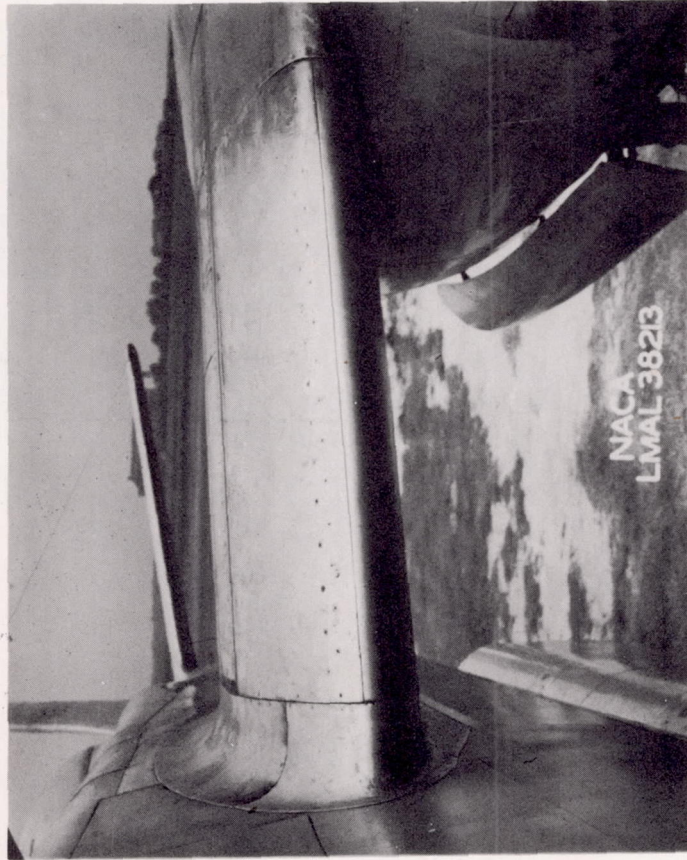
(c) Leading edge inboard of nacelle.

Figure 2.- Concluded.

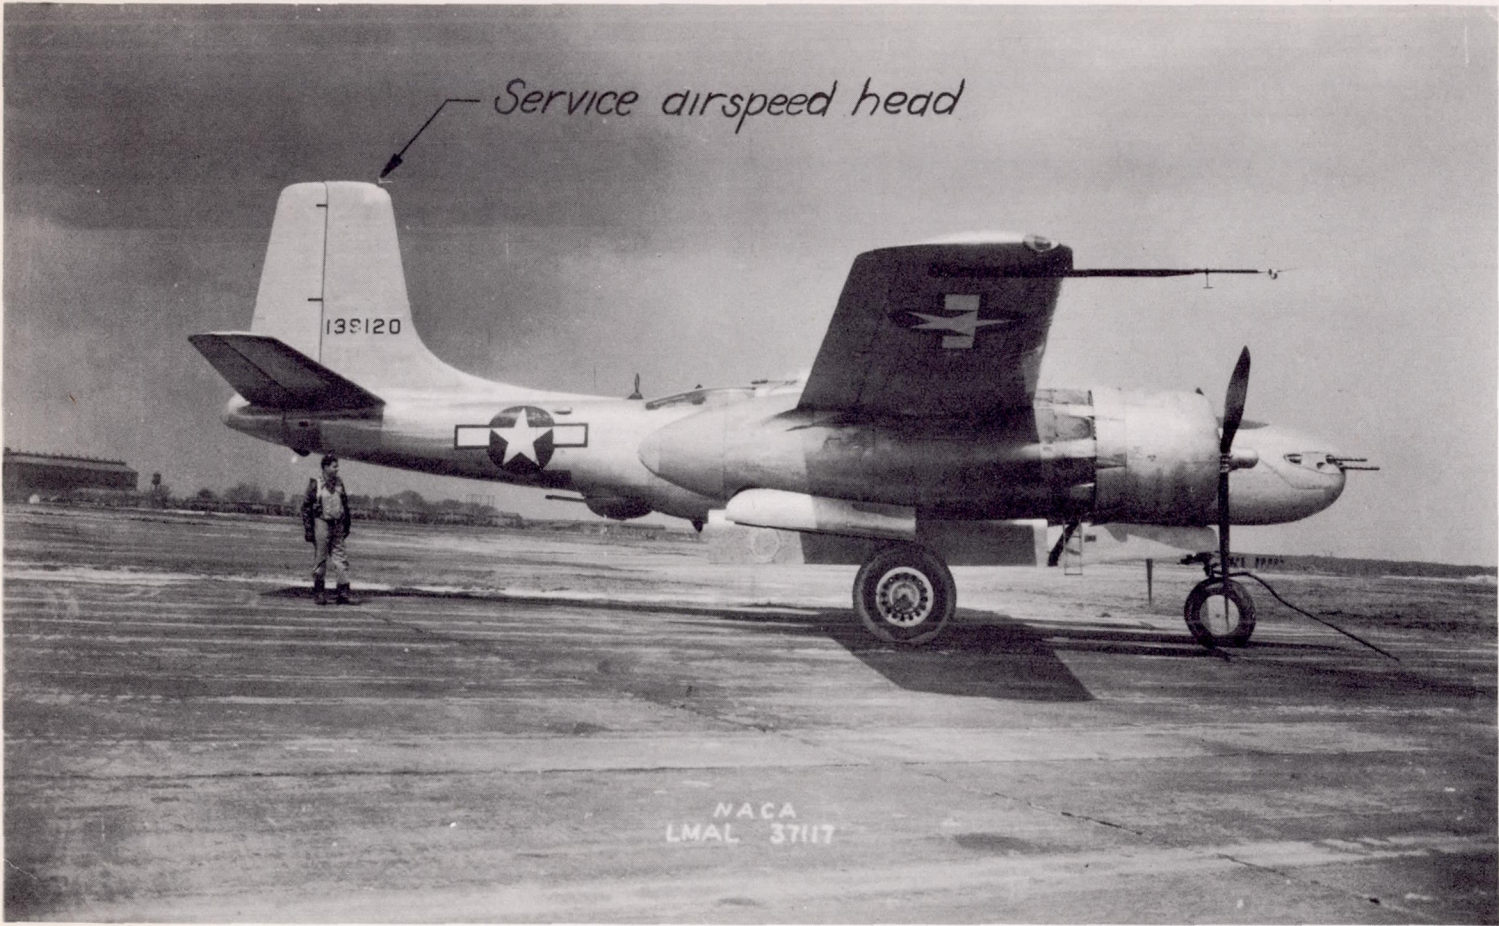
Figure 3.- Side view of Douglas A-26B airplane showing service airspeed head.
