RESEARCH MEMORANDUM

FACILITIES AND METHODS USED IN FULL-SCALE
AIRPLANE CRASH-FIRE INVESTIGATION

By Dugald O. Black

Lewis Flight Propulsion Laboratory
Cleveland, Ohio

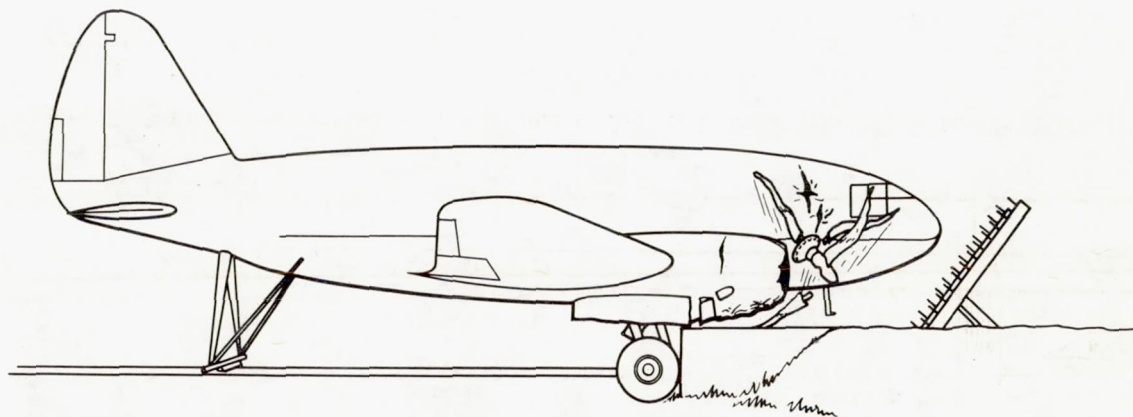
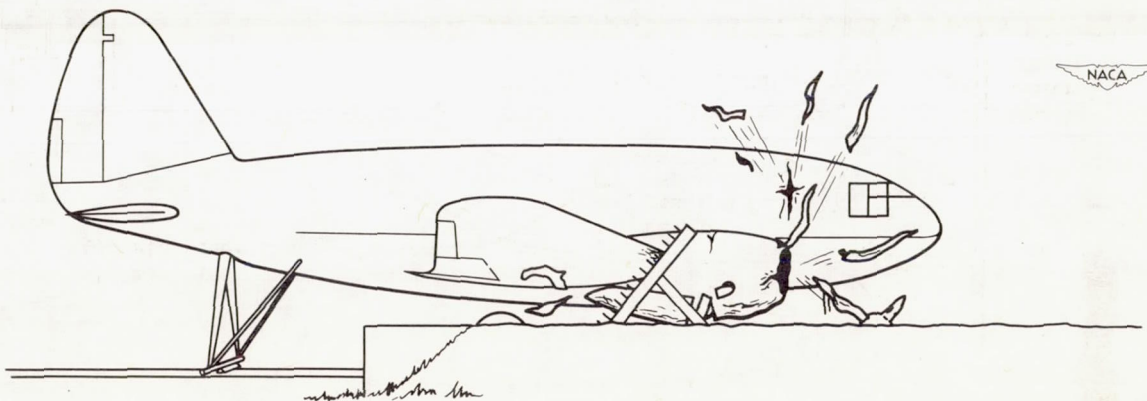
(a) Airplane approaching crash barrier.

Figure 2. - Schematic diagrams showing location of crash and pole barrier with respect to various components of C-46 airplane.

(b) Propeller strikes crash barrier.

(c) Main landing gear strikes crash barrier.

(d) Wings about to strike pole barrier.

The diagrams presented in figure 2 show how the barriers on the crash site produced the type of crash desired. The airplane as it approaches the crash barrier is shown in figure 2(a). First, the propellers of the airplane contact the crash barrier (fig. 2(b)); second, the main landing-gear wheels come in contact with the crash barrier (fig. 2(c)); and third, the leading edge of the wings come in contact with the pole barrier (fig. 2(d)).

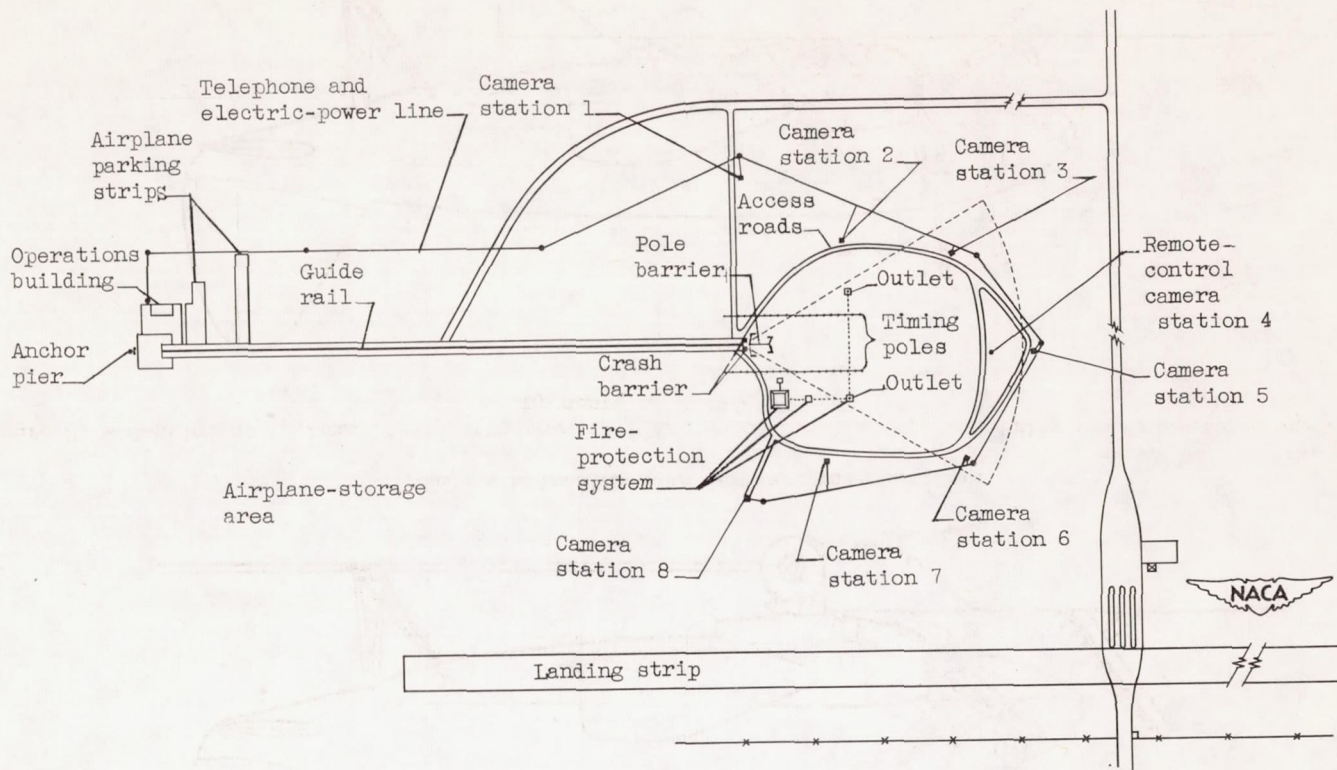
Figure 3. - Plan view of test site for conducting full-scale crash-fire investigation.

The crash tests were conducted on a portion of the United States Army Ravenna Arsenal. A plan view of the test site is shown in figure 3. The preparation or launching area includes operations building, airplane parking strips, and storage area. A runway for guiding the unmanned airplanes is located between the launching area and the crash area. The crash area includes the crash barrier, the pole barrier, the fire-protection system and the camera platforms. Electric and telephone lines connected each platform with the operations building. Located on the southern edge of the test site is an unpaved strip for landing the airplanes that were used in the crash-fire investigation. The airplanes were towed from the landing strip over the connecting roads to the airplane-storage area.

Camera platforms, from which motion pictures of the crash were recorded, were located at seven places around the crash area (fig. 3). Each platform was constructed of steel framework and armour plate for protection against flying debris (fig. 18). The height above the ground varied with each platform according to the requirements imposed by the terrain of the crash area.

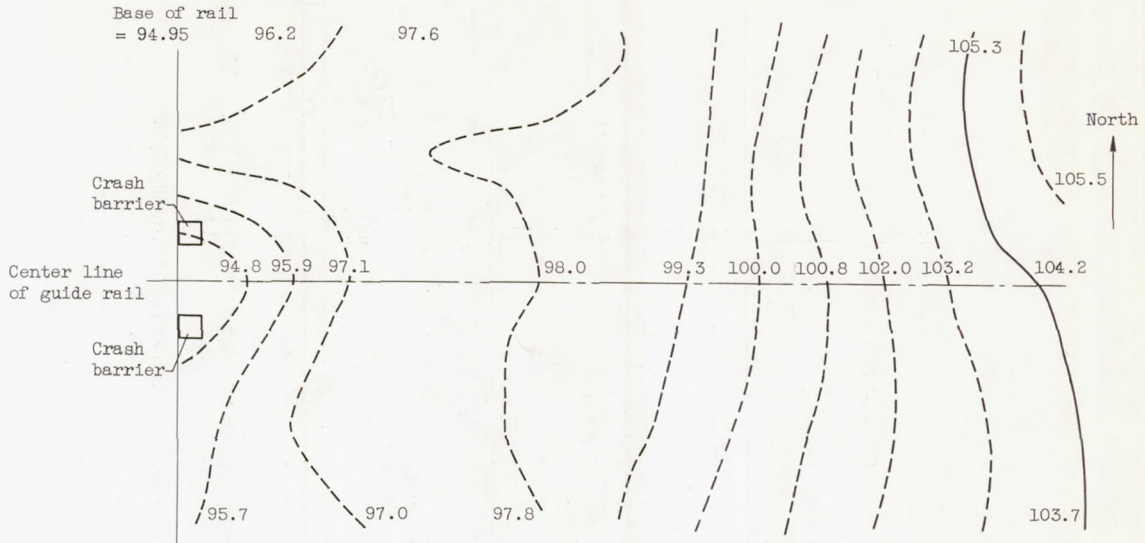
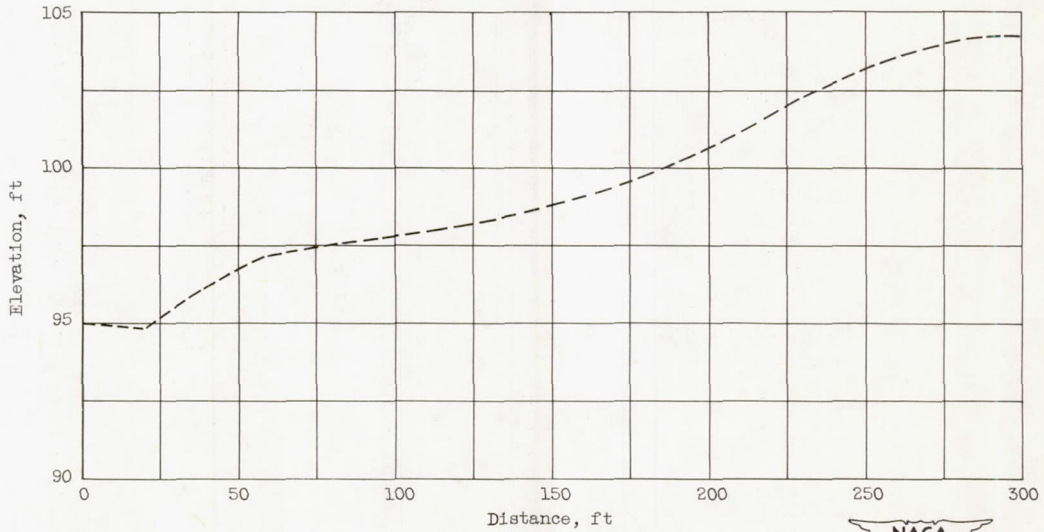
(a) Plan view.

(b) Profile view.

Figure 4. - Crash area in which the crash-fire investigation was conducted.

Plan and profile views of the crash area in which the crash-fire investigation was conducted are shown in figure 4. Photographs showing the side and front views of a C-82 airplane being prepared for a crash test are presented in figures 5(a) and 5(b), respectively.

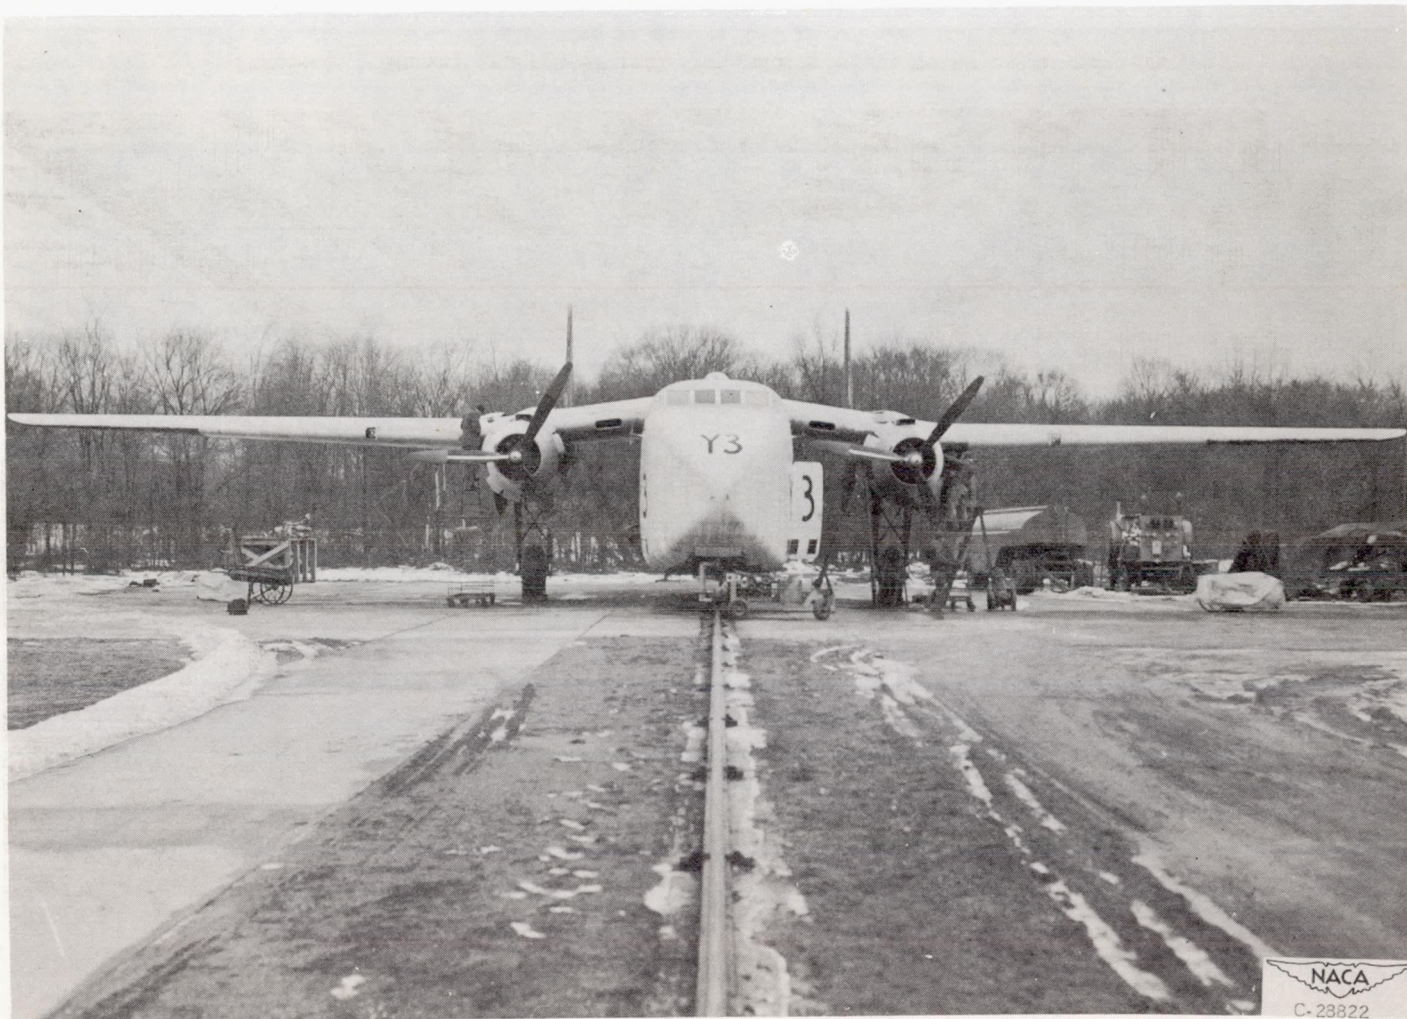
(a) Side view.

Figure 5. - C-82 Airplane being readied in preparation area for test.

(b) Front view.

An anchor pier (fig. 10) was erected at the end of the guide rail in the preparation area to retain the airplane under take-off power without brakes just before release. It was constructed of four separate concrete piers set in the ground with heavy iron framework connecting them. The restraining cable attached between the anchor pier and the glider tow mechanism of the C-82 airplane is shown in figure 5(a).

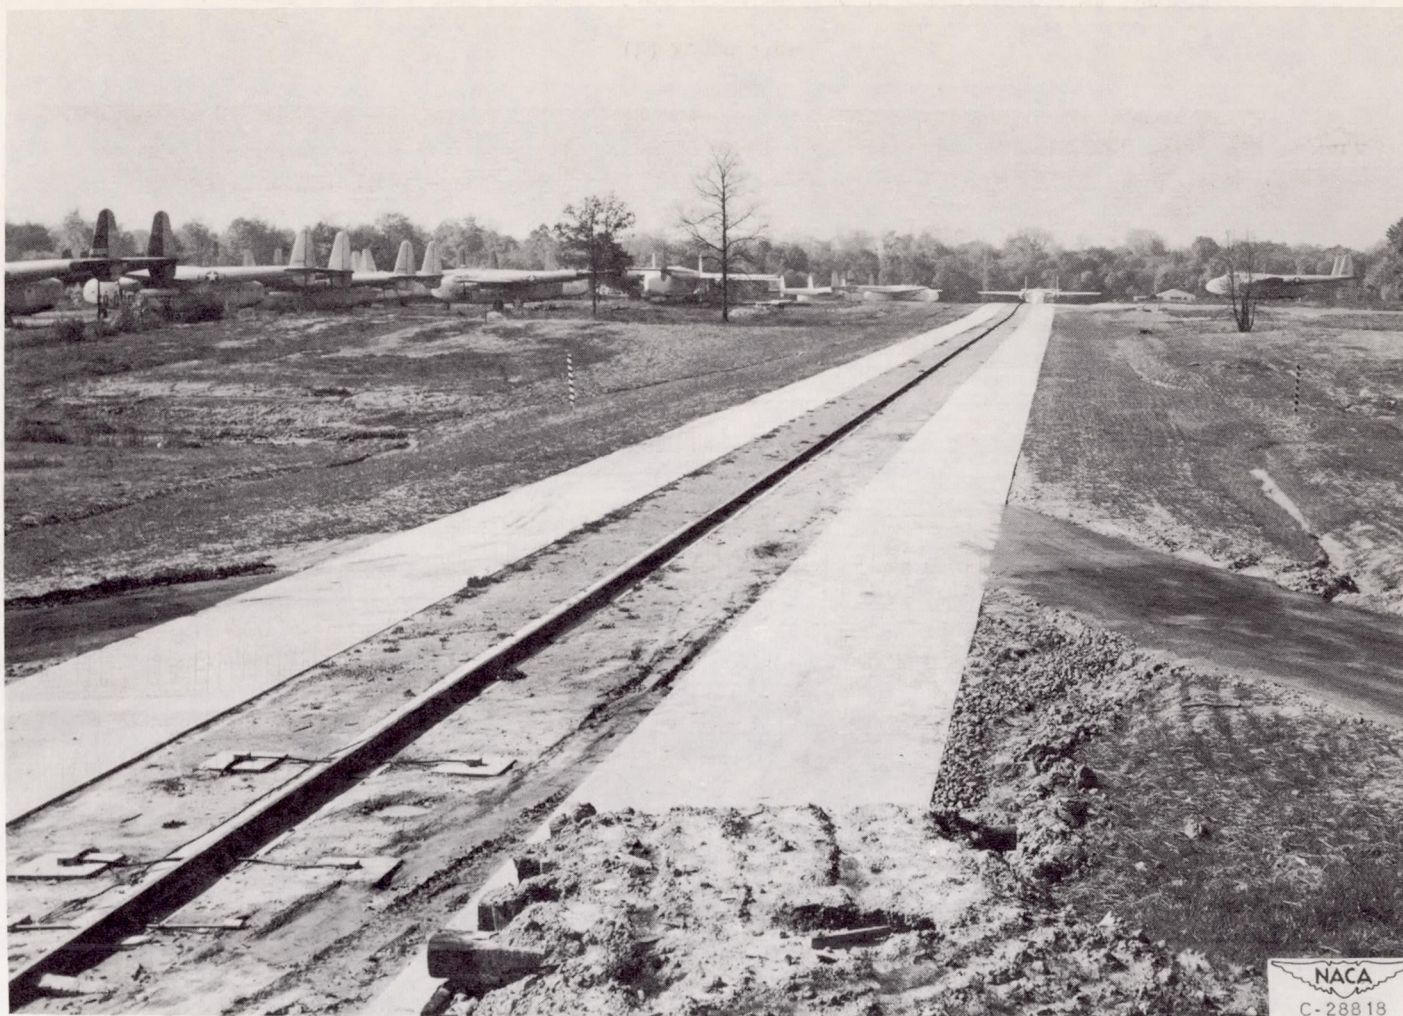
Figure 6. - Runway and center rail for guiding airplane to crash barrier.

The specially prepared runway and the center rail used to guide the test airplanes to the crash barrier are shown in figure 6. The rail and the runway were 1700 feet long. The runway was constructed of two concrete strips 10 feet wide separated by 15 feet. Between these two concrete strips one 80-pound rail was installed.

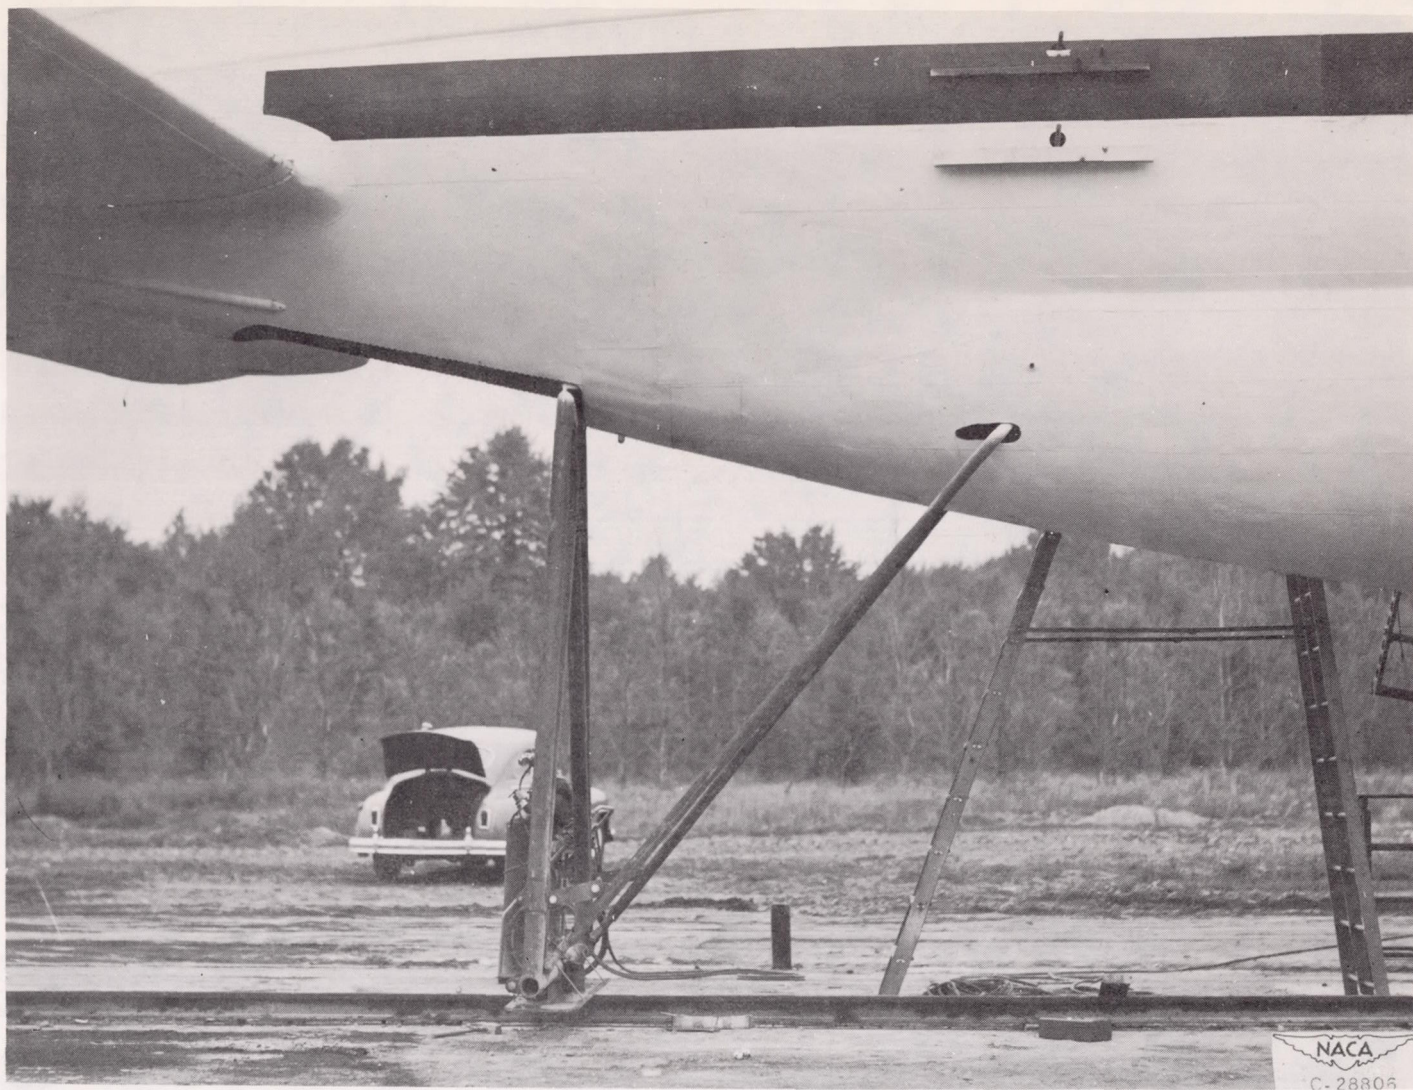
Figure 8. - Extended tail-truss support for holding C-46 airplane in flight attitude.

In order to support the C-46 airplane in flight attitude as it proceeded down the runway, a tail truss was bolted to the lugs on the tail-wheel bulkhead (fig. 8), the tail-wheel assembly having been removed. Welded to the bottom of the tail truss was a 4-inch I-beam which was attached to a 1/2-inch-thick steel plate that slid along the top of the center rail (fig. 8).

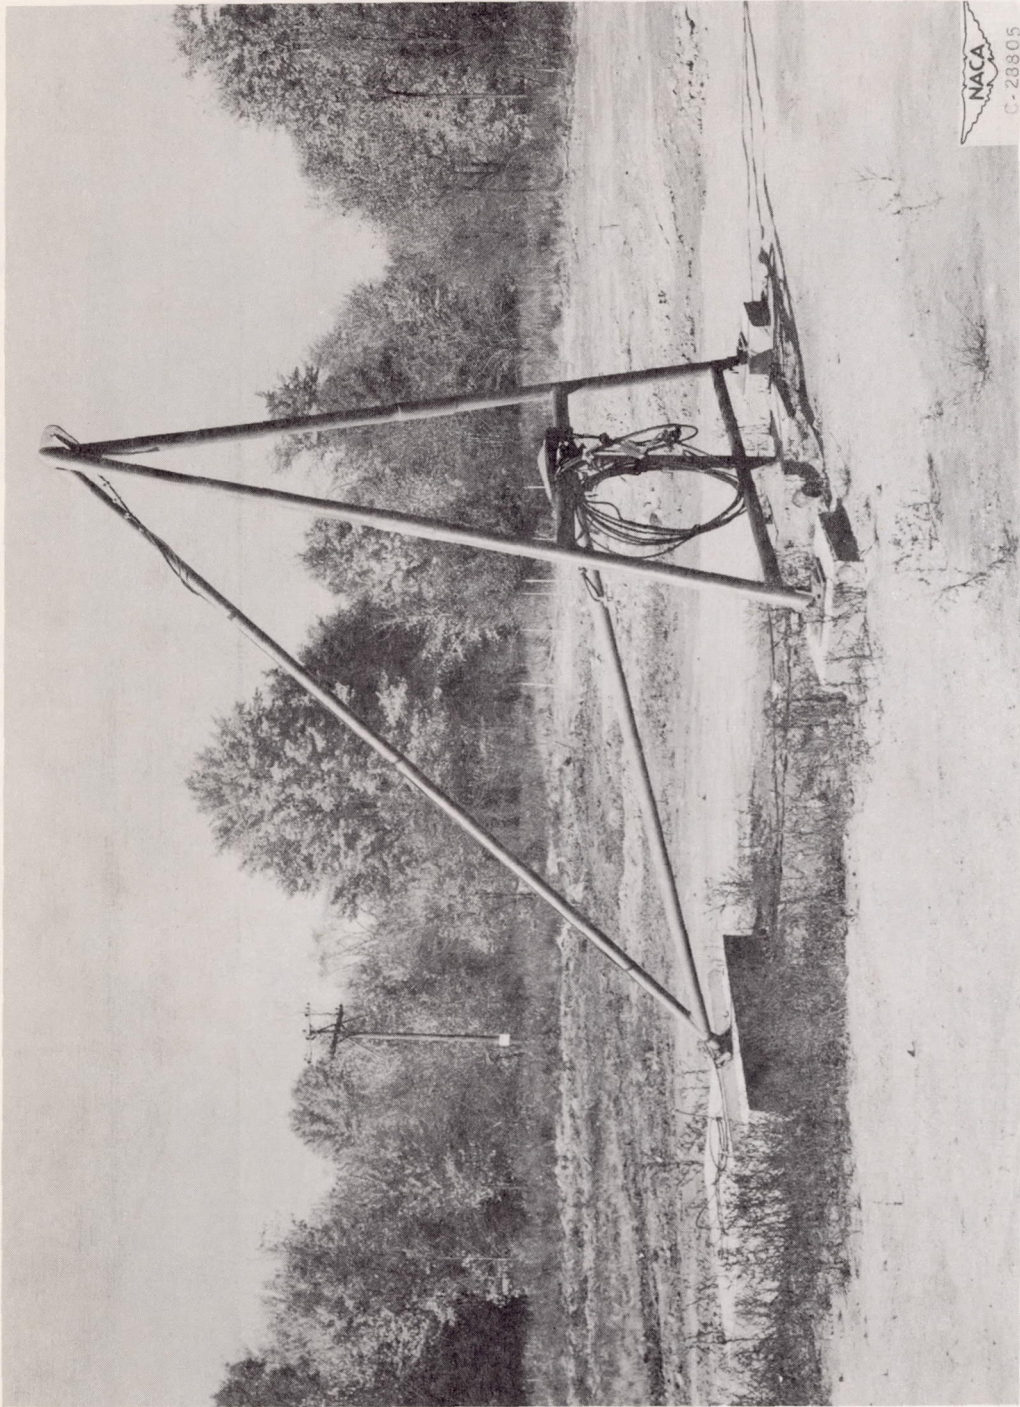
Figure 10. - Anchor pier for retaining airplane before release.

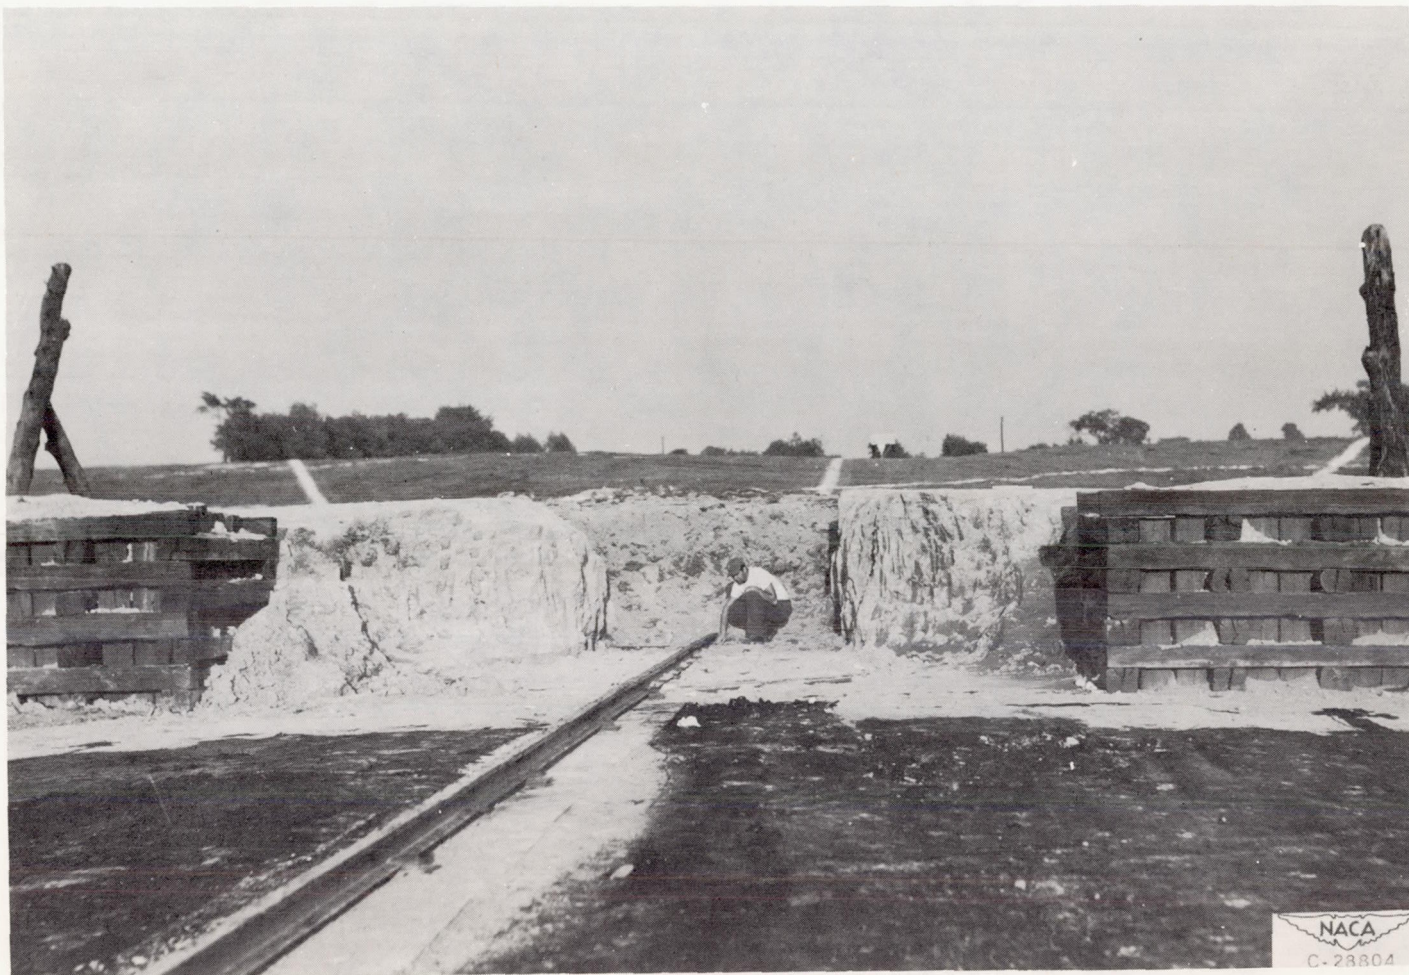
(a) For C-46 airplanes.

Figure 11. - Crash and pole barriers.

(b) For C-82 airplanes.

The crash barrier used to disrupt the engine propeller and to remove the main landing gear of the C-46 airplane is shown in figure 11(a). It was constructed of 8-foot-long wooden railroad ties interlocked and spiked together to form a hollow cube approximately the height of the main landing-gear wheels. This hollow cube was then filled and packed with dirt. Dirt was removed from between the abutments when tests were made with the C-82 airplanes to allow the low fuselage of the airplane to slide between the abutments as shown in figure 11(b).

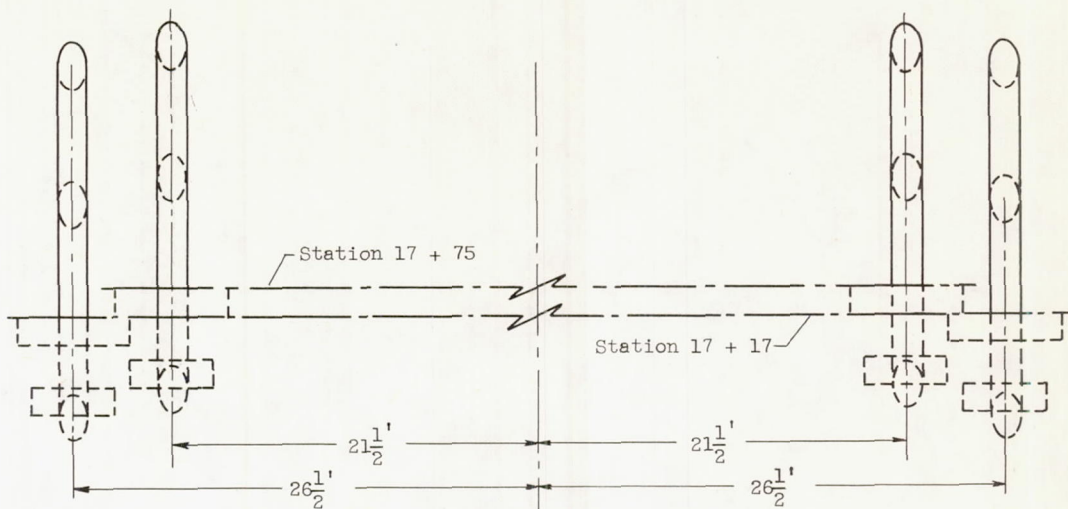
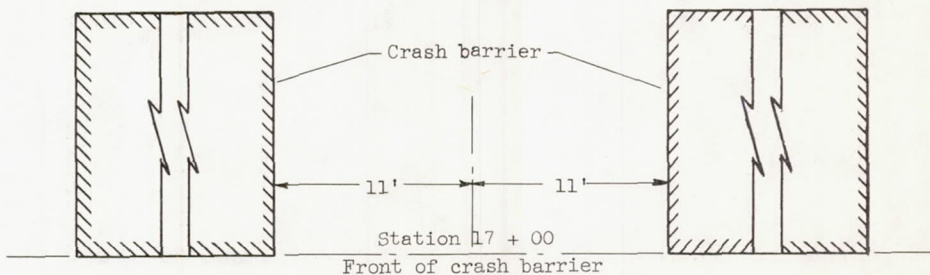
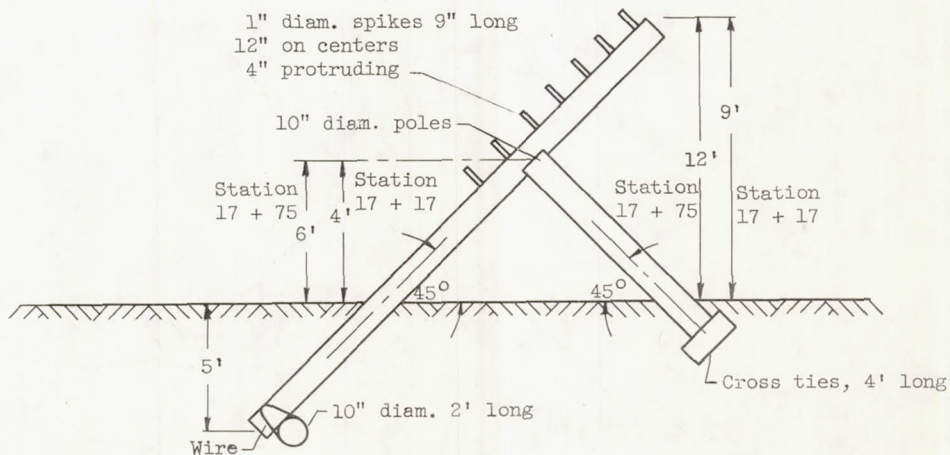
(a) Plan view of crash barrier.

(b) Side view of pole barrier.

Figure 14. - Sketch showing location of pole barrier for C-32 airplane crash tests.

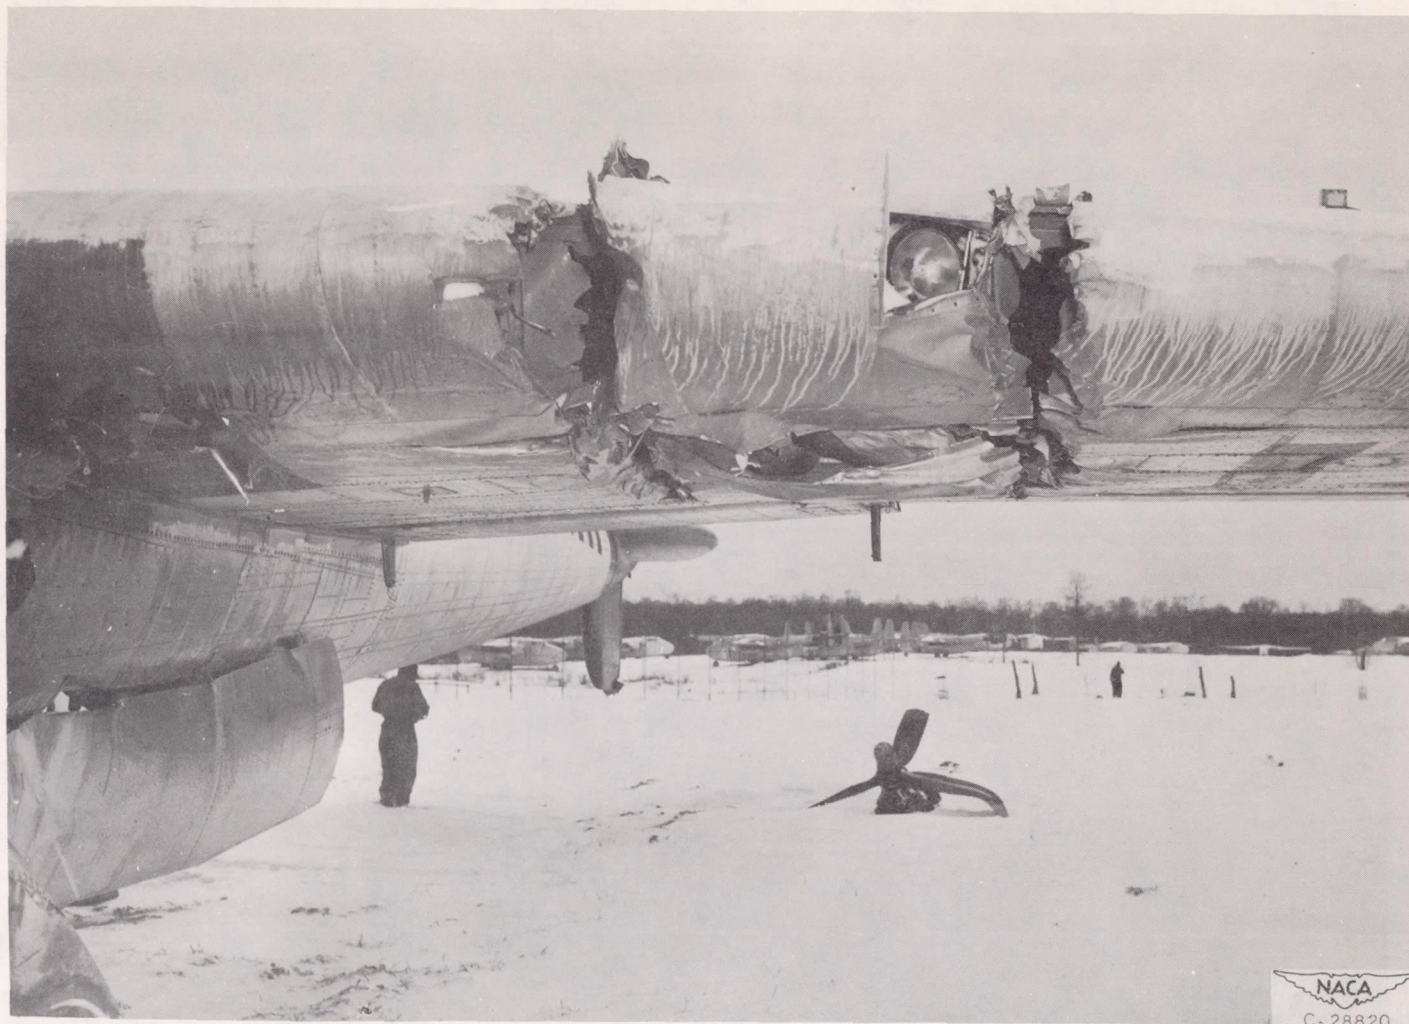
Figure 15. - Damage to left wing and fuel tanks of C-82 airplane produced by pole barriers.

The poles installed behind the crash barrier simulated trees which ruptured the wings and fuel tanks of the airplanes. These poles, which had a minimum diameter of 10 inches, were buried 5 feet below the surface of the ground at a 45° angle. Each pole had seven 1-inch-diameter steel spikes 9 inches long protruding 4 inches above the upper surface and spaced 12 inches apart as shown in figure 12. The location of the two poles used in the tests with the C-46 airplane are shown in the sketch on figure 13. The location of the four poles used in the tests with the C-82 airplane are shown in figure 14. Because of differences in construction of the fuel tanks in these airplanes, four poles were required in the C-82 crash tests to duplicate the rate of fuel spillage obtained with two poles in the C-46 crash tests. A photograph showing the damage to the left wing and the fuel tanks of a C-82 airplane produced by the pole barriers is presented in figure 15.

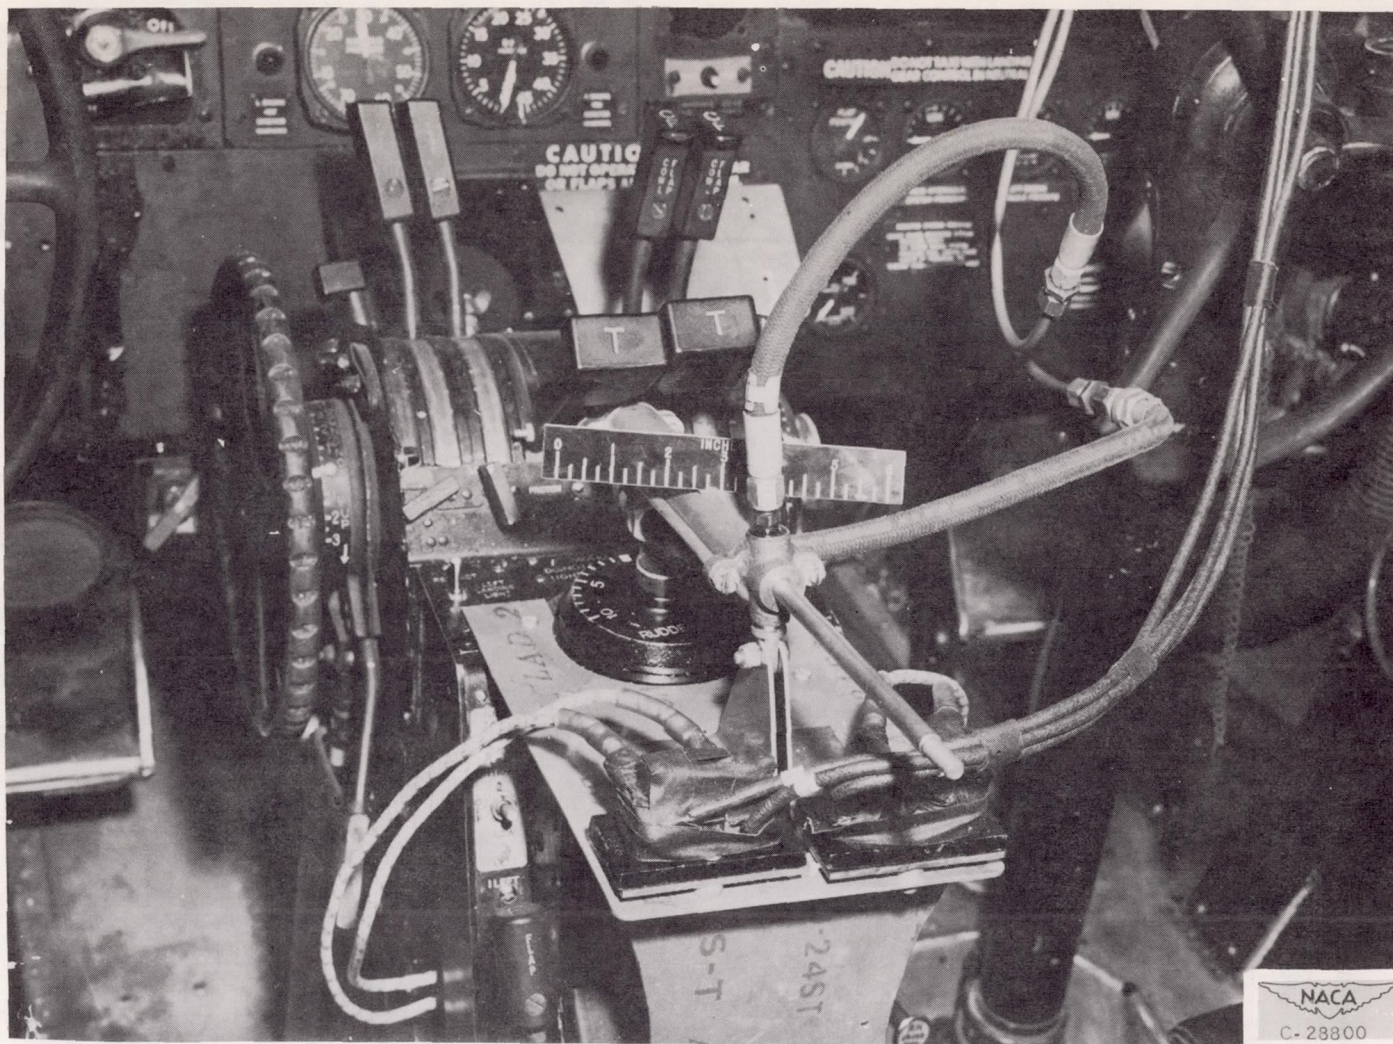
Figure 17. - Remote-control throttle mechanism located in cockpit of C-82 airplane.

Operation of the engines from outside the airplane was accomplished by installing a hydraulic remote-control mechanism that was attached to the throttles in the cockpit and actuated by a control installed on the outside of the fuselage at the rear. The control for operating throttles, instrument-box light, airplane release cable, engine speed, and manifold-pressure indicators were located on the left side of the fuselage at the rear door (fig. 16). The instrument box cable was attached to a switch which provided power to the instruments inside the fireproof box and the light indicated that all instruments were energized.

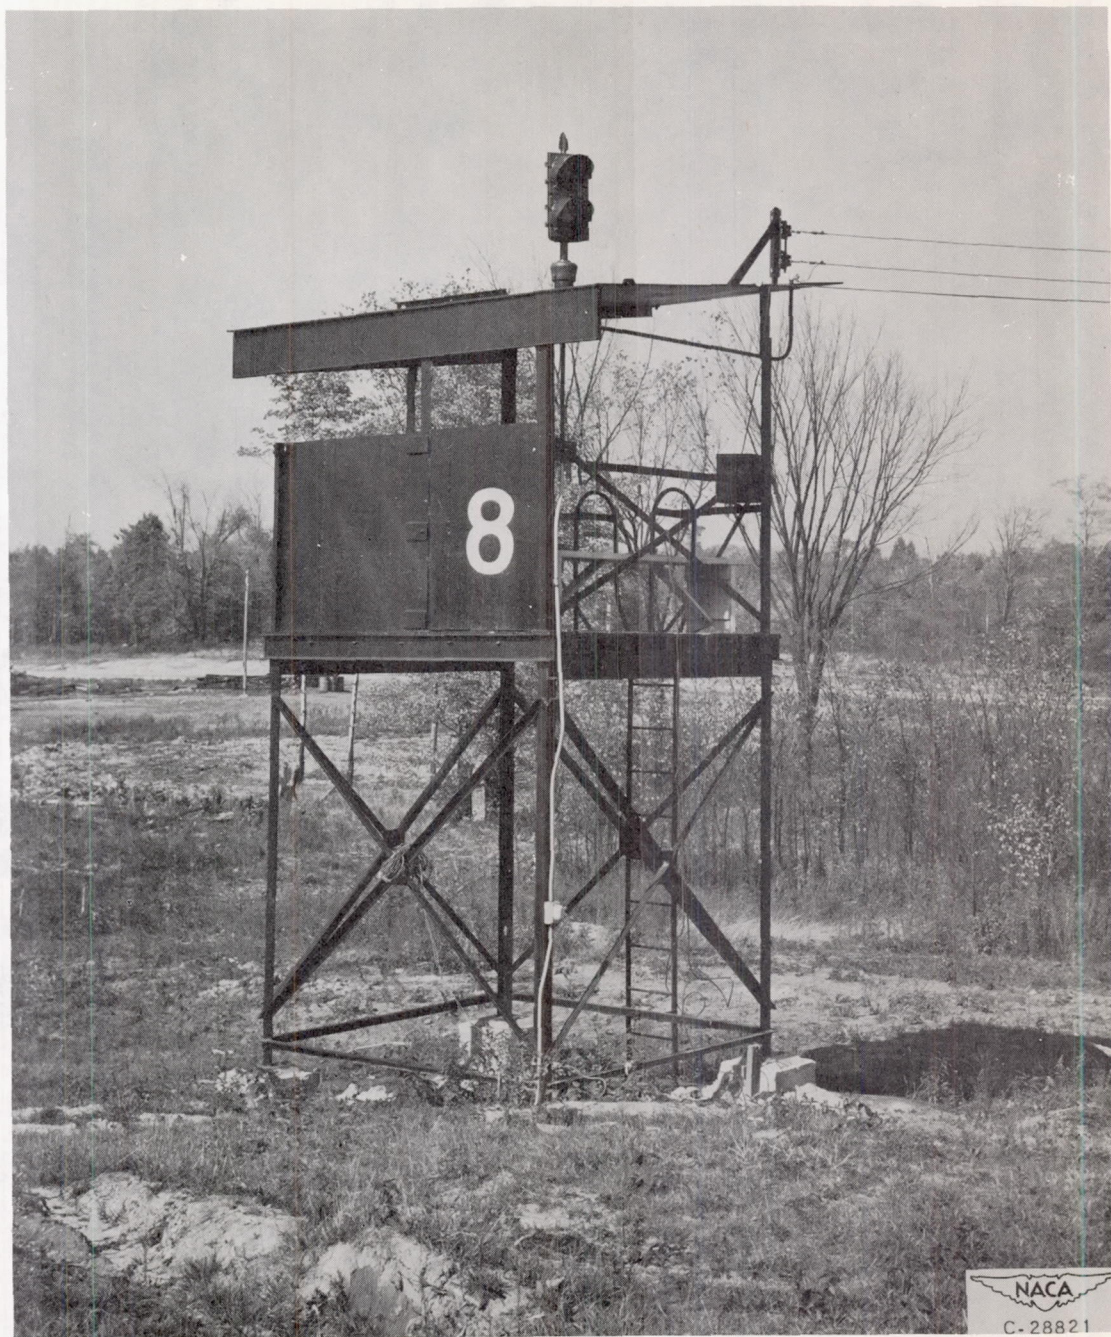
Figure 18. - Typical camera platform installation in crash area.

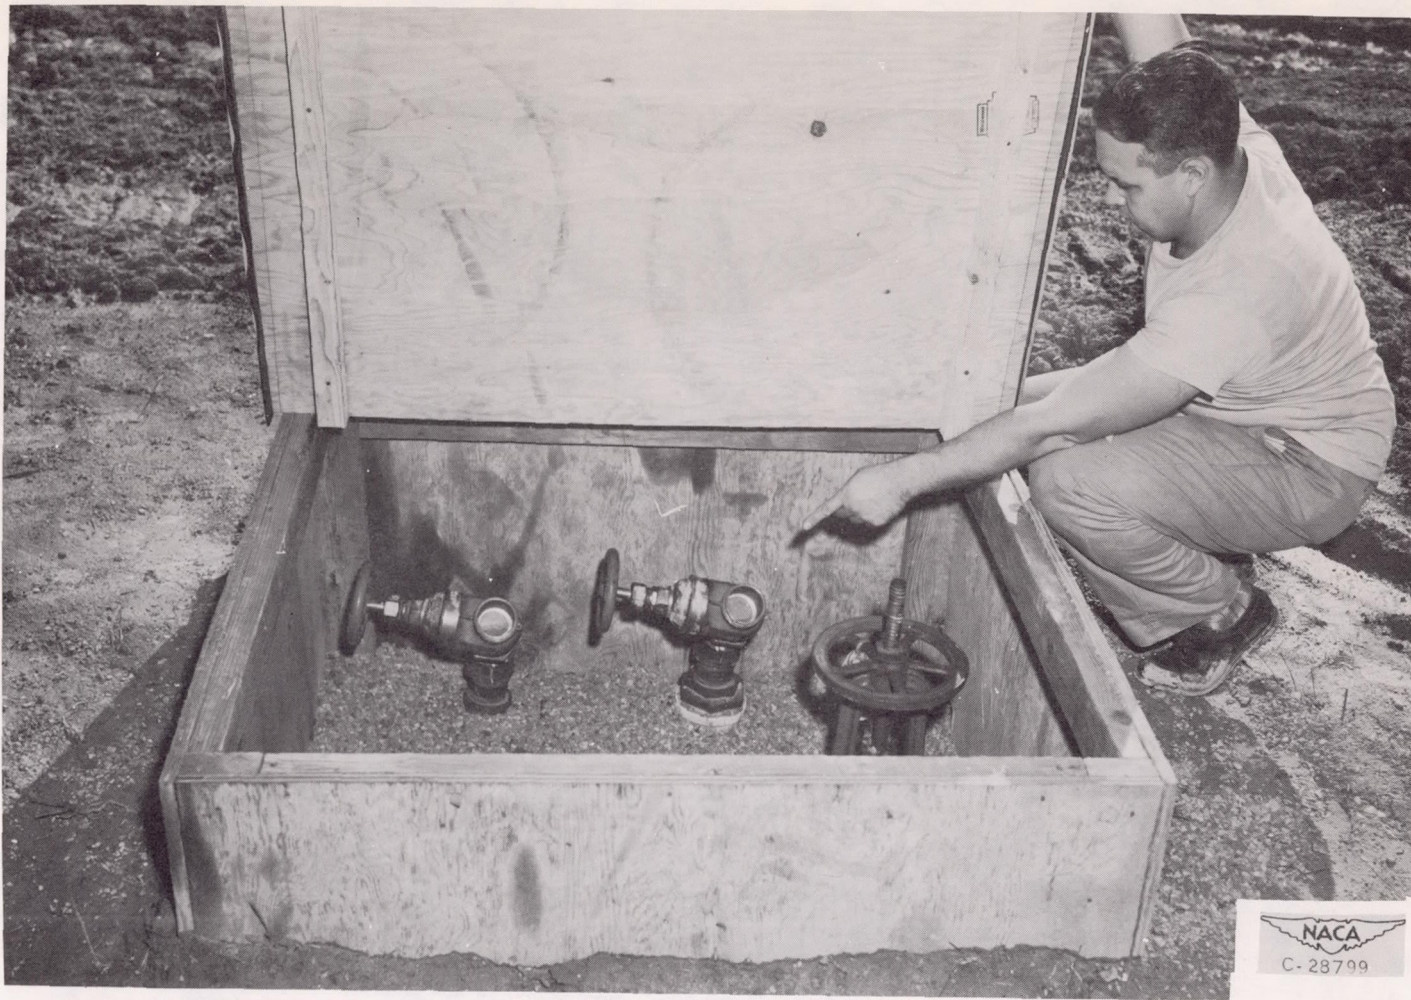
Figure 19. - Fire protection outlet located on each side of crash area.

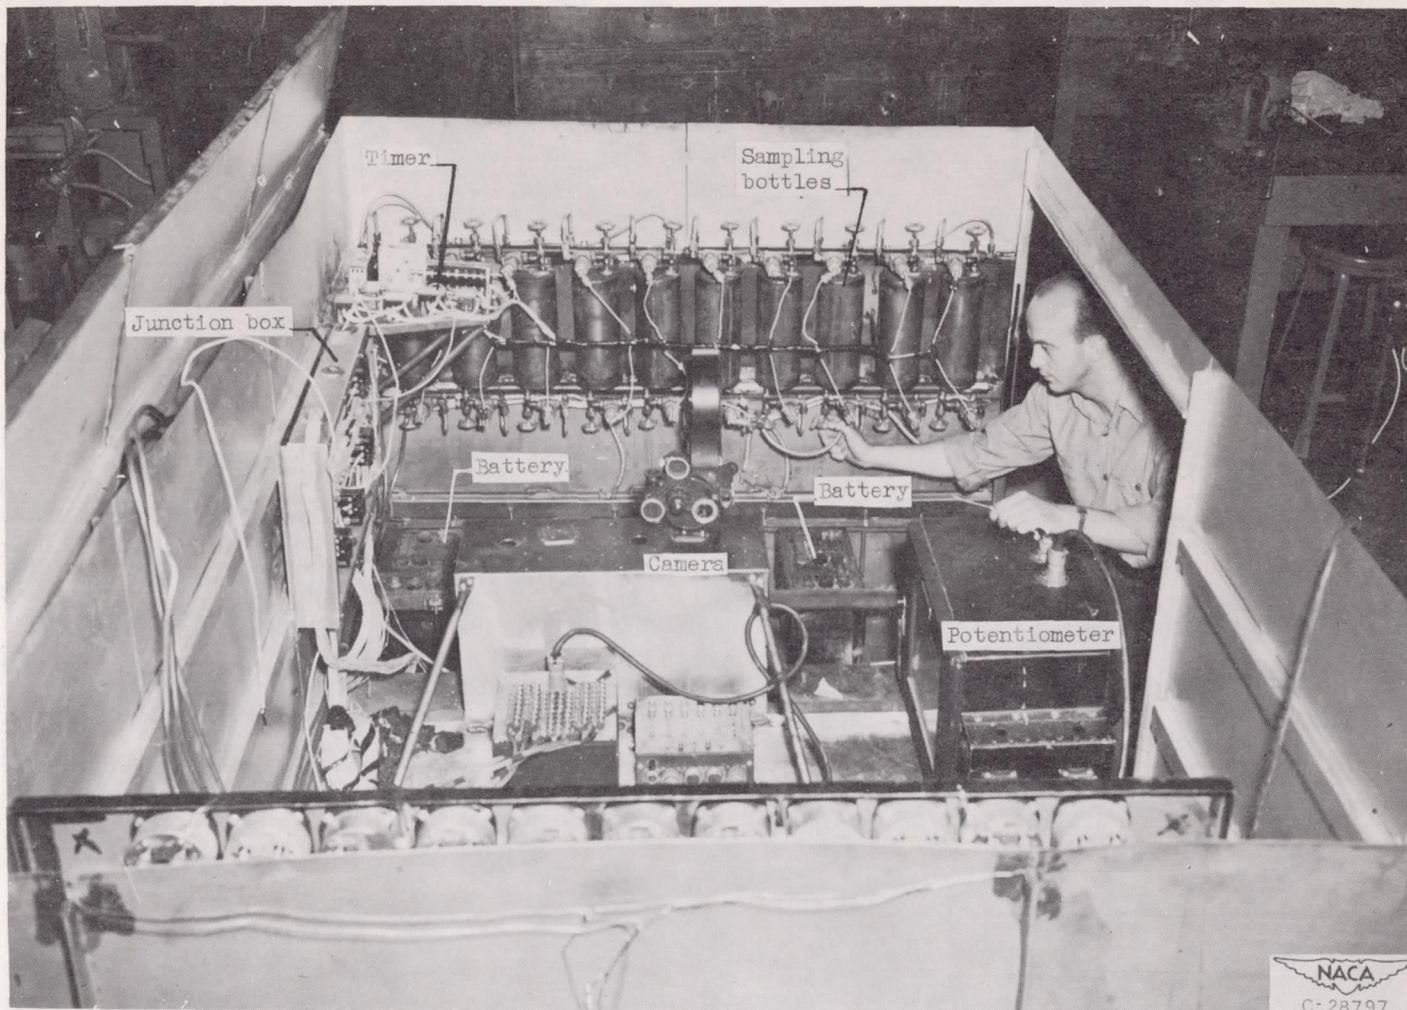
Figure 23. - Installation of cabin-air sampling bottles, camera, junction box, batteries, potentiometer, and timer in fireproof instrument box.

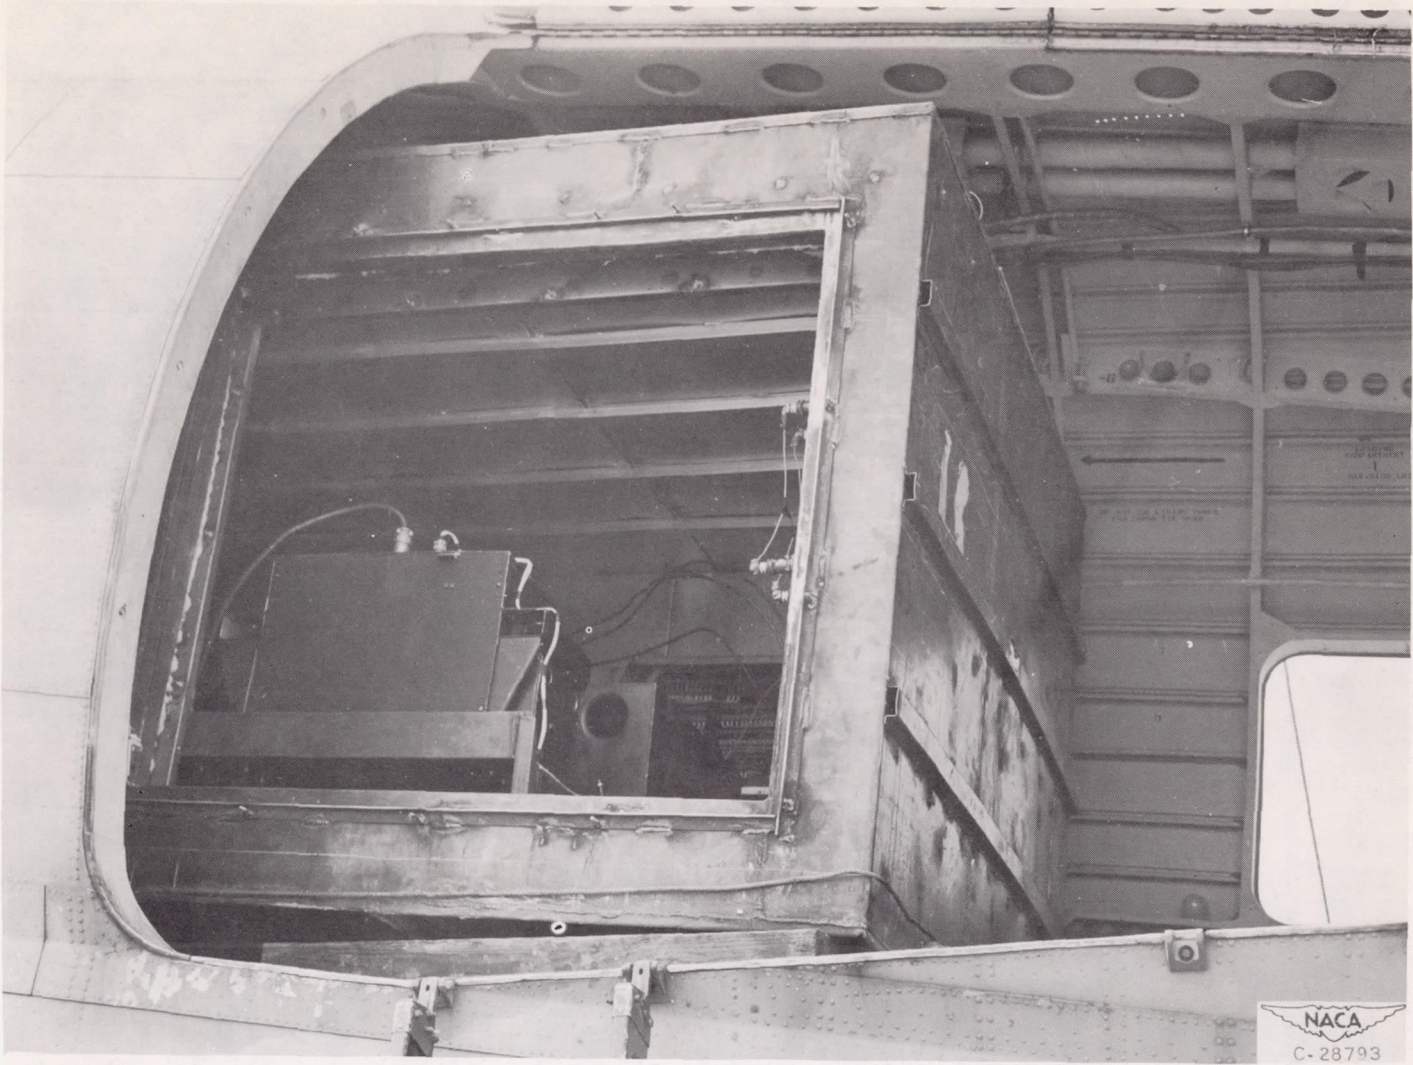
Figure 27. - Fireproof instrument box installation in C-46 airplane; side view.
