RESEARCH MEMORANDUM

FACILITIES AND METHODS USED IN FULL-SCALE
AIRPLANE CRASH-FIRE INVESTIGATION

By Dugald O. Black

Lewis Flight Propulsion Laboratory
Cleveland, Ohio

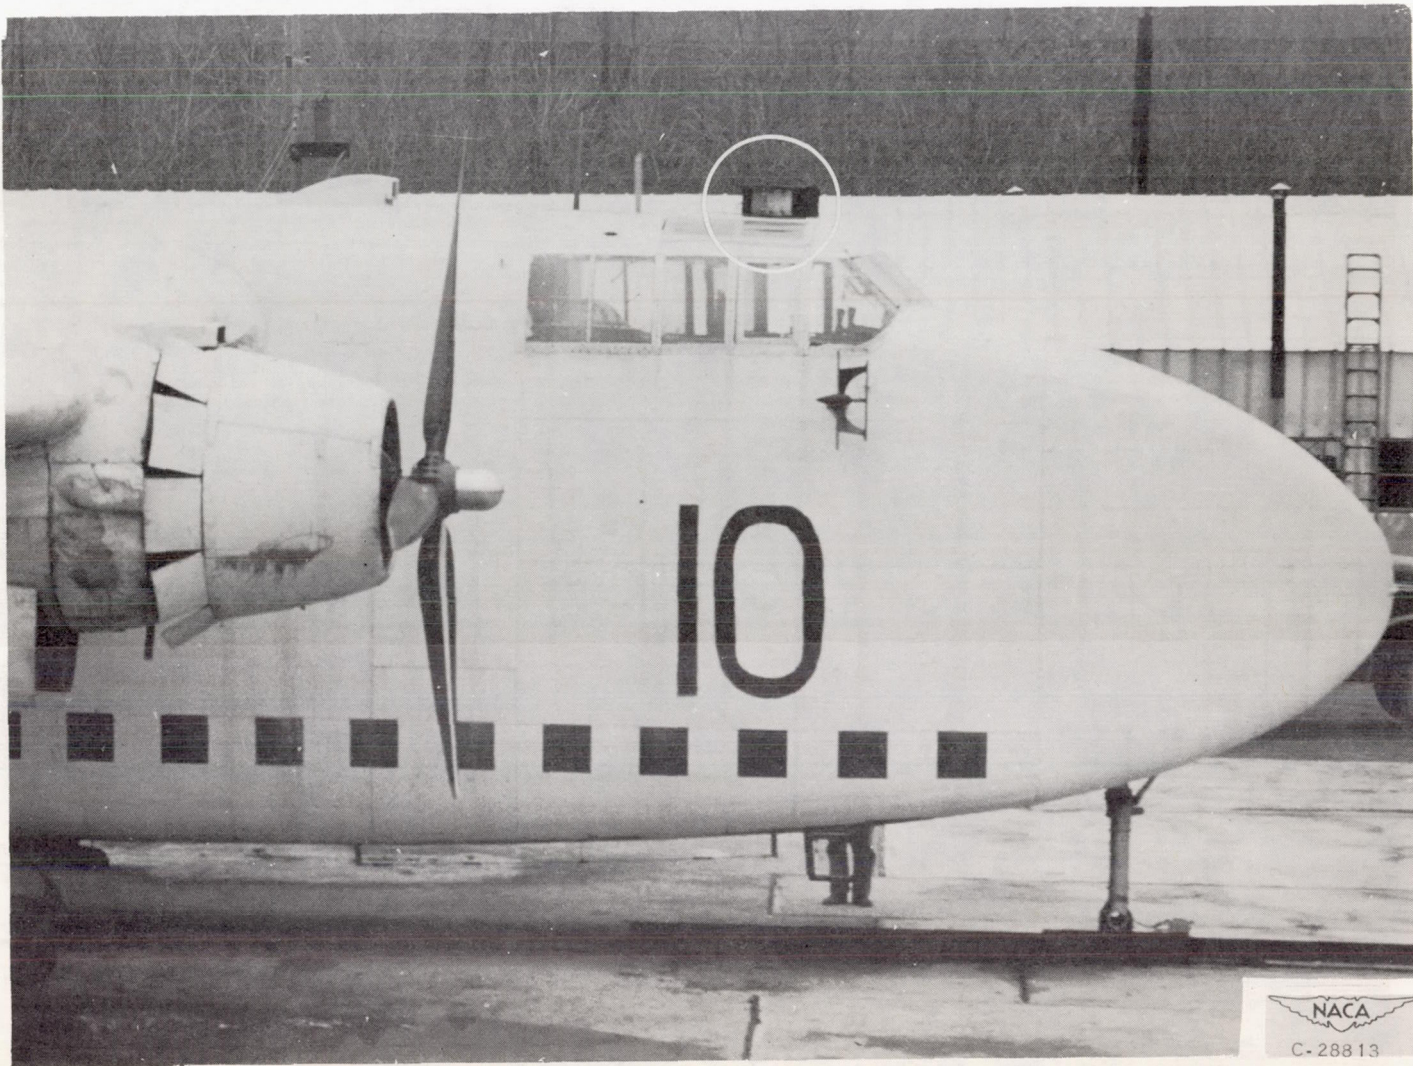
(a) On top of fuselage.

Figure 28. - Timing lights installed on C-82 airplane.

(b) On right wing tip.

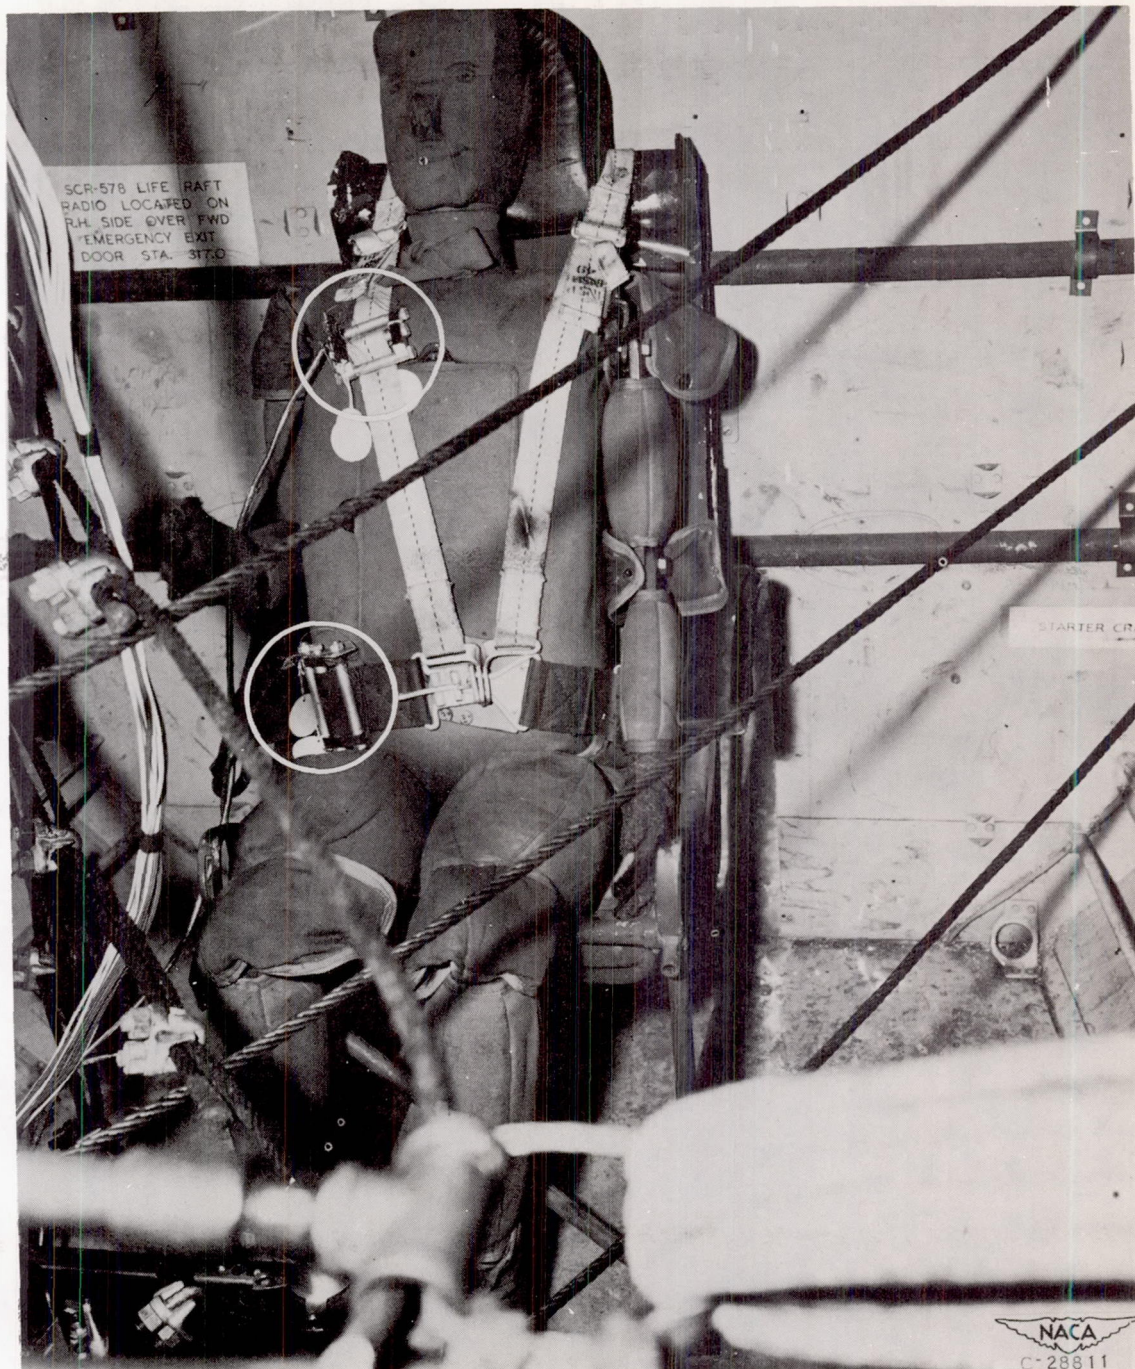
Figure 37. - Typical seat and dummy installation in pilot compartment of C-82 airplane.

Personnel-seat-harness strain measurement. - In addition to measuring the accelerations in the structure of the airplane, forces were measured in the shoulder and seat harnesses of dummies strapped in the seats. A typical installation of a dummy and the seat located in the pilot compartment is shown in figure 37. The forces applied on the dummy during a crash were measured by strain-gage links threaded through each shoulder and seat harness in such a manner that the strain gages indicated tension in the harness. As tension was applied to the harness by the dummy moving forward during a crash, bending of the side members of the strain-gage links was indicated by the strain gages. The strain-gage links installed on the shoulder and seat harness of a dummy are shown in figure 38. The location of these dummies in the airplane is shown in figure 36. Standard United States Air Force type dummies, each weighing 200 pounds, were used.
