HANDLING QUALITIES OF HIGH-SPEED AIRPLANES

By W. C. Williams and A. S. Crossfield

Langley Aeronautical Laboratory
Langley Field, Va.

RESEARCH MEMORANDUM

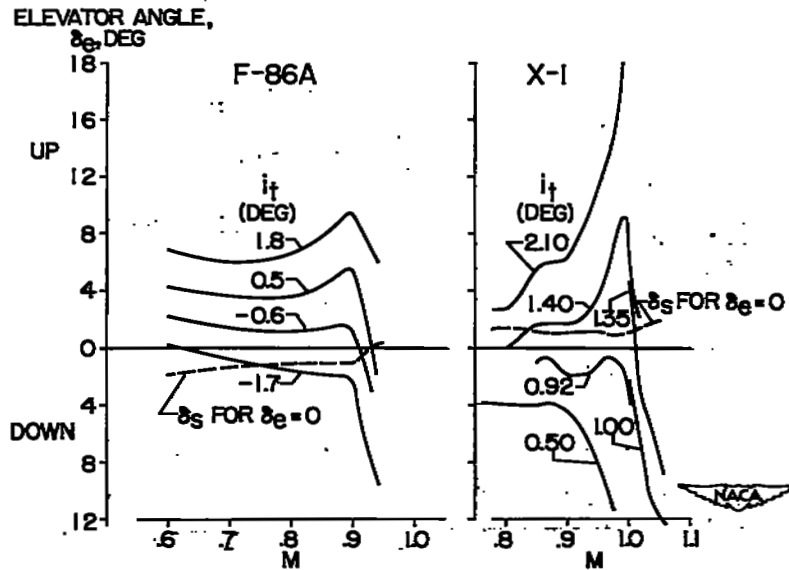
Figure 2.- Variation of elevator angle with Mach number at various stabilizer settings for both the X-1 airplane and the F-86A airplane.

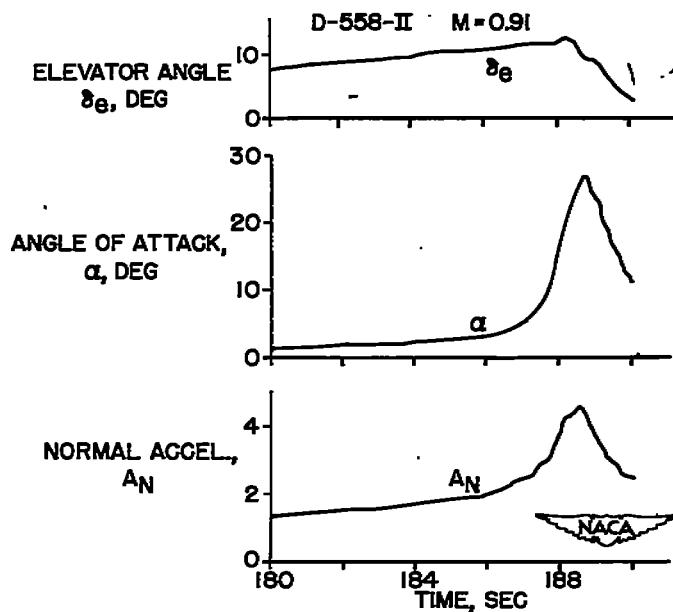
Figure 5.- Time history of elevator angle, angle of attack, and normal acceleration in a wind-up turn.

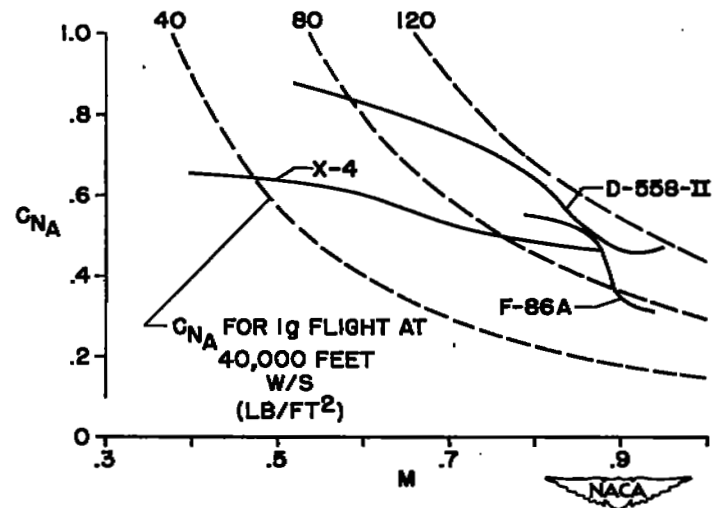
Figure 7.- Variation with Mach number of the normal-force coefficient at which pitch-up occurs for the X-4, the D-558-II, and F-86 airplanes.

From a series of maneuvers such as these, the normal-force coefficient at which the airplanes pitch up or become unstable through the transonic Mach number range has been determined. The results of these measurements are shown in figure 7 which presents the variation with Mach number of the normal-force coefficient at which pitch-up occurs for the X-4 airplane, the D-558-II airplane, and the F-86A airplane. Also presented is the variation with Mach number of the lift coefficient required for level flight at 40,000 feet with wing loadings of 40, 80, and 120 pounds per square foot. In the case of the X-4, the boundary has only been described up to a Mach number of 0.86 since above this Mach number insufficient elevator control is available to reach the lift coefficients at which pitch-up occurs. In the case of the D-558-II, the boundary has been defined up to a Mach number of 0.95. At a Mach number of 0.95, the pitch-up occurs, as can be seen, at a normal-force coefficient of about 0.45. Above this Mach number and up to a Mach number of 1.30, the airplane has been maneuvered up to normal-force coefficients of 0.4 to 0.5 and has not encountered an instability which indicates, at least, that the C_{NA} for pitch-up does not decrease further as the Mach number is increased. Whether such a boundary exists supersonically is not known at this time. In the case of the F-86A, the

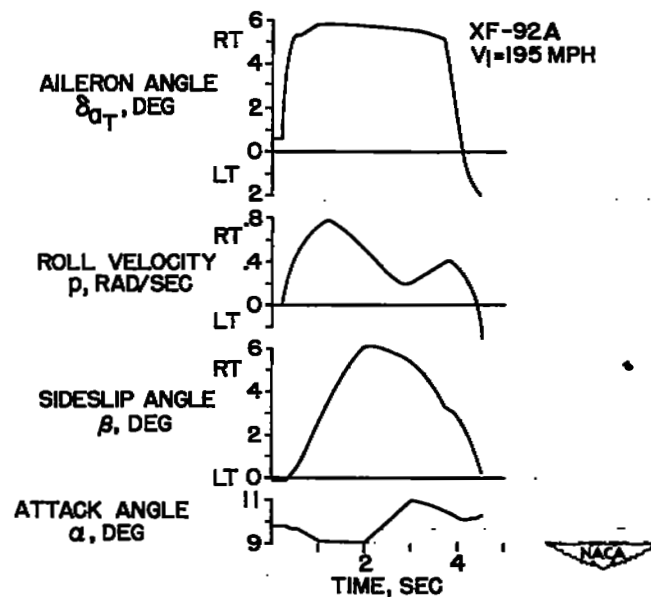
Figure 8.- Time history of a rudder-fixed aileron roll in a landing configuration at 195 miles per hour.

The lateral and directional stability and control characteristics of these airplanes are now discussed. As far as the static directional stability is concerned, no serious problems have arisen with the possible exception of a characteristic of the XF-92A airplane in aileron rolls in approach condition. This was reported during the Air Force evaluation and the pilots described it as excessive adverse yaw. Figure 8 presents a time history of a rudder-fixed aileron roll in landing configuration at 195 miles per hour. Notice that while the sideslip does not exceed 6° , which is not excessive, the dihedral is very high and reduces the rate of roll to a very low value until the sideslip diminishes. Because the airplane rolls about the body axis at high angles of attack, the yaw develops rapidly with the angle of bank. A combination of high dihedral and low directional stability has given similar results in airplanes in the past. With the XF-92A there is also high side force which may add to the pilot's discomfort. When the NACA receives the airplane the problem will be studied with a view to solution.

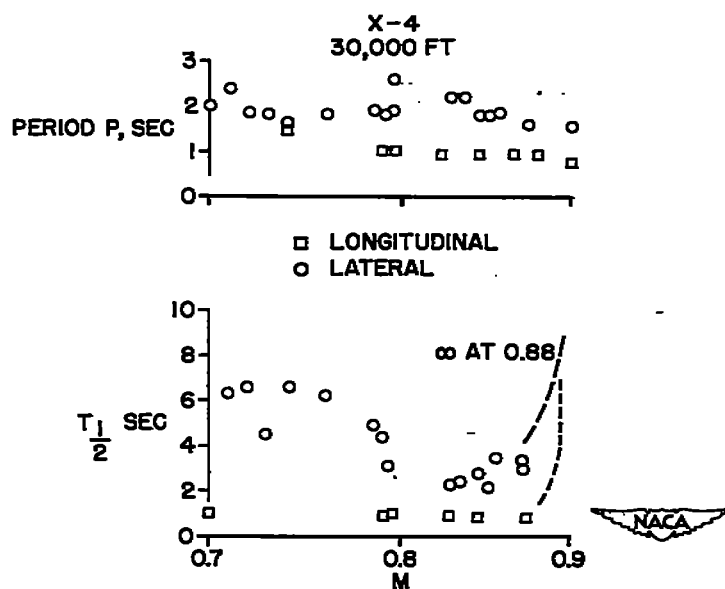
Figure 10.- Period and time to damp to one-half amplitude plotted against Mach number.

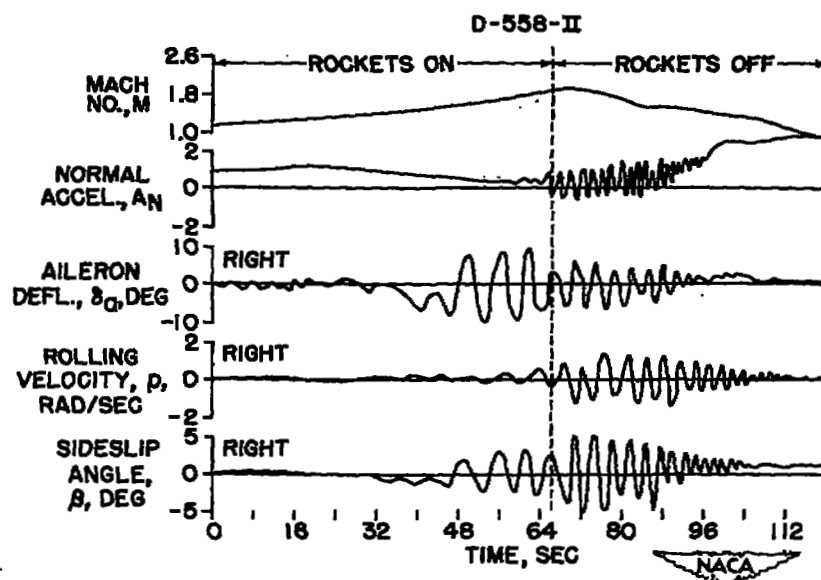
Figure 12.- Time histories from manufacturer's demonstration flight of D-558-II airplane.

An explanation is the wide expansion of the rocket exhaust at the low atmospheric pressures above 60,000 feet, which causes a family of shock waves in the rudder region. The rudder was locked and the speed range was extended to 1.87 Mach number. A large lateral oscillation occurred at the higher speeds and is shown in figure 12 where time histories of Mach number, normal acceleration, aileron angle, rolling velocity, and sideslip are given.

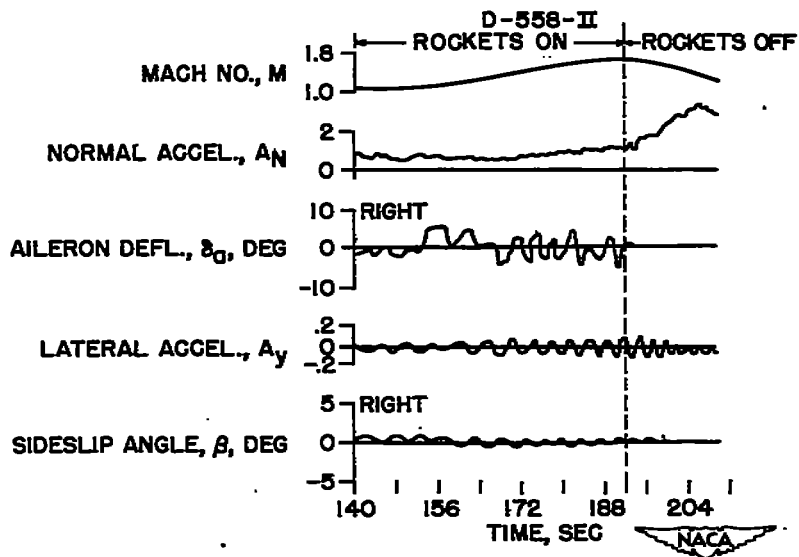
Figure 13.- Time histories from NACA flight of D-558-II airplane.

In order to isolate the effects of Mach number and lift coefficient, the NACA flew a similar flight but at higher normal acceleration which is shown in figure 13. The main difference of the two flights is the higher g and lower maximum speed on the NACA flight. The motion was much less violent but again 1.4 Mach number appeared to bound the oscillation. As was predicted and as shown in figure 14, the directional stability $C_{n\beta}$ is decreasing with Mach number increase. Also shown is a test point from the Langley 4- by 4-foot supersonic pressure tunnel. An explanation for the oscillation lies in the diminishing directional stability of the airplane.
