# NATIONAL ADVISORY COMMITTEE FOR AERONAUTICS

TECHNICAL NOTE

No. 1203

A FLIGHT INVESTIGATION TO INCREASE  
THE SAFETY OF A LIGHT AIRPLANE

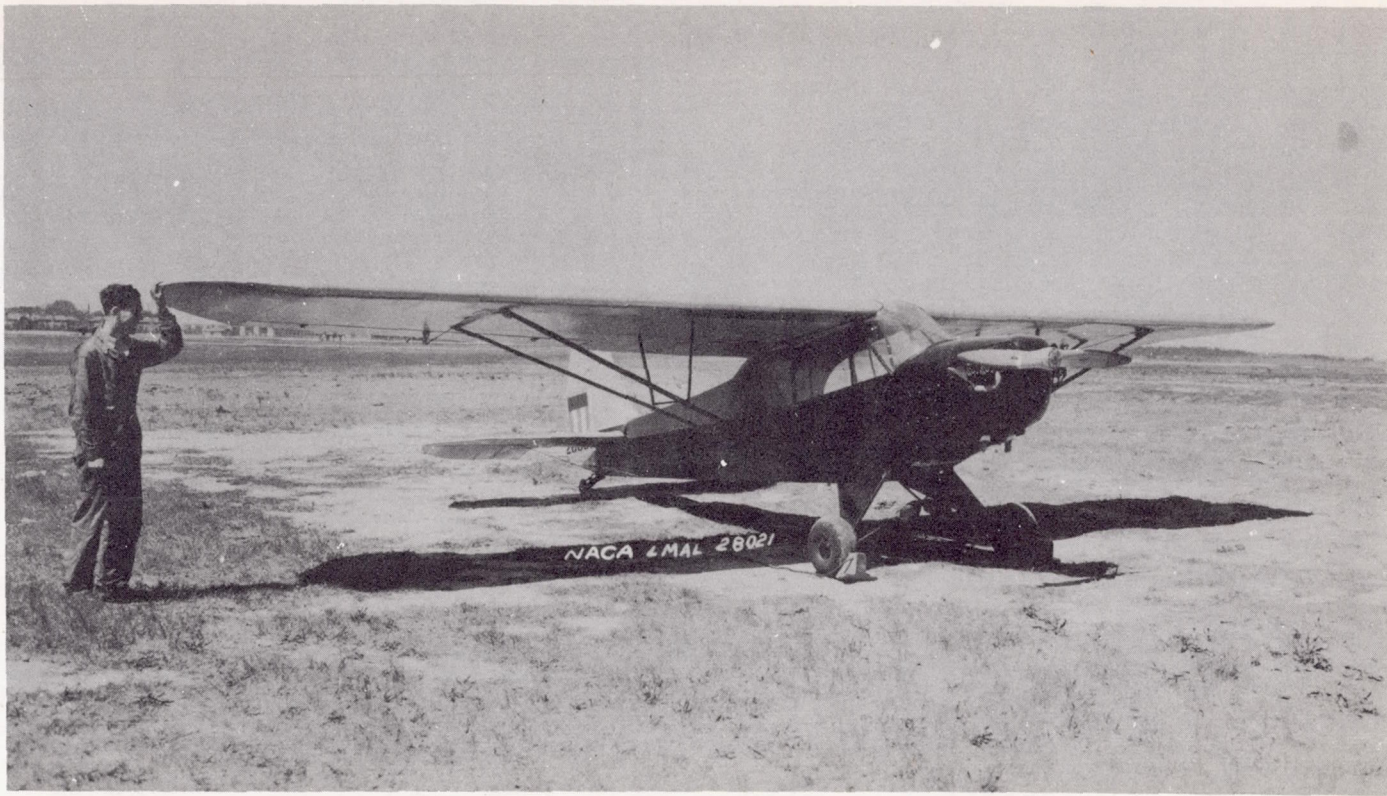
Figure 1.- Airplane used in tests.

(a) Three-quarter front view.

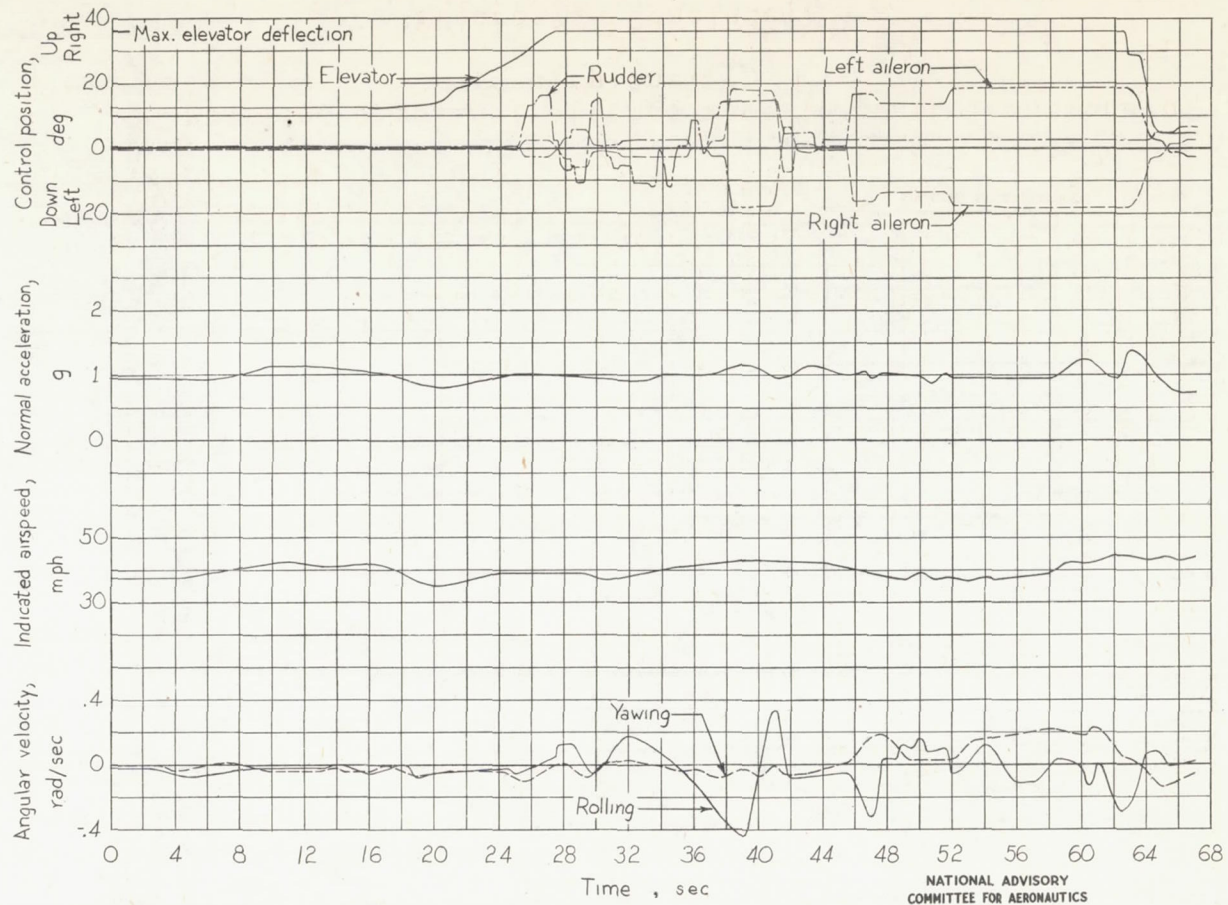
Figure 7.- Time history of a stall with power off. Stabilizer set full tail heavy.

(a) Original airplane; attempt made to control motions of airplane.

Stalls from straight level flight were produced, for power-on and power-off conditions, at various center-of-gravity positions. Entry to the stalled condition was made by a gradual reduction in airspeed with the wings held laterally level. Time histories of typical stalls from straight and level flight are shown in figures 7 and 8.

Power off.- During the power-off stall, the time history of which is shown in figure 7(a) for the original airplane, the pilot held the elevator full up and attempted to control the motions of the airplane first with rudder and ailerons and then with ailerons alone. Instability occurred about all three axes as shown by the angular velocities and the normal acceleration. Figure 7(b) shows a power-off stall in the modified airplane in which the pilot held the elevator full up and attempted to control the airplane by use of the ailerons. This figure indicates that some slight motions of the airplane occurred which were not initiated by the pilot but that a surplus of aileron and rudder control was available to counteract the rolling velocities that existed. A mild pitching oscillation of constant amplitude set in after the elevator had been held up for a long period. Comparison of figures 7(a) and 7(b) shows that motions accompanying the stall were small for the modified airplane as compared with the motions for the original airplane.
