**N93-30859****COMPARISON OF HAND LAID-UP TAPE AND FILAMENT WOUND COMPOSITE CYLINDERS  
AND PANELS WITH AND WITHOUT IMPACT DAMAGE**

Dawn C. Jegley and Osvaldo F. Lopez  
NASA Langley Research Center  
Hampton, VA

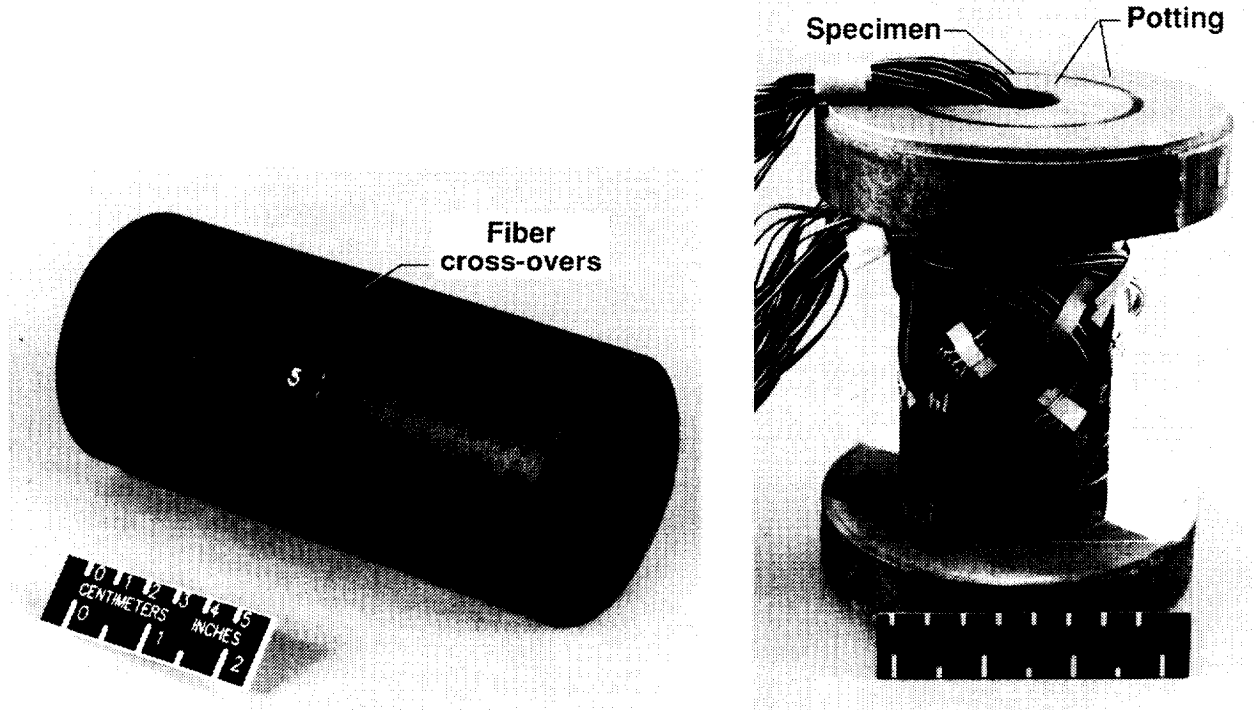
Figure 2

A filament wound cylindrical specimen with a band of fiber cross-overs around the circumference in the axial center of the specimen is shown in figure 2. Four specimens were filament wound and cut to length in this configuration. Four specimens were filament wound and cut to length in a configuration with no fiber cross-overs in the test section. Each cylinder is six inches long and has an inner diameter of 2.5 inches. The ends of each cylindrical specimen were potted in one inch of an epoxy material prior to testing, simulating clamped loaded edges. A hand laid-up tape specimen which has been potted and gaged with interior and exterior back-to-back strain gage rosettes is also shown in figure 2. This specimen has the same nominal dimensions as the filament wound specimen. All cylinders were constructed from AS4-3502 graphite-epoxy material. Loaded edges were ground flat and parallel prior to loading to ensure uniform edge displacement during loading. One side of each specimen was painted white so a moire fringe technique could be used to monitor out-of-plane displacements during the test.

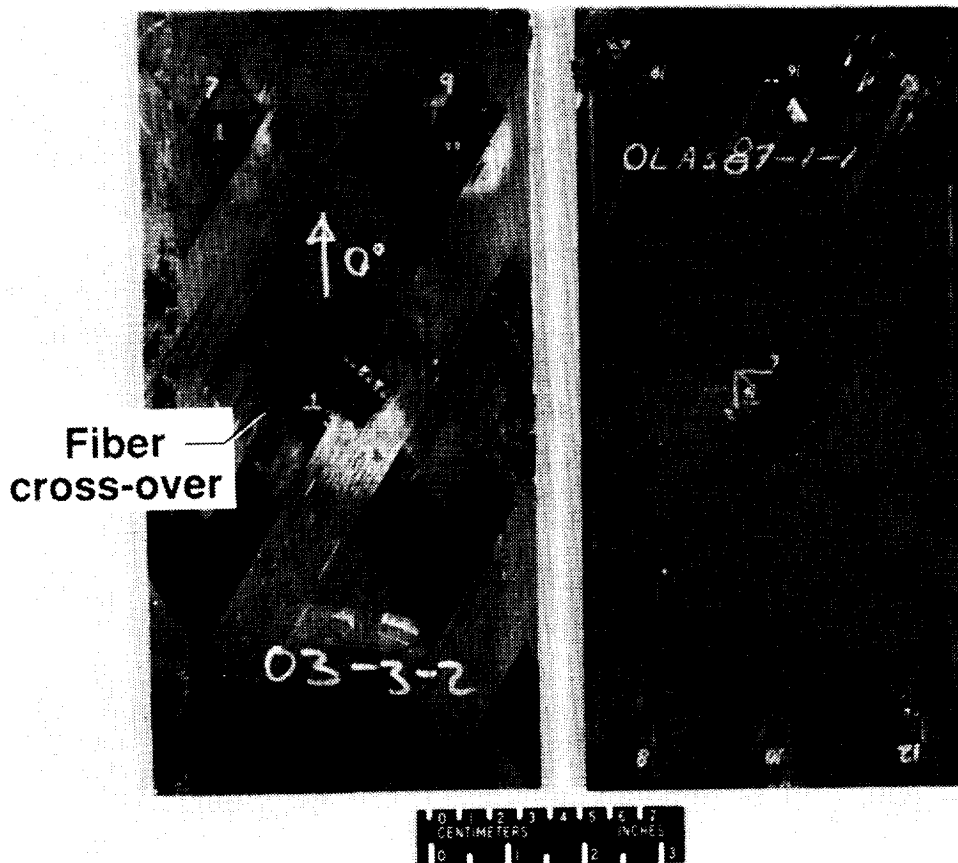
Figure 3

Eight filament wound flat plate specimens with stacking sequence  $[\pm 30/90]_{10}$ , one hand laid-up tape flat plate specimen with stacking sequence  $[\pm 30/90]_{16}$  and eight flat plate specimens with stacking sequence  $[\pm 45/90]_{4S}$  were loaded to failure in axial compression. All flat plates had clamped loaded edges and simple support knife edge constraints on the unloaded edges during testing. A photograph of two specimens after loading in axial compression is shown in figure 3. A filament wound plate specimen is shown on the left side of the photograph and a hand laid-up tape plate specimen is shown on the right. Fiber cross-overs can be seen in the filament wound plate. Four filament wound plates had fiber cross-overs and four did not. Each plate with stacking sequence  $[\pm 30/90]_n$  is five inches wide, ten inches long and approximately .25 inches thick.

A delamination failure occurred near the top of the tape specimen along the loaded edge. The filament wound specimen delaminated and failed along a fiber cross-over band located at the center of the plate. Each flat control (unimpacted) specimen buckled immediately prior to failure. One control specimen of each type was tested and the rest were subjected to impact damage prior to compressive loading.

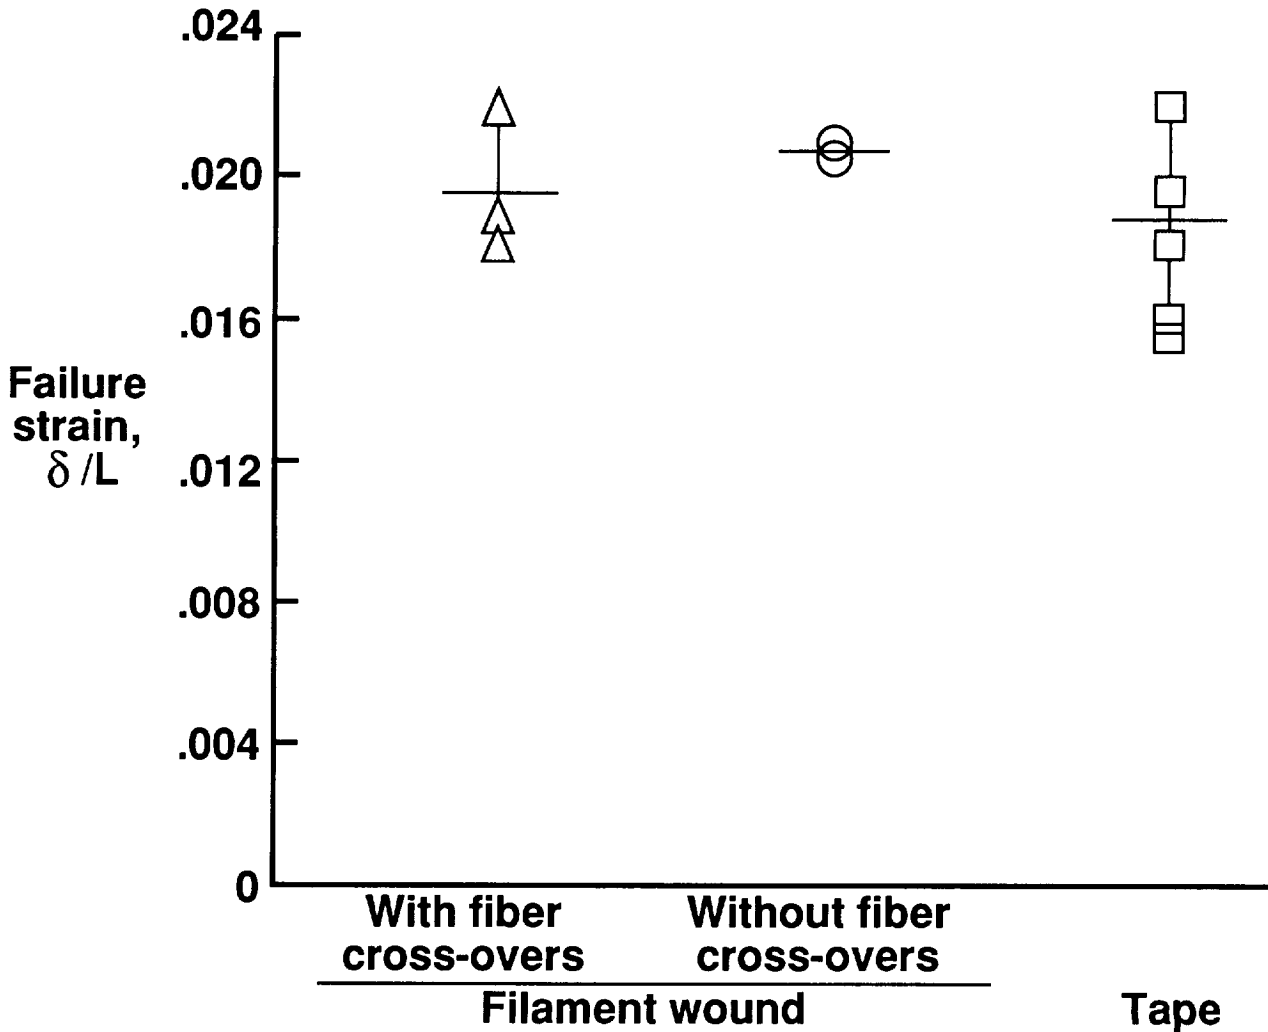
Figure 4

Five control (unimpacted) filament wound and six control hand laid-up tape cylinders with stacking sequence  $[\pm 45/90]_{3s}$  were loaded in axial compression to failure. Three filament wound specimens had fiber cross-overs mid-length. Two cylinders had no fiber cross-overs in the test section. Failure strains based on measured end shortening  $\delta$  and initial specimen length  $L$  of each control cylinder are shown in figure 4. The symbols in the figure represent the failure strain  $\delta/L$  of each specimen and horizontal bars represent average failure strains of specimens of each type. Individual data points are shown to demonstrate the scatter in failure strains within each group. A small difference in average failure strains between the filament wound specimens with and without cross-overs can be seen from the data; however, scatter in the data indicates that this difference may be an artifact of the limited number of specimens tested. The scatter range for the tape specimens also suggests that there is no real evidence of a difference in failure strain among the three type of specimens.

The results of this experimental comparison of filament wound control (unimpacted) cylinders loaded to failure in axial compression indicates that one fiber cross-over location has no effect on the failure mode or strain in thick-walled filament wound graphite-epoxy specimens with stacking sequence  $[\pm 45/90]_{3s}$ . A comparison between filament wound and hand laid-up tape control cylinders indicates that there is little or no difference in the response of cylinders constructed by using the two different fabrication methods. However, unimpacted panels with many fiber cross-overs fail at up to 15 percent lower strains than panels with no fiber cross-overs.

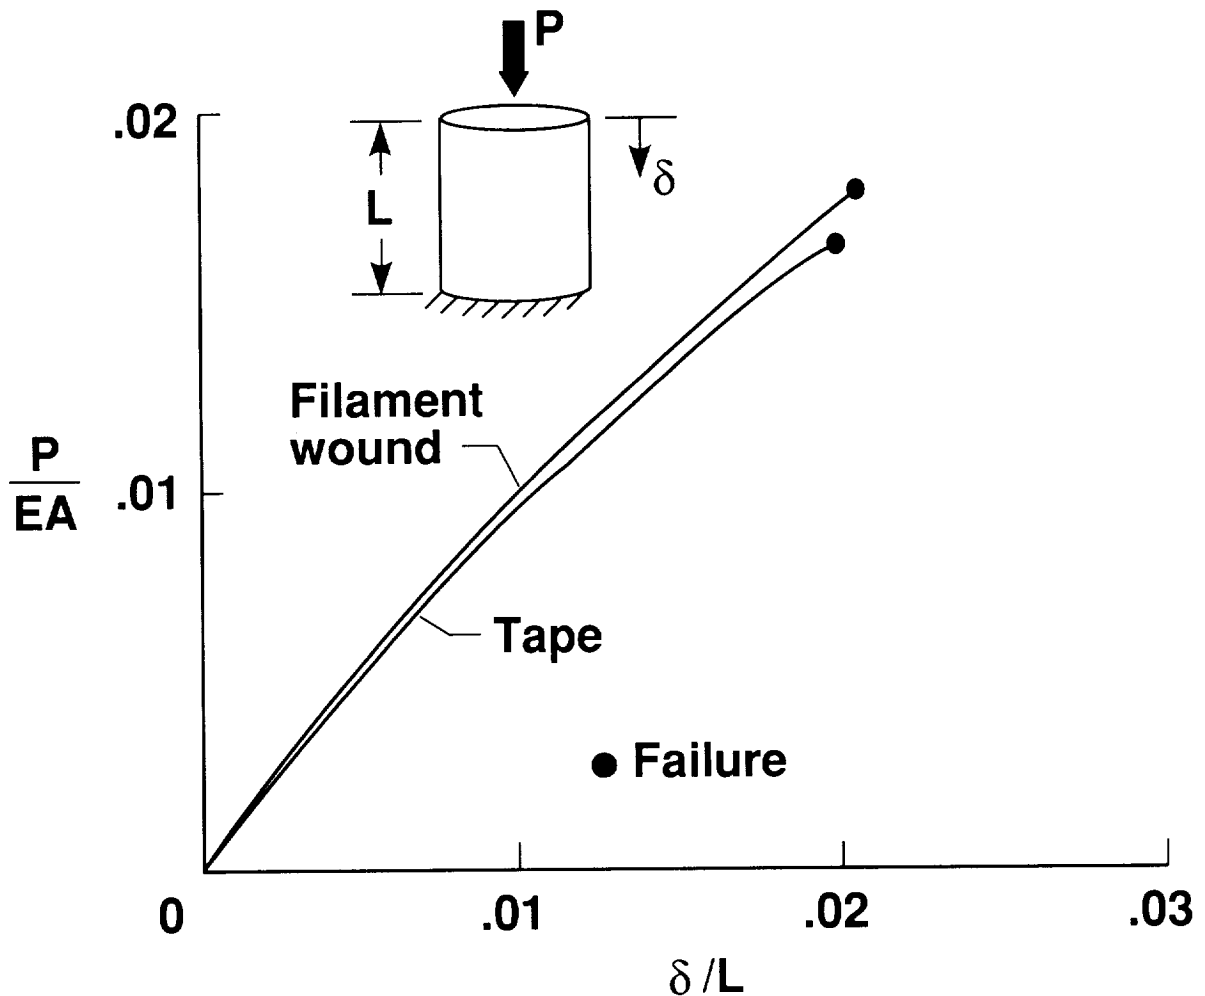
Figure 5

The relationship between normalized load  $P/EA$  (where  $P$  is applied load,  $E$  is specimen axial stiffness and  $A$  is specimen cross-sectional area) and normalized displacement  $\delta/L$  (where  $\delta$  is end shortening and  $L$  is initial specimen length) for two typical control cylinders is shown in figure 5. The axial stiffness calculated from experimental data in the linear-elastic range indicate that the filament wound cylinder's average stiffness is about 5 percent below that of the tape specimens. When cross-sectional area is considered, this difference reverses. The average  $EA$  for the filament wound cylinders is 420,000 lb while the average  $EA$  for the tape cylinders is 380,000 lb. In both types of cylinders, the scatter of values for  $EA$  among the cylinders tested is about 8 percent while the scatter for  $E$  is about 20 percent. However, the load-displacement relationship is nonlinear in both types of cylinders and the stiffness decreases when the average strain is above about .01 in both types of specimens.

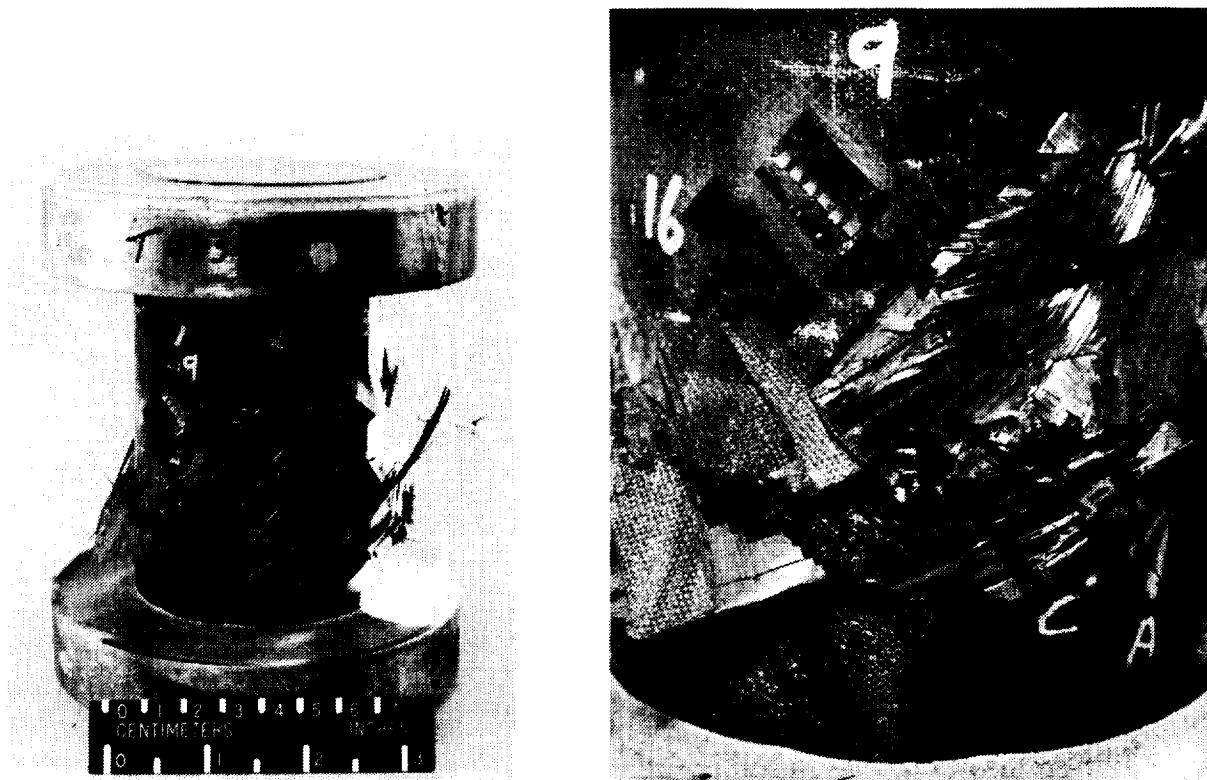
Figure 6

Photographs of a graphite-epoxy tape cylinder after failure are shown in figure 6. The entire specimen is shown to demonstrate the extent of damage induced at failure. The damage region extends around the entire circumference and over one third or more of the length of the test section and is concentrated around the axial centerline. The failure mode involved delamination of the innermost and outermost plies. Delaminated fibers broke, leading to specimen failure. Little visible or audible warning occurred prior to failure. Failure quickly progressed around the circumference of the tube. Measured axial surface strains were just over .02 at failure for each specimen. Strain gages in the direction of the outermost fibers (45 degrees) recorded a failure strain in the range of .007 to .008. A close-up view of one section of the cylinder is also shown on the right of the figure to show that the exterior layers of fibers pulled away from the cylinder during failure. The outer two plies are of stacking sequence +45 and -45 degrees. Both of these plies separated from the interior plies of the cylinder. The same failure mode was seen in the filament wound cylinders as in the tape cylinders.

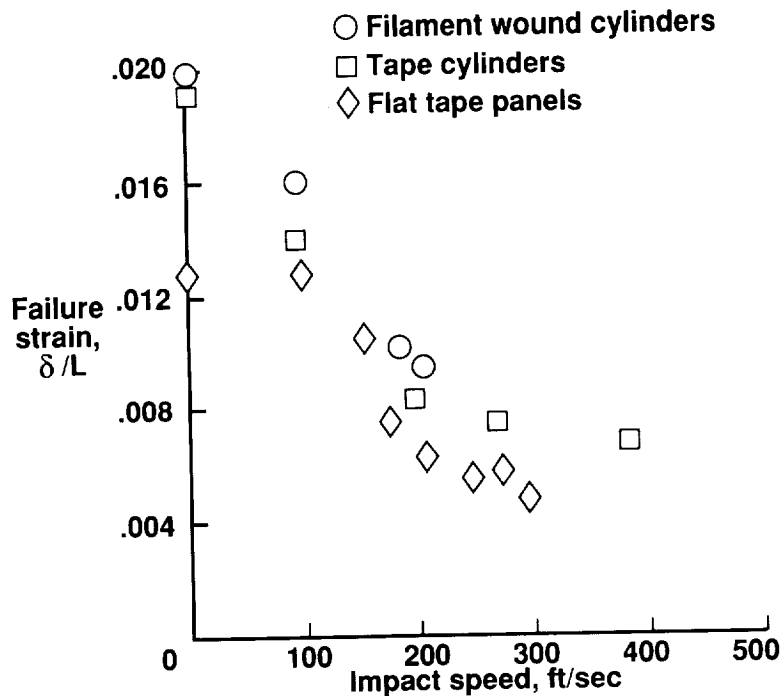
Figure 7

Impact damage was induced into many specimens by propelling a .5-inch-diameter aluminum sphere at the center of the specimen at a specified speed (as described in reference 1). Three filament wound and four hand laid-up tape cylinders with stacking sequence  $[\pm 45/90]_{3s}$  were impacted prior to loading with impact speeds up to 400 ft/sec (impact energies up to 16 ft-lb). All cylinders were impacted at mid-length. Seven hand laid-up tape flat panels with stacking sequence  $[\pm 45/90]_{4s}$  were impacted at the center of the panel prior to loading. All specimens had a nominal thickness of .14 inches. The failure strain of each impacted specimen and the average failure strain of all control specimens of each type are shown in figure 7. These results indicate that impact damage reduces the failure strain to approximately 60 percent of the average failure strain of unimpacted specimens for impact speeds over 200 ft/sec (impact energy 4 ft-lb) for filament wound and tape cylinders. Failure modes for impacted cylinders were the same as for unimpacted cylinders. All cylinders failed at the mid-length of the specimen (through the impact site). Flat panels impacted at speeds above 200 ft/sec did not buckle prior to failure and failed through the impact site. Flat panels failed at lower axial strains than the cylinders for each impact speed. However, this difference is most pronounced in the control specimens where the flat panel buckled and the cylinders did not. The percentage reduction in failure strain in flat panels is smaller because the flat control specimen failed at a lower strain than the cylindrical control specimens. The minimum failure strain of each type of specimen is achieved for impact speeds above 200 ft/sec. This minimum threshold is lower for the flat panels than for the cylinders because of curvature effects.

A comparison of specimens subjected to low speed impact damage prior to compressive loading indicates that impact damage reduces the strain at failure by over 60 percent in tape and filament wound graphite-epoxy cylinders and in tape flat panels. The presence of fiber cross-overs were observed to reduce the strength of filament wound impact-damaged panels, but to have no significant effect on the strength of filament wound impact-damaged cylinders.

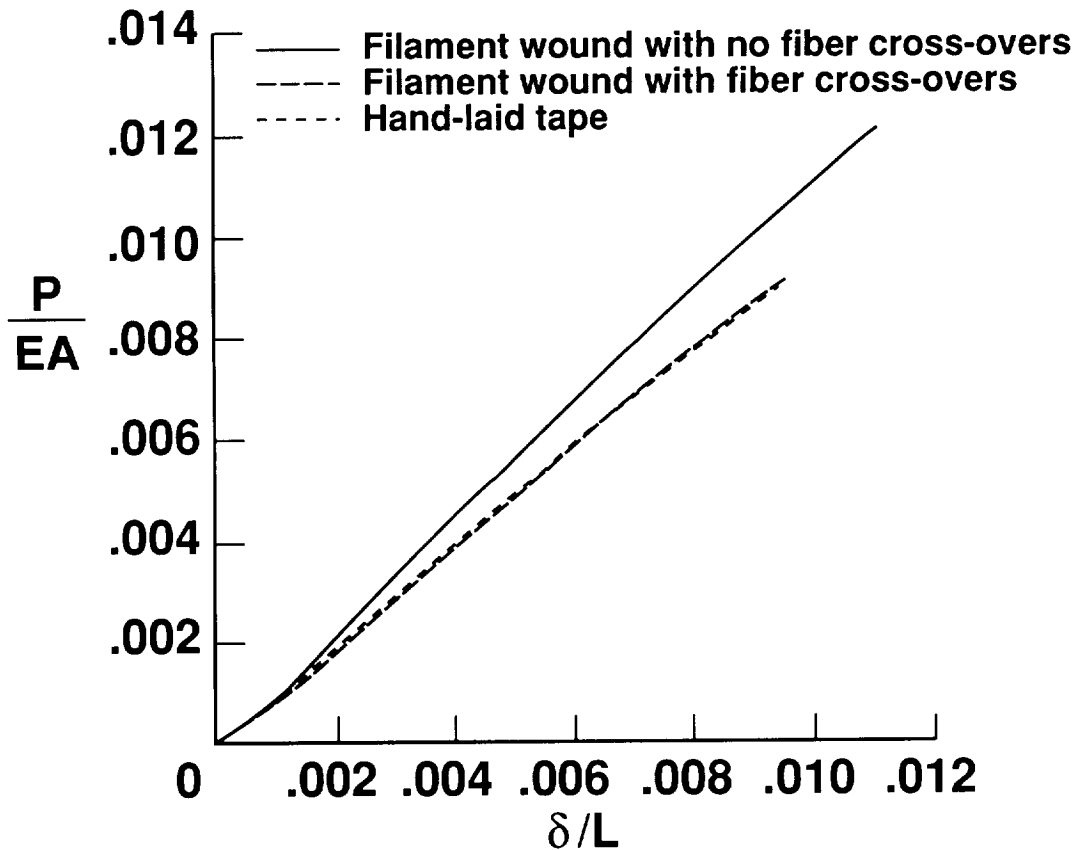
Figure 8

The relationship between normalized load  $P/EA$  and normalized end shortening  $\delta/L$  for three control plate specimens with stacking sequence  $[\pm 30/90]_n$  is shown in figure 8. Two of the control specimens are filament wound plates. One filament wound plate contains fiber cross-overs and the second plate does not. The third control specimen is a hand-laid tape plate (with no fiber cross-overs). The filament-wound plates were fabricated from Celion 6k fiber and Shell Epon 9400 resin and the tape-laid plate was fabricated from AS4/3502 prepreg tape.

The test results indicate a similar load-displacement behavior between the filament-wound plate with fiber cross-overs and the tape-laid plate; however, since these plates were fabricated from different materials, the similarity may not be caused by factors relating to plate construction. A stiffness comparison of nominally identical plates constructed of the two material systems indicate that the AS4-3502 plate has a noticeably higher bending stiffness than the Celion 6k-9400 plate. However, the load-displacement response differs in the two filament-wound plates. For example, at an end shortening of .0095 in/in, a 20 percent difference is obtained in normalized load between both filament-wound plates. This comparison suggests that fiber cross-overs may affect the load-displacement response in filament-wound plates.

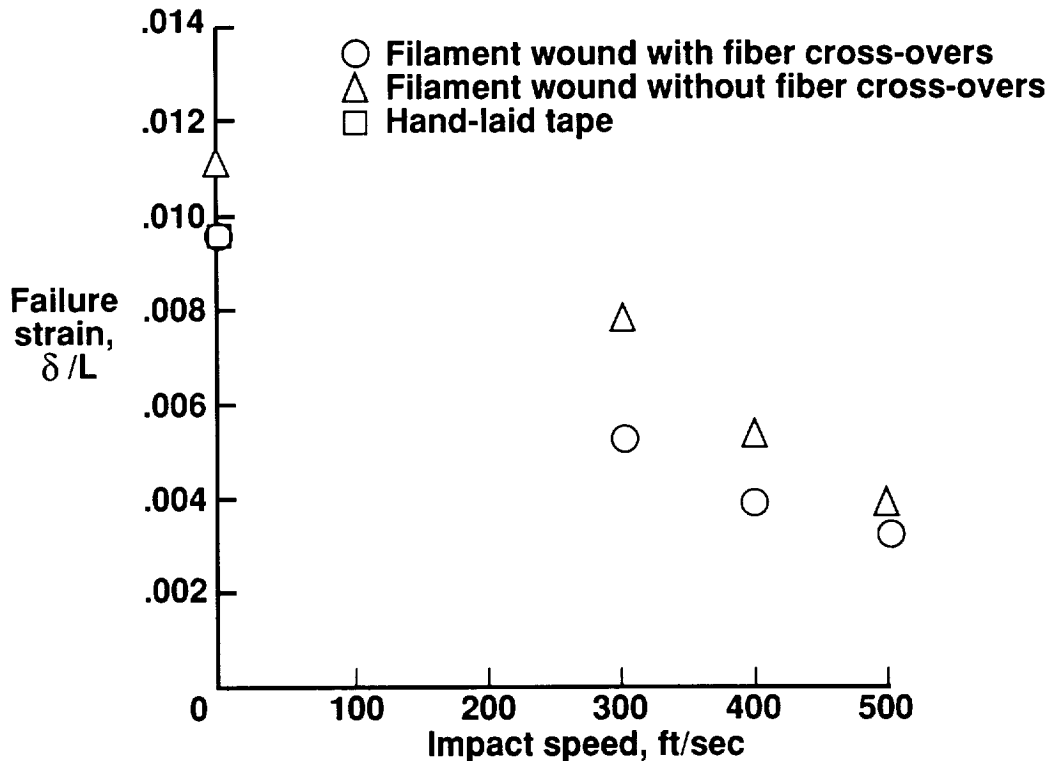
Figure 9

The relationship between failure strain and impact speed for eight filament-wound plate specimens with stacking sequence  $[\pm 30/90]_{10}$  and one hand laid-up tape plate specimen with stacking sequence  $[\pm 30/90]_{16}$  is shown in figure 9. Six plate specimens were impacted at the center of each specimen with a .5-inch-diameter aluminum sphere at speeds ranging from 300 to 500 ft/sec. Three of the impacted specimens contained fiber cross-overs and three did not. The failure strain for three control (unimpacted) specimens is also shown.

The results of these compression-after-impact tests indicate that for all impact speeds examined, the plate specimens without fiber cross-overs failed at higher strains than specimens with fiber cross-overs. This comparison suggests that fiber cross-overs can affect the performance of filament-wound plates. The percentage difference in failure strain for the two types of specimens diminishes as the impact speed increases. At an impact speed of 300 ft/sec, a 30 percent reduction in failure strain is obtained for specimens with fiber cross-overs compared to specimens which have no fiber cross-overs. However, at an impact speed of 500 ft/sec, the difference in failure strain between specimens with and without fiber cross-overs is only 12 percent.

The results also show that failure strain decreases as impact speed increases for specimens with fiber cross-overs and for specimens without fiber cross-overs. Specimens impacted with an impact of speed 500 ft/sec failed at a strain level less than half that of the control specimen for each type of specimen.
