NASA Contractor Report 189095

Inelastic Deformation of Metal Matrix Composites

Part I—Plasticity and Damage Mechanisms

B.S. Majumdar and G.M. Newaz
Battelle Memorial Institute
Columbus, Ohio

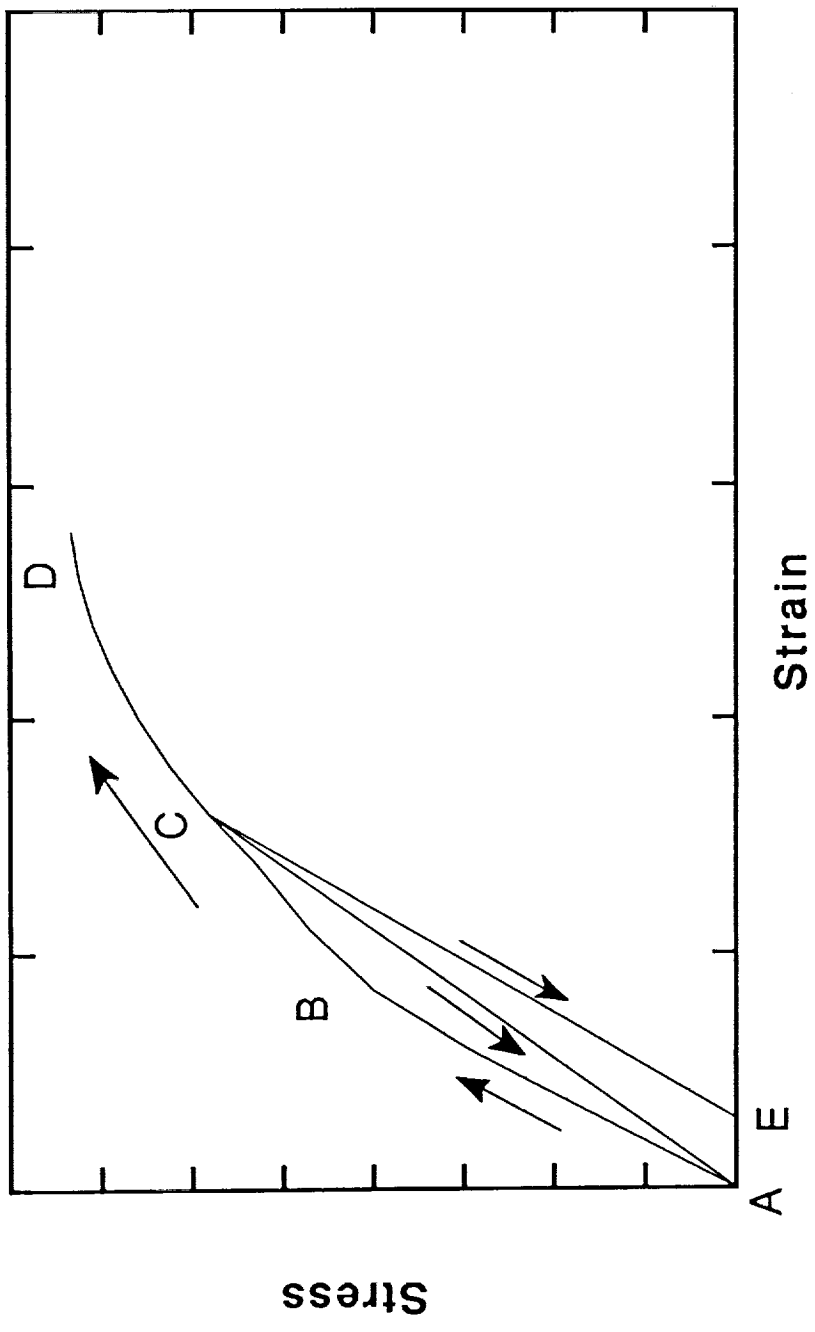
Figure 1. Schematic Illustrating Compliance Changes Associated with Plasticity and Damage

- Figure 1. Schematic illustrating compliance changes associated with plasticity and damage.
- Figure 2. Schematic illustrating effects of plasticity and damage on the Poisson's ratio.

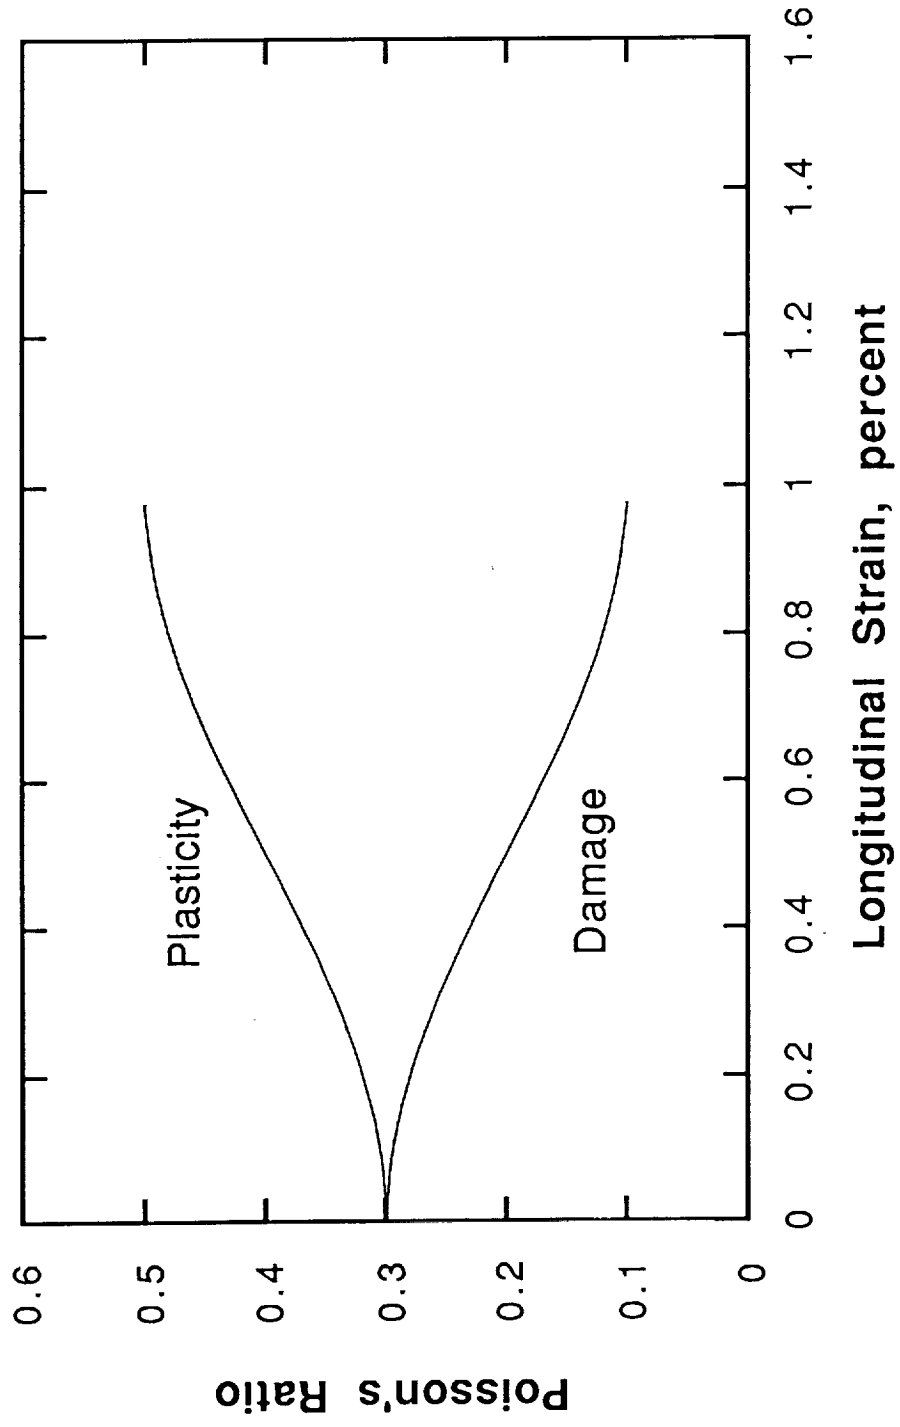
Figure 2. Schematic Illustrating Effects of Plasticity and Damage on the Poisson's Ratio

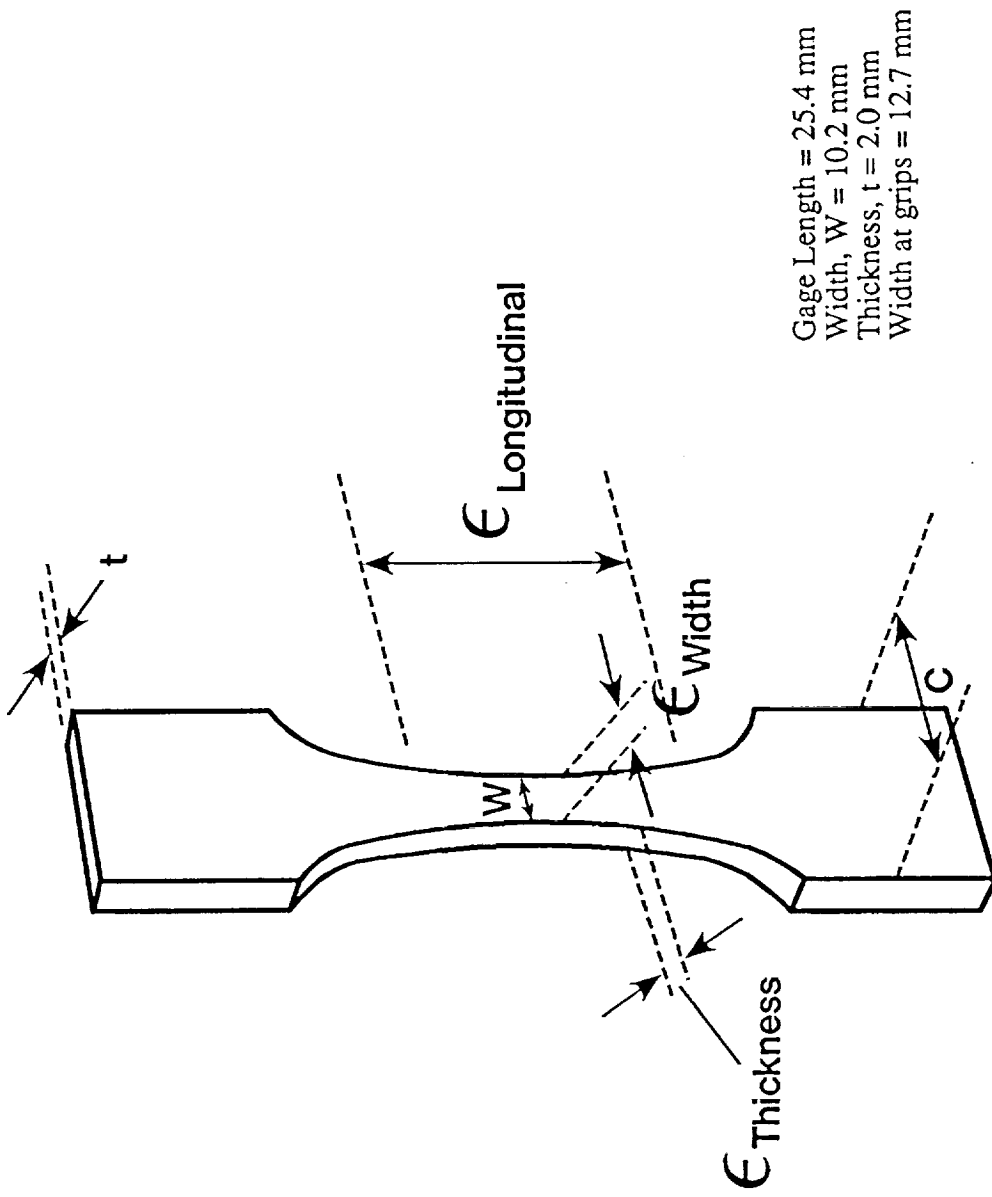
Figure 3. Schematic showing definitions of the longitudinal, width, and thickness strains.

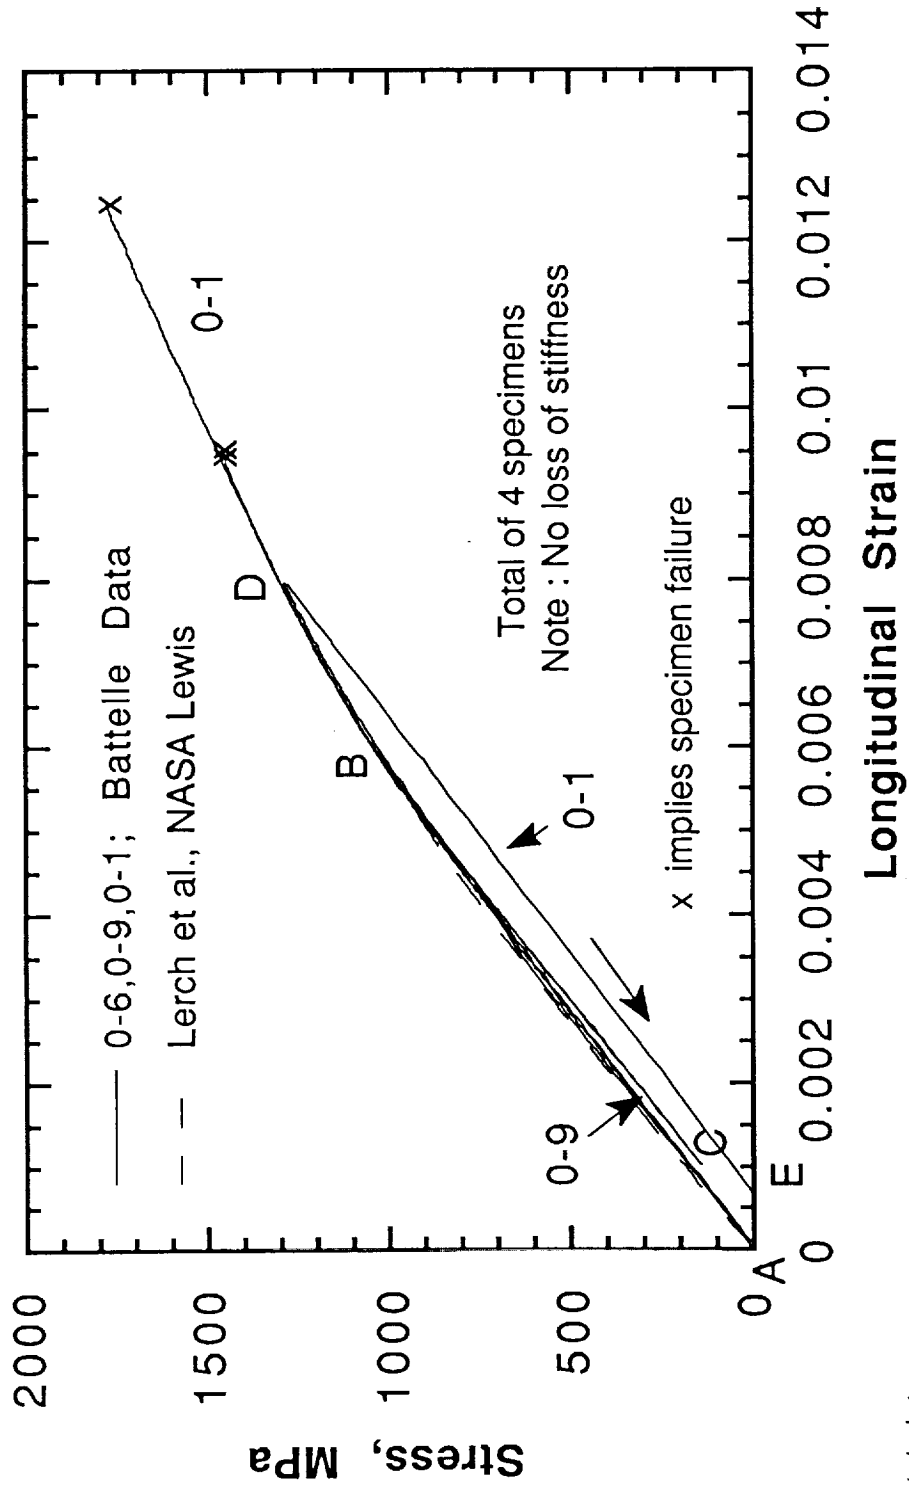
Figure 4. Stress Versus Longitudinal Strain for 0-Degree TI 15-3/SCS6 Composites

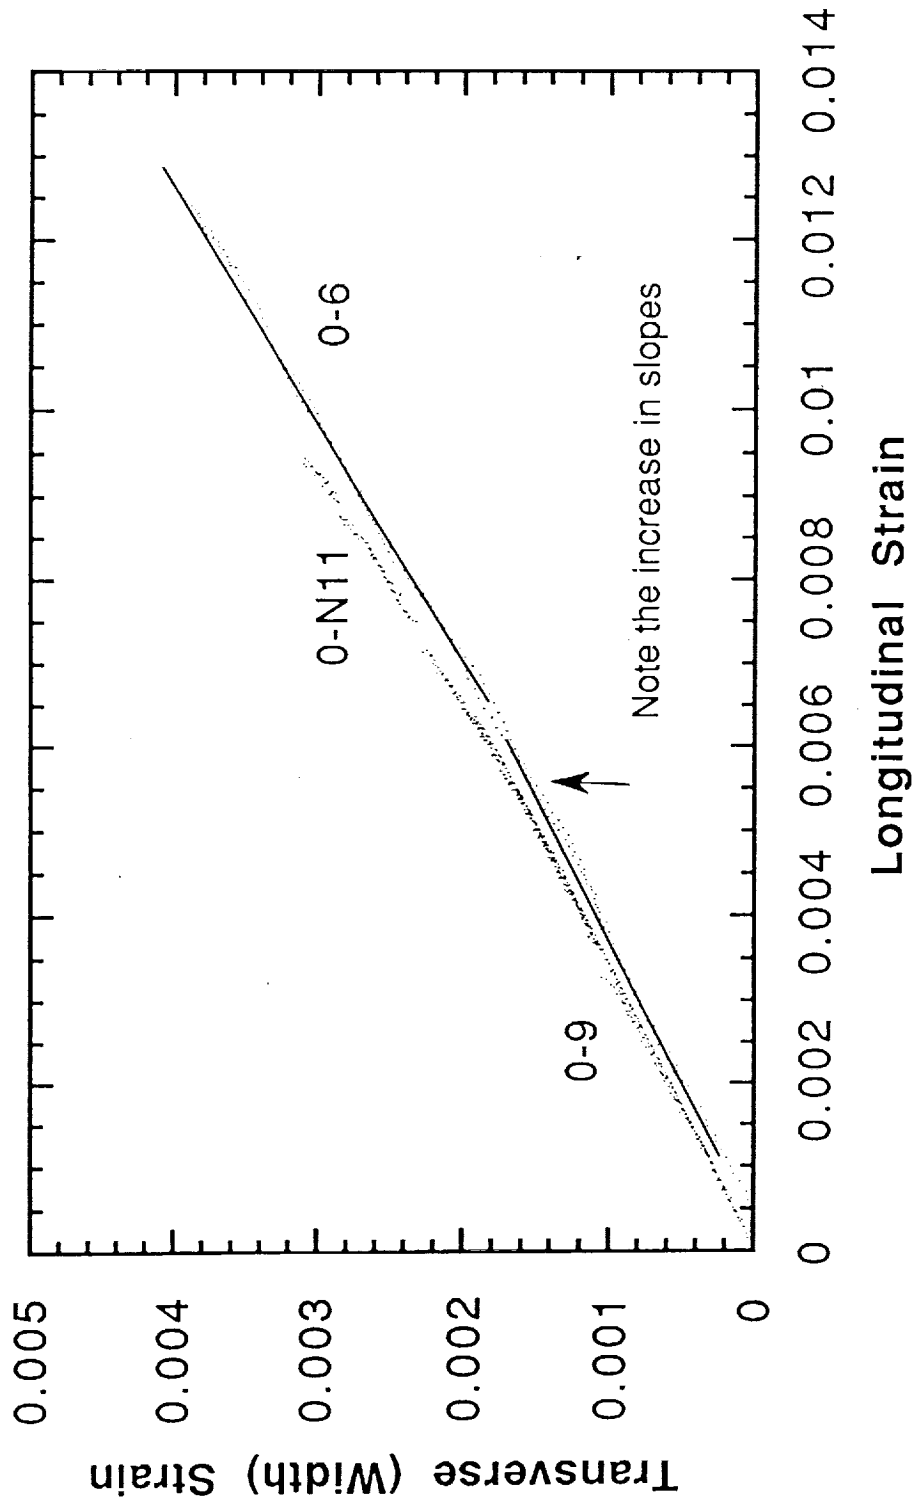
Figure 5. Width Strain Plotted Versus the Longitudinal Strain for the 0-Degree Ti 15-3/SCS6 Composite

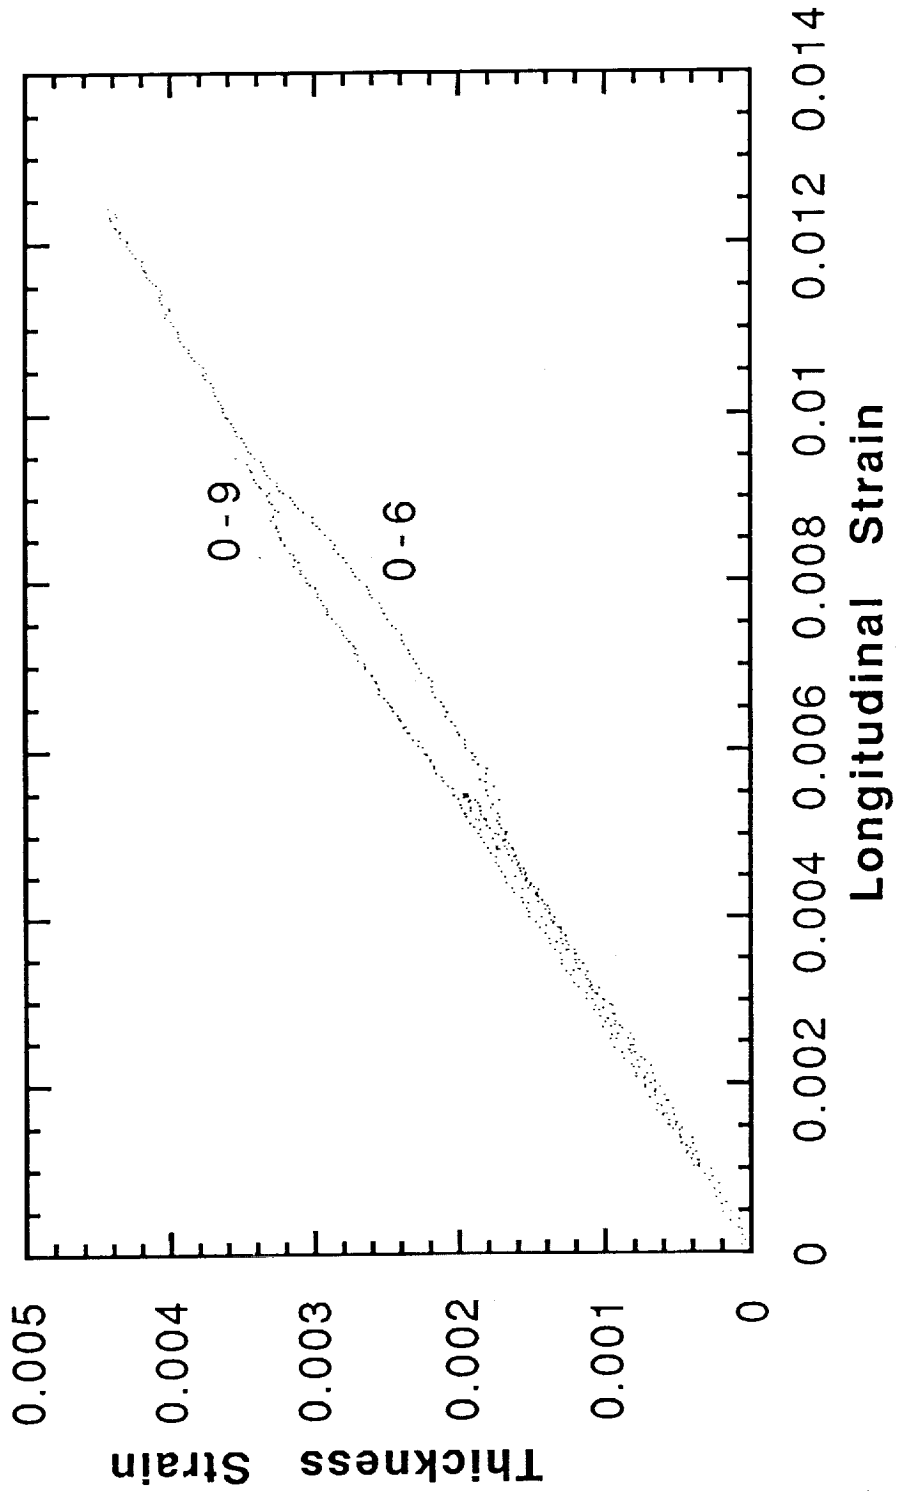
Figure 6. Thickness Strain Plotted Versus the Longitudinal Strain for the 0-Degree TI 15-3/SCS6 Composite

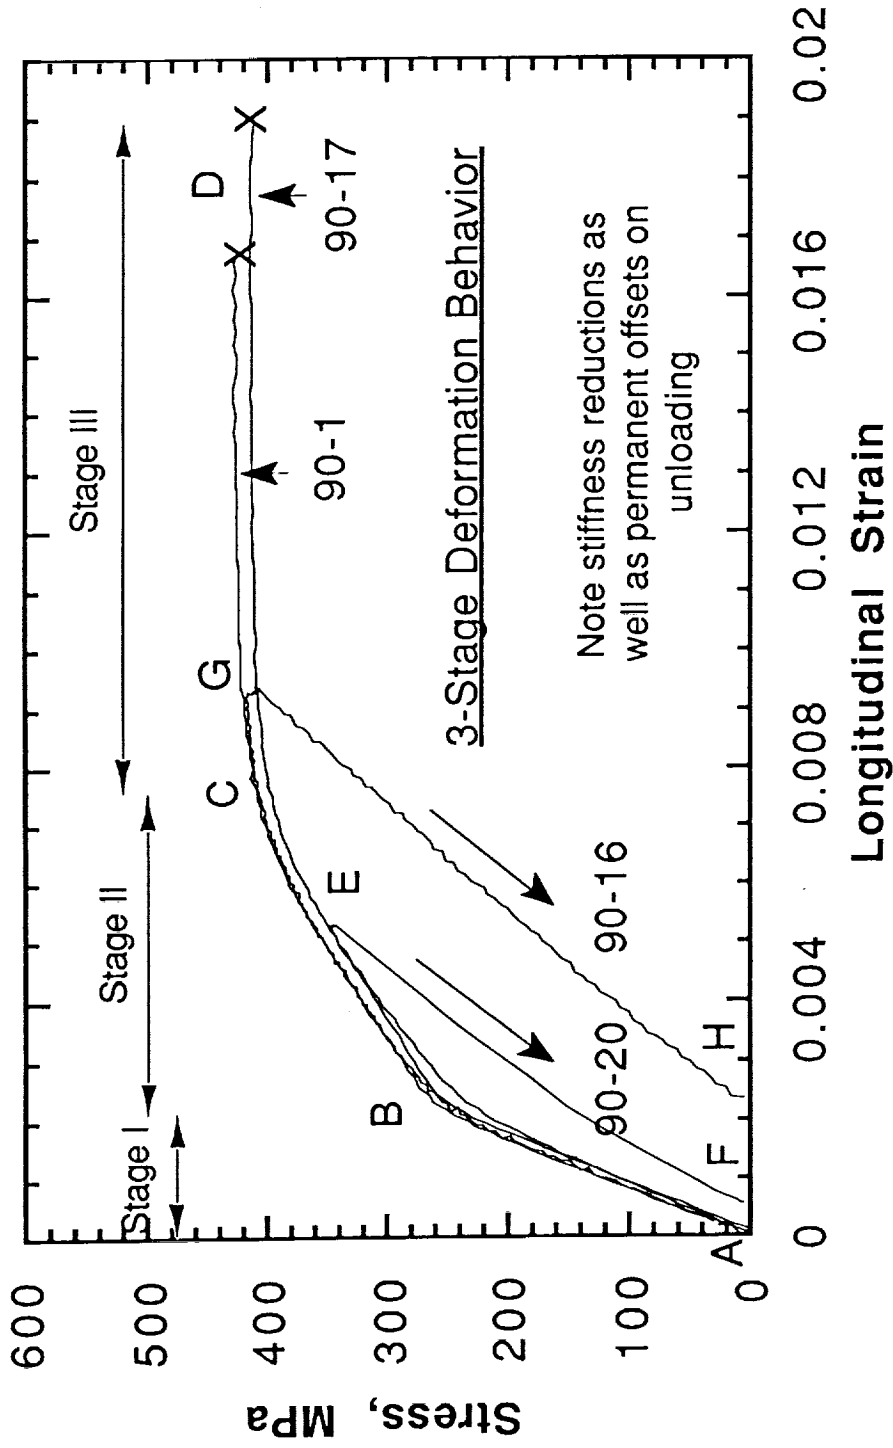
Figure 7. Stress Versus the Longitudinal Strain for 90-Degree Ti 15-3/SCS6 Specimens

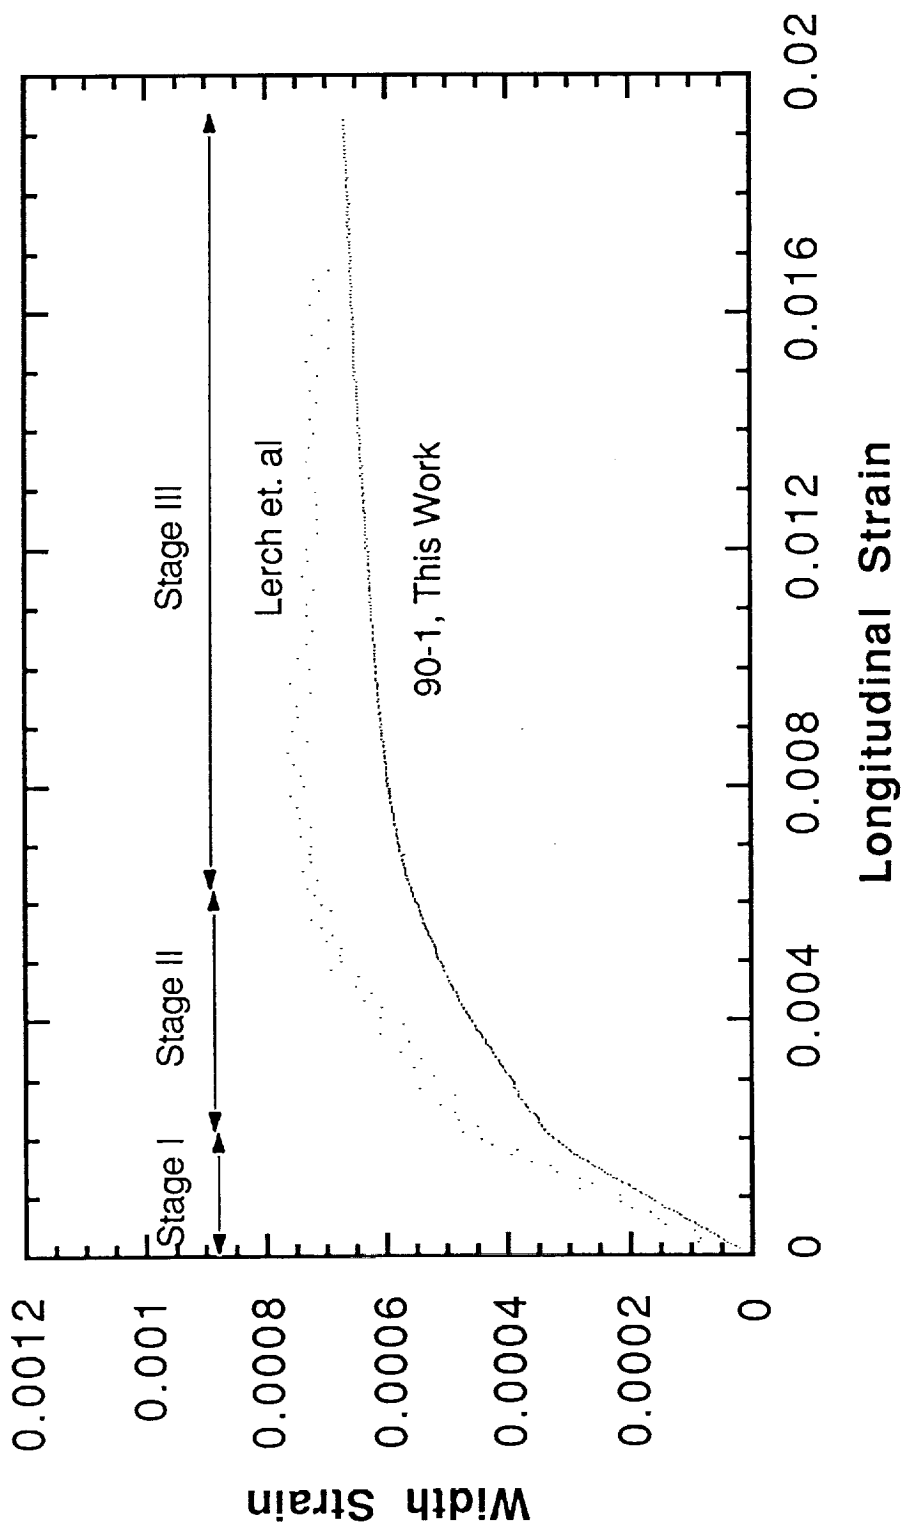
Figure 8. Width Strain Plotted Versus the Longitudinal Strain for the 90-Degree Ti 15-3/SCS6 Composite

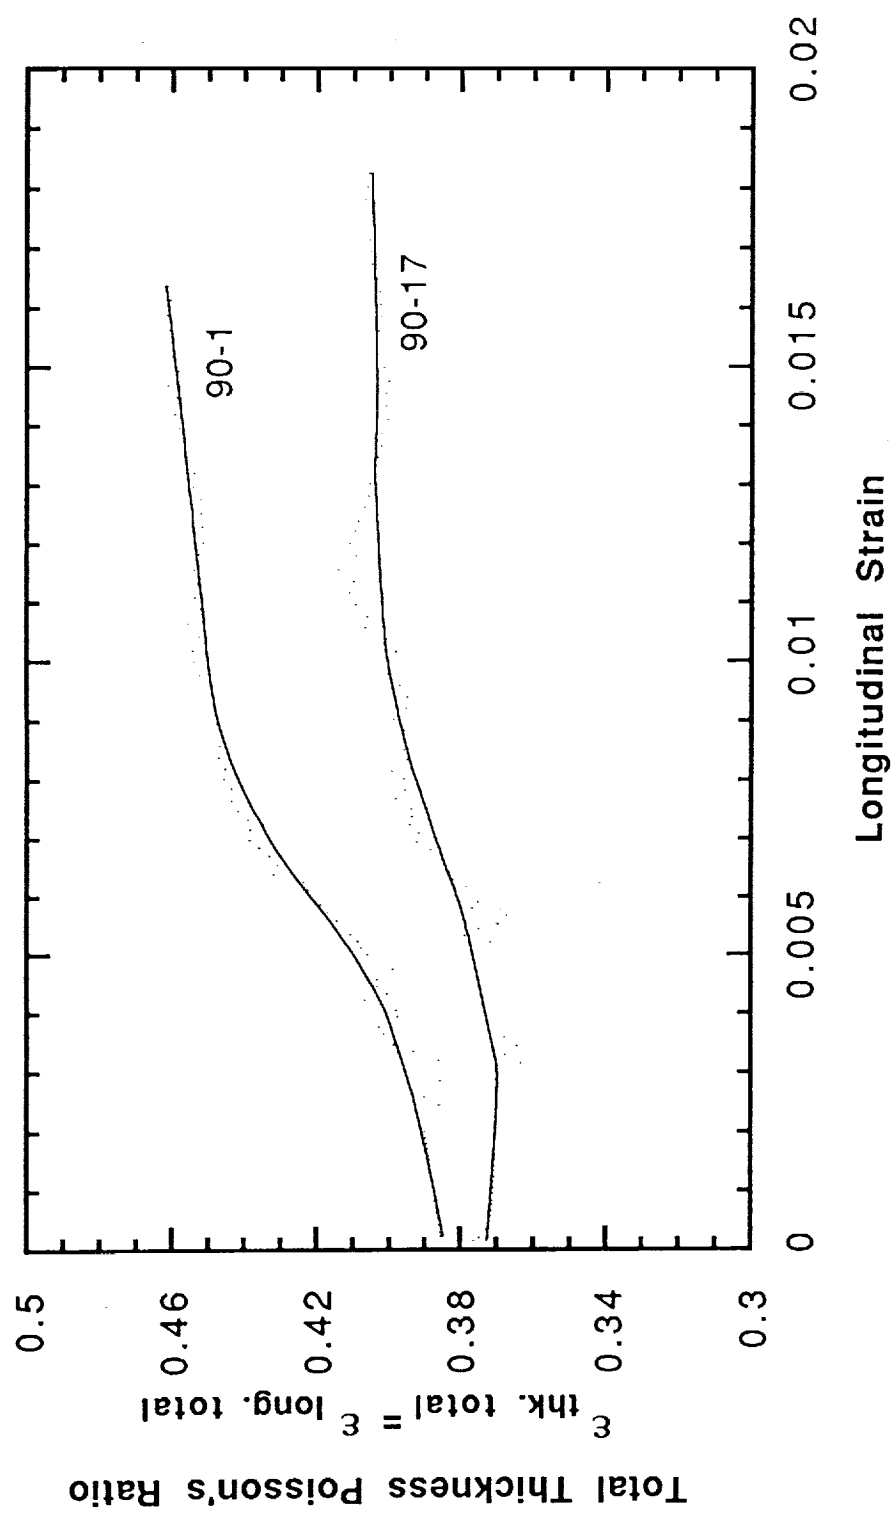
Figure 9. Total Thickness Poisson's Ratio Plotted Versus the Longitudinal Strain for the 90-Degree Ti 15-3/SCS6 Composite

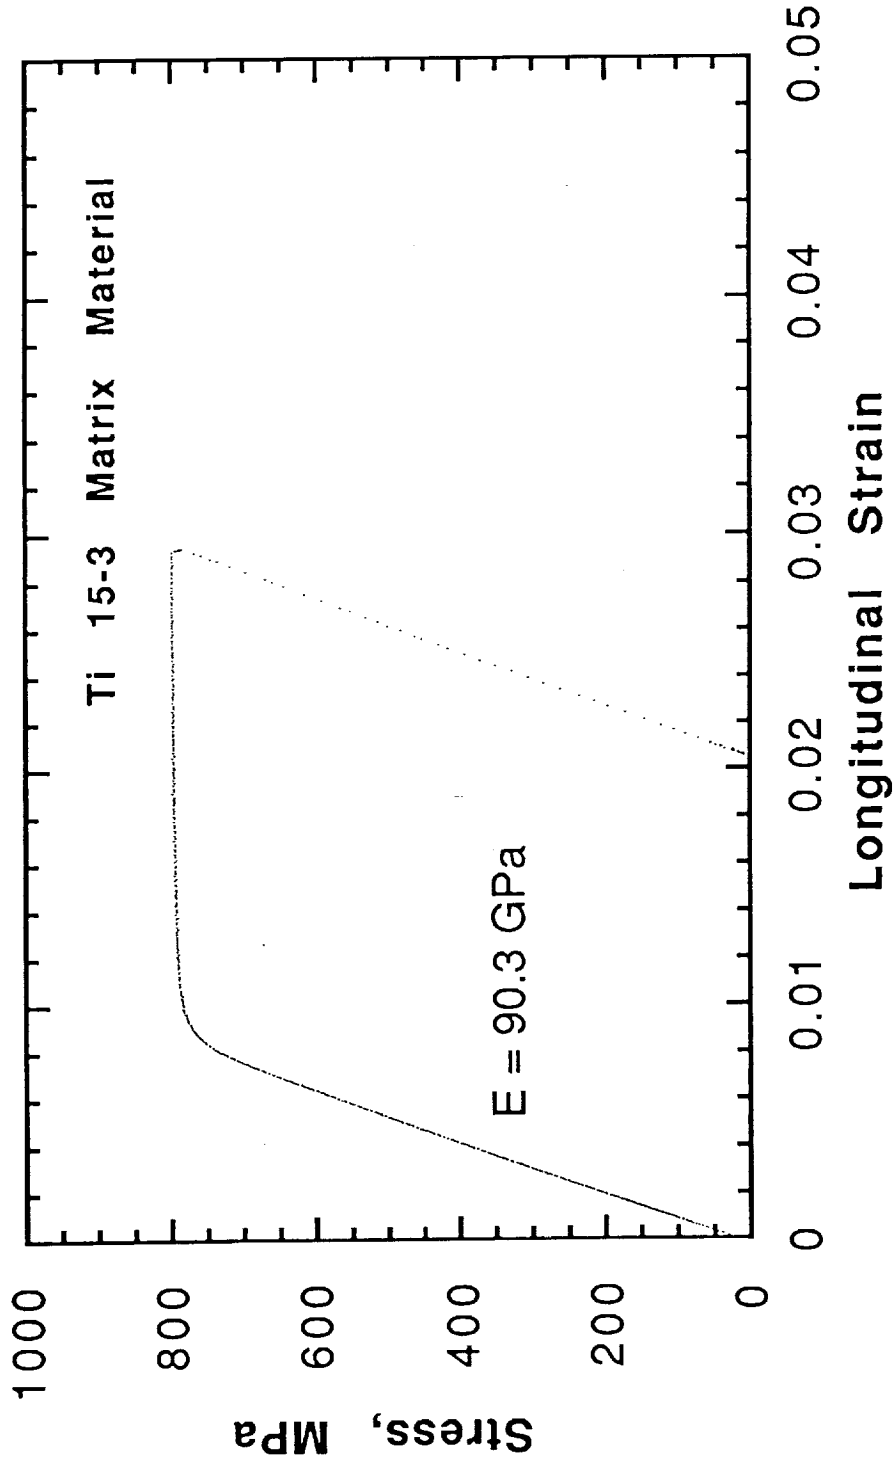
Figure 10. Stress Versus Longitudinal Strain for the Ti 15-3 Matrix Material Obtained by Foil Consolidation

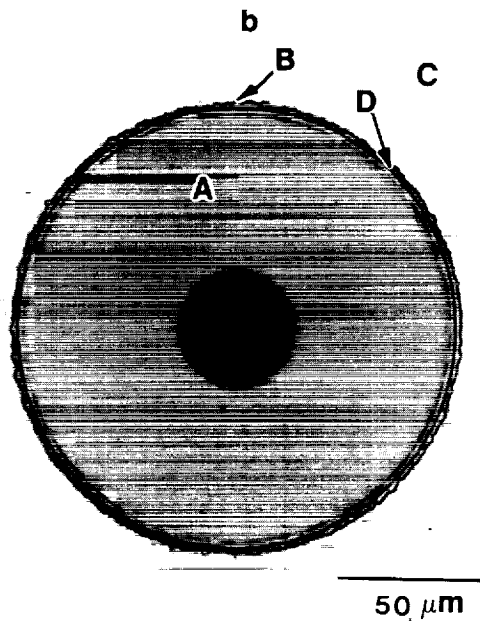
Figure 11. (a) Longitudinal, and, (b) transverse cross sections of the as-received Ti 15-3/SCS6 composite; as-polished sample. A, B, and C correspond to the fiber, reaction-zone, and matrix, respectively.

- Figure 11. (a) Longitudinal, and, (b) transverse cross sections of the as-received Ti 15-3/SCS6 composite; as-polished sample. A, B, and C correspond to the fiber, reaction-zone, and matrix, respectively.

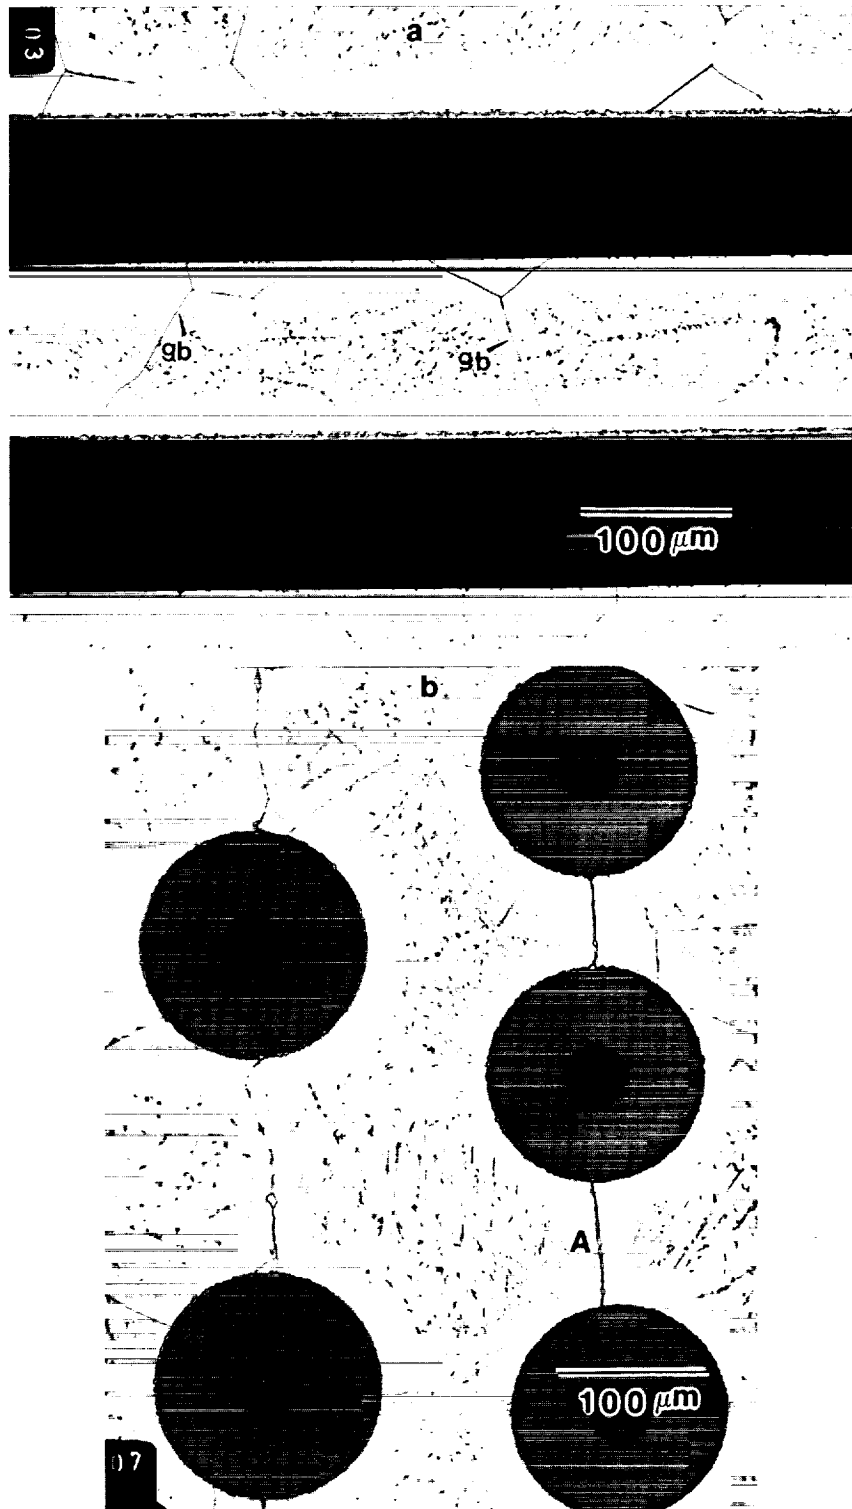
Figure 12. (a) Longitudinal, and, (b) transverse cross sections of the as-received Ti 15-3/SCS6 composite; polished and etched sample. The arrow shows a grain-boundary.

- Figure 12. (a) Longitudinal, and, (b) transverse cross sections of the as-received Ti 15-3/SCS6 composite; polished and etched sample. The arrow (gb) shows a grain-boundary.

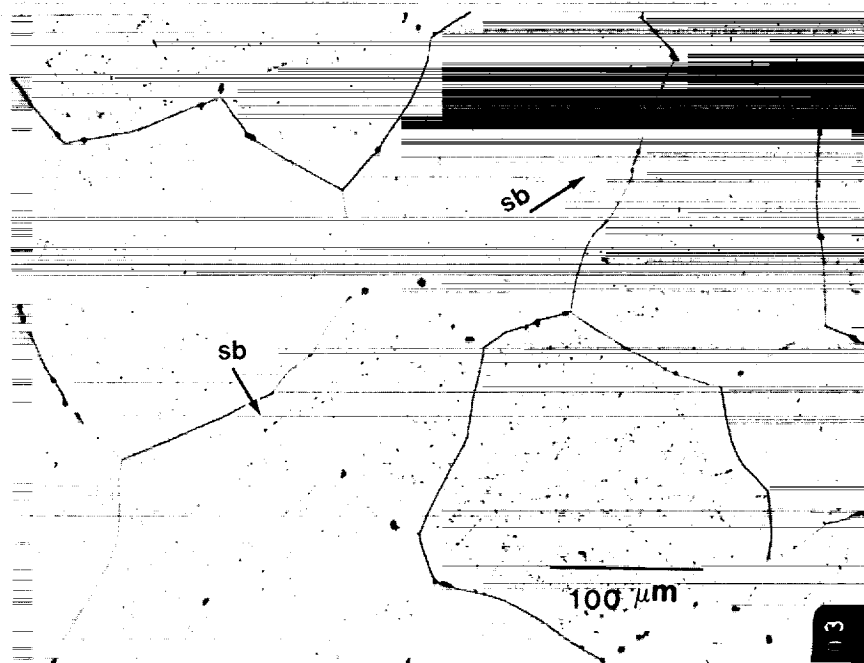
Figure 13. Etched microstructure of the surface of a 0-degree Ti 15-3/SCS6 composite, unloaded from a total strain of 0.9 percent. The slip bands (indicated by arrows) may be seen emanating from grain boundaries.

- Figure 13. Etched microstructure of the surface of a 0-degree Ti 15-3/SCS6 composite, unloaded from a total strain of 0.9 percent. The slip bands (sb), indicated by arrows, may be seen emanating from grain boundaries. Loading axis is vertical.

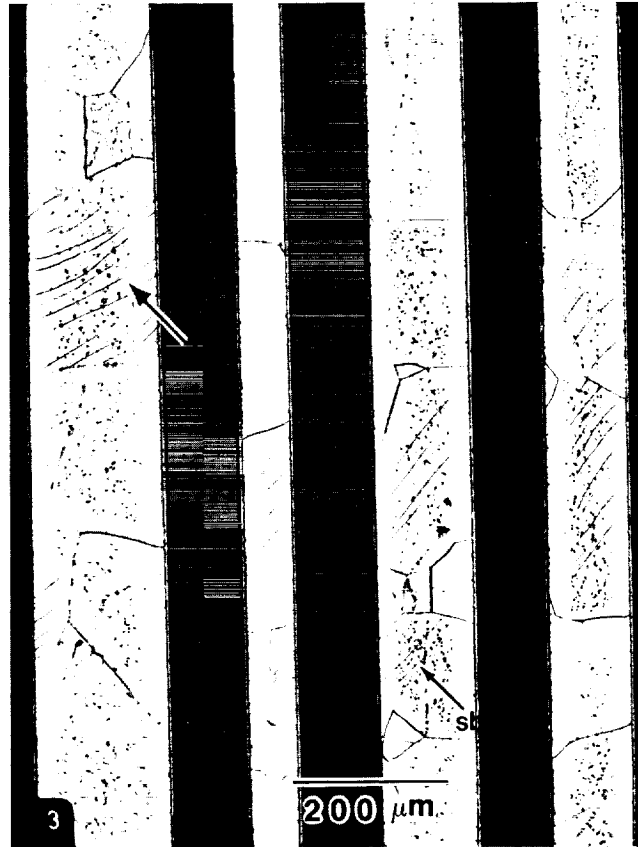
Figure 14. Etched microstructures of a 0-degree Ti 15-3/SCS6 composite, unloaded from a total strain of 0.9 percent. The specimen has been polished down to the first set of fibers. Large slip band activity confirms plasticity in the MMC.

- Figure 14. Etched microstructures of a 0-degree Ti 15-3/SCS6 composite, unloaded from a total strain of 0.9 percent. The specimen has been polished down to the first set of fibers. Large slip band (sb) activity confirms plasticity in the MMC. Loading axis is along fiber direction.

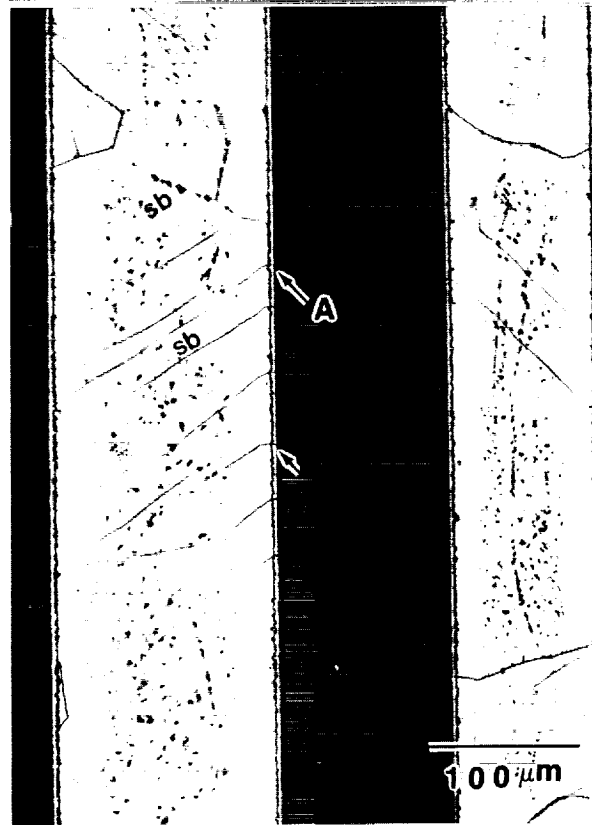
Figure 15. (a) Higher magnification optical micrograph, corresponding to Figure 14, showing slip bands associated with reaction-zone cracks; (b) SEM micrograph of another region, showing slip bands emanating from the reaction-zone/matrix interface.

- Figure 15. (a) Higher magnification optical micrograph, corresponding to Figure 14, showing slip bands (sb) associated with reaction-zone cracks; (b) SEM micrograph of another region, showing slip bands (sb) emanating from the reaction-zone/matrix interface.

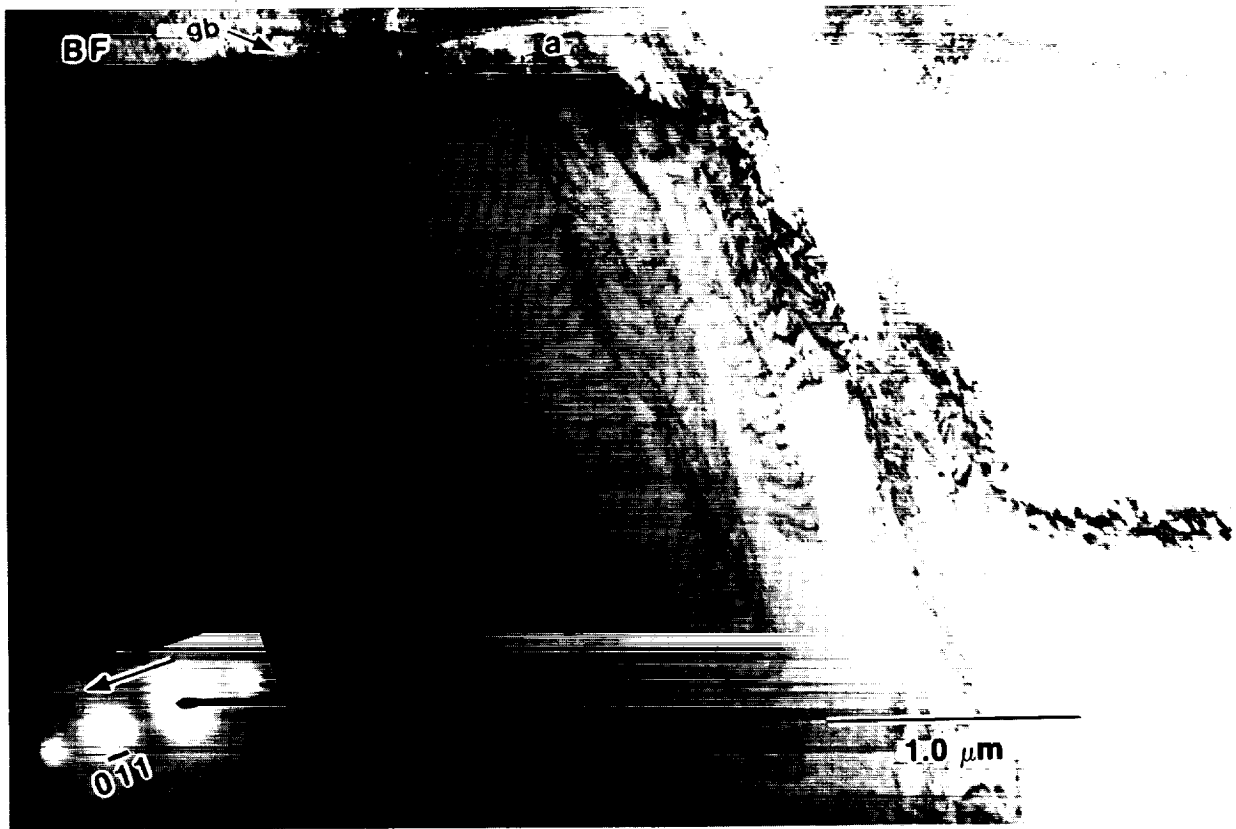
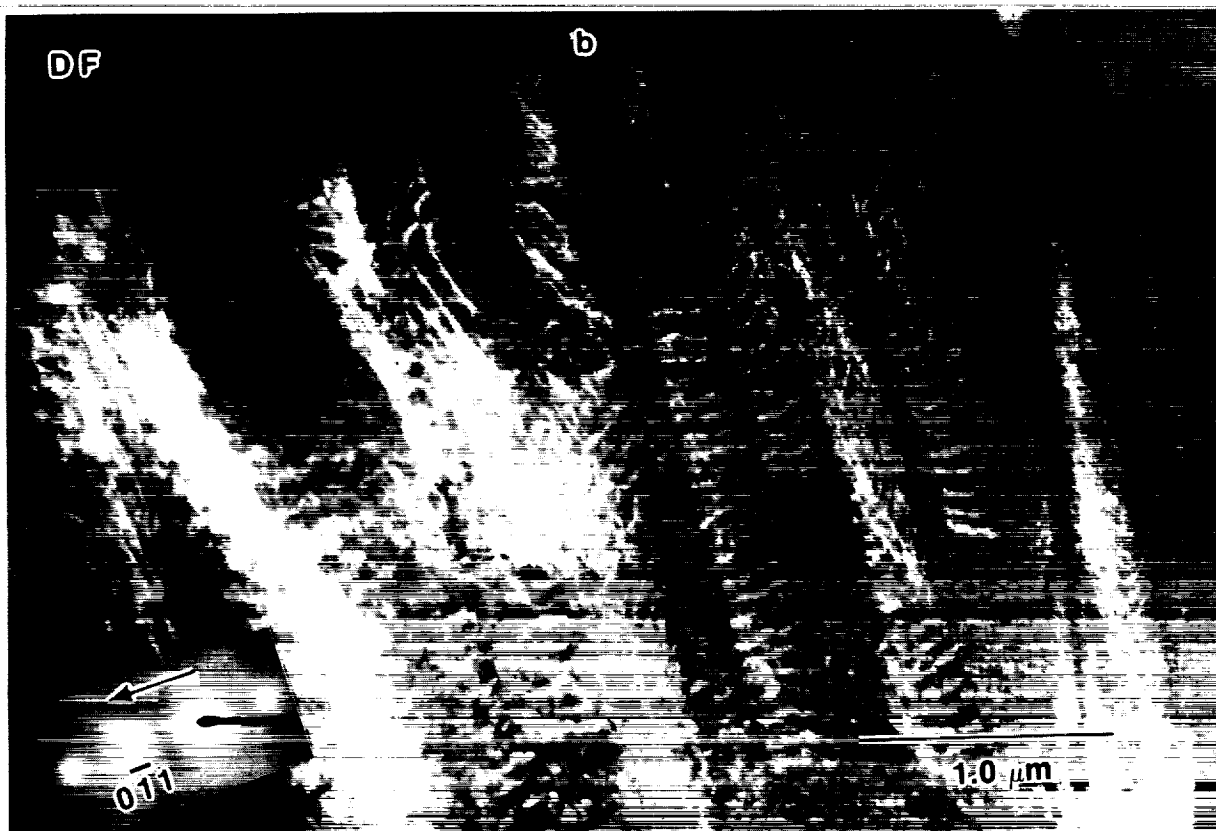
Figure 19. TEM micrographs of the deformed 0-Degree Ti 15-3/SCS6 composite. Images taken around the [011] zone axis. (a) Bright field, and (b) Dark field.

Figure 19. TEM micrographs of the deformed 0-degree Ti 15-3/SCS6 composite. Images taken around the [011] zone axis. (a) Bright field, and (b) Dark field.

- Figure 19. TEM micrographs of the deformed 0-Degree Ti 15-3/SCS6 composite. Images taken around the [011] zone axis. (a) Bright field, and (b) Dark field.

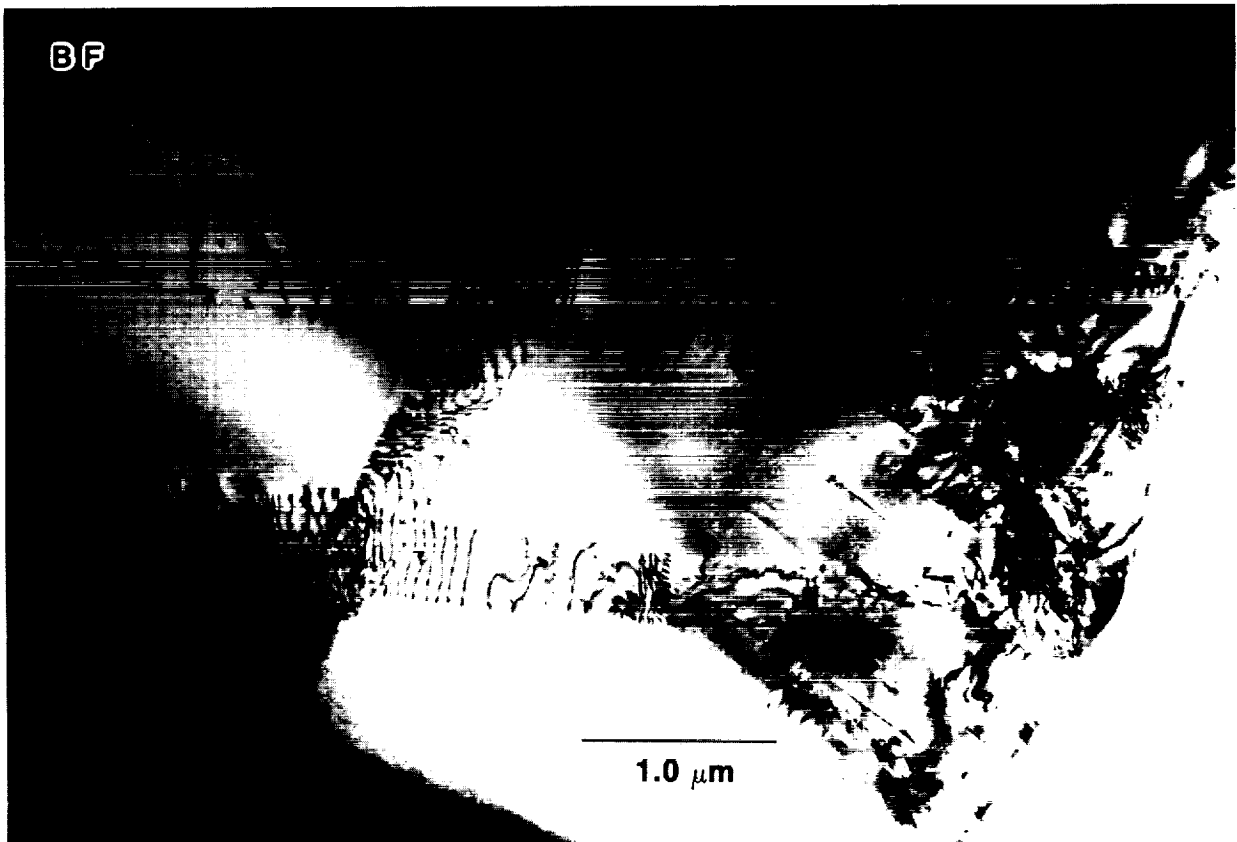
Figure 20. TEM micrographs of the deformed 0-Degree Ti 15-3/SCS6 composite, showing intersecting slip bands.

- Figure 20. TEM micrographs of the deformed 0-Degree Ti 15-3/SCS6 composite, showing intersecting slip bands.
- Figure 21. Series of four selected area diffraction patterns (SADP) showing streaking associated with the extremely fine ω -phase (hcp) in the β (bcc) matrix. (a) $\mathbf{B} - (110)_{\beta}$, (b) $\mathbf{B} - (111)_{\beta}$, (c) $\mathbf{B} - (120)_{\beta}$ and (d) $\mathbf{B} - (331)_{\beta}$. The directions of the streaks in each SADP were determined to be in agreement with the ω -phase being distributed in rows along the $\langle 111 \rangle_{\beta} \parallel \langle 0001 \rangle_{\omega}$ direction. The points a, b, and c in (c) correspond to $(\bar{1}011)$, $(\bar{2}020)$ and (0001) reflections of the ω -phase.

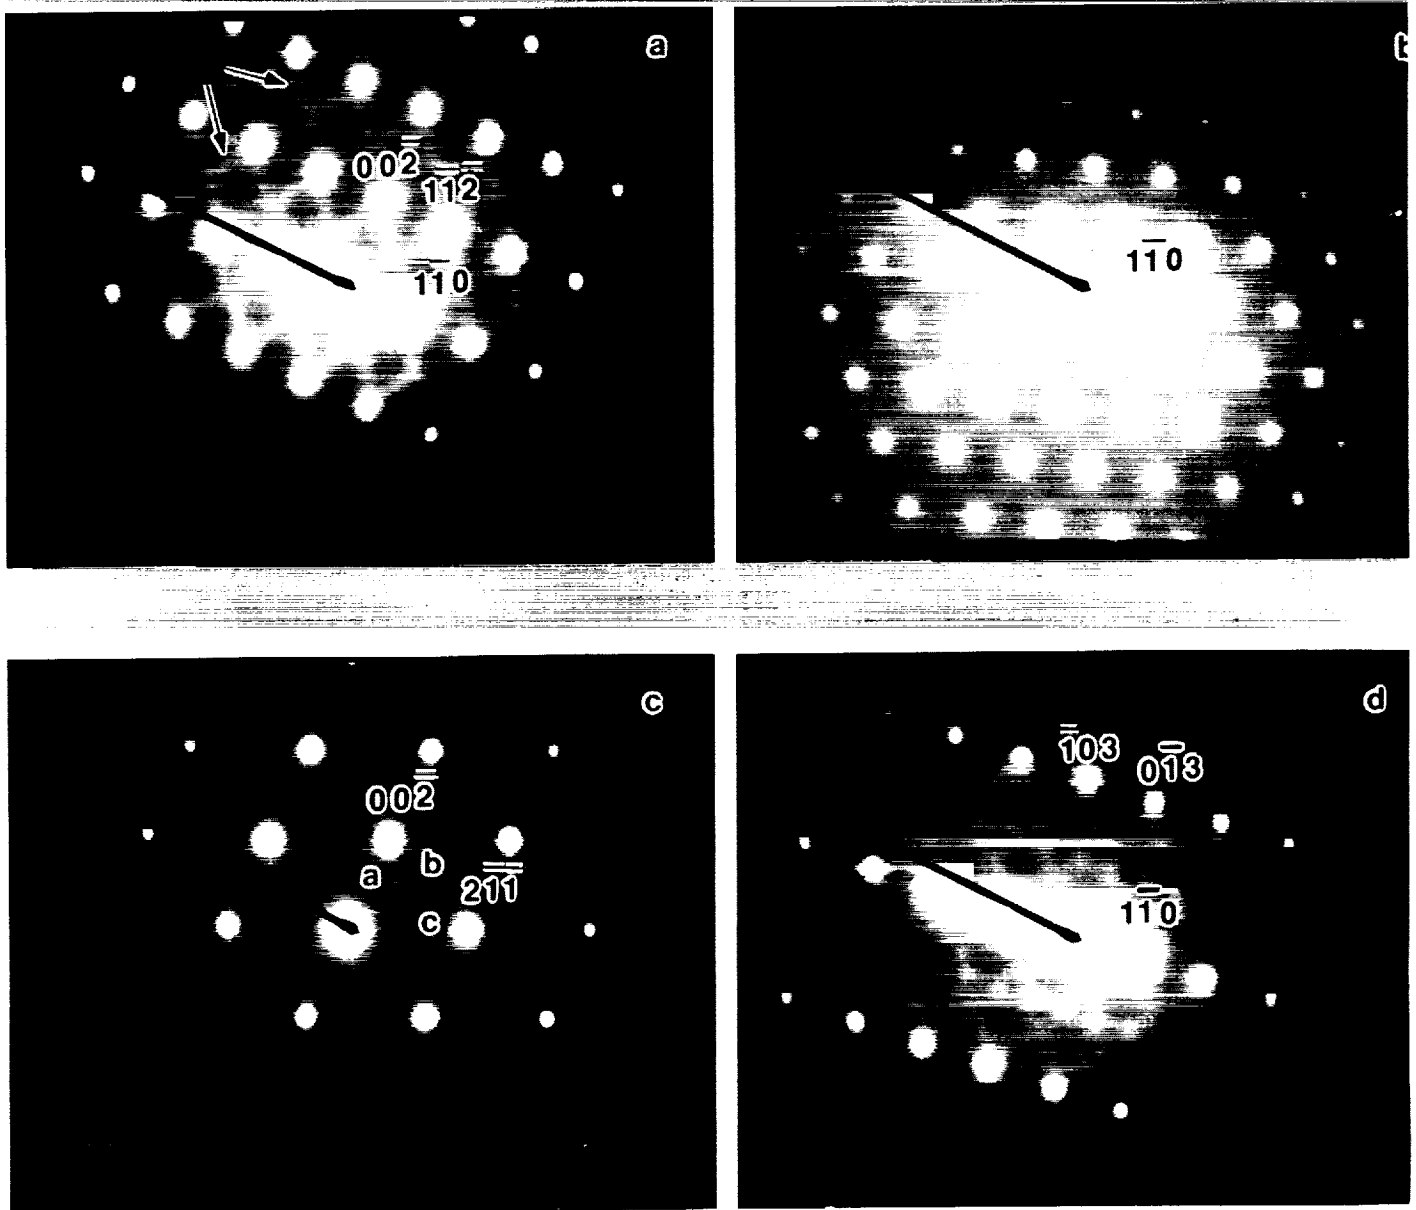
Figure 21. Series of four selected area diffraction patterns (SADP) showing streaking associated with the extremely fine ω -phase (hcp) in the β (bcc) matrix. (a) $\mathbf{B} - (110)_{\beta}$, (b) $\mathbf{B} - (111)_{\beta}$, (c) $\mathbf{B} - (120)_{\beta}$ and (d) $\mathbf{B} - (331)_{\beta}$. The directions of the streaks in each SADP were determined to be in agreement with the ω -phase being distributed in rows along the $\langle 111 \rangle_{\beta} \parallel \langle 0001 \rangle_{\omega}$ direction. The points a, b, and c in (c) correspond $(\bar{1}011)$, $(\bar{2}020)$ and (0001) reflections of the ω -phase.
