NASA Contractor Report 189095

Inelastic Deformation of Metal Matrix Composites

Part I—Plasticity and Damage Mechanisms

B.S. Majumdar and G.M. Newaz
Battelle Memorial Institute
Columbus, Ohio

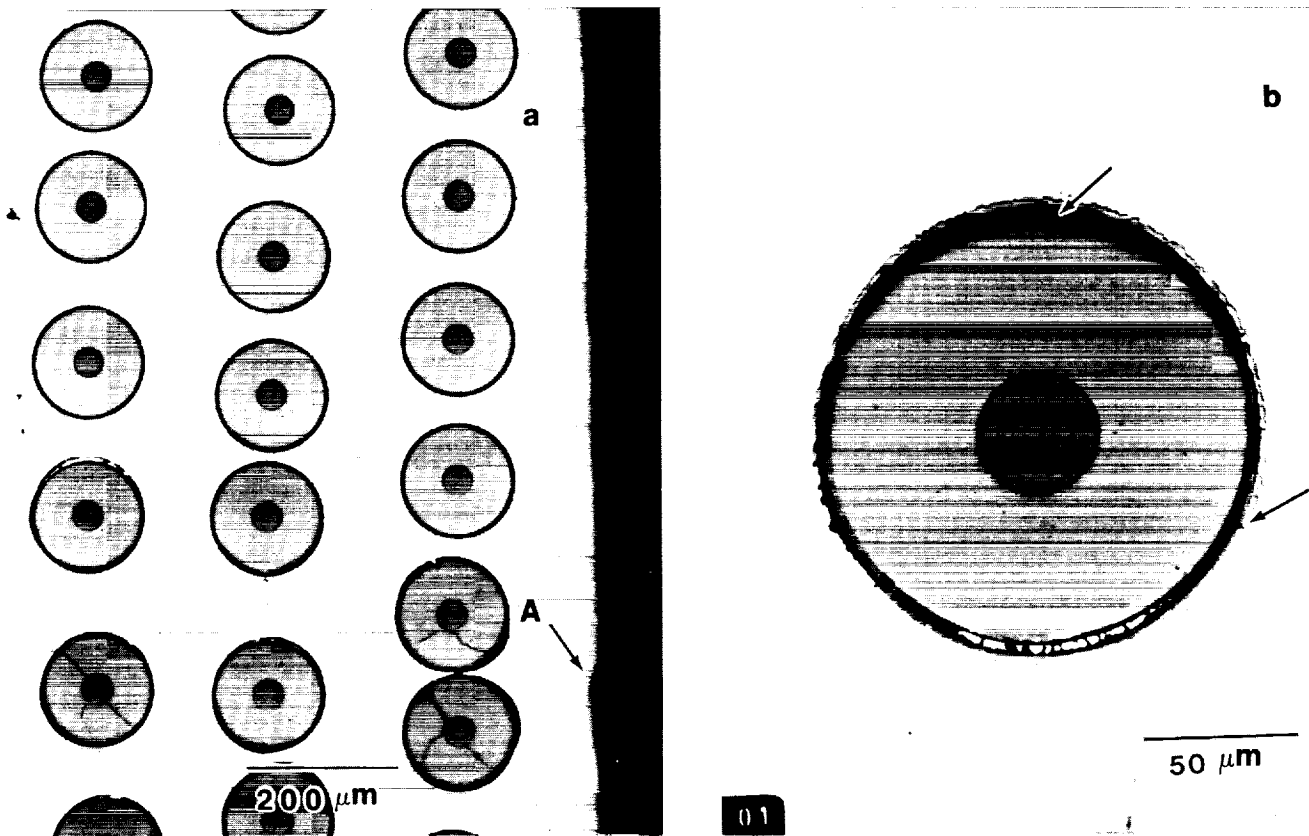
Figure 22. Optical micro-photographs of the edge cross-section of a 90-degree composite, strained to approximately 1.6 percent (Stage III); as-polished sample, and the loading axis is vertical. The higher magnification micrograph (b) illustrates both debonding and cracking of the reaction zone.

- Figure 22. Optical micrographs of the edge cross-section of a 90-degree composite, strained to approximately 1.6 percent (Stage III); as-polished sample, and the loading axis is vertical. The higher magnification micrograph (b) illustrates both debonding and cracking of the reaction zone.

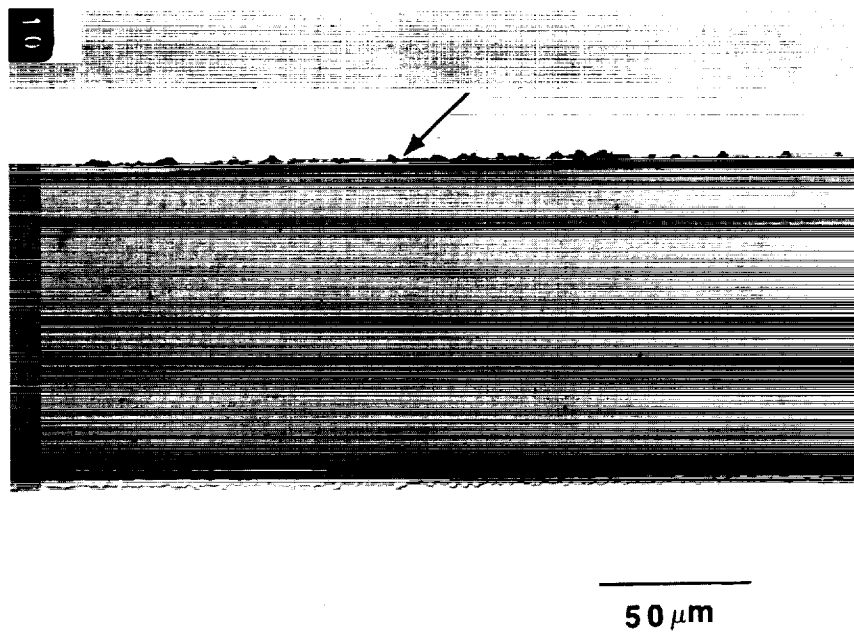
Figure 23. Longitudinal section of a 90-degree composite deformed into Stage III. Debonding and cracking at the fiber-matrix interface is shown by an arrow.

- Figure 23. Longitudinal section of a 90-degree composite deformed into Stage III. Debonding and cracking at the fiber-matrix interface is shown by an arrow.

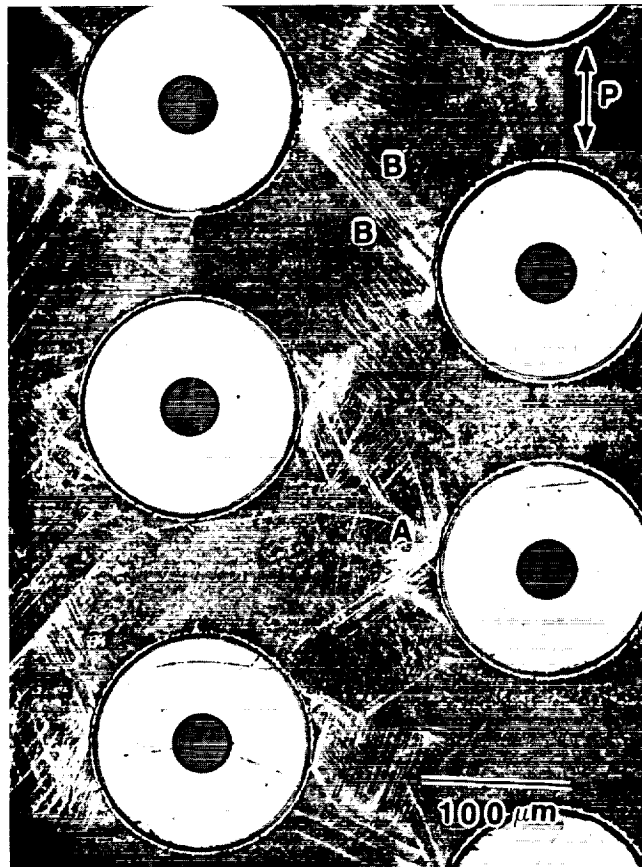
Figure 24. Etched microstructure of a 90-degree specimen, loaded into Stage III. Slip bands are indicated by arrows. Final failure of the composite occurred by crack initiation and failure along the intense shear bands.

- Figure 24. Etched microstructure of a 90-degree specimen, loaded into Stage III. Two types of slip band activity are indicated by regions A and B. Final failure of

the composite occurred by crack initiation and failure along the intense shear bands.

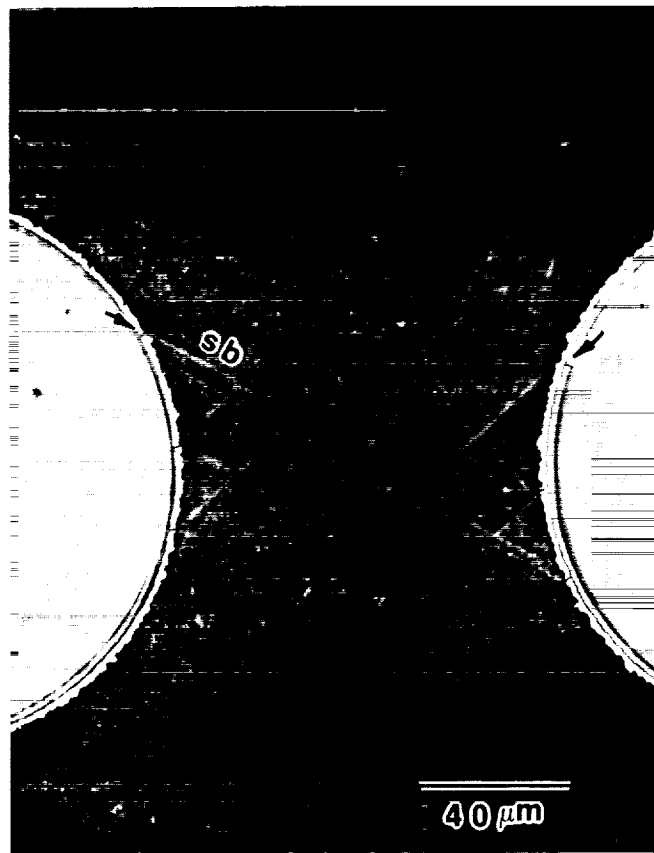
Figure 25. Optical photomicrograph of a 90-degree specimen, unloaded from a strain of 0.5 percent (Stage II). The slip bands (white lines) are mostly associated with reaction-zone cracks; the latter, although faint in this figure, are indicated by arrows.

- Figure 25. Optical photomicrograph of a 90-degree specimen, unloaded from a strain of 0.5 percent (Stage II). The slip bands (white lines) are mostly associated with reaction-zone cracks; the latter, although faint in this figure, are indicated by arrows. Loading axis is vertical.

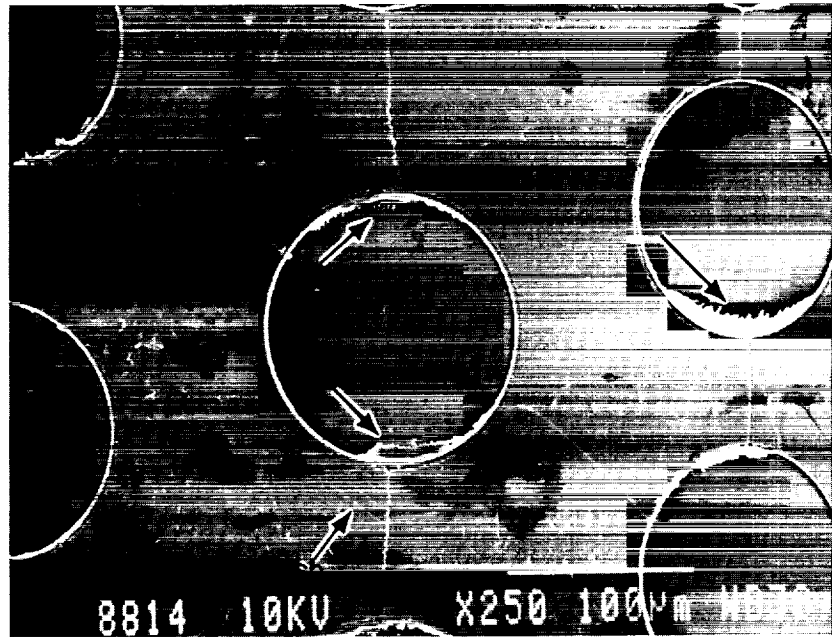
Figure 26. Surface replica of a 90-degree specimen strained to 0.5 percent (Stage II); replica taken at full load. The region indicated by arrow corresponds to the acetate tape entering into the debonded fiber-matrix interface. The loading axis is vertical.

- Figure 26. Surface replica of a 90-degree specimen strained to 0.3 percent (the beginning part of Stage II); replica taken at full load. The region indicated by arrow corresponds to the acetate tape entering into the debonded fiber-matrix interface. The loading axis is vertical.

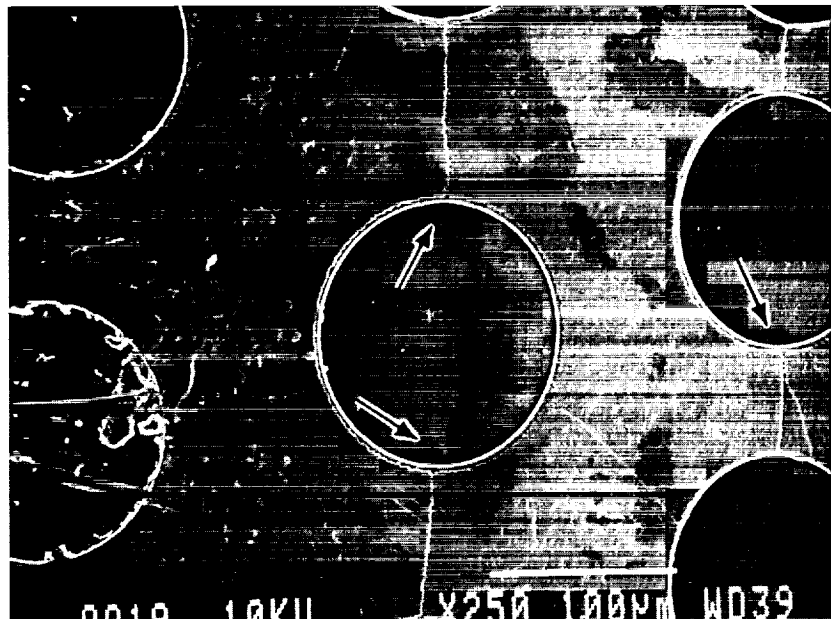
Figure 27. Replica of the same region as Figure 26, after the load had been reduced to zero. There is no acetate tape protruding, indicating that the fiber-matrix separation has largely closed upon unloading.

- Figure 27. Replica of the same region as Figure 26, after the load had been reduced to zero. There is no acetate tape protruding, indicating that the fiber-matrix separation has largely closed upon unloading.

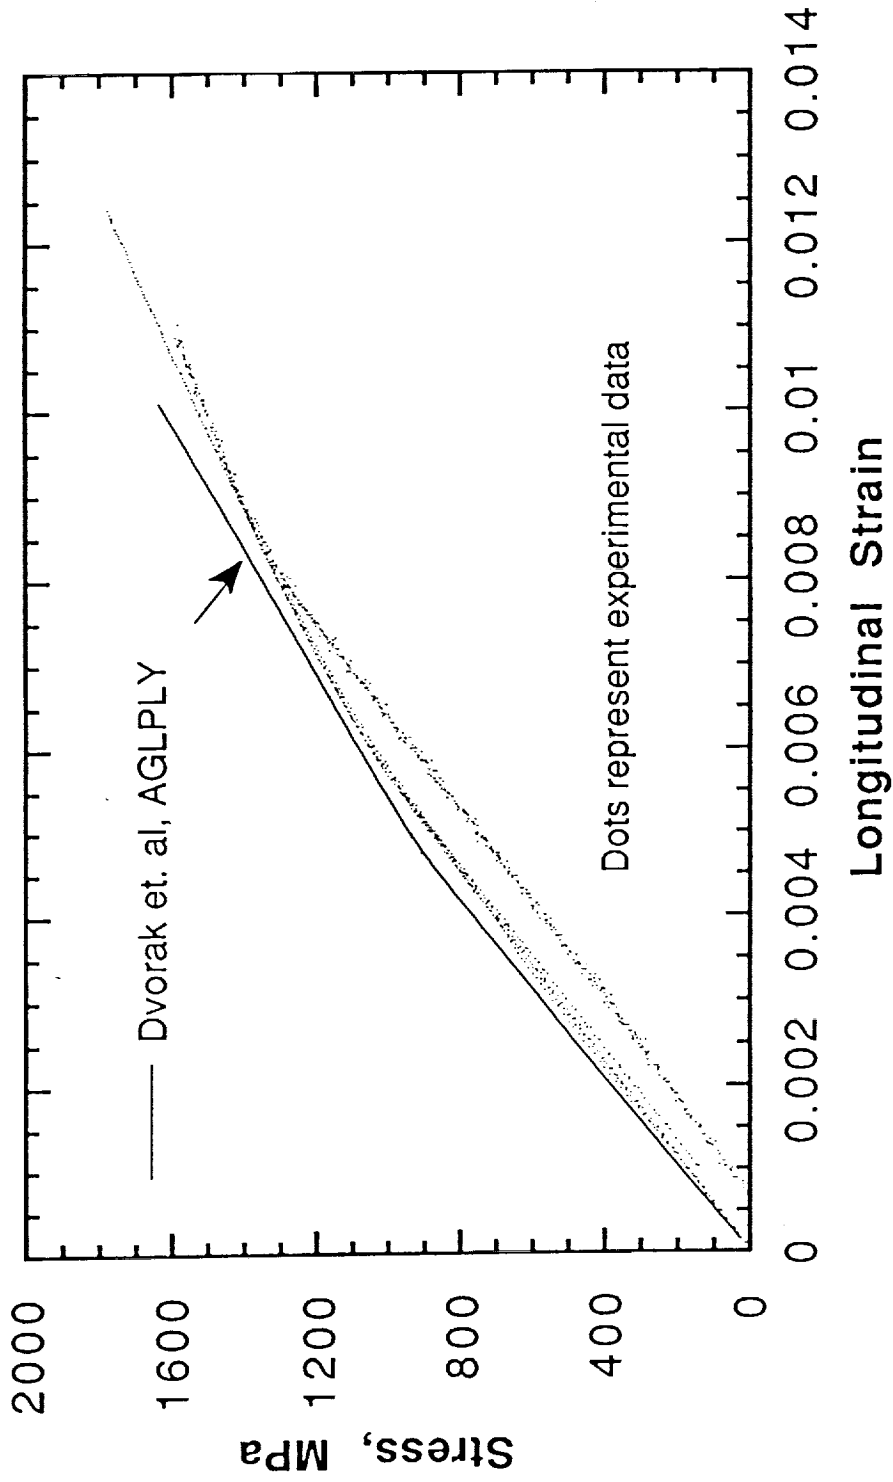
Figure 28. Comparison of model predictions with experimental data for the 0-degree Ti 15-3/SCS6 composite.

- Figure 28. Comparison of model predictions with experimental data for the 0-degree Ti 15-3/SCS6 composite.
- Figure 29. Comparison of model predictions with experimental data for the 90-degree Ti 15-3/SCS6 composite.

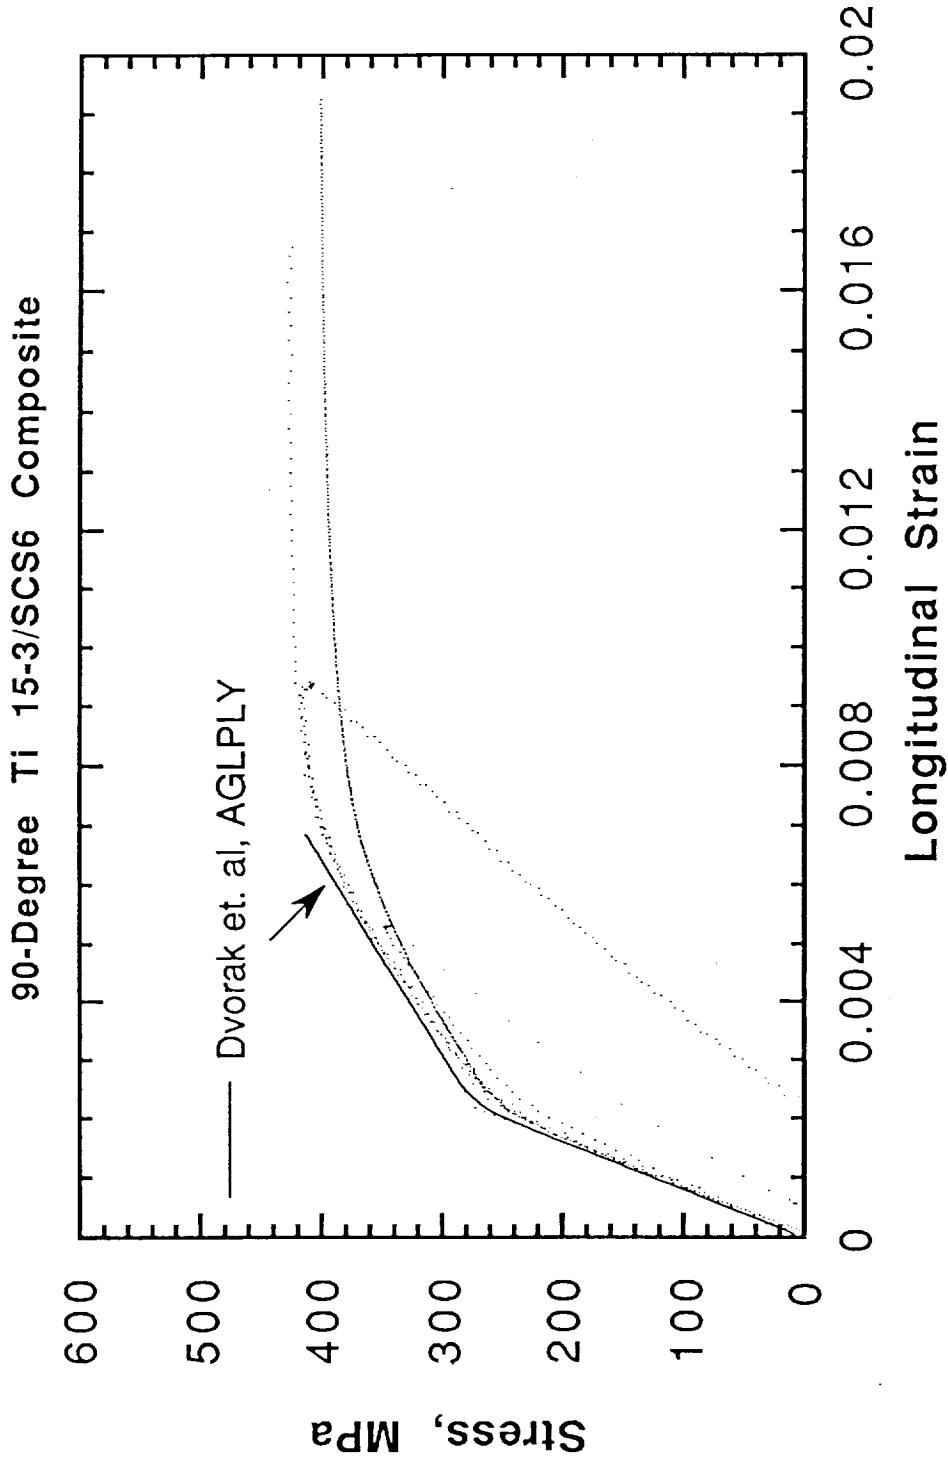
Figure 29. Comparison of model predictions with experimental data for the 90-degree Ti 15-3/SCS6 composite.

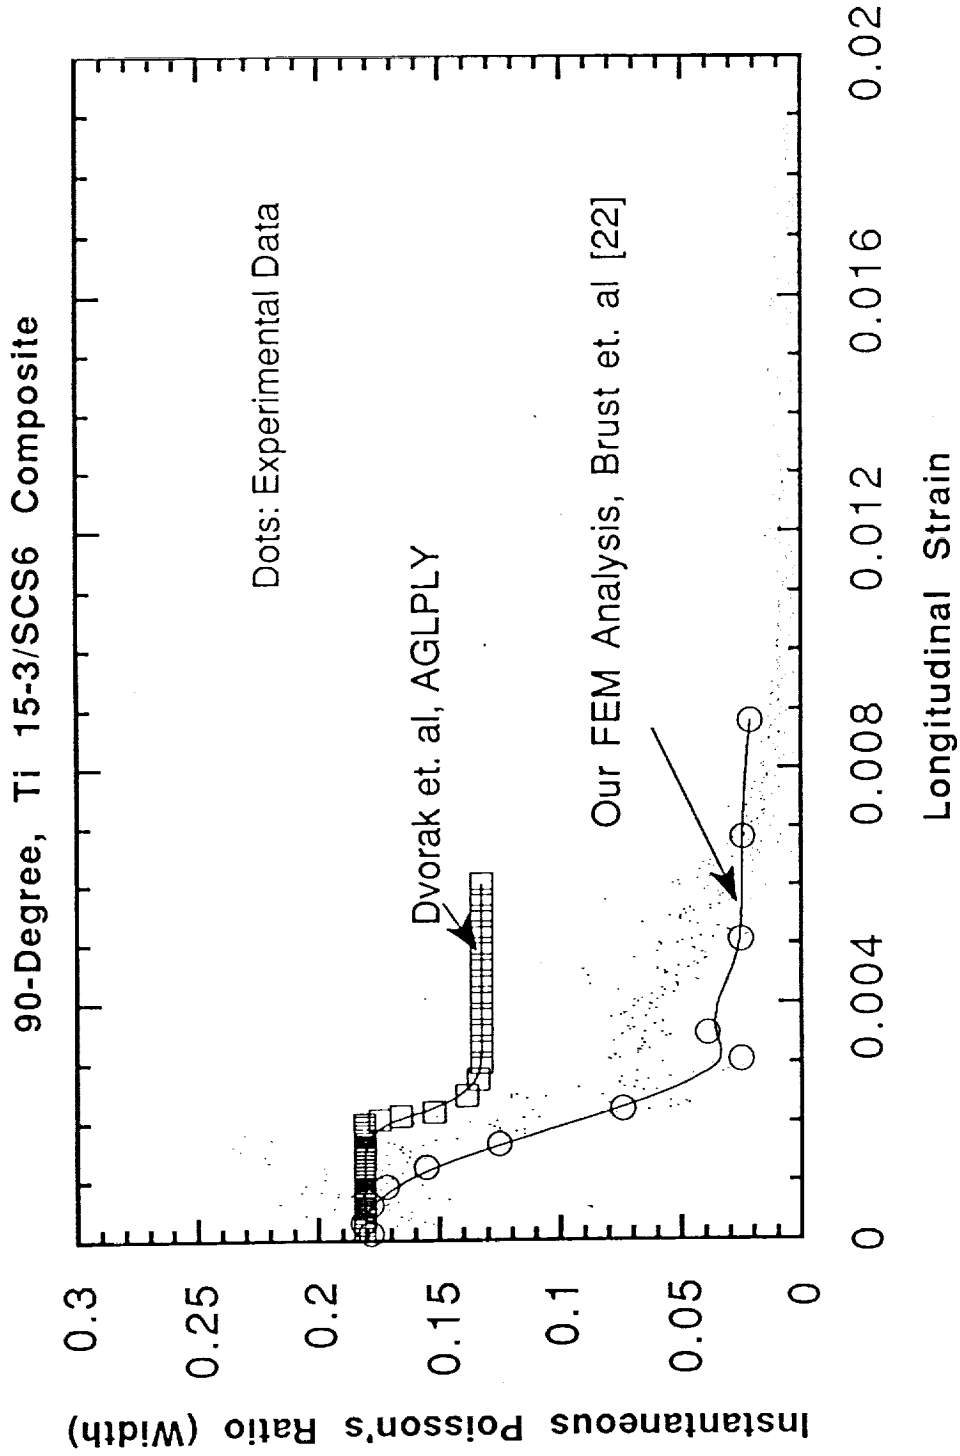
Figure 30. Comparison of model predictions with experimental data for the 90-degree Ti 15-3/SCS6 composite.

- Figure 30. Comparison of model predictions with experimental data for the 90-degree Ti 15-3/SCS6 composite.
- Figure 31. Plot showing effects of temperature on the stress versus longitudinal strain response for the 90-degree composite.

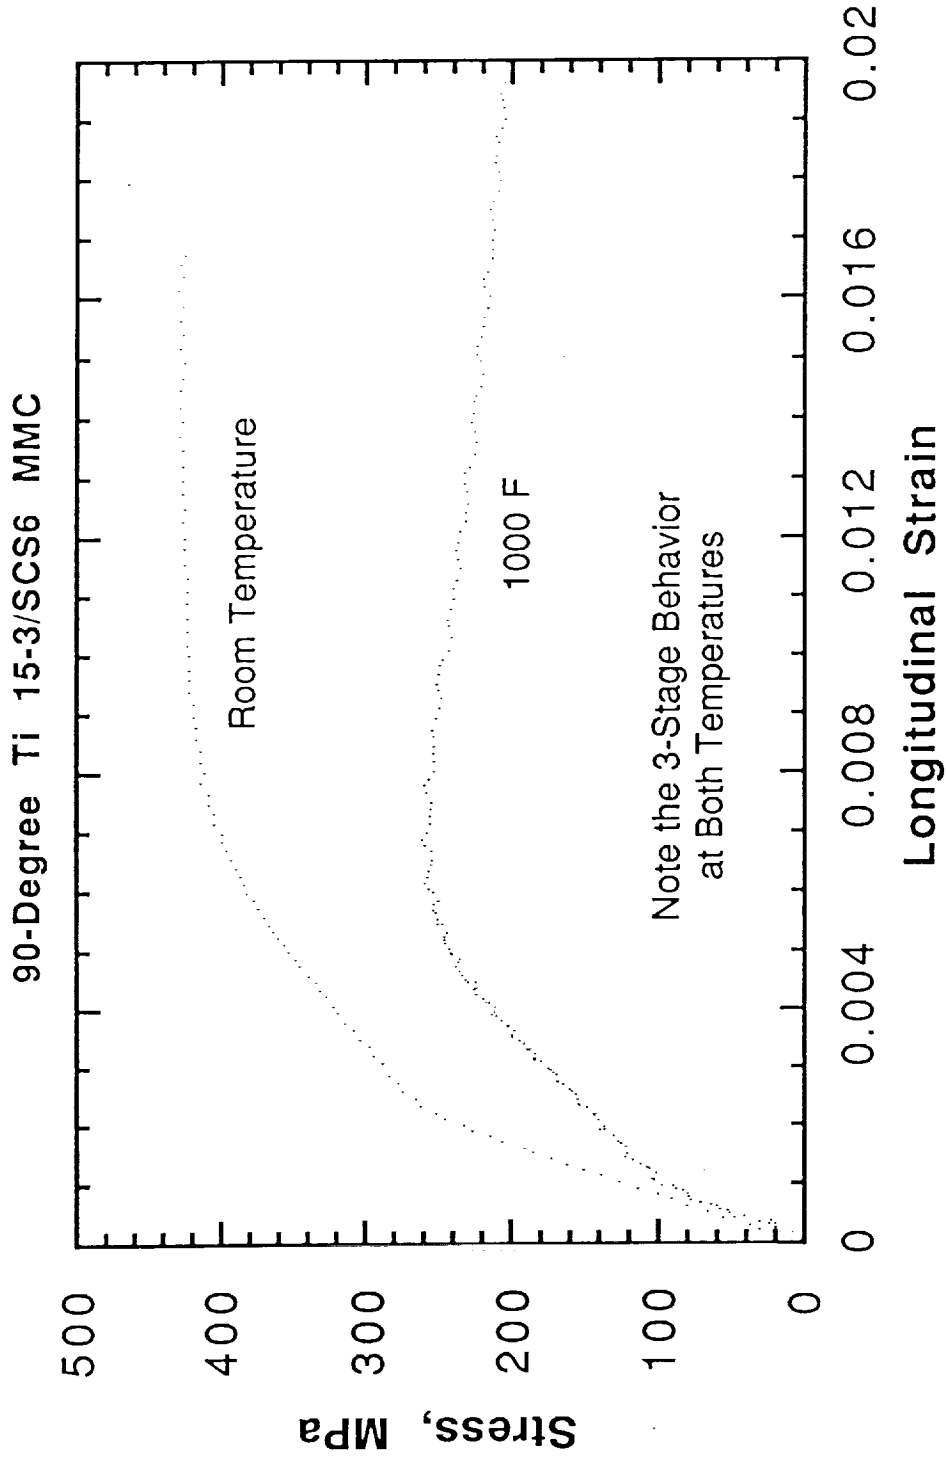
Figure 31. Plot showing effects of temperature on the stress versus longitudinal strain response for the 90-degree composite.

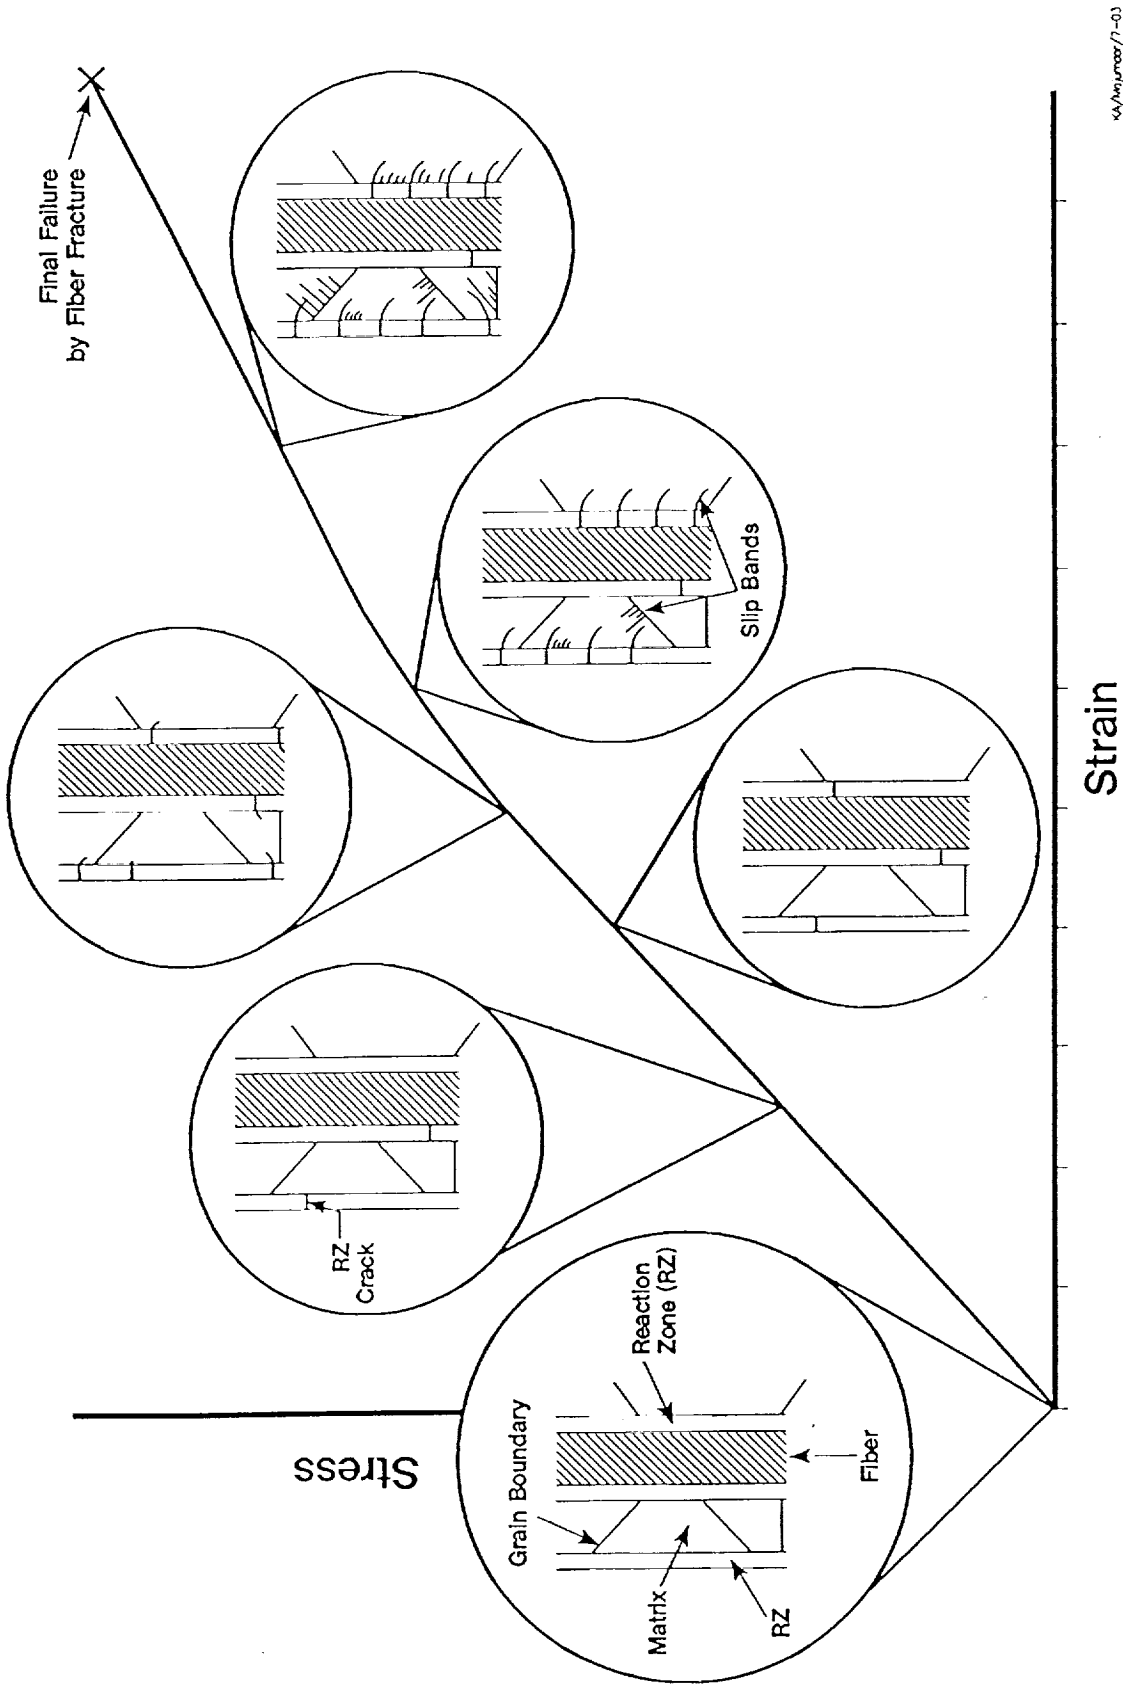
Figure 32. Deformation sequence for the 0-degree composite, based on current observations.

associated with the deformation of 0-degree and 90-degree MMCs. These figures are based on the measurements and mechanisms observed in this investigation. They indicate that both plasticity and damage must be incorporated in any comprehensive model of MMCs. Additionally, models must include the effect of reaction zones and the processing histories. To our knowledge, extremely little attention has been focussed on these aspects of the problem in modeling studies.

- Figure 32. Deformation sequence for the 0-degree composite, based on current observations.
- Figure 33. Deformation sequence for the 90-degree composite, based on current observations.
