AN EVALUATION OF THE INTERFACIAL BOND PROPERTIES BETWEEN CARBON PHENOLIC AND GLASS PHENOLIC COMPOSITES*

Kelvin Jordan
Hughes Aircraft Company
Tucson, Arizona

Raymond Clinton
NASA - Marshall Space Flight Center
Huntsville, Alabama

Shaik Jeelani
Materials Research Laboratory
Tuskegee University, Tuskegee, Alabama

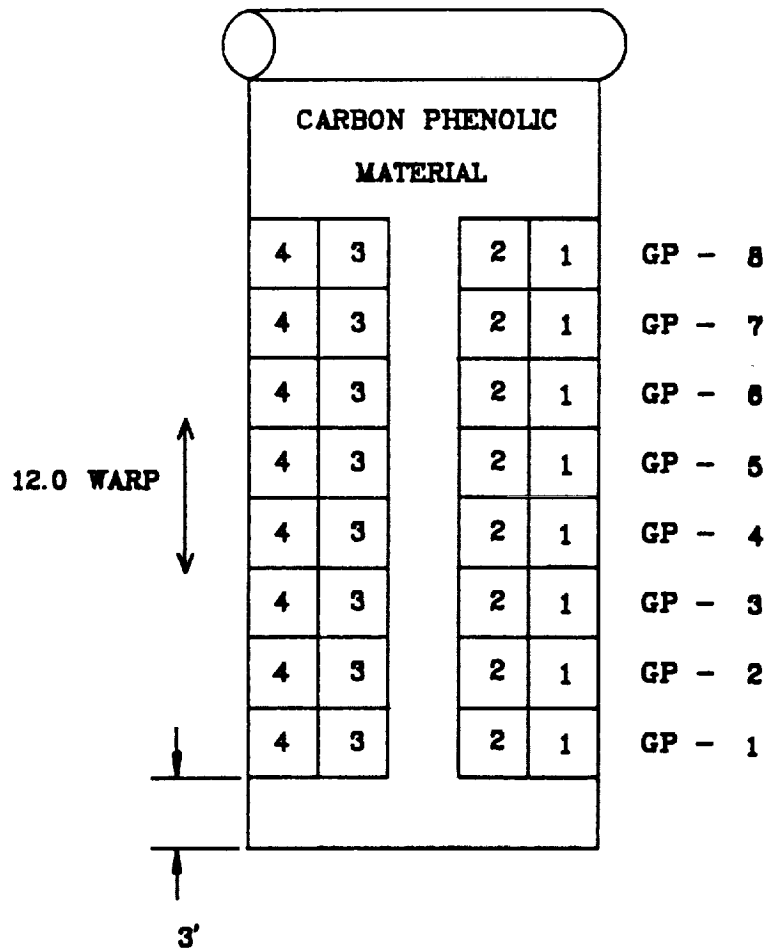
1. CUT 3 FOOT SWATCHES AT THE BEGINNING AND AFTER EVERY 168 PLYS UNTIL 504 PLYS ARE CUT.
2. CUT 504 [10 IN BY 12 IN (WARP)] PLYS OF C/P MATERIAL. MAKE 6 STACKS (84 PLYS PER STACK), BY STACKING THE FIRST 4 PLYS, SMOOTH SIDE UP, IN STACK CP - 1, THE NEXT 4 IN STACK CP - 2, ETC. UNTIL EACH STACK CONTAINS 84 PLYS.

Figure 1. Cutting and stacking plan for carbon phenolic material (Roll 1B).

Three C/P laminates were assembled using the six debulked stacks CP-1 thru CP-6 (figure 1) as follows: (a) Panel A consisted of stacks CP-1 and CP-2, (b) Panel B consisted of stacks CP-3 and CP-4, and (c) Panel C consisted of stacks CP-5 and CP-6. The three panels were assembled and bagged on a trilateralcure tool. The hydroclave trilateral tool was designed to simultaneously cure three flat panel laminates with cured thickness of 2.5 inches each. The laminates were cured according to the hydroclave cure cycle designed by MTI [15].

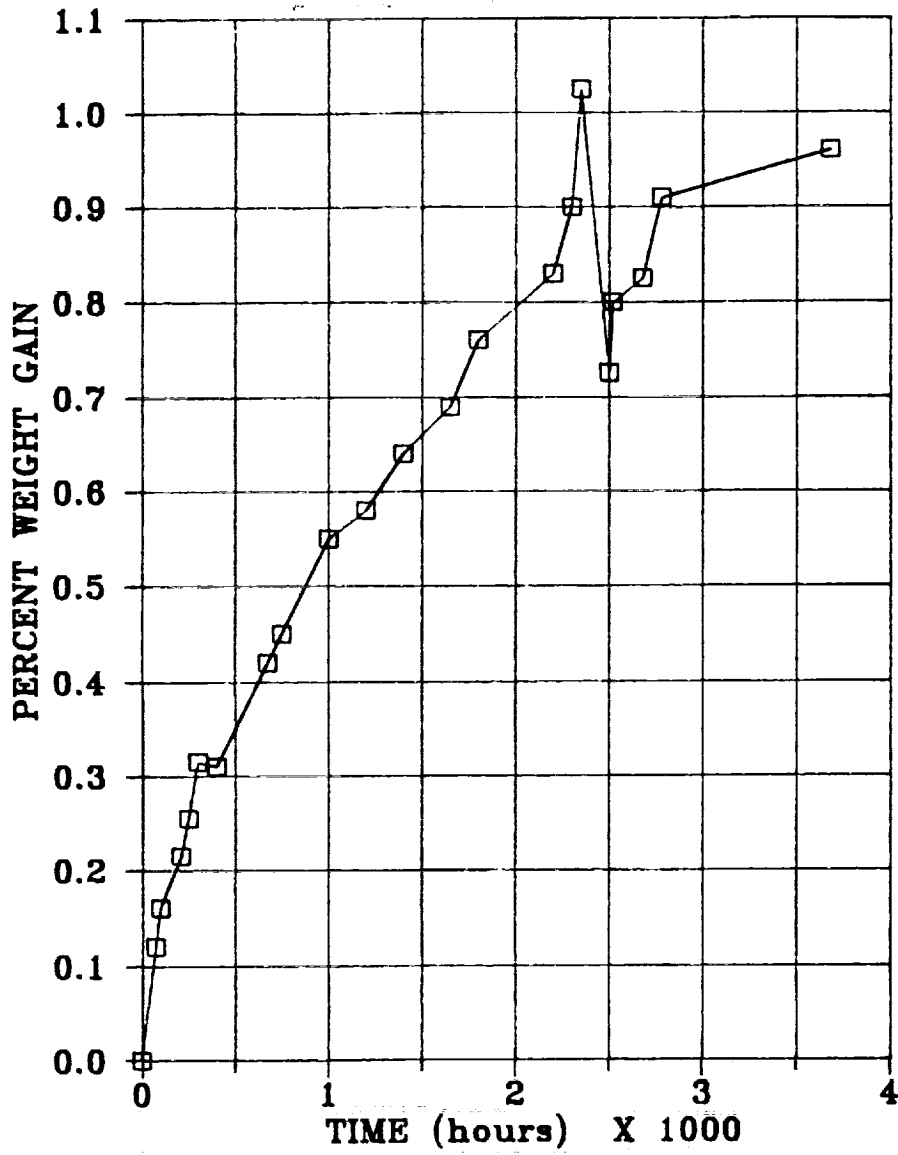
Figure 2. Percent weight gain for wet panel.

Percent weight gain versus time data were plotted as shown in Figure 2. The conditioning resulted in a 0.96 percent weight gain.

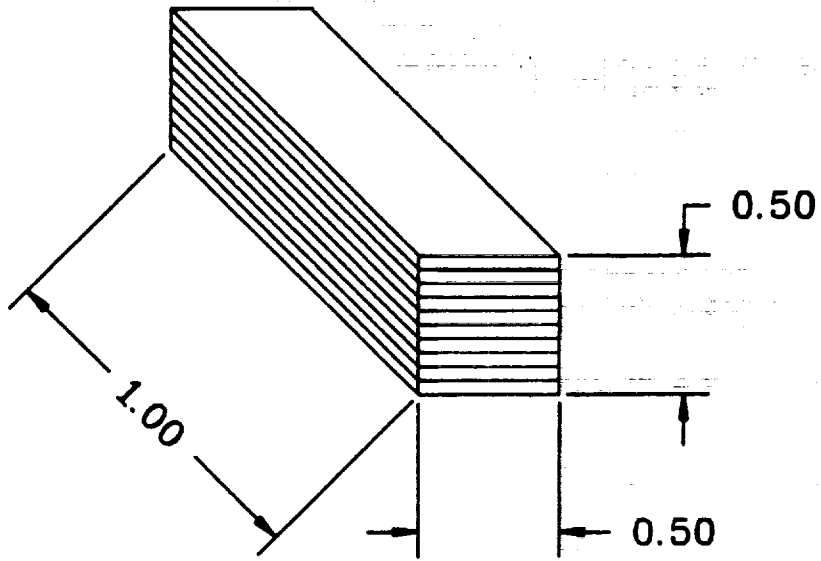
Figure 4. Specimen geometry of specific gravity, residual volatile, and resin content tests.

sisted of residual volatile content, specific gravity and resin content [19]. The MTI specifications require that resin content tests be performed using the tested residual volatile specimens. The same test geometry was used for each of the above three tests. The specimen geometry is shown in Figure 4.

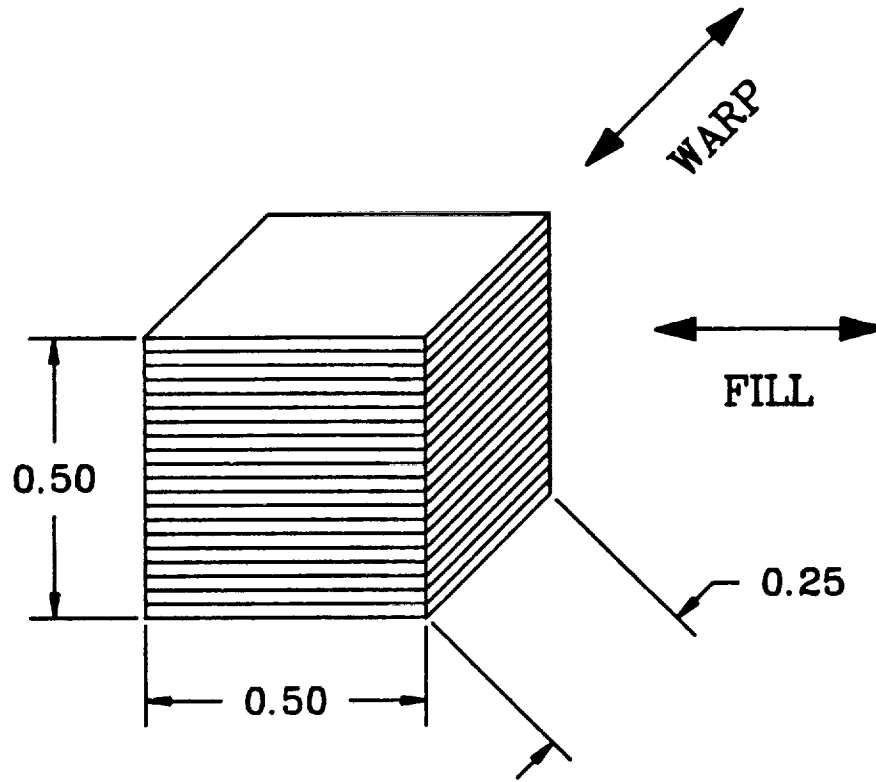
Figure 5. Specimen geometry for photomicroscopy evaluation.

Optical photomicroscopy examinations were conducted on specimens taken from the C/P, G/P and at the interfaces of each laminate. The objectives were to : (a) observe material for possible microstructural damage; (b) characterize the appearance of the microstructure of the C/P and G/P materials; and (c) characterize the appearance of the different interfaces between the C/P and G/P laminates. A typical final machined specimen is presented in Figure 5. Prior to the examination, each specimen was mounted in epoxy and then polished. Photomicrographs were taken of each specimen at several magnifications.

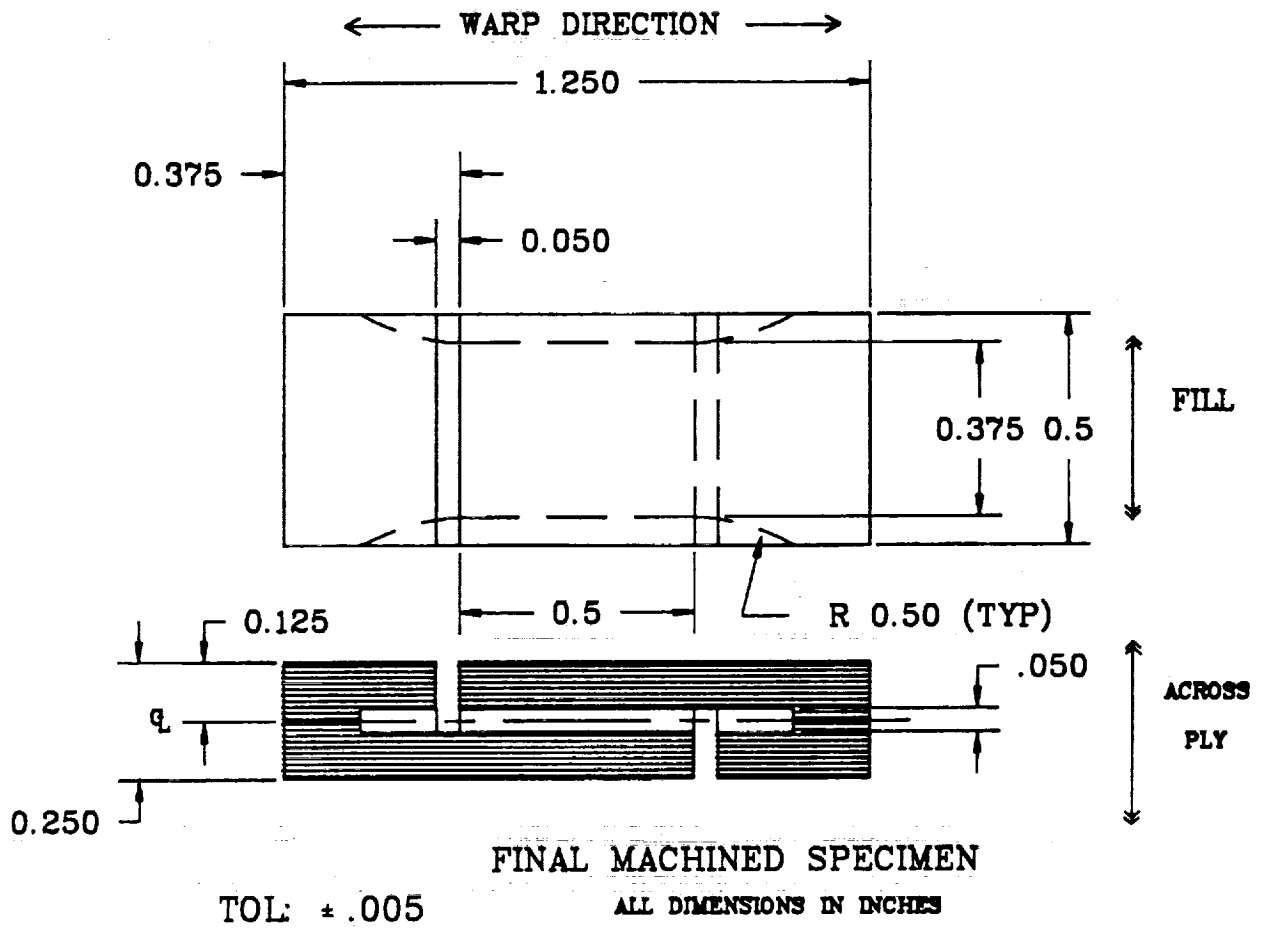
Figure 6. Specimen geometry for DNS test.

The basic cutting plans for the specimen removal may be found elsewhere [14]. Specimens were first excised as blanks, then machined to the specified dimensions shown in the schematic presented in Figure 6. The gage section was maintained at 0.375 inches (fill) by 0.300 inches (warp) by 0.050 inches (A/P), allowing four plies to be isolated in the gage section for the C/P specimens and two plies in the gage section for the G/P specimens. The number of plies isolated in the gage section was determined by dividing the A/P dimension of the gage section by the cured ply thickness of each material. For the interface specimens, approximately 2 plies of C/P and 1 ply of G/P were isolated in the gage section with the bondline centered in the gage section. The specimens were loaded in axial compression to provide pure shear at the gage section. Each specimen was loaded at a rate of 10,000 pounds per minute [21]. The load versus time plot obtained from the Instron for each specimen was transformed into a stress versus time plot by dividing load values by the shear (gage) area. The data obtained from the linear stress versus time plot were used to determine the ultimate interlaminar shear strength.

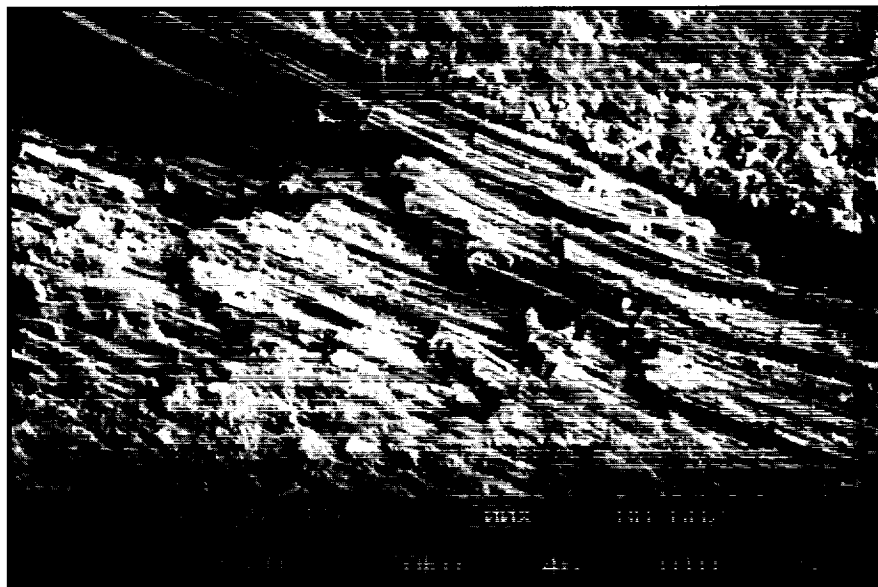
Figure 7b. SEM photomicrograph at 200X of fracture surface depicting interlaminar failure.

Interlaminar failure (presented in Figure 7) was characterized by a fracture surface exhibiting one or more of the following features: (a) large areas of exposed denuded fibers, (b) thin cracks between the fibers and matrix, and (c) clear imprints in the matrix where fibers were removed. This type of failure was characteristic of the interface specimens of the wet laminate and the glass phenolic material of all laminates.

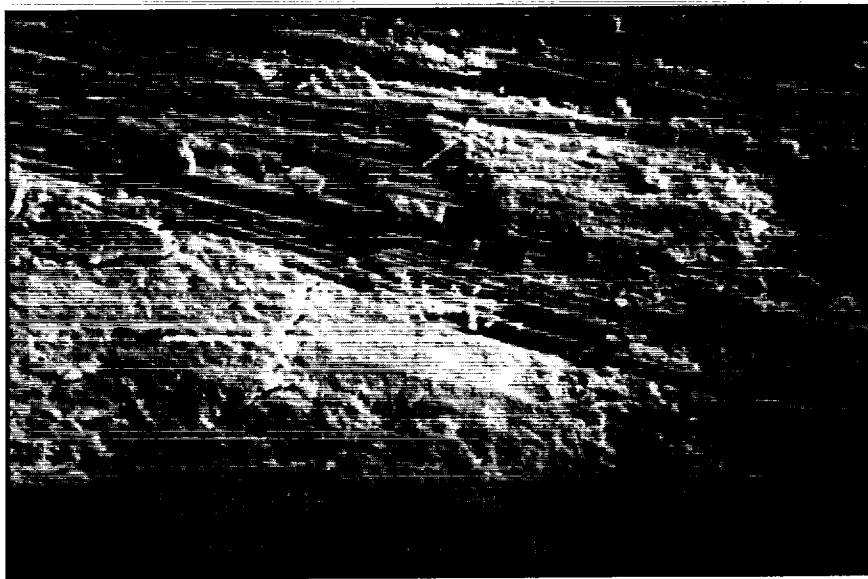
Figure 7c. SEM photomicrograph at 200X of fracture surface depicting interlaminar failure.

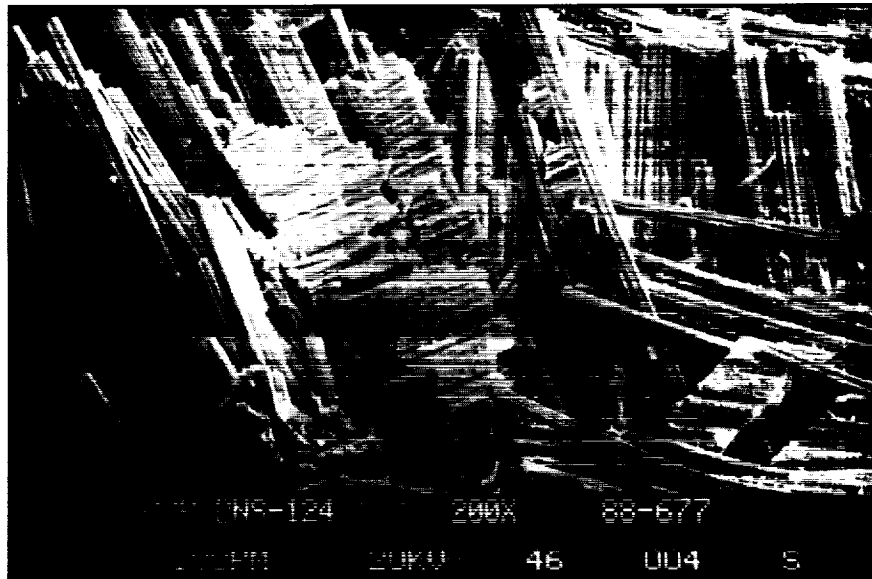
Figure 8b. SEM photomicrograph at 200X of fracture surface depicting cross-laminar failure.

Across-laminar failure (presented in Figure 8) was characterized by a fracture surface exhibiting similar features on interlaminar failure with the addition of some extensive fiber breakage across individual plies of material. This type of failure was common to all carbon phenolic material and the bondline specimens of the dry, as-received and the cocure laminates. From analysis of fracture surfaces of failed DNS C/P specimens by SRI, it was found that the predominate mode of failure was interlaminar although the presence of across-laminar failure was observed [21].

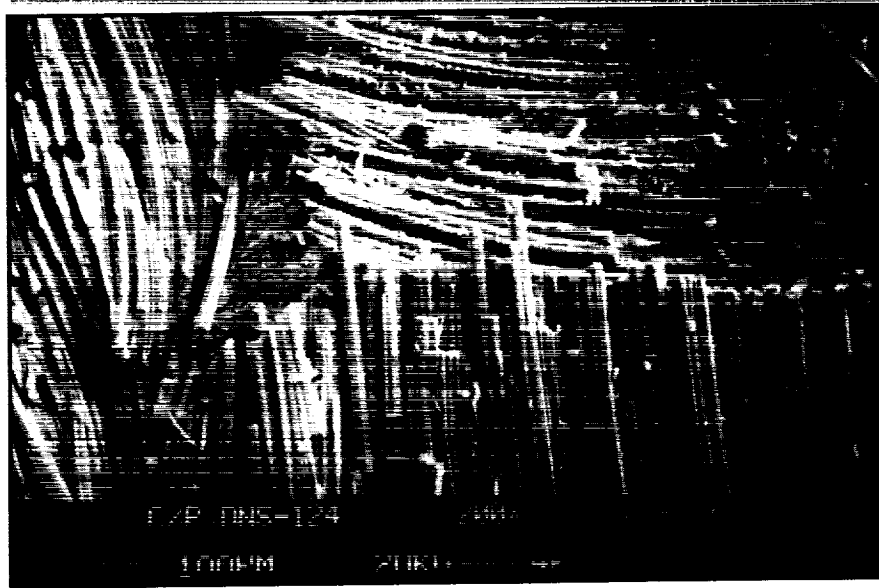
Figure 8c. SEM photomicrograph at 200X of fracture surface depicting cross-laminar failure.
