## WEAR CHARACTERISTICS OF BONDED SOLID FILM LUBRICANT UNDER HIGH LOAD CONDITION

Naofumi Hiraoka, Akira Sasaki, Noritsugu Kawashima\* and Toshio Honda\*\*

### ABSTRACT

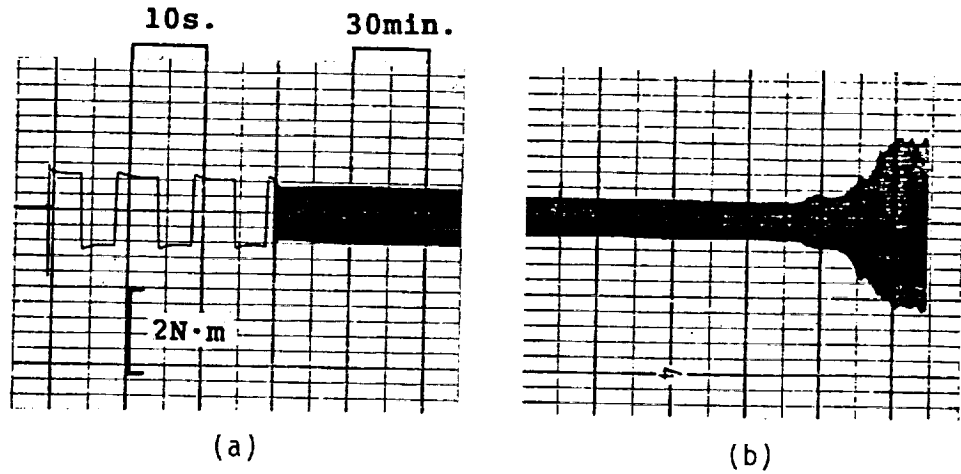
Figure 2. Typical Frictional Torque Trend  
 Specimen: SET 1, Angular Velocity: 10 deg./s, Load: 1470N  
 (a): at the Beginning of the Test,  
 (b): at the End of the Test

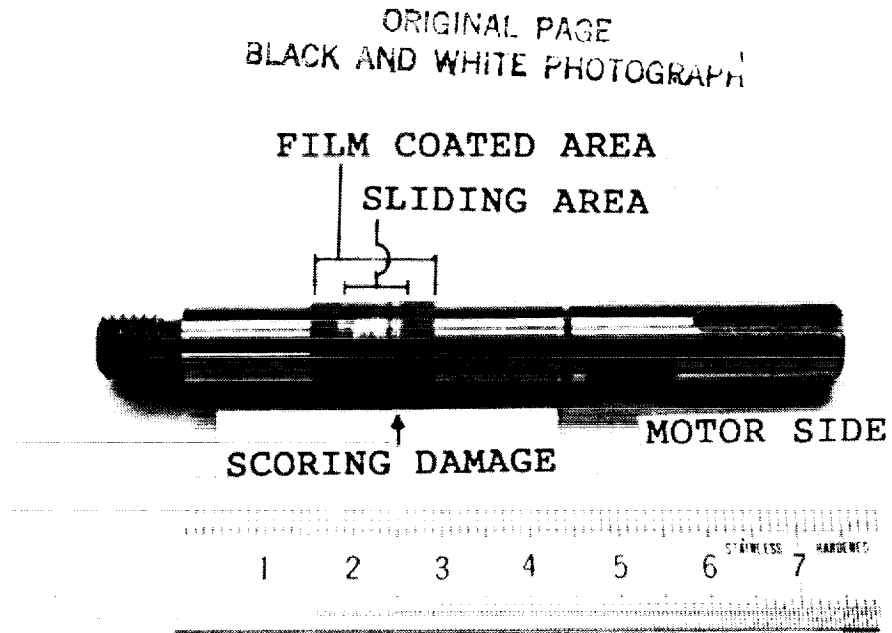
Figure 3. No Longer Usable Bearing Shaft

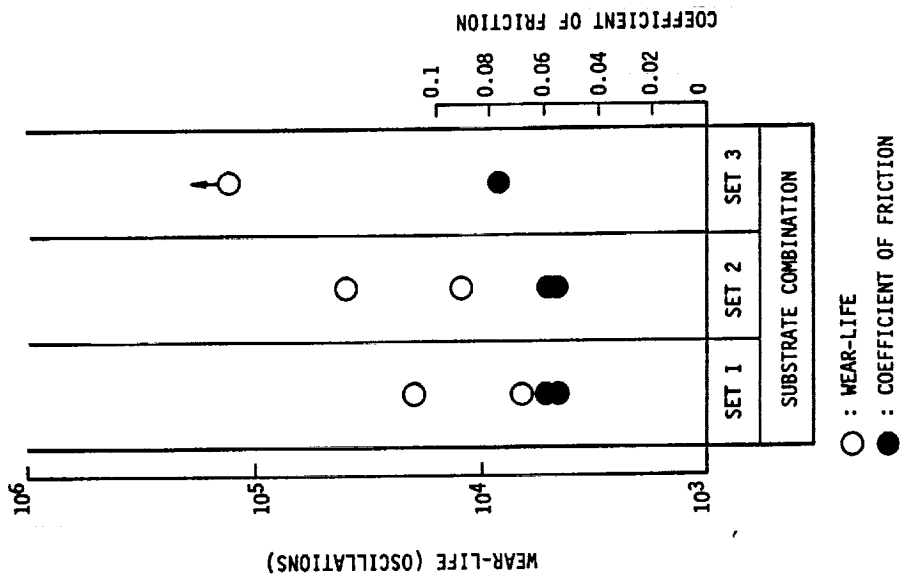
Figure 4. Wear Life and Coefficient of Friction for Three Substrate Combinations  
Angular Velocity: 10 deg./s  
Load: 1470N

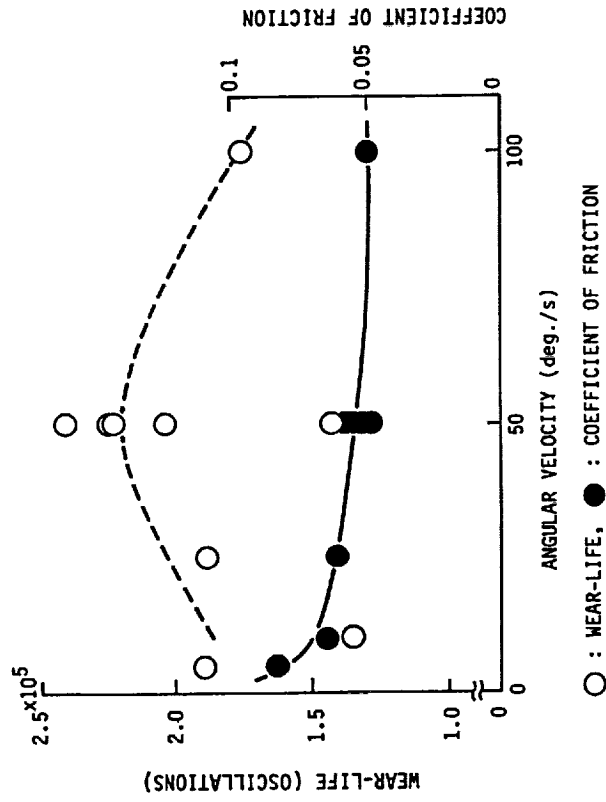
Figure 5. Wear-life and Coefficient of Friction at Several Angular Velocities  
Specimen: SET 3, Load: 1960N

Figure 5 shows the film wear-life and the coefficient of friction at several angular velocities. Although the wear-life seems to decrease at lower angular velocity, more experiments are required to confirm this trend because of the large data scatter. The coefficient of friction increases with the decrease in angular velocity.

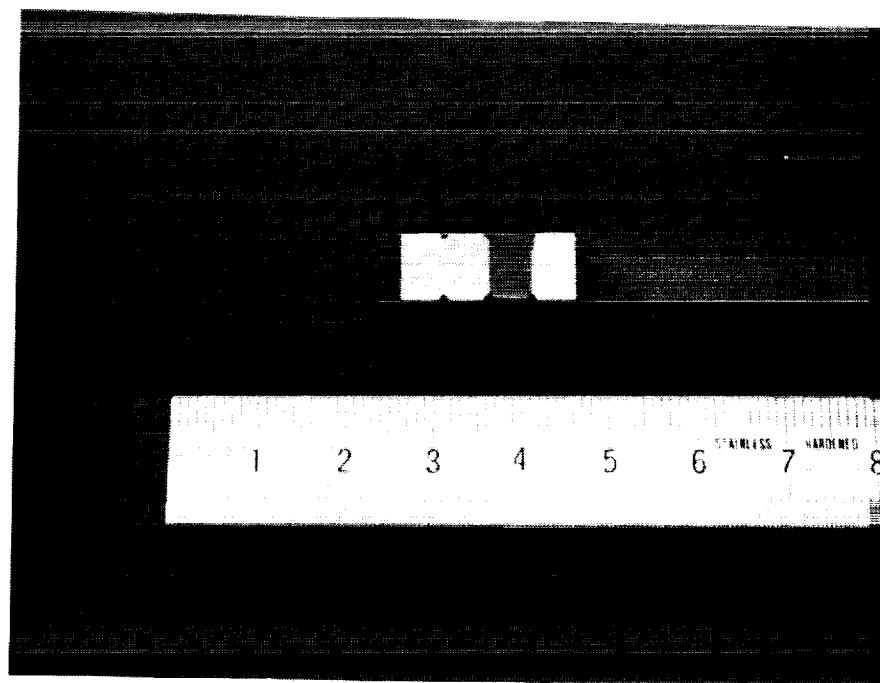
Figure 6. Pretreatment Surface Specimen

It was reported that the wear-life generally increases with the increase in hardness for the substrate (7). However, such was not the case with these tests, i.e., the SET 3 wear-life exceeded that for SET 2. In order to reveal the reasons for these results, pretreated surfaces of materials used in the tests were investigated. Specimens with a flat surface of these materials were prepared for this investigation. Figure 6 shows the shape of the specimen. These flat surfaces were partially pretreated, and film was bonded to half of the pretreated area.

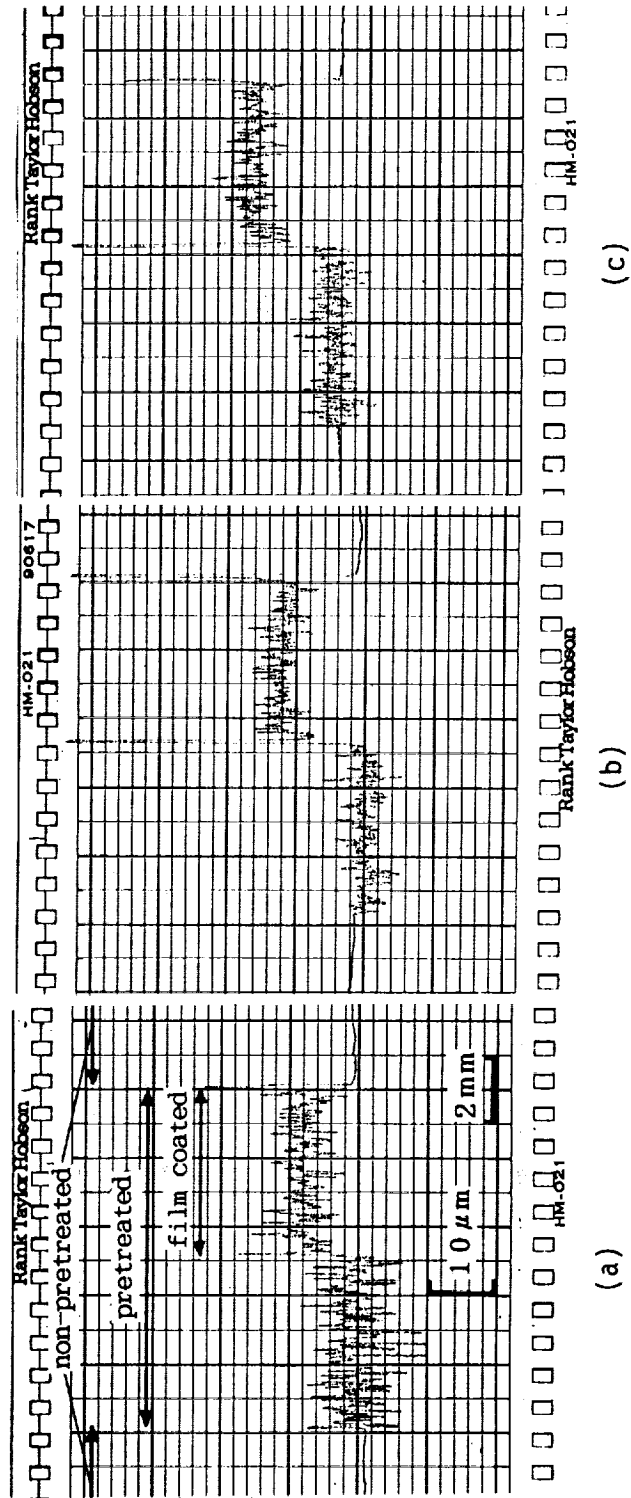
Figure 7. Surface Profiles for Pretreated Surface Specimens  
 (a): 2017 Aluminum Alloy, (b): 440C Stainless Steel, (c): 304 Stainless Steel

Figure 7 shows surface profiles for the specimens measured with TALYSURF. Corresponding numerical data are shown in Table 3. The aluminum alloy pretreated surface (Fig. 7-a) indicates a large degree of roughness, owing to sand-blasting. Heights of some peaks are comparable to lubricant film thickness, which means that films on such peaks had only a slight thickness, or even that there was no film on them. This is probably the most important reason for the short wear-life for the aluminum substrate bearing, besides low mechanical toughness of

The pretreated surface of 440C stainless steel (martensitic stainless steel) in Fig. 7-b exhibits lower roughness height, on the average, than non-pretreated surface. This is because material was removed from the surface by sand-blasting. On the other hand, the pretreated surface of 304 stainless steel (austenitic stainless steel) in Fig. 7-c retained about the same height, on the average, as that for a non-pretreated surface. This is because plastic deformation was predominant, compared to material removal in sand-blasting on 440C stainless steel.

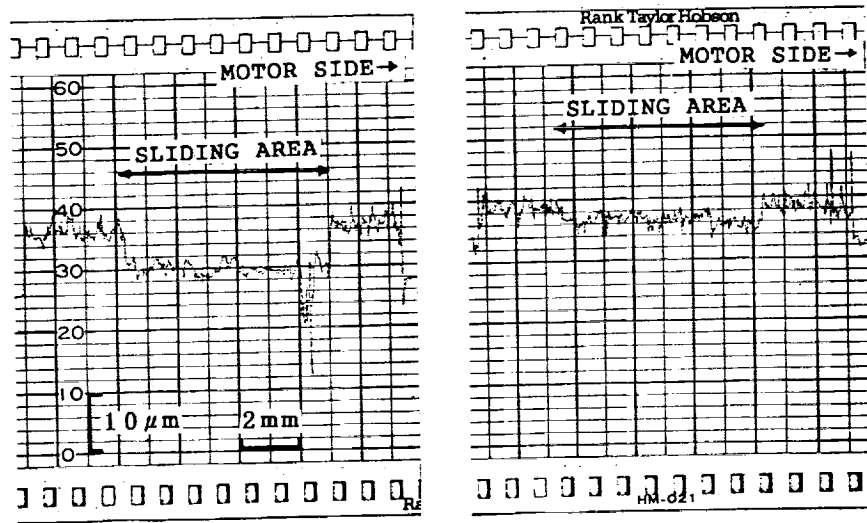
Figure 10. Surface Profiles for Worn Film on 304 Stainless Steel Shaft  
 (a): No Longer Usable (b): After  $1.27 \times 10^5$  Oscillations

Figures 9 and 10 show the worn film surface on a 304 stainless steel shaft and its profile. Figure 9 indicates many pits around flat surface. The width scale for these pits is on the order of a hundred microns and corresponds to that for profile's valleys of the corresponding area shown in Fig. 10a. Pits several microns in depth appear in the figure. In pertinent literature(10)(11)(12), 'blisters' were observed under much larger velocity conditions, but it is not clear whether the pits have anything in common with the blisters mentioned in the literature or not.

Figure 10-b shows the worn film surface profile for the shaft at approximately a half of the number of oscillations for the life-ended bearings. A wide, deep groove is observed on the motor side end of the worn surface. Figure 12 shows a microscopic image of this groove. The groove appears not to be the trace of abrasion, but to be an aggregation of pits or a trace of flaking in Fig. 12. Thus, the pitting or flaking wear is considered to dominate the film decrement.

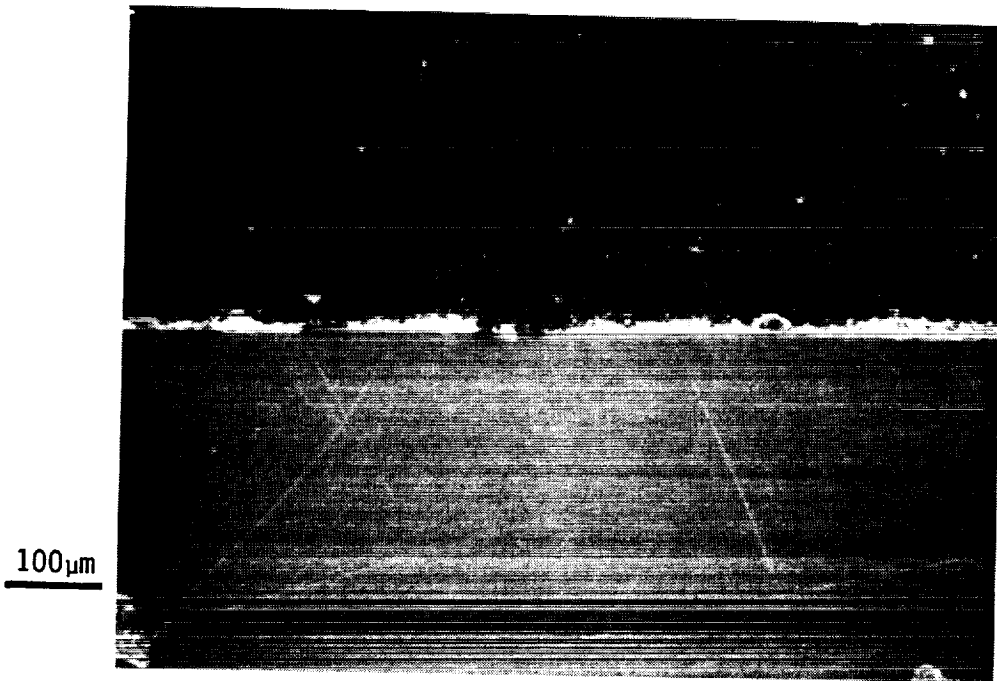
Figure 13. Cross Section of Ring Specimen

Figure 13 shows a cross section of the film coated ring specimen, which was used in the block-on-ring wear test in nitrogen gas in another study(13). A deep wear groove was observed, including ring material between thick remaining films. This could be considered the trace of abrasion of the film wear particles to the ring material, as stated above.
