NASA Contractor Report 4330

Current Emergency Locator Transmitter (ELT) Deficiencies and Potential Improvements Utilizing TSO-C91a ELTs

Bernard J. Trudell and Ryland R. Dreibelbis
Atlantic Research Corporation
Landover, Maryland

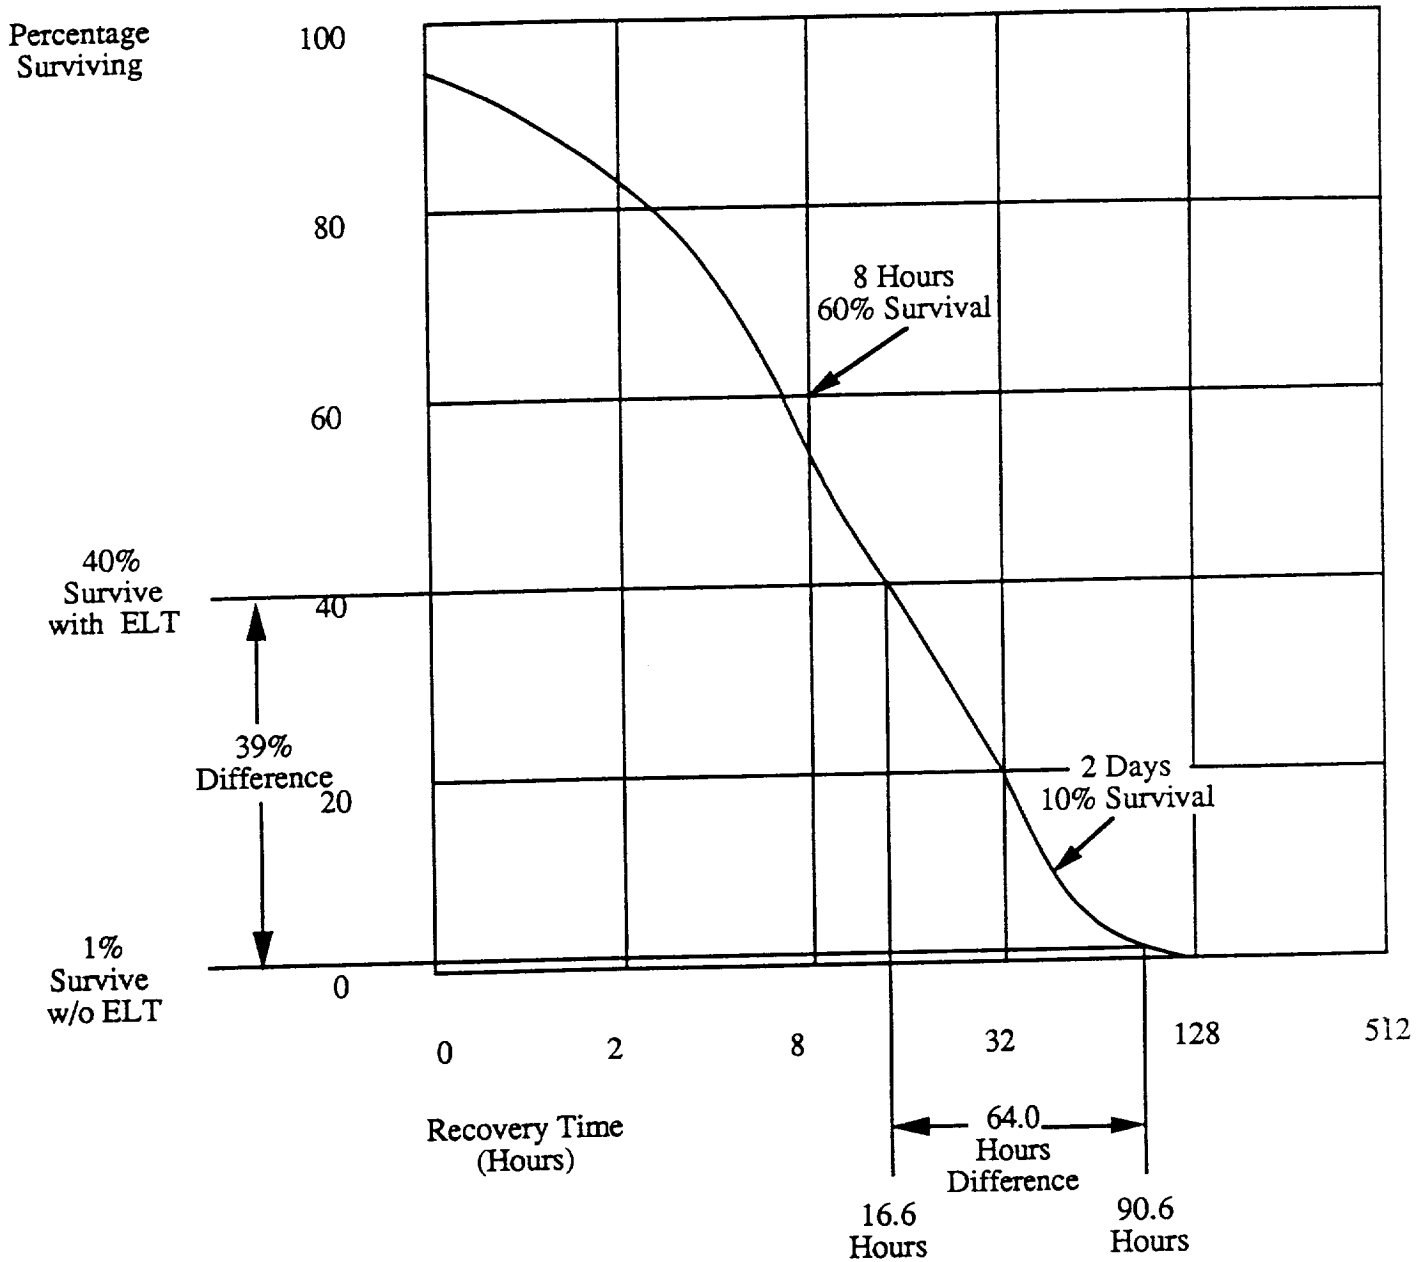
Figure 2
SURVIVAL AS A FUNCTION OF RECOVERY TIME

From NTSB Form 6120.4, Factual Report Aviation Accident/Incident, Supplement M, Search/Rescue/Firefighting/Medical Treatment Section and AFRCC data (See Tables 9 and 10).

REF: Final Report ICSAR Ad Hoc Working Group Report on Satellites for Distress Alerting and Locating.
Oct. 1976, pg. 6-15.

The above data can be used to project the expected improvement in survivability when an ELT is used during a search for a missing aircraft. If we average the difference in time from the two data sources (NTSB and AFRCC records) a projection of improved survivability can be derived from the DOT survival curve as shown in Figure 2.
