NASA Technical Memorandum 103095

Fatigue Crack Growth in a Unidirectional SCS-6/Ti-15-3 Composite

Prepared for the
Third Symposium on Composite Materials: Fatigue and Fracture
sponsored by the American Society for Testing Materials
Orlando, Florida, November 6-9, 1989

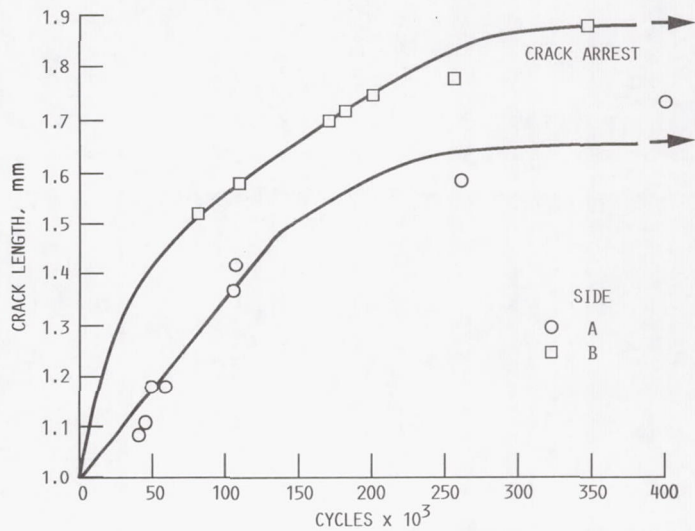
FIGURE 2. - CRACK LENGTH VERSUS CYCLES FOR THE $[0]_8$ ORIENTED SEN SPECIMEN.

rates and finally lead to full crack arrest (Fig 2). The very efficient transfer of the load from the cracked matrix to the unbroken fibers resulted in no apparent change in compliance as measured by the extensometer mounted in the crack mouth. This points to the inadequacy of the far field measuring devices to characterize the fatigue crack growth behavior of a complex material such as this composite.

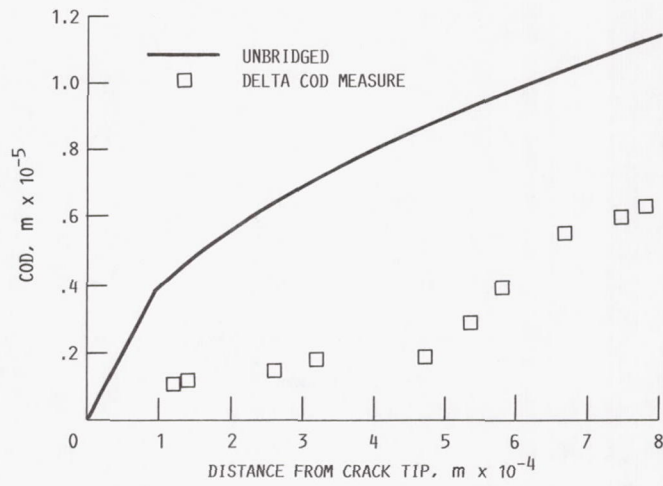
DISPLACEMENT PROFILE VERSUS DISTANCE FROM CRACK TIP

FIGURE 6. - COMPARISON OF THE MEASURED DELTA COD'S WITH ANALYTICALLY CALCULATED COD'S FOR AN UNBRIDGED SEN SPECIMEN.

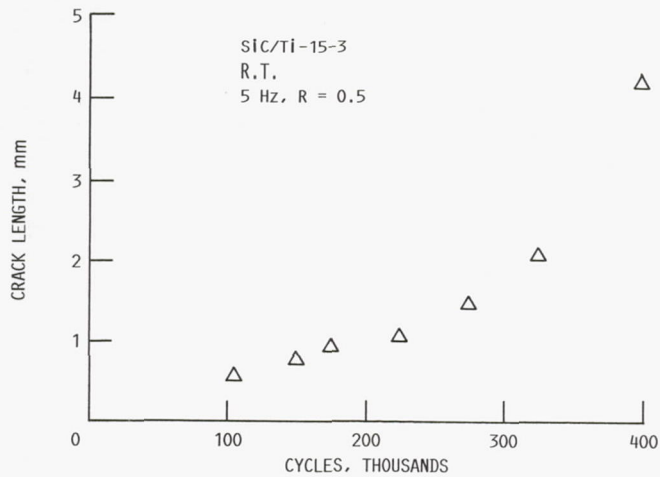
(a) CRACK LENGTH VERSUS CYCLES.

(b) CRACK GROWTH RATE VERSUS CRACK LENGTH.

FIGURE 8. - FATIGUE CRACK GROWTH RATE DATA FOR CT [0]_g SPECIMENS.

In contrast to the SEN specimens, the overall direction of fatigue failure for $[0]_s$ oriented CT specimens was parallel to the loading direction and perpendicular to the machined notch, as shown in Fig 7. The FCG data for the $[0]_s$ specimens is shown in Fig 8 in
