Model 0A Wind Turbine Generator FMEA

William E. Klein
National Aeronautics and Space Administration
Lewis Research Center
Plum Brook Station

Vincent R. Lalli
National Aeronautics and Space Administration
Lewis Research Center

Prepared for the
1990 Annual Reliability and Maintainability Symposium
cosponsored by the ASME, ASQC, IIE, IEEE, SOLE,
IES, AIAA, SSS, and SRE
Los Angeles, California, January 23-25, 1990

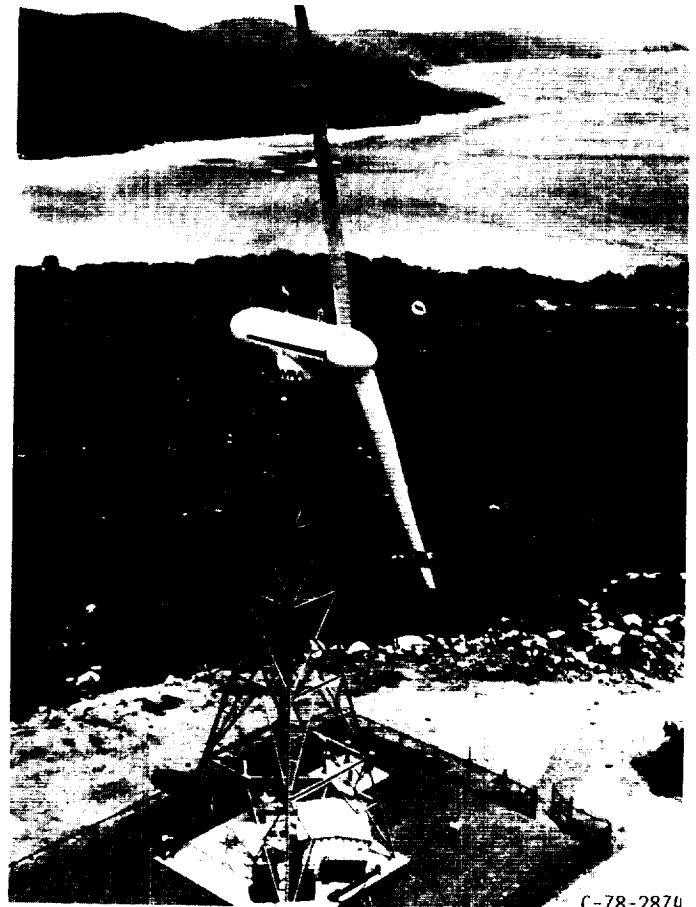
A photograph of one MOD-OA machine, located on Culebra Island, Puerto Rico, is shown as Fig. 1. Nearly identical machines were located in Clayton, New Mexico, Block Island, Rhode Island, and Oahu, Hawaii. The blades measured 125 ft, tip-to-tip. The hub center was 100 ft above ground level. The blades rotated at 40 rpm. The blades were mounted on the rotor hub, as shown in the cutaway drawing included as Fig. 2. The pitch actuator pitched the blades through a set of bevel gears located inside the hub. The hub was attached to a low-speed shaft which was connected to a speed increaser gearbox. A fluid coupling, attached to the 1800 rpm output shaft of the gearbox helped dampen out power oscillations. A high-speed shaft then transmitted power to V-belts which drove a synchronous alternator. The machine was housed in an 8-ft diameter nacelle.

FIGURE 1. - MOD OA WIND TURBINE AT CULEBRA ISLAND, PUERTO RICO.

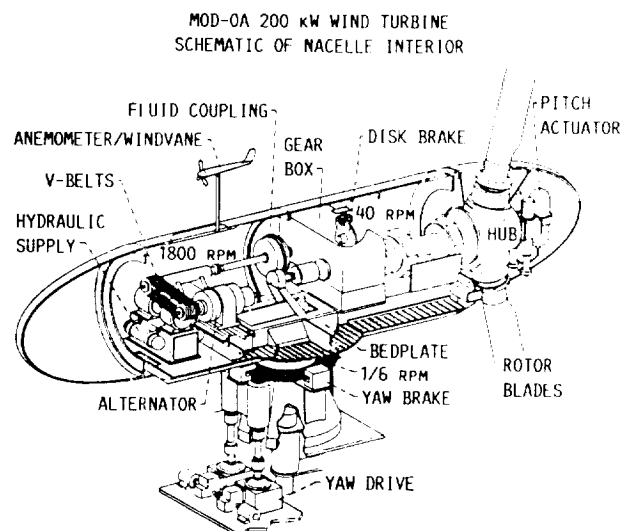
FIGURE 2. - CUTAWAY DRAWING OF TOWER MOUNTED EQUIPMENT.
