# **INDEPENDENT ORBITER ASSESSMENT**

## **ANALYSIS OF THE MAIN PROPULSION SYSTEM**

WORKING PAPER NO. 1.0-WP-VA86001-22

INDEPENDENT ORBITER ASSESSMENT  
ANALYSIS OF THE ORBITER MAIN PROPULSION SYSTEM

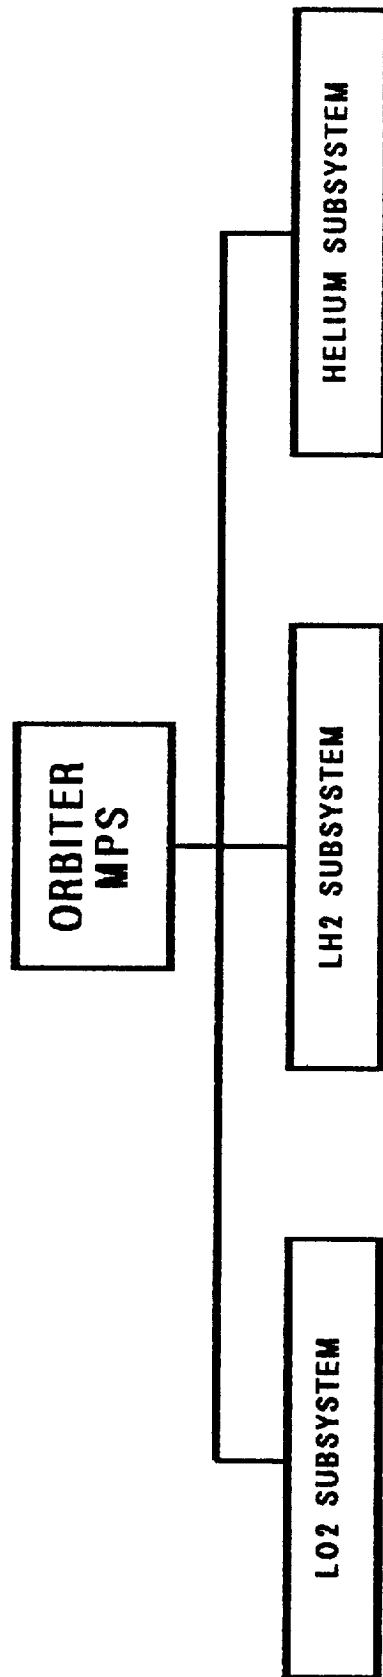
Figure 2A - ORBITER MPS SUBSYSTEMS

The Orbiter Main Propulsion System is composed of the Propellant Management Subsystem (PMS) consisting of the LO2 and LH2 subsystems and the Helium Subsystem (Figures 2A thru 2D). The PMS is a system of manifolds, distribution lines, and valves by which the liquid propellants pass from the ET to the SSMEs. Some of the propellants are vaporized in the engine and returned to the ET to maintain ullage pressure. The Helium Subsystem consists of a series of helium supply tanks and their associated regulators, check valves, distribution lines, and control valves. The Helium Subsystem supplies helium that is used within the SSMEs for in-flight purges and provides pressure for actuating SSME valves during emergency pneumatic shutdowns. The balance of the helium is used to provide pressure to actuate all the pneumatically operated valves within the PMS.

Figure 2 illustrates the hierarchy of the MPS hardware components.

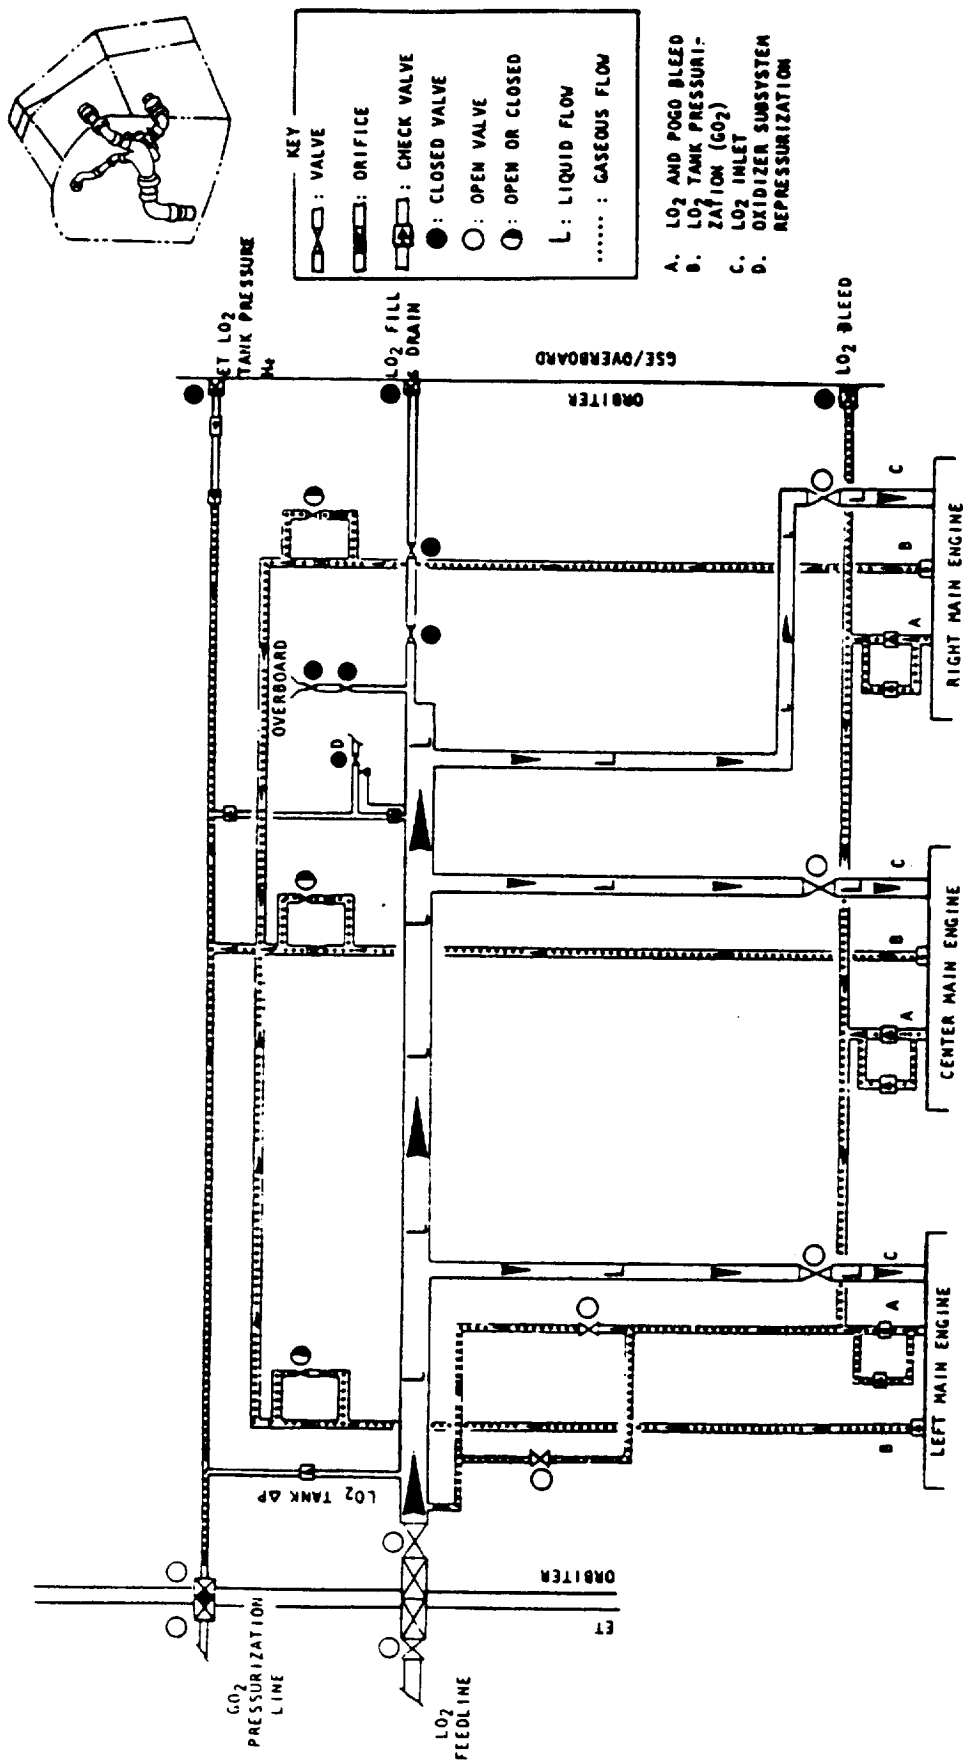
Figure 3 - PROPELLANT MANAGEMENT SUBSYSTEM OXIDIZER FLOW

During engine burn, propellants under tank pressure flow from the ET to the Orbiter through two umbilicals; one for LO2 and the other for LH2 (Figures 3 and 4, respectively).

The PMS contains the following major components (Figures 3 and 4).

- A. Liquid Propellant Supply and Distribution Network. The network is composed of all the liquid propellant lines used to load propellants during prelaunch, feed propellants to the SSMEs during engine burn, and dump residual propellants after ET separation. Specifically, the network consists of:

1. Propellant Feedline Manifolds - There are two 17-inch diameter manifolds in the Orbiter, one for LO2 and one for LH2. Both of the manifolds have a feedline disconnect valve at one end and two fill and drain valves (one inboard, one outboard) connected in series at the other end. The feedline manifolds connect to the ET liquid propellant

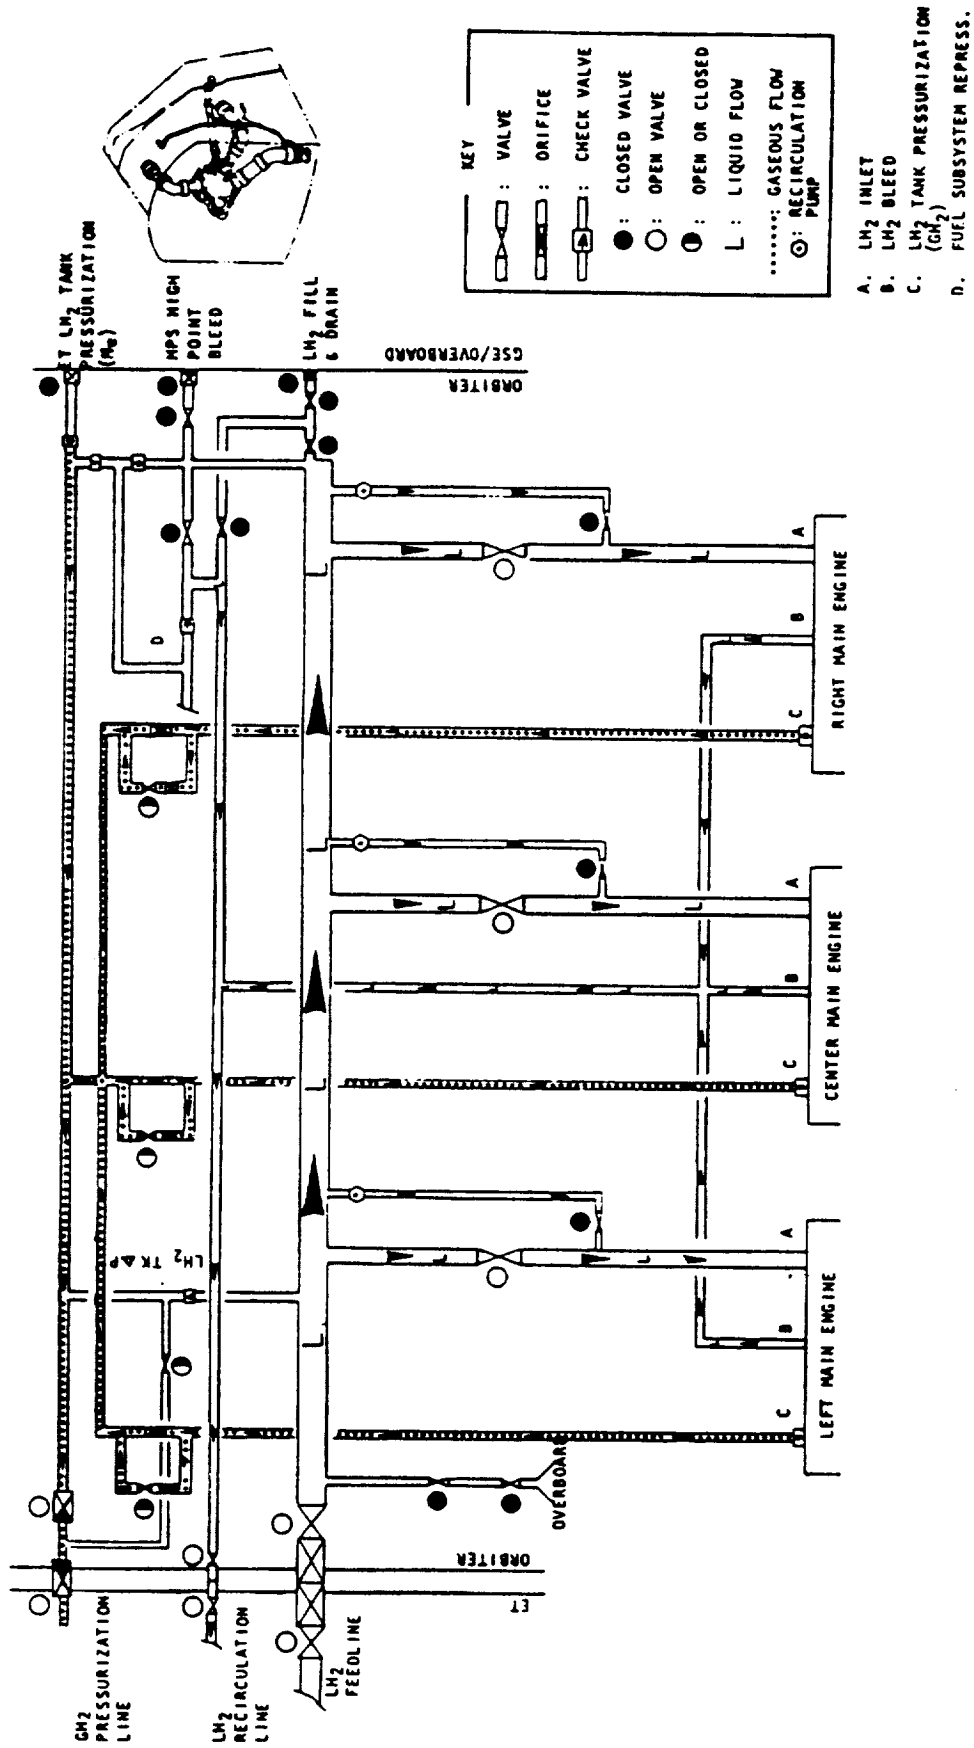
Figure 4 - PROPELLANT MANAGEMENT SUBSYSTEM FUEL FLOW

umbilicals at the feedline disconnect valve, and to either GSE liquid propellant umbilicals (prelaunch only), or overboard at the outboard fill and drain valves.

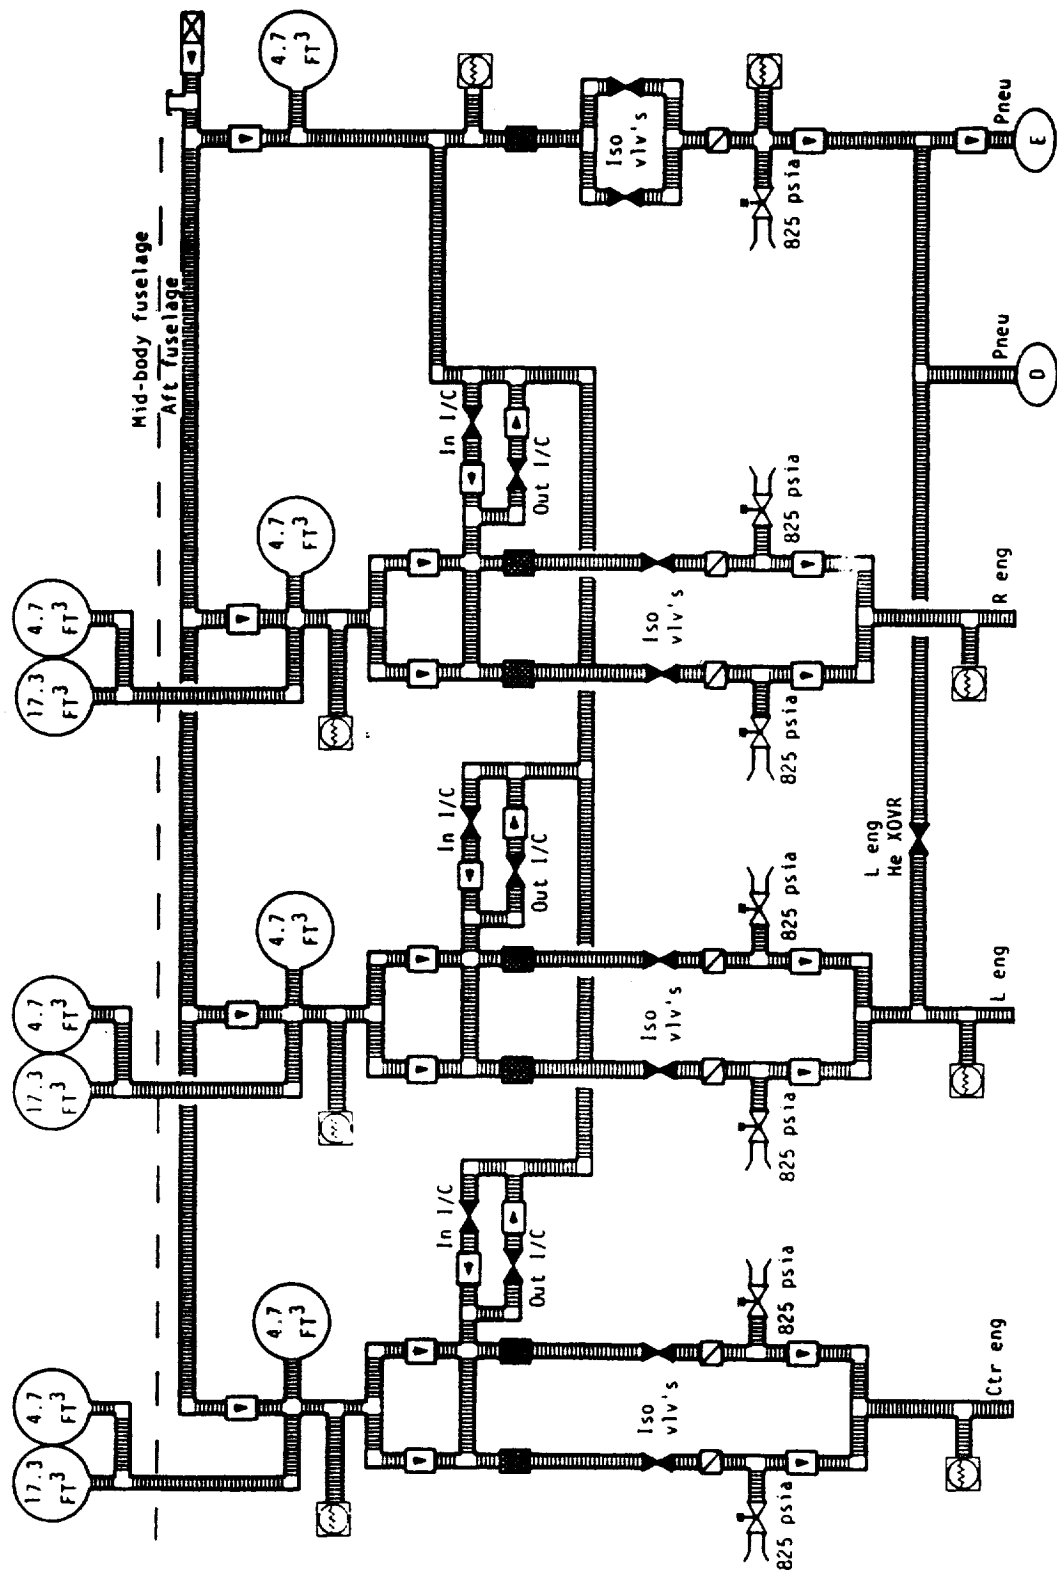
Figure 5 - HELIUM SUBSYSTEM; STORAGE AND REGULATION

The helium subsystem consists of seven 4.7-ft<sup>3</sup> helium supply tanks, three 17.3-ft<sup>3</sup> helium supply tanks, and their associated regulators, check valves, distribution lines, and control valves (Figure 5). Four of the 4.7-ft<sup>3</sup> helium supply tanks are located within the Orbiter aft of the payload bay area. The other three 4.7-ft<sup>3</sup> supply tanks and the three 17.3-ft<sup>3</sup> supply tanks are located below the payload bay liner and above the main landing gear cavity. Each of the 17.3-ft<sup>3</sup> supply tanks is plumbed to two of the 4.7-ft<sup>3</sup> supply tanks (one in the mid-body, the other in the aft body) to form three sets of three tanks. Each set of tanks, thus formed, normally provides helium to only one engine and for this reason is commonly referred to by the engine's designation; for example, "left engine helium." This helium is used for in-flight purges of engines, aft compartments, and provides pressure for actuating engine valves during emergency pneumatic shutdowns.

The remaining 4.7-ft<sup>3</sup> helium supply tank (the one which is not connected to a 17.3-ft<sup>3</sup> tank) is called the "pneumatic helium" supply tank. It normally provides pressure to actuate all of the pneumatically operated valves within the propellant management subsystem (Figure 5).
