NASA Technical Memorandum 101986

Undercutting of Defects in Thin Film Protective Coatings on Polymer Surfaces Exposed to Atomic Oxygen

Prepared for the
16th International Conference on Metallurgical Coatings
sponsored by the American Vacuum Society
San Diego, California, April 17-21, 1989

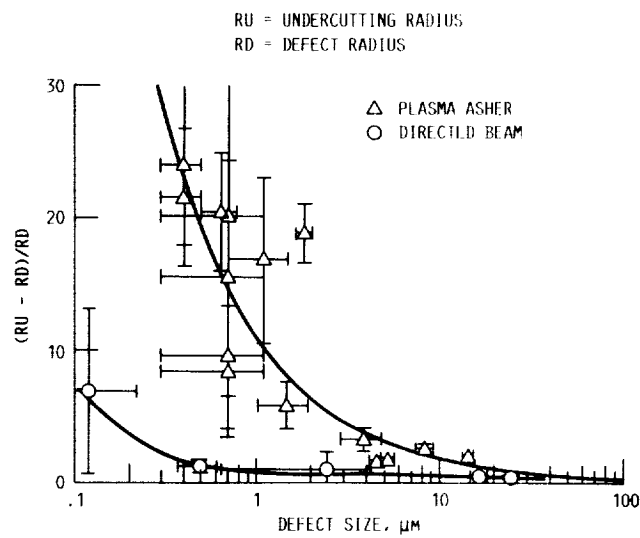
FIGURE 6. - EXTENT OF UNDERCUTTING IN COMPARISON TO THE ORIGINAL DEFECT SIZE FOR PLASMA ASHER EXPOSED AND DIRECTED BEAM EXPOSED SILICON DIOXIDE COATED KAPTON.

Energetic directed versus a thermal random oriented atomic oxygen arrival. - In the plasma of the asher, the atomic oxygen arrives with low energy (0.1 eV) from many different angles while in space the arrival is closer to a rotated, directed beam at higher energy (4.2 to 4.6 eV). To bound the degree of undercutting one might expect in LEO, data from the plasma asher was compared to that from a 57 eV directed oxygen ion beam exposure. The energetic ions would be expected to have a higher first impact reaction probability than in the plasma asher or LEO. Thus one could expect less undercutting, but deeper erosion of the Kapton at the site of the defect. Samples of the SiO₂ coated Kapton were exposed to atomic oxygen in the plasma asher and the directed beam for an equivalent fluence of 1.5x10²¹ atoms/cm² and 1.2x10²¹ atoms/cm² respectively which corresponds to almost 1 yr in the Space Station Freedom constant density orbit (ref. 10). Figure 5 contains the photomicrographs of these samples after exposure. Although undercutting is present for the sample exposed in the energetic directed beam (fig. 5(b)), the extent of undercutting in comparison to the size of the defect is smaller than for the plasma asher exposed defects. This is illustrated in figure 6. In general, the radius of undercutting compared to the defect size is smaller for larger defects in both cases as would be expected. A directed atomic oxygen beam rotating around a surface, which is closer to the arrival in LEO, would tend to produce more undercutting than a fixed directed beam.
