DOE/NASA/50111-2
NASA TM-101439

Hot Corrosion of Ceramic Engine Materials

Dennis S. Fox, Nathan S. Jacobson, and James L. Smialek
National Aeronautics and Space Administration
Lewis Research Center

Prepared for the
Twenty-sixth Automotive Technology Development
Contractors' Coordination Meeting
sponsored by the U.S. Department of Energy
Dearborn, Michigan, October 24-27, 1988

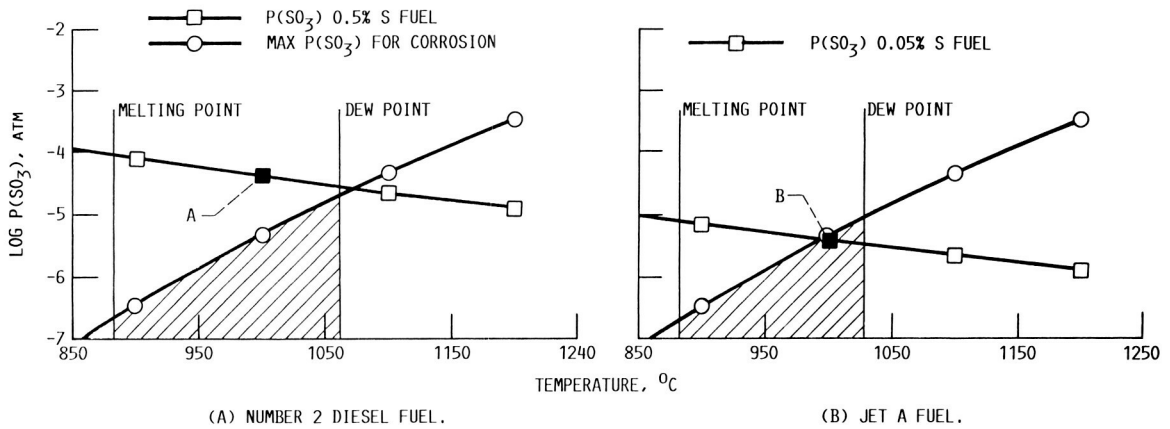
FIGURE 1. - CALCULATED CORROSION REGIME (SHADED AREA) FOR SiO_2 AS A FUNCTION OF TEMPERATURE AND SO_3 PARTIAL PRESSURE FOR (A) NUMBER 2 DIESEL FUEL AND (B) JET A FUEL. WITH NUMBER 2 DIESEL FUEL, THE $\text{P}(\text{SO}_3)$ LINE DOES NOT INTERSECT THE SHADED AREA AT 1000°C (POINT A) - CORROSION DOES NOT OCCUR. WITH JET A FUEL, THE $\text{P}(\text{SO}_3)$ LINE INTERSECTS THE CORROSION REGIME AT 1000°C (POINT B) - CORROSION DOES OCCUR. CORROSION OCCURS AT ALL TEMPERATURES WHERE THE $\text{P}(\text{SO}_3)$ LINE INTERSECTS THE SHADED AREA.

The NASA-CEC program can then be used to determine the partial pressure of SO_3 above the deposit in the combustion (e.g., turbine engine) environment. This is plotted as the lines through the square markers in figure 1. Dissolution of the protective silica scale is predicted in the region where these lines intersect the corrosion regime. Similar diagrams have been generated for a variety of conditions (ref. 16). It has been found that corrosion regimes are limited. However, when corrosion does occur it can be quite severe, as will be discussed.

To substantiate the predictions, high purity SiO_2 (quartz) coupons were exposed in the burner rig. It should be noted that these specimens were purer than that which would form on SiC or Si_3N_4 . At 1000 °C, the high partial pressure of SO_3 resulting from the use of number 2 diesel fuel is predicted to limit corrosion (point A in fig. 1(a) lies outside the regime). However, when low sulfur Jet A fuel is used, corrosion is predicted at 1000 °C (point B in fig. 1(b) lies inside the regime). These predictions were verified in the rig tests (ref. 16). Negligible dissolution took place in the former case, while considerable corrosion occurred in the latter.
