Damage Tolerant Composite Wing Panels for Transport Aircraft

Peter J. Smith and Robert D. Wilson

CONTRACT NAS1-16863
DECEMBER 1985

DAMAGE TOLERANT COMPOSITE WING PANELS FOR COMMERCIAL TRANSPORT AIRCRAFT

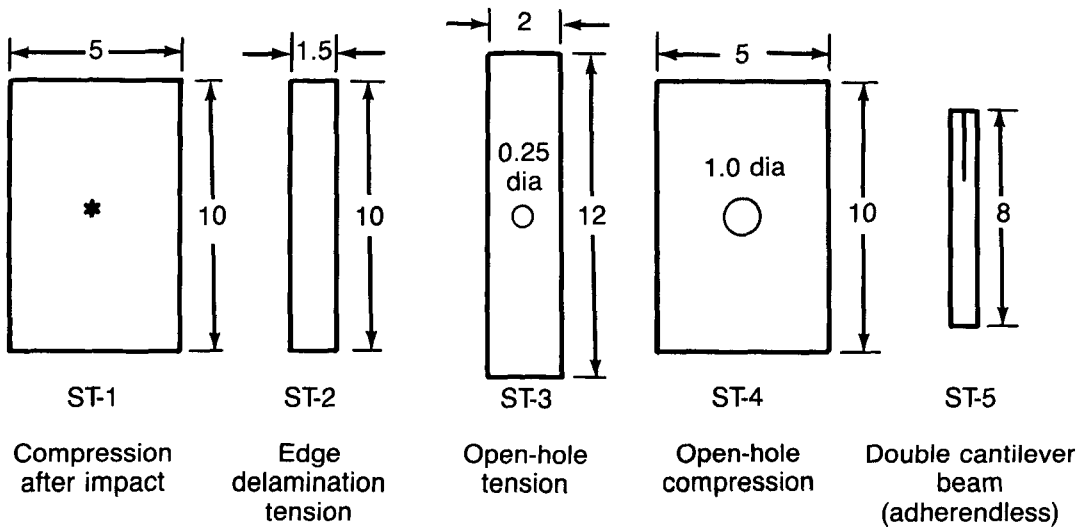
Figure 2. Standard Material Screening Tests

As a part of the development of more damage tolerant wing structure, several candidate toughened material systems were selected for evaluation in a material screening test program. NASA standard tests per reference 2 were used to evaluate these materials. These standardized tests (fig. 2) were mutually agreed upon by NASA, Boeing, Douglas, and Lockheed for use in the wing key technology contracts.

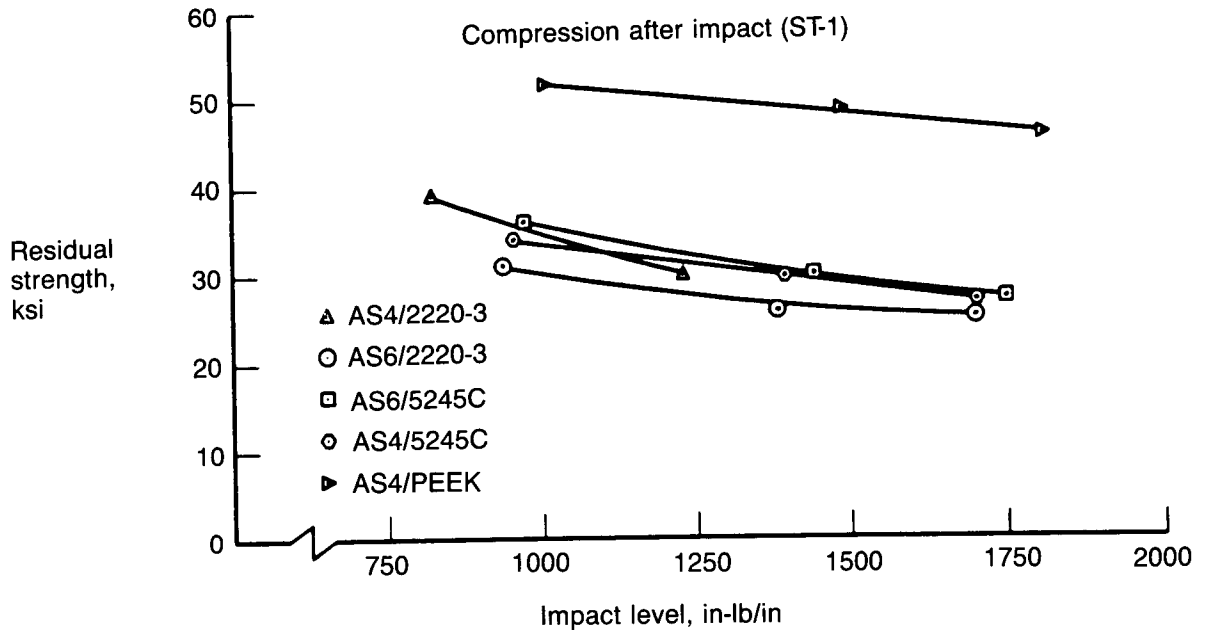
Figure 3. Compression After Impact Test Results

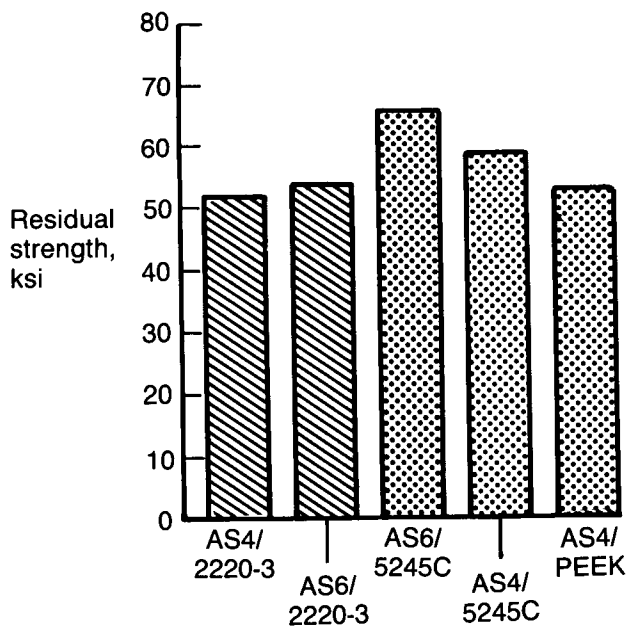
Figure 4. Open Hole Tension (ST-3) Test Results

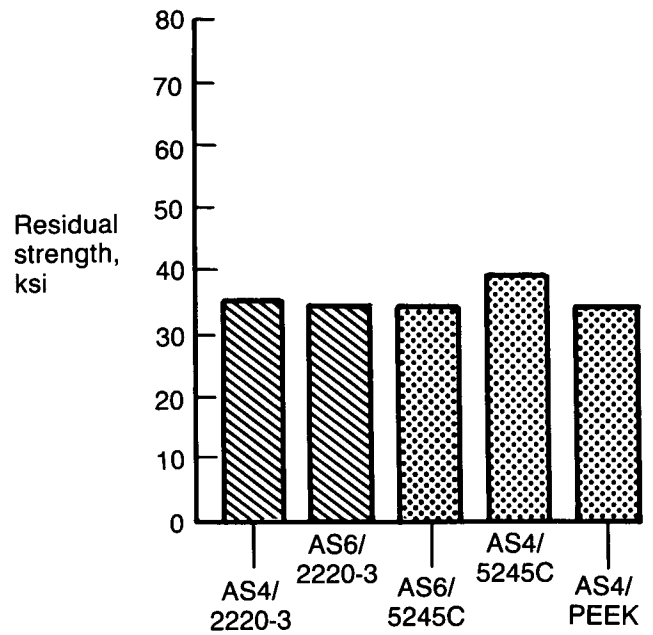
Figure 5. Open Hole Compression (ST-4) Test Results

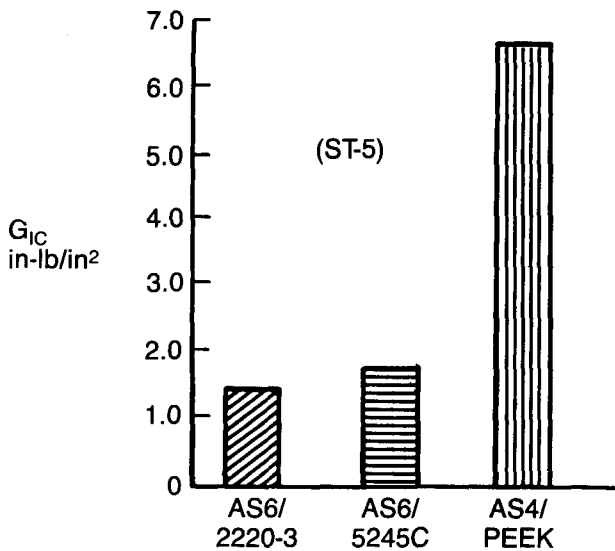
Figure 6. Mode I Fracture Toughness Test Results

Figures 6 and 7 present the results of the adherendless double cantilever beam (DCB) (ST-5) tests performed on the AS6/2220-3, AS6/5245C, and AS4/PEEK materials only.

The large panel damage tolerance program tests were performed to validate the final panel design. Four long column five-stiffener panels were tested in static compression to assess the effect of skin and stiffener damage on the ultimate, limit, and safe flight load capabilities of the final upper surface wing panel design. The panels were 37-in wide with five stiffeners and 60-in long to simulate two rib bays. Aluminum ribs were attached to the stiffener caps with C-clamps and the ends of the panels had cobonded doublers and were potted in order to provide stable load introduction. The panel design retained the enhanced panel damage tolerance features with the added feature that the rows of grid stitches in the skins were doubled. This reduced row spacing had demonstrated increased damage containment and residual compression-after-impact strength (ref. fig. 13) during the damage growth coupon test program. Three of the panels retained the skin-stiffener flange stitching of the enhanced panels, and one panel was fabricated without this feature. One other change from the enhanced panels was the selection of AS6/5245C material. This material had demonstrated an 11% increase in compression-after-impact strength (ref. fig. 3) and 20% increase in Mode I fracture toughness (ref. fig. 6) over the AS6/2220-3 baseline material during the material screening tests.

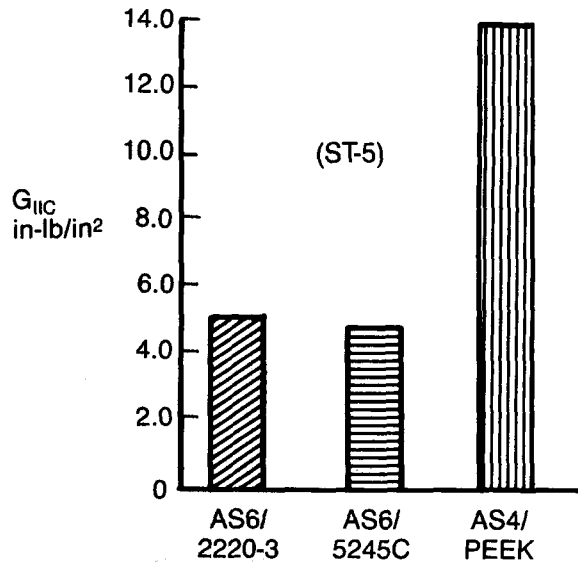
Figure 7. Mode II Fracture Toughness Test Results

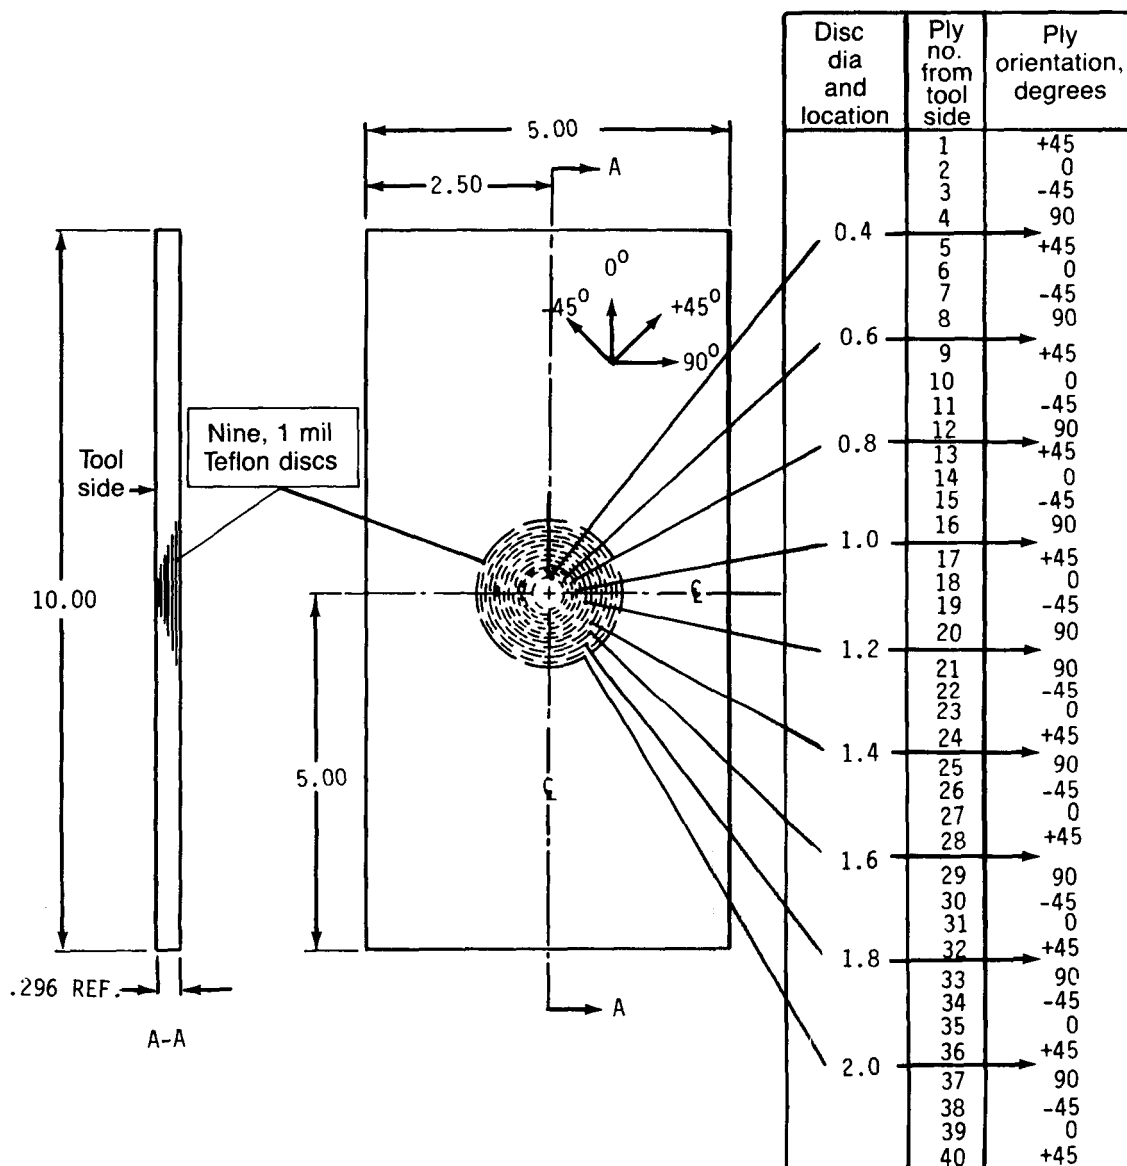
Figure 8. Simulated Impact Multidelamination Specimen Configuration

The toughened thermoset material, AS6/2220-3, was chosen as the Phase II baseline material for damage growth evaluations at both coupon and panel level. The purpose of the damage growth coupon test program was to evaluate the damage growth characteristics of low velocity impact damaged coupons after load cycling. The test program included five types of known initial damage, two fatigue environments, various different strain levels, and utilized the compression-after-impact coupon ST-4 (ref. fig. 2). The five types of known initial damage were: delaminations from 280 in-lb of impact energy; delaminations from 500 in-lb of impact energy; open hole with delamination damage; delaminations from 500 in-lb of impact energy in through-stitched laminates (Kevlar stitches in rows of four stitches/inch at both .25-in and .05-in row spacing); and multiple delamination simulation of impact damage, using nine Teflon discs of varying sizes inserted between plies in a cone-shaped arrangement through the laminate thickness. The configuration of the simulated multiple delamination specimen is presented in Figure 8.

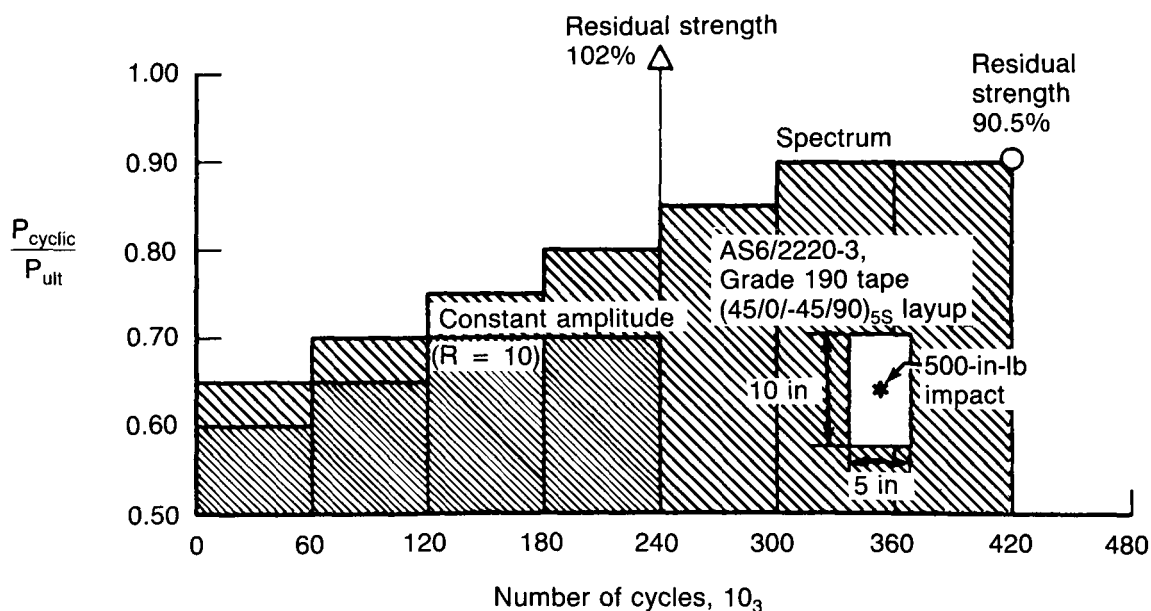
Figure 9. Fatigue Performance of 500-in-lb Impact Damaged Coupons

The maximum strain levels used during the damage growth cycling were selected based on the static strength of each damage type. For the constant amplitude ($R=10.0$) cycling, the strains at maximum cyclic load (P_{min}) were 60%, 65%, 70% up to 75% of those strains of the static strength (P_{ult}) of each damage type. For the spectrum fatigue cycling, the strains at the maximum load excursions (P_{min} cyclic) were 65%, 70%, 80%, 85%, and 90% of the strains at P_{ult} of each damage type. For all of the damage types, it was found that the constant amplitude cycling was much more detrimental to the delaminated laminates than the spectrum cycling. This can be seen in Figure 9 which presents the two fatigue environmental effects on specimens with similar damage types. The residual strength of the spectrum cycled specimen with seven total lifetimes of load cycling up to P_{min} cyclic/ $P_{ult} = 90\%$ was almost that of the constant amplitude cycled specimens with four lifetimes of load cycling up to $P_{min}/P_{ult} = 70\%$.

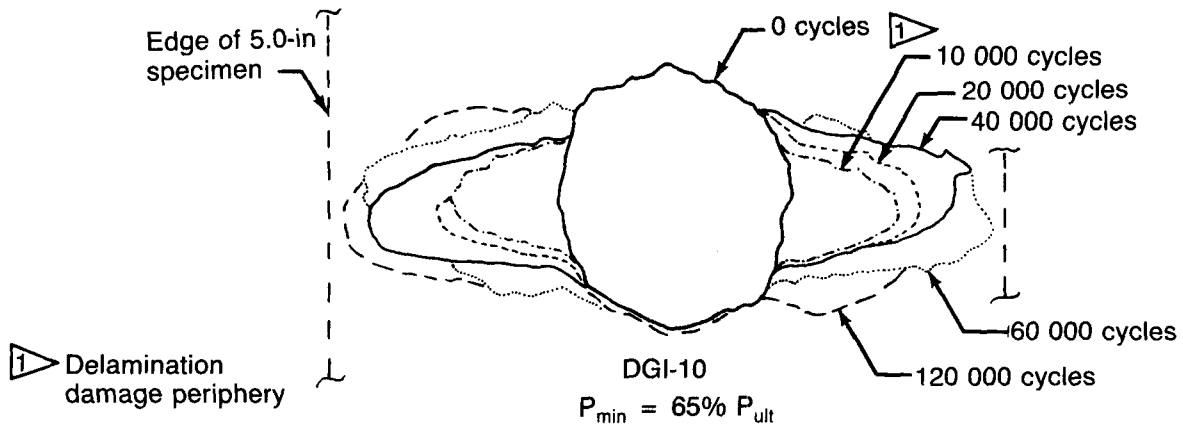
Total number of cycles = 120 000

Residual compression load = 33.4 kpis (22.6 ksi, 0.0035 in/in)

Figure 10. Damage Growth of 280-in-lb Impact-Damaged Specimen Subjected to Constant Amplitude ($R = 10.0$) Cycling

In general, little or no damage growth was detected for those specimens subjected to the spectrum fatigue, even at maximum cyclic loads up to 80% of P_{max} . Of the specimens cycled at constant amplitude fatigue, only those specimens containing simulated delaminations and delamination damage around a 1.0-in diameter open hole displayed significant internal damage growth. Figures 10 and 11 present the results of constant amplitude cycling on both damage types. Even on these damage types, the strain levels that promoted damage growth were 65% and 70% of the ultimate strains for those damage types. The constant amplitude strain that grew damage for the specimen with delaminations around the 1.0-in diameter hole was 0.0028 and that for the simulated impact damaged specimen was 0.0024. The maximum load, which occurs once every 5000 flights in the 767 cyclic fatigue spectrum, is equivalent to 0.0029 strain for an upper wing surface designed to 0.006 ultimate strain. The only damage type which exhibited damage growth strain below this level for spectrum fatigue cycling was the simulated delamination specimen. This specimen was designed to simulate an impact damage of 280 in-lb energy, but when tested uncycled, demonstrated only 76% of the static strength of an uncycled specimen with 280 in-lb of impact damage, indicating that it is not representative of typical impact damage.

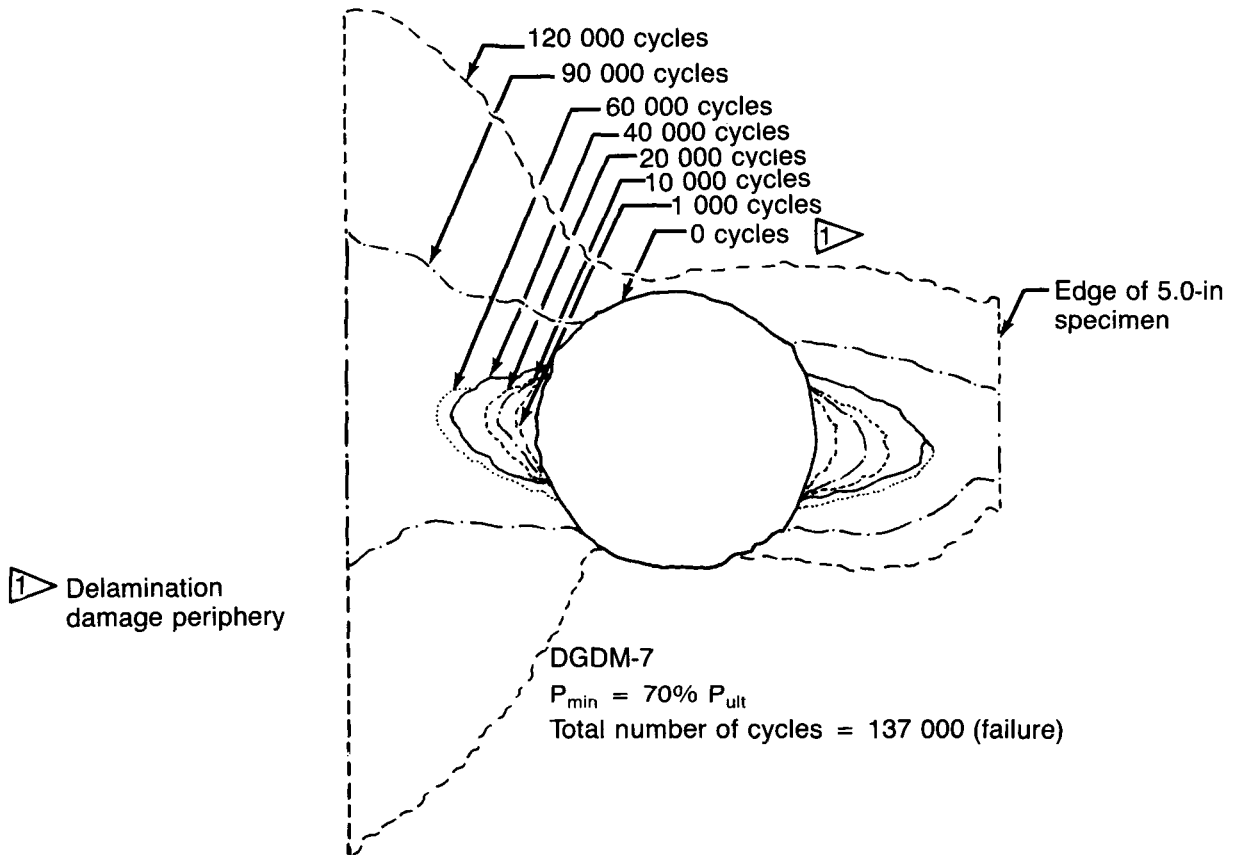
Figure 11. Damage Growth of Simulated Multiple Delamination Specimen Subjected to Constant Amplitude ($R = 10.0$) Cycling

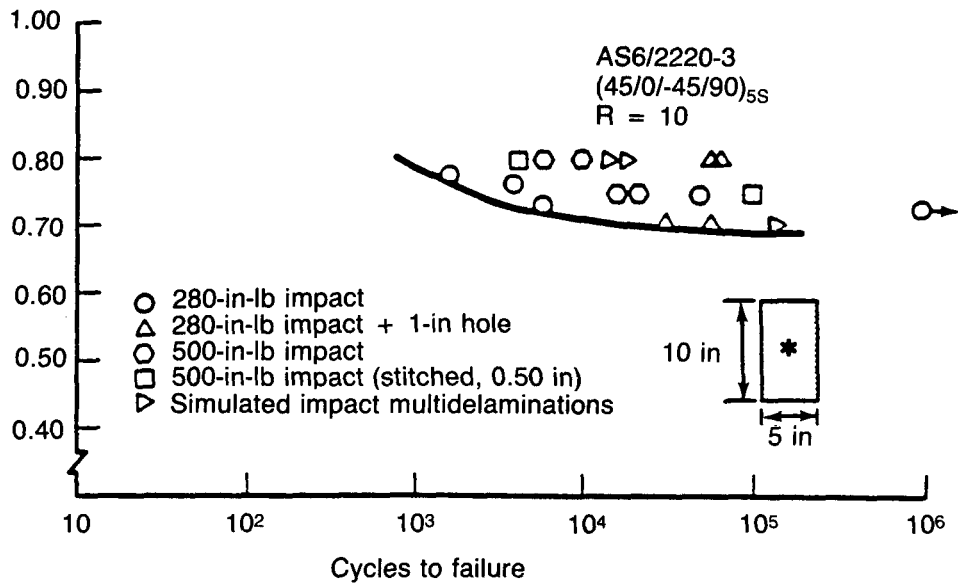
Figure 12. Fatigue Performance of Impact Damaged Coupons

Figure 12 presents the constant amplitude fatigue performance of the damage types tested showing fatigue endurance runout at about 70% of the static strengths. Figure 13 presents the residual static compression strength of all of the damage types for both uncycled and cycled specimens. The fatigue loaded specimens had all been cycled for several lifetimes and their residual compression strengths had degraded very little from the uncycled strengths. The specimens with Kevlar stitches at 0.25 row spacing which had been subjected to 500 in-lb impact damage exhibited the best static and fatigue compression after impact strength.

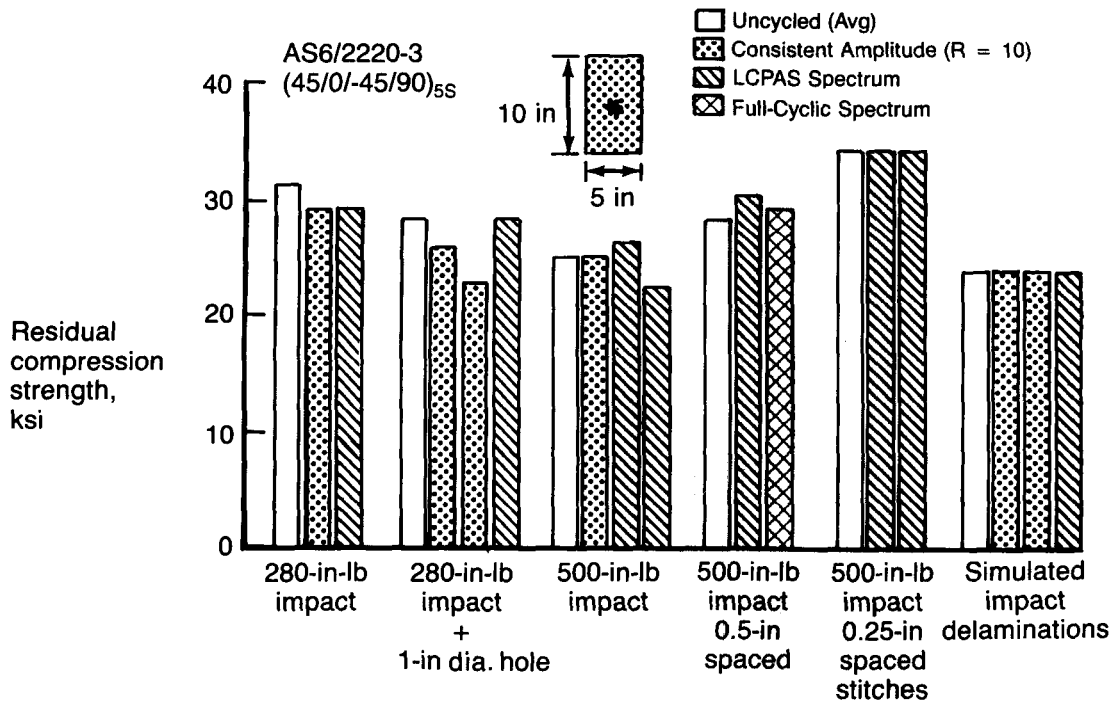
Figure 13. Residual Compression Strength of Impact Conditioned Specimens After Fatigue Cycling

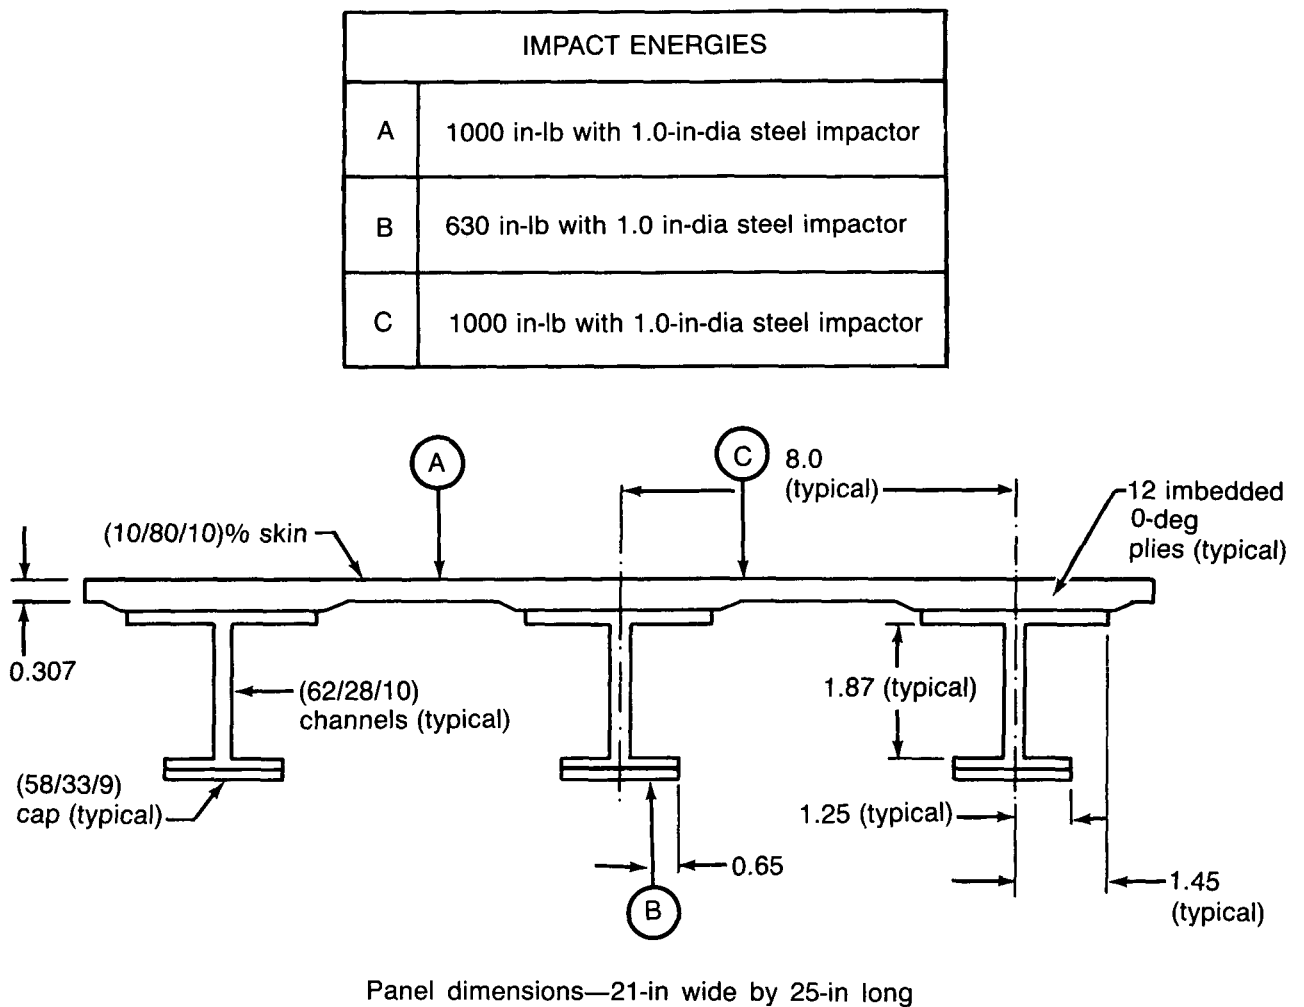
Figure 14. Baseline Panel Configuration and Impact Locations

The critical impact locations highlighted in the wing damage study were addressed in this test program. These impact locations and energy levels are presented in Figure 14. The skin impact damages (A) and (C) were not easily visible with impact dents in the laminate surfaces of approximately 0.03 inch. The stiffener cap impact (B) was more visible with a larger dent, approximately .06-in deep.

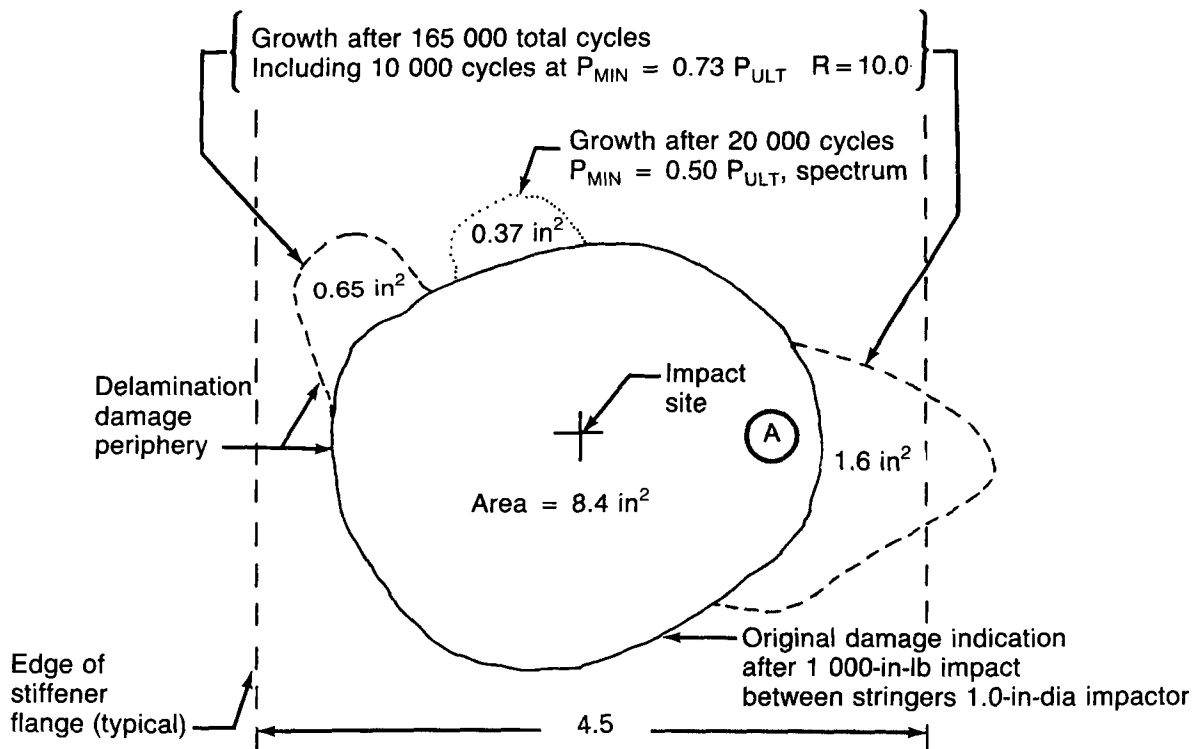
Figure 15. Damage Growth Results of Fatigue Cycling of Impact Damage Panel 65C23890-2

After 5000 cycles, the panel was reinspected and again no damage growth was detected. The maximum cyclic loading was increased to P_{min} equal to 495 kips (73% of P_{ult} and P/AE strain of .0044). This time damage growth was detected after 10,000 cycles. The load cycling was continued and another inspection performed after 10,000 additional cycles. No damage growth was detected and the cycling was continued again. The panel failed through the damage after 9660 additional cycles at $P_{min}=.73 P_{ult}$. Figure 15 presents the damage growth and initial impact damage size for this panel.

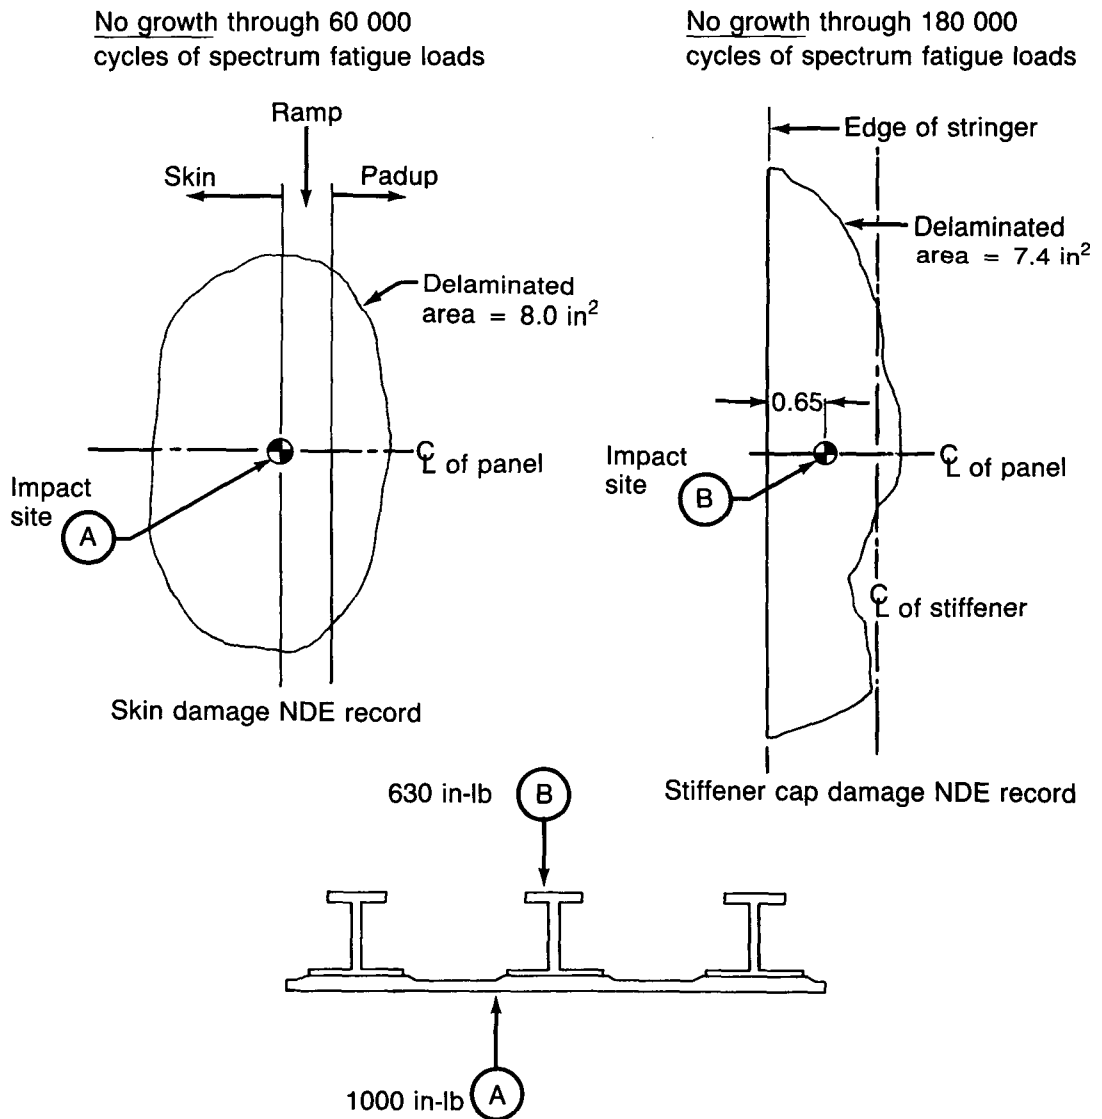
Figure 16. Damage Growth Results of Fatigue Cycling of Impact Damaged Panel 65C23890-3

The third baseline panel, 65C23890-3, was impacted on the central stiffener cap at location (B) (ref. fig. 11) with 630 in-lb of energy. This impact level had been determined to produce barely visible stiffener cap damage from the results of a Boeing IR&D studies, but the actual damage incurred was easily visible. The panel was cycled in spectrum fatigue for two lifetimes (120,000 cycles) and two limit load surveys without any damage growth detected during periodic pulse echo inspections. The maximum cyclic load (P_{min}) was 340 kips (50% of P_{ult} at P/AE strain of .0030). The panel was then removed from the test machine, impacted on the skin at the panel centerline at location (A) (ref. fig. 14) with 1000 in-lb of energy. The panel was then spectrum cycled to one more lifetime with P_{min} equal to 50% of P_{ult} . No damage growth at either damage site was observed during the periodic pulse echo inspections. The panel was then being loaded to limit load (450 kips) when two-piece failure occurred at 430 kips (96% of design limit load and P/AE strain of 0.0038). The failure occurred at the center of the panel through both damage sites. The NDE history for panel 65C23890-3 is presented in Figure 16.

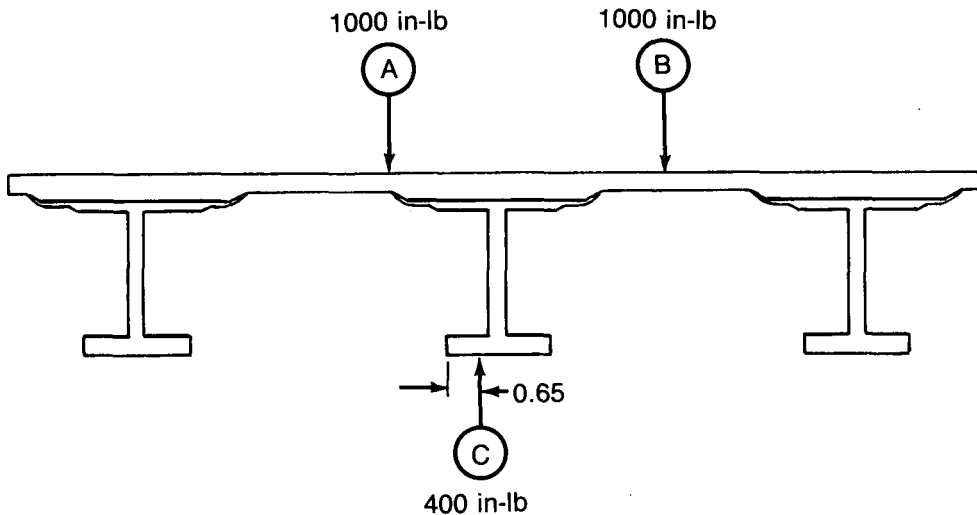
Figure 19. Enhanced Test Program Impact Locations and Energy Levels

Three-stiffener test panels were fabricated from AS6/2220-3 material to provide a direct design comparison with the baseline three-stiffener panel tests. Stiffener spacing and panel dimensions were identical. The test program included three panels tested in static compression to determine the damage tolerance of the enhanced design. The baseline damage growth panel test program had shown that durability was not as critical as damage tolerance. The Phase 1 panel tests had demonstrated that the ultimate load case with barely visible damage was the most critical design case. Figure 19 presents the enhanced panel impact damage locations and energy levels.

The 1000 in-lb impacts to the skins were similar to those of the baseline panel tests. The 650 in-lb impact to the baseline panel stiffener cap had produced damage which was considered greater than barely visible; therefore, the enhanced panel stiffener cap damage was reduced to 400 in-lb. The results of the pulse echo NDE inspections of the skin impacts at location (A) on panel 65C23891-1 and location (B) on panel 65C23891-2 are presented and compared to the results of the baseline panel skin impact inspections in Figure 20. It can be seen that the 0.50-in row spaced grid stitching of the skins significantly reduces the area of delaminations caused by the impacts. Each of the impacts caused barely visible damage and the associated dents were less than 0.05-in deep.

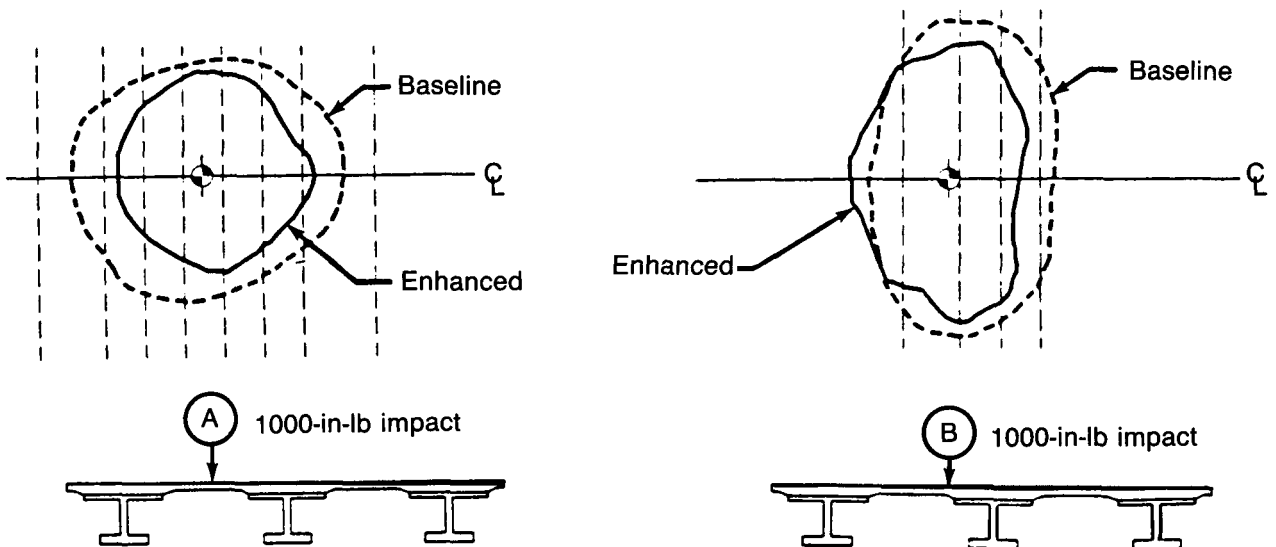
Figure 20. NDE Records of Impact Delaminations, Baseline Versus Enhanced Designs

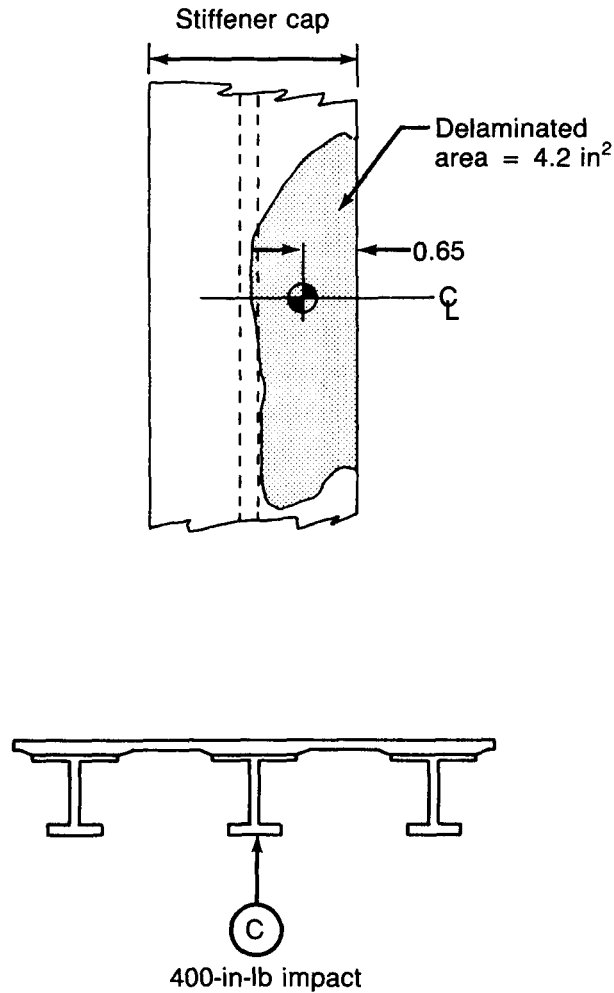
Figure 21. NDE Record of Impact Delaminations in Center Stiffener Cap of Panel 65C23891-3

Figure 21 presents the results of the NDE inspection of the stiffener cap damage of panel 65C23891-3. It can be seen that even the reduced level of impact energy still caused a large area of delaminations in the cap, 4.2 in² compared to 7.4 in² of the baseline 630 in-lb of impact energy.

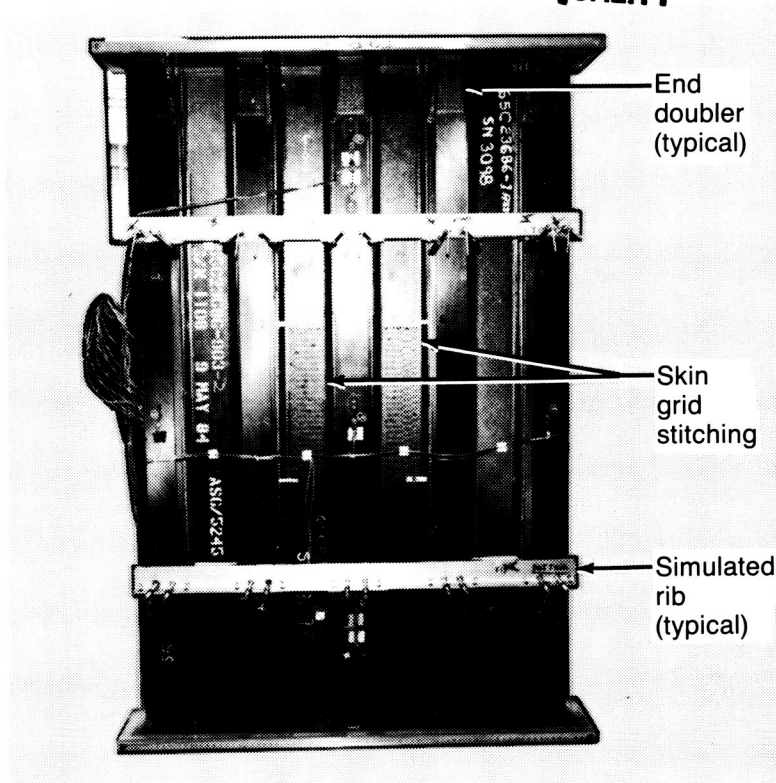
Figure 22. Five-Stiffener Test Panel

The five-stiffener panel test configuration is presented in Figure 22. The end-potting, cobonded doublers, and simulated ribs are shown together with installed test instrumentation. The instrumentation consisted of axial strain gages to record panel strains, deflectometers to record out-of-plane deflections, and acoustic emission transducers to monitor damage growth. The skin side of the panels was painted with Moire fringe material in order to provide a record of any skin deflections and buckles.

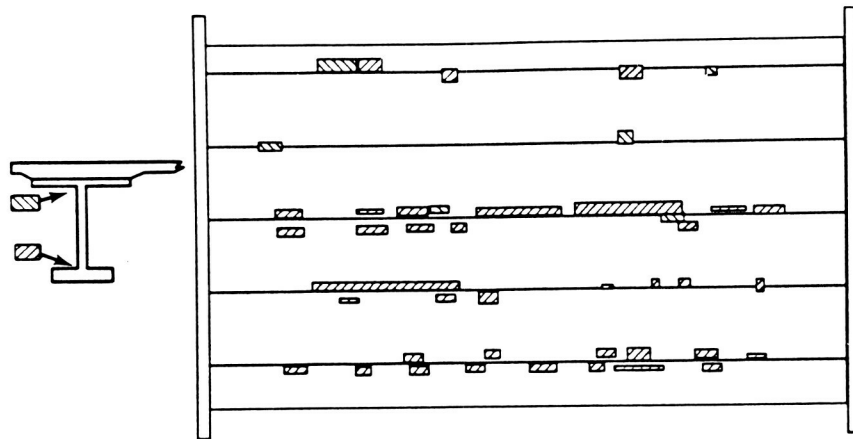
Figure 23. Pulse Echo Indications of Anomalies in Panel ①

Each of the panels was tested to two-piece static compression failure. All panels failed through their damage sites. The results of the enhanced panel tests are presented in Table 8. The two panels with the impact damage in the skin yielded an average of 15% greater residual compression strength than the stiffener damaged panel. All three stiffeners were completely detached from the skin after failure of the stiffener damaged panel. The panels with the skin damage did not exhibit this interface failure. Panels 65C23891-2 and 65C23891-3 had NDE indications of voids or cracks and delaminations in the skin flanges of the stiffener adjacent to the precured strips in the skin-stiffener interfaces. Panel 65C23891-3, with the stiffener cap damage, had more of these indications than panel 65C23891-2. The effect of these anomalies on the structural integrity of the panel skin-stiffener interface is not known. The NDE inspections of the five-stiffener panels (ref. fig. 23) revealed considerably more of these anomalies.

During the fabrication of the five-stiffener panels, a number of material processing problems arose. The AS6/5245C material was difficult to use because of lack of tack and boardiness. These material problems made stiffener ply lay-down on the tools extremely difficult. Each ply was compacted after lay-down as standard practice, but the complete compaction of the stiffeners and skin-stiffener interfaces containing the cobonded precured strip was in doubt. The pulse echo inspection results of the completed panel ① are shown in Figure 23. Panels ②, ③, and ④ had similar, but fewer, pulse echo indications.

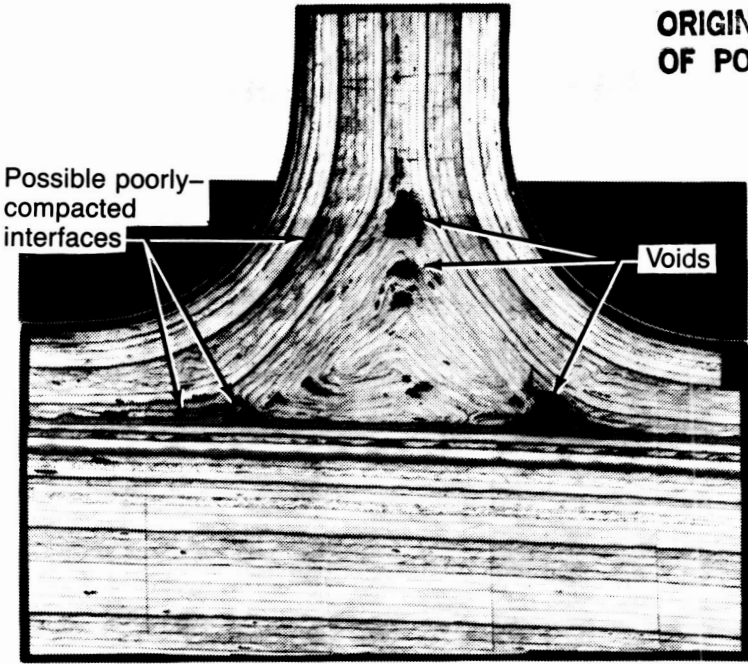
Figure 24. Photomicrograph of Sectioned Stiffener and Skin Area

End trim from panel ① was sectioned through a number of the pulse echo indicated areas, and photomicrographs were taken. Figure 24 presents a photomicrograph of one of these sections. A number of voids and suspect compaction areas can be clearly noted in the stiffener radius and stiffener-skin interface.

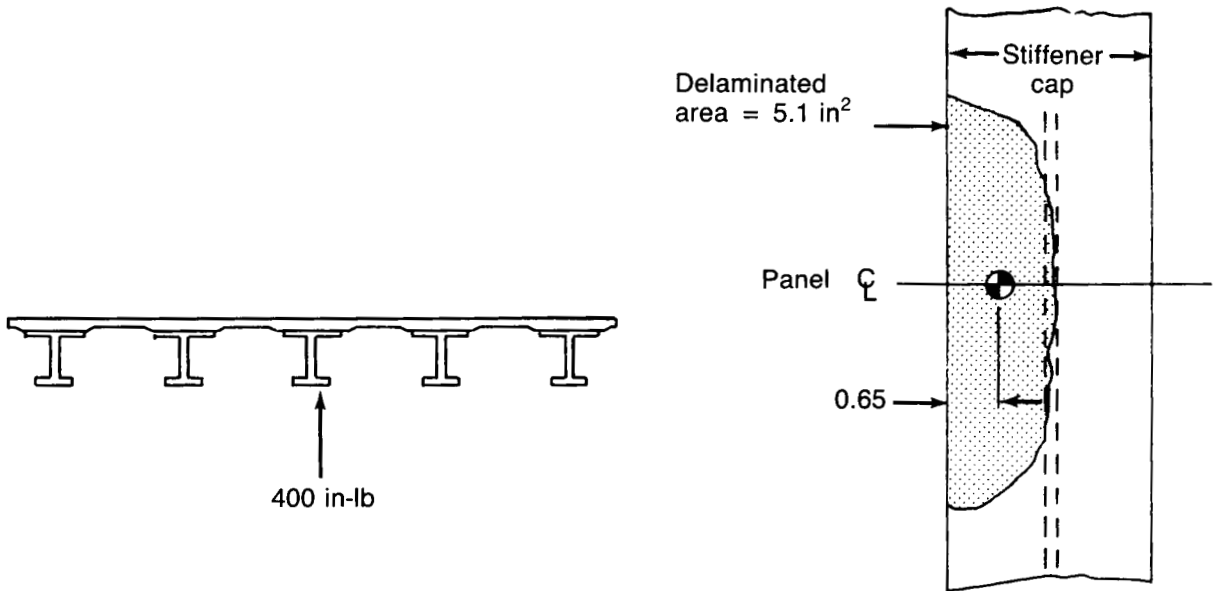
Figure 25. Stiffener Cap Damage to Panel ①

The results of the pulse echo inspections of the impact sites for the 400 in-lb stiffener damage of panel ① and the 2000 in-lb skin damages of panels ② and ③ are presented in Figures 25 and 26. The total area of delamination discovered in the stiffener cap of panel ① after a 400 in-lb impact with a 1.0 diameter steel impactor was larger than of the three-stiffener enhanced stiffener cap after a similar impact (ref. fig. 21). The damage was also more visible with some evidence of the stiffener cap being bent at the impact site.

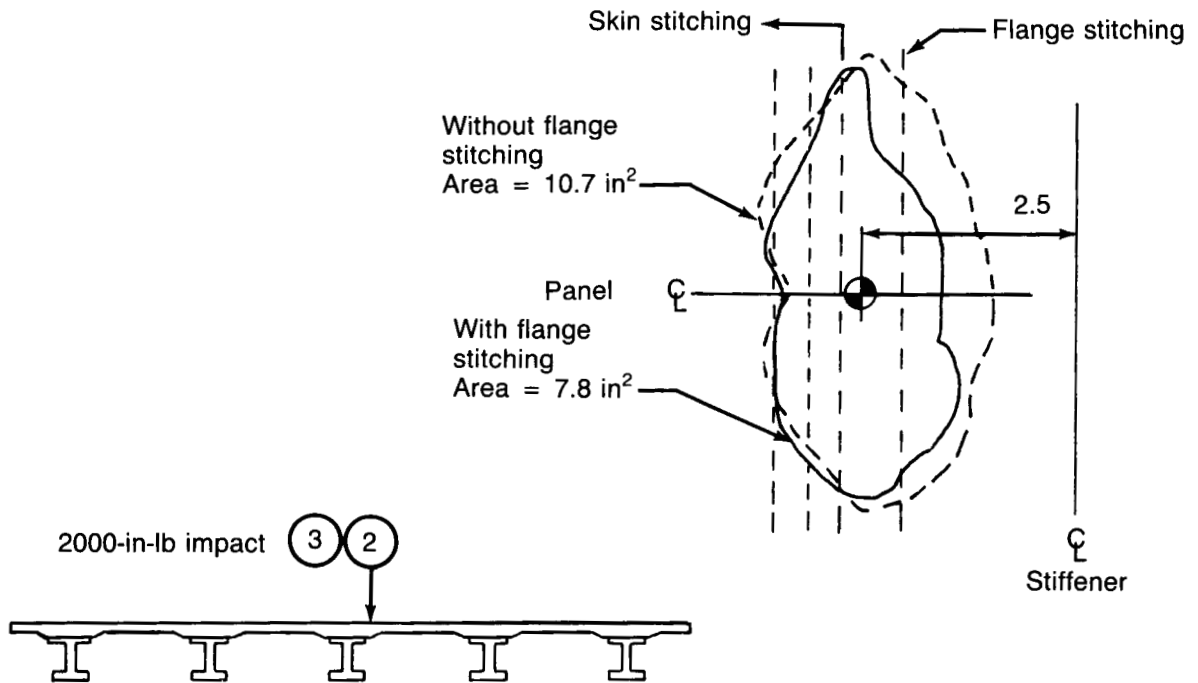
Figure 26. Inspection Results of Impacted Skins of Panels ② and ③

The 2000 in-lb impacts, with a 0.5-in diameter impactor, on the skins of panels ② and ③ produced visible surface damage. The dents were in excess of .07-in with some fiber breakage, and fiber break-out on the backside of the skin. Panel ②, which featured the skin-stiffener flange stitching, was found to have less total delaminated area than the non-flange-stitched panel ③.

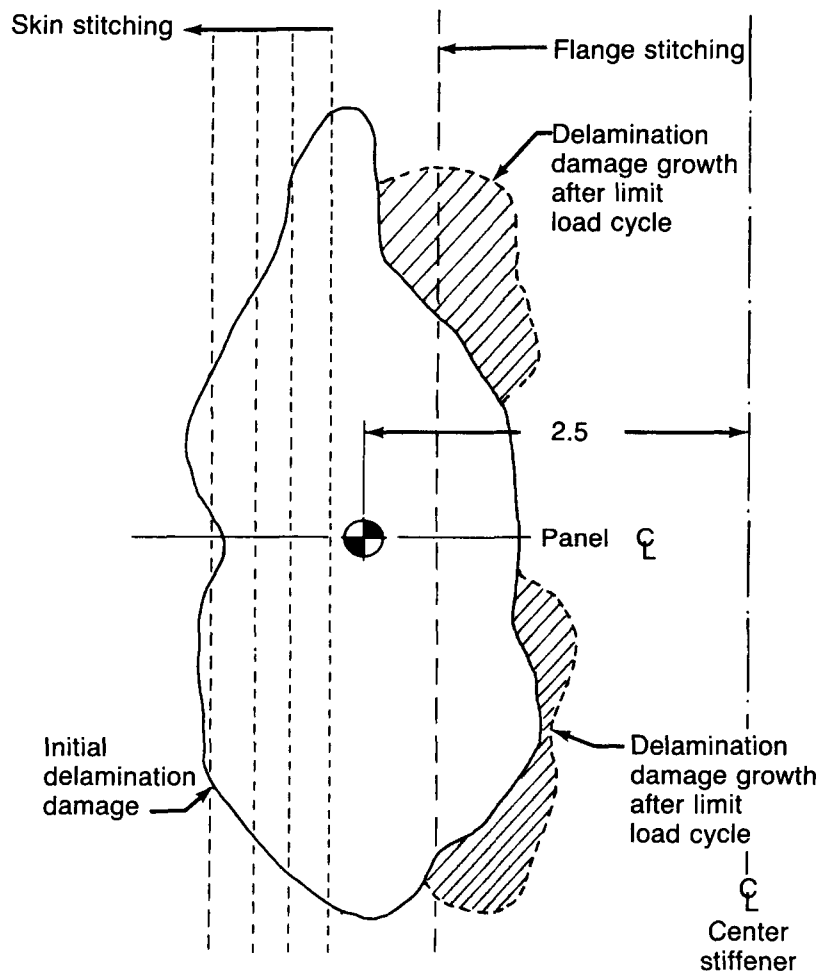
Figure 27. Pulse Echo Indications of Damage Growth After Limit Load Cycle of Panel ②

Panel ②, with the 2000 in-lb impact damage to the skin, was initially tested to the design limit load of 785 kips. Some delamination growth occurred (ref. fig. 27) due to this load which represents 20 kips/inch end load and a P/AE strain of .0041. The damage was increased incrementally by sawcut as shown in Figure 28. The panel was loaded to the continued safe flight load of 470 kips after each sawcut increment. There was no further evidence of growth due to these load cycles. After the third sawcut extension with the skin, central skin pad-up and stiffener flange completely severed with the 0.25-in wide sawcut for a length of 6.4 in, the panel was tested to determine the residual compression strength with this severe damage. The panel failed at a load of 573 kips which represents 122% of the continued safe flight load and a P/AE gross area strain of .0030. The failure, shown in Figure 29, was through the damage site with the skin and stiffeners fractured. There was no evidence of skin-stiffener separation except locally adjacent to the failure.

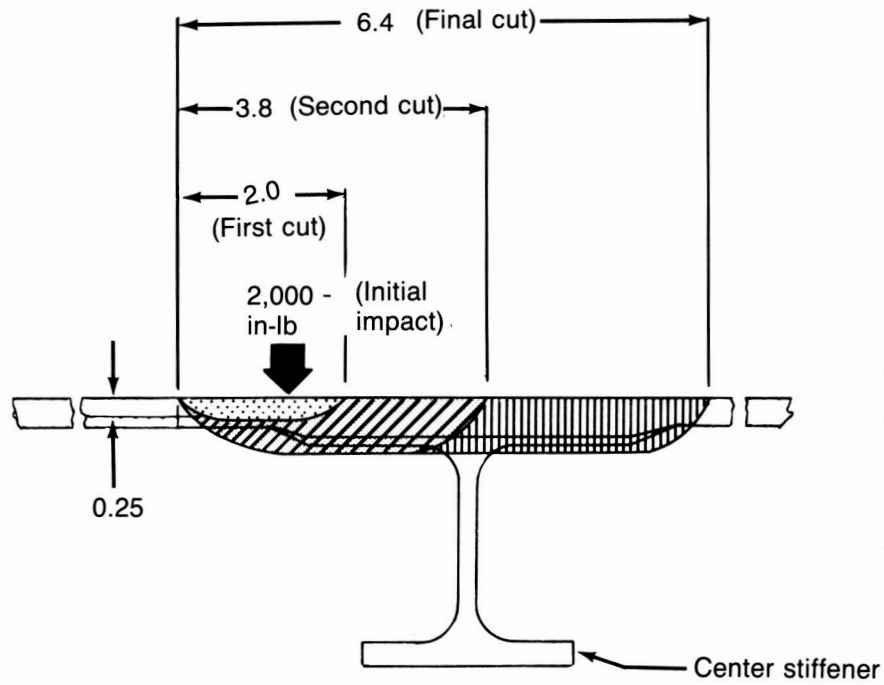
Figure 28. Sawcut Damage Increments of Panel ②

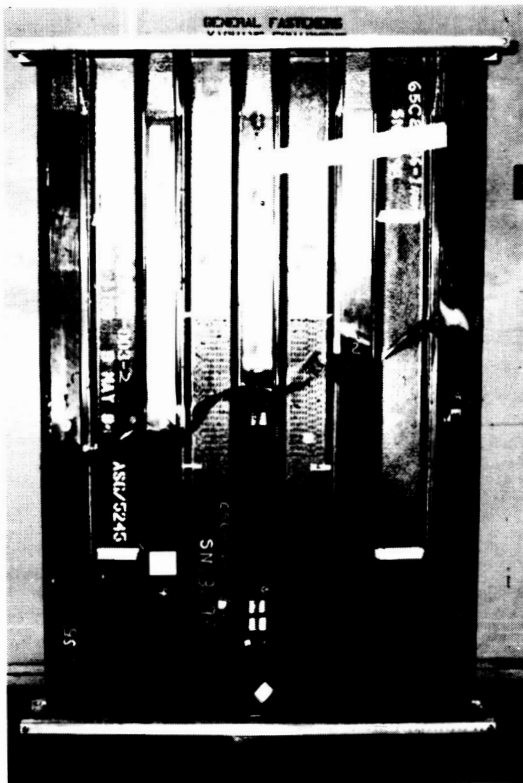
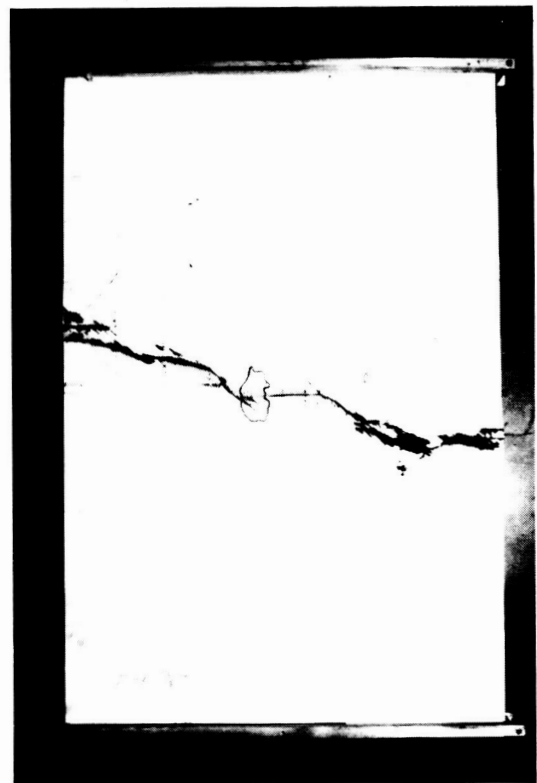
Figure 29. Failure of Panel ② After Sawcut Damage
