Damage Tolerant Composite Wing Panels for Transport Aircraft

Peter J. Smith and Robert D. Wilson

CONTRACT NAS1-16863
DECEMBER 1985

DAMAGE TOLERANT COMPOSITE WING PANELS FOR COMMERCIAL TRANSPORT AIRCRAFT

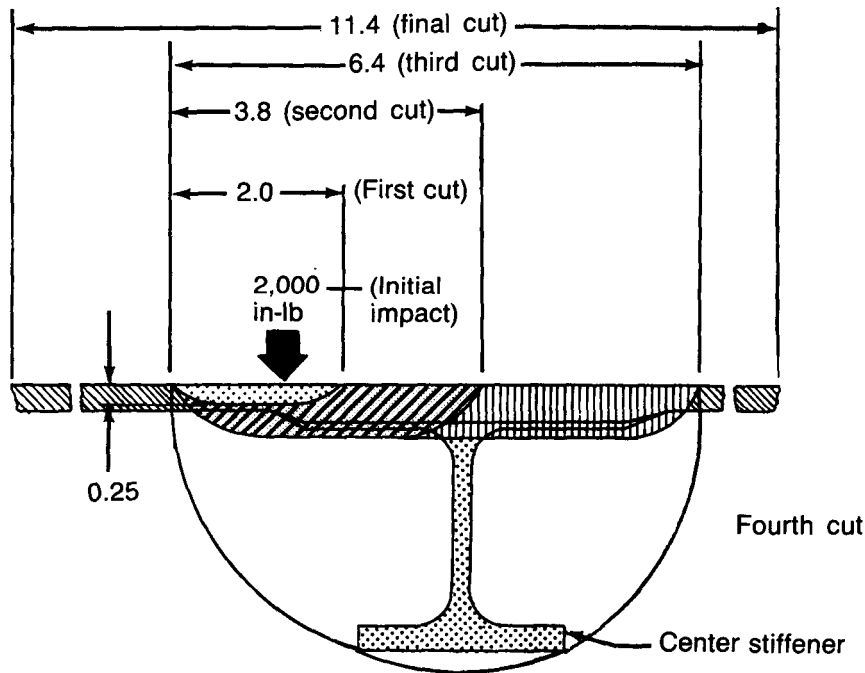
Figure 30. Sawcut Increments of Panel ③

The loading sequence for panel ③ was similar to that of panel ②. The panel did not contain the skin-stiffener-flange stitching of panel ② and the area of delamination damage due to the initial impact of 2000 in-lb was larger than that of panel ②. The panel was initially tested to limit load and no damage growth was recorded due to this load cycle. The damage was then increased incrementally by sawcutting as shown in Figure 30.

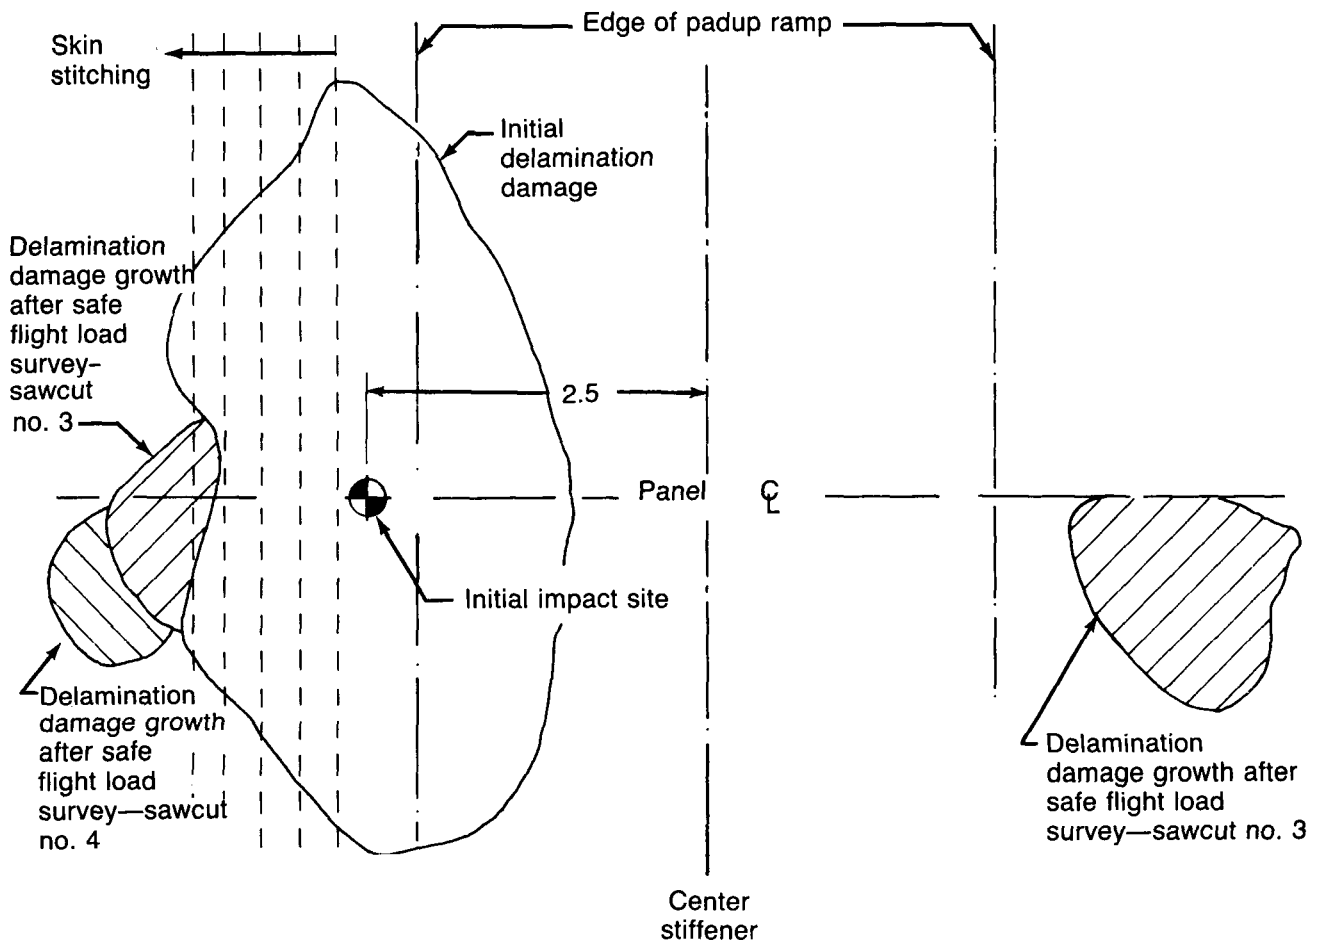
Figure 31. Pulse Echo Indications of Damage Growth in Panel ③

The panel was loaded to the continued safe flight load after each sawcut increment. There was damage growth discovered after the safe flight load surveys of the third and fourth sawcut increments as shown in Figure 31. After the fifth sawcut extension with the center stiffener, skin pad-up, and skin completely severed for a total of 11.4 inches, the panel failed at a load of 460 kips. This load represented 98% of the continued safe flight load and a gross P/AE strain of 0.0024. The failure, similar to that of panel ②, was through the damage site with skins and stiffeners fractured.

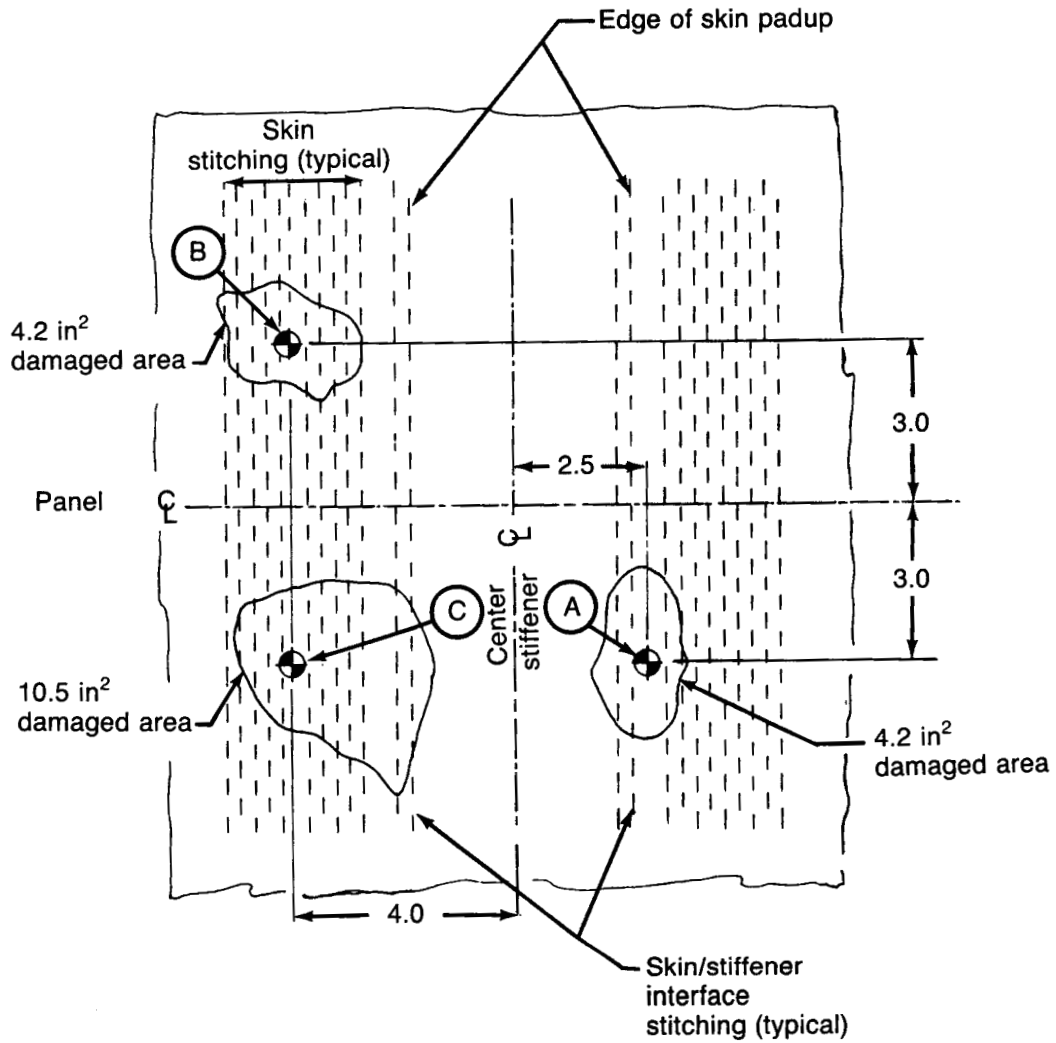
- Ⓐ 1000 in-lb (1-in-dia impactor) on skin at edge of ramp
- Ⓑ 1000 in-lb (1-in-dia impactor) on skin between stiffeners
- Ⓒ 2000 in-lb (0.5-in dia impactor) on skin between stiffeners

Figure 32. Impact Sites and Pulse Echo Inspection Results of Panel ④

Panel ④ was tested to the ultimate compression load condition with multiple impact damage. The panel was initially impacted with 1000 in-lb of energy, using the 1.0-in diameter steel impactor, on the skin at the edge of the pad-up ramp at site (A) as shown in Figure 32. The damage was barely visible with a dent of less than .04-in. The panel was loaded to the ultimate load of 1178 kips without failure. This load represents 52 KSI stress and a P/AE strain of 0.0062. The post-test pulse echo inspection indicated no damage growth.

The panel was again impacted with 1000 in-lb of energy at site (B) on the skin between stiffeners. The damage was again barely visible with similar delaminated area indications to the impact at site (A). The panel was again loaded to ultimate load without failure. The post-test pulse echo inspection indicated no damage growth at either damage site.

The panel was finally impacted with 2000 in-lb of energy, using a 0.5-in diameter impactor, on the skin between stiffeners at site (C). The damage was easily visible with a dent similar in depth to those of panels (2) and (3) with some fiber breakage on the impact surface and fiber breakout on the inner skin surface. The panel was loaded to limit load of 782 kips without failure. This load represents a P/AE strain of 0.0041. The post-test pulse echo inspection did not detect any damage growth at any of the three impact sites.

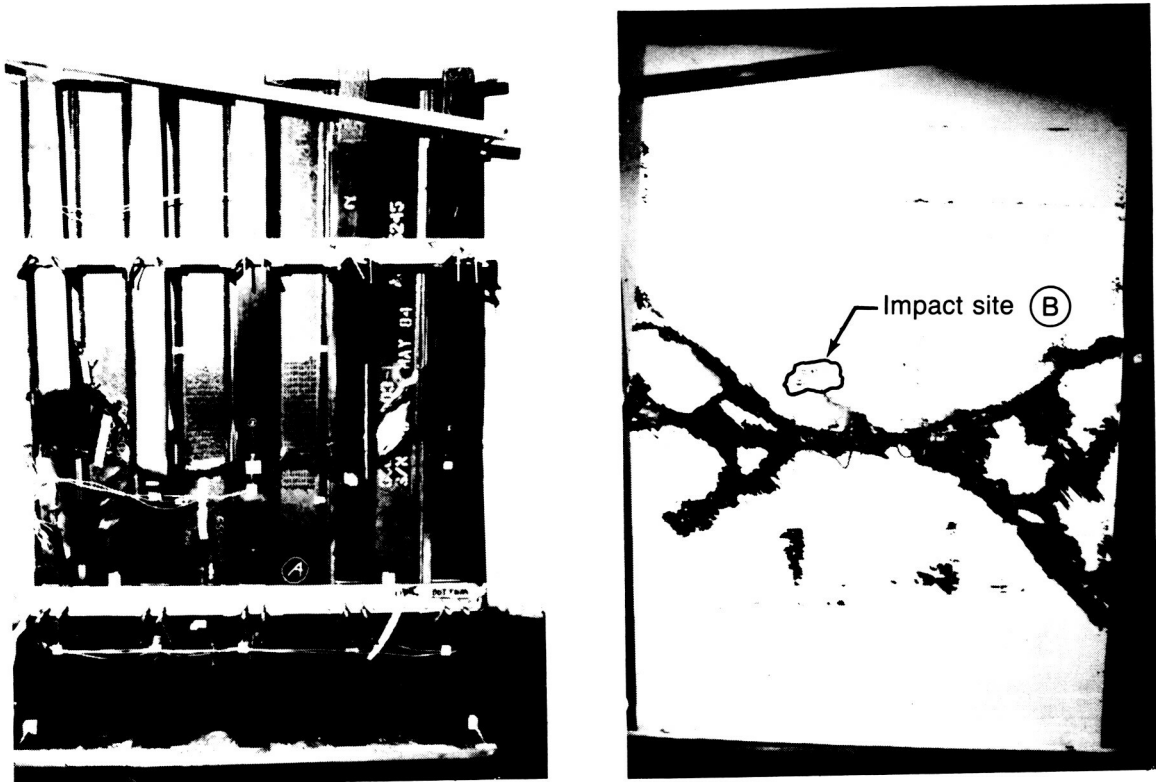
Figure 33. Failure of Panel (4) After Multiple Impact Skin Damage

The panel was finally loaded to failure to determine the residual compression strength. The panel failed through damage sites (A) and (C) at 1197 kips. This represents 102% of the design ultimate load and a P/AE strain of 0.0063. Figure 33 presents the failed panel with the failure running through the 2000 in-lb damage site.

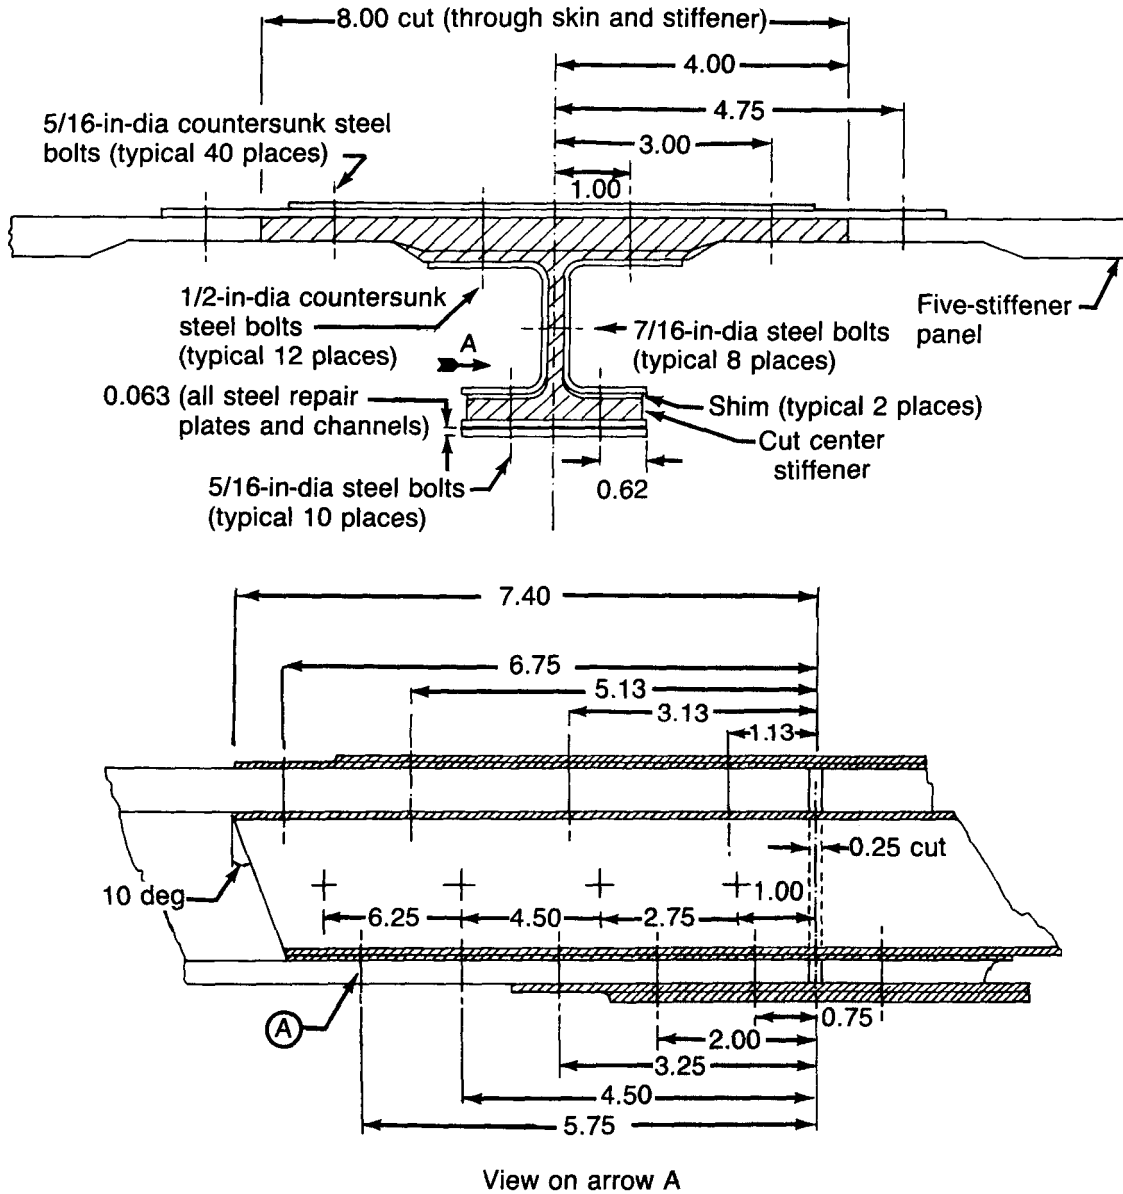
Figure 34. Initial Repair Configuration

A five-stiffener panel of the same configuration as used in the large panel damage tolerance validation test program was damaged with a sawcut. The sawcut severed the center stiffener, skin pad-up and skin for a total length of 8.0 in. The basic repair philosophy was to use a typical service repair that requires no special equipment. The repair was made using steel plates and channels assembled to the panel with steel bolts. Figure 34 presents a cross-section through the repair. The repair design

matched proportional element stiffnesses (AE) while replacing the cut AE with 125% of that lost. Bending strains were kept to a minimum by tailoring the load paths, and where possible, the fasteners were sized to develop the repair element capabilities. The steel plates and channels were all fabricated from 0.063-in 4130 steel sheet heat treated to 180 ksi ultimate tension strength. The fasteners were 180 ksi steel Hi-Loks installed wet with fuel tank sealant in close tolerance holes. The fasteners in the skin repair had countersunk heads typical of wing panel structure.

The failure originated at the first fastener in the stiffener cap repair (ref. point A in fig. 34) and propagated across the panel outside of the repair plates. All five stiffeners failed and were separated from the skin in a manner similar to that of the five-stiffener panel with the center stiffener cap impact damage. The strain in the skin, .05-in from the end of the sawcut, was .008 at failure. There was no evidence of damage emanating from either end of the sawcut. The failure location and strain values are presented in Figure 37. Figure 38 shows the panel at failure with the skin separated intact from the stiffeners.

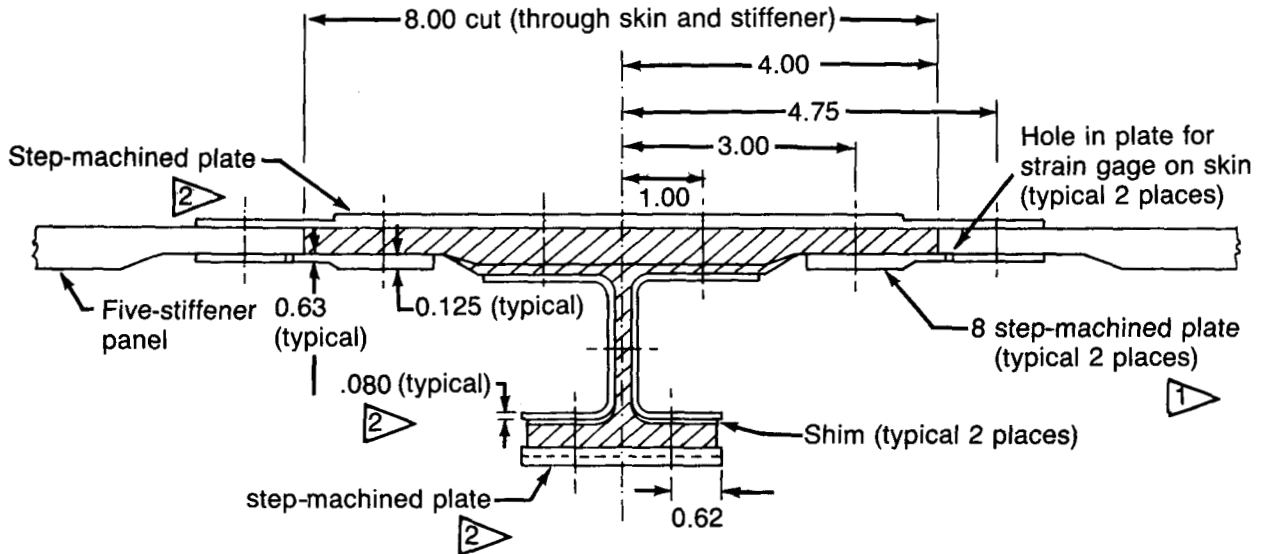
- 1 Additional repair hardware
- 2 Modified repair hardware
- All fastener protruding head oversized up to 1/32 in from original repair

Figure 35. Modified Repair

The above modifications were made to the repair. Also, the stacked 0.063-in steel plates replaced with stepped machined plates with the gage of the steel channels increased from 0.063-in to .080-in to minimize load line shift due to the increase in skin repair plate AE. Figures 35 and 36 present the modified repair configuration.

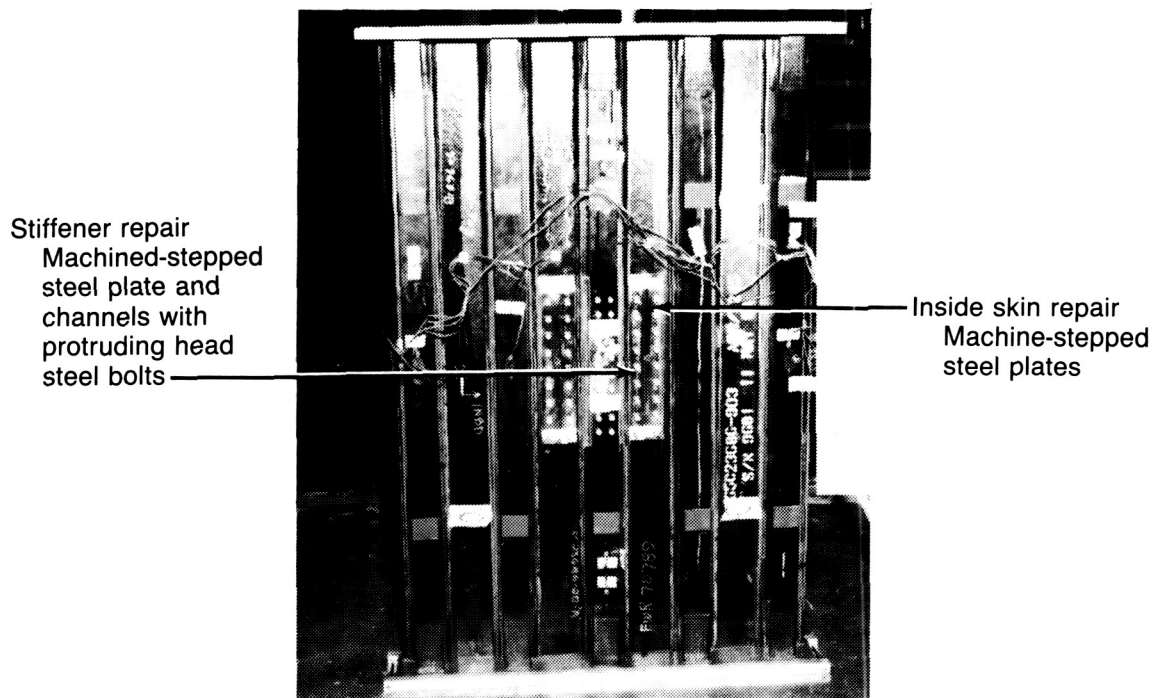
Figure 36. Modified Repair Panel

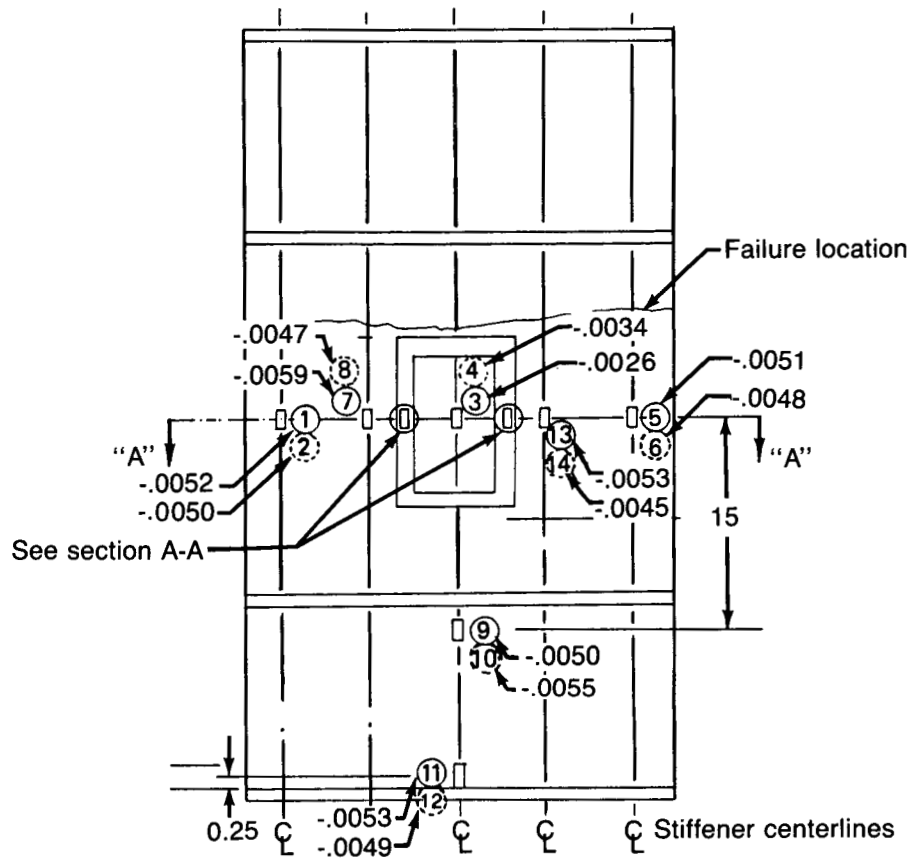
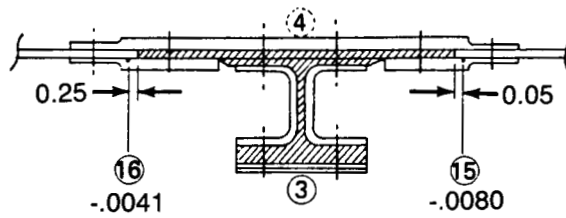
Section "A-A" — through repair

Figure 37. Repair Panel Failure Location and Strains

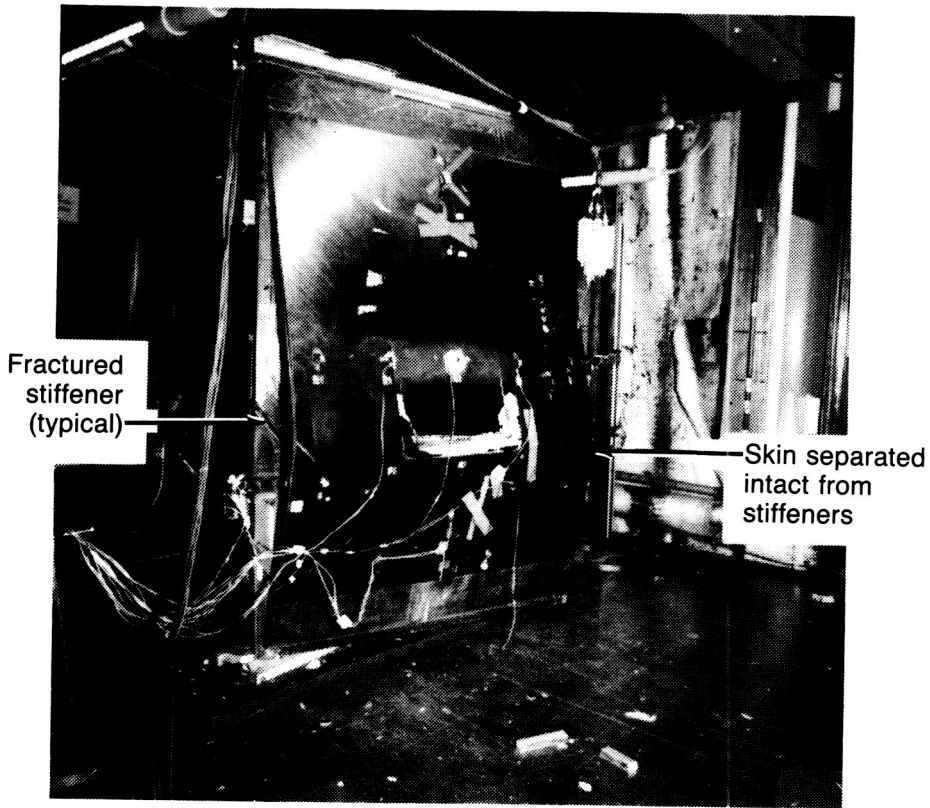
Figure 38. Repair Panel Failure

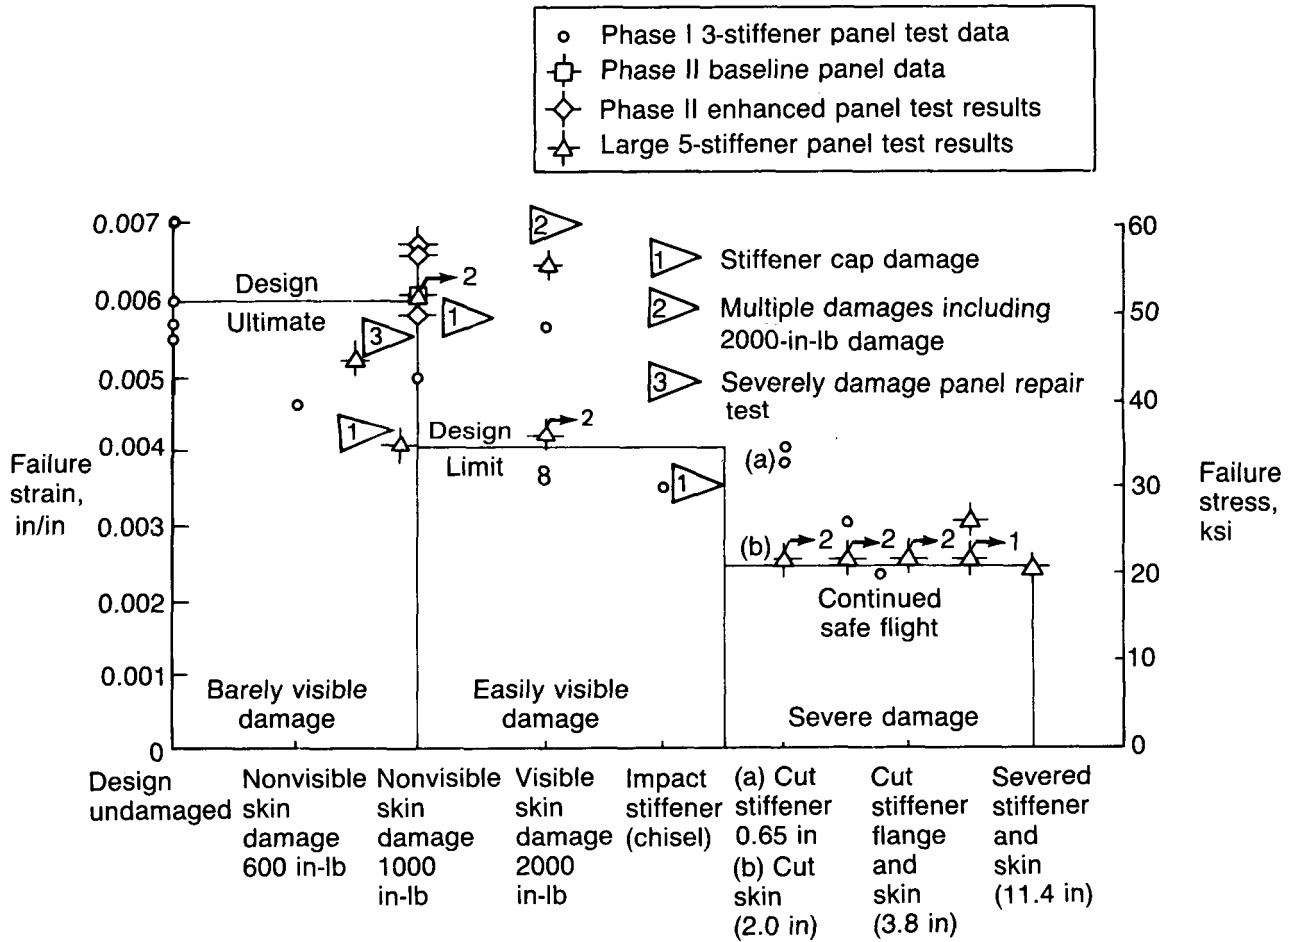
Figure 39. Damage Tolerance Validation Test Results

Figure 39 summarizes the results of the Phase I and Phase II panel tests. All of the panel test data for both Phase I and Phase II are shown relative to the design strains and corresponding stresses. The stresses were normalized for full skin bays, assuming the skins were fully effective. This assumption was validated by the strain gage data which in all cases indicated no skin buckling prior to failure. The strains are gross area P/AE strains using moduli gained from basic material property coupon tests.

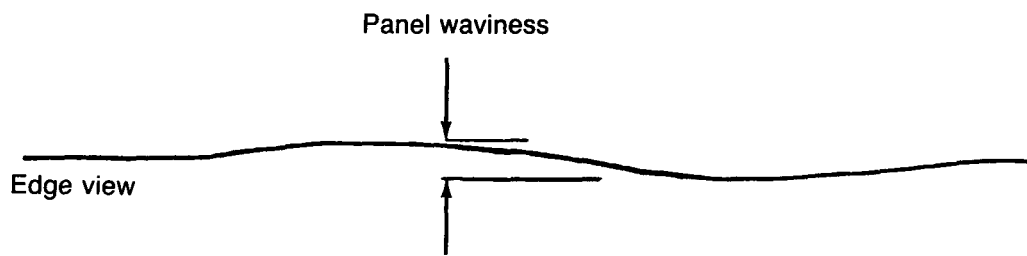
Figure 1. Contour Deviation Defect

Panel Waviness, Warpage, Contour Deviation—These defects (Figure 1) are usually caused by warped tools or thermal expansion mismatch between the part and the tooling, and primarily affect assembly and aerodynamic requirements.

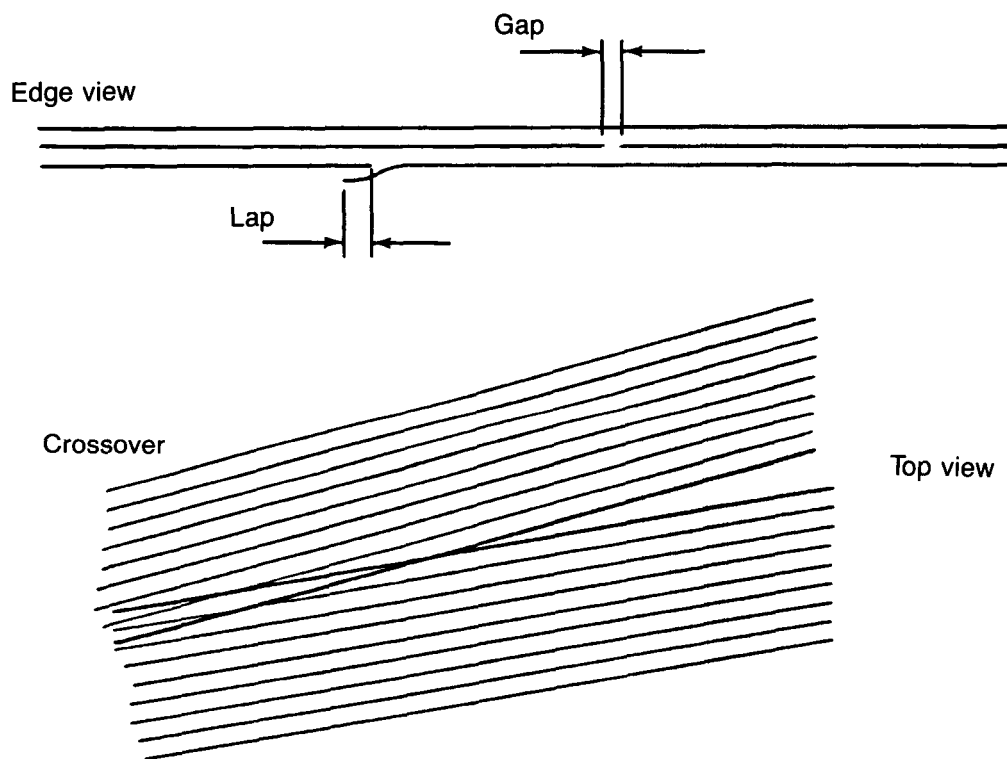
Figure 2. Ply Layup Defects

Laps, Gaps, Crossovers—These defects (Figure 2) are caused by poor manual layup methods and automatic ply layup and are nearly impossible to detect without a cross-sectional view of the laminate. Current tolerances allow a 0.1-in maximum overlap or gap. Some testing indicates that these defects can cause approximately a 10% strength reduction.

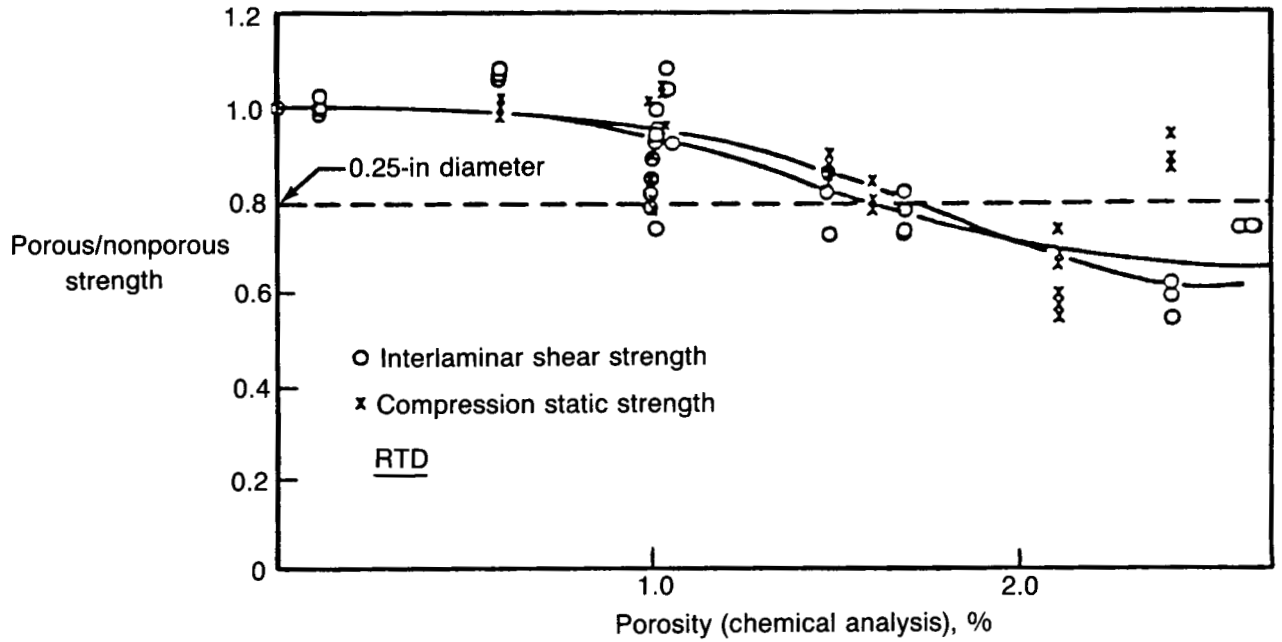
Figure 3. Influence of Porosity Level on Room Temperature Dry Interlaminar Shear and Compression Static Strength

Severe porosity (greater than 1% by volume) can reduce interlaminar and compression strength, as shown in Figure 3, although strength loss may not occur for Boeing's current porosity tolerance limit of 0.5%. It should be noted that obtaining consistent porosity measurements is difficult and results may depend on the technique used. Figure 3 also shows that in terms of strength, a .25-in diameter hole will overshadow porosity above the tolerance limit.

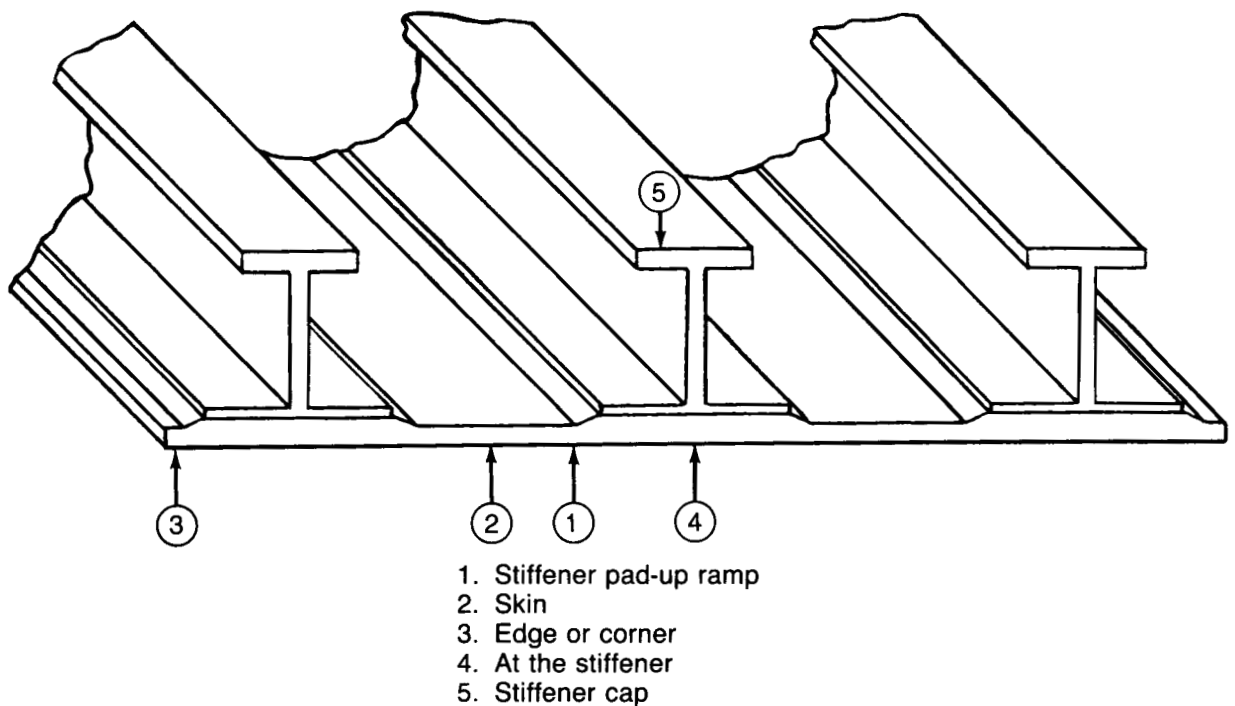
Figure 4. Critical Impact Damage Locations

Because compression members are more sensitive to damage, the locations to be considered here are primarily the wing upper surface. The general exterior areas of the wing differentiated for impact criticality (fig. 4) are as follows:

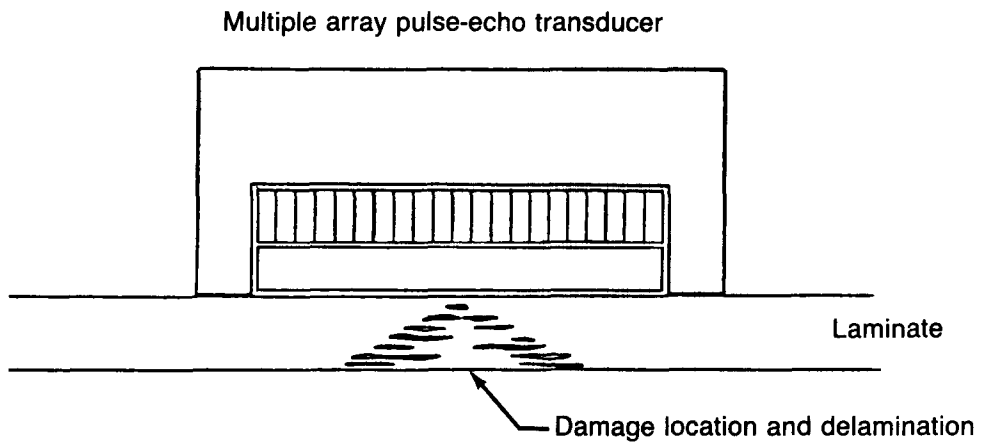
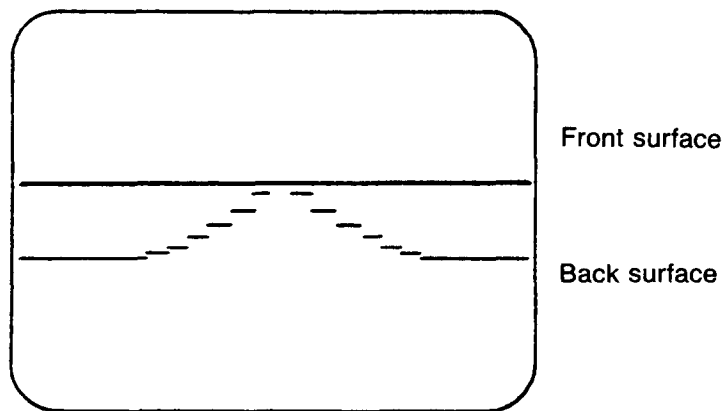
Oscilloscope view

Figure 5. Multiple Array Pulse-Echo Transducer

Boeing has constructed an experimental multiple array pulse echo transducer with its associated monitoring electronics using principles taken from a similarly operating medical device. Specifically, the transducer consists of 32 closely spaced elements (as shown in Figure 5), each 0.050-in wide, for a total width of 1.6 in. The design frequency of this prototype is 5 MHz, optimum for laminates up to 0.3-in thick with a practical limit of 0.5-in thick. Thicker laminates (1-in or more) could be scanned with a transducer designed to operate at lower frequencies.

This system is useful for creating images of disbonds, delaminations, impact damage and porosity. Figure 5 shows an oscilloscope view of a panel cross-section containing a flaw under the stiffener and a view of the sectioned area revealing the small delamination. These diagrams were taken from an original micrograph and photograph of the oscilloscope screen.

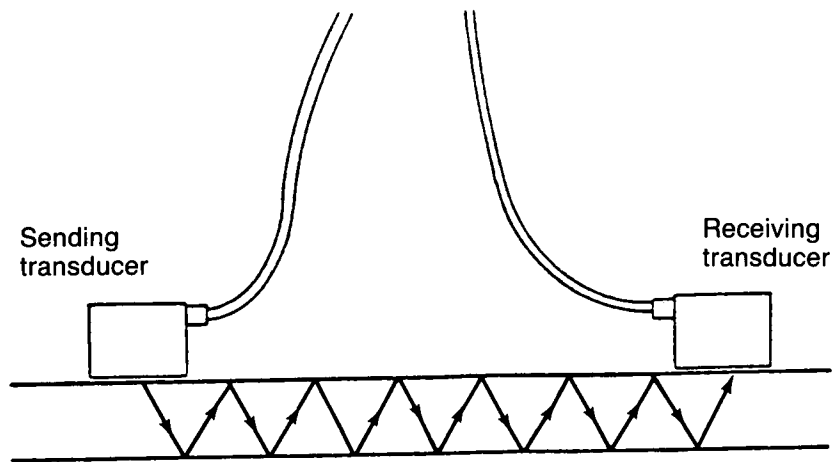
Figure 6. Two Ultrasonic Transducers

One method uses two ultrasonic transducers, one transmitting and one receiving, on the same side of the laminate (Figure 6). The system measures a stress wave factor or the number of reflected acoustic wave peaks received from a specified transmitted wave form. The stress wave factor depends on the input signal characteristics, transducer characteristics, system gain, reset time, threshold voltage, repetition rate, distance between transducers, etc.; therefore, results are generally comparable only when these factors are consistent. Experimenters have obtained good correlation between the stress wave factor and the number of impact events, and between the stress wave factor and tensile strength of graphite/epoxy coupons.

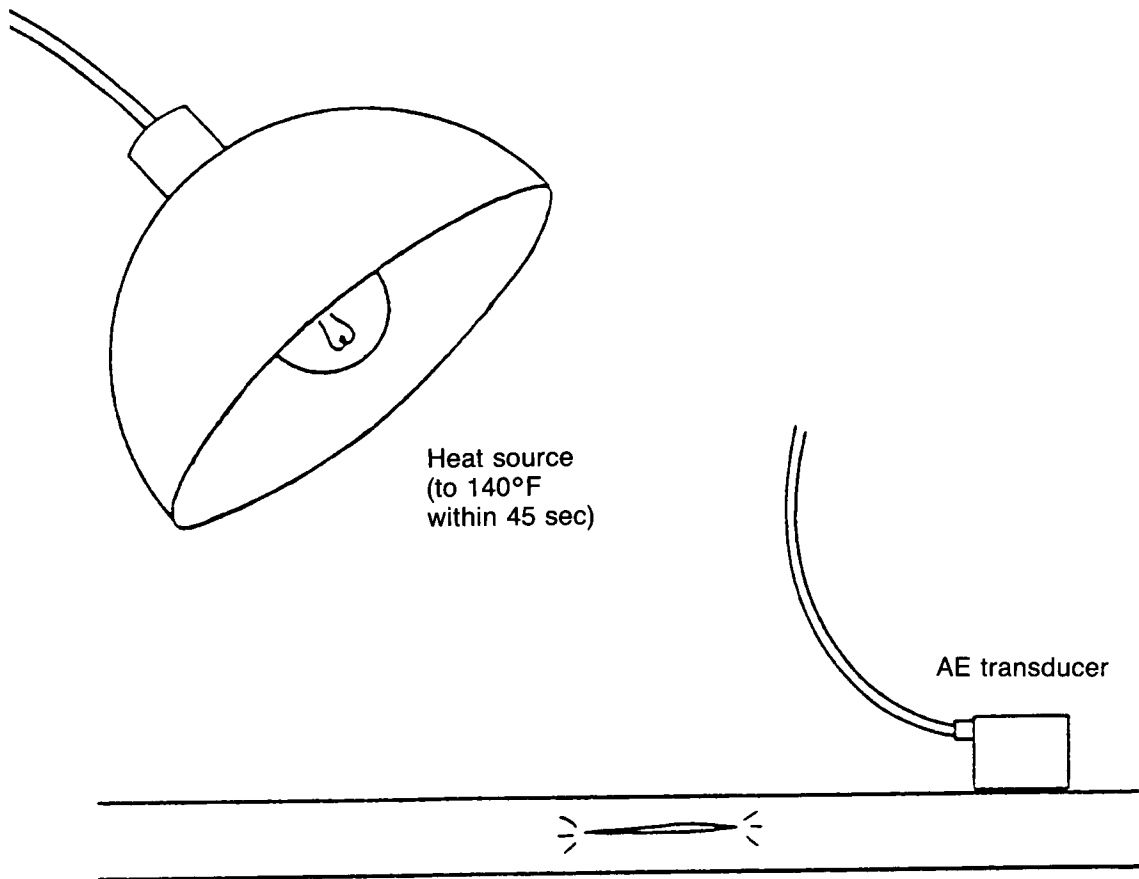
Figure 7. AE Response to Thermal Shock

Another technique involves exciting an AE response from a structure using a thermal shock (Figure 7). This method has been informally tested on small panels before and after impact damage. Experimenters propose that a system could be devised for rapid scanning of large structures incorporating two roller transducers in a fixture with an attached heat lamp for the thermal shock input. A two transducer system could geometrically locate damaged or anomalous areas. A computerized AE data system could aid in developing the thermal AE technique as well as the more traditional AE methods.

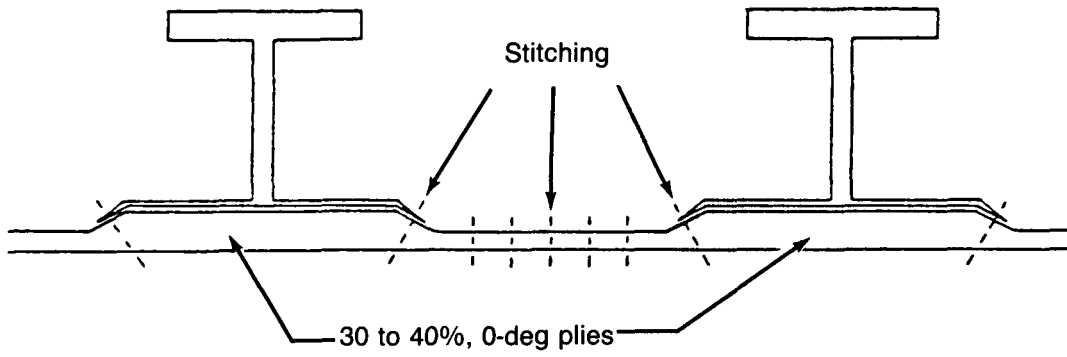
Figure 8. Structural Design Details for Impact Damage Tolerance

Skin Design—Design criteria affecting skin design include variations in the skin directional fiber%ages. Panels with skins consisting primarily of 45-deg plies are damage tolerant due to the low load level in the skin. In this design, the primary load carrying member is the stiffener. Grid stitching with Kevlar yarn in the area between the stiffeners has potential to restrict impact damage and inhibit growth (fig. 8). This has been demonstrated in both Phase II coupon level and three-stringer panel testing.

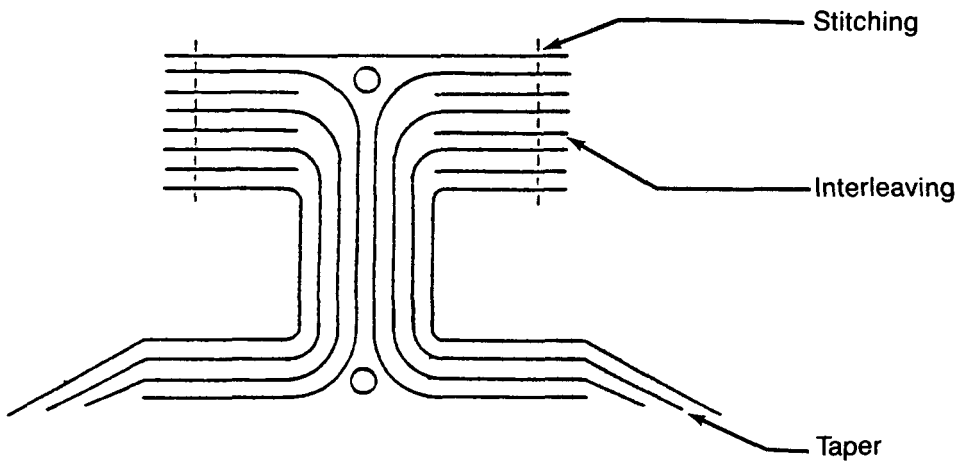
Figure 9. Structural Design Details for Impact Damage Tolerance—Stiffener
