SSME

TECHNOLOGY TEST BED

FAST SHUTDOWN ASSESSMENT

FINAL REPORT

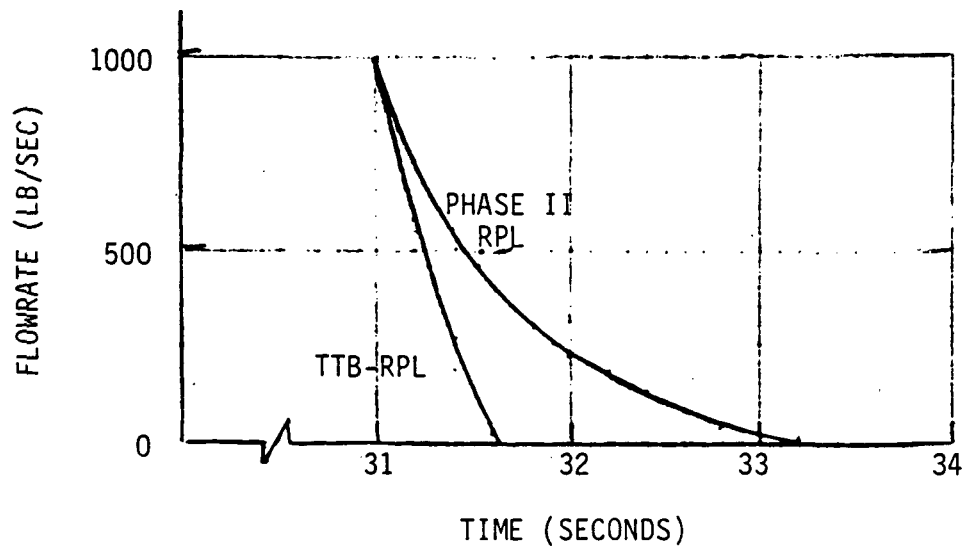
FIGURE 12

OXIDIZER FLOWRATE
