NASA Technical Memorandum 88874

Effect of Hard Particle Impacts on the Atomic Oxygen Survivability of Reflector Surfaces With Transparent Protective Overcoats

Daniel A. Gulino
Lewis Research Center
Cleveland, Ohio

Prepared for the
25th Aerospace Sciences Meeting
sponsored by the American Institute of Aeronautics and Astronautics
Reno, Nevada, January 12-15, 1987

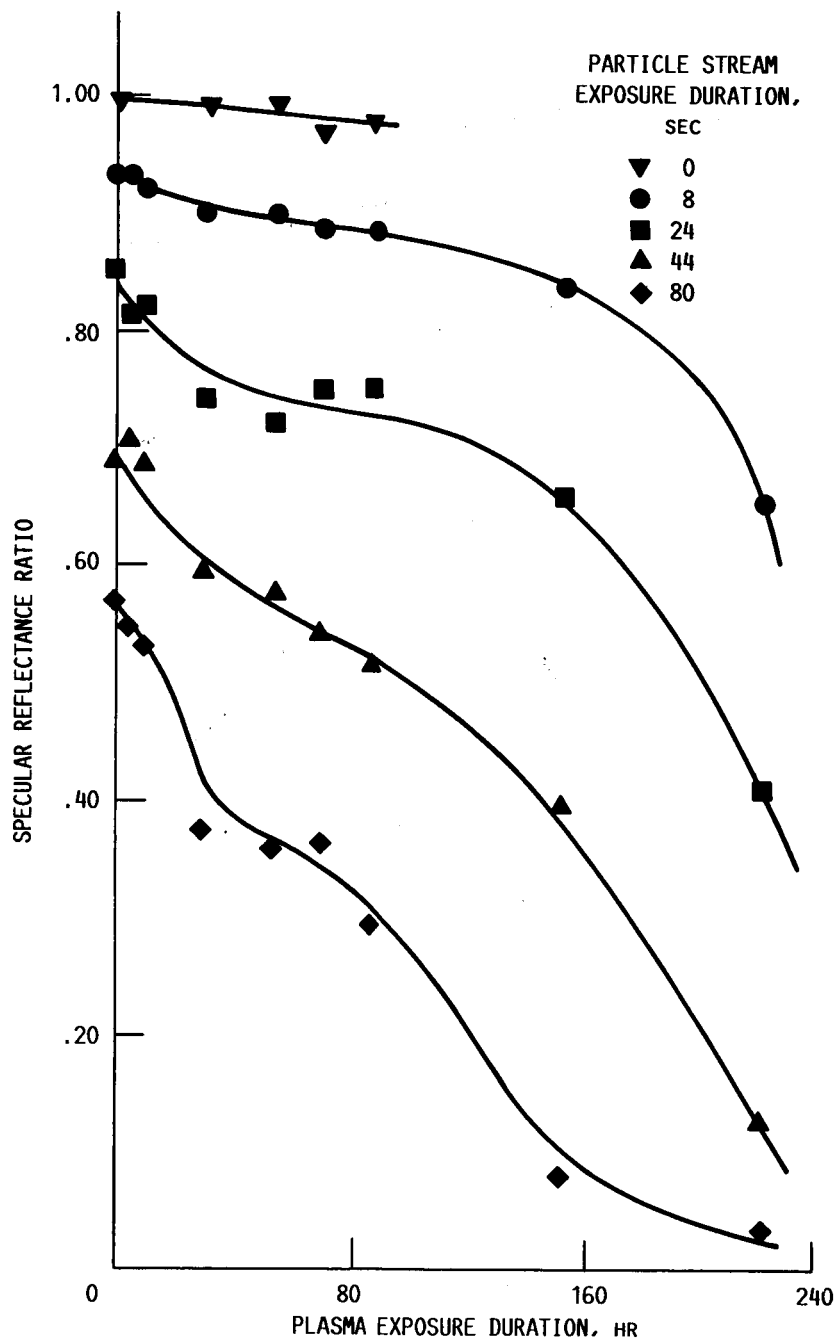
FIGURE 1.- SPECULAR REFLECTANCE RATIO VERSUS PLASMA EXPOSURE TIME FOR SEVERAL GRAPHITE-EPOXY SUBSTRATE SAMPLES FOR VARIOUS LENGTHS OF TIME OF EXPOSURE TO THE EROSIIVE PARTICLE STREAM. THE RATIO IS CALCULATED BY DIVIDING THE REFLECTANCE AT A GIVEN TIME BY THE REFLECTANCE MEASURED PRIOR TO PARTICLE EXPOSURE.

In Figs. 1 and 2 are plotted, respectively, the specular and total reflectance ratios of several of the graphite-epoxy substrate samples as a function of oxygen plasma exposure duration. The reflectance ratios were obtained by dividing the reflectance at a given time by the initial, non-eroded, non-ashed reflectance. The data points at zero hours thus indicate the effect on the reflectance of only the erosive particle stream as a function of duration of exposure to the particle stream. In these plots, three rather broadly defined regions can be observed. During the first roughly 30 hr of exposure, the reflectances fell rather markedly from their initial values, with the degree of fall directly proportional to the length of time of exposure to the particle flux. For the next 60 hr, the reflectances remained roughly constant. After this, they began to decrease once again, and with a rate of decrease that increased with time. These effects were somewhat more pronounced on the specular reflectance plots.

These photos clearly show that while oxidative undercutting is a process that does not begin immediately, once it does start, its rate accelerates with increasing asher exposure time. This finding explains the shape of the reflectance versus exposure time curves shown in Figs. 1 and 2, particularly the later, rapid fall-off in reflectance. As a final observation in this series, Fig. 9 is a micrograph of the lower right portion of Fig. 8, taken at a tilt angle of 60°. This figure shows that wherever the undercutting occurred, the surface of the sample had collapsed. This is an indication that oxidation of the substrate had occurred.

The series of SEM micrographs discussed above (Figs. 3 to 9) indicates that the reflectance data (Figs. 1 to 2) may be explained by the following mechanism: the initial, rapid drop in reflectance was caused by oxidation of those parts of the silver layer directly exposed as a result of the particle-induced damage. After some time (about 30 hr in this case), this

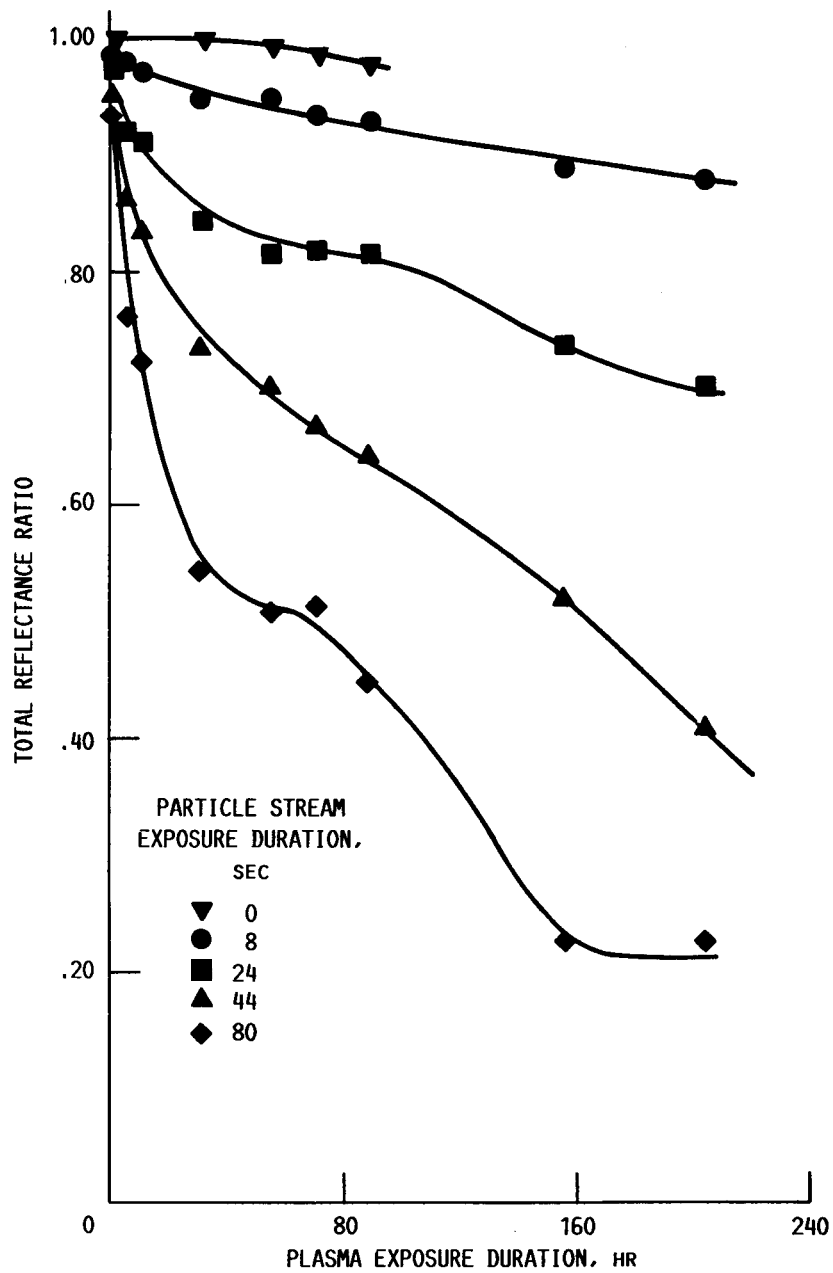
FIGURE 2.- TOTAL REFLECTANCE RATIO VERSUS PLASMA EXPOSURE TIME FOR SEVERAL GRAPHITE-EPOXY SUBSTRATE SAMPLES FOR VARIOUS LENGTHS OF TIME OF EXPOSURE TO THE EROSIIVE PARTICLE STREAM. THE METHOD OF CALCULATION IS IDENTICAL TO THAT OF FIGURE 1.

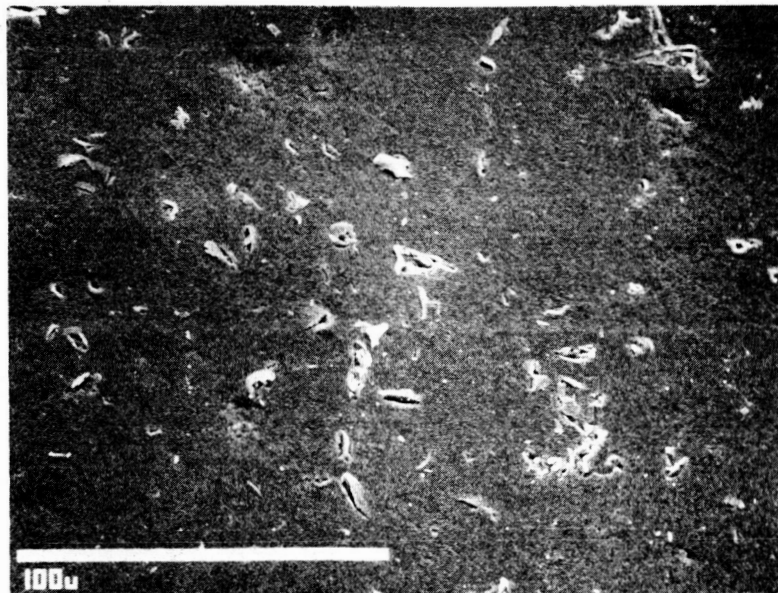
FIGURE 4. - MICROGRAPH TAKEN AT 500x SHOWING THE EFFECT OF THE EROSIIVE PARTICLE STREAM ONLY (NO PLASMA EXPOSURE) ON A GRAPHITE-EPOXY SUBSTRATE SAMPLE. A NUMBER OF DEFECT SITES ARE EVIDENT.

SEM micrographs were obtained after a variety of different treatments and exposure times. Figure 3 is a micrograph of a non-eroded, non-ashed sample on a graphite-epoxy substrate. (The white, irregularly shaped object in the lower left is a dust particle which aided in focusing.) The only feature visible is the ridged structure of the graphite-epoxy substrate. Figure 4 is a micrograph of a sample similar to that in Fig. 3, except that this sample had been exposed to the particle stream. A number of defect sites are evident.

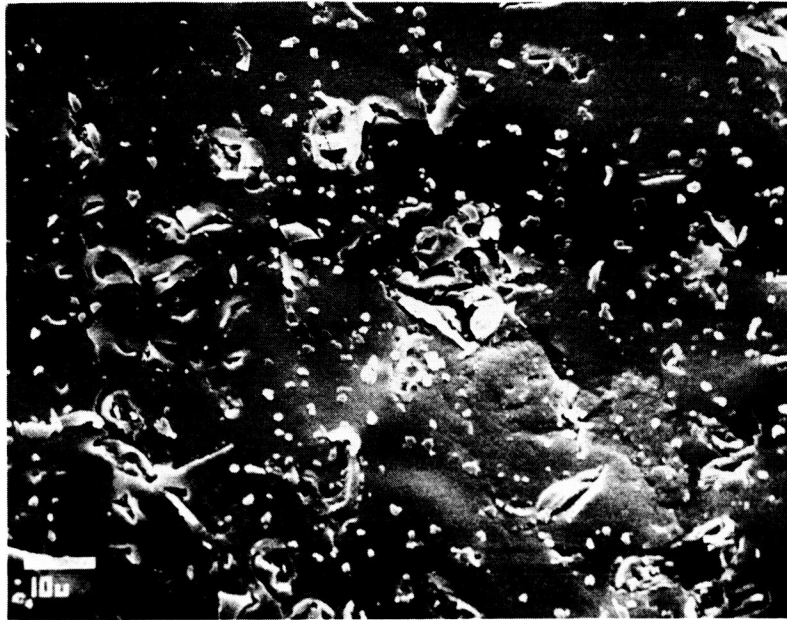
FIGURE 5. - MICROGRAPH TAKEN AT 1000X SHOWING A PARTICLE ERODED SURFACE AFTER 50 HOURS OF EXPOSURE TO THE OXYGEN PLASMA. THE APPEARANCE IS SIMILIAR TO THAT OF FIGURE 4. NO EVIDENCE OF UNDERCUTTING IS VISIBLE.

Figures 5 to 9 show the effect of exposure of the particle-eroded, graphite-epoxy substrate samples to the plasma for different lengths of time.

Figure 5 is a micrograph of a sample that had been exposed in the asher for 50 hr. While the region photographed is a different from that of Fig. 4, their appearance is the same: a variety of differently sized and shaped defect sites. Figure 6 is a micrograph of a sample exposed in the asher for 90 hr. The heart-shaped, darkened "rim" surrounding the defect site in the lower left of this photo is a result of oxidation of the silver and/or the substrate surrounding that defect site. The width of the rim is very roughly the diameter of the pinhole defect. Figure 7 is an enlarged view of another defect site on the same sample as Fig. 6. Oxidative undercutting (the darkened rim) is clearly evident. Figure 8 is a micrograph of a sample exposed in the asher for 240 hr. In this figure it is evident that oxidative undercutting has occurred to a large degree. The widths of the darkened rims are now nearly ten times the diameter of the defect site.

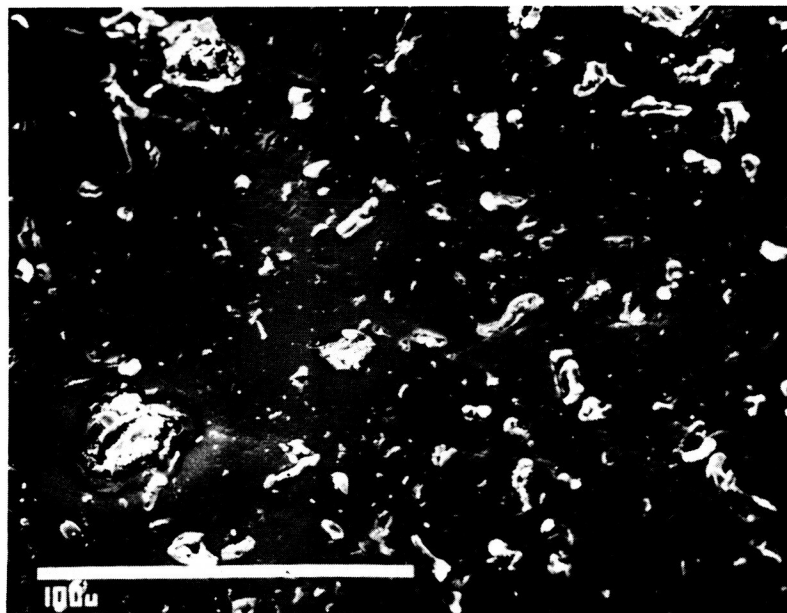
FIGURE 6. - MICROGRAPH TAKEN AT 500X SHOWING A PARTICLE ERODED SURFACE AFTER 90 HOURS OF EXPOSURE TO THE OXYGEN PLASMA. THE DARKENED "RIM" SURROUNDING THE HEART-SHAPED DEFECT IN THE LOWER LEFT IS OXIDATION OF THE SILVER LAYER AND/OR THE SUBSTRATE BENEATH THE PROTECTIVE COATING.

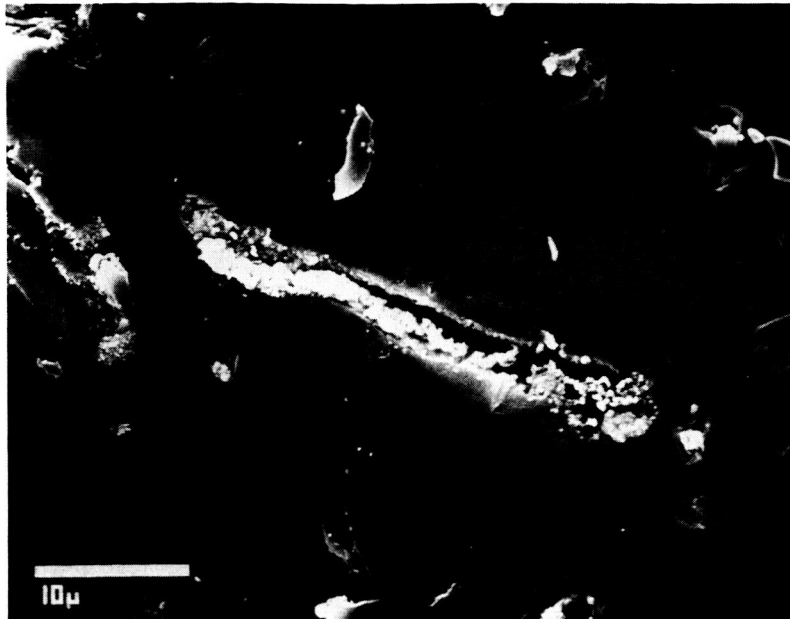
FIGURE 7. - MICROGRAPH TAKEN AT 2000X OF A FEATURE ON THE SAME SAMPLE AS DEPICTED IN FIGURE 6. OXIDATIVE UNDERCUTTING CAN BE SEEN CLEARLY AS THE DARKENED "RIM" SURROUNDING THE ELONGATED DEFECT.

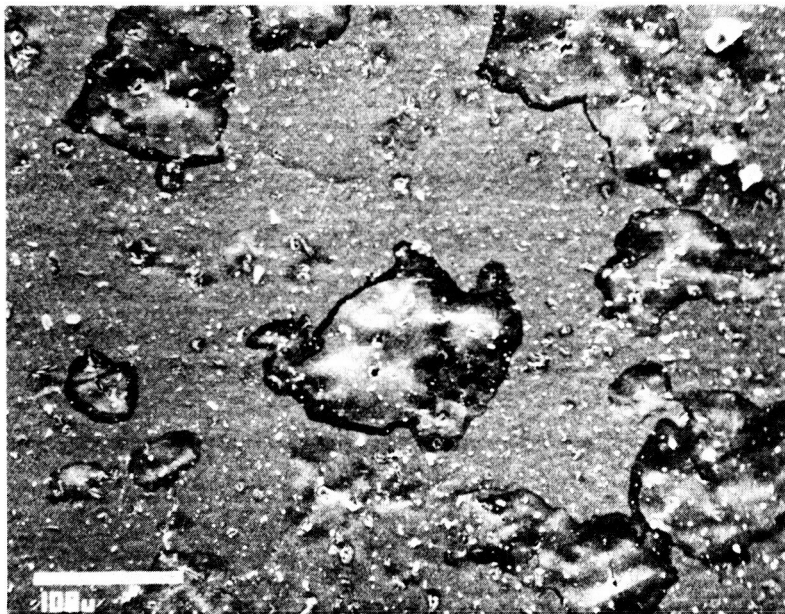
FIGURE 8. - MICROGRAPH TAKEN AT 200X SHOWING A PARTICLE ERODED SURFACE AFTER 240 HOURS OF EXPOSURE TO THE OXYGEN PLASMA. THE DARKENED AREAS SURROUNDING THE DEFECT SITES HAVE GROWN CONSIDERABLY IN SIZE RELATIVE TO THE SIZE OF THE PINHOLE, INDICATING THAT OXIDATIVE UNDERCUTTING HAS OCCURRED TO A SIGNIFICANT DEGREE.

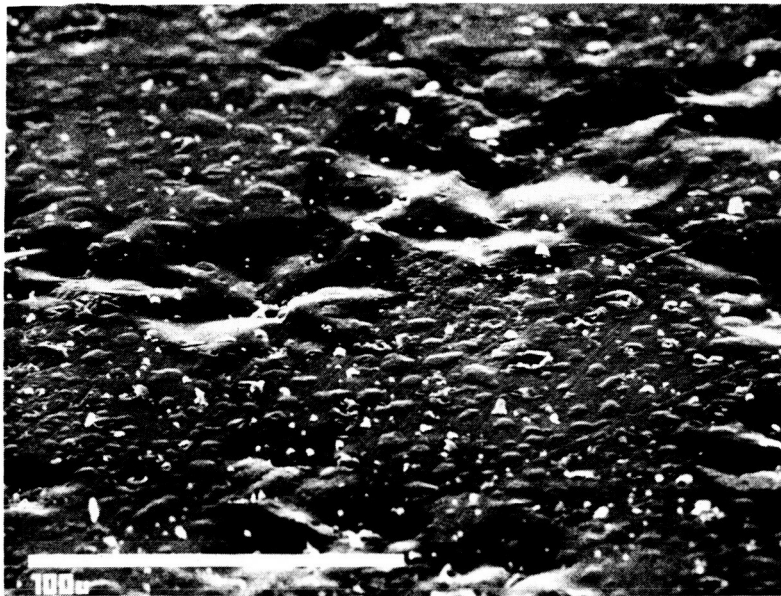
FIGURE 9. - MICROGRAPH TAKEN AT 500X OF THE LOWER RIGHT PORTION OF FIGURE 8 AT A SHARP ANGLE (60°) SHOWS THAT WHEREVER UNDERCUTTING HAD OCCURRED, THE SURFACE HAD COLLAPSED.

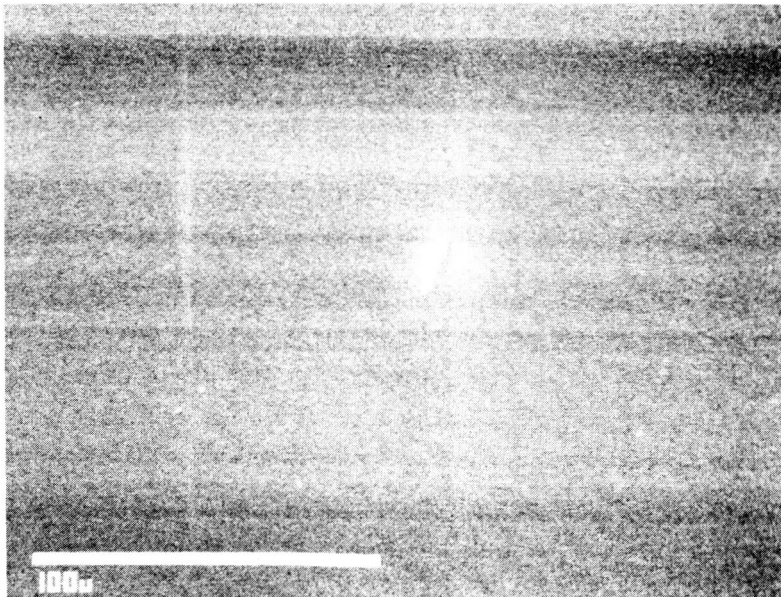
FIGURE 10. - MICROGRAPH TAKEN AT 500X SHOWING A NON-ERODED, NON-ASHED FUSED QUARTZ SUBSTRATE SAMPLE.

Figures 10 to 17 show the effects of exposure of the fused quartz substrate samples to the plasma environment for different lengths of time. For comparison purposes, Fig. 10 (like Fig. 3) shows a non-eroded, non-ashed sample. Figure 11 is a micrograph of a sample similar to that in Fig. 10, except that it has been exposed to the particle stream. As before, a number of defect sites resulting from the particle impacts is evident. Figure 12 is a micrograph of a pitted surface after 50 hr of exposure. While no undercutting (transverse oxidation of the silver, in this case) is readily observed, oxidation of the freshly exposed silver layer is evident as the puffed material protruding from the defect sites. This is more apparent in Fig. 13, which is the same surface as shown in Fig. 12, but at a higher magnification and at a sharp tilt (60°).

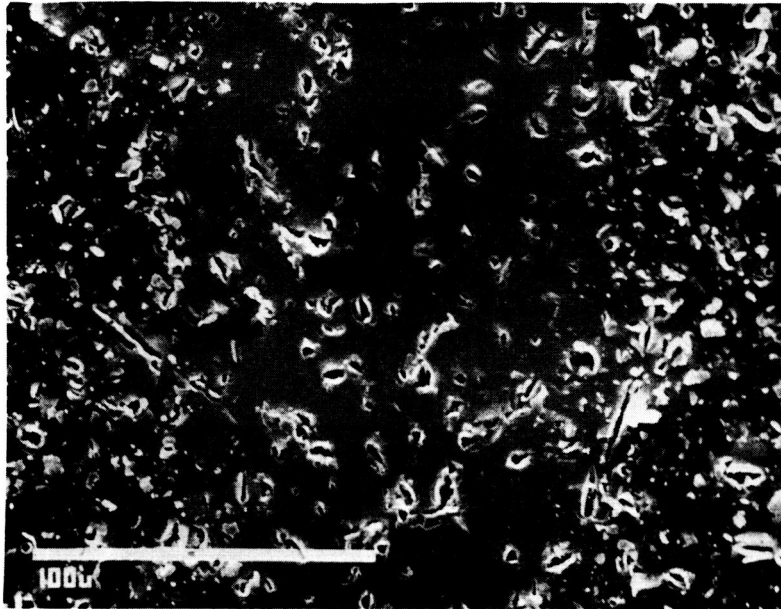
FIGURE 11. - MICROGRAPH TAKEN AT 500X SHOWING THE SURFACE OF A FUSED QUARTZ SUBSTRATE SAMPLE AFTER EXPOSURE TO THE PARTICLE STREAM BUT PRIOR TO EXPOSURE TO THE OXYGEN PLASMA.

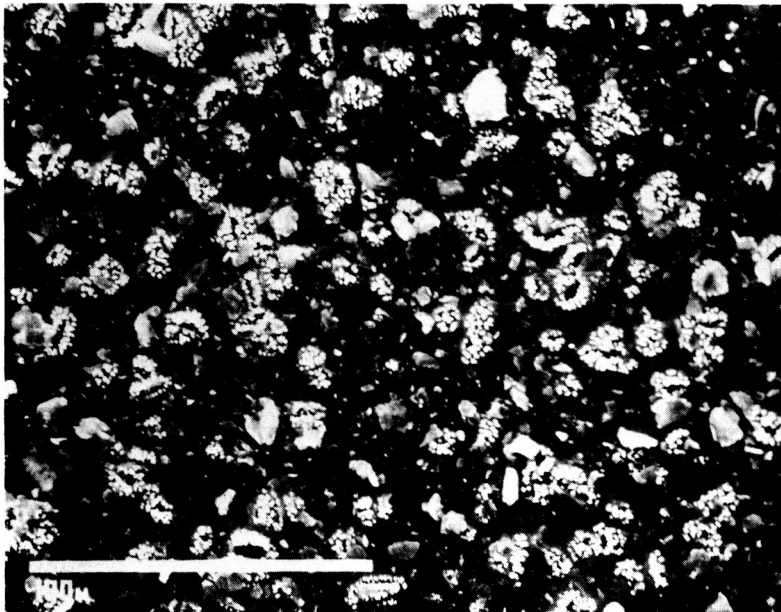
FIGURE 12. - MICROGRAPH TAKEN AT 500X SHOWING THE SURFACE OF A SAMPLE IDENTICAL TO THAT OF FIGURE 11, BUT AFTER 50 HOURS OF EXPOSURE TO THE OXYGEN PLASMA. WHILE NO TRANSVERSE OXIDATION CAN BE SEEN, OXIDATION OF THE SILVER LAYER IS EVIDENT AS THE PUFFY MATERIAL PROTRUDING FROM THE DEFECT SITES.

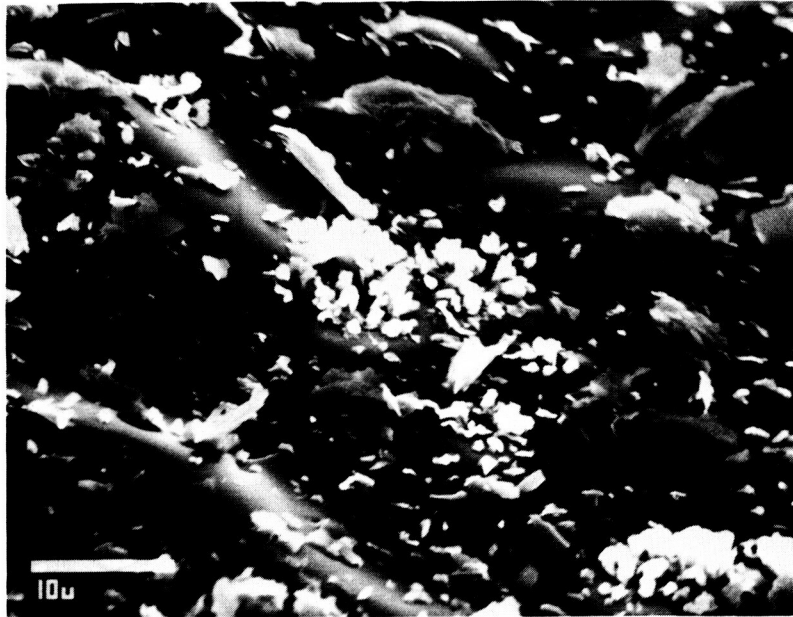
FIGURE 13. - MICROGRAPH OF THE SAME SAMPLE AS THAT OF FIGURE 12 BUT AT 2000X AND AT A 60° TILT ANGLE. THE OXIDIZED SILVER, WHICH TAKES THE FORM OF A PUFFY MATERIAL PROTRUDING THROUGH THE DEFECT SITES, IS CLEARLY EVIDENT.

samples. However, a comparison of Fig. 13 with Fig. 17 (the latter of which is an enlargement of the same surface seen in Fig. 16, but at a 60° tilt) shows that the outgrowths of silver oxide had continued unabated.

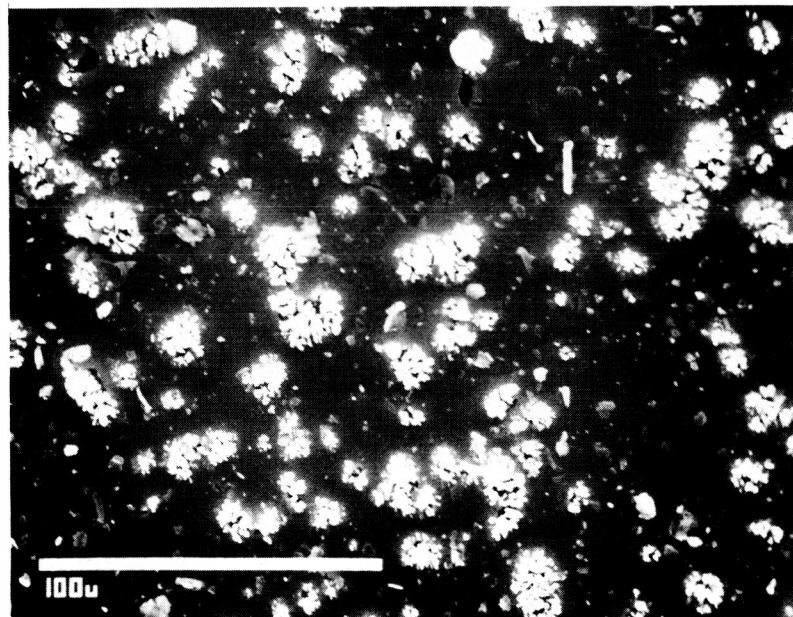
FIGURE 14. - MICROGRAPH TAKEN AT 500X SHOWING THE SURFACE OF A FUSED QUARTZ SUBSTRATE SAMPLE AFTER PARTICLE EROSION AND 90 HOURS OF EXPOSURE TO THE OXYGEN PLASMA. OXIDIZED SILVER IS SEEN PROTRUDING THROUGH THE DEFECT SITE. TRANSVERSE OXIDATION IS VISIBLE AS A BRIGHTER RIM SURROUNDING THE DEFECT SITE.

Figure 14 is a micrograph of an eroded surface after 90 hr of exposure. As before, oxidized silver protruding through the defect sites is clearly evident. Transverse oxidation of the silver after 90 hr of exposure is more clearly seen in Fig. 15, which is an enlargement of Fig. 14. As in the previous samples, the oxidative damage appears as a discolored rim surrounding the defect site. In Fig. 15, the rim appears brighter in color.

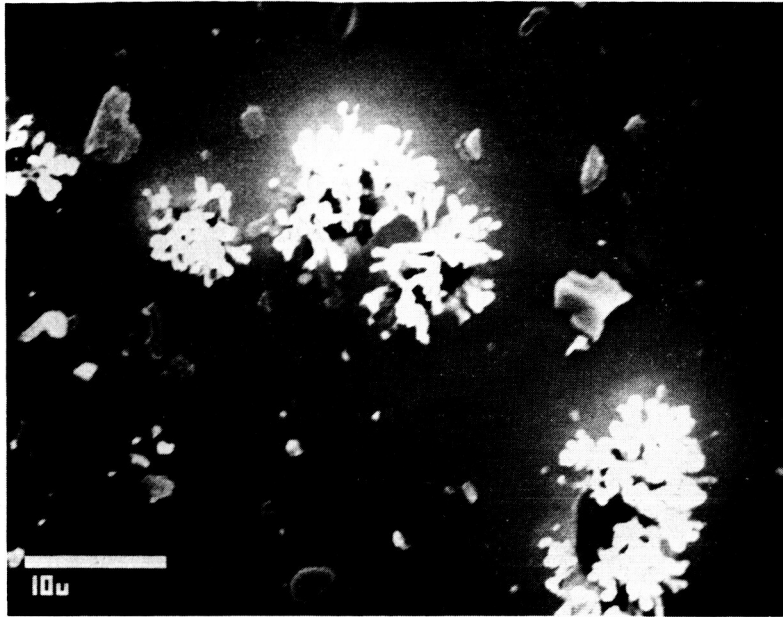
FIGURE 15. - MICROGRAPH OF THE SAME SAMPLE AS THAT OF FIGURE 14, BUT AT 2000X. TRANSVERSE OXIDATION IS CLEARLY EVIDENT AS A BRIGHTER RIM SURROUNDING THE DEFECT SITE.

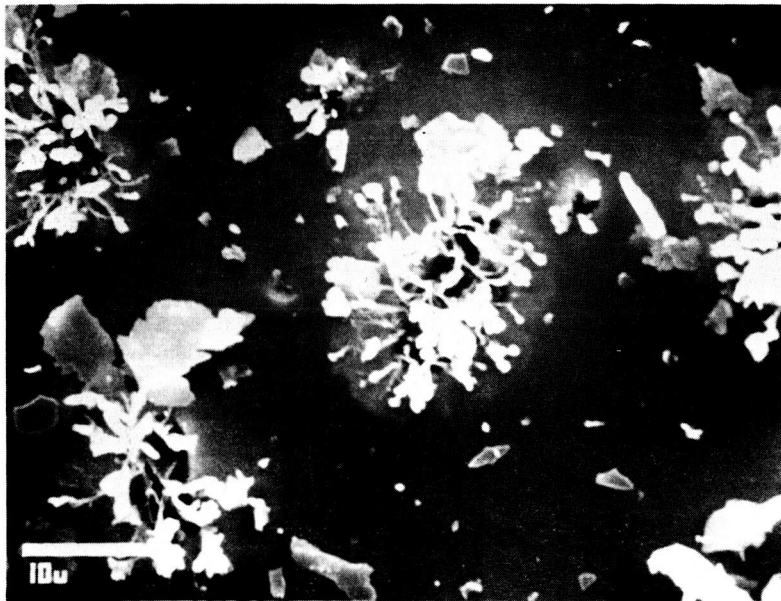
FIGURE 16. - MICROGRAPH TAKEN AT 2000X SHOWING THE SURFACE OF A FUSED QUARTZ SUBSTRATE SAMPLE AFTER PARTICLE EROSION AND 240 HOURS OF OXYGEN PLASMA EXPOSURE. TRANSVERSE OXIDATION IS EVIDENT; HOWEVER, ITS EXTENT DID NOT INCREASE SIGNIFICANTLY OVER THAT OF THE 90 HOUR SAMPLE (FIGS. 14 AND 15).

Figure 16 is micrograph showing a pitted surface after 240 hr of asher exposure. As in Fig. 15, a rim lighter in color and surrounding each defect site is evident. Unlike the graphite-epoxy substrate samples, the width of the rim did not appear to increase significantly between the 90 hr and 240 hr

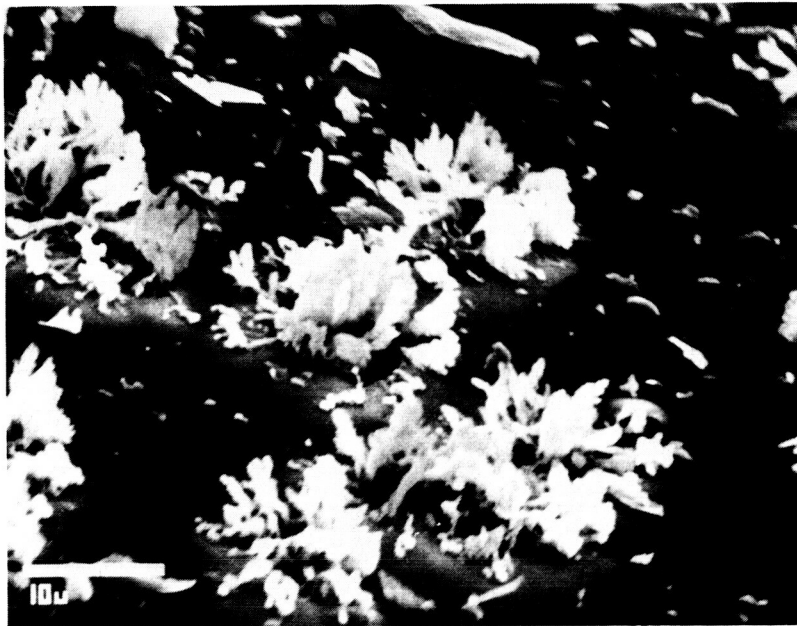
FIGURE 17. - MICROGRAPH OF THE SAME SAMPLE AS THAT OF FIGURE 16
AT THE SAME MAGNIFICATION AND A 60° TILT. OUTGROWTH OF OXIDIZED
SILVER HAD BEEN CONTINUING AS OF 240 HOURS.
