**NASA  
Reference  
Publication  
1161**

**Evaluation of Multilayer  
Printed Wiring Boards by  
Metallographic Techniques**

*An Illustrated Guide to the  
Preparation and Inspection  
of Plated-Through Hole  
Test Coupons Based on the  
Requirements of MIL-P-55110D*

Jane Jellison

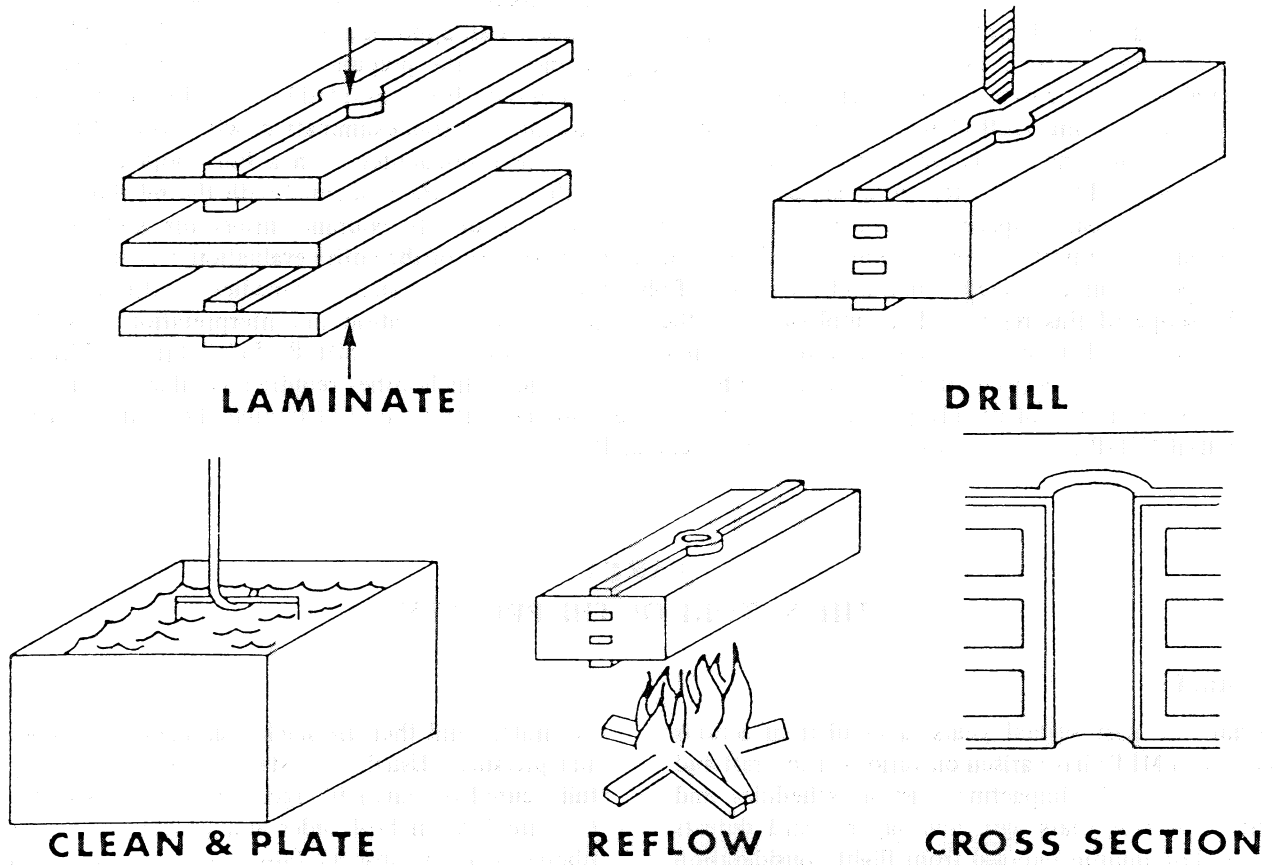
Figure 1. Multilayer board construction.

**SCHEMATIC REPRESENTATION OF MAJOR STEPS IN MULTILAYER BOARD FABRICATION**

**CROSS-SECTION THROUGH A RESISTOR MOUNTED ON A 4-LAYER BOARD.**

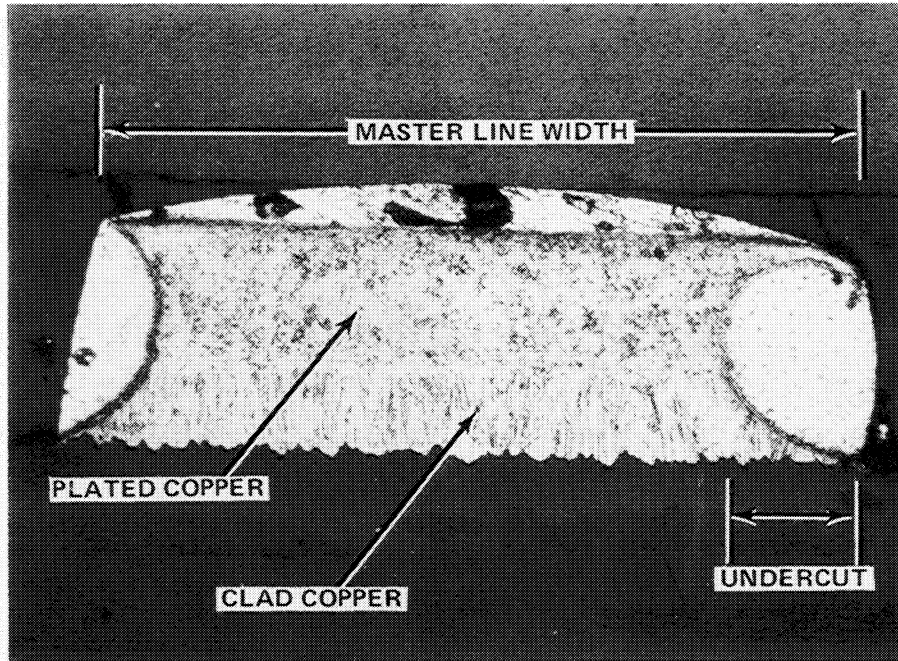
Figure 22. Undercutting must be less than the total thickness of clad and plated copper, or 10% of the conductor width, whichever is less.

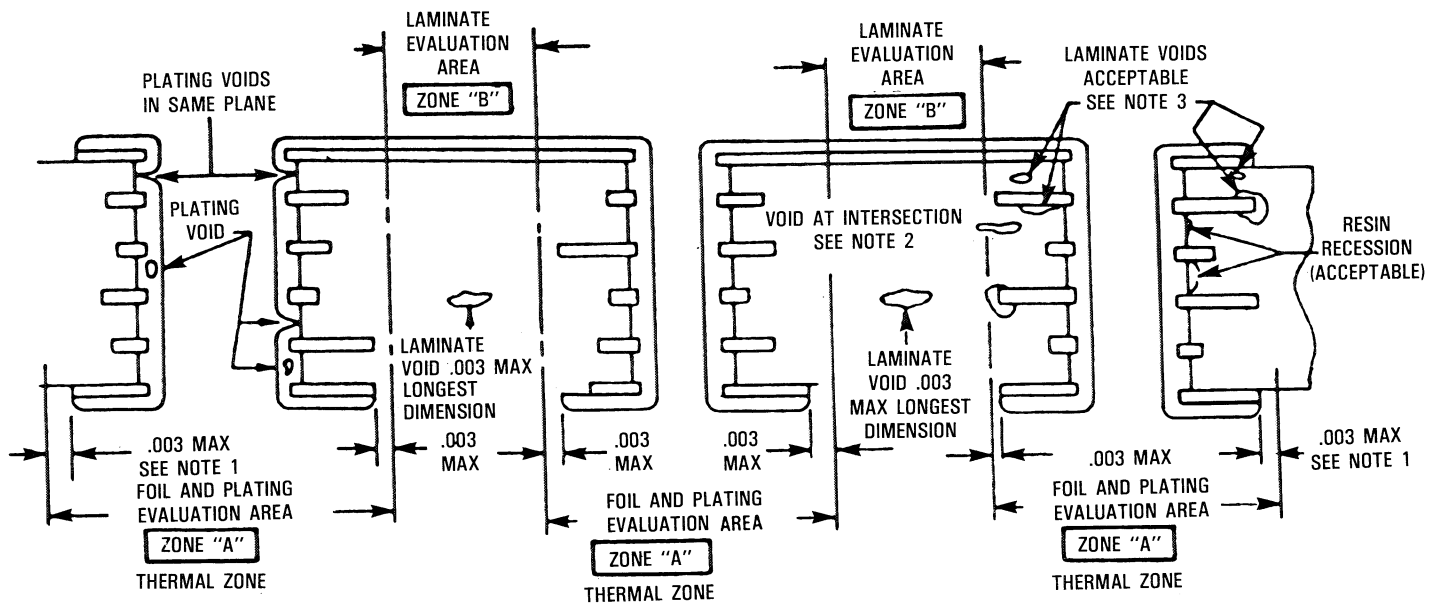
1. TYPICALLY BEYOND LAND EDGE MOST RADIALLY EXTENDED.
2. VOID AT INTERSECTION OF ZONE A AND ZONE B. LAMINATE VOIDS GREATER THAN .003 (0.08 mm) IN LENGTH WHICH EXTEND INTO THE LAMINATE EVALUATION AREA ARE REJECTABLE.
3. LAMINATE VOIDS ARE NOT EVALUATED IN ZONE A. LAMINATE VOIDS GREATER THAN .003 (0.08 mm) THAT EXTEND INTO ZONE B ARE REJECTABLE.
4. DIMENSIONS ARE IN INCHES.
5. METRIC EQUIVALENTS ARE GIVEN FOR GENERAL INFORMATION ONLY.

Figure A-8. Typical plated-through hole cross section (3 hole sample) (after thermal stress and rework simulation).
