Flight Service Evaluation of Advanced Composite Ailerons on the L-1011 Transport Aircraft

Second Annual Flight Service Report

**LOCKHEED-CALIFORNIA COMPANY
BURBANK, CALIFORNIA**

**CONTRACT NAS 1-15069
December 1984**

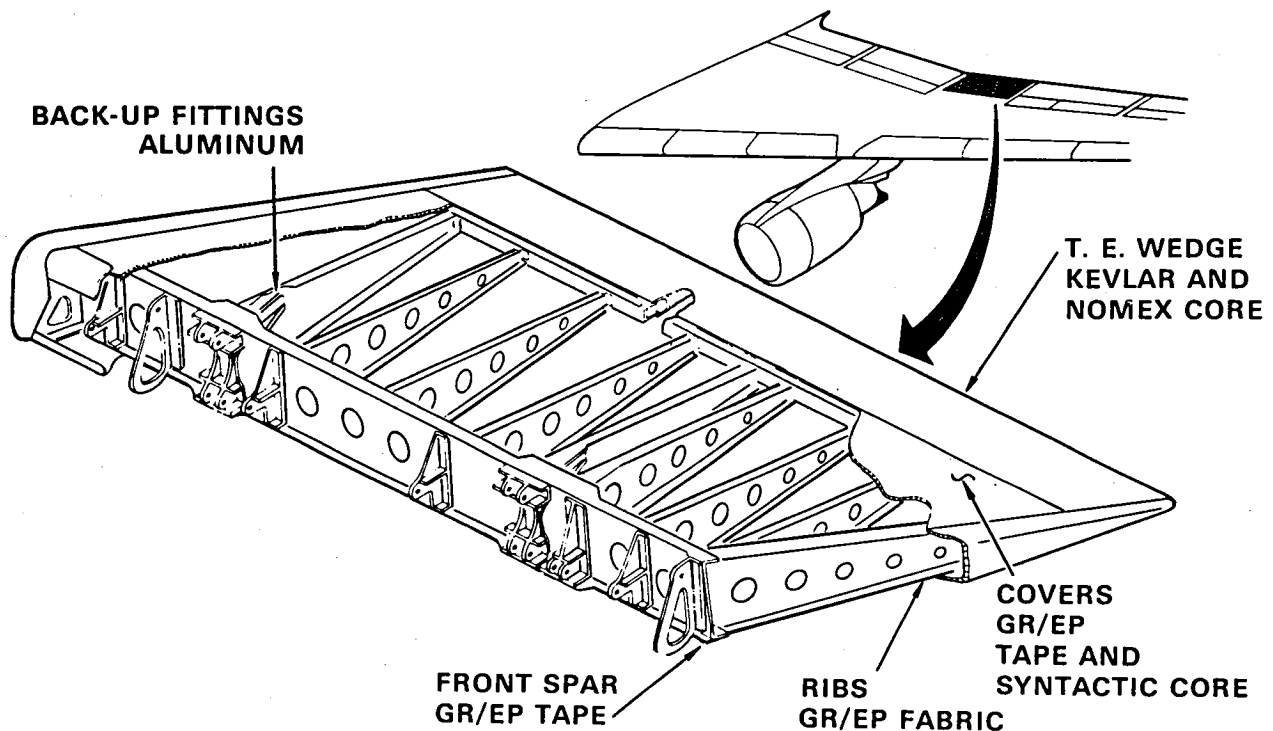
Figure 1. - Advanced composite aileron assembly.

The composite aileron design, shown in Figure 1, is a multirib configuration with single piece upper and lower covers mechanically fastened to the substructure. Three basic materials were utilized in the aileron design: Narmco 5208/T300 graphite/epoxy unidirectional epoxy tape; Narmco 5208/T300 graphite/epoxy bidirectional fabric; and Hysol ADX 819 syntactic epoxy core.

The aileron covers, ribs, and front spar were fabricated using standard vacuum bag autoclave molding procedures. The aileron covers are thin sandwich plates with graphite/epoxy tape facesheets and a syntactic epoxy core. The ribs and spars are constant thickness channel sections, laid up and cured on male tools. The intermediate ribs are fabricated of bidirectional graphite/epoxy fabric. The main ribs which react hinge and actuator loads are fabricated of graphite/epoxy fabric, with the caps reinforced with graphite/epoxy tape. The front spar is fabricated of graphite/epoxy tape laid up in approximately a quasi-isotropic orientation.
