NASA Contractor Report 168345

Balloon-Borne Pressure Sensor  
Performance Evaluation Utilizing  
Tracking Radars

G. A. Norcross

**Goddard Space Flight Center**  
Wallops Flight Facility  
Wallops Island, Virginia 23337

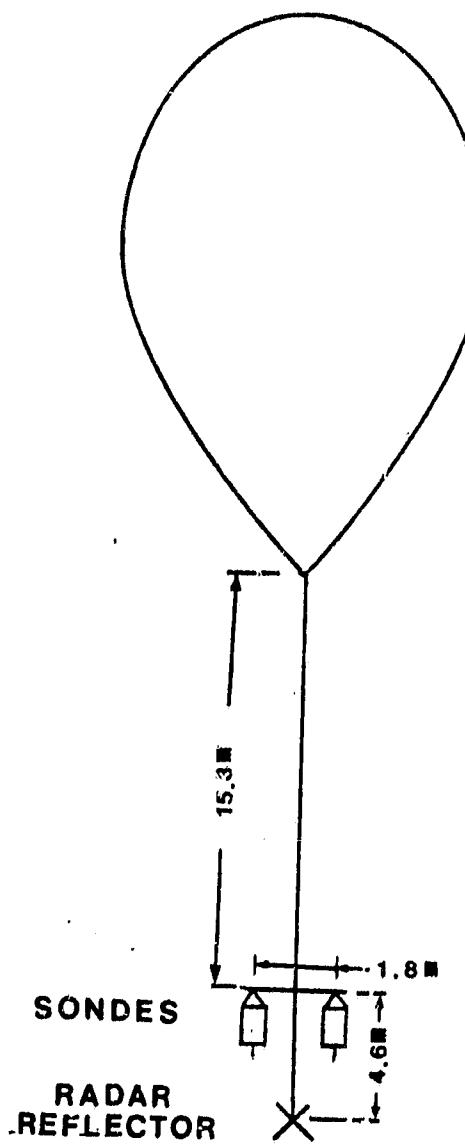
Figure 1 - Launch Configuration for All Sondes Tested.

The two sondes were attached to a narrow platform 15.3m beneath the balloon. The sondes were separated by 1.8m, mid-point to mid-point. The radar reflector was suspended an additional 4.6m below the sondes. The launch configuration is depicted in Figure 1.

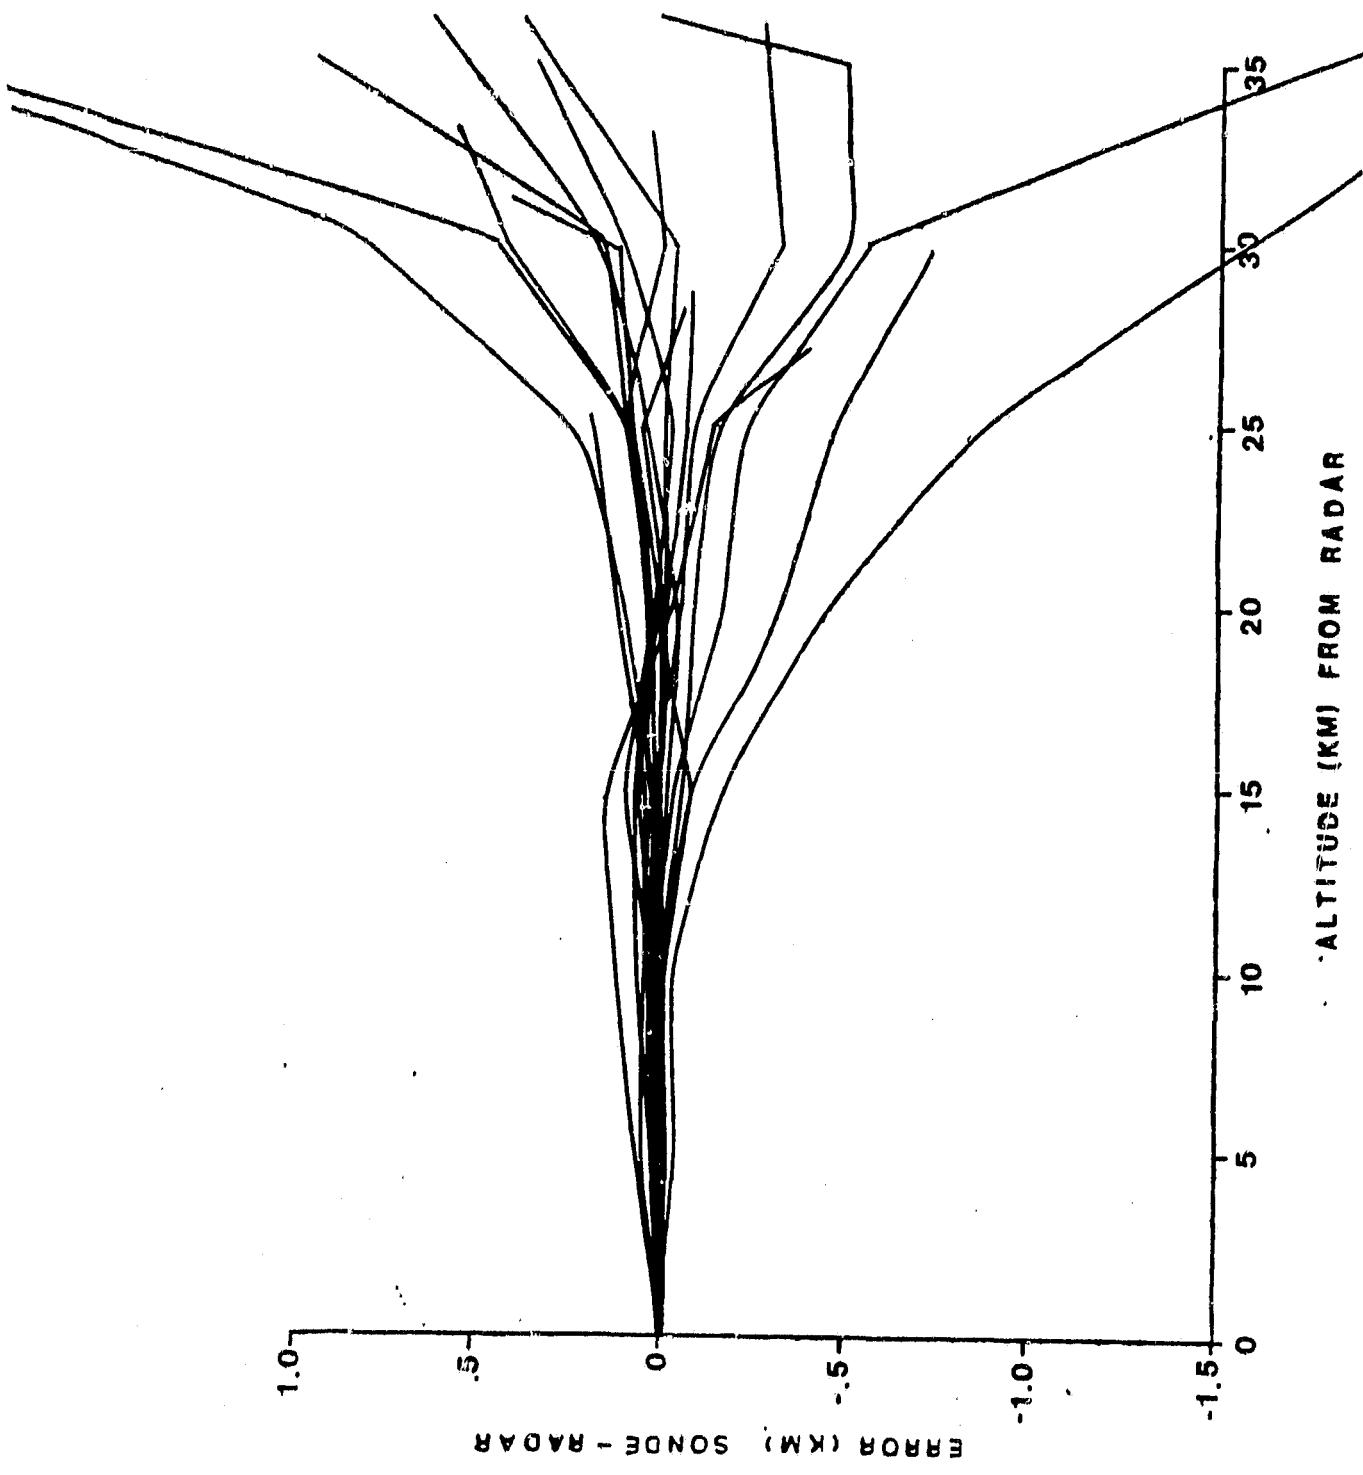
Figure 2 - Difference of Sonde-Derived Altitude Minus Radar Altitude for Each Standard Baroswitch Sonde.

The sonde-minus-radar differences for all 19 standard baroswitches are combined in Figure 2. In this Figure, the differences are plotted as a function of altitude. The standard baroswitches generally perform well up to 25 km; above that level, there is rapid divergence.

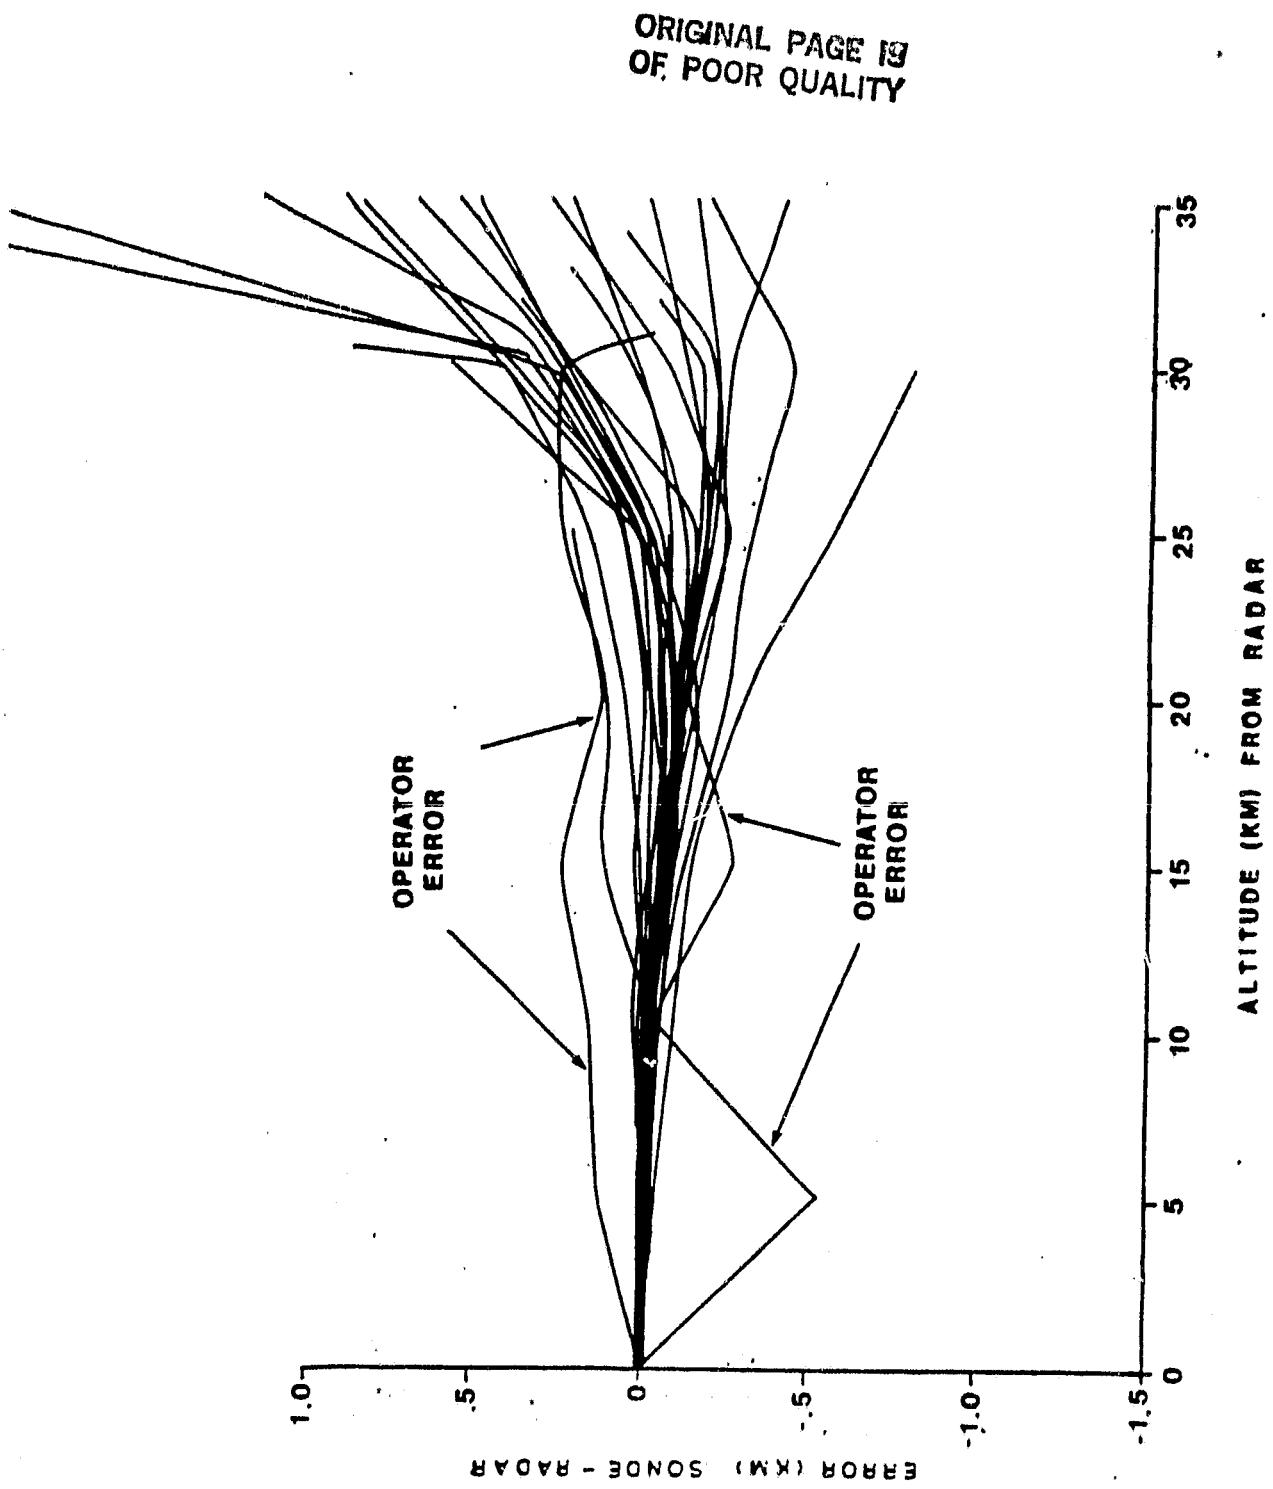
Figure 3 - Difference of Sonde-Derived Altitude Minus Radar Altitude for Each Premium Baroswitch Sonde.

premium baroswitches are combined in Figure 3. As in Figure 2, the differences are plotted as a function of altitude. Except for the operator errors, as noted, the premium baroswitches versus radars tend to be more tightly bunched than the standard baroswitch differences. An additional difference is that the premium baroswitch differences from the radar are generally positive at the burst altitudes.

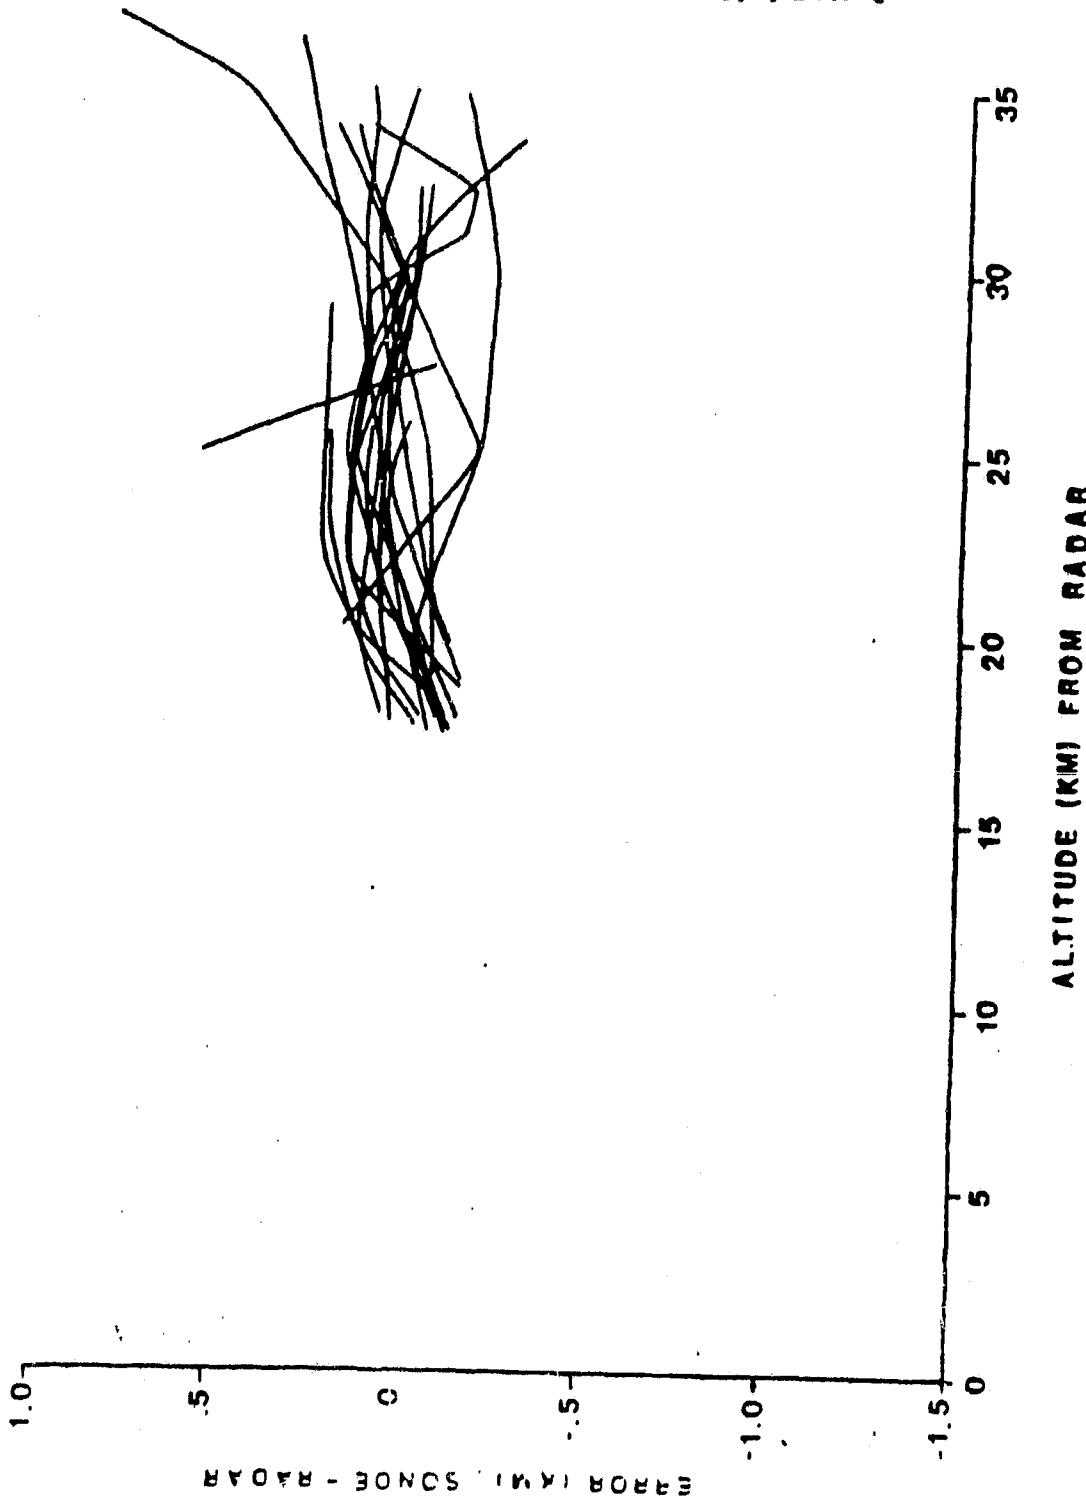
Figure 4 - Difference of Sonde-Derived Altitude Minus Radar Altitude for Each Hypsometer Sonde.

The combined difference plots for the twenty-two hypsometers are shown in Figure 4. The hypsometer-derived altitudes are generally within  $\pm 300$  m of the radar standard at the burst altitudes.

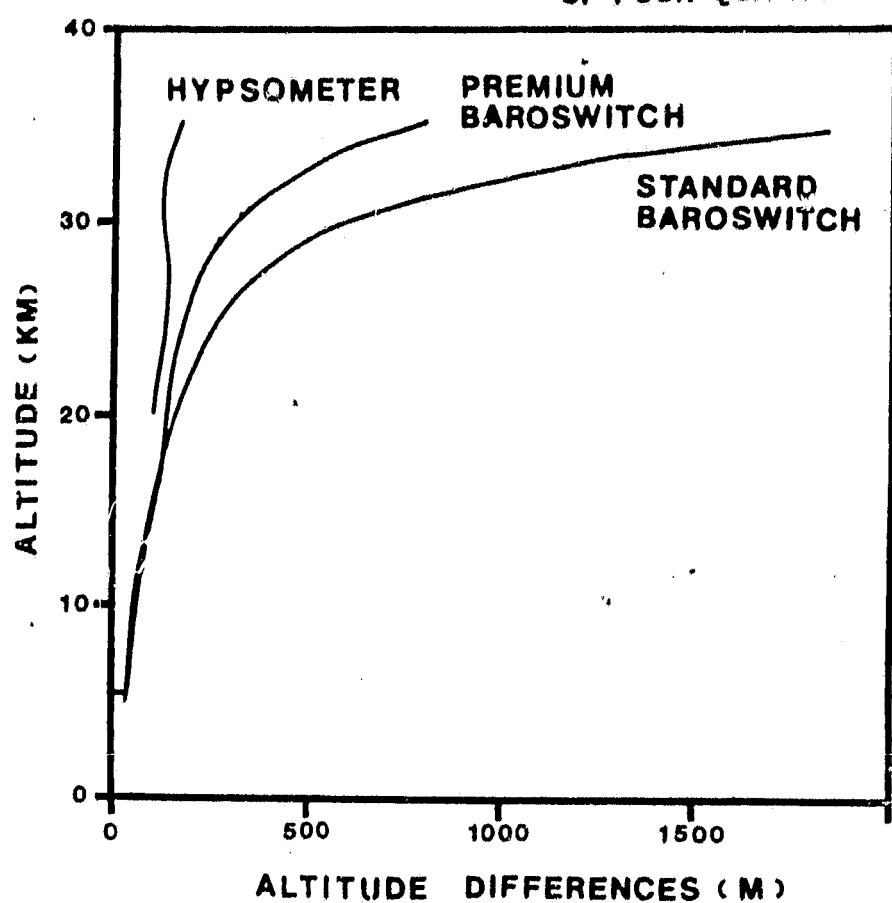
Figure 5 - Rms Differences Between Sonde-Derived Altitude  
and Radar Altitude for Each Type Sonde Tested.

The rms differences between the pressure sensor-derived altitudes and radar-derived altitudes are listed at 5 km intervals in Table 3. These same rms values are graphically depicted in Figure 5. The sondes with indications of operator errors are not included in the rms computations.
