NASA Contractor Report 165745

THE STRUCTURE AND PROPERTIES OF DIFFUSION
ASSISTED BONDED JOINTS IN 17-4 PH, TYPE 347,
15-5 PH AND NITRONIC 40 STAINLESS STEELS

D. A. Wigley

Contract NAS1-16000
July 1981

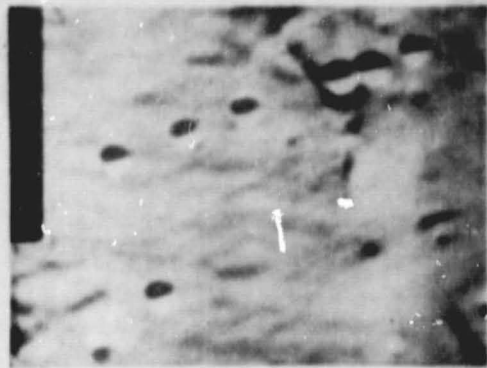
e) Microprobe, x 1800, Topographical

f) Microprobe, x 1800, Copper X-ray

g) Microprobe, x 1800, Nickel X-ray

h) Microprobe, x 1800, Chromium X-ray

In Figure 1e) the electron-microprobe analyzer has been used to form a topographical image at $\times 1800$ of a region of the bond identified by the seven small craters which are microhardness indentations. The image is not, unfortunately, very clear but the bond line can be seen to pass from top center to bottom right of the picture. The microprobe analyser is also capable of forming images from the characteristic X-rays generated by different elements in the material and Figure 1f) shows such an image generated by copper K_{α} X-rays. The strong signal for the bond line stands out even above the rather high background caused by the $\approx 4\%$ copper present in 17-4 P. H. stainless steel. Figure 1g) shows an image generated by nickel K_{α} X-rays. Again the background signal is high but it is possible to make out a nickel deficient region in the bond line itself, with a nickel enhanced region on each side of the bond. Upon investigation, it has been learned that the shop which carried out the electroplating followed the standard commercial practice of laying down a flash coat of nickel prior to the copper coating thus accounting for the nickel rich area. Figure 1h) is a chromium K_{α} X-ray image showing chromium deficiency in the bond line.

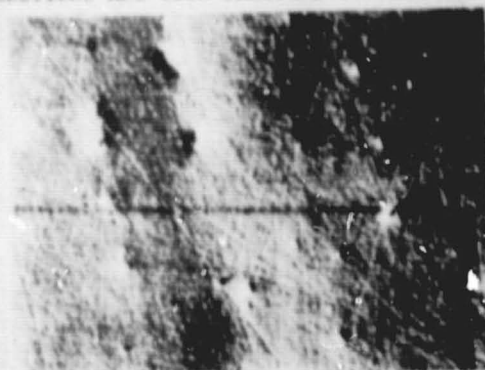
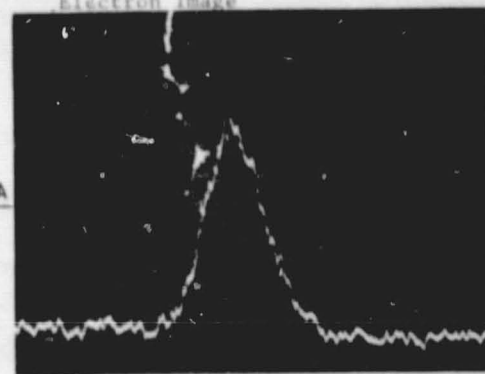
FIG. 5: TYPE 347 STAINLESS STEEL, SECTIONS AND 300K FRACTURE SURFACE

a) Metallographic section, x 200

b) Microprobe, x 500, Scanning Electron Image

c) Microprobe, x 500, Copper X-ray and trace

It was, however, difficult to achieve a good, stain-free, etched surface because the polishing fluid and etchant "wept" copiously from the bond line. Figure 5a) shows some evidence of this staining even after prolonged cleaning: it also reveals the grain structure to be as expected for a 300 series stainless steel, with many parallel-sided annealing twins visible within the main grain. Figure 5b) shows a scanning electron image of the bond line at a magnification of x500, while 5c) presents the copper K_{α} X-ray image of the same region. Also shown is the intensity of the copper X-ray signal as it is scanned across the bond line at the position indicated by the dark horizontal line visible in Figure 5b) and marked AA' in 5c). This line traverses one of the diffusion bonded portions of the interface and the trace shows the copper diffusion zone to have a width of approximately 40 microns ($\sim 1.6 \times 10^{-3}$ inches). For comparison the original copper plated layer was stated by NASA to have a thickness of ~ 5 microns (2×10^{-4} inches).

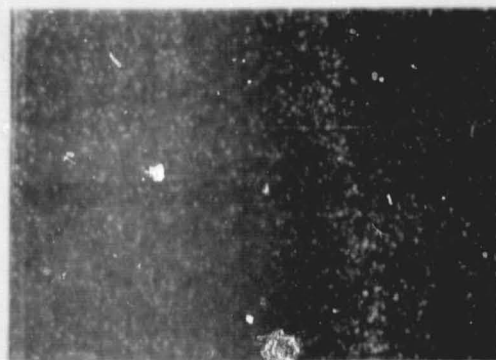
e) Microprobe, x 4750, Scanning Electron Image.

f) Microprobe, x 4750, Copper X-ray

g) Microprobe, x 4750, Manganese X-ray

h) Microprobe, x 4750, Nickel X-ray

Figures 7a), b), c) and d) show micrographs obtained from a polished and etched section of the Nitronic 40 sample supplied by NASA. The low power view of 7a) illustrates the general nature of the grain structure with its characteristic annealing twins similar in many respects to that shown in Figure 5a) for type 347 stainless steel, but with a much larger grain size in Nitronic 40. Bands of large inclusions can be seen running parallel to the bond line, indicating that the original plate rolling direction was also in this direction. The size of the inclusions can be judged by comparing Figure 7c) through h) at a magnification of x4750. The copper X-ray image of magnification. There was little or no "weeping" from the polished and etched surface and few, if any, voids are present. Indeed, the section shown at a magnification of x900 in Figure 7d) indicates that the copper-rich phase fits tightly into the boundary between the two plates and does not appear to crack at break-up. The results of microprobe analysis on this sample are shown in Figures 7e) through h) at a magnification of x4750. The copper X-ray image of 7f) shows only limited diffusion into the parent metal, while the manganese X-ray image of 7g) indicates that there is manganese enhancement in the copper rich region of the bond. As the copper electrodeposit contained no manganese, this must have occurred by diffusion of manganese from the Nitronic 40 into

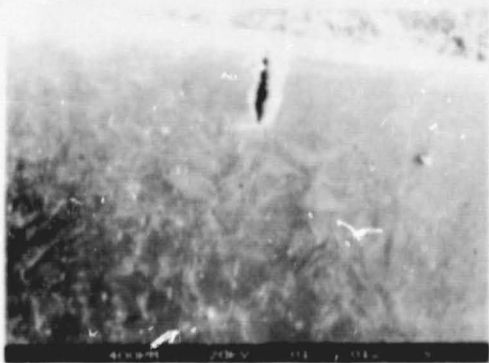
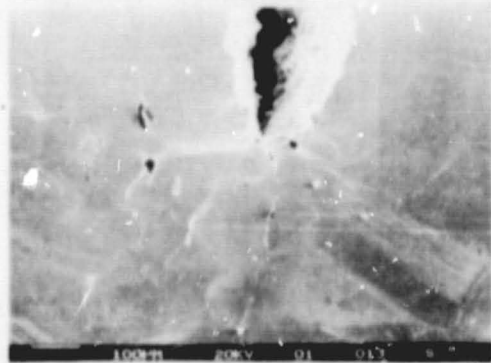
FIG. 8: NITRONIC 40 STAINLESS STEEL, 300K, 60° BEND ON POLISHED SURFACE

a) Stereoscan, x 20 (edge crack)

b) Stereoscan, x 80 (edge crack)

c) Stereoscan, x 800 (edge crack)

The photographs illustrated in Figure 8 show the results of a very significant experiment in which one side of a slice of Nitronic 40, 20mm long \times 10mm wide \times 2mm deep, with a through thickness bond at its mid span, was highly polished to a 1 micron diamond finish. This specimen was then bent through a 60° angle in 3 point bending with the polished surface put under tension. Only a limited degree of bond failure occurred and this was at the specimen edge as shown in 8a). Figures 8b) and 8c) show the tip of this crack at magnifications of x80 and x800 respectively and illustrate the very ductile, tearing nature of the failure. Figures 8d) and 8e) portray a smaller region of debonding further in from the specimen edge at magnifications of x200 and x400 respectively.

In most of these photographs many slip lines are visible, all having the same parallel orientation within a grain, but whose directions change at the grain boundaries. These are indications of the crystallographic nature of slip in materials which only occurs on certain planes and in specific directions. Cross slip is visible in some grains, e. g. center left in Figure 8e), where two intersecting slip systems are in operation within the same grain. These markings only appear as a result of plastic deformation of the metal and they are, therefore, an infallible indication that stresses in these grains have exceeded the local yield stress. With this in mind, examination of the photographs of a typical intact region of the bond line, Figures 8f), g) and h), permits an interpretation of the characteristics of the copper-rich phase in the boundary. Slip lines are clearly visible within the copper-rich phase which must therefore be ductile and which must also be strong enough to remain unbroken at stresses large enough to cause yield and plastic deformation of the adjacent grains of Nitronic 40.

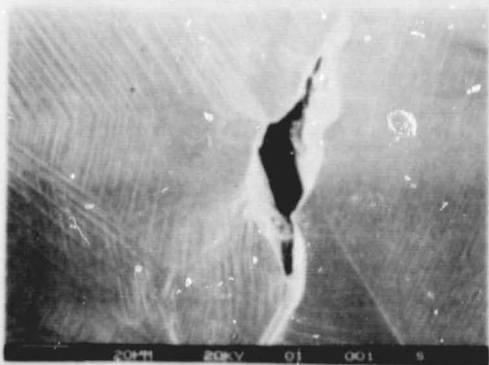
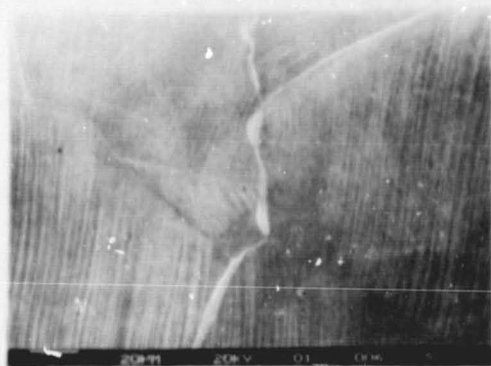
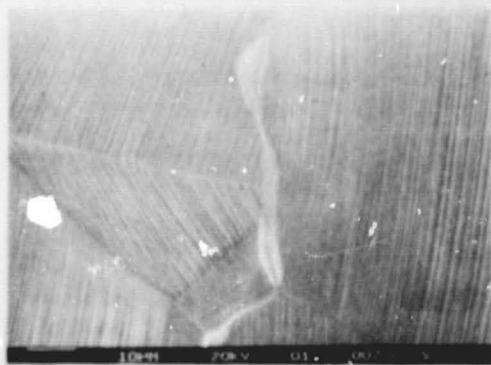
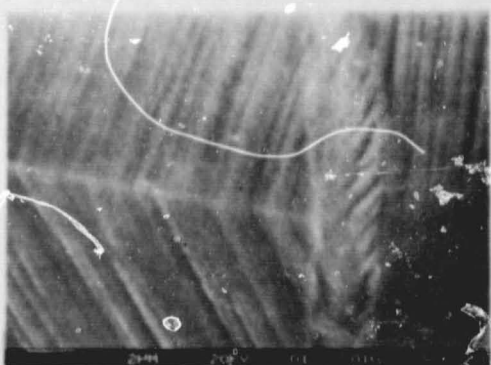
f) Stereoscan, x 400 (bond line)

d) Stereoscan, x 200 (internal crack)

g) Stereoscan, x 800 (bond line)

e) Stereoscan, x 400 (internal crack)

h) Stereoscan, x 4000 (bond line)

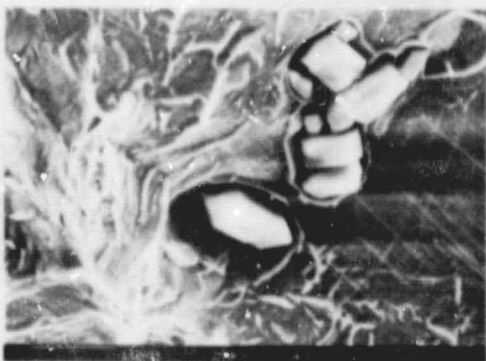
h) Stereoscan, x 1400 (inclusions)
