NASA Technical Memorandum 81252

**NASA Aviation Safety
Reporting System:
Quarterly Report No. 12**

Ames Research Center
Moffett Field, Calif. 94035

Aviation Safety Reporting System Office
Battelle's Columbus Division
Mountain View, Calif. 94043

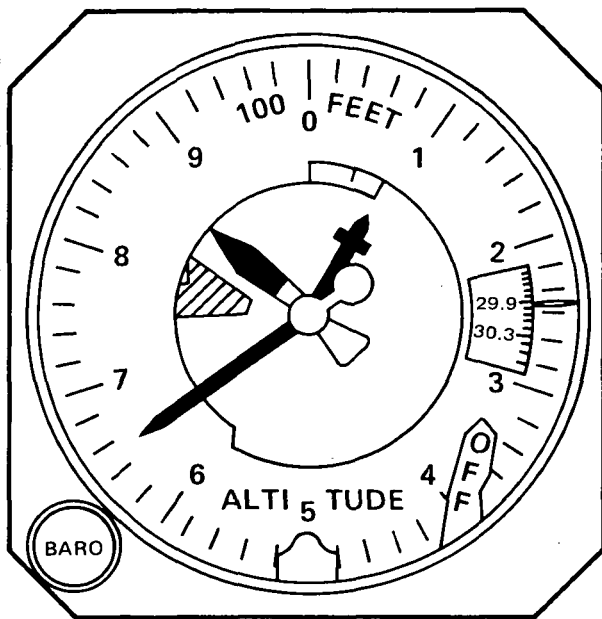
Figure 1.— Three-pointer altimeter.

A typical "three-pointer altimeter" is shown in figure 1. The three progressively shorter needles denote altitude in 100-, 1,000-, and 10,000-ft intervals, respectively. Each complete revolution of the 100-ft pointer indicates a change in altitude of 1,000 ft, as indicated by the 1,000-ft pointer. The shortest 10,000-ft needle is incremented one unit with each complete revolution of the 1,000-ft pointer.

Kollsman windows appear on all four instruments and display barometric pressure reference settings in either millibars or inches of mercury or both. Adjustments are made by means of the small knob on the front of the instrument cases.

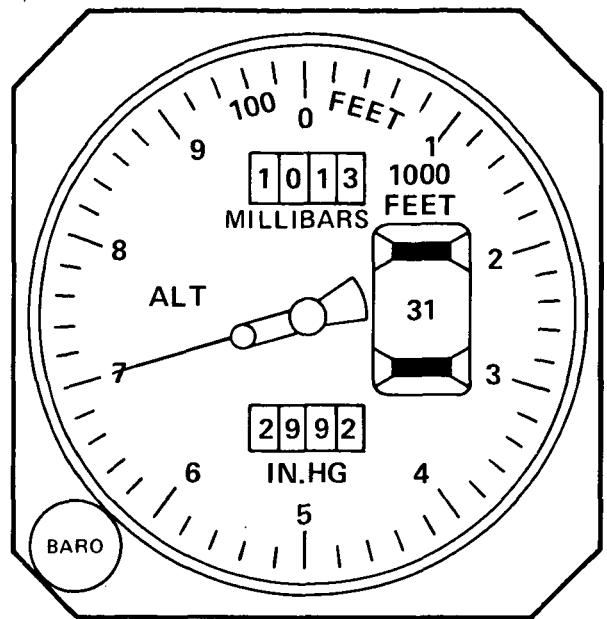
Figure 2.— Drum-pointer altimeter.

A "drum-pointer-type altimeter" is shown in figure 2. To the right of center of this instrument is a window containing two rotating counters which indicate feet in units of thousands and ten-thousands. Each complete revolution of the single pointer increments altitude by 1,000 ft. Whenever the aircraft is below 10,000 ft, a yoke flag appears over the innermost counter.

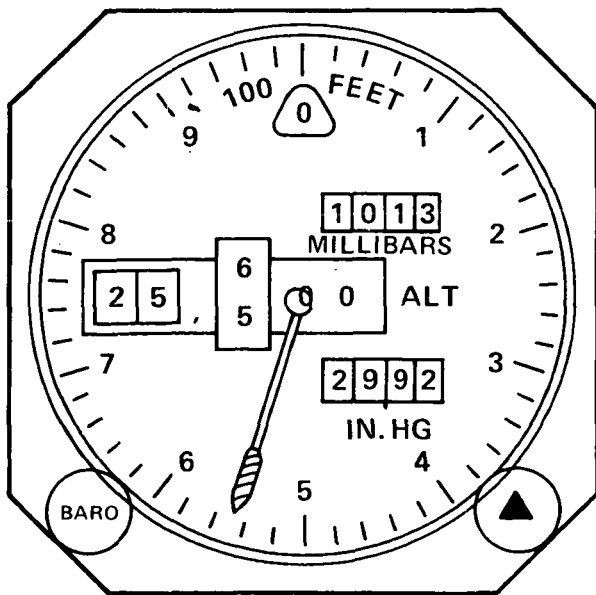
Figure 3.— Counter-drum-pointer altimeter.

Typical "counter-drum-pointer and counter altimeters" are illustrated in figures 3 and 4. Precise altitude tracking is maintained by means of the single pointer; a five-place numeric readout is available on the dial face for quick altitude reference. The basic design of these two instruments is similar, except that newer counter-pointer altimeters employ a snap-type action to rotate the digits; the counter-drum-pointer retains an analog motion with an expanded hundreds window to permit correct interpolation to the nearest hundreds place.

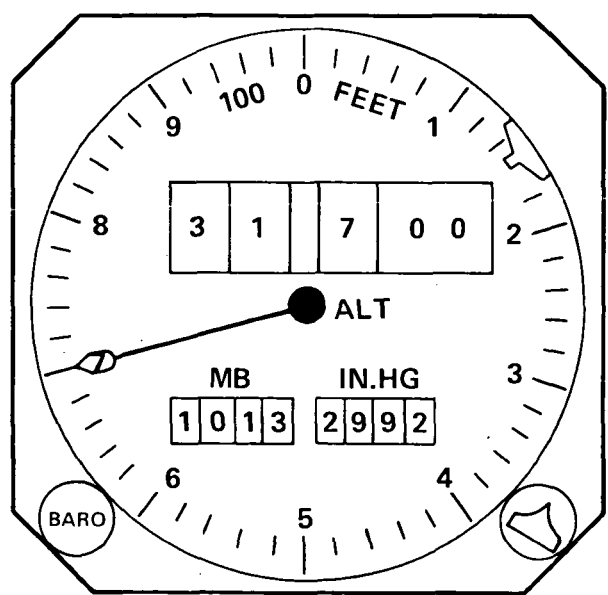
Figure 4.— Counter-pointer altimeter.
