# NASA Contractor Report 159261

## VISUALIZATION OF IMPACT DAMAGE OF COMPOSITE PLATES BY MEANS OF THE MOIRÉ TECHNIQUE

W. G. Knauss, C. D. Babcock,  
and H. Chai

CALIFORNIA INSTITUTE OF TECHNOLOGY  
Pasadena, California 91125

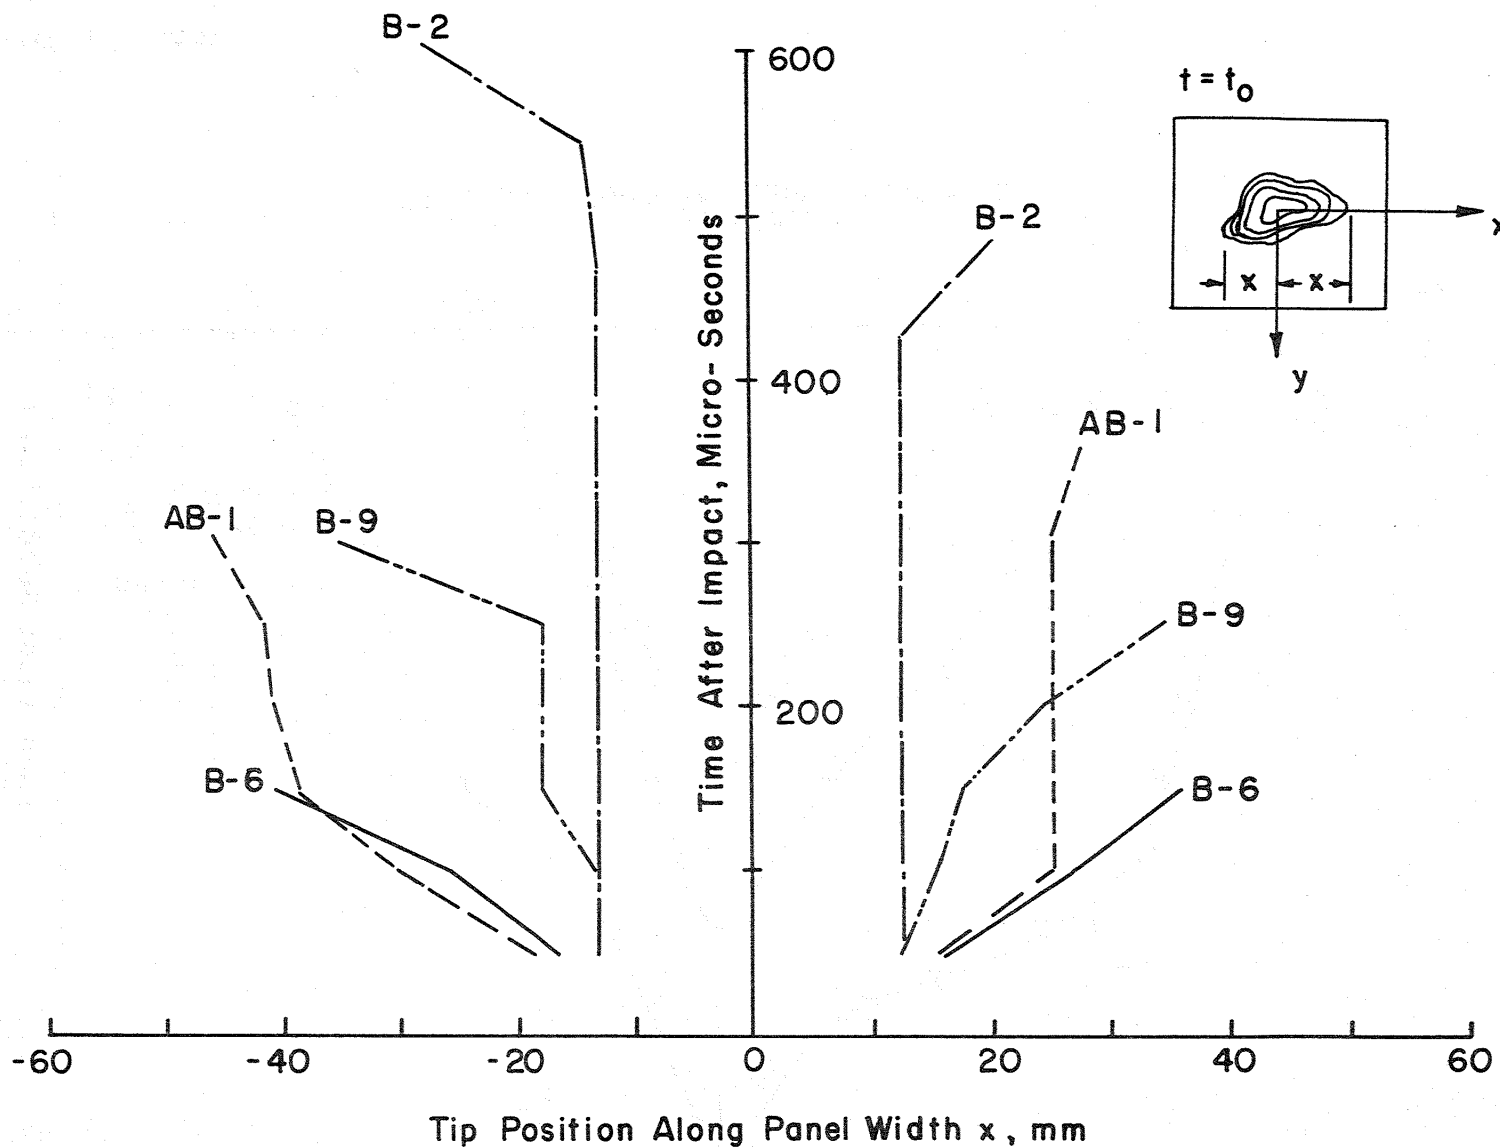
FIG.18 DELAMINATION TIP POSITION ALONG PANEL WIDTH AS FUNCTION OF TIME

FIG. 18 Cont.
