Diagnostic Procedures for Trend Monitoring System (TMS) Communications

MARCH 1979

MITRE Technical Report
MTR-4724

THE
MITRE
CORPORATION
HOUSTON, TEXAS

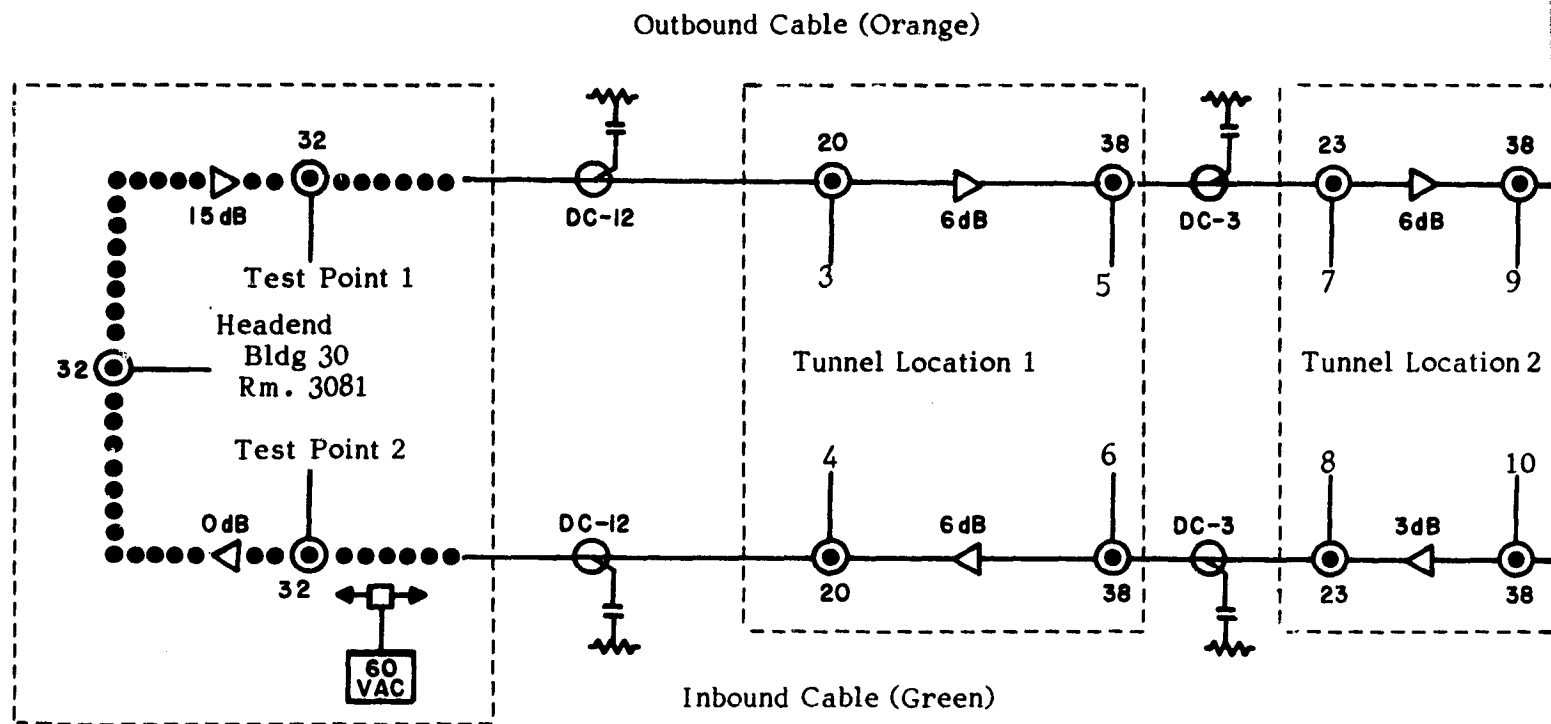
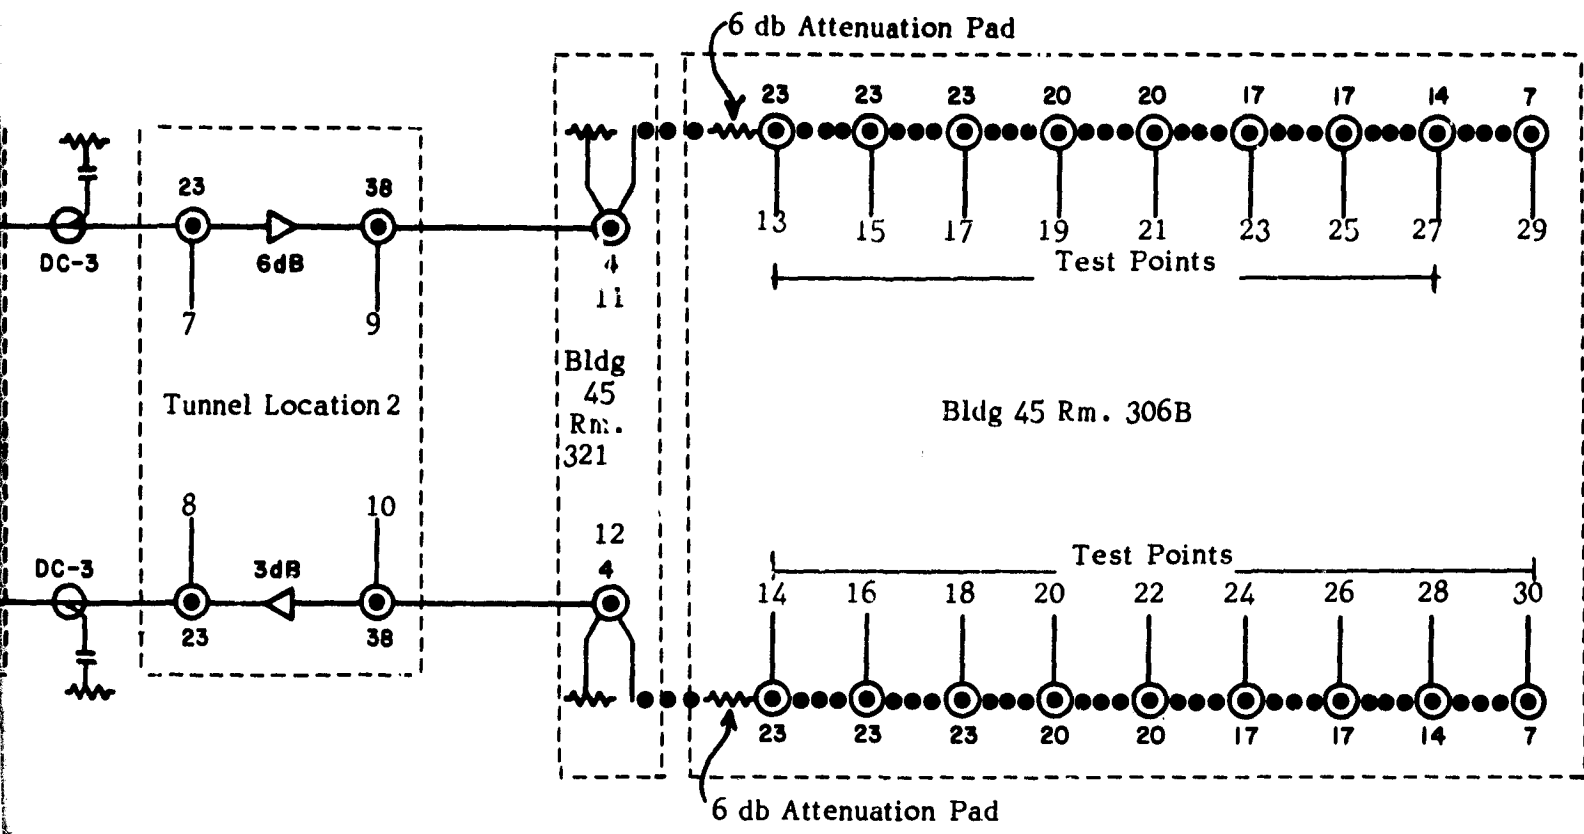
Figure 2.1-10 TMS Cable Network Schem

Key: Directional Coupler

Numbers beside amplifiers are
attenuation pad values

- Numbers beside multitaps indicate the tap values; numbers beside multitap drop connections are test point numbers

2. Use the MODCOMP test program VOLLEY to isolate the location of cable bus failure by following the steps given below. The locations referenced in the steps are keyed to the schematic diagram of the cable system shown in Figure 2.1-10 (more information about the cable system is found in [2]).

- d. If the failed component is a directional coupler, replace the interior part of the directional coupler (leave the shell in place) with a coupler of the same isolation (as shown in Figure 2.1-10).
