NASA TECHNICAL MEMORANDUM

NASA TM-75351

COMPOSITE COMPONENTS UNDER IMPACT LOAD AND EFFECTS OF
DEFECTS ON THE LOADING CAPACITY

R. Aoki and D. Wurzel

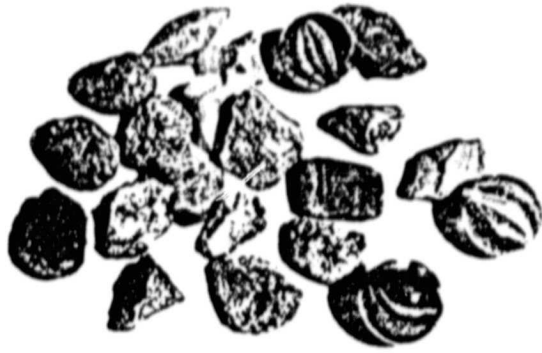
Stone Projectiles for Simulation of Stone Damage

Experimental Nose-Section with Damage after Bombardment with Glass Bullets and Stones

Damage on the Side of the Nose (Vicotex 1452) by impact of a Screwdriver from a Height of 1.8 m with a mass of 113 g

Fig. 7. Impact tests on fiber composite--noses.

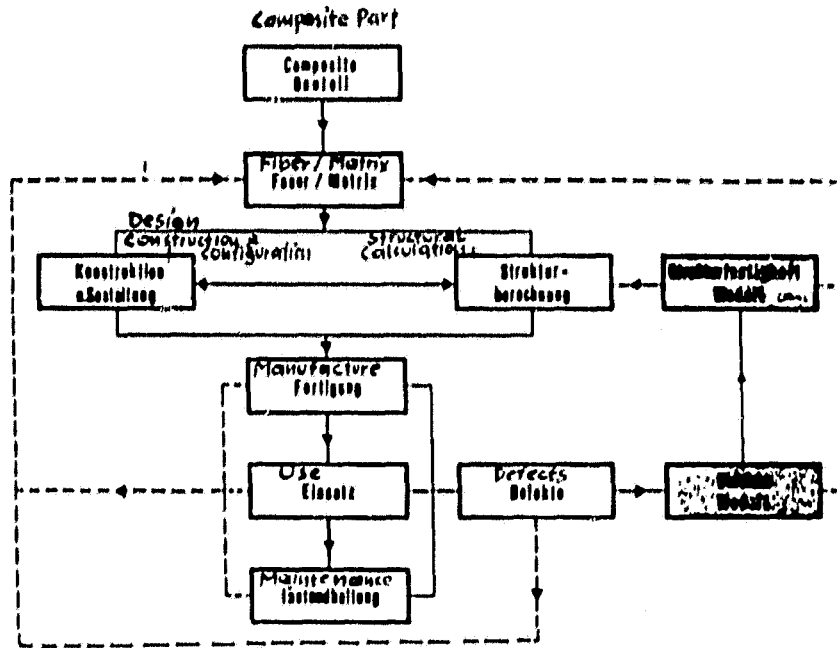
Fig. 10. Rough sketch of various phases of a composite structure. The models for field defects and structural strength for fiber-reinforced materials are only in the development stage.

The various phases of a composite part are sketched roughly in Fig. 10. This shows in which phases defects can occur. The structural-strength model, as well as the defect model for fiber

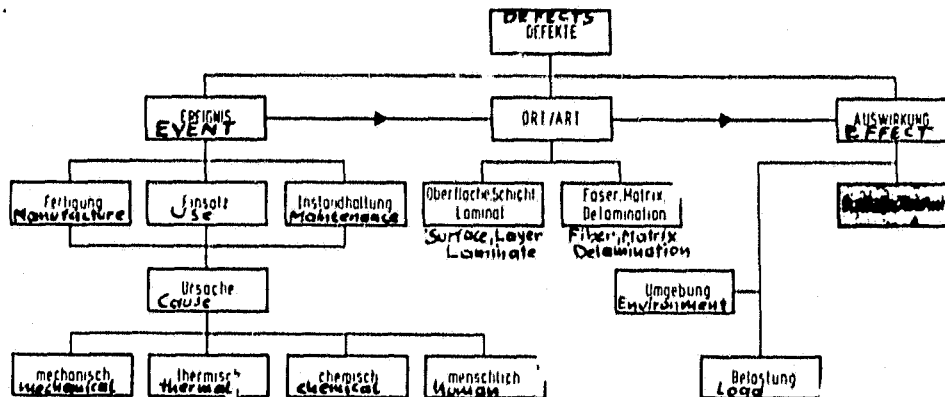
Fig. 11. Fault tree for classification of defects that can occur in composite structures.

Looking first at the event, a tabulation can be made in which the causes can be mechanical, thermal, chemical, human or a combination of these facts (see Fig. 11). In a classification according to the damage location, defects on the surface, in the laminate layer proper, or between the laminates, can occur or extend over the whole laminate. When classifying according to the type of damage, differentiation can be made between fiber-specific, resp. matrix-specific damages, such as differences in the fiber strength, fiber breaks during manufacture, wrong mixture ratio during resin application, or delaminations, foreign bodies and air bubbles that may appear singly or in combination.

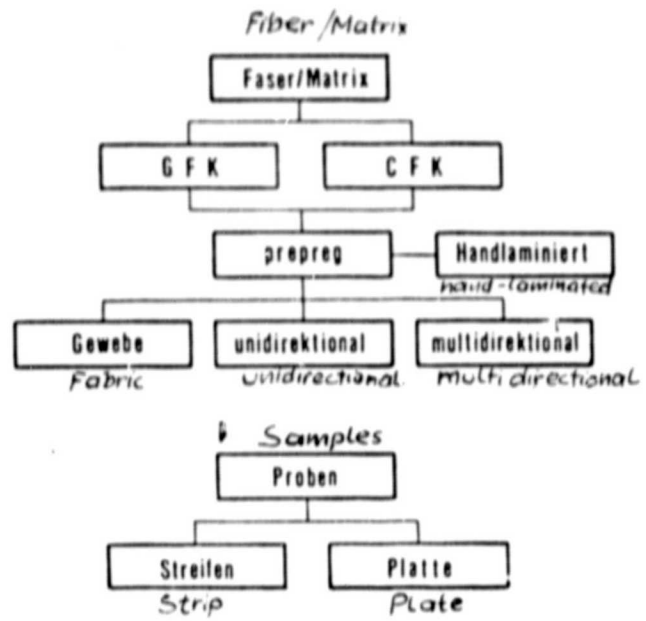
Fig. 12. Program survey 1BK detects and their effects.

The investigations will extend to real, simulated and idealized defects and, not the least, to defect free samples, as shown in Fig. 12.

1. The bombardment test with a glass bullet (Fig. 12).
2. Generation of a defect through a punch mark.

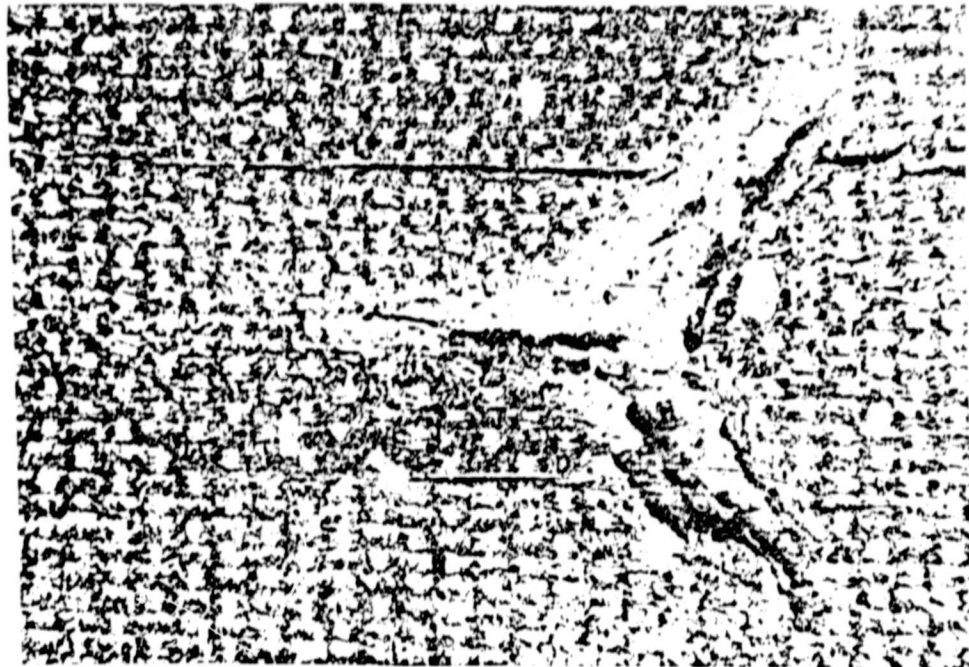
Fig. 16. CFK-T300/Code 69---[0/90]_{3S}.

As with the GFK samples, the generation of the star-shaped damage (Fig. 16) is carried out by means of a punch, but with variations in the depth of penetration.

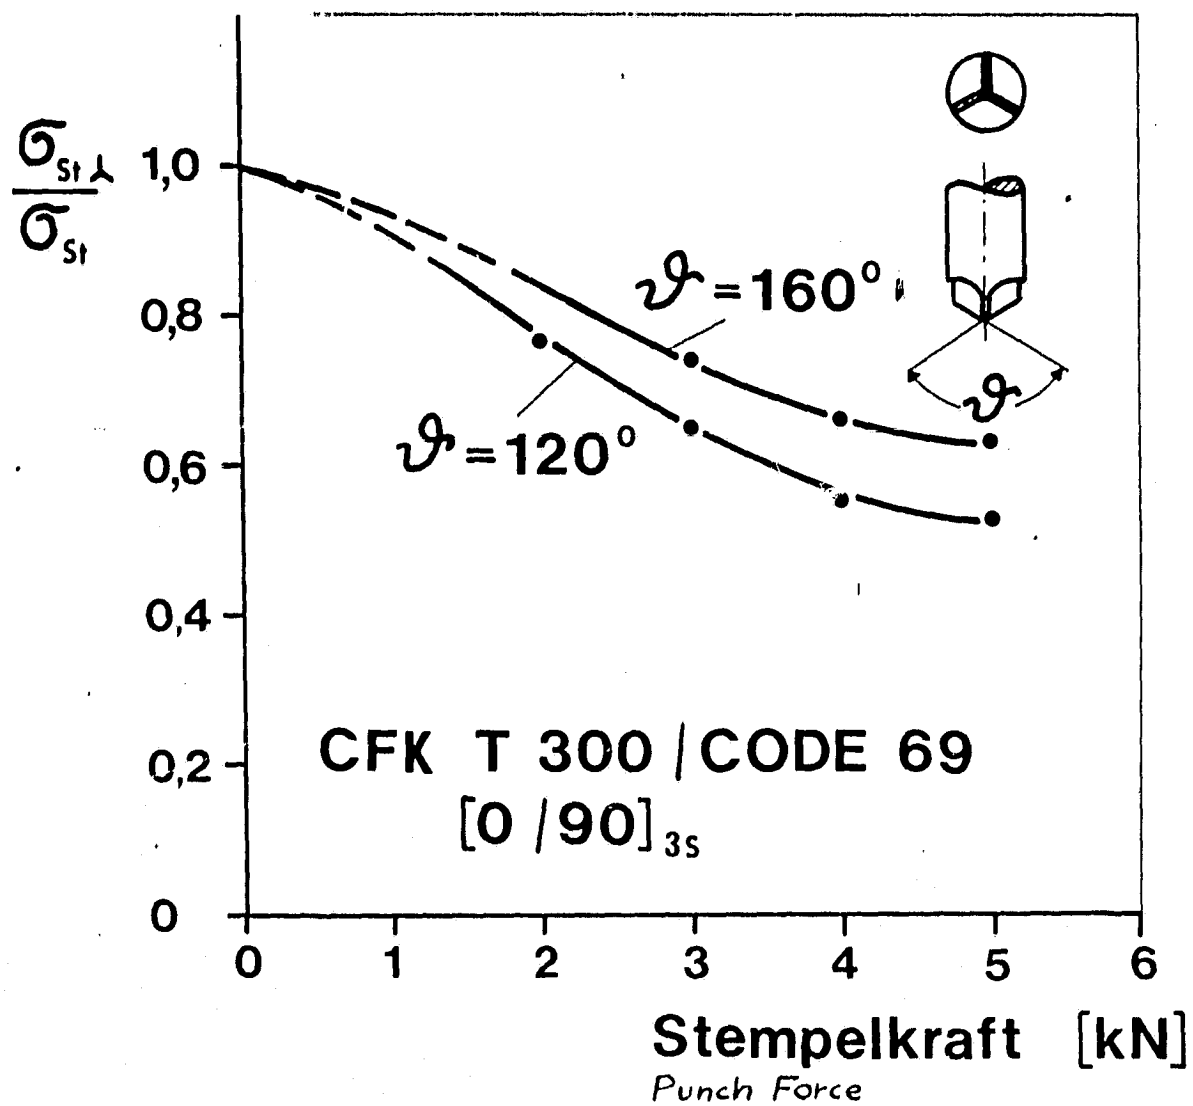
Fig. 17. Influence of damage parameters.

The influence of the damage parameters, pointed angle and punch force P , on the static tensile strength (σ_{st}) is shown on hand of the example of the B-sample with star-shaped damage (Fig. 17).
