CF6 JET ENGINE PERFORMANCE IMPROVEMENT

NEW FRONT MOUNT

Final Report

W.A. Fasching

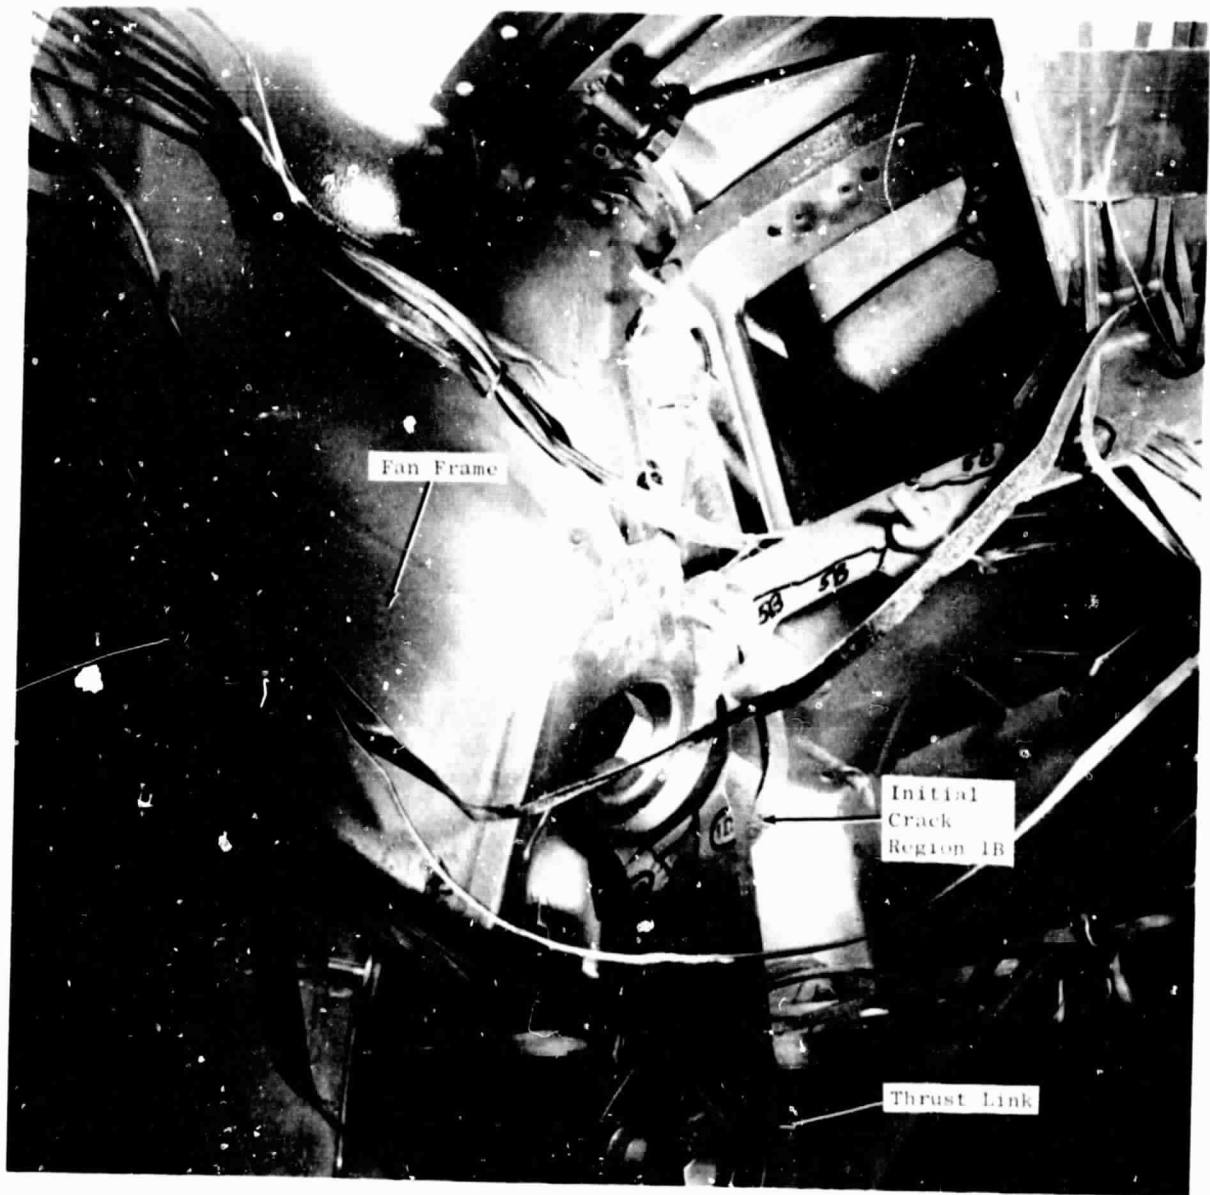
Figure 5.5. Photograph of Stresscoat Map Pattern.

Initial Stresscote cracks developed on the axial thrust link as shown on Figures 5.5 and 5.6, region 1B. Initial crack patterns developed at 66,720 N (15,000 lb) axial load. The thrust links are the primary load-carrying members for the axial load and initial crack formation on these links was anticipated. During this test run suspicious formation of Stresscote cracks developed on the fan frame and side link, region 2B, Figures 5.6 and 5.8. Subsequent investigation of strain gage data showed high strain readings on the fan frame and a side load pickup in the center link. A visual inspection of the test facility detected that the mount facility loading fixture had rotated and made contact with the fan frame clevis at the 12 o'clock location and also with the lock plate on the right side (aft looking forward) thrust link at locations shown in Figure 5.3. It was determined that the rotation was caused because the right side actuator was not vented. After the hydraulic actuator was properly vented, the test facility fixture was reassembled. A checkout of the system was completed and the axial load test was repeated. Stresscote cracks that developed in the side link and fan frame from the test fixture movement are valid for indicating the critical stress areas on the fan frame, side link, and mount platform.

Initial Stresscote cracks in the fan frame clevises in line with the thrust links developed at 88,960 N (20,000 lb) axial load, Figures 5.4 and 5.5. The load was increased to 111,200 N (25,000 lb) and additional stress cracks developed in new areas on the fan frame and mount platform as shown on Figures 5.4 and 5.6, region 5B.

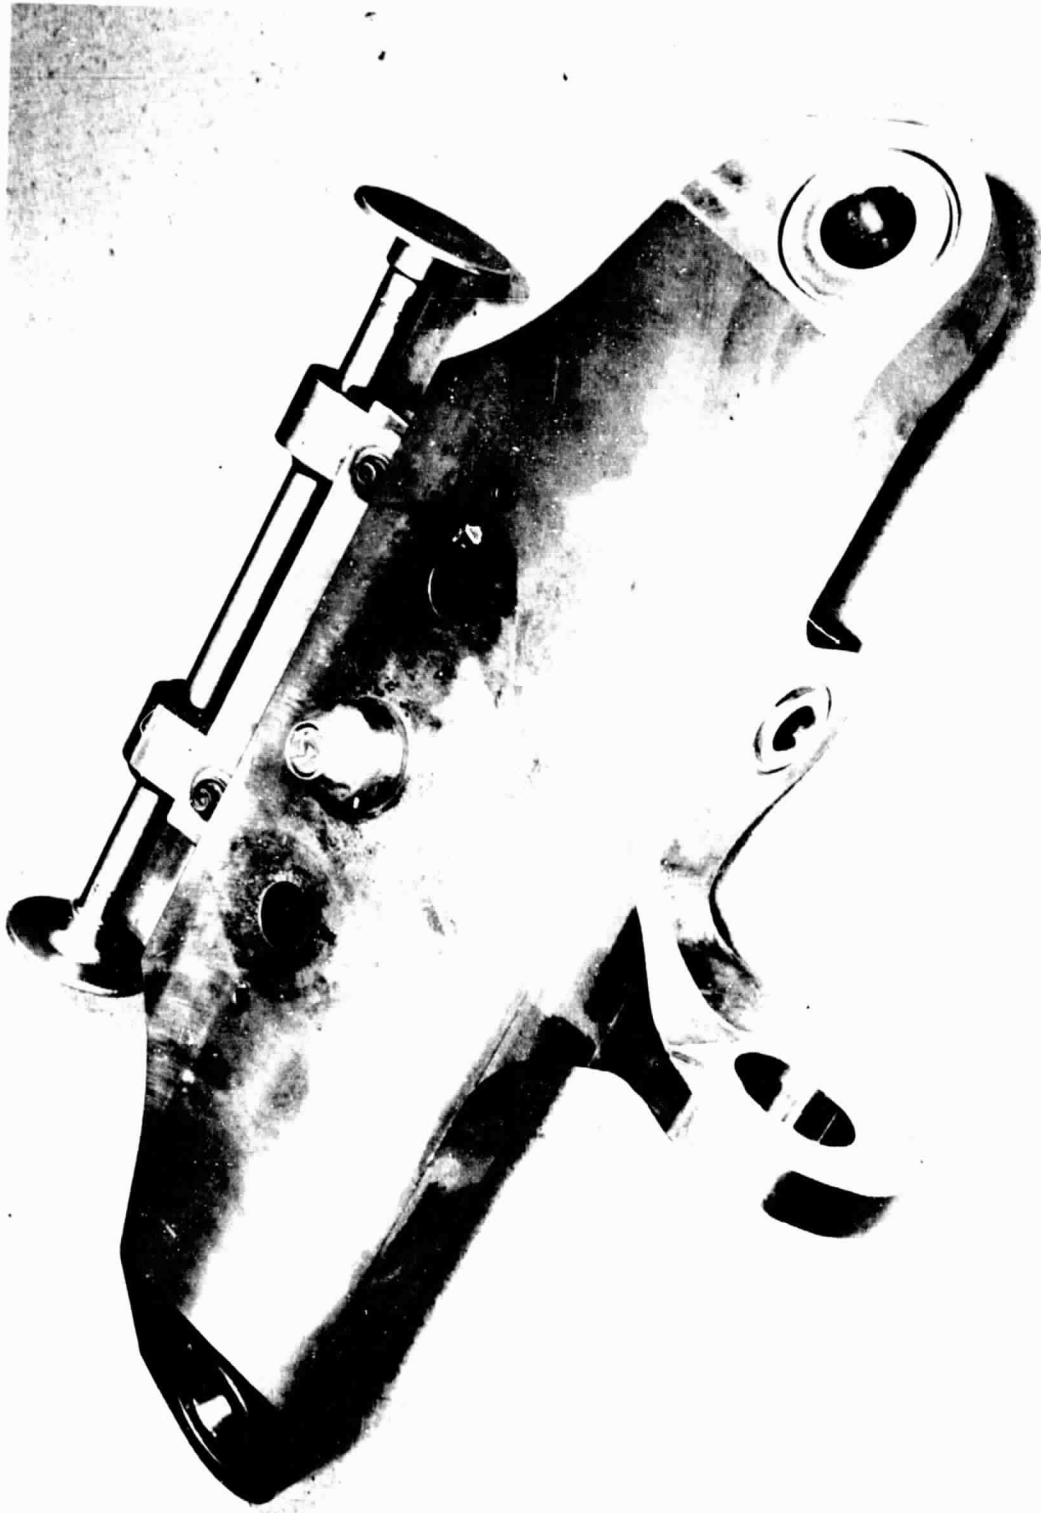
Figure 8.2. New Front Mount Platform from Engine 455-508 After 204 Hours.
