# ON-ORBIT SPACECRAFT RELIABILITY

PRC R-1863

30 SEPTEMBER 1978

Prepared for  
Headquarters, National Aeronautics  
and Space Administration  
Washington, D.C.

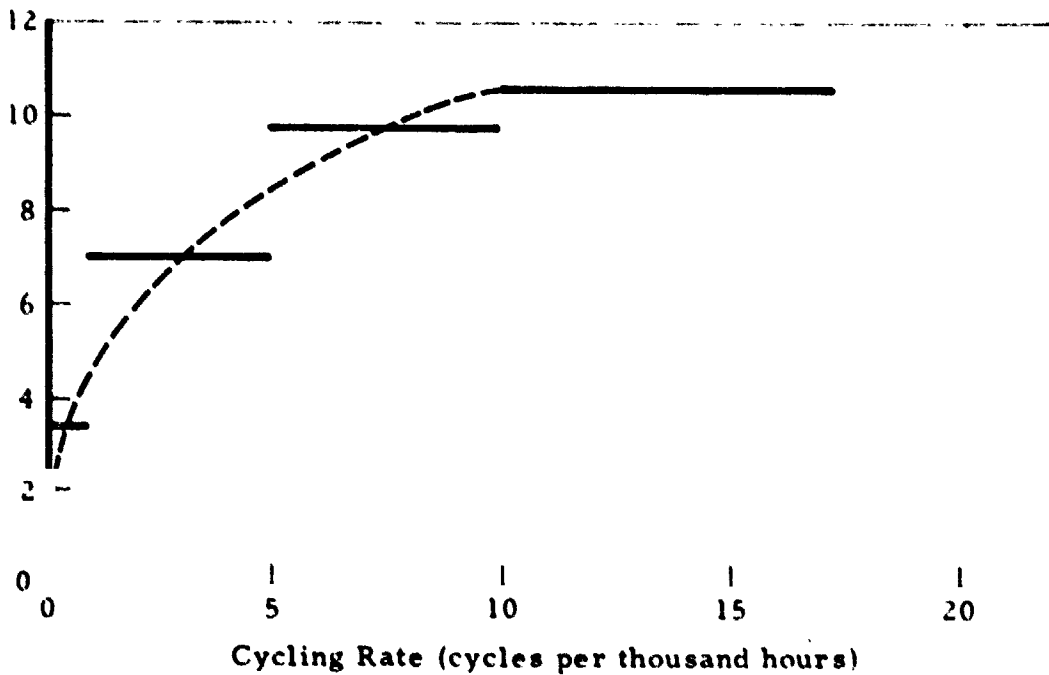
Failure Rate (failures per million hours)

EXHIBIT 26 - FAILURE RATE VERSUS CYCLING RATE AND DUTY CYCLE FOR SPACEBORNE SCIENTIFIC EXPERIMENTS (FROM REFERENCE 2)

There may well be compensating tendencies in the cyclic mode of operation in that turning a component on and off may be detrimental to reliability whereas periods of no or reduced stress (ie., "dormancy") may be beneficial. In the analysis of Reference 5, the detrimental effect of on/off switching was found for the various scientific experiment packages of an observatory class satellite; the beneficial effects of dormancy were not found. These relationships are repeated here in Exhibit 26. The data on spacecraft components shown in Exhibits 24 and 25 were analyzed in a manner similar to that which produced the results of Exhibit 31.
