INTEGRATION OF REMOTE SENSING AND  
SURFACE GEOPHYSICS IN THE DETECTION OF FAULTS

P.L. Jackson  
R.A. Shuchman  
H. Wagner

Environmental Research Institute of Michigan  
Ann Arbor, Michigan

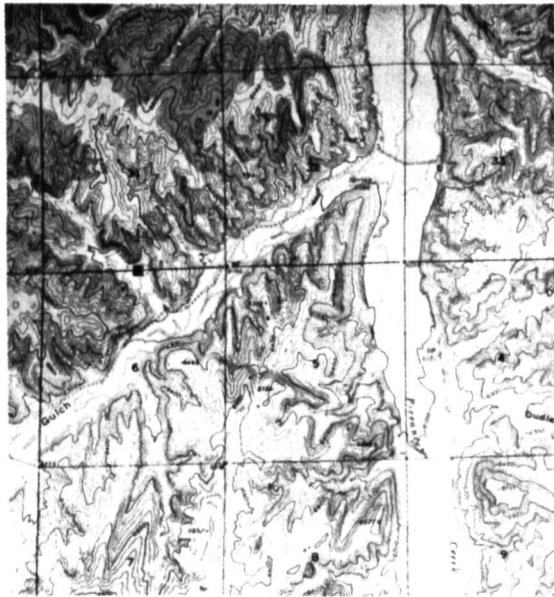
FIGURE 1. TOPOGRAPHIC MAP OF TEST SITE REGION. Black square on central horizontal section line is the location of the observation well. (USGS Square S Ranch Quadrangle, Colorado)

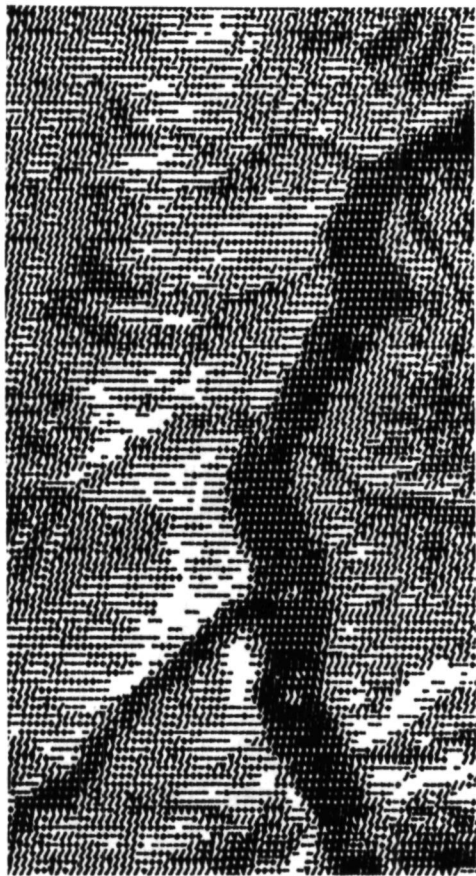
FIGURE 5. DENSITY SLICED IMAGE OF LANDSAT BAND 5. Light areas occur along wide vertical linear.

Figure 5 is a channel 5 density sliced image that is intended to show a series of linears in close proximity to the test site. Linear A appears to be the same linear enhanced on the 5/7 ratio image previously shown.

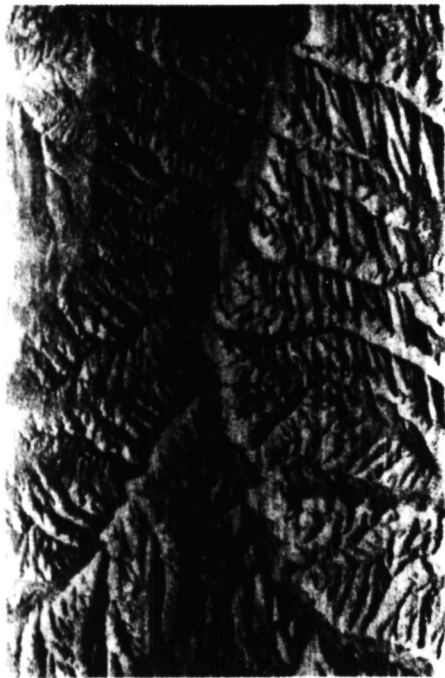
FIGURE 7. SAR IMAGE OF TEST SITE REGION.

In Figure 6, note the clear indication of a linear aligned with Ryan Gulch extending northeast toward the White River uplift. Although outside our test area, this long, persistent linear concerns the test area. If this linear were subsequently proven to be a fault through further geologic or geophysical investigation, it would indicate more structural activity than previously thought to be the case within the test region. Also, the straight portion of Ryan Gulch might be fault controlled. This northeast linear is also present on the four LANDSAT channels shown in Figure 2. Figure 7 is a SAR image of the test site area which does not indicate this linear.
