**NASA TECHNICAL  
MEMORANDUM**

NASA TM X-73994

FATIGUE DAMAGE OF NOTCHED BORON/EPOXY  
LAMINATES UNDER CONSTANT AMPLITUDE LOADING

Presented at the ASTM Symposium on Fatigue of Filamentary Composites,  
November 15-18, 1976, Denver, Colorado.

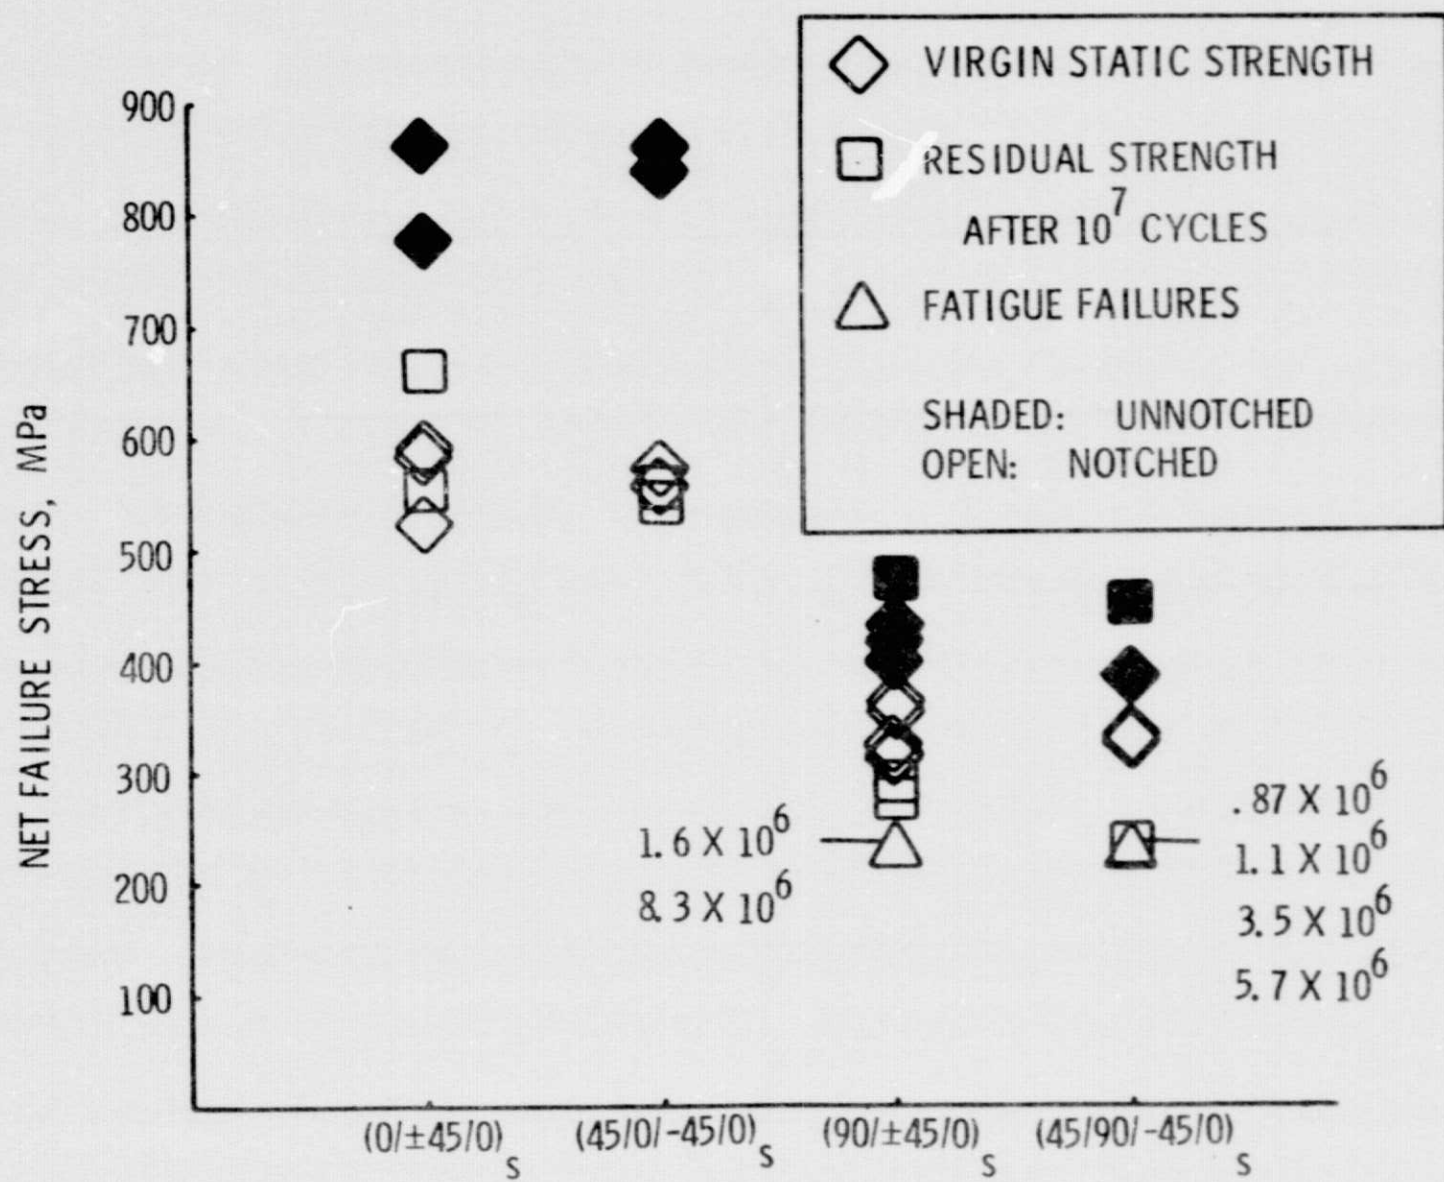
Figure 11. Residual strength after tension fatigue

Figure 11 shows the net failure stress of virgin laminates as diamonds, the residual strength after  $10^7$  cycles as squares, and fatigue failures occurring before  $10^7$  tensile load cycles as triangles labeled with the number of cycles to failure. For reference, a few unnotched specimens were also tested; these test results are shown by shaded symbols.
