**NASA TECHNICAL
MEMORANDUM**

NASA TM X-3494

**NASA AVIATION SAFETY REPORTING SYSTEM:
SECOND QUARTERLY REPORT
JULY 15-OCTOBER 14, 1976**

*Ames Research Center
Moffett Field, Calif. 94035*

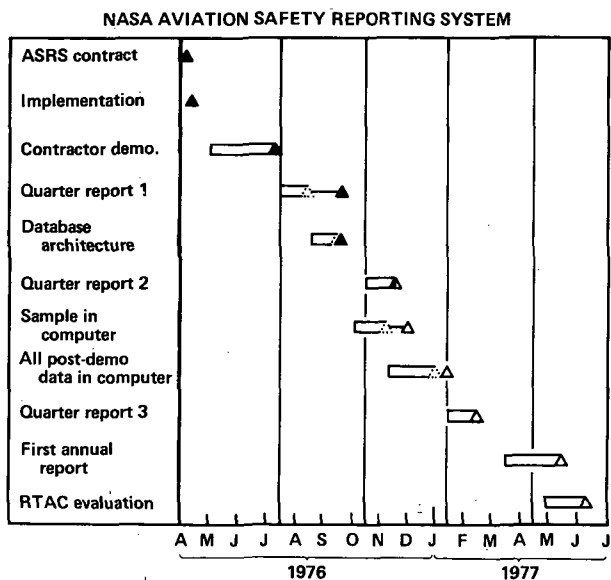
Figure 5.— Milestone schedule.

Present schedules call for all second quarter data and as much third quarter data as possible to be available for automated data processing by the end of the third quarter on January 15, 1977. The variety and complexity of analyses that can be performed will increase substantially after that time. Figure 5 shows near-term ASRS milestones.
