**NASA TM X-73947**

CONCORDE NOISE-INDUCED BUILDING VIBRATIONS  
MONTGOMERY COUNTY, MARYLAND - REPORT NO. 3

Staff-Langley Research Center

August 1976

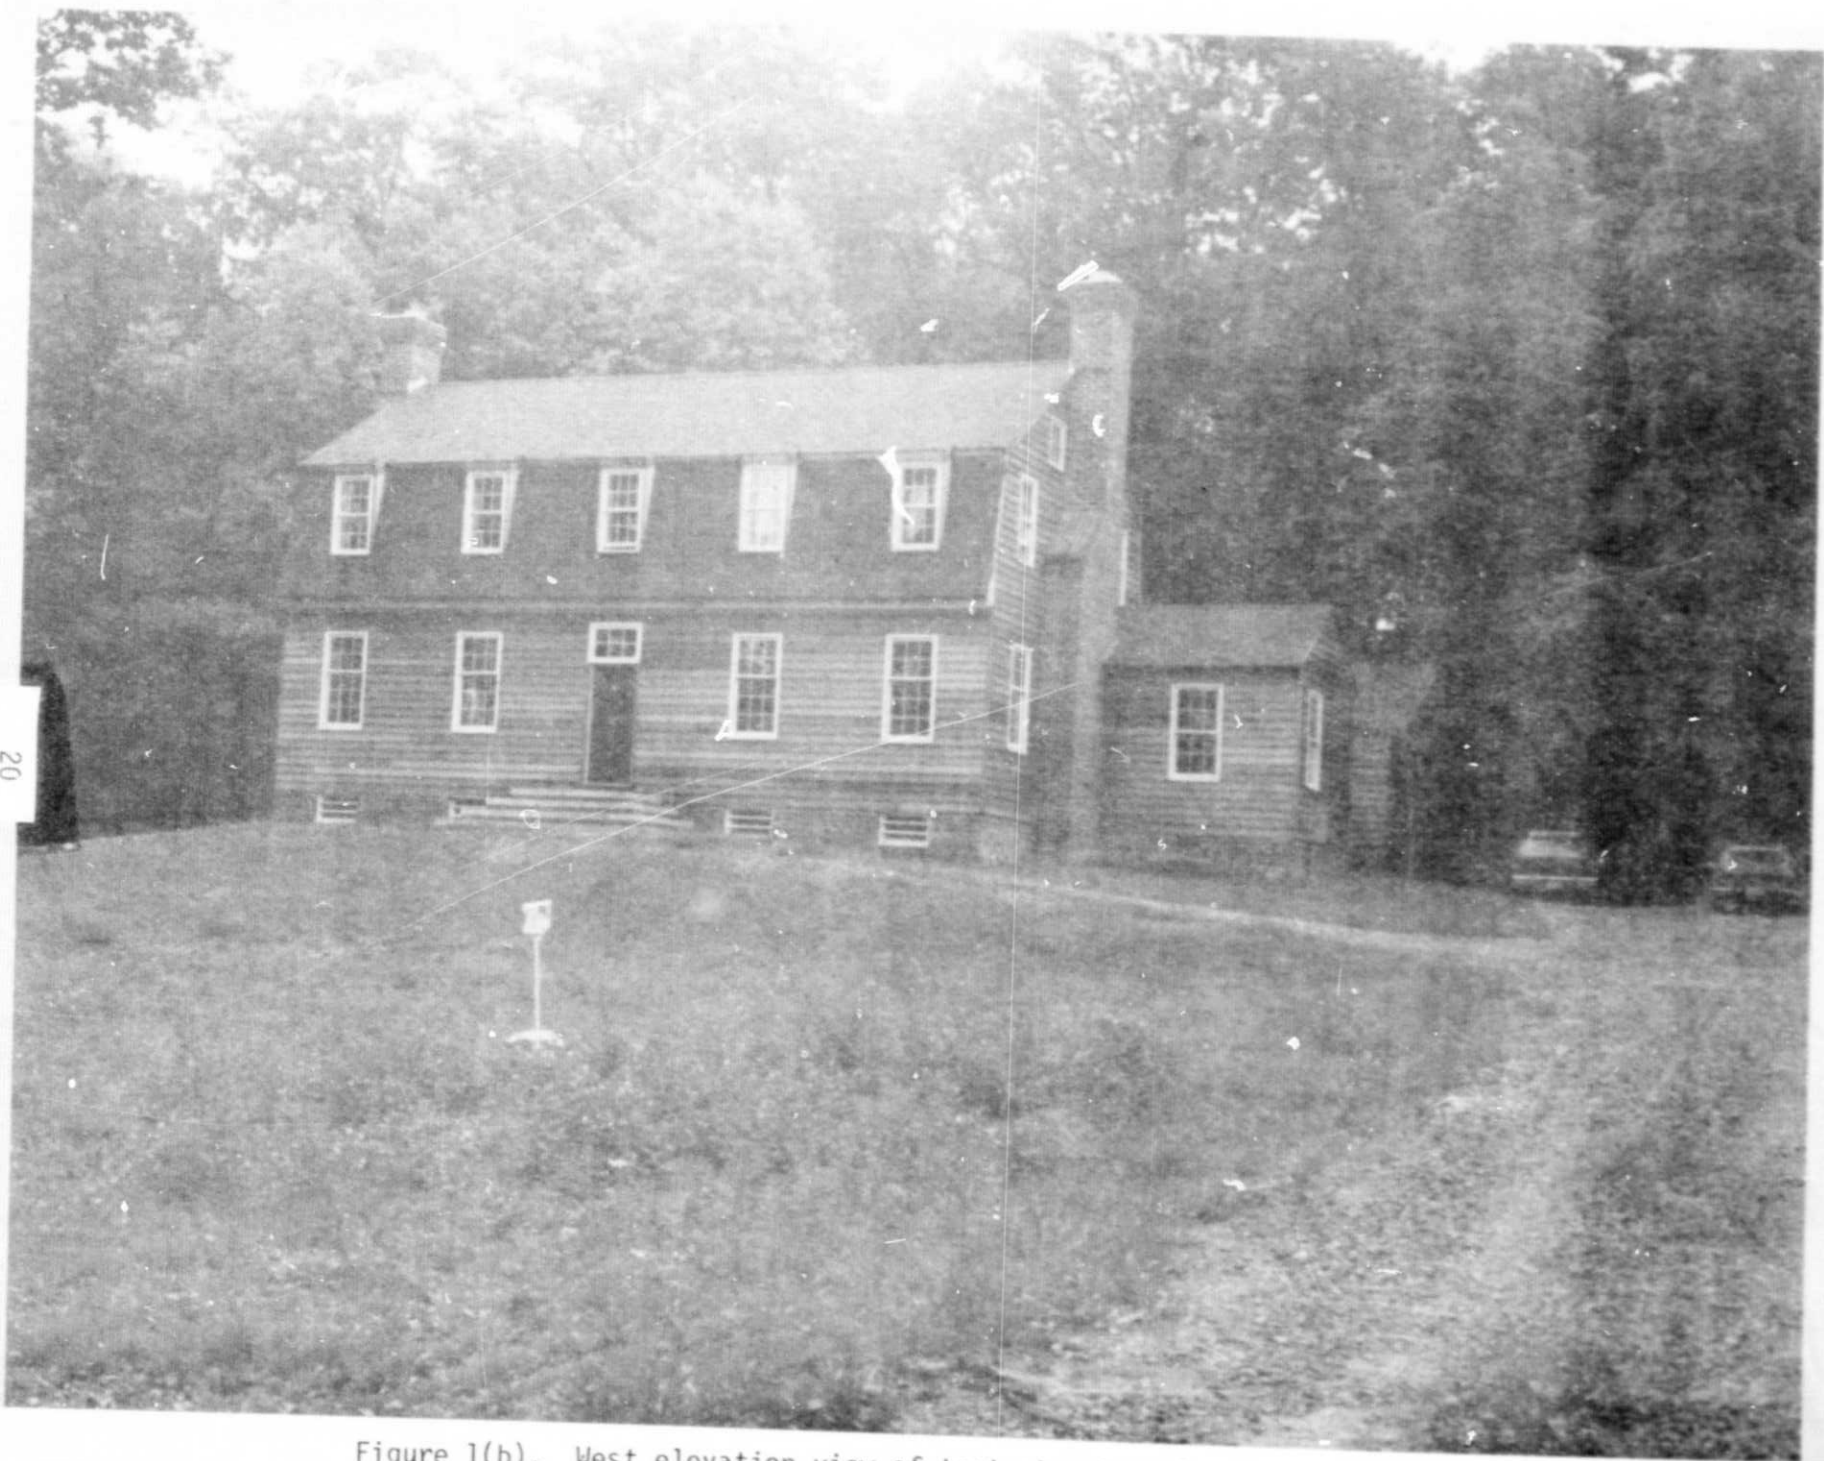
Figure 1(b). West elevation view of test structure 1.

Test structure 1.- Figure 1(b) is a photo of the west face of the recently constructed two-story "Williamsburg" style frame structure, which is situated on a west facing slope of a knoll in wooded surroundings. A sketch of the plan view of the house is provided in figure 1(c). The house is of typical wood frame construction with the exception of styrofoam insulation which was used in lieu of weatherboard before the exterior was sheathed with redwood siding. The interior walls of the house are of

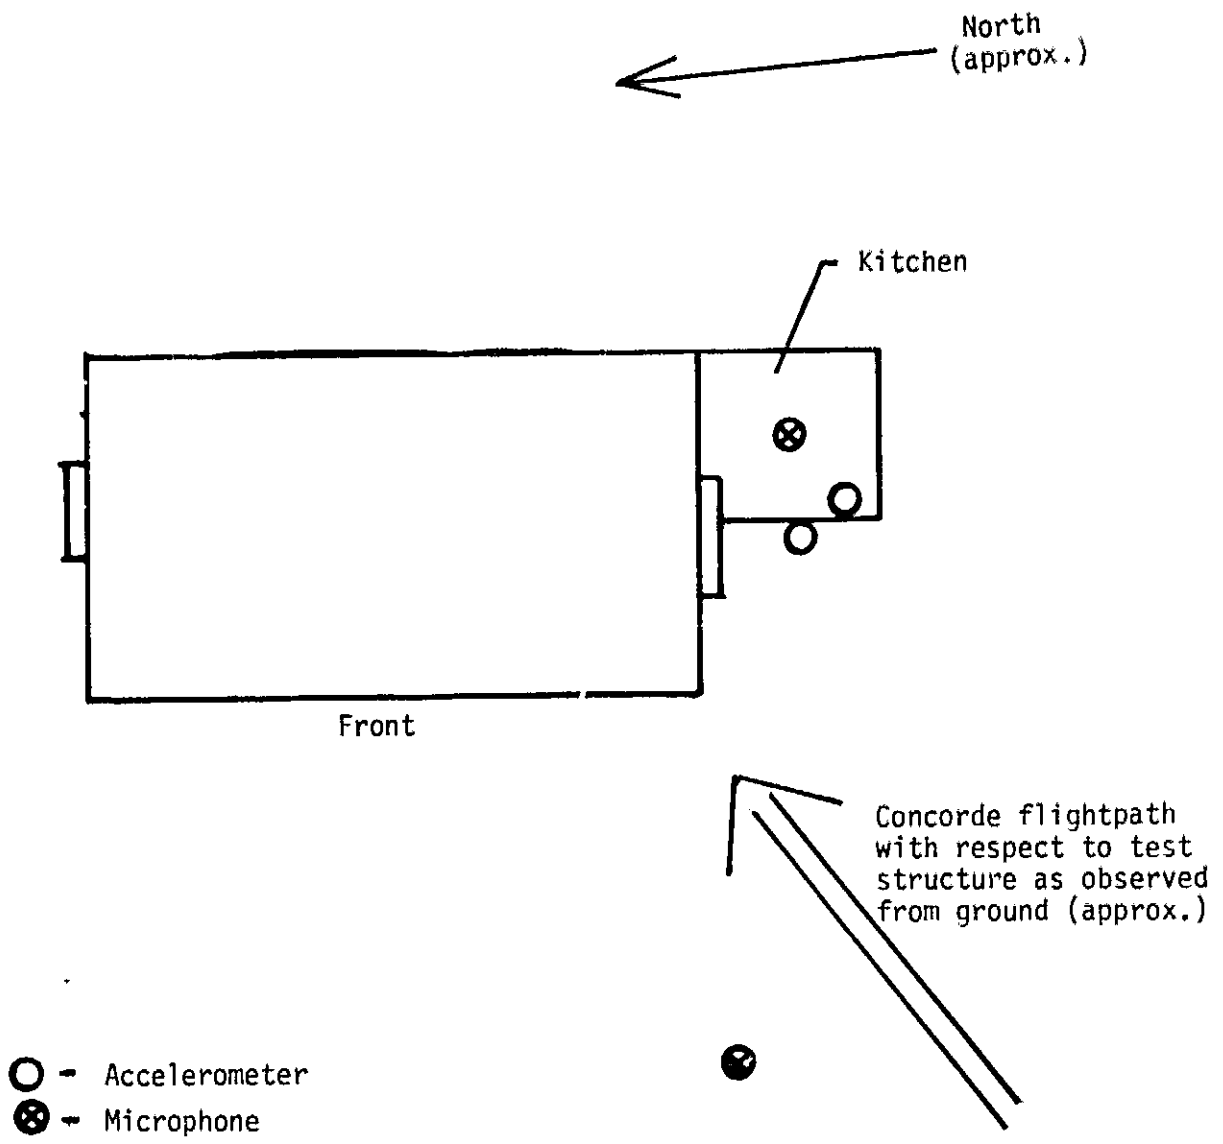
Figure 1(c). Plan view sketch of test structure 1.

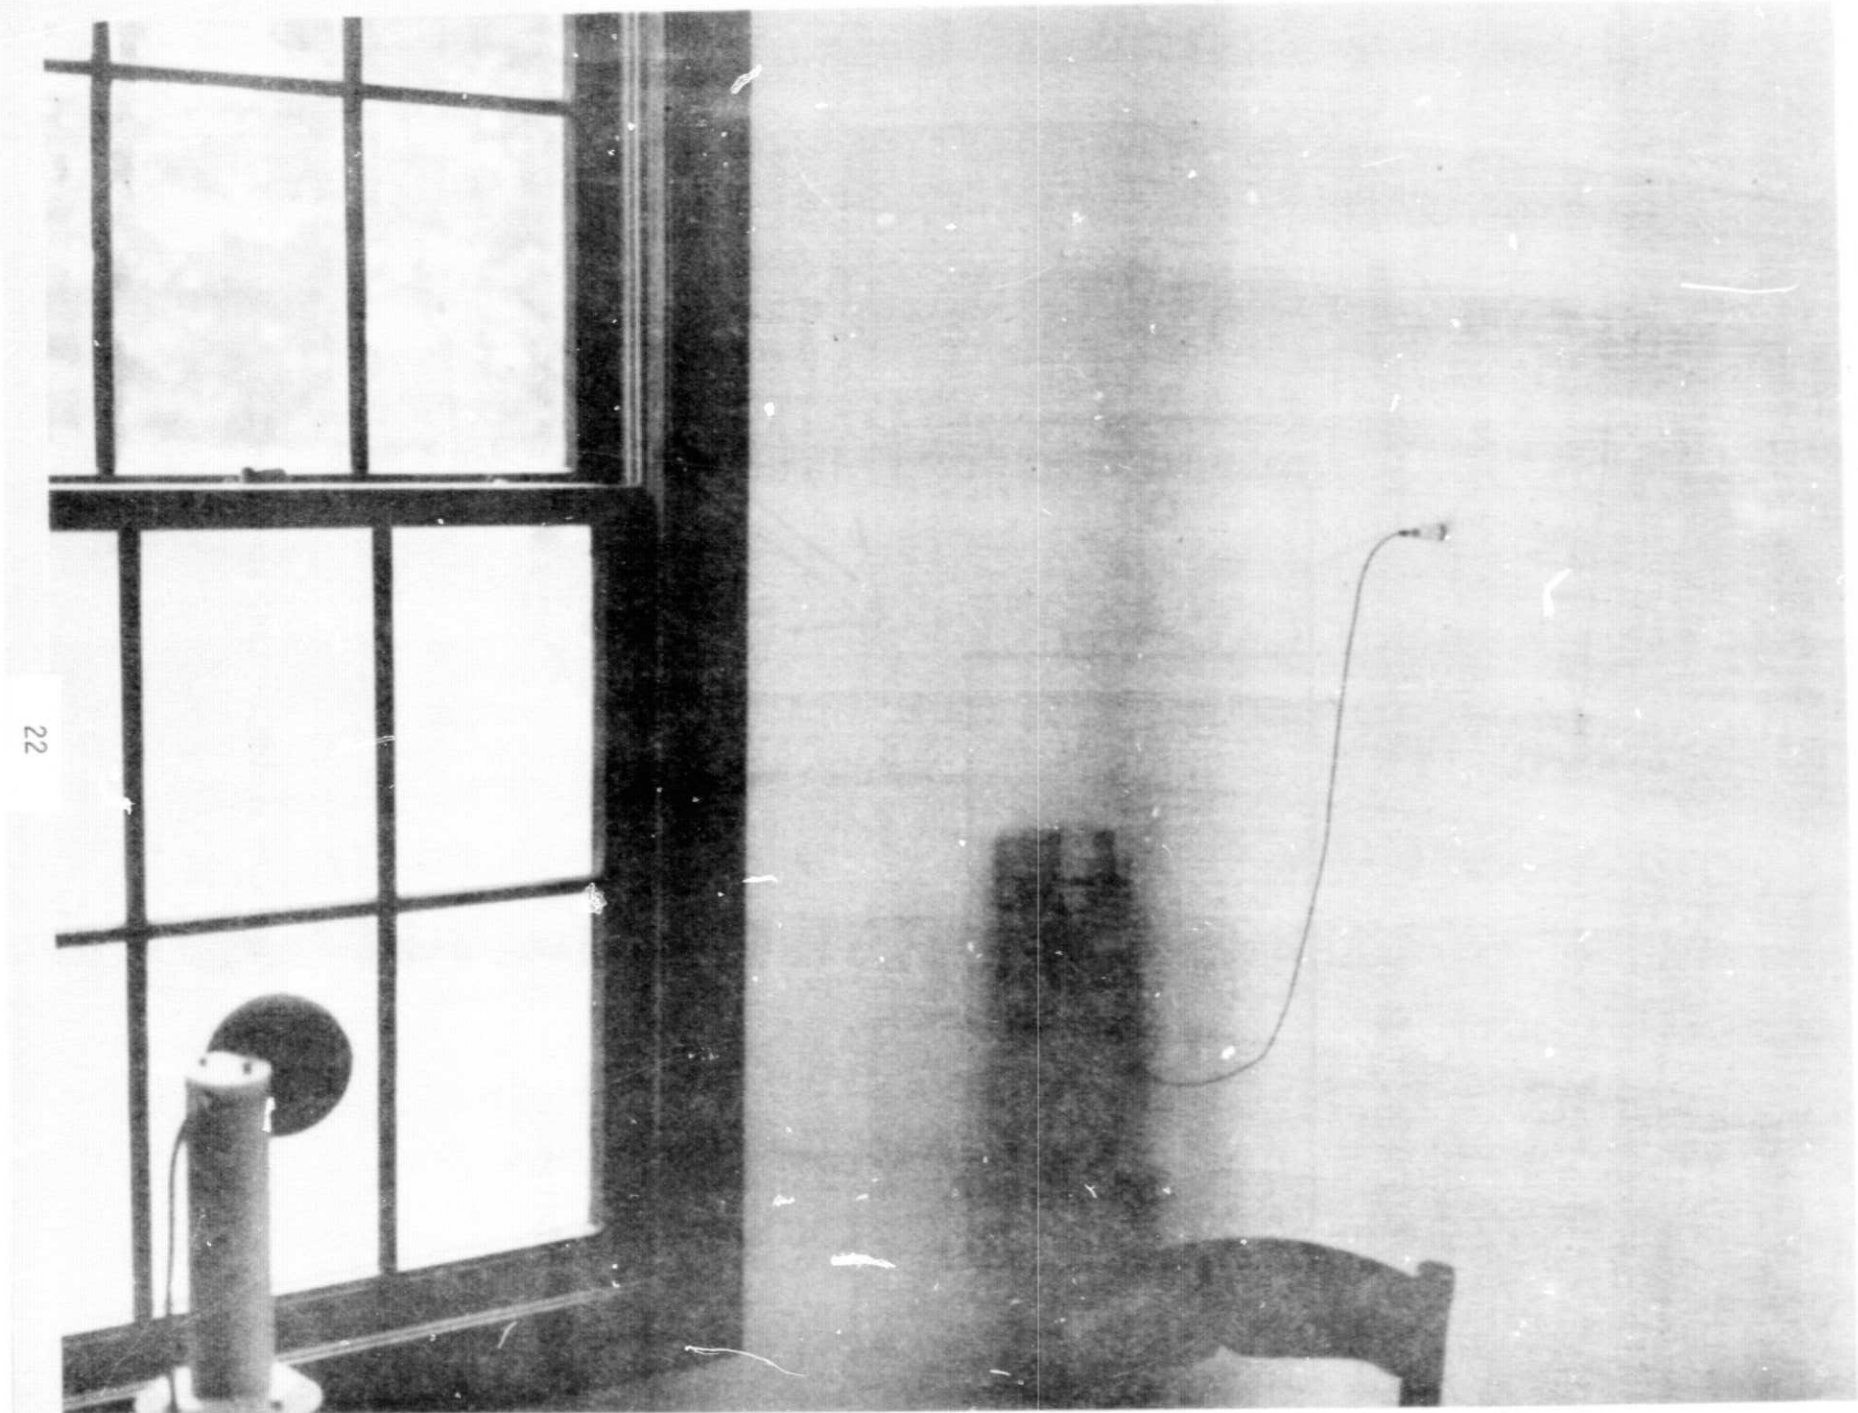
Figure 1(d). Location of accelerometer for wall vibration measurements. Site 1.

typical drywall construction and were placed on the west wall. Because the south and west sides of the house received the largest exposure to the Concorde overflights (based on information provided by the owner), the south and west facing kitchen area was chosen as the location for measuring the wall and window acceleration responses. Figure 1(d) shows the location of the accelerometer as positioned on the west wall of the kitchen. The other accelerometer was centered on the outside of the west kitchen window as shown in figure 1(e). The window pane measured 76.2 cm wide by 76.2 cm long and was of double thickness (thermopane) construction. To measure inside and outside sound pressure levels, one microphone was placed in the kitchen and one was placed in the front (west) yard clear of trees.

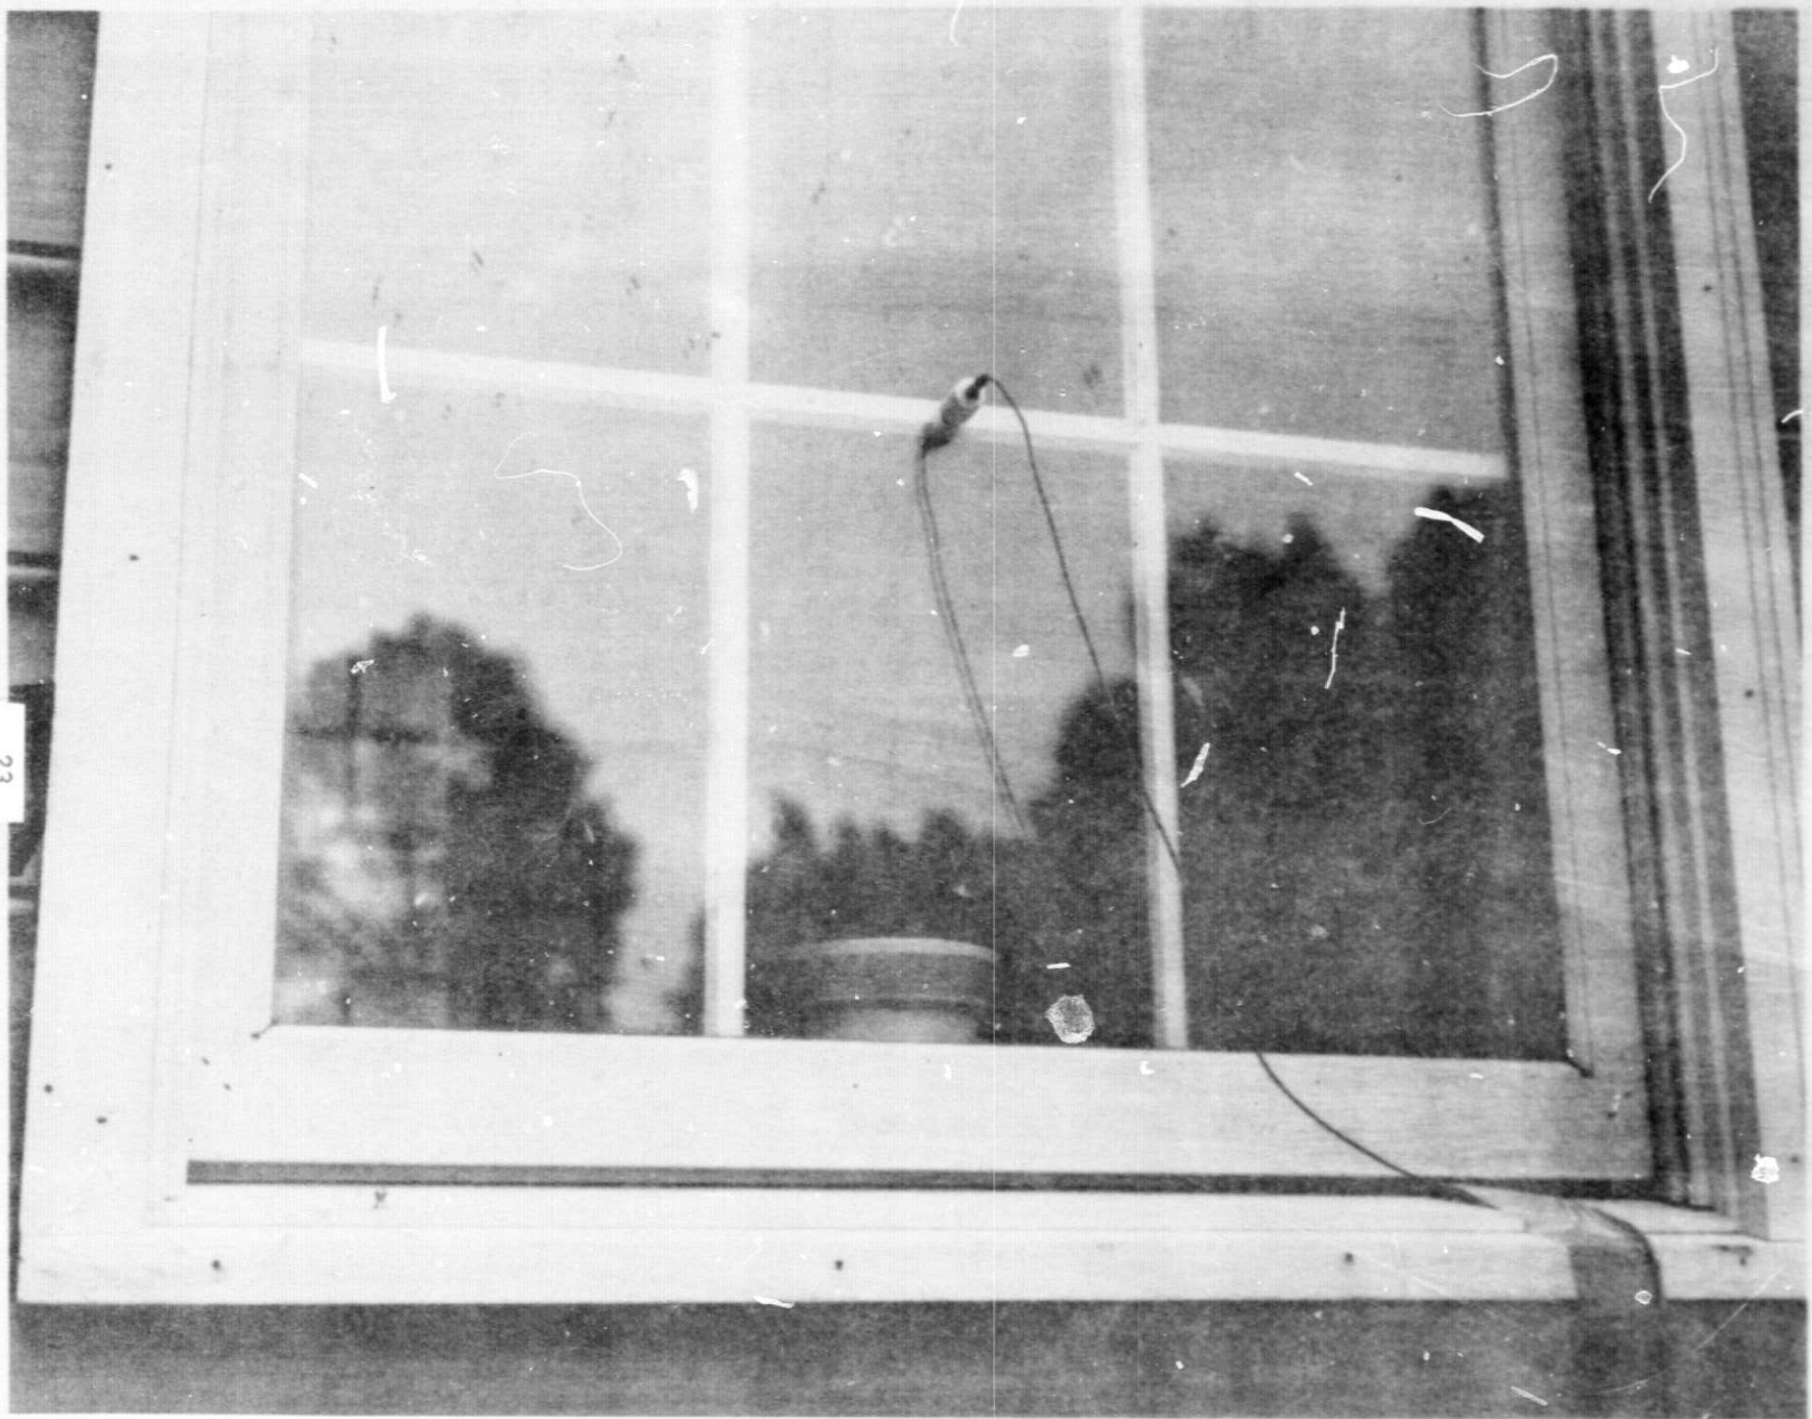
Figure 1(e). Location of accelerometer for window vibration measurements. Site 1.

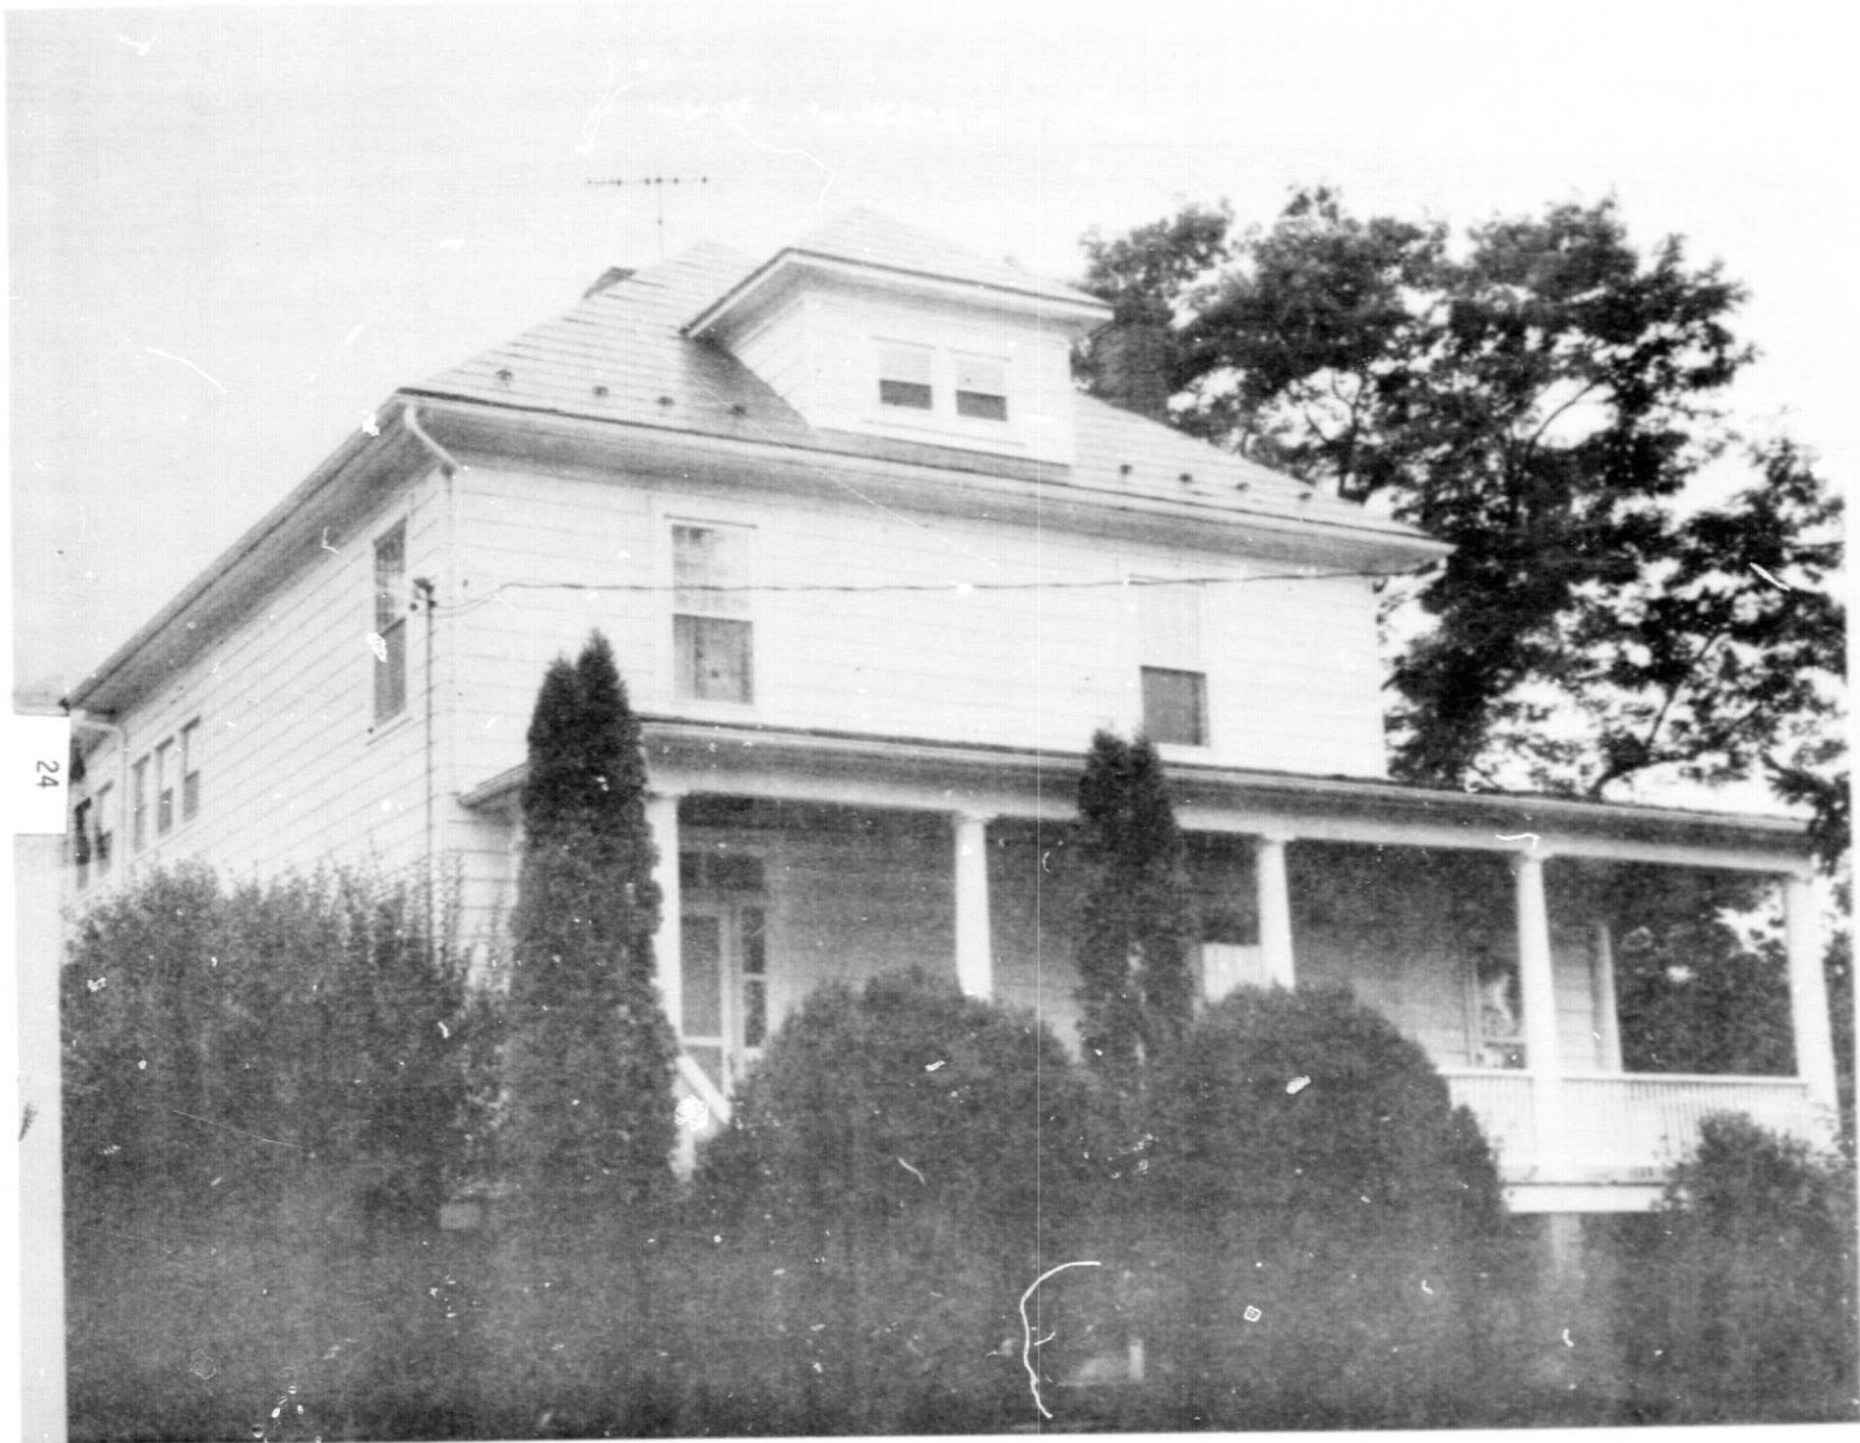
Figure 2(a). North elevation view of test structure 2.

Test structure 2.- Figure 2(a) is a picture of the north side (front) of the 60 year old two-story frame structure situated on a north facing slope of a knoll in the rural village of Barnesville, Maryland. A sketch of the plan view of the house is provided in figure 2(b). The house is of wood frame construction with aluminum siding over wood clapboards. The interior wall studs of the house are covered with lath and plaster. The original plaster has since been covered with wallpaper. As was the case with test structure 1, information was received from the owner which determined that portion of the house which appeared to receive most of the Concorde exposures. Subsequently, the dining room was chosen as the room for locating the two accelerometers. Figure 2(c) shows the location of the accelerometer on the south wall of the dining room, behind the china closet. Another accelerometer was centered on the outside of the south dining room aluminum framed storm window as shown in figure 2(d). The storm window was of single thickness construction and measured 71.1 cm by 76.2 cm and covered a window with 16 sashings. Two microphones were used to measure inside and outside

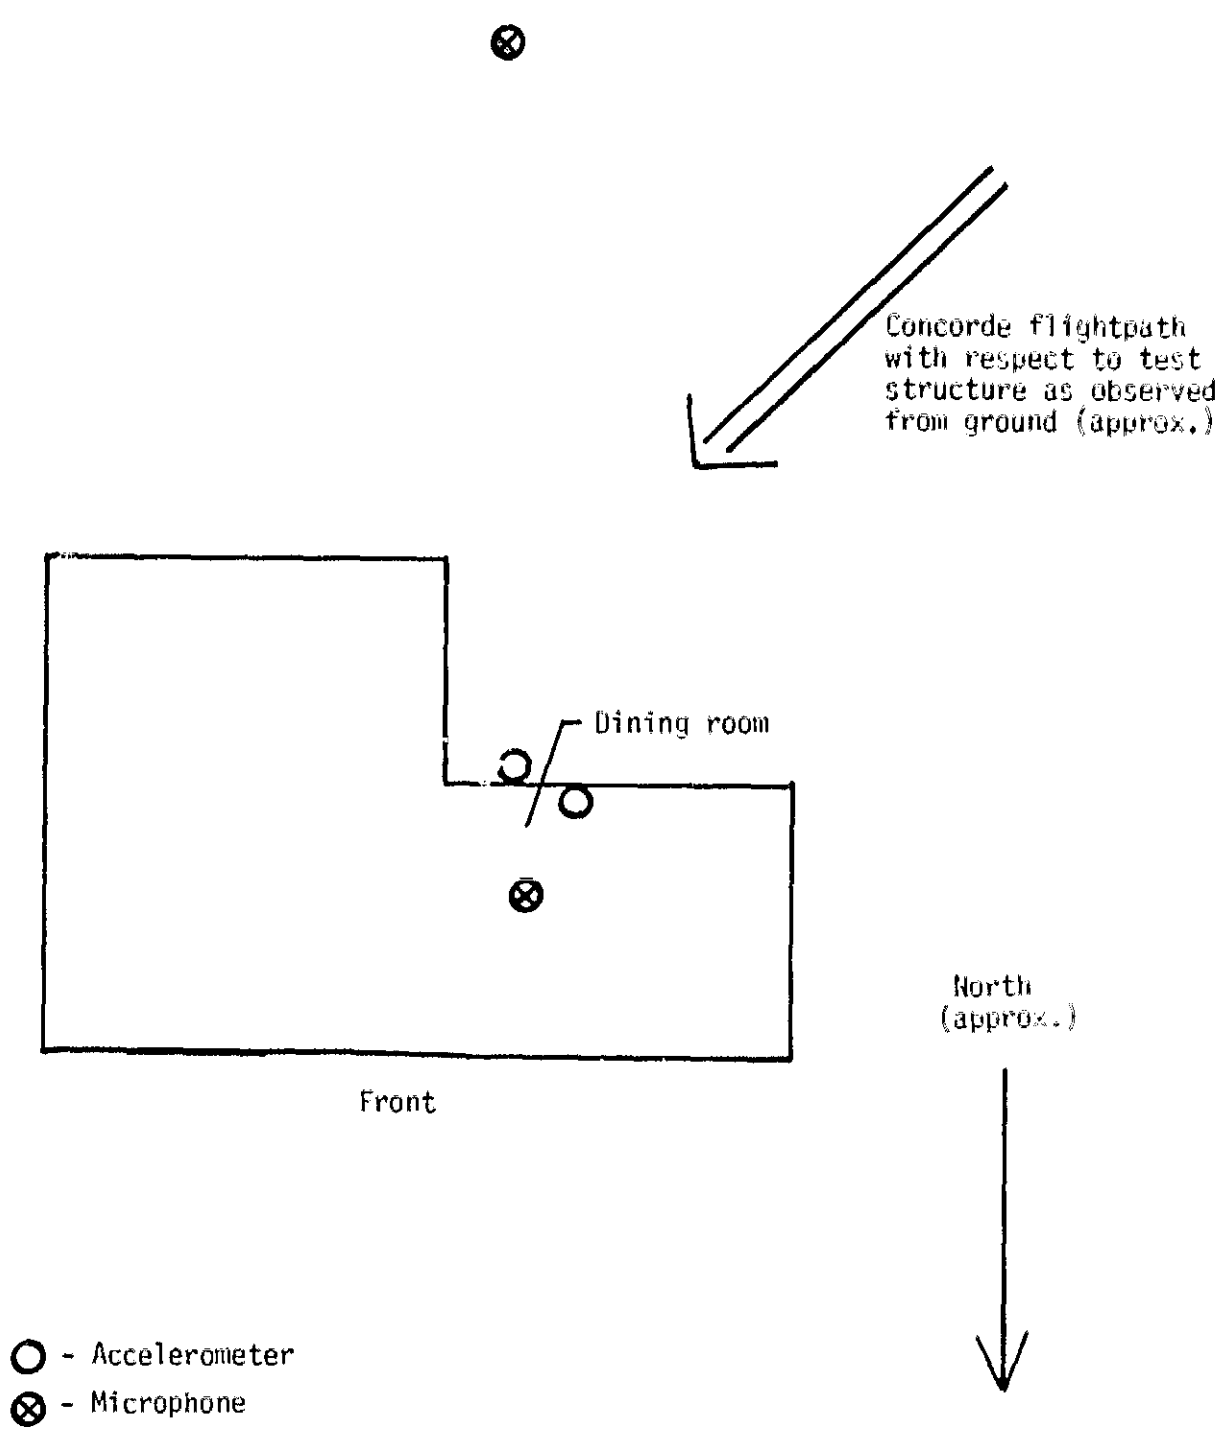
Figure 2(b). Plan view sketch of test structure 2.

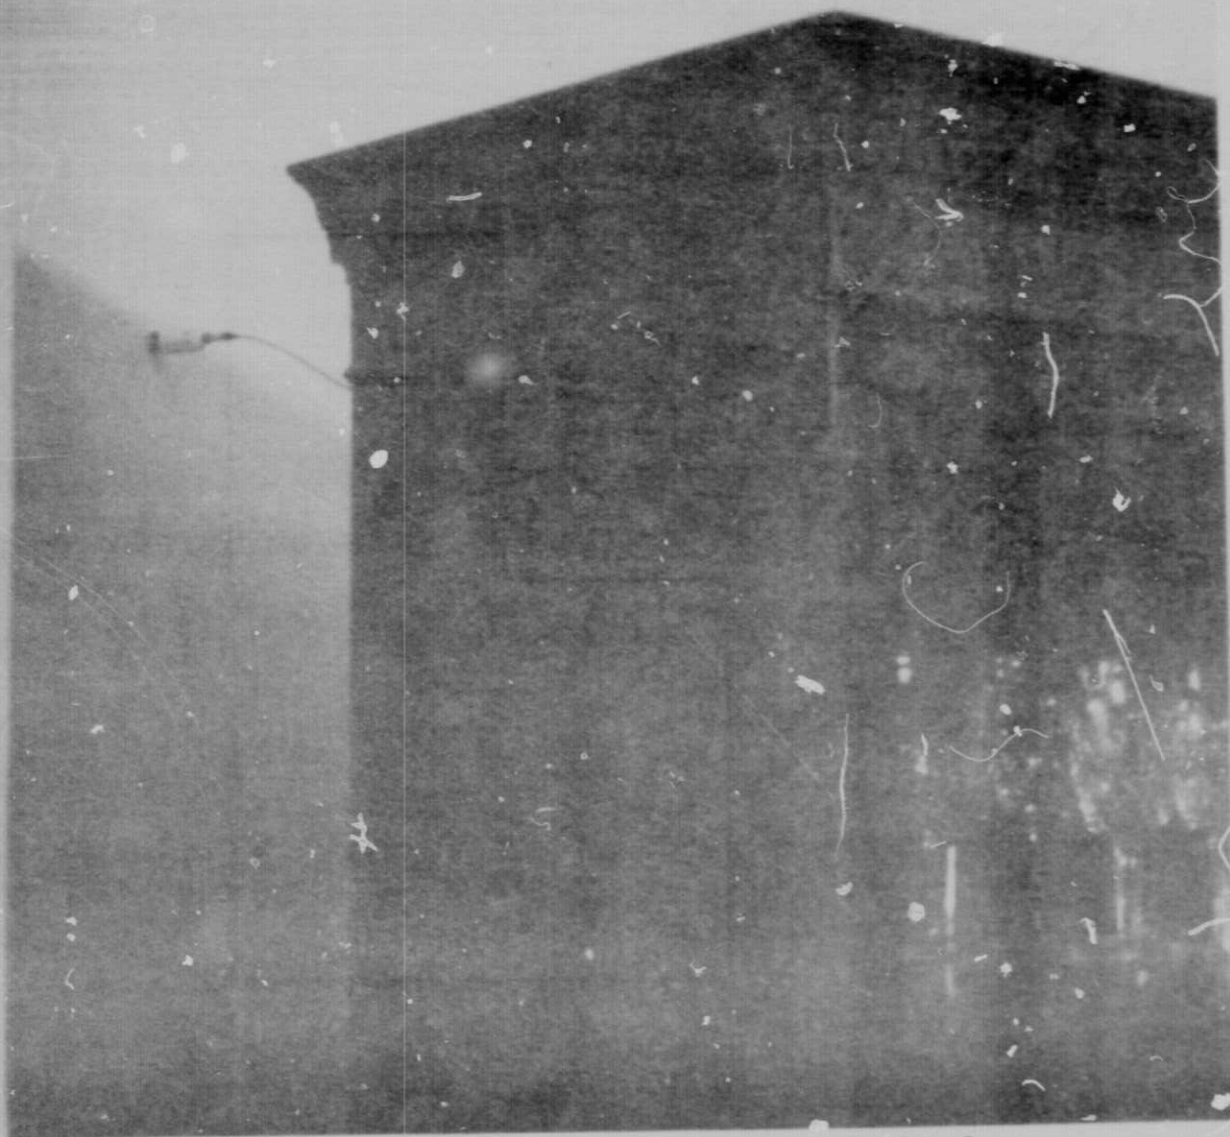
Figure 2(c). Location of accelerometer for wall vibration measurements. Site 2.

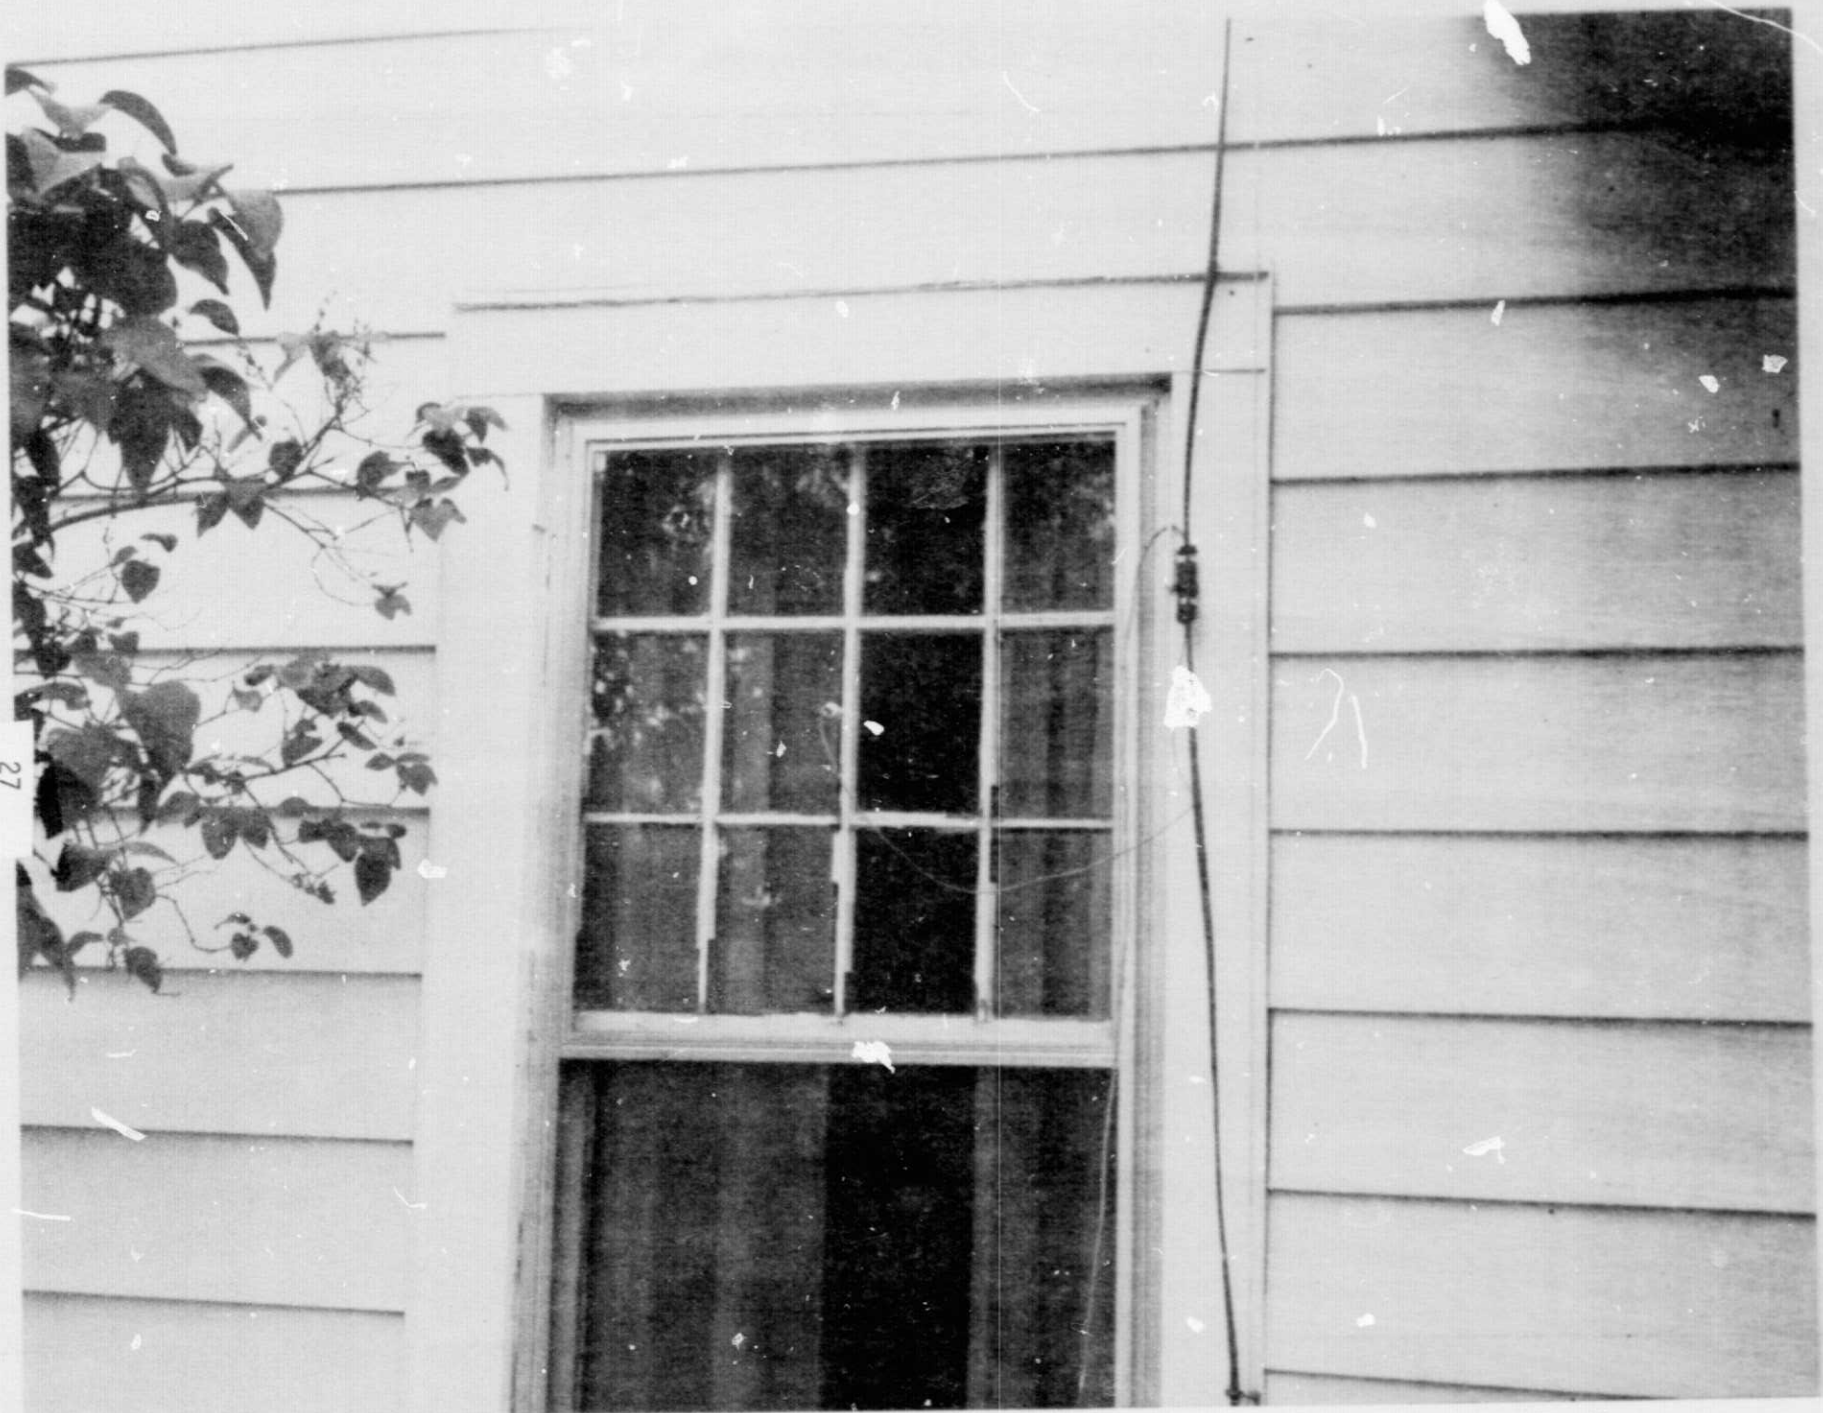
Figure 2(d). Location of accelerometer for window vibration measurements. Site 2.

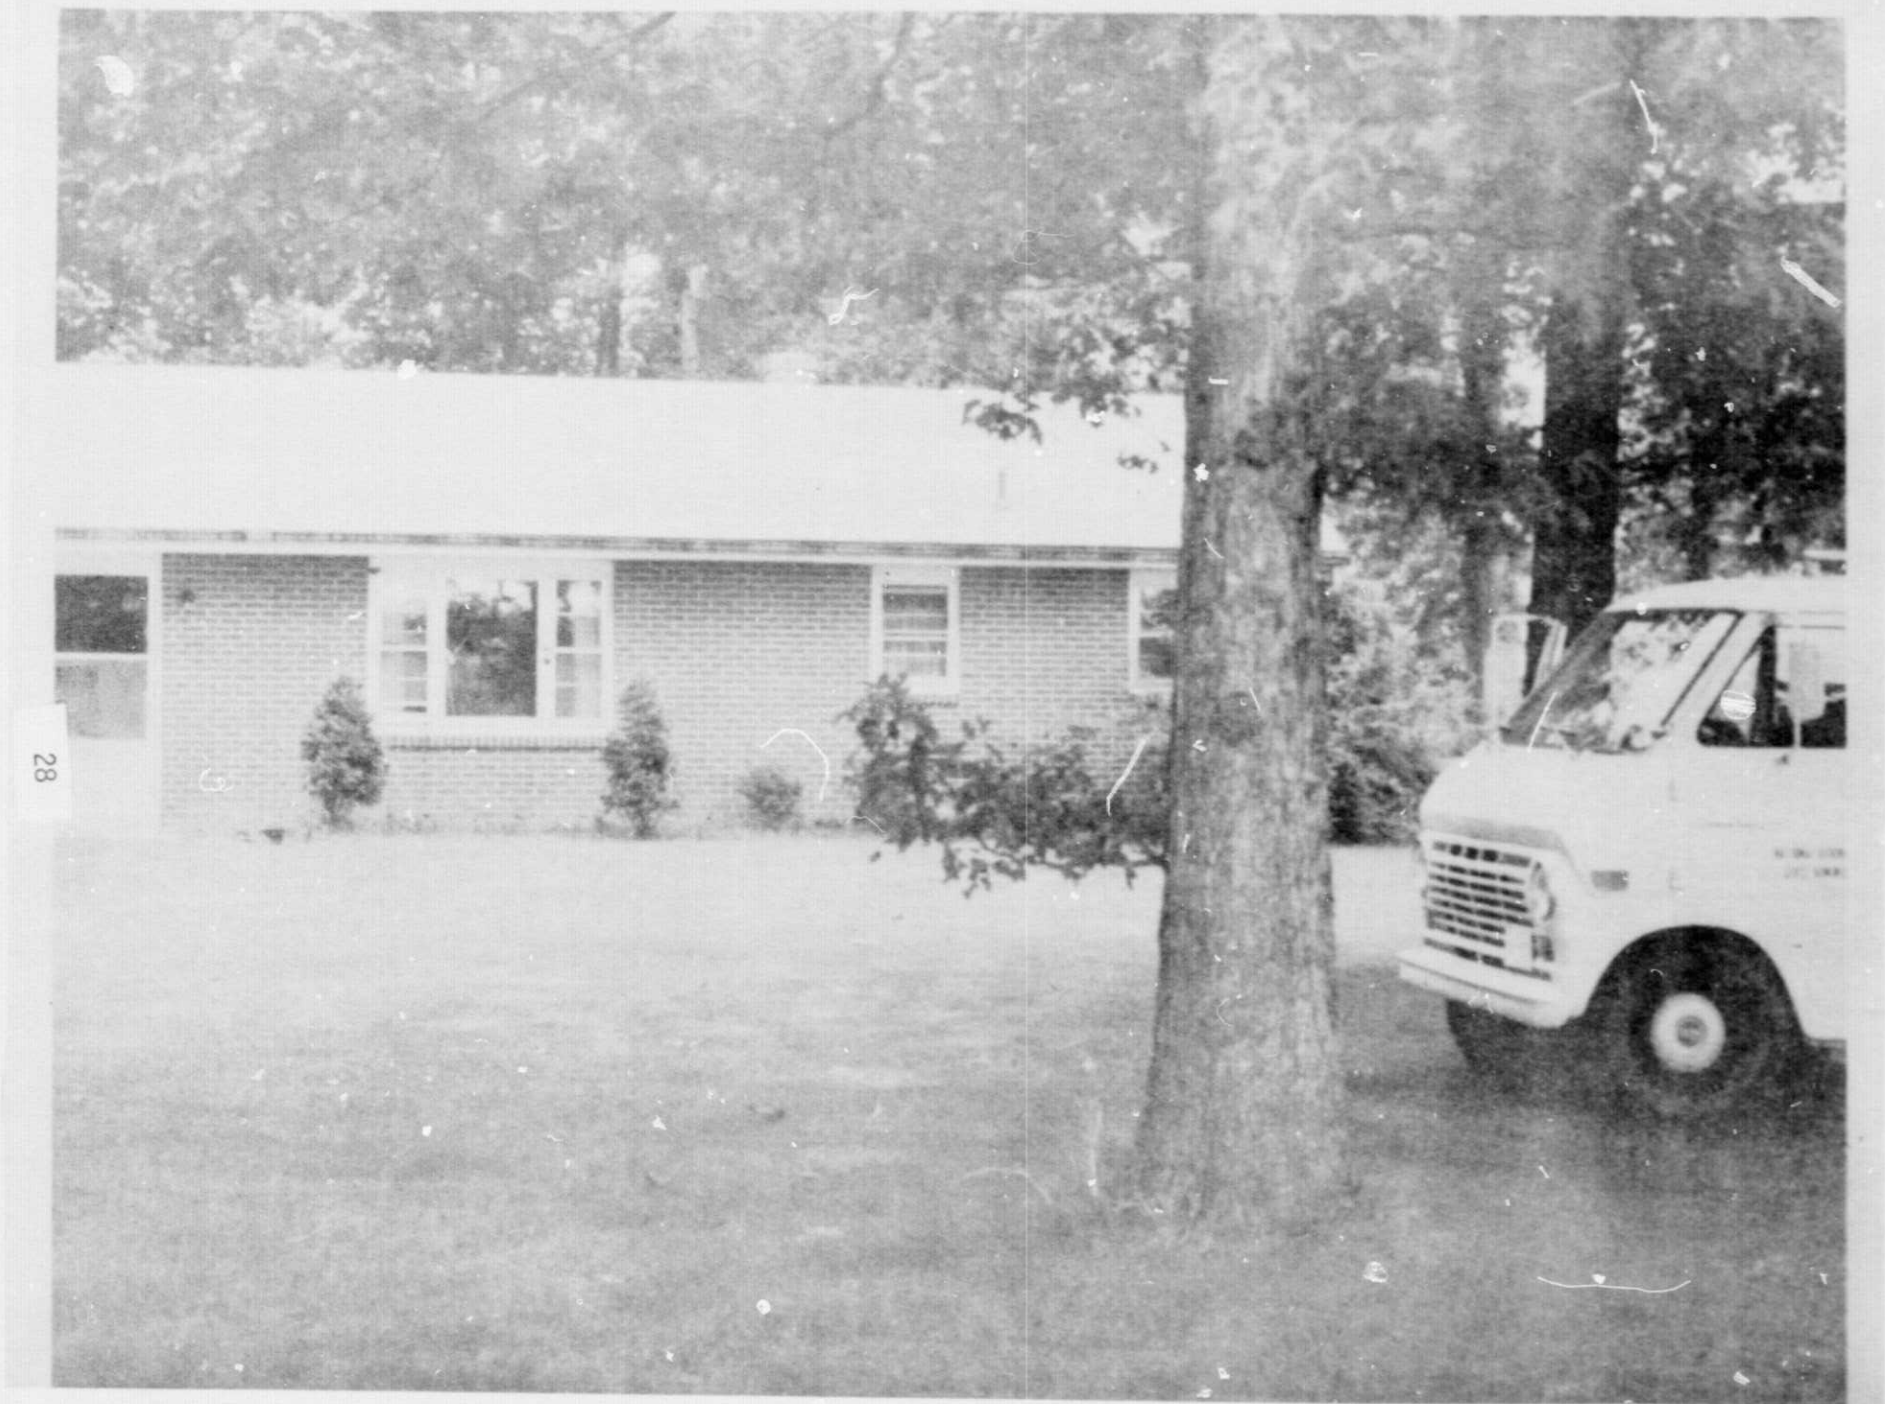
Figure 3(a). West elevation view of test structure 3.

Test structure 3.- Figure 3(a) shows the west side of the one-story house located on relatively level terrain in Dickerson, Maryland, and used as test structure 3. Figure 3(b) is a sketch of the plan view of the residence. The house is of typical wood frame construction and faced with brick veneer. The interior walls are covered with wood paneling. Because the owner indicated that the west side of the house received the most exposure to Concorde overflights, the test instrumentation was located in the living room of the house. Figure 3(c) shows the location of the accelerometer as it was positioned on the west wall of the living room. Another accelerometer was centered on the outside of the aluminum framed storm window on the west living room wall as shown in figure 3(d). The storm window was of single thickness construction and measured 78.7 cm wide by 129.5 cm long and covered a picture window of equal dimensions. Two microphones were used to measure inside and outside sound pressure levels and were located in the living room near the west window and near the (west) yard in a vacant field which was clear of trees.
