**NASA TM X-73947**

CONCORDE NOISE-INDUCED BUILDING VIBRATIONS  
MONTGOMERY COUNTY, MARYLAND - REPORT NO. 3

Staff-Langley Research Center

August 1976

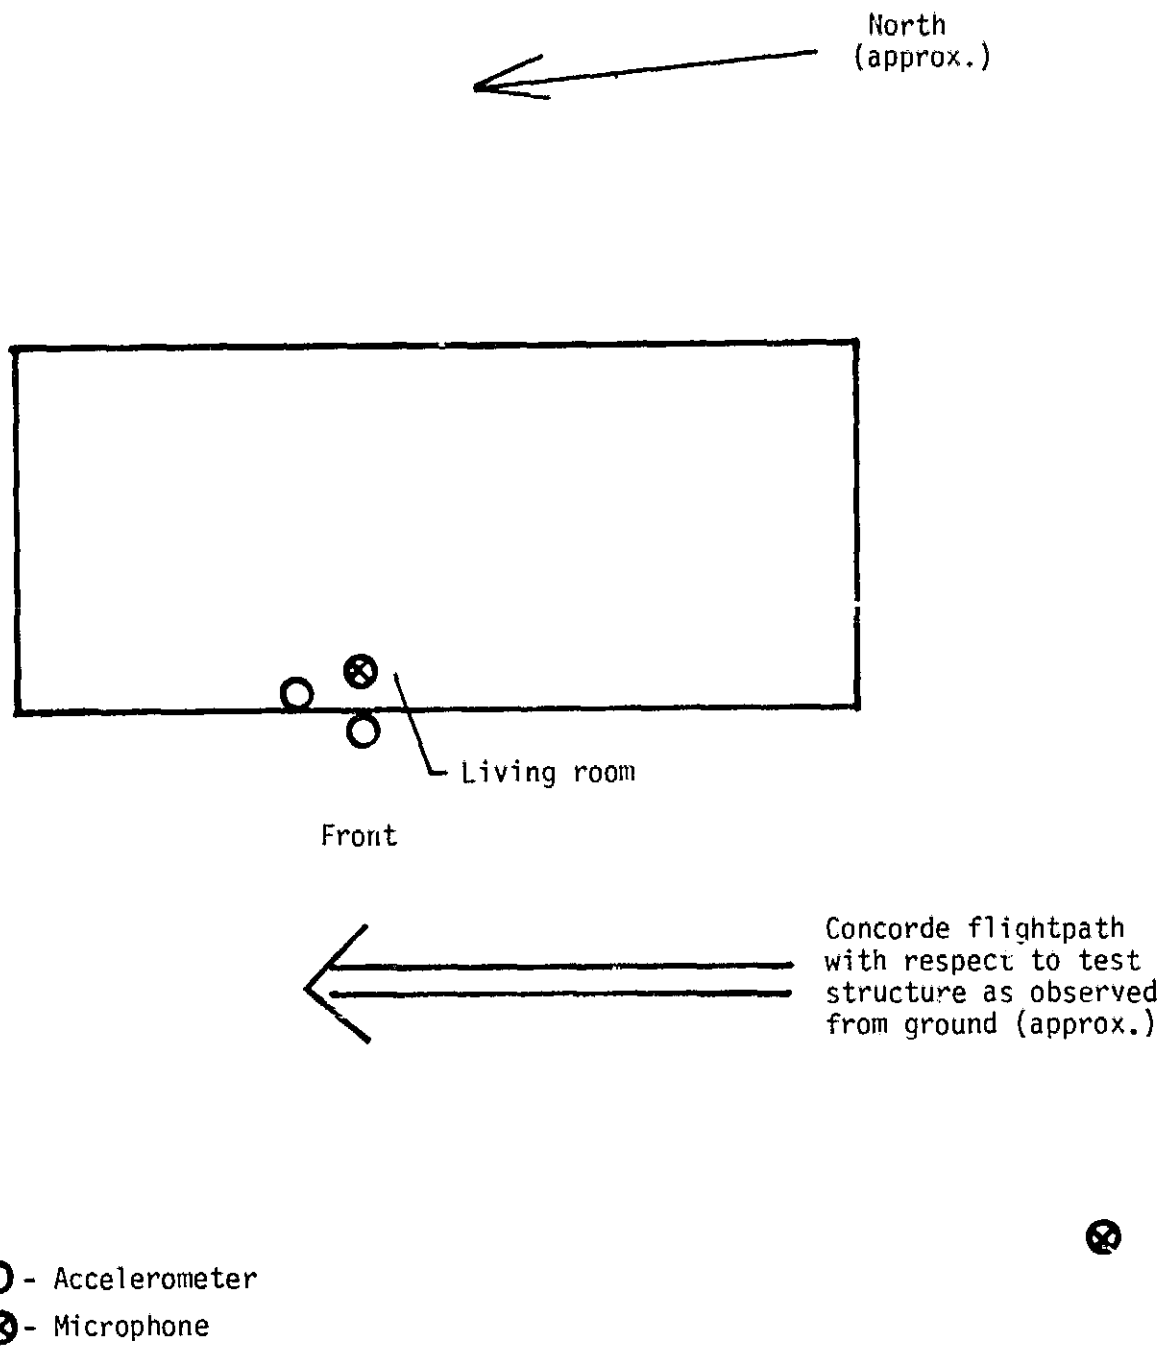
Figure 3(b). Plan view sketch of test structure 3.

Test structure 3.- Figure 3(a) shows the west side of the one-story house located on relatively level terrain in Dickerson, Maryland, and used as test structure 3. Figure 3(b) is a sketch of the plan view of the residence. The house is of typical wood frame construction and faced with brick veneer. The interior walls are covered with wood paneling. Because the owner indicated that the west side of the house received the most exposure to Concorde overflights, the test instrumentation was located in the living room of the house. Figure 3(c) shows the location of the accelerometer as it was positioned on the west wall of the living room. Another accelerometer was centered on the outside of the aluminum framed storm window on the west living room wall as shown in figure 3(d). The storm window was of single thickness construction and measured 78.7 cm wide by 129.5 cm long and covered a picture window of equal dimensions. Two microphones were used to measure inside and outside sound pressure levels and were located in the living room near the west window and near the (west) yard in a vacant field which was clear of trees.

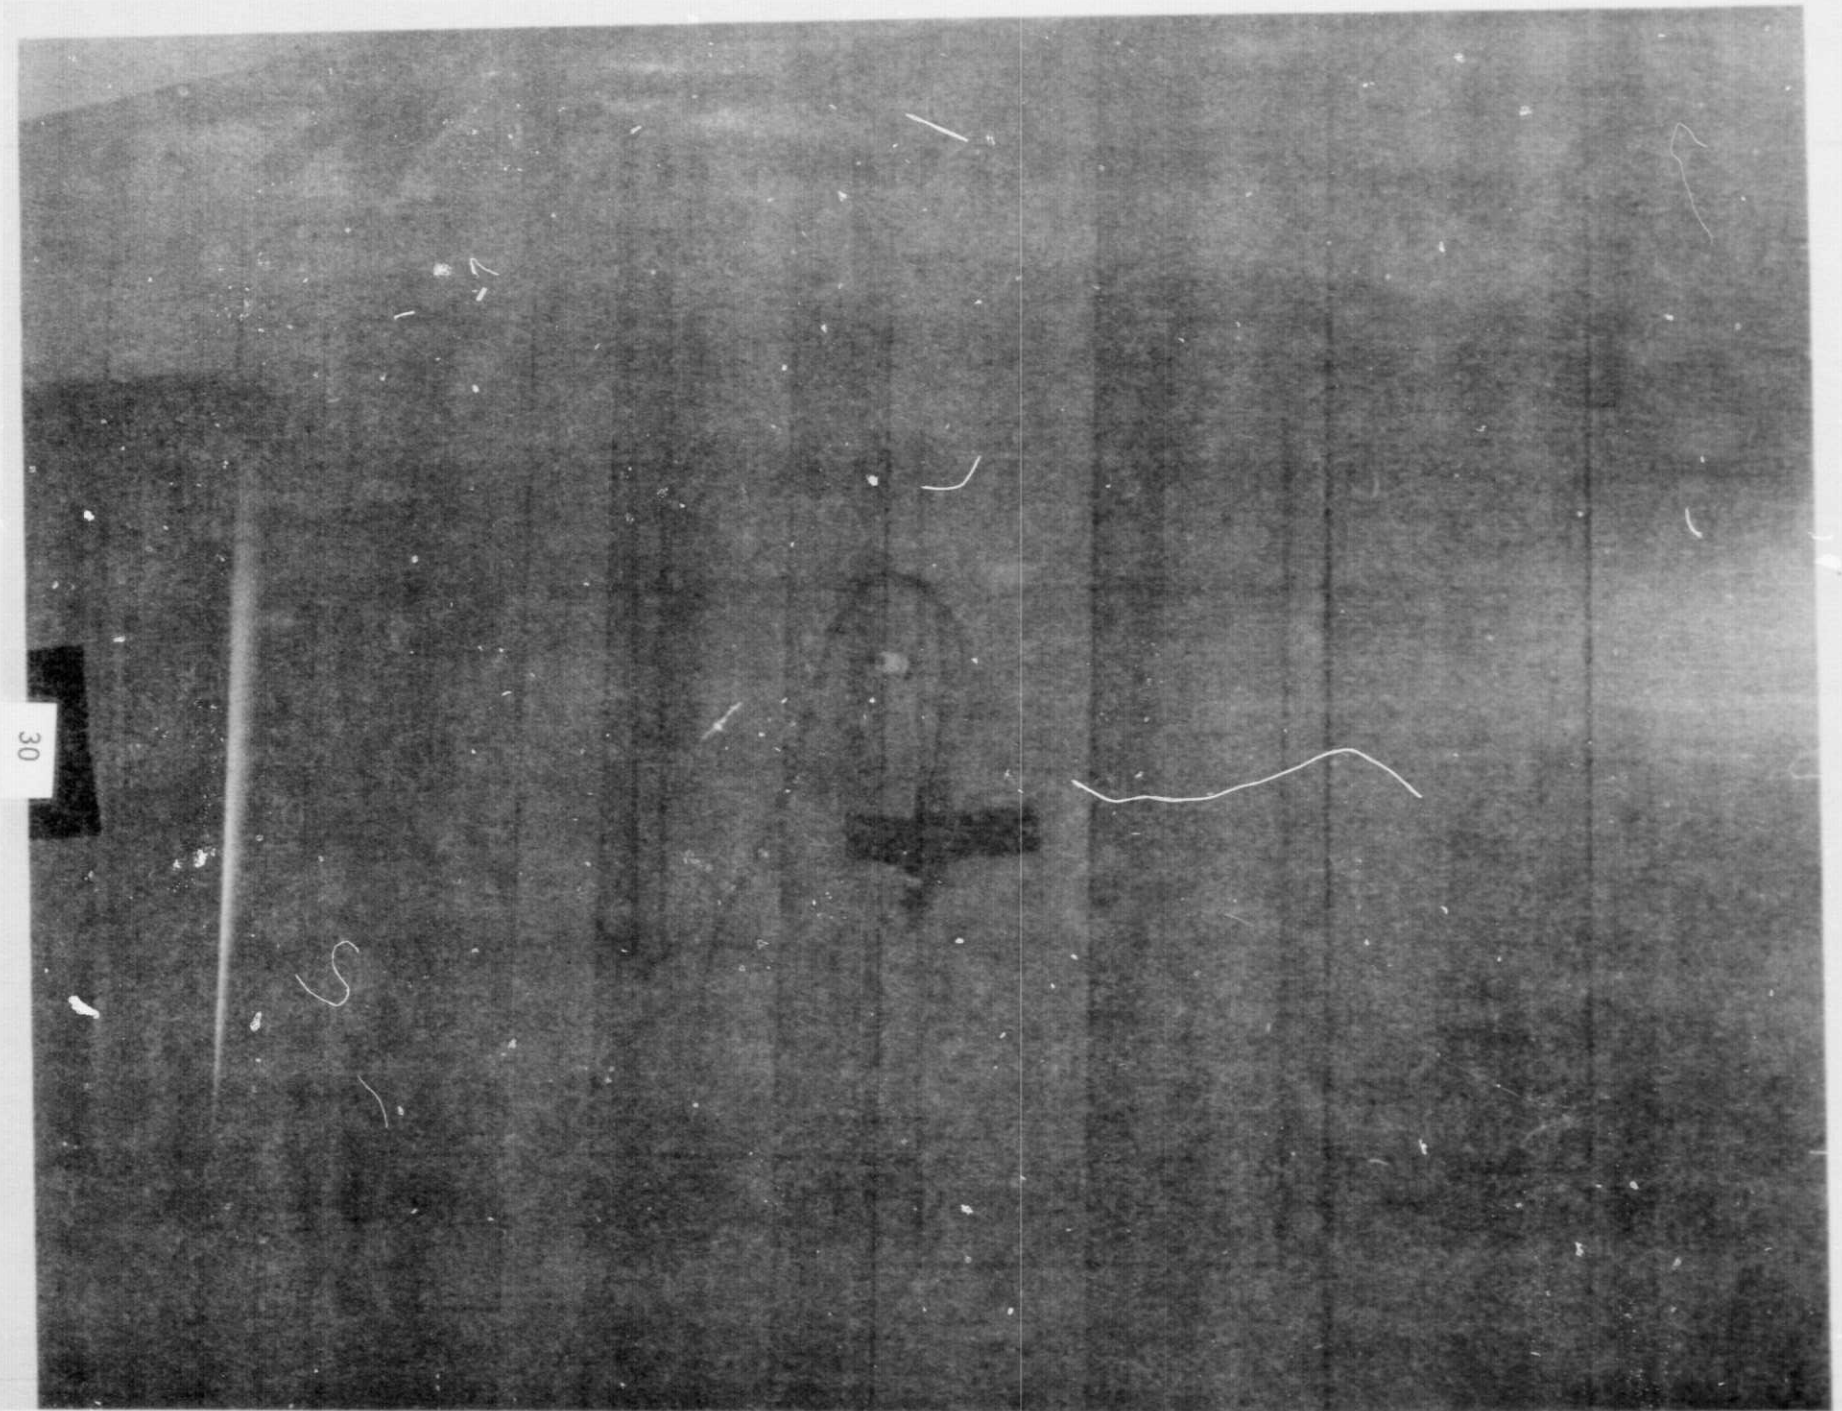
Figure 3(c). Location of accelerometer for wall vibration measurements. Site 3.

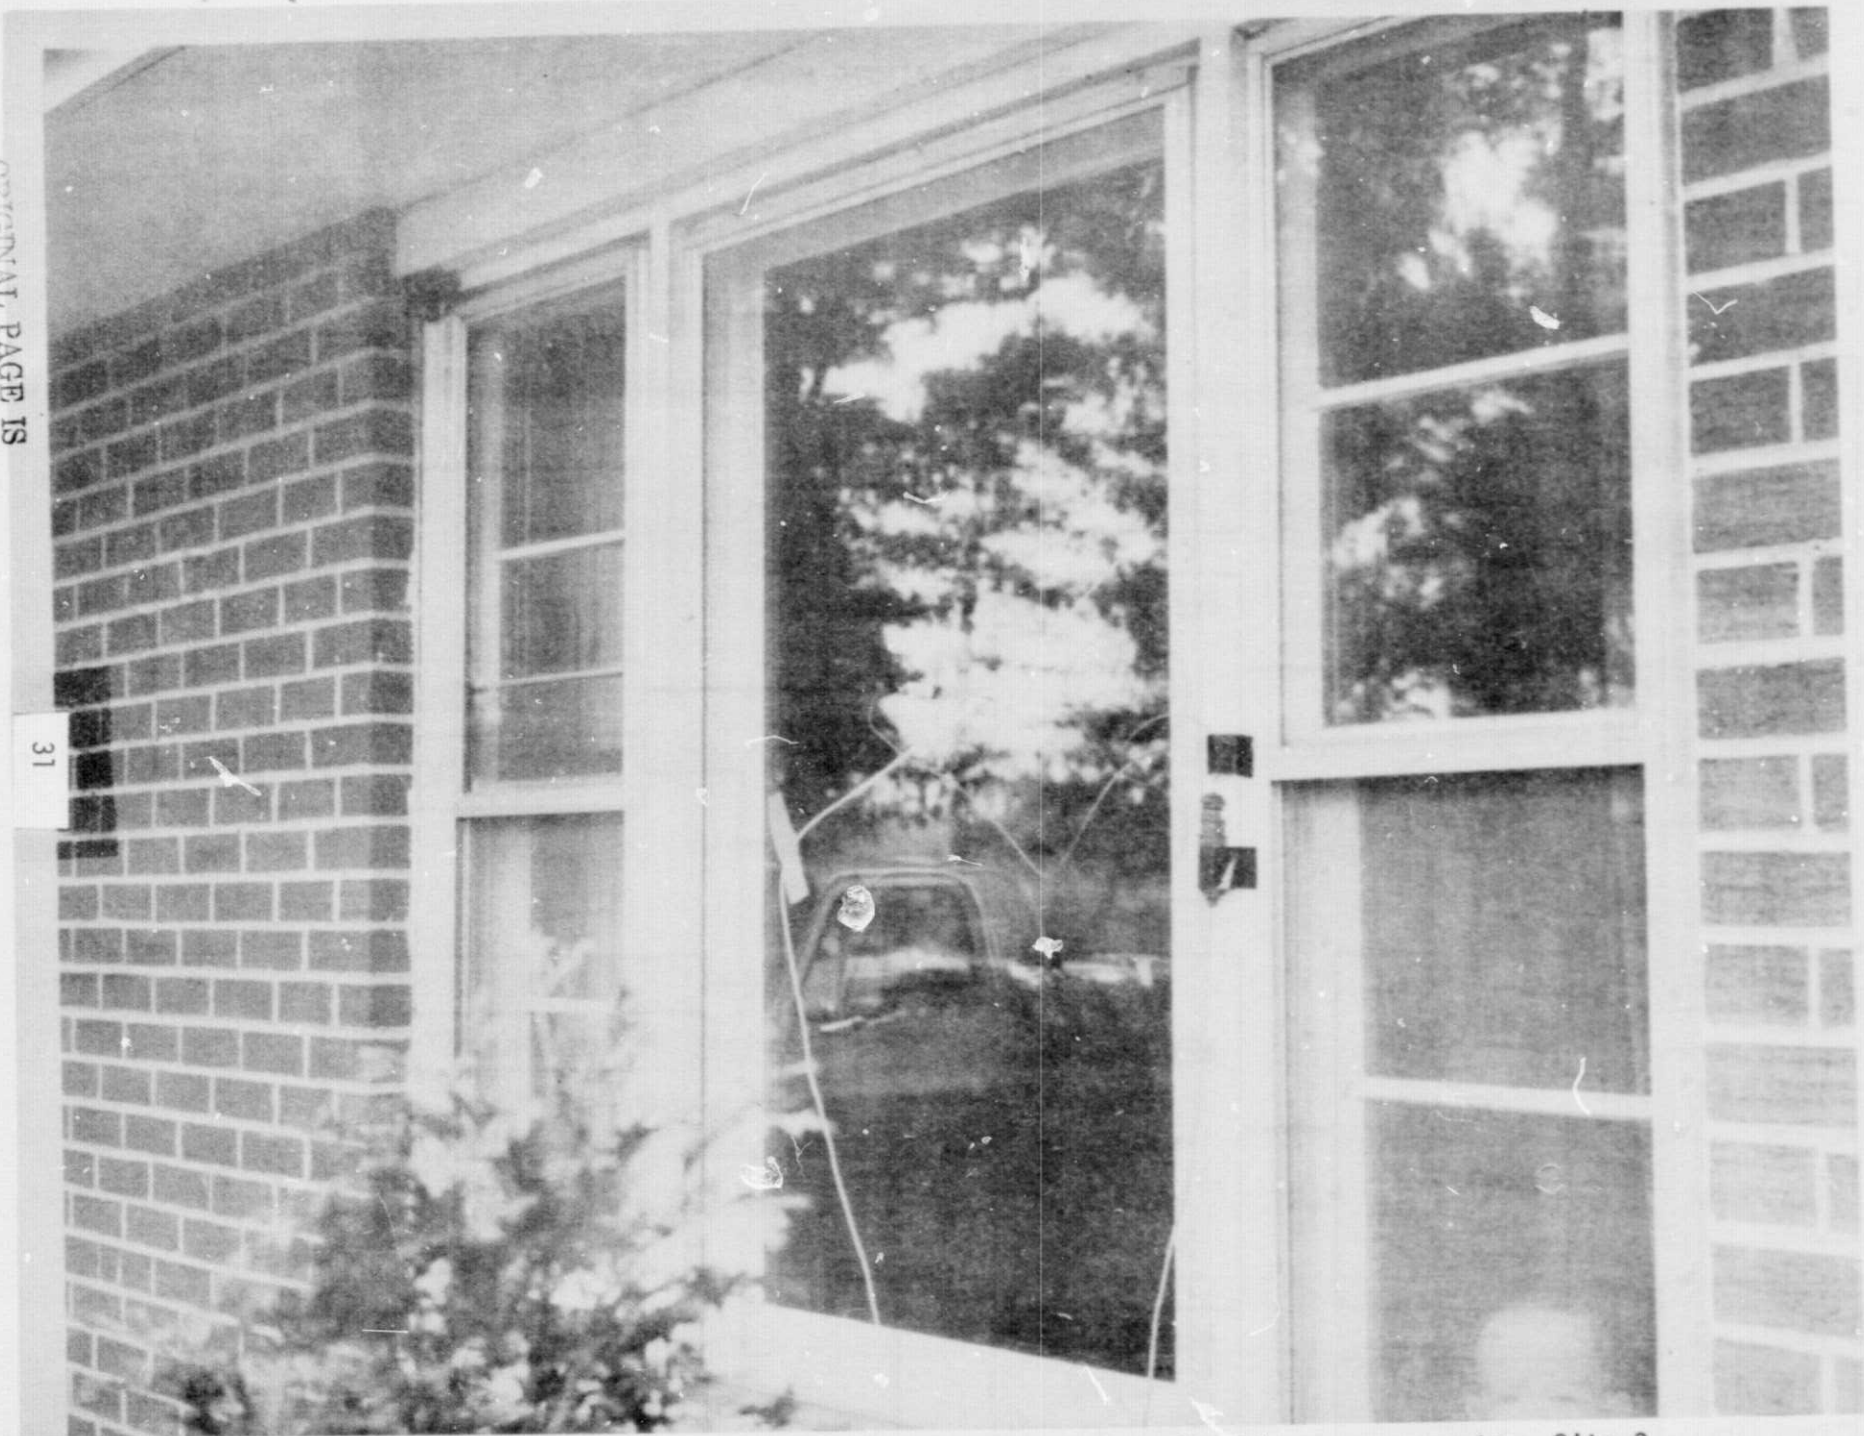
Figure 3(d). Location of accelerometer for window vibration measurements. Site 3.

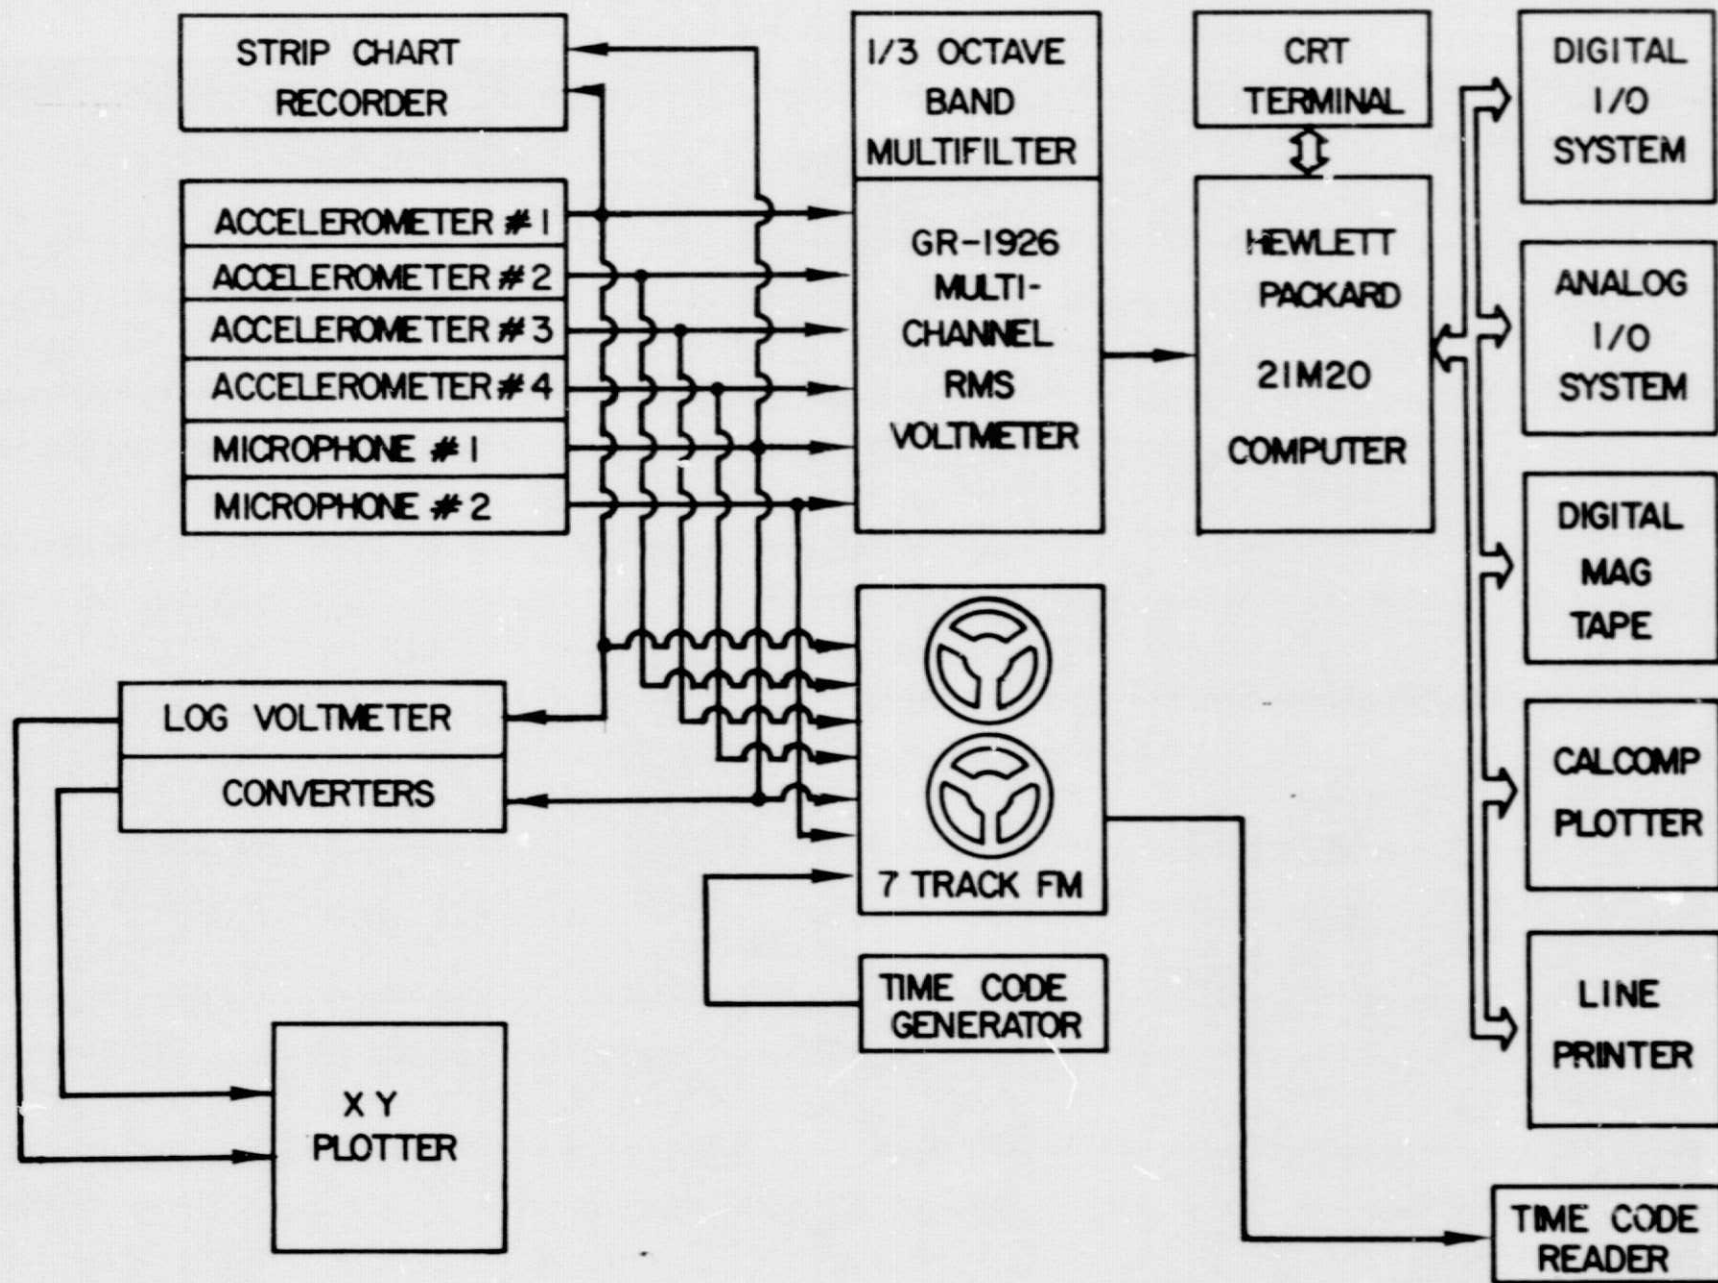
Figure 4.- Block diagrams of mobile data acquisition and processing system.

The details of the instrumentation system are described in reference 1. The measurements made in Montgomery County, August 1976, were conducted using three instrumented vans, one of which comprised a mobile laboratory containing both an analog acquisition system and an on-line digital processing system. Acoustic measurements of interior and exterior sound pressure levels were made, as well as vibration levels of the wall and window at selected single family dwellings. Conventional Bruel and Kjaer equipment was used for the sound measurements. Piezoelectric crystal accelerometers, employing in-house developed signal conditioning, were used for the vibration measurements. All data were recorded on analog FM tape for further analysis. On-line analog x-y plots of window vibration response versus outside sound pressure level were obtained for many of the events. The primary system used for on-line acquisition consisted of a General Radio 1926 true rms log voltmeter which provided overall or magnitude values for each second on the five information channels. A Hewlett-Packard 21M20 digital computer was then used to assemble these data into tabulations of the time history values for line printing and for "Calcomp" plots of the noise and acceleration time histories as well as plots of selected acceleration levels as a function of outside sound pressure levels. Figure 4 is a block diagram of the instrument system used in this test.

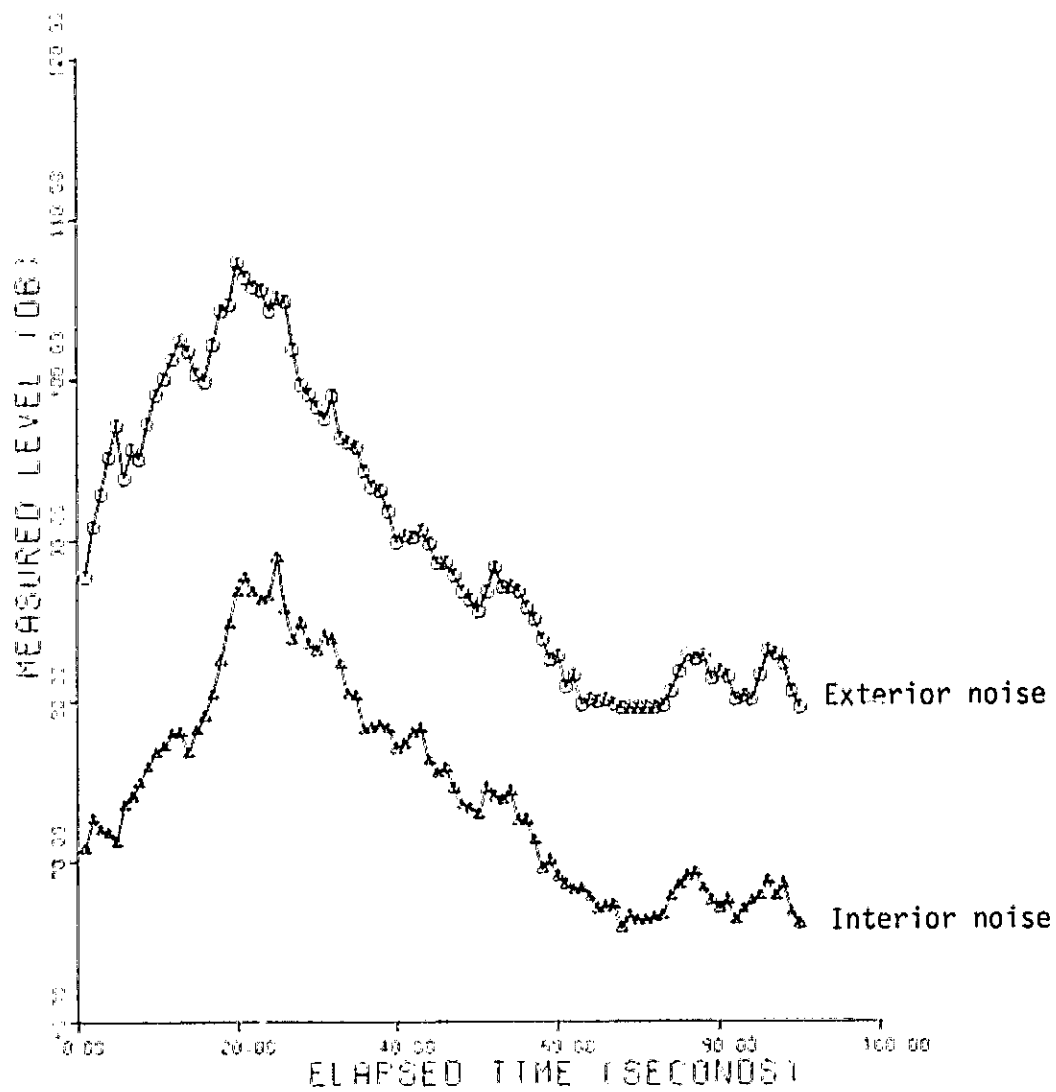
Figure 5(a).- Time history of sound pressure levels during Concorde takeoff.  
(event 665 at site 3)

Overall levels of sound and vibration (no frequency weighting) have been plotted at 1-second intervals for the duration of each flyover. Figures 5 illustrate the data format. These figures describe a Concorde event at Dickerson, Maryland, some 21 kilometers north of Dulles Airport. The outdoor acoustic time history is shown on each figure as a reference, along with the time history of one of the other transducers; either the inside microphone or one of the accelerometers. Acoustic transmission losses can be determined from the outdoor/indoor sound level plots while the sound/vibration time histories reveal the correlation between sound pressure level and vibration level as well as the threshold of sound pressure level necessary to induce above ambient vibration levels in each structure for a given flyover. Printed listings for each flyover time history were also generated.

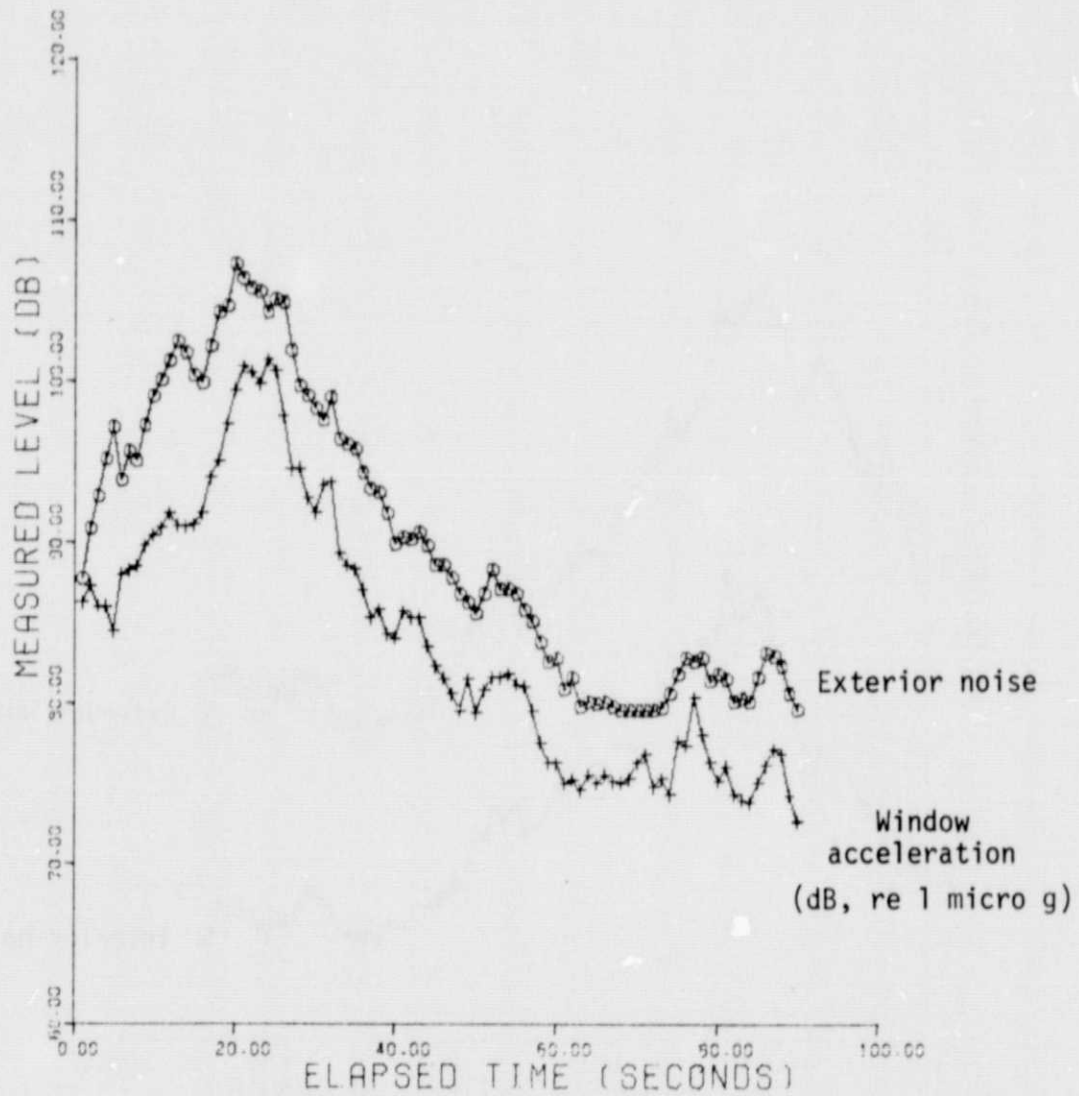
Figure 5(b).- Time history of sound pressure level and window acceleration level during Concorde takeoff. (event 665 at site 3)

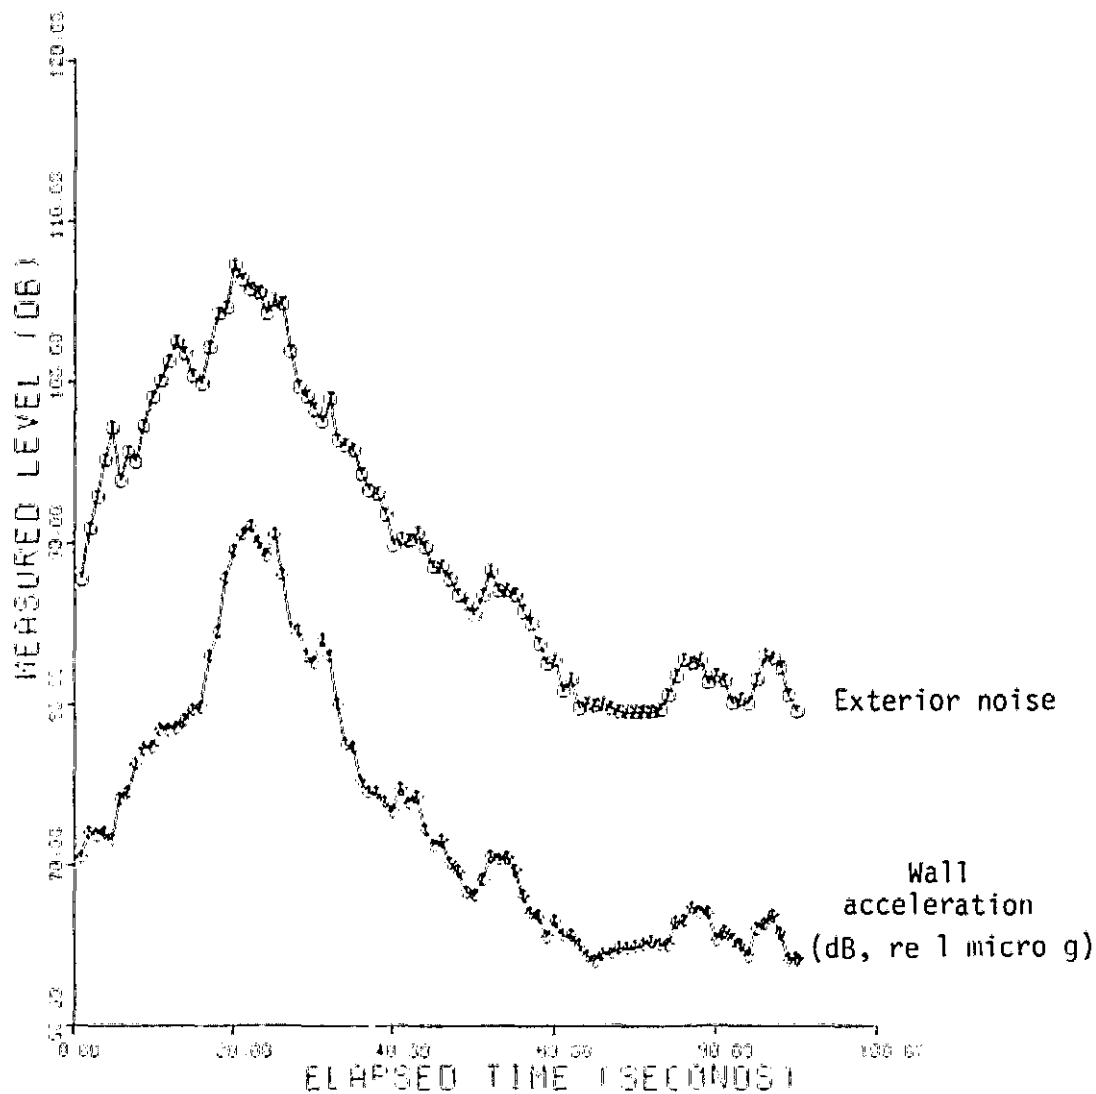
Figure 5(c).- Time history of sound pressure level and wall acceleration level during Concorde takeoff. (event 665 at site 3)

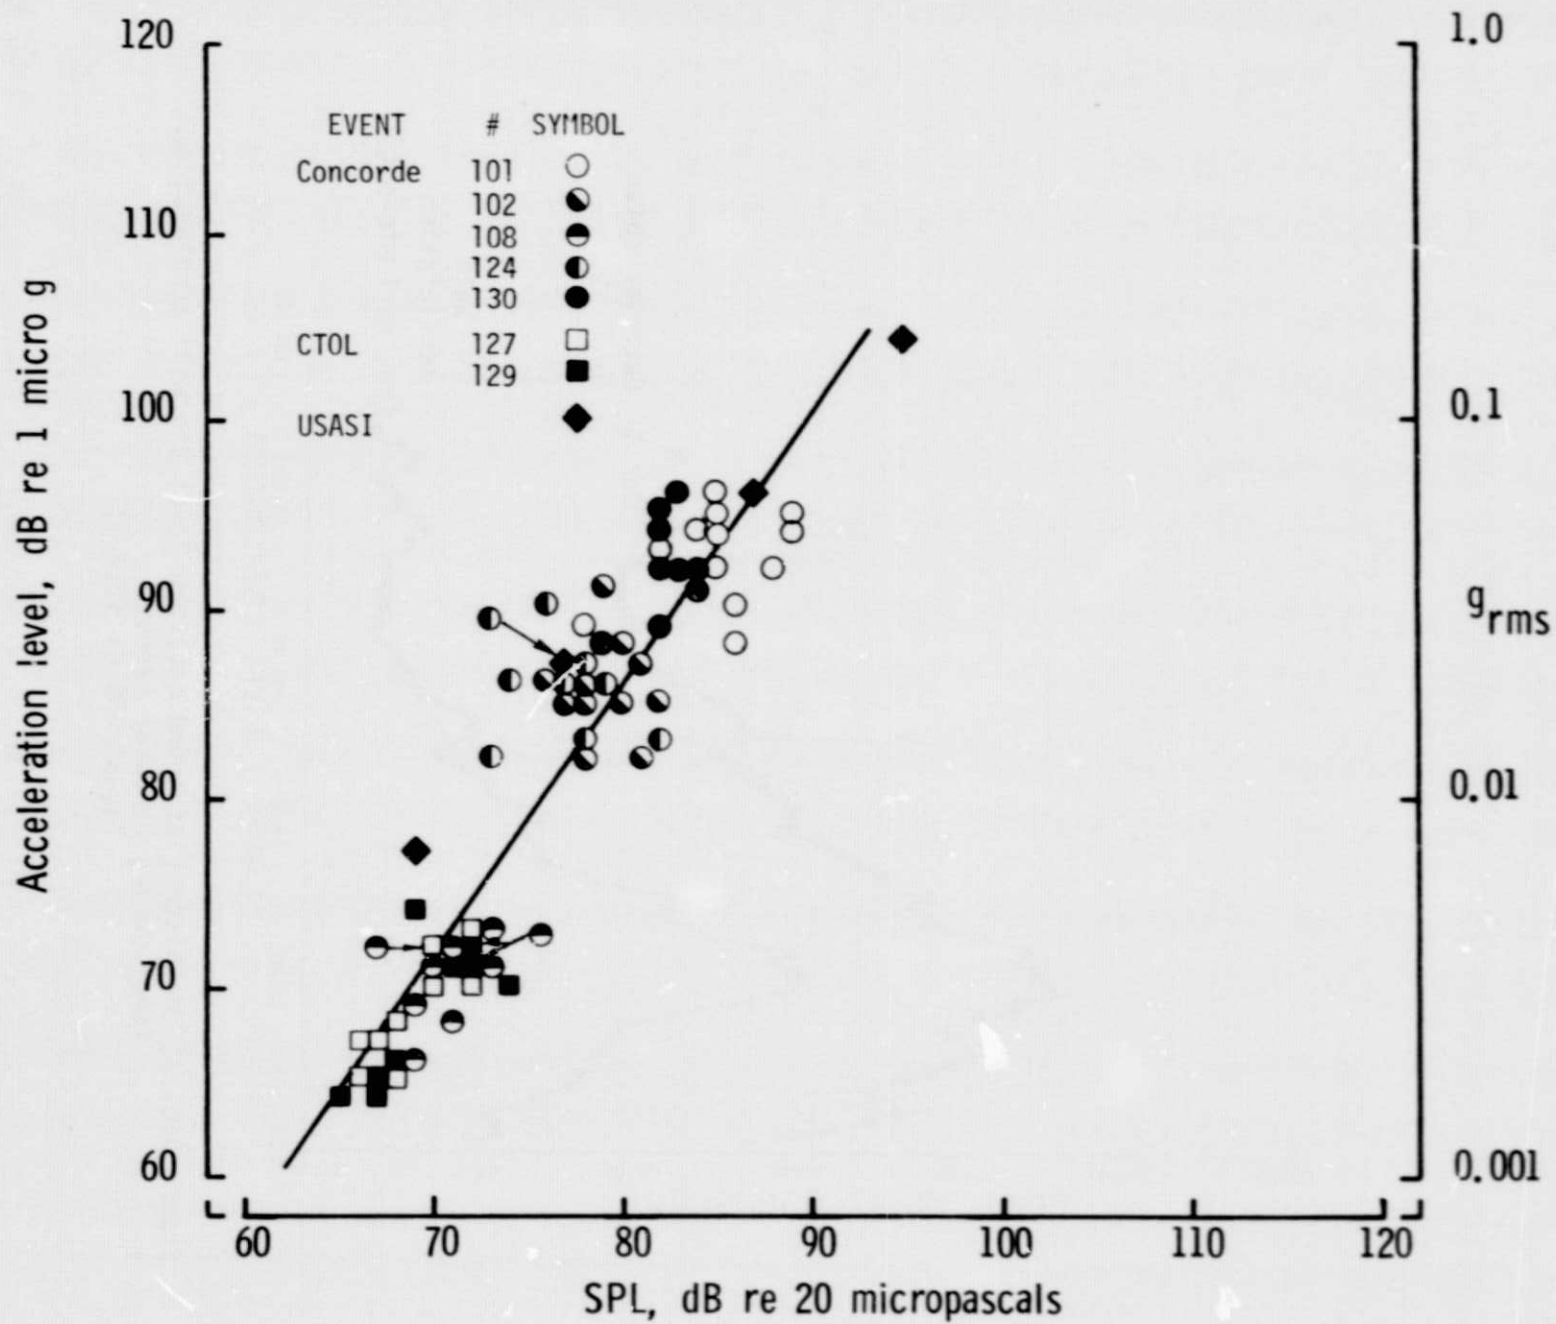
(a) Site 1 - Window

Figure 6.- Vibration response signatures

In order to quantitatively assess the relationships between aircraft noise levels and the corresponding levels of vibration induced in the windows and walls, response signatures (plots of window acceleration versus sound pressure level) were made for each flyover which exceeded the ambient. Data obtained at the three sites are presented in figures 6(a) through (f). In addition, the response to the USASI noise is presented. As noted, all of these sources cluster about a faired line which to a first approximation would appear to be independent of source differences. The fact that the speaker system closely simulated the aircraft induced-response suggests that this reproduction technique could be used as a standard for determining house response characteristics for a given noise level or for comparing with subjective responses.

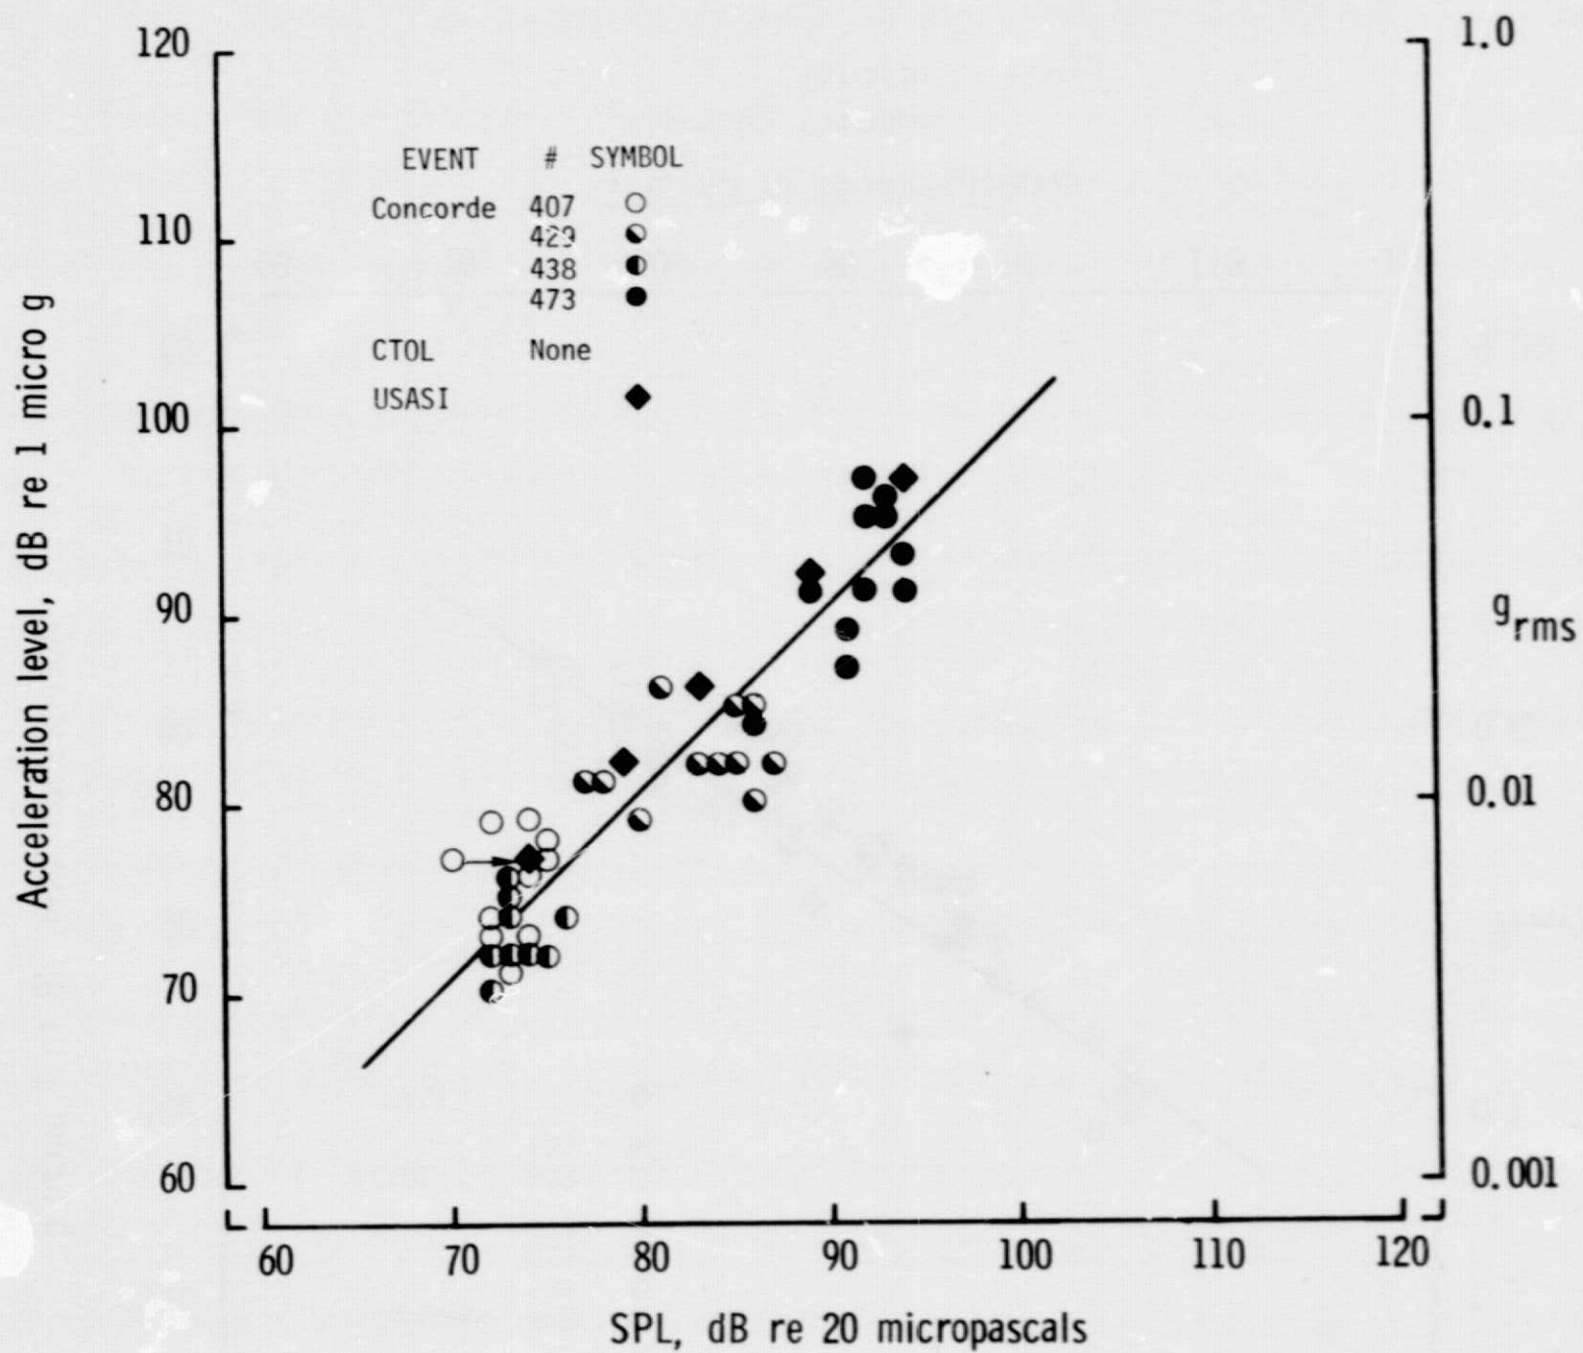
(b) Site 2 - Window

Figure 6.- Continued

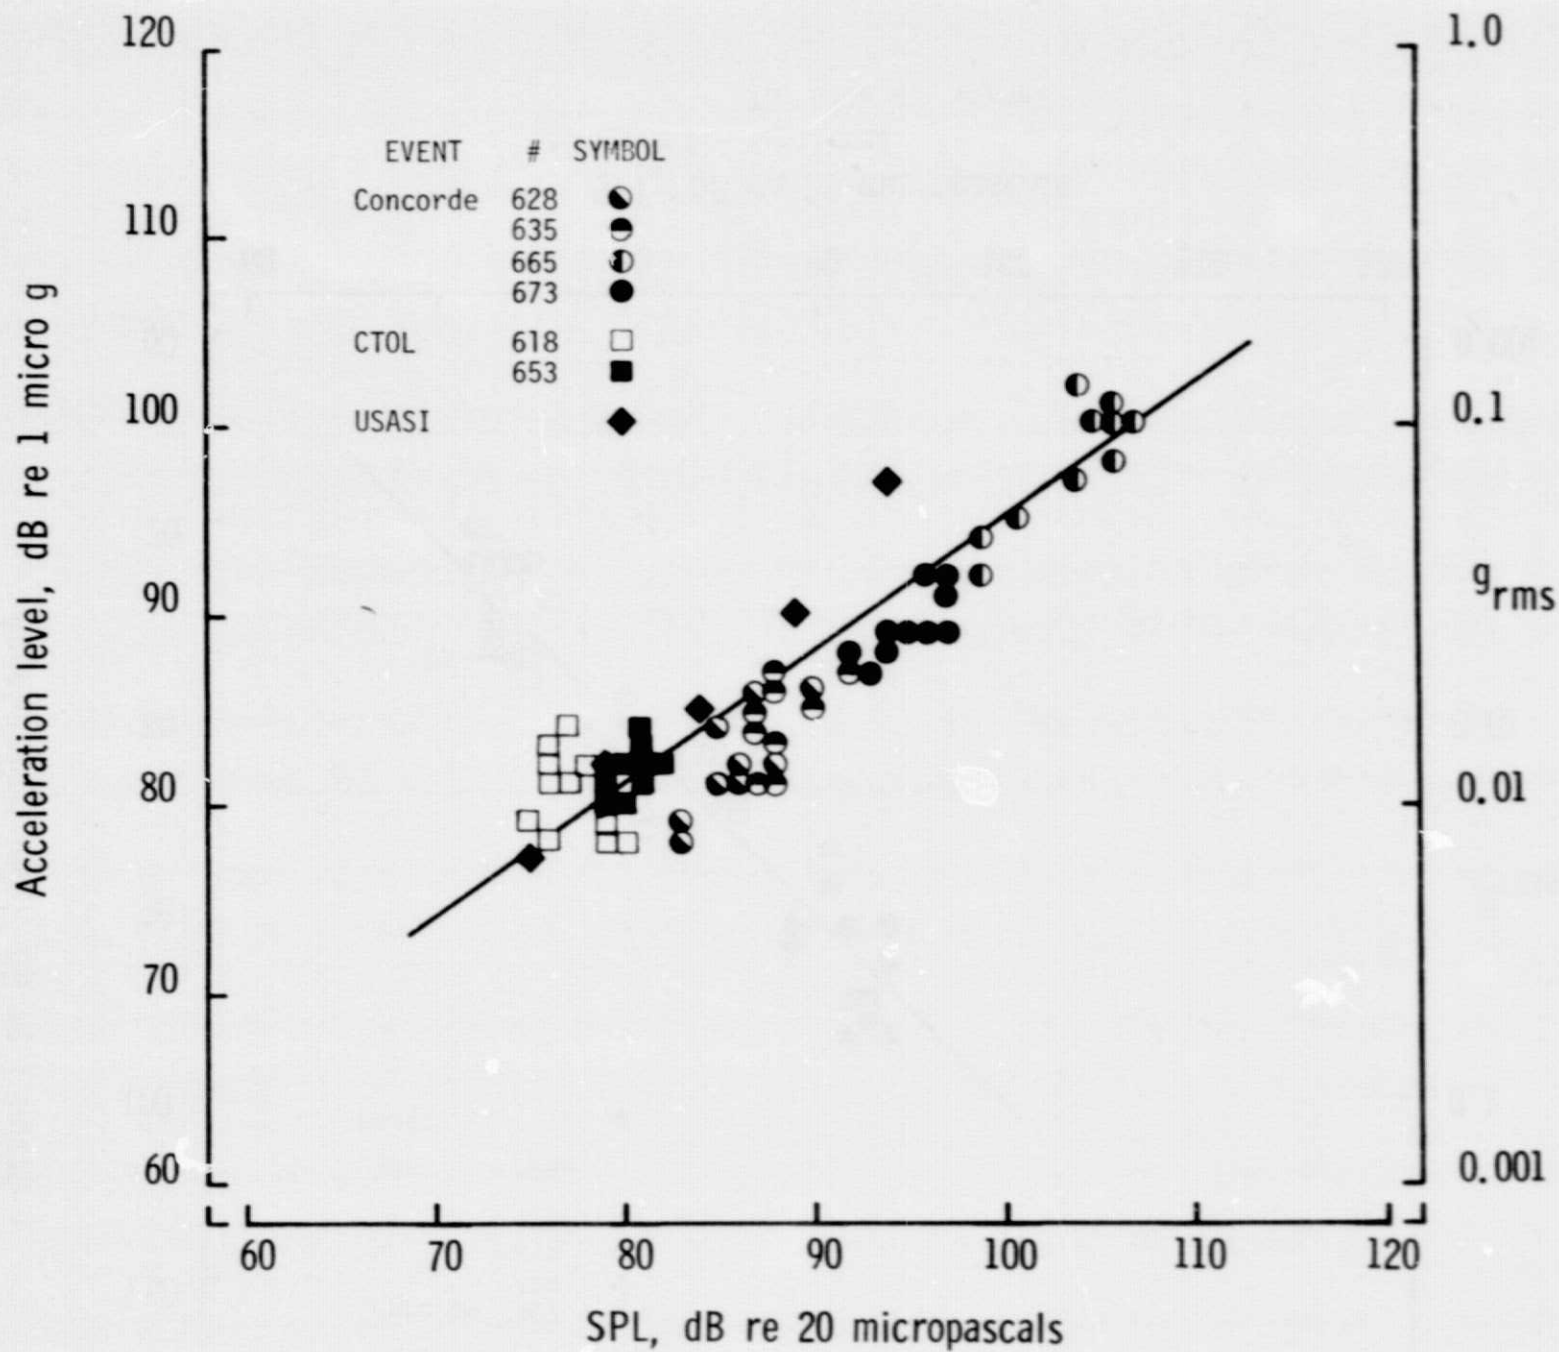
(c) Site 3 - Window

Figure 6.- Continued

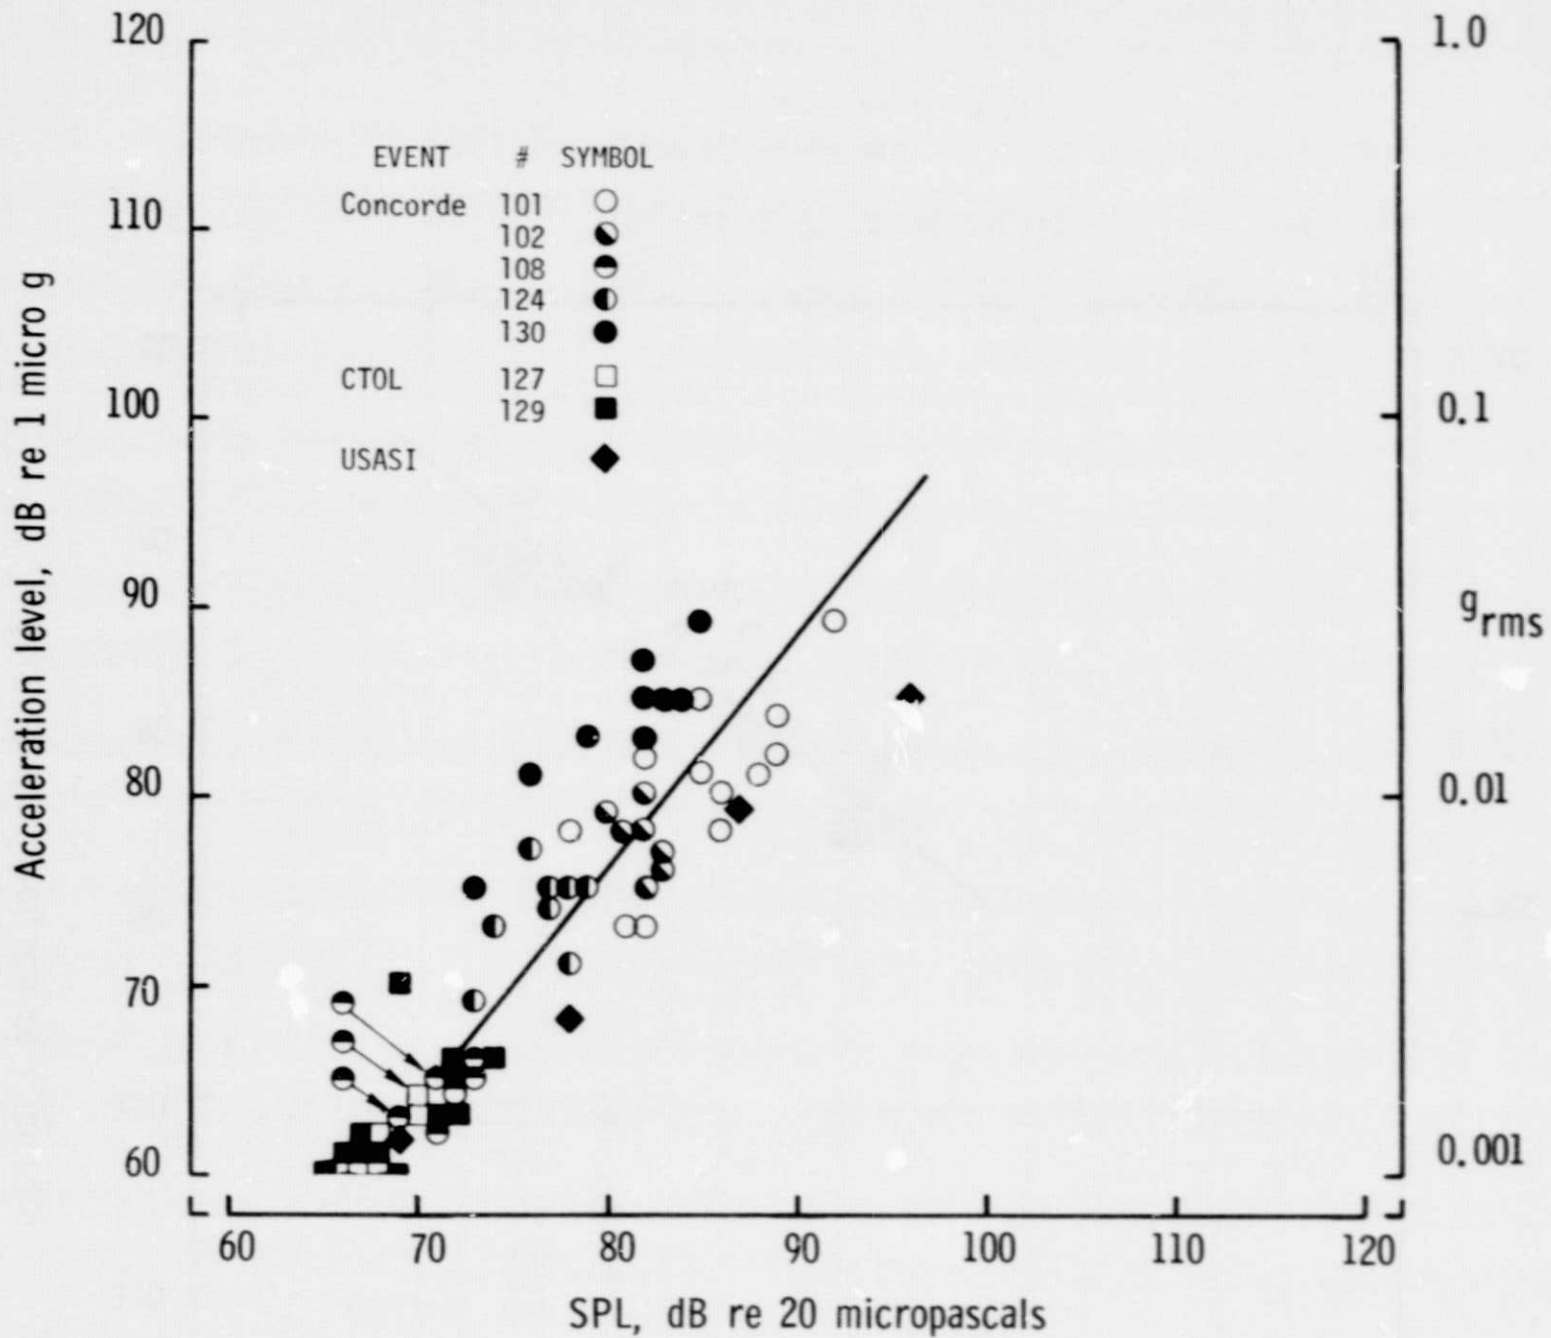
(d) Site 1 - Wall

Figure 6.- Continued
