**NASA TM X-73947**

CONCORDE NOISE-INDUCED BUILDING VIBRATIONS  
MONTGOMERY COUNTY, MARYLAND - REPORT NO. 3

Staff-Langley Research Center

August 1976

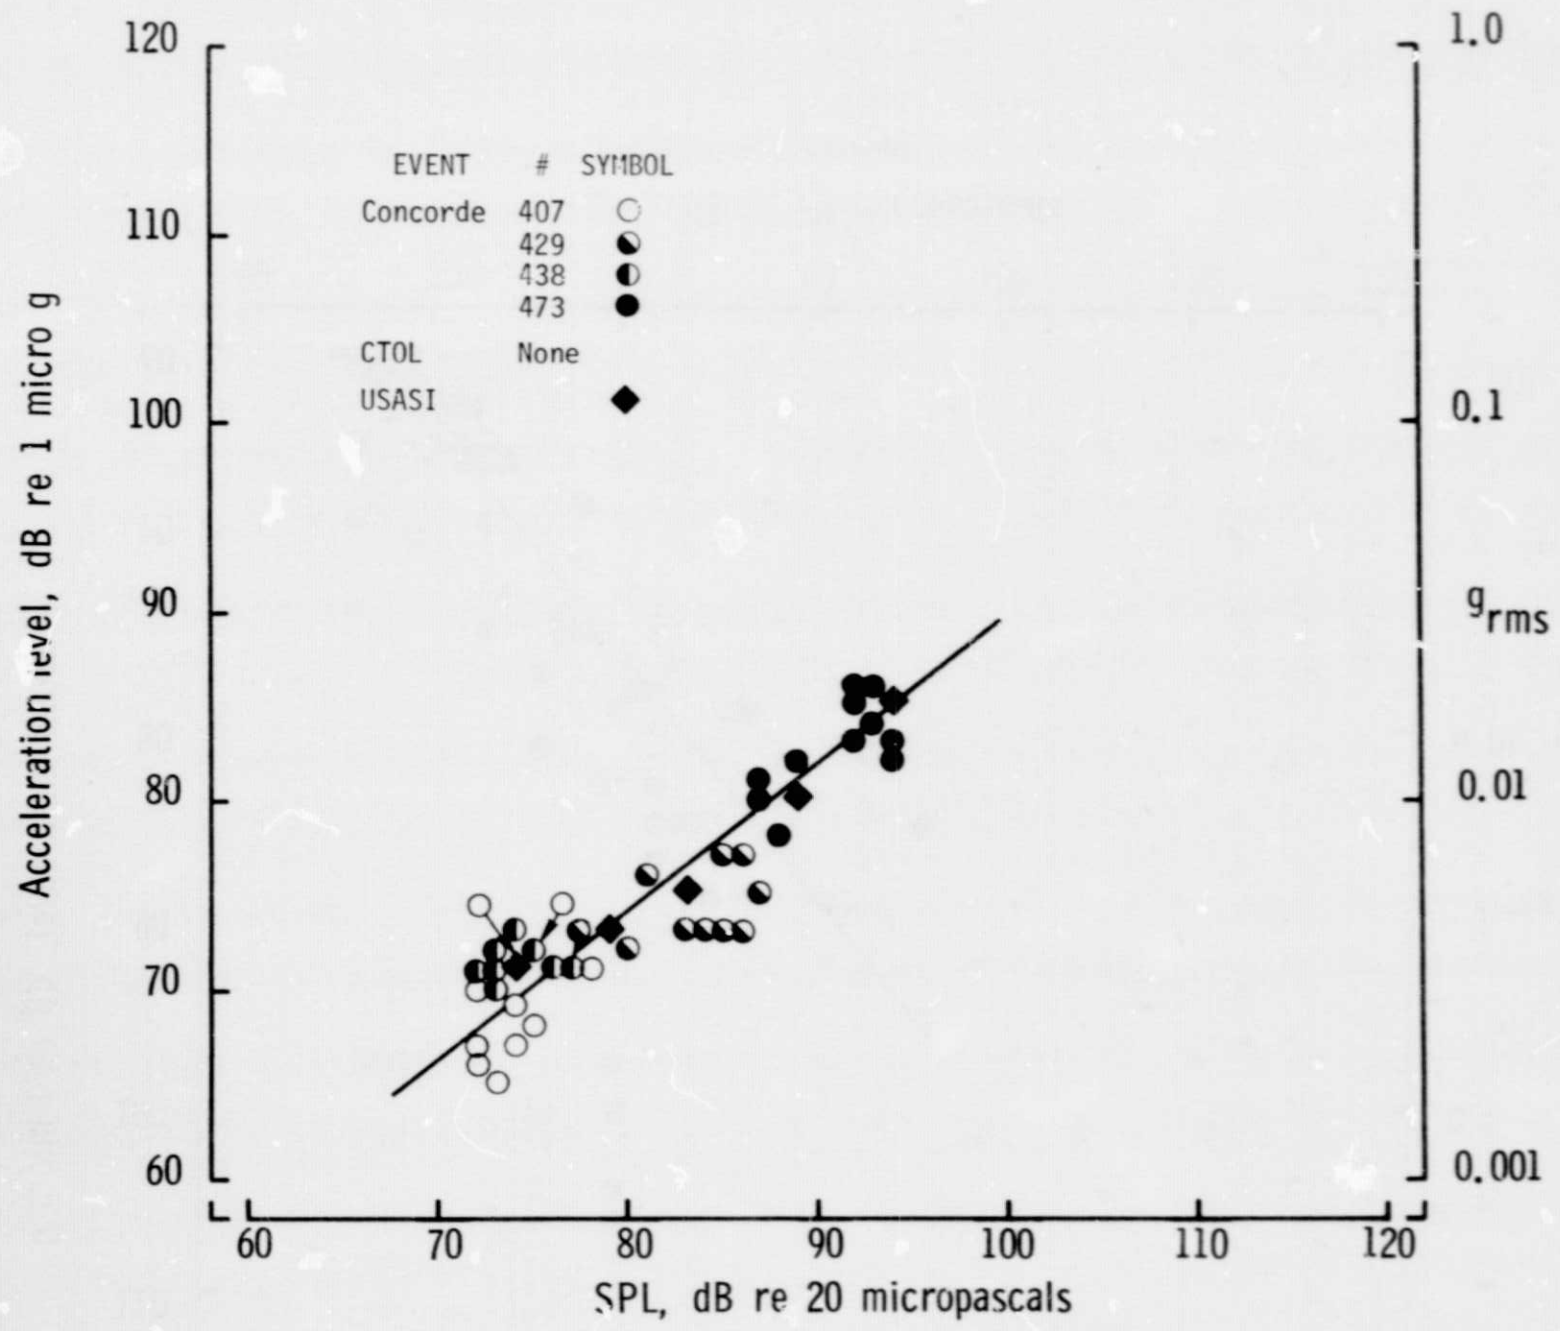
Figure 6.- Continued  
 (e) Site 2 - Wall

In order to quantitatively assess the relationships between aircraft noise levels and the corresponding levels of vibration induced in the windows and walls, response signatures (plots of window acceleration versus sound pressure level) were made for each flyover which exceeded the ambient. Data obtained at the three sites are presented in figures 6(a) through (f). In addition, the response to the USASI noise is presented. As noted, all of these sources cluster about a faired line which to a first approximation would appear to be independent of source differences. The fact that the speaker system closely simulated the aircraft induced-response suggests that this reproduction technique could be used as a standard for determining house response characteristics for a given noise level or for comparing with subjective responses.

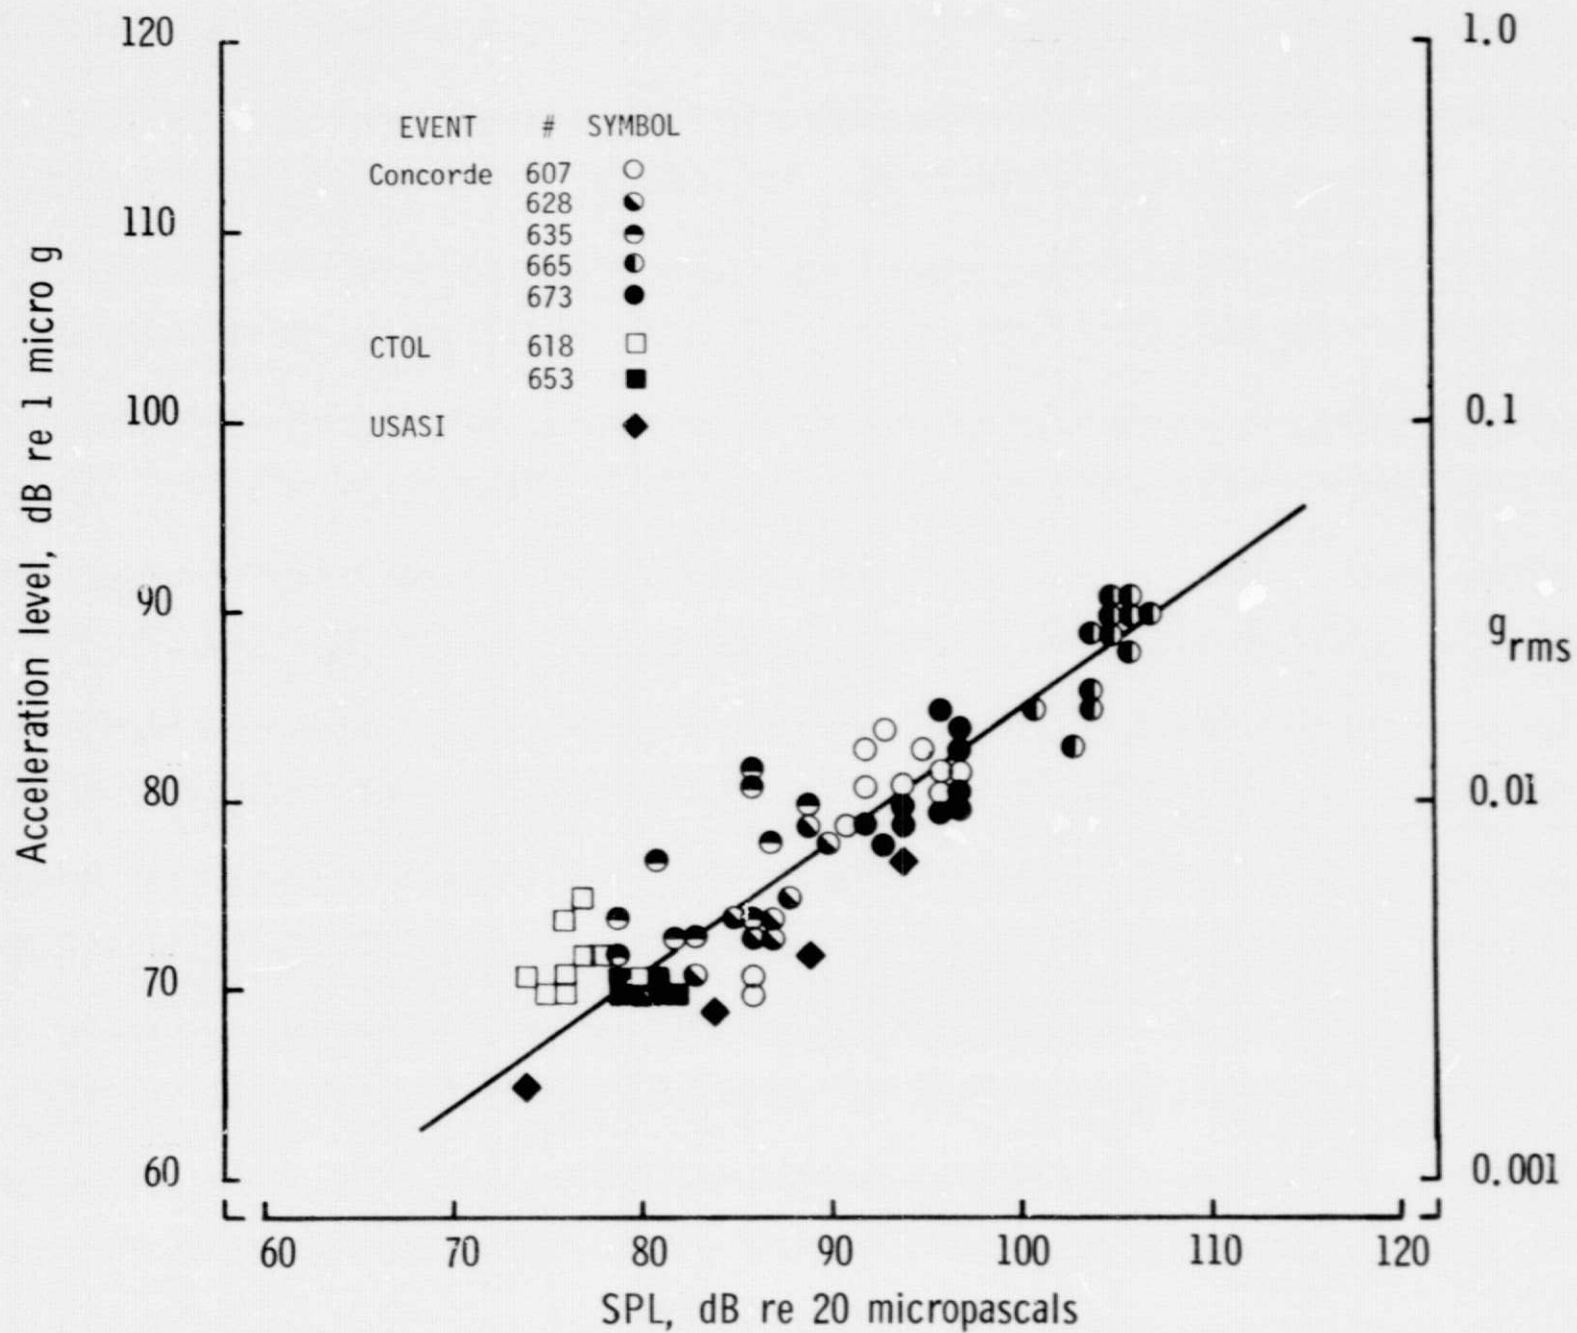
(f) Site 3 - Wall

Figure 6.- Continued
