**NASA TECHNICAL NOTE**

**NASA TN D-7859**

**APOLLO EXPERIENCE REPORT -  
GUIDANCE AND CONTROL SYSTEMS:  
COMMAND AND SERVICE MODULE  
ENTRY MONITOR SUBSYSTEM**

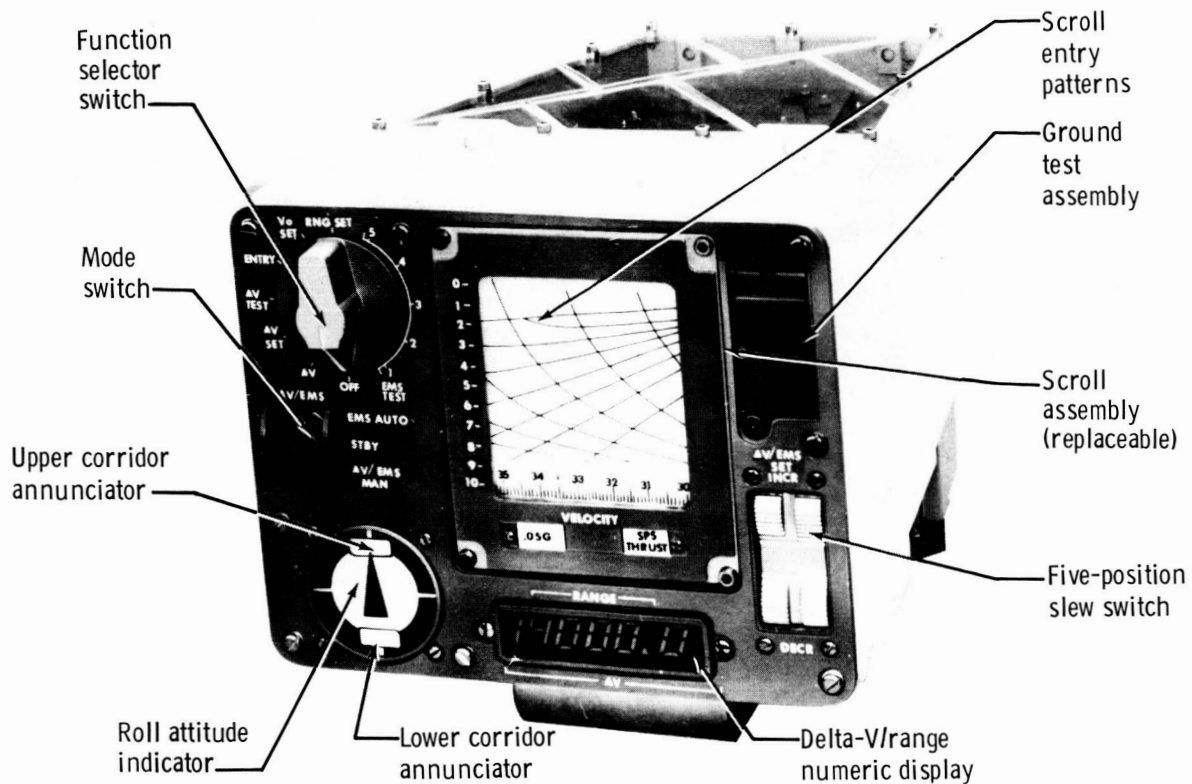
Figure 2. - Entry monitor subsystem.

Physically, the EMS (fig. 2) consists of two basic assemblies: the entry monitor control assembly (EMCA) and the entry monitor scroll assembly (EMSA). The EMCA contains the electronic components and is composed of integrated circuits; circuit boards; a range integrator; an accelerometer; a delta-V/range-to-go counter logic; a pulse scaler; power supplies, relays, and switches; and all associated wiring. The EMSA or G-V plotter assembly consists of a scroll of Mylar tape or film imprinted with rays called G-onset, G-offset, and range-potential lines. The stepper motors, servomotors, gear trains, and electronic components necessary to drive the scroll are enclosed within the EMSA.

The EMS display is composed of five functional components essential to entry trajectory monitoring and flight control. The five components are the RAI, the entry threshold indicator (0.05G), the corridor verification indicator, the delta-V/range-to-go counter, and the flight monitor or scroll.

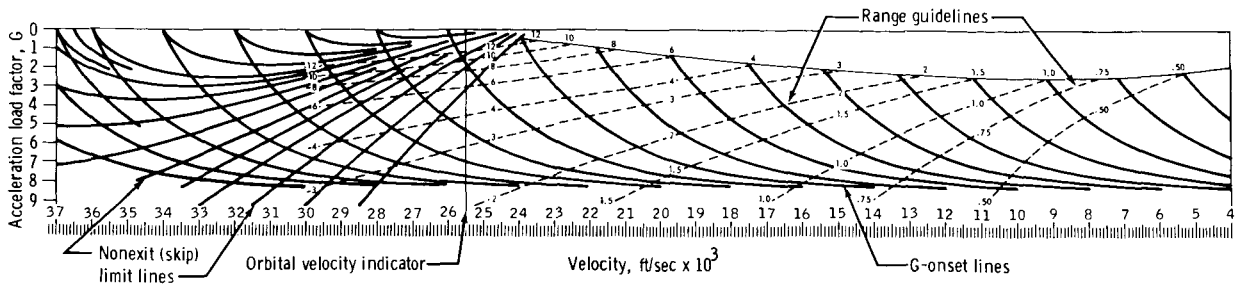
(a) Lunar 3500-nautical-mile range limit pattern.

Figure 3. - Entry monitor subsystem scroll patterns for lunar-return entries.

Flight-pattern limit-line generation and developmental criteria. - The procedures are outlined for the three types of flight limits incorporated into the EMS software. The flight limits and the associated procedures for their development may be generated to any criterion that can be defined as a function of velocity and acceleration variables. The procedures presented herein pertain only to criteria that have been specifically defined for the Apollo lunar missions. The EMS scroll patterns for Apollo lunar-return entries are shown in figures 3(a) and 3(b).

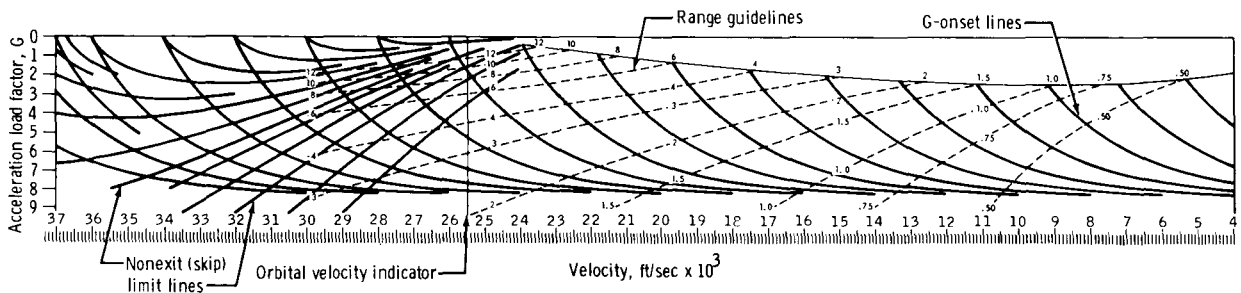
(b) Lunar nonexit range limit pattern.

Nonexit G-offset limits: The criterion for the nonexit G-offset limits is to maintain trajectory conditions that do not result in exiting from the atmosphere, as defined by a selected minimum G-level ( $G = 0.20$ ), or do not exceed a specified maximum range. The requirements for meeting this criterion are similar to those needed for the G-onset limits in that the limiting  $dG/dV$  ratio as a function of G and V must be
